# Leopold Road Character Assessment

LEOPOLD ROAD  
CONSERVATION AREA

Character Assessment

London Borough of Merton  
2005

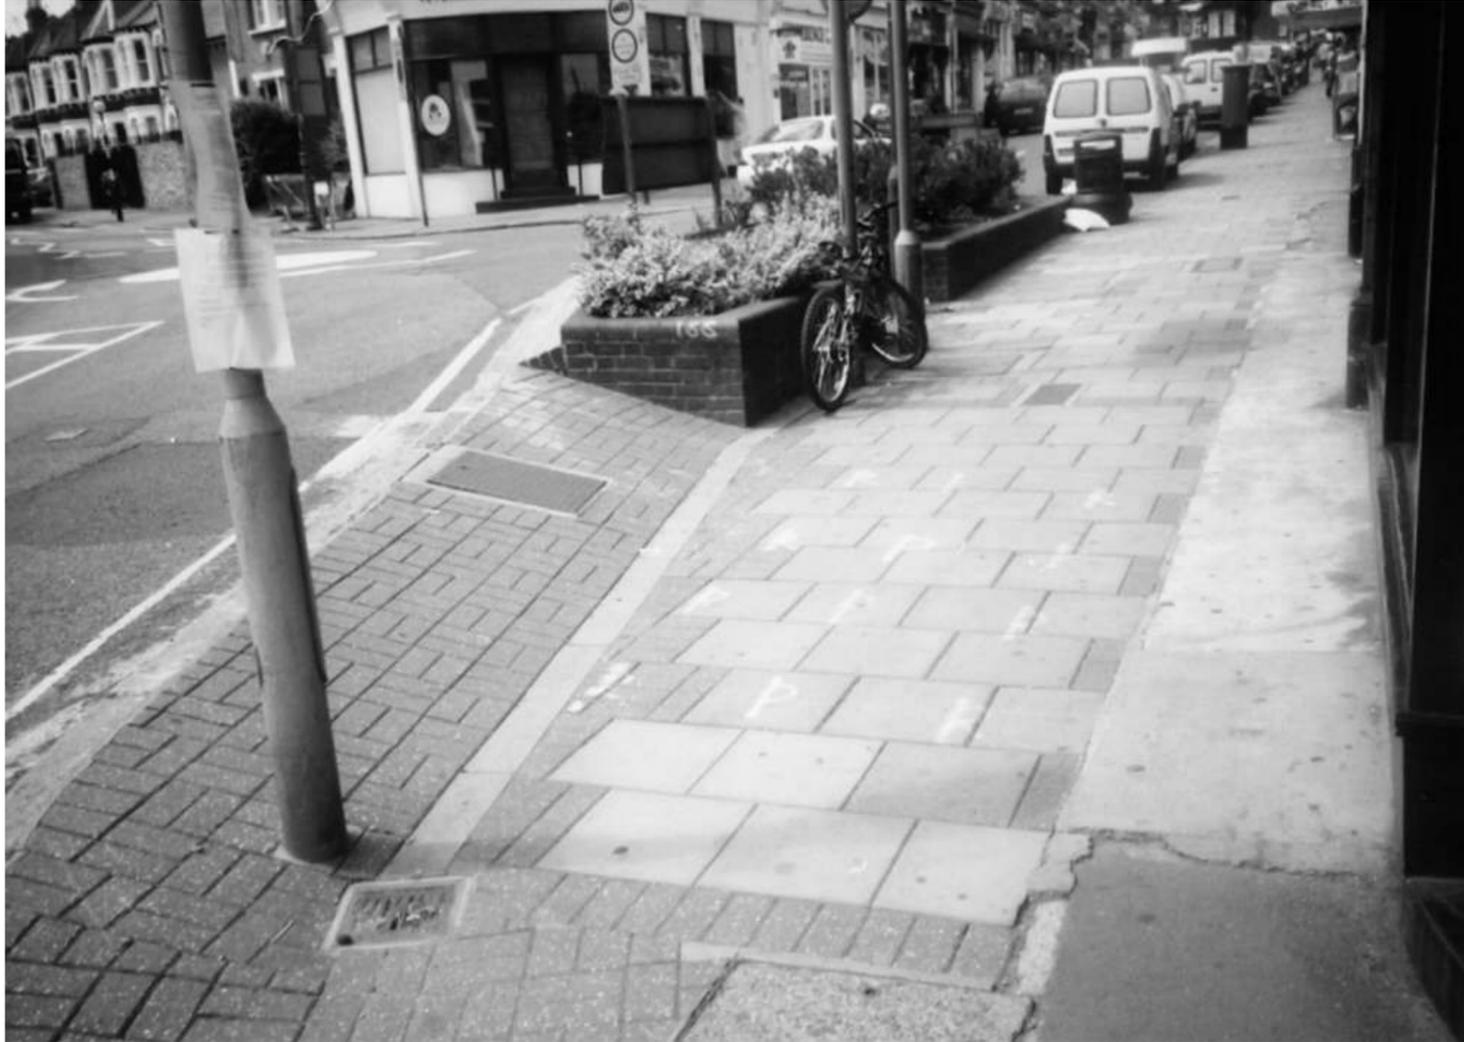
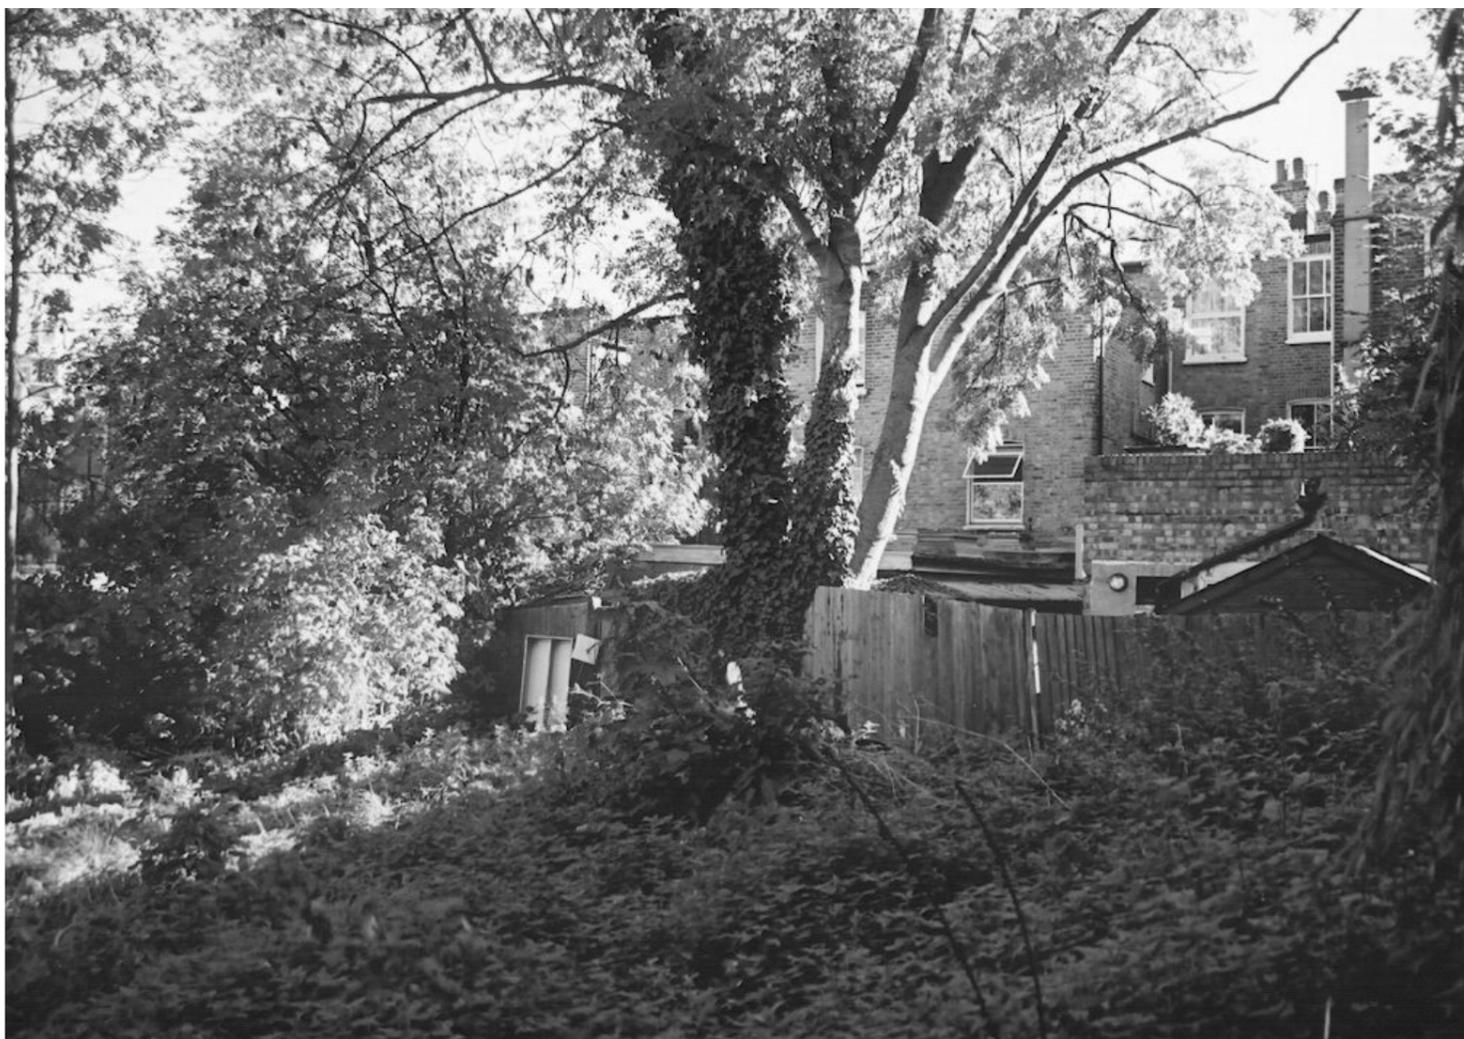
*Above: Leopold Road Conservation Area from the eastern end, showing the over-elaborate paving and landscaping. Below: The extensive areas of undergrowth and semi-mature trees to the rear of the buildings on the north side of Leopold Road.*

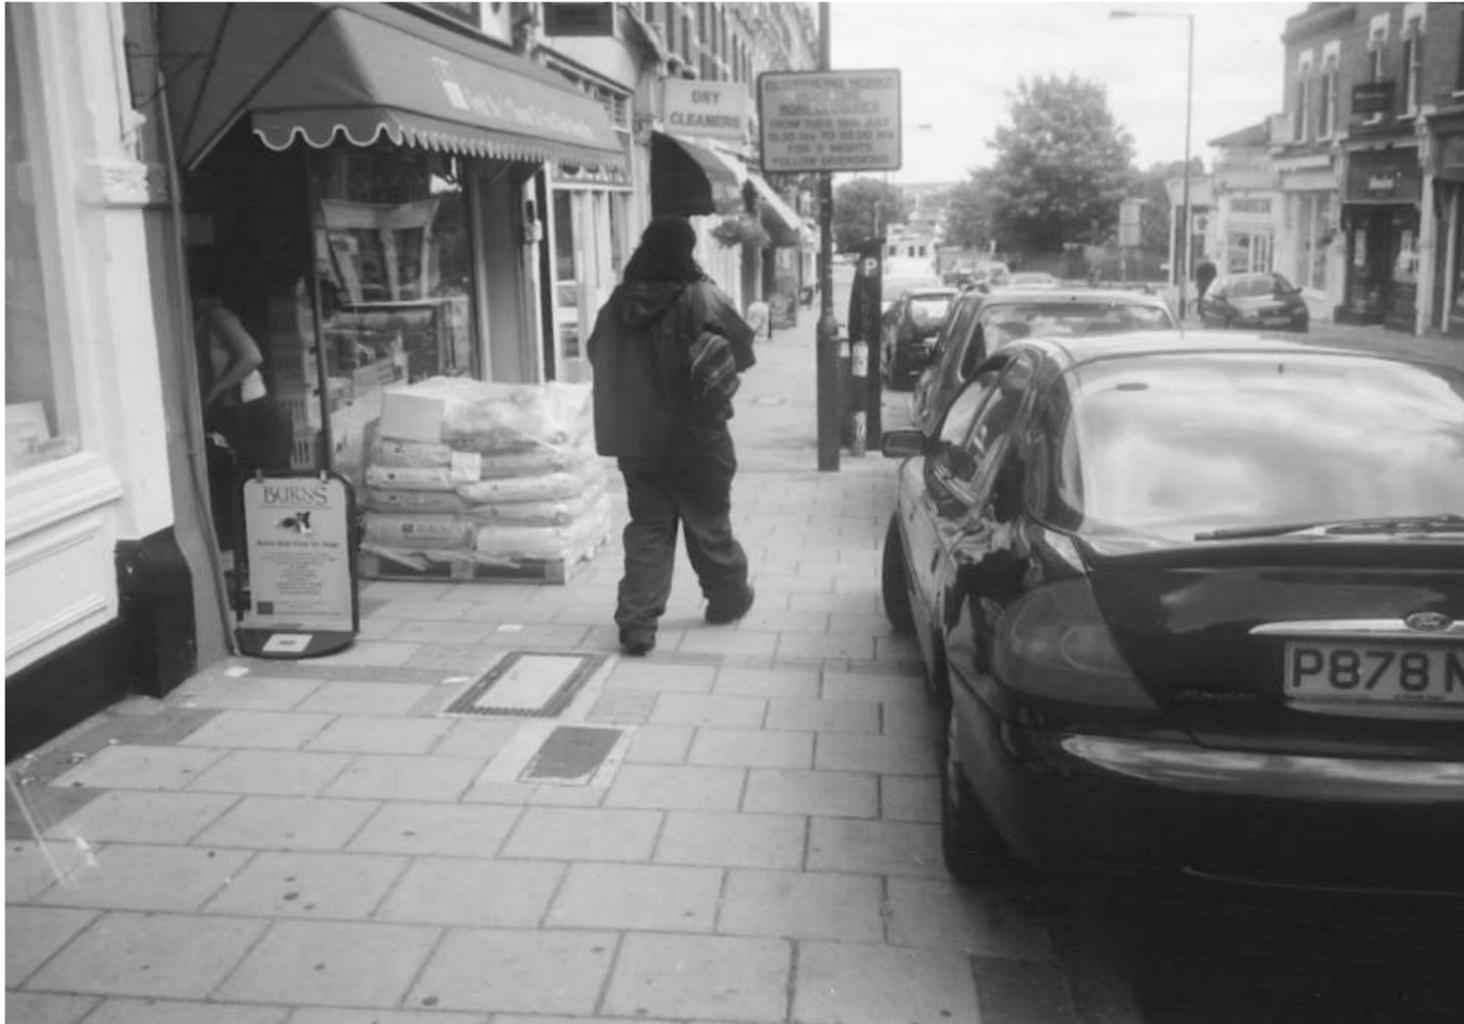
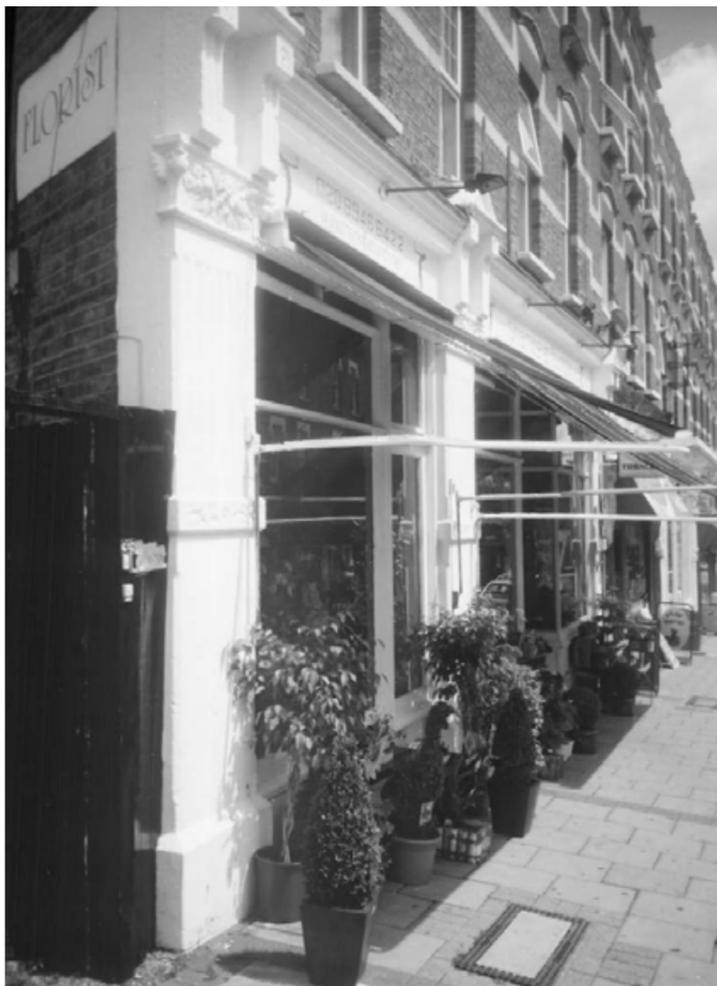
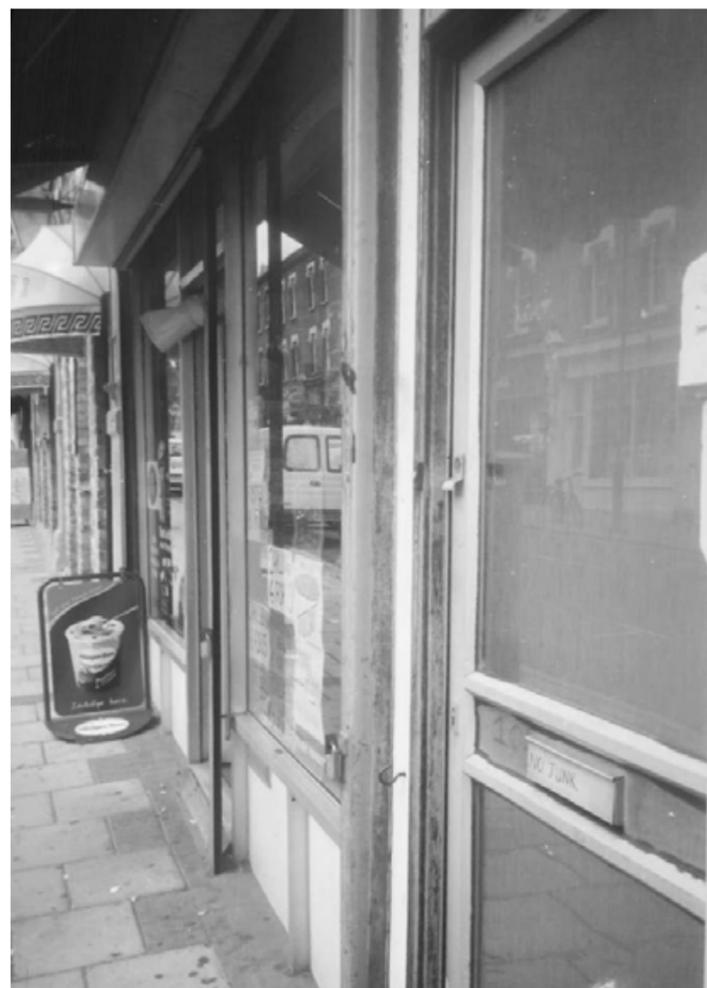
*Above: Typical streetscape showing the somewhat chaotic nature of the street furniture, car parking and shop deliveries. Below: Examples of an elegant period shop front (No.32) which retains most of the original features, and a modern utilitarian one (No. 10) in aluminium.*

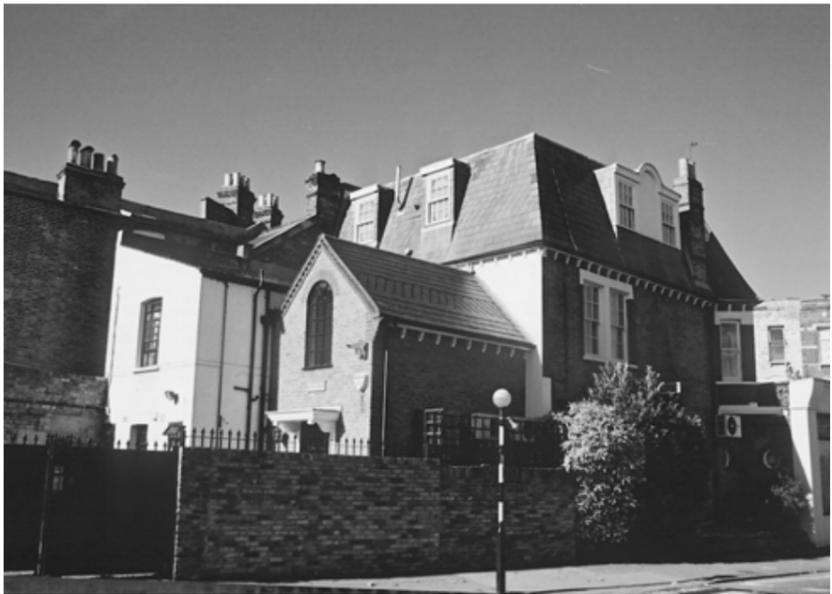
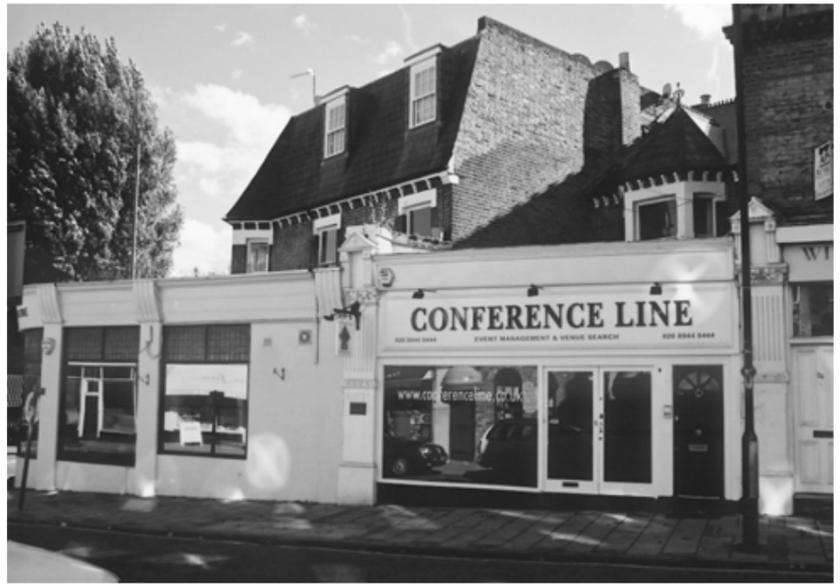
*Nos. 1 and 3 Leopold Road from the east and north.*

**Nos. 1 and 3:** No.1 is a two storey house dating from 1892 which has been considerably extended: a third storey with sash windows was added behind a mansard roof in 1986; a small two storey ornamental gable-ended extension has been placed at the rear; and a single storey flat roofed shop has been added to the front and side. Except for a square oriel first floor window and brackets to the eaves, No. 1 has lost most of its original features. The shop, which has been used as a veterinary health centre since 1976, wraps around the corner and takes up all of the original front and part of the side garden. The façade is painted crème with large picture windows in dark blue and small leaded lights of frosted glass above door height. The façade and ornamental pilasters have been simplified, and an incongruous 'traditional' panelled and stained door inserted centrally. **Contribution to the CA:** neutral.

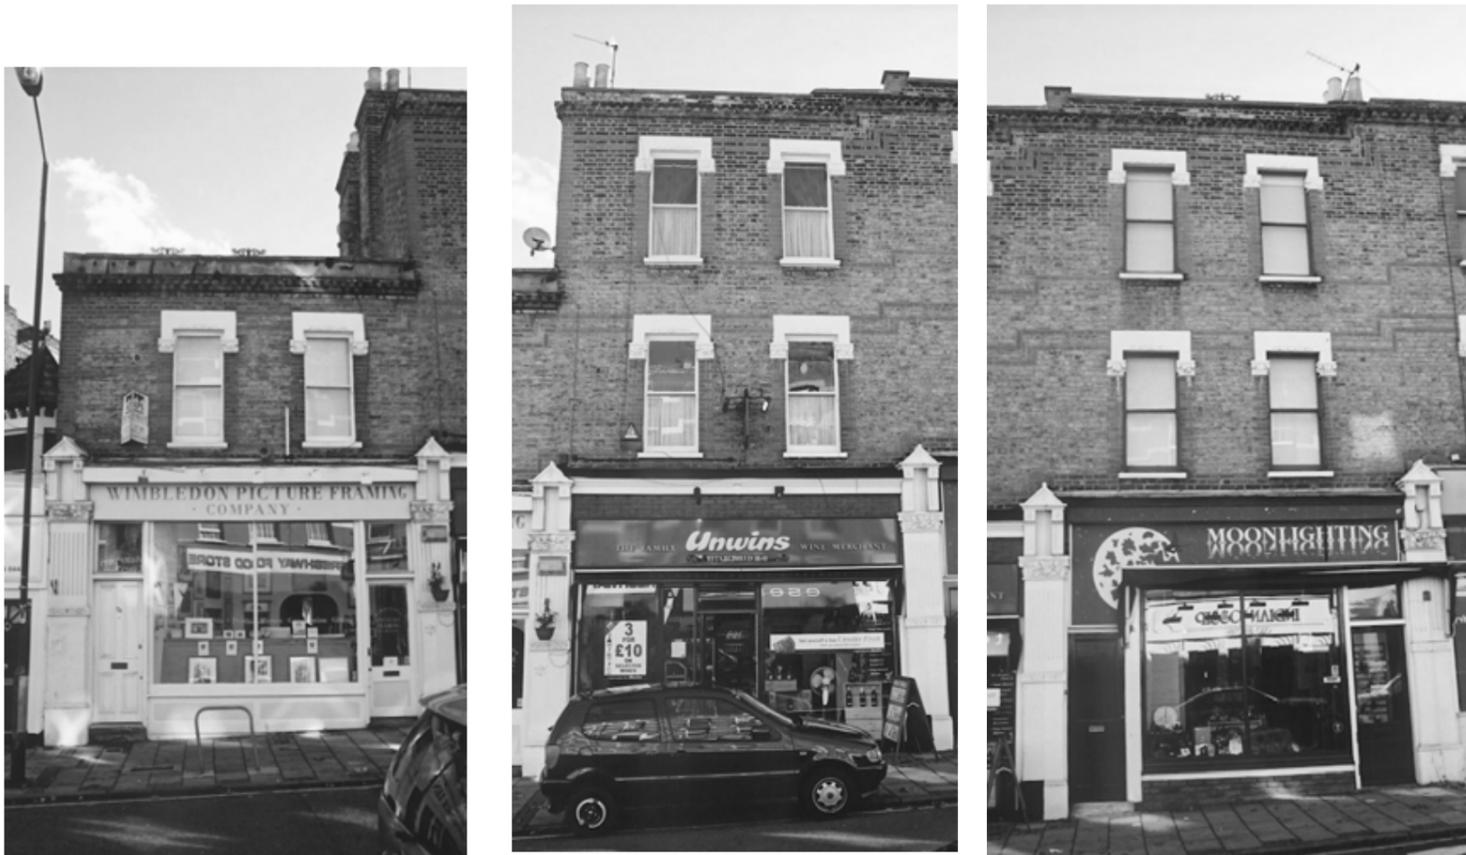
**NOS. 7, 9 AND 11 LEOPOLD ROAD.** Below: historic features which have been retained:

**No.9:** A wine merchants with a modern elegant shop front installed in 1984. **Shop front:** The narrow dark green coloured frames to the glazing give it an elegant appearance. Central shop door. **Fascia:** Dark green glazed fascia with lettering in gold; a mixture of classic upright capitals, and the shop name in modern script which tends to undermine the attempt at elegance. The fascia fails to meet the cornice, and the space has been filled with brickwork which may be intended to match the surrounds to the windows above, but fails to blend with them. **Side access:** Presumably internal. **Level of maintenance:** The shopfront appears to have been recently installed. **Apparent level of prosperity:** High. **Contribution to the CA:** Neutral.

**No.11:** A shop selling antiques and ornaments whose shop front attempts to be 'different'. **Shop front:** Eccentrically designed modern front which projects slightly, excluding the door giving access to the upper floors. The outer frames are in white with dark blue inner frames and doors. Shop door at side. The blind to the shop front extends across the pilaster to No. 13, and the appearance is marred by a brick stall riser. **Fascia:** The blue fascia has been brought down on one side to the level of the head of the upper floor access door. The lettering is of white classic upright serif capitals. **Side access:** The modern dark blue side access door is in its original position. **Upper floors:** The frames to the upper floor windows are painted blue to match the shop front. **Level of maintenance:** fair. **Apparent level of prosperity:** Moderate. **Contribution to the CA:** Neutral.

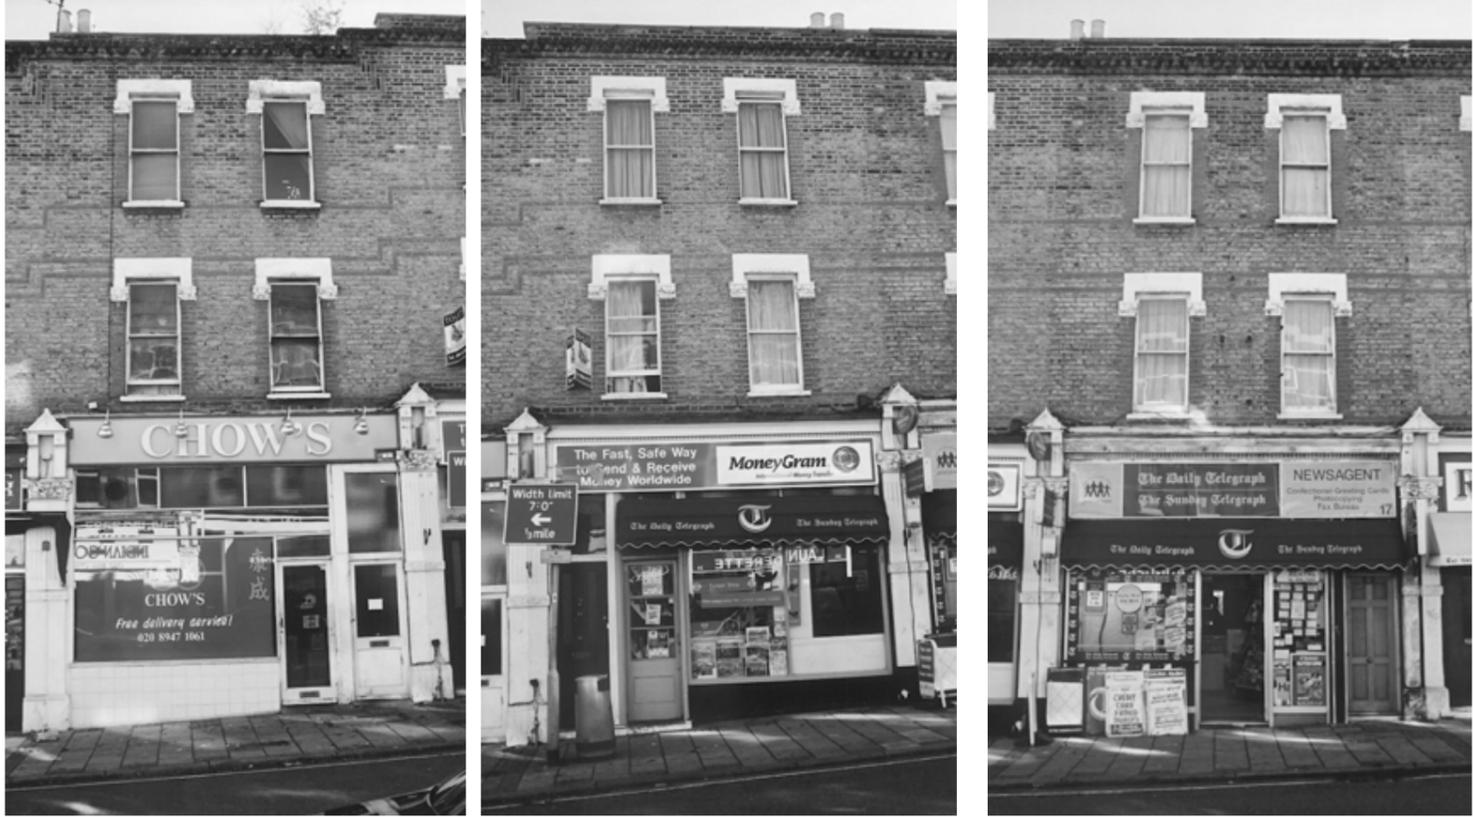
**Nos. 13, 15 and 17 Leopold Road.** Below: Historic features which have been retained.

**Nos. 15 and 17:** A newsagents whose modern shop fronts tend to be used as advertisement hoardings and would be better blanked out. **Shop Front: No. 15:** The shop front, which was installed in 1997, follows the design of the original, although the frames and door painted grey-green, with a black painted stall riser and a dark blue 'Dutch' blind containing advertising over the shop but not the side access door. No attempt is made to provide a window display, the left of the two glazed panels being covered with advertising and photos, and the right one is partly obscured by a white internal panel. **No. 17:** Metal frames and a centrally placed shop access door. Both windows are covered in adverts. A dark blue 'Dutch' blind below the fascia is used for advertising. The stall riser is in grey render. **Fascia: No. 15:** Red and white, and devoted to advertising. **No. 17:** Used as an advertisement hoarding in blue and yellow. **Side access:** The modern access doors in their original positions. **Level of maintenance:** Fair. **Apparent level of prosperity:** Poor. **Contribution to the CA:** Negative.

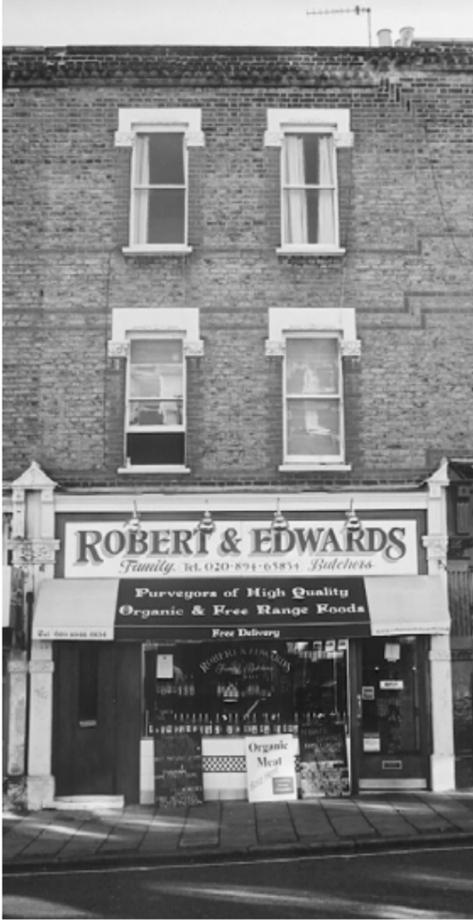
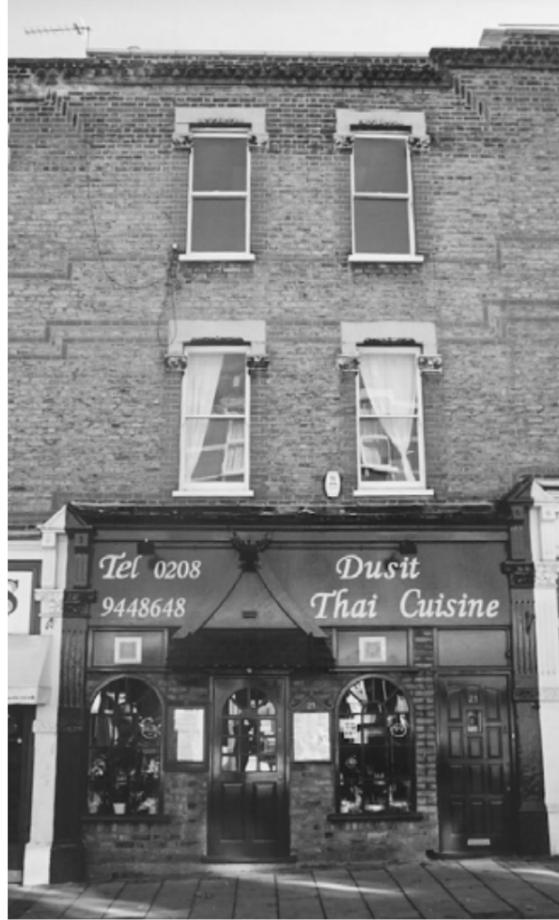
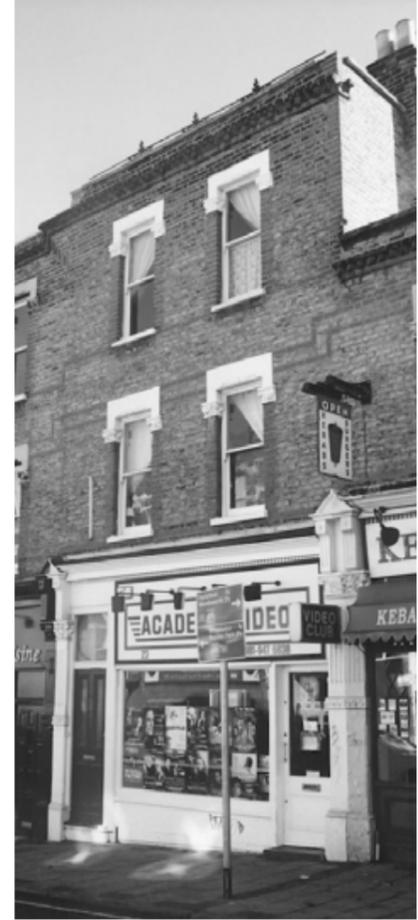
**NOS. 19, 21 AND 23.** Below: Historic features which have been retained.

**No. 19,** A butchers which makes a bold attempt to create the effect of a family grocer's. **Shop front:** A recent traditionally designed front in dark stained timber with a modern glazed side shop door, a stall riser in blue and white glazed tiles, and a 'Dutch' blind in light grey and dark blue, with white lettering advertising the shop. (Although the shop is advertised as a family butchers, the window is full of bottles of wine, etc, presumably for health reasons.) **Fascia:** A white panel on a dark background, with 19<sup>th</sup> C. lettering. **Side access:** Traditionally designed access door in its original position. **Level of maintenance:** High. **Apparent level of prosperity:** High. **Contribution to the CA:** Positive.

**No. 21,** A Thai restaurant which attempts to create an 'oriental' shop front. **Shop front:** Installed in 1980 when it was changed to a restaurant. A basically solid front of stock bricks (matching those above) with a dark-stained central standard mass-produced doorway topped with a pseudo-Thai canopy, and dark-stained semi-circular arched windows each side. Dark stained panels above the windows accommodate air conditioning extractor grills. The dark stain extends across the halves of the pilasters within the curtilage of No. 21, **Fascia:** The dark stained canopy continues the oriental theme, with gold script lettering and flood lights along the top. **Side access:** The dark stained multi-panelled door is in its original position. **Level of maintenance:** High. **Apparent level of prosperity:** High. **Contribution to the CA:** Neutral.

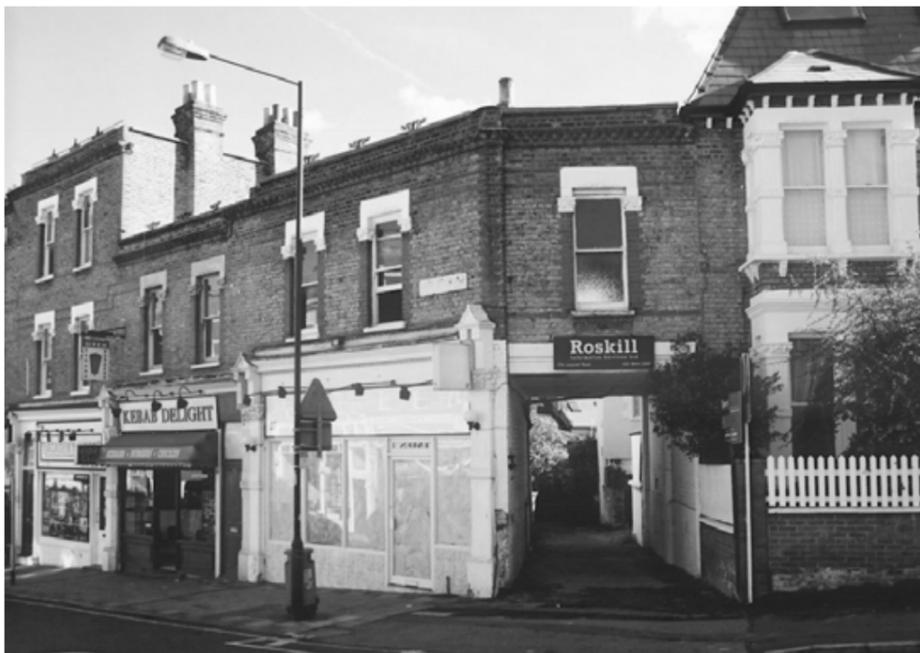
**No. 27,** empty at time of inspection. **General impression:** A newly installed modern utilitarian shop front with an off-centre entrance door, painted white throughout, with a stallriser of off-white glazed tiles. **Contribution to CA:** Neutral. **Passageway:** Narrow single storey passageway to small rear yard. **Upper floor:** The first floor fenestration continues that of the adjoining shops.

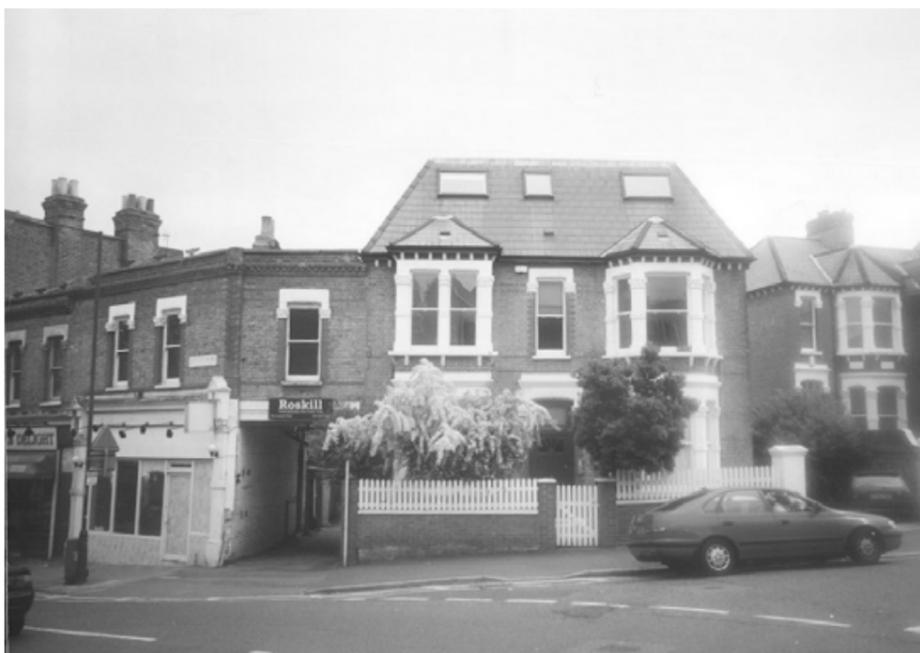
**No. 1 Woodside:** A double-fronted two-storey house with canted bays to one side and squared bays to the other, In yellow brick with red brick string courses and rusticated quoins which repeat the details of the adjoining shops, as do the ornamental capitals to the sash windows. Centrally placed doorway with a window above. The slate roof has been increased in pitch to accommodation which are lit by large sloping rooflights. The small front garden is filled with mature shrubs and is bordered with a white picket fence above a brick wall, and the central white picket front gate is supported on red brick piers. **Contribution to CA:** Positive.

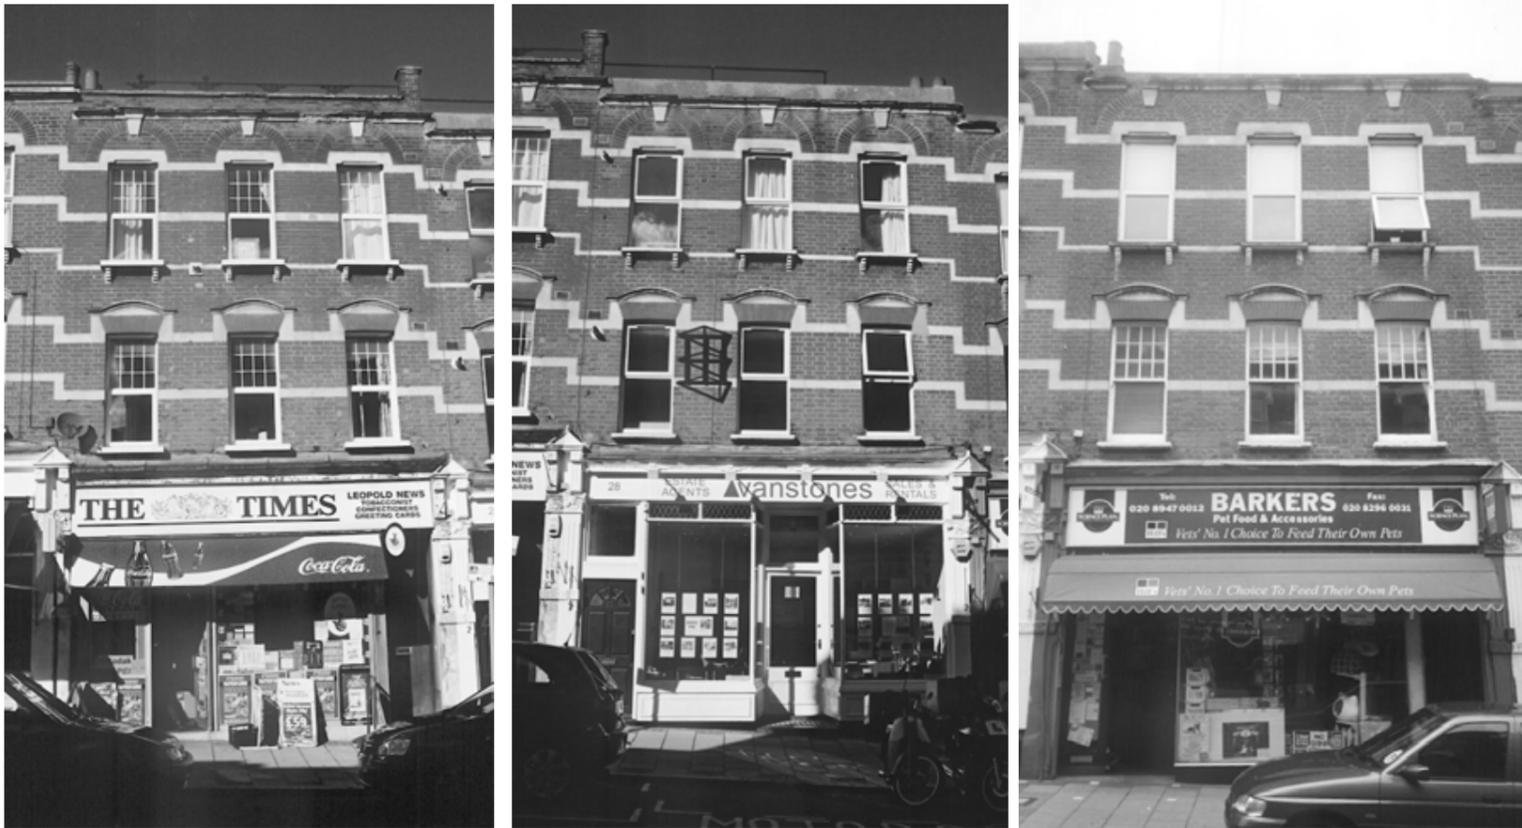
**NOS. 30, 28 AND 26 LEOPOLD ROAD.** Below: Historic features which have been retained.

**No. 30,** A newsagent/tobacconist whose front is used as an advertising hoarding. **Shop front:** modern utilitarian front installed in 1974 with a central shop door. No attempt has been made to provide a window display, the window being full of small adverts and notices. The stall riser and traditional red and white blind are also used as advertising space, as is the white **fascia**. **Side Access:** Retained with dark stained side access door. **Upper floors:** Lower lights to sash windows replaced with top hung casements. **Level of maintenance:** poor. **Apparent level of prosperity:** Low. **Contribution to the CA:** Negative.

**No.28,** An estate agent with a straightforward utilitarian shop front. **Shop front:** Modern, fairly smart front with white frame, stall risers and central shop doorway. Property adverts neatly displayed. **Fascia:** Neat, white, with shop sign in elegant modern lower case sans serif. **Side access:** Retained, with standard modern 'half-moon' black painted door. **Upper floors:** Upper lights to sash windows replaced with top hung casements. **Level of maintenance:** High. **Apparent Level of prosperity:** High. **Contribution to CA:** Positive.

**No. 26:** A shop selling pet food and accessories whose front is used as an advertising hoarding. **Shop front:** Modern, metal frame, picture window with low stall riser. **Fascia:** Dominant, white lettering on red ground. **Side access:** retained. **Blind:** Dominant red Dutch blind used as hoarding. **Upper levels:** The first floor windows are original but the upper lights to 2<sup>nd</sup> floor sash windows have been replaced by top hung casements, 12-light on first floor. **Level of maintenance:** fair. **Apparent level of prosperity;** fair. **Contribution to CA:** Neutral.

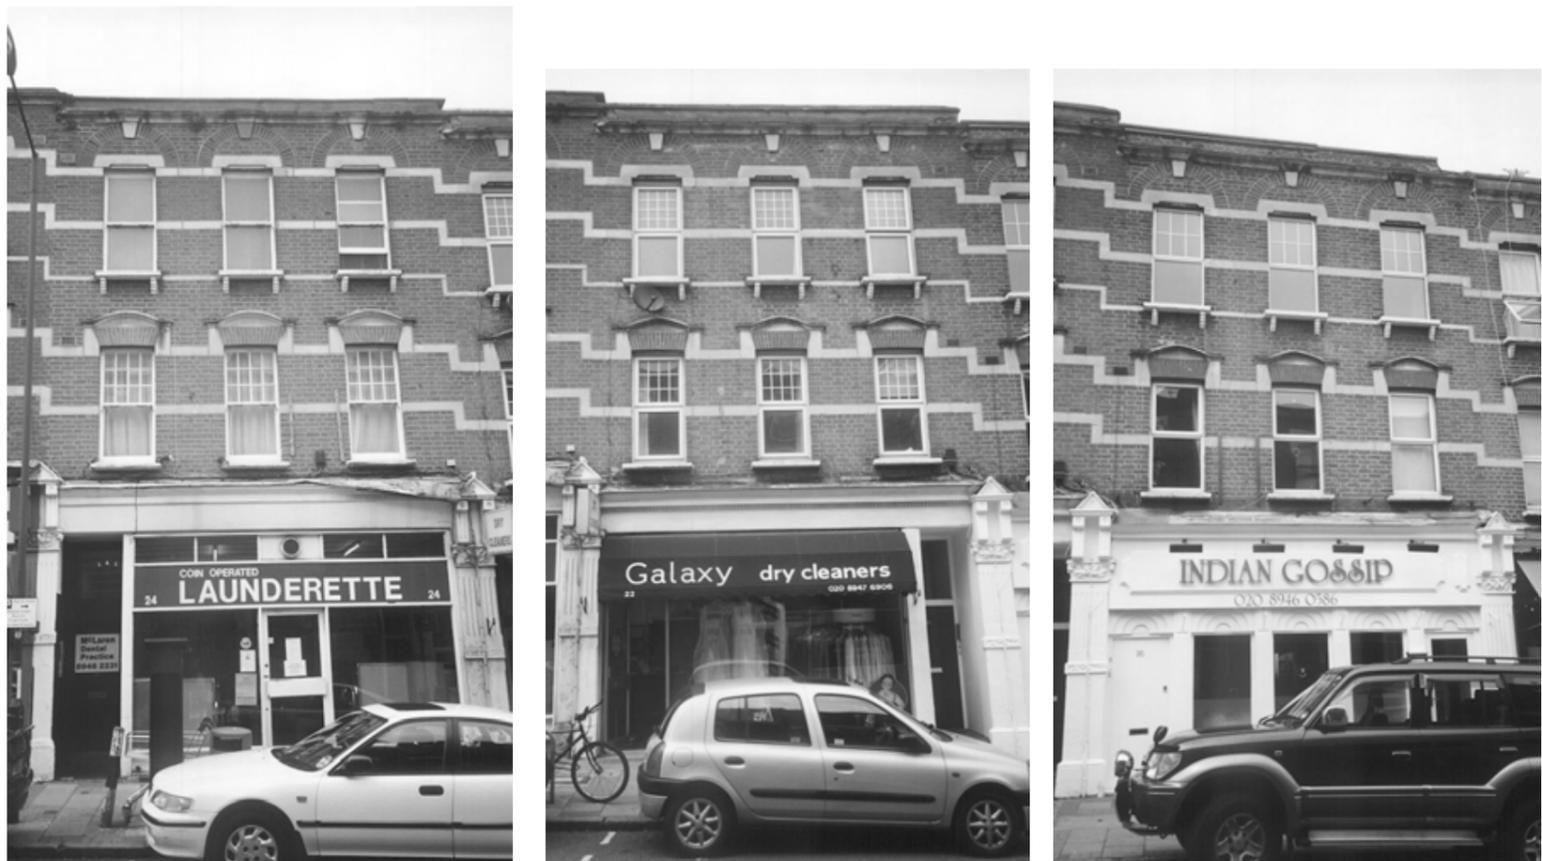
**NOS. 24, 22 AND 20 LEOPOLD ROAD.** Below: Historic features which have been retained.

**No.22:** A **dry cleaners** with a smart, modern utilitarian front. **Shop front:** large picture window revealing clothes hanging on racks. In contrast to the washing machines next door, their exposure is not detrimental to the street scene. **Blind:** Smart dark blue Dutch blind with white lettering immediately below original fascia. **Side access:** retained. **Upper floors:** Original windows replaced with modern plastic replicas. **Level of maintenance:** high. **Apparent level of prosperity:** high. **Contribution to CA:** positive.

**No. 20:** Used as an Indian restaurant since 1972, with an attractive modern front installed in 1990 which attempts at period character in the detailing; painted white throughout. **Shop front:** A 5-bay design, with the restaurant entrance at one end, the side entrance at the other and three windows in the centre. Ornamental 'lintels' over the doors and windows. **Fascia:** deepened to accommodate elegant raised lettering on raised panel, spot lit. **Blind:** retained. **Side access:** retained and arranged to form part of composition. **Upper floors:** Original windows replaced with modern plastic replicas. 6-light to upper half of 2<sup>nd</sup>. floor. **Level of maintenance:** high. **Apparent level of prosperity:** high. **Contribution to CA:** positive.

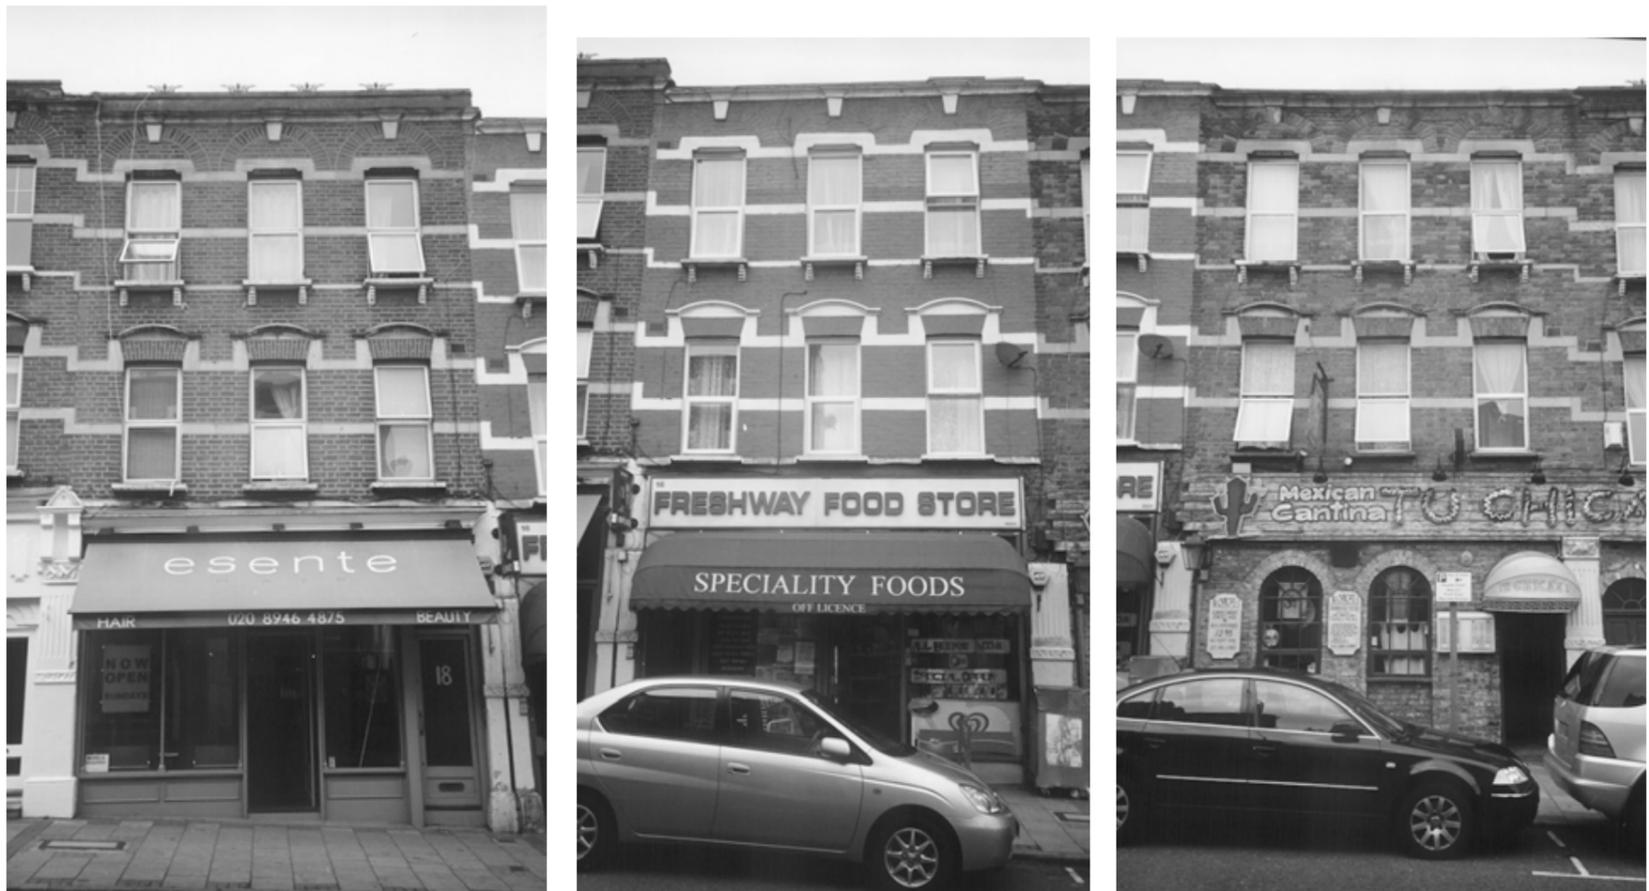
**NOS. 18, 16 AND 14 LEOPOLD ROAD.** Below: Historic features which have been retained.

**No. 18:** A hair and beauty salon extended at the rear in 1988, with an elegantly designed, modern front, painted throughout in discrete café latté. **Shop front:** Four-light front with asymmetrically placed entrance; windows separated with thin ornamental mullions; panelled stall riser. **Fascia:** hidden by blind. **Blind:** retained; coloured to match shop front, with elegant white lettering. **Side entrance:** retained, designed and coloured to match the shop front. **Upper floors:** Original windows replaced by modern top hung replicas. **Level of maintenance:** high. **Apparent level of prosperity:** high. **Contribution to CA:** positive.

**No. 14:** (with No. 12): Used as a licensed Mexican cantina and coffee bar since 1982 which apparently attempts to create a Mexican 'Wide West' impression, which is a totally unsuitable treatment to a sensitively designed period property. **Shop front:** replaced with two round-arched windows and a doorway in bright blue frames surrounded by multi-coloured yellow brickwork. Menus and other notices in panels between the windows. Pilasters painted yellow and corbels removed. **Fascia:** replaced with rough-hewn horizontal boarding soiled to look weather-beaten. Lettering which may be intended to look as though it is made out of cacti; with a sketch of a cactus at one end. **Blind:** removed. Bright yellow 'Dutch' blind over doorway. **Side entrance:** removed. **Upper floors:** Original windows replaced by modern top-hung casements. A hanging sign has been installed at first floor level. **Level of maintenance:** moderate. **Apparent level of prosperity:** moderate. **Contribution to CA:** Seriously detrimental.

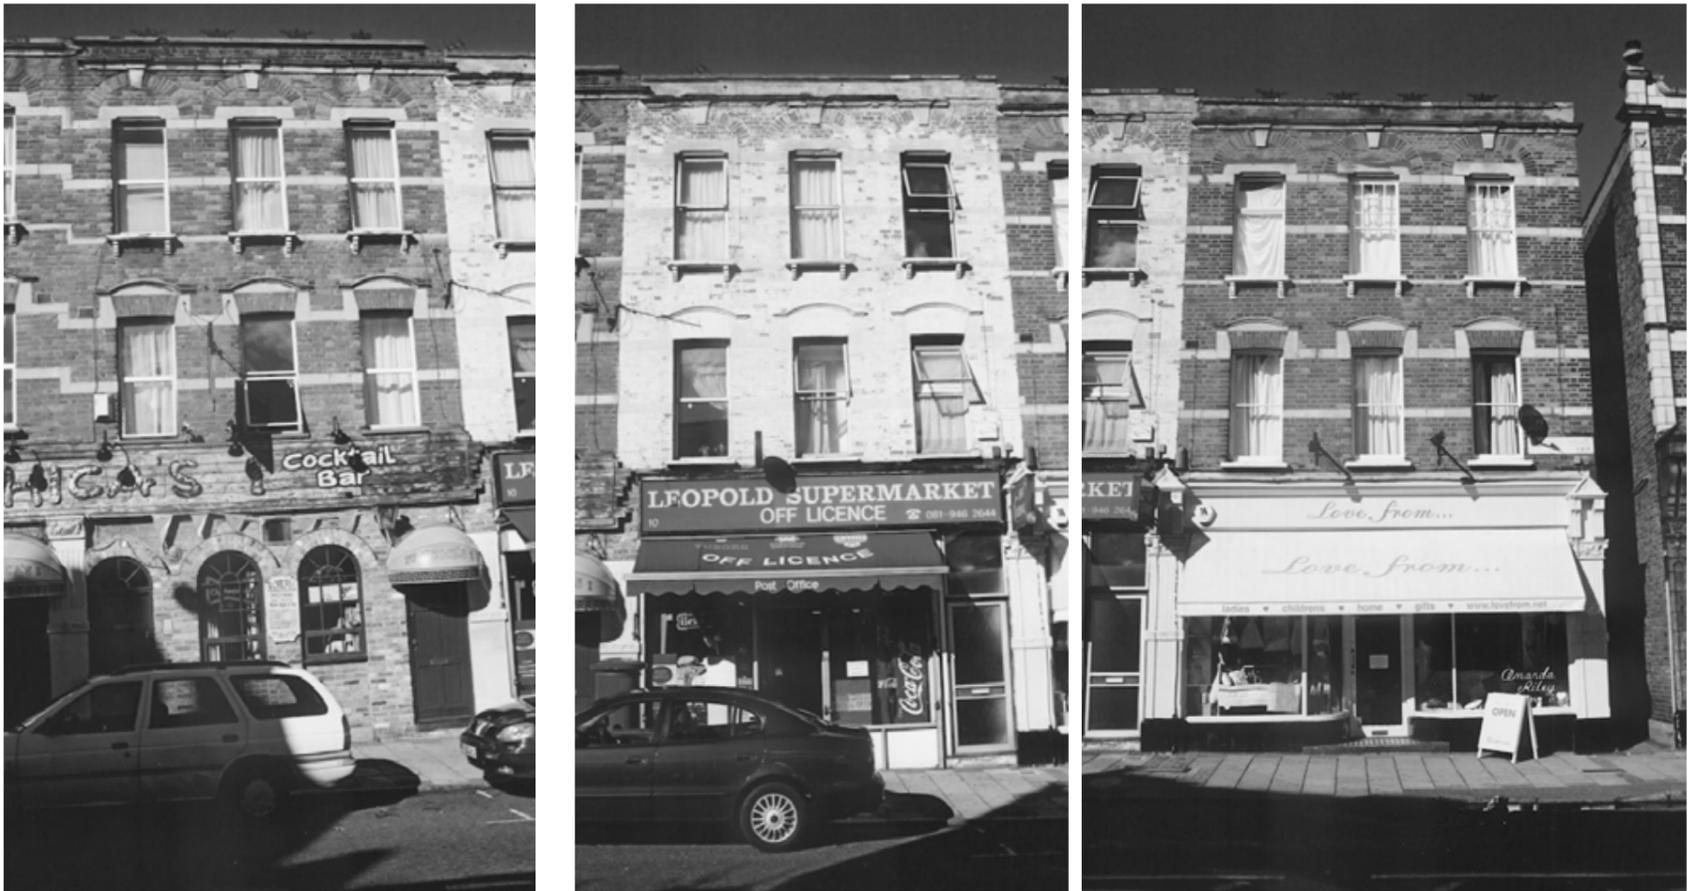
**NOS. 12, 10 AND 8. LEOPOLD ROAD.** Below: historic features which have been retained.

**No. 10:** A supermarket, off-licence and post office with a modern with a utilitarian front installed in 1984. **Shop front:** Modern metal framed picture windows with white painted stall risers, the entrance being placed centrally. The windows are used as advertisement hoardings, cluttered with adverts and notices. **Fascia:** replaced with deeper modern fascia in green with large yellow lettering. Hanging sign at fascia level. **Blind:** Traditional blind under fascia, in dark green with white lettering. **Side access:** retained, modern metal framed door. **Upper floors:** Brickwork painted white, much of which has peeled off. The original windows have been replaced with modern top hung replicas. **Level of maintenance:** poor, particularly upper floors. **Apparent level of prosperity:** poor. **Contribution to CA:** negative.

**No. 8:** A decorous candy-coloured gift shop designed to appeal to the feminine shopper. **Shop front:** A pair of symmetrically arranged picture windows with low black stall risers, each side of curved glazing and a central recessed door, the narrow frames, pilasters and corbels painted pale pink. **Fascia:** Painted pale pink to match, with red script lettering. **Blind:** Traditional blind below fascia in white with pink script lettering. **Side entry:** Down alleyway. **Upper floors:** Original sashes retained, except for top left window, which is modern top hung casement. **Level of maintenance:** high. **Apparent level of prosperity:** high. **Contribution to CA:** positive.

- Owners should be encouraged to replace such lost historic features as fascias, blinds, entrances to upper floors and first and second floor windows. The owners of Nos. 10 and 16 should be encouraged to remove the paintwork from brick facades, and no further painting or other defacing of the upper floors should be permitted. A scheme of grant aid, possibly funded from S.106 Agreements, should be considered to ensure that any repairs are sympathetic with the original character and materials.
