# Leopold Road Character Assessment

LEOPOLD ROAD  
CONSERVATION AREA

Character Assessment

London Borough of Merton  
2005

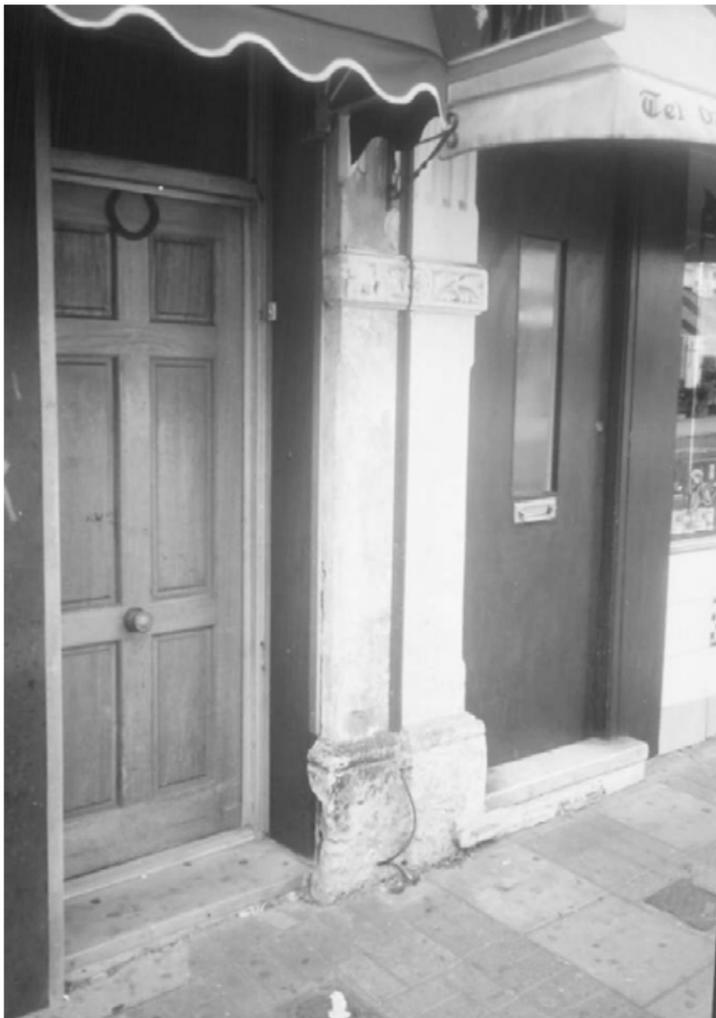
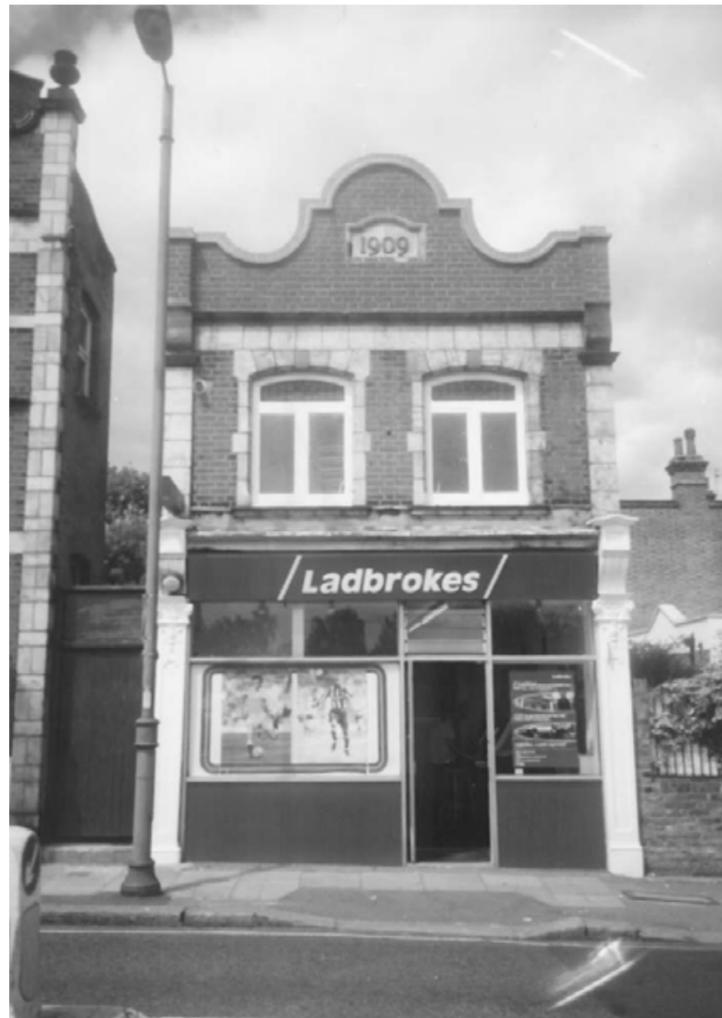
*Below: Left, typically inappropriate examples of modern doors providing access to the upper floors; and right, the façade to No. 1a Strathearn Road.*

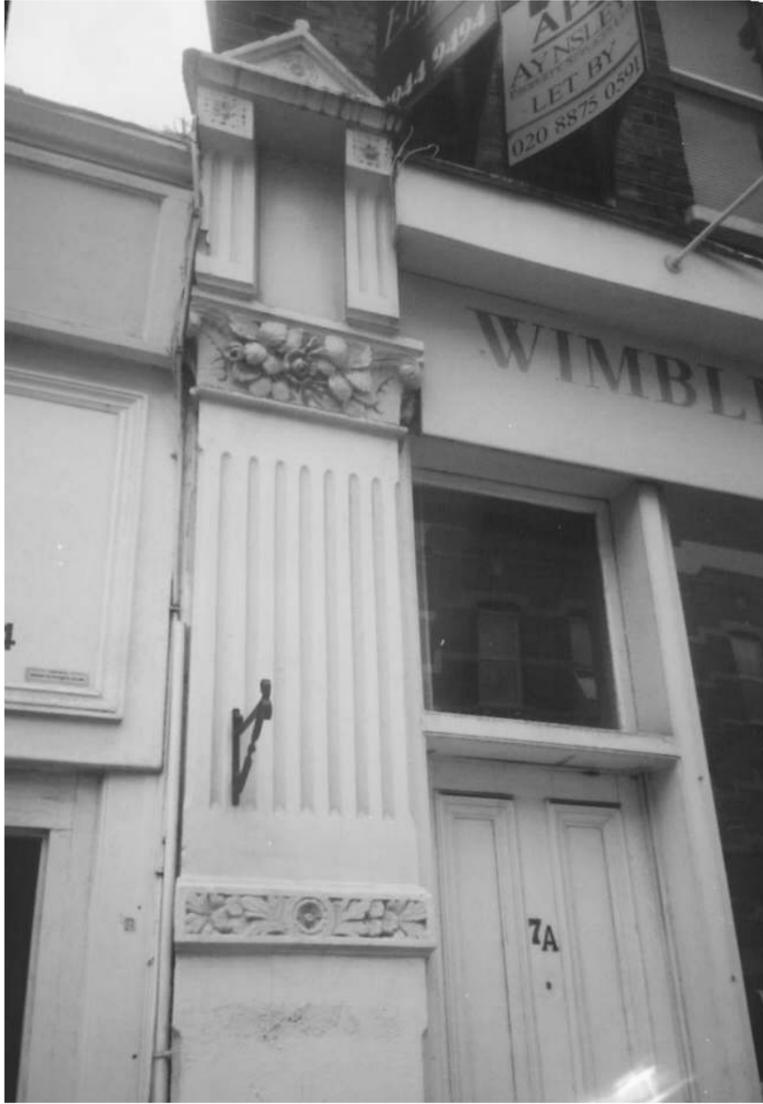
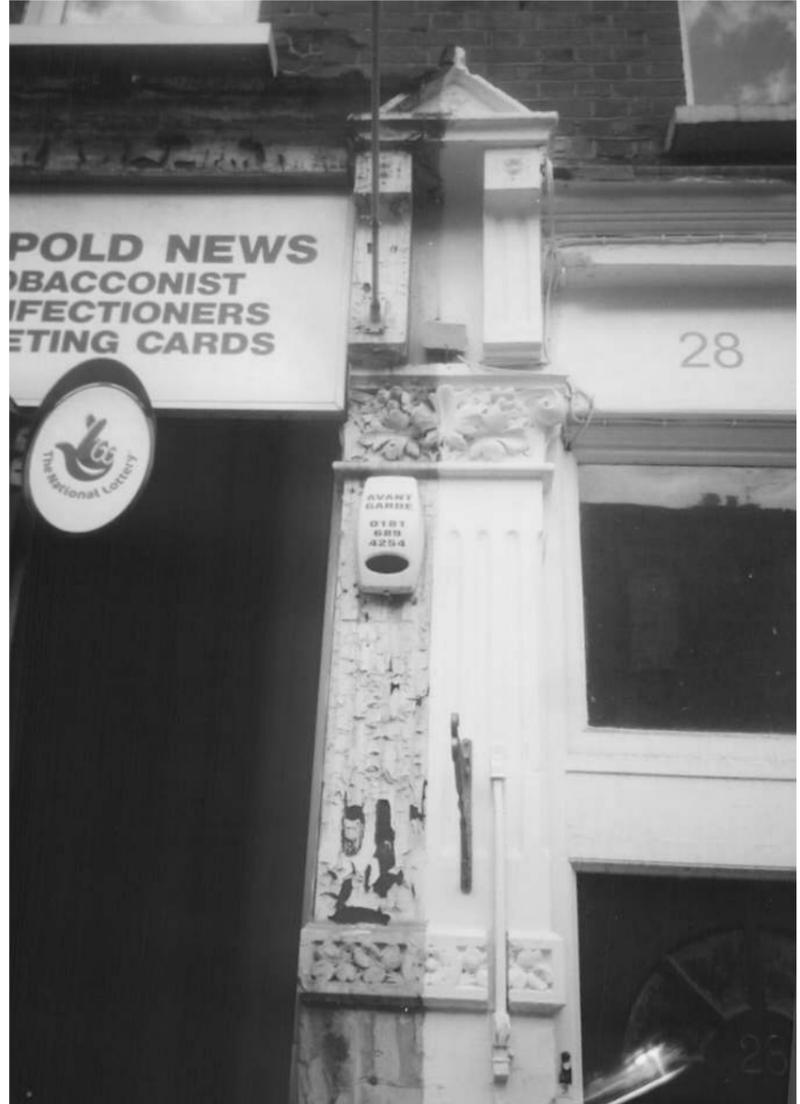
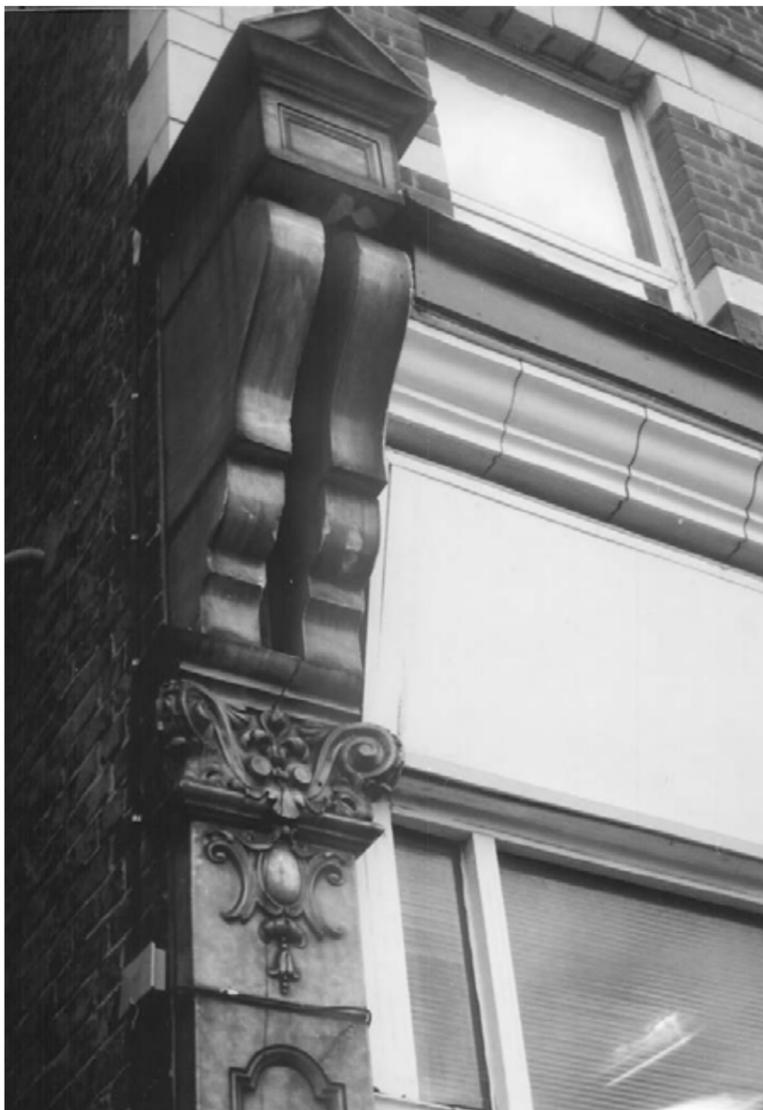
*Typical examples of the ornamental pilasters and corbels between the shop fronts: Top left, a carefully restored example between Nos. 5 and 7; top right contrasting badly and well maintained examples between Nos 28 and 30; bottom left, an example of the ornate terracotta decoration to shop Nos. 2 to 6; and bottom right, the recently restored corbels and capitals to No.1a Strathearn Rd.*

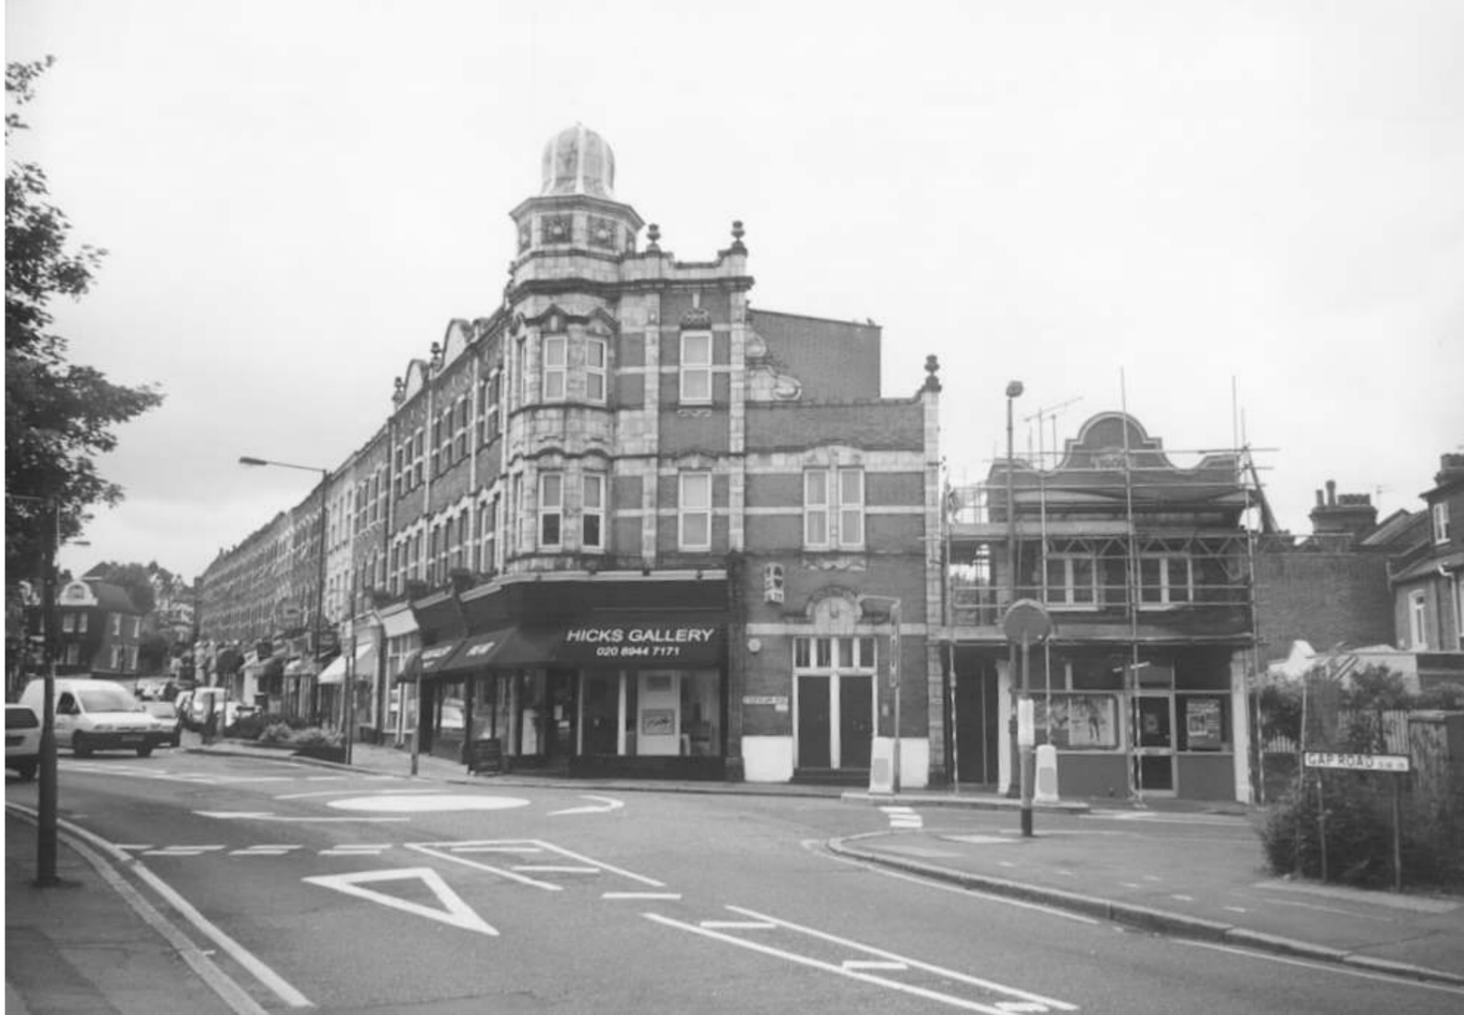
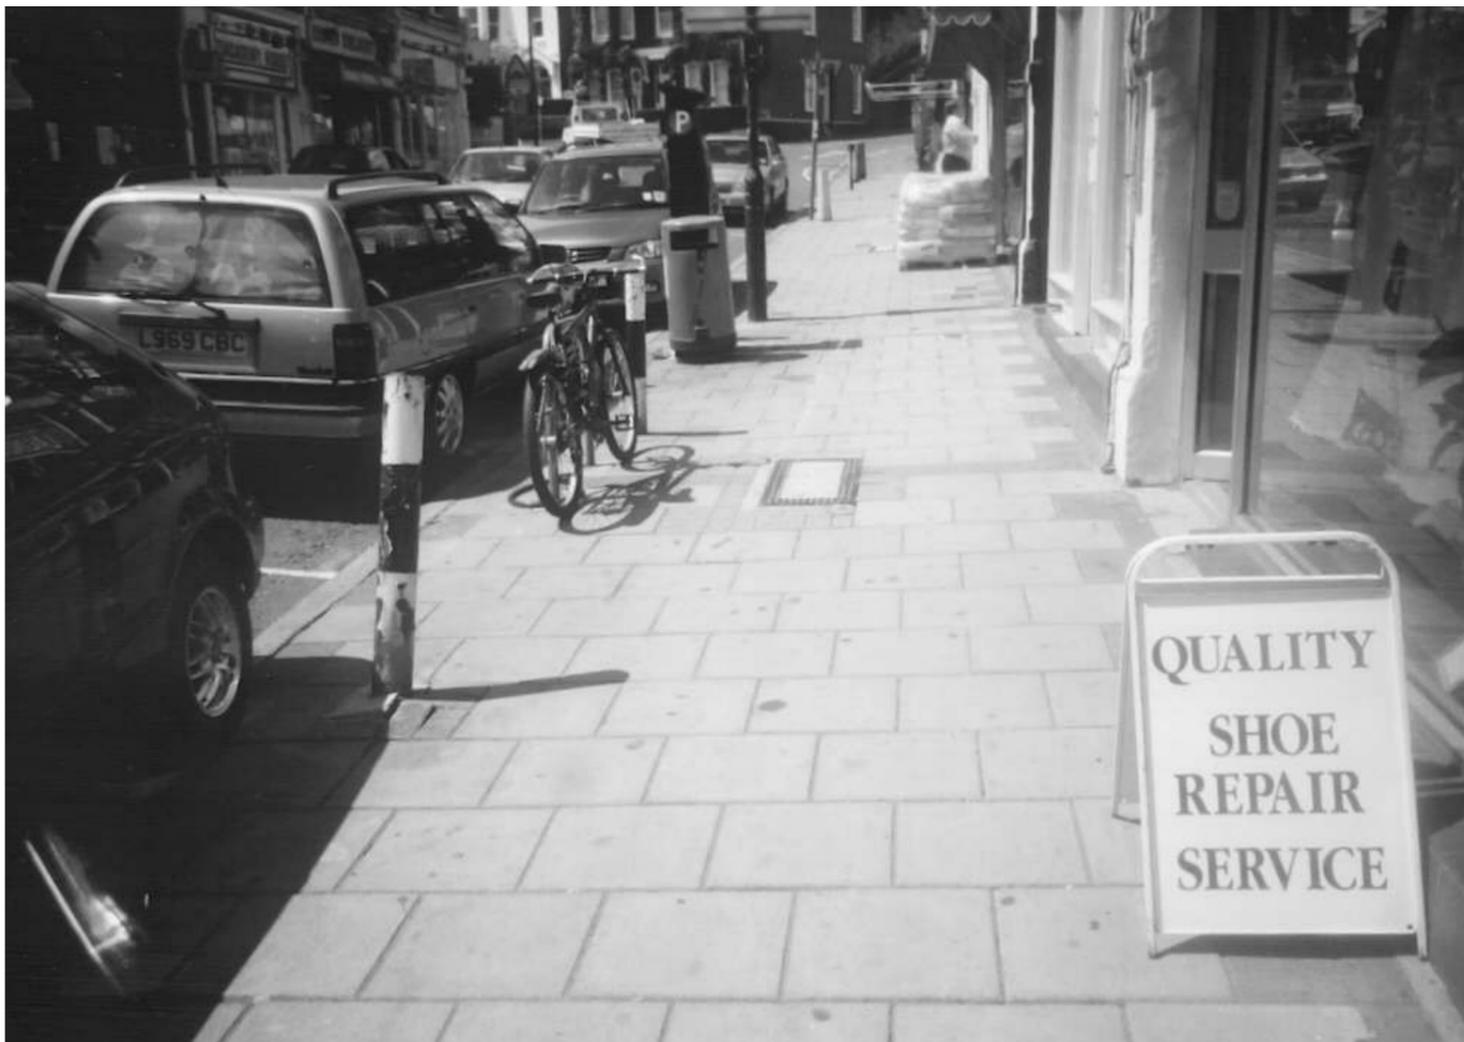
*Above: the western end of the northern parade adjoining the junction of Leopold, Strathearn and Alexandra Roads, seen from Gap Road. Below: a view of the pavement on the northern side of Leopold Road, showing the typical clutter of street furniture.*

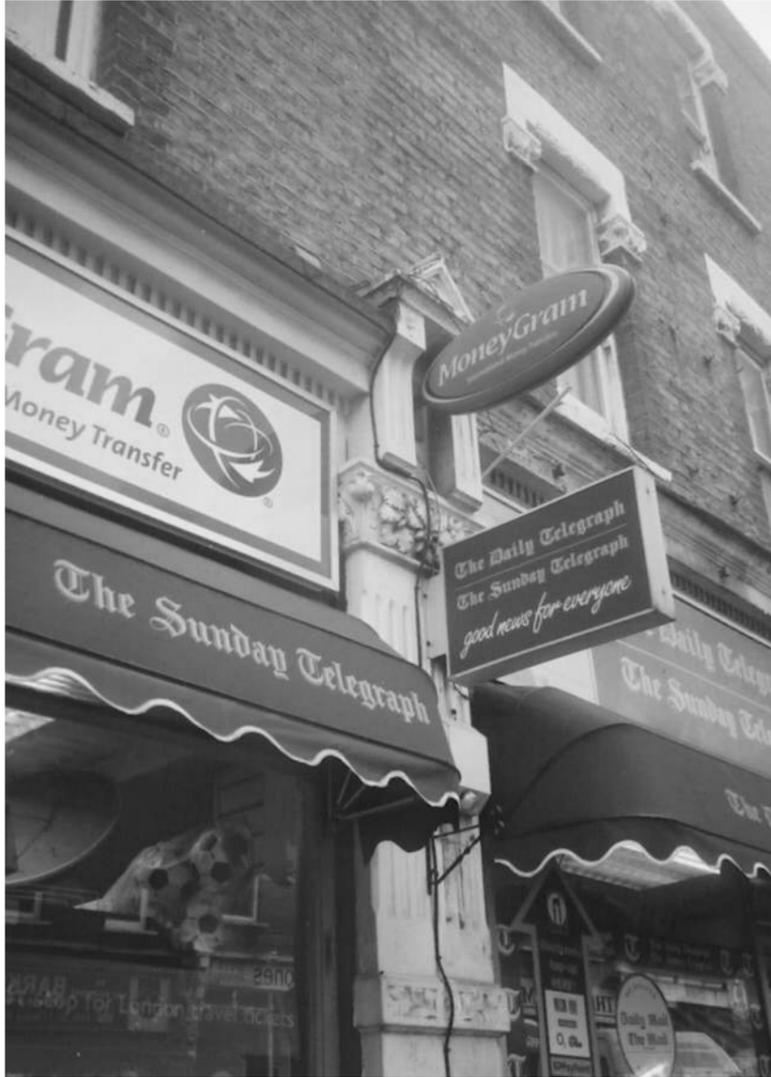
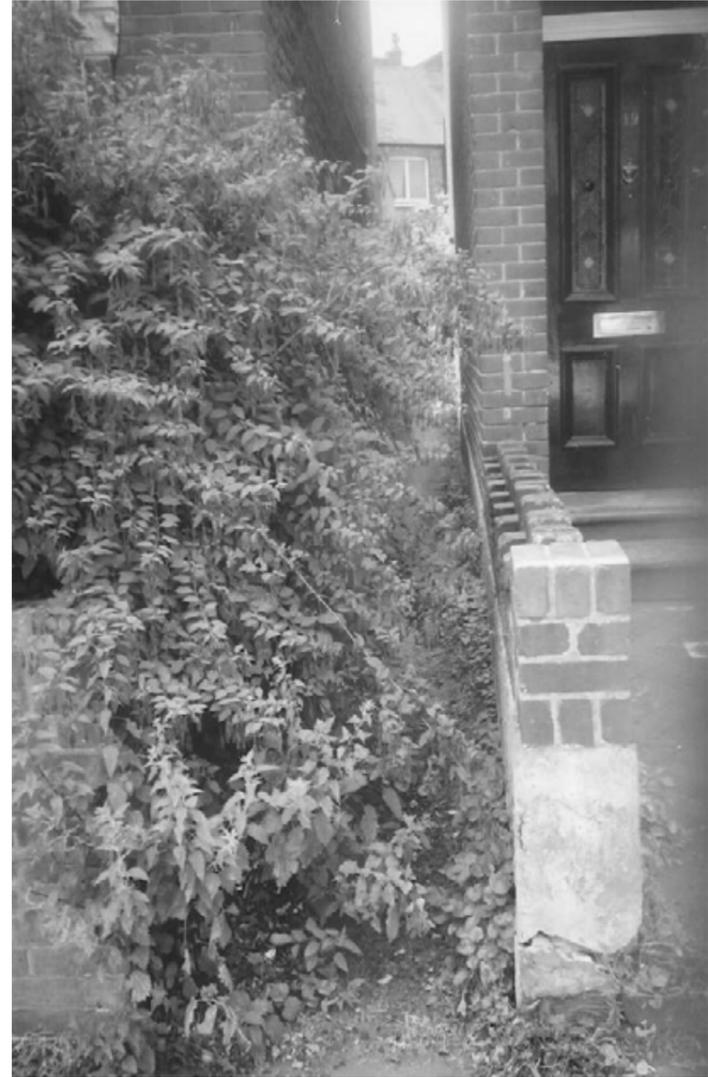
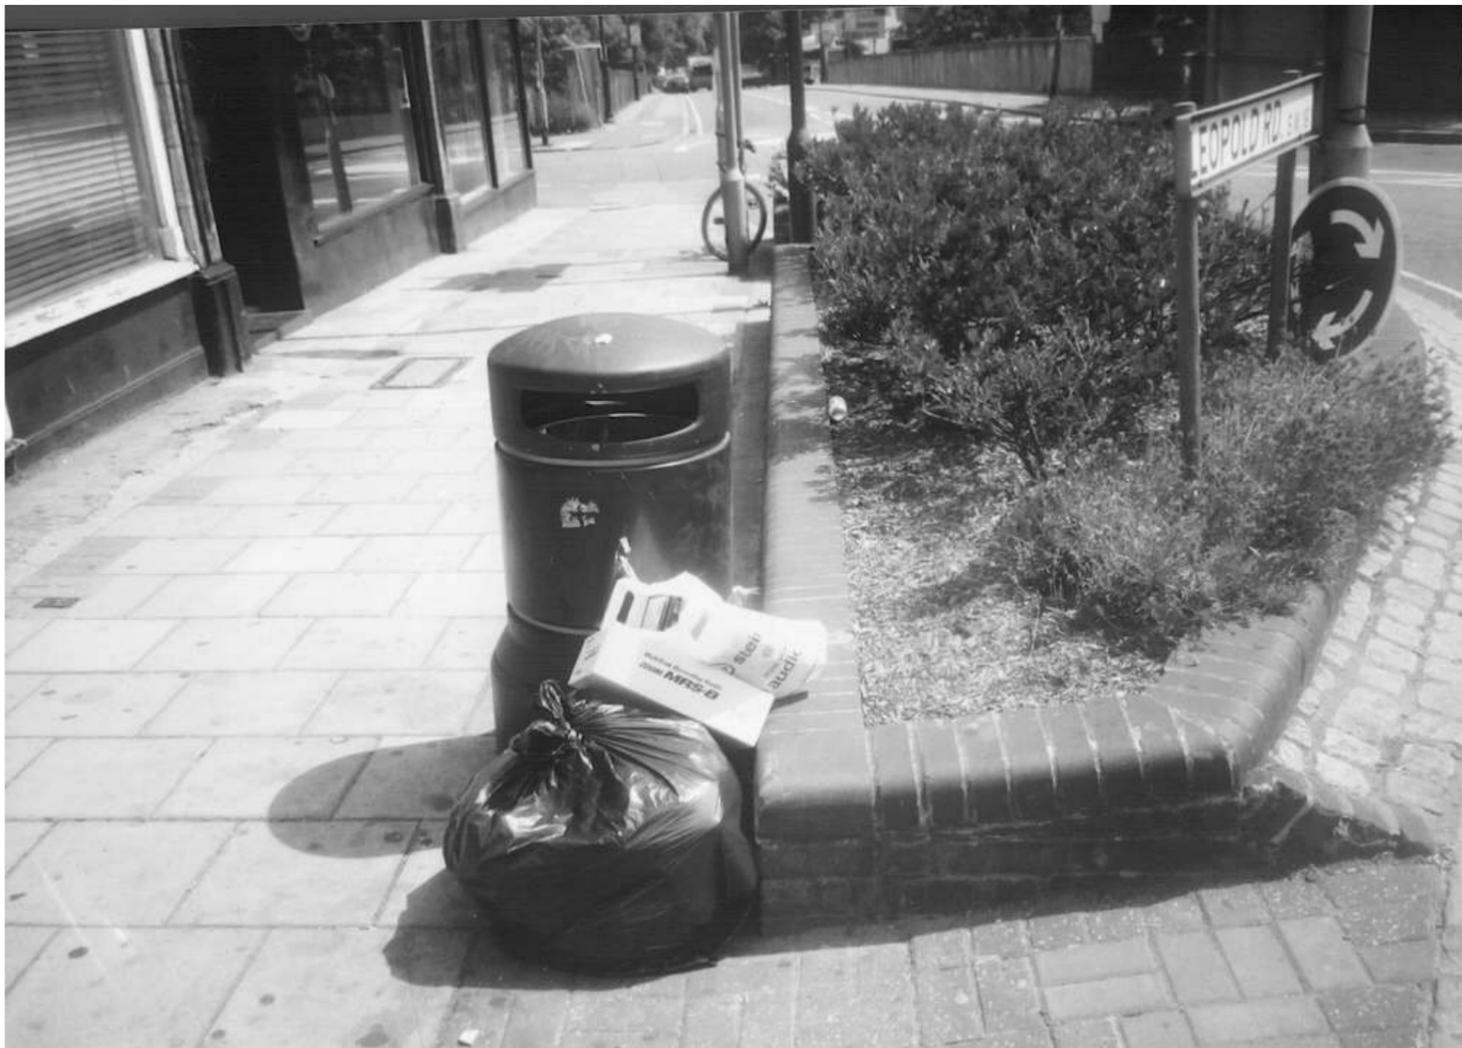
*Three typical examples of features which detract from the character of the Conservation Area and which would need to be considered in any enhancement scheme: top left, a typical clutter of discordant signage and shop fittings; top left, the less than inviting access the space at the rear of the north parade; and bottom, unattractive streetscape.*
