**Asbestos Survey Report  
Refurbishment Survey  
(with Priority Assessments)  
Cricket Green School  
Lower Green West, Mitcham, Surrey, CR4 3AF**

Job Number: B13844/1  
Issue Date: 25/02/2021  
Issue No: 1

Carry out a refurbishment survey to the single storey flat roof covering of the Sensory block.

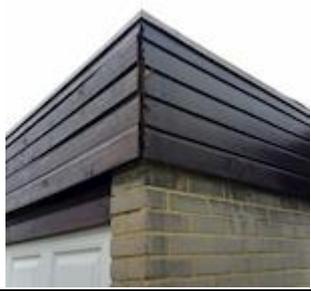
<b>Building</b>	Cricket Green School			<b>Floor</b>	0		
<b>Location Description</b>	Ext: External						
<b>Item</b>	Area inspected behind timber cladding to roof

<b>Level of Identification (ID)</b>	Inspected Area (IA)	<b>Sample No.</b>					
<b>Material</b>		<b>Extent</b>					
<b>Accessibility</b>							
<b>Identification</b>							
<b>Material Assessment</b>							
<b>Product Type</b>		<b>Condition</b>		<b>Surface Treatment</b>		<b>Asbestos Type</b>	
<b>Priority Assessment (for more detail see Section 6.0)</b>							
<b>Occupant Activity</b>		<b>Disturbance</b>		<b>Human Exposure</b>		<b>Maintenance Activity</b>	
<b>Scoring Summary</b>							
<b>Material Score</b>		<b>Priority Score</b>		<b>Total Risk</b>		<b>Risk Priority</b>	
<b>Recommended Action</b>	<b>No Recommendation Required</b>						
<b>Further Information</b>	The timber cladding is fixed to the exterior wall using timber battens with a plastic membrane and timber behind

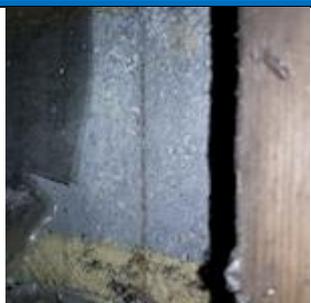
<b>Building</b>	Cricket Green School			<b>Floor</b>	0		
<b>Location Description</b>	Ext: External						
<b>Item</b>	Area inspected behind timber cladding to roof

<b>Level of Identification (ID)</b>	Inspected Area (IA)	<b>Sample No.</b>					
<b>Material</b>		<b>Extent</b>					
<b>Accessibility</b>							
<b>Identification</b>							
<b>Material Assessment</b>							
<b>Product Type</b>		<b>Condition</b>		<b>Surface Treatment</b>		<b>Asbestos Type</b>	
<b>Priority Assessment (for more detail see Section 6.0)</b>							
<b>Occupant Activity</b>		<b>Disturbance</b>		<b>Human Exposure</b>		<b>Maintenance Activity</b>	
<b>Scoring Summary</b>							
<b>Material Score</b>		<b>Priority Score</b>		<b>Total Risk</b>		<b>Risk Priority</b>	
<b>Recommended Action</b>	<b>No Recommendation Required</b>						
<b>Further Information</b>	The timber cladding is fixed to the exterior wall using timber battens with a plastic membrane, timber and concrete blocks behind

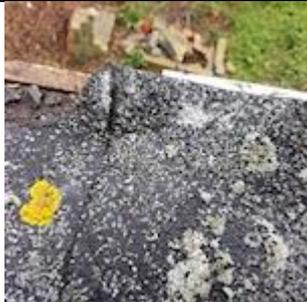
<b>Building</b>	Cricket Green School			<b>Floor</b>	0		
<b>Location Description</b>	Ext: External						
<b>Item</b>	Roof felt

<b>Level of Identification (ID)</b>	Sample (S)	<b>Sample No.</b>	S0001				
<b>Material</b>	Bitumen Product	<b>Extent</b>	130 m <sup>2</sup>				
<b>Accessibility</b>							
<b>Identification</b>	No Asbestos Detected						
<b>Material Assessment</b>							
<b>Product Type</b>	0	<b>Condition</b>	0	<b>Surface Treatment</b>	0	<b>Asbestos Type</b>	0
<b>Priority Assessment (for more detail see Section 6.0)</b>							
<b>Occupant Activity</b>	0	<b>Disturbance</b>	0	<b>Human Exposure</b>	0	<b>Maintenance Activity</b>	0
<b>Scoring Summary</b>							
<b>Material Score</b>	0	<b>Priority Score</b>	0	<b>Total Risk</b>	0	<b>Risk Priority</b>	N/A
<b>Recommended Action</b>	No Recommendation Required						
<b>Further Information</b>

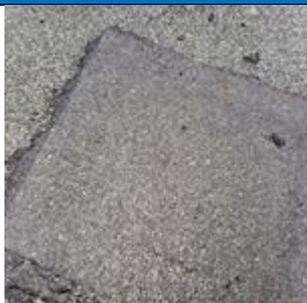
<b>Building</b>	Cricket Green School			<b>Floor</b>	0		
<b>Location Description</b>	Ext: External						
<b>Item</b>	Roof felt

<b>Level of Identification (ID)</b>	Sample (S)	<b>Sample No.</b>	S0002				
<b>Material</b>	Bitumen Product	<b>Extent</b>	10 m <sup>2</sup>				
<b>Accessibility</b>							
<b>Identification</b>	No Asbestos Detected						
<b>Material Assessment</b>							
<b>Product Type</b>	0	<b>Condition</b>	0	<b>Surface Treatment</b>	0	<b>Asbestos Type</b>	0
<b>Priority Assessment (for more detail see Section 6.0)</b>							
<b>Occupant Activity</b>	0	<b>Disturbance</b>	0	<b>Human Exposure</b>	0	<b>Maintenance Activity</b>	0
<b>Scoring Summary</b>							
<b>Material Score</b>	0	<b>Priority Score</b>	0	<b>Total Risk</b>	0	<b>Risk Priority</b>	N/A
<b>Recommended Action</b>	No Recommendation Required						
<b>Further Information</b>

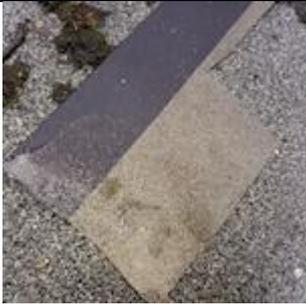
<b>Building</b>	Cricket Green School			<b>Floor</b>	0		
<b>Location Description</b>	Ext: External						
<b>Item</b>	Roof felt

<b>Level of Identification (ID)</b>	Sample (S)	<b>Sample No.</b>	S0003				
<b>Material</b>	Bitumen Product	<b>Extent</b>	2 m <sup>2</sup>				
<b>Accessibility</b>							
<b>Identification</b>	No Asbestos Detected						
<b>Material Assessment</b>							
<b>Product Type</b>	0	<b>Condition</b>	0	<b>Surface Treatment</b>	0	<b>Asbestos Type</b>	0
<b>Priority Assessment (for more detail see Section 6.0)</b>							
<b>Occupant Activity</b>	0	<b>Disturbance</b>	0	<b>Human Exposure</b>	0	<b>Maintenance Activity</b>	0
<b>Scoring Summary</b>							
<b>Material Score</b>	0	<b>Priority Score</b>	0	<b>Total Risk</b>	0	<b>Risk Priority</b>	N/A
<b>Recommended Action</b>	No Recommendation Required						
<b>Further Information</b>

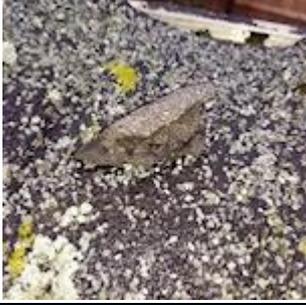
<b>Building</b>	Cricket Green School			<b>Floor</b>	0		
<b>Location Description</b>	Ext: External						
<b>Item</b>	Bitumen

<b>Level of Identification (ID)</b>	Sample (S)	<b>Sample No.</b>	S0004				
<b>Material</b>	Bitumen Product	<b>Extent</b>	150 lm				
<b>Accessibility</b>							
<b>Identification</b>	No Asbestos Detected						
<b>Material Assessment</b>							
<b>Product Type</b>	0	<b>Condition</b>	0	<b>Surface Treatment</b>	0	<b>Asbestos Type</b>	0
<b>Priority Assessment (for more detail see Section 6.0)</b>							
<b>Occupant Activity</b>	0	<b>Disturbance</b>	0	<b>Human Exposure</b>	0	<b>Maintenance Activity</b>	0
<b>Scoring Summary</b>							
<b>Material Score</b>	0	<b>Priority Score</b>	0	<b>Total Risk</b>	0	<b>Risk Priority</b>	N/A
<b>Recommended Action</b>	No Recommendation Required						
<b>Further Information</b>

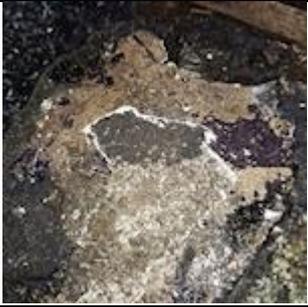
<b>Building</b>	Cricket Green School			<b>Floor</b>	0		
<b>Location Description</b>	Ext: External						
<b>Item</b>	Paper lining to bitumen

<b>Level of Identification (ID)</b>	Sample (S)	<b>Sample No.</b>	S0005				
<b>Material</b>	Textile	<b>Extent</b>	130 m <sup>2</sup>				
<b>Accessibility</b>							
<b>Identification</b>	No Asbestos Detected						
<b>Material Assessment</b>							
<b>Product Type</b>	0	<b>Condition</b>	0	<b>Surface Treatment</b>	0	<b>Asbestos Type</b>	0
<b>Priority Assessment (for more detail see Section 6.0)</b>							
<b>Occupant Activity</b>	0	<b>Disturbance</b>	0	<b>Human Exposure</b>	0	<b>Maintenance Activity</b>	0
<b>Scoring Summary</b>							
<b>Material Score</b>	0	<b>Priority Score</b>	0	<b>Total Risk</b>	0	<b>Risk Priority</b>	N/A
<b>Recommended Action</b>	No Recommendation Required						
<b>Further Information</b>
