**EXPERIMENTAL ROAD CLOSURE,
BALFOUR ROAD, LB MERTON**

**STAGE 1/2 - ROAD SAFETY AUDIT
NOVEMBER 2015**

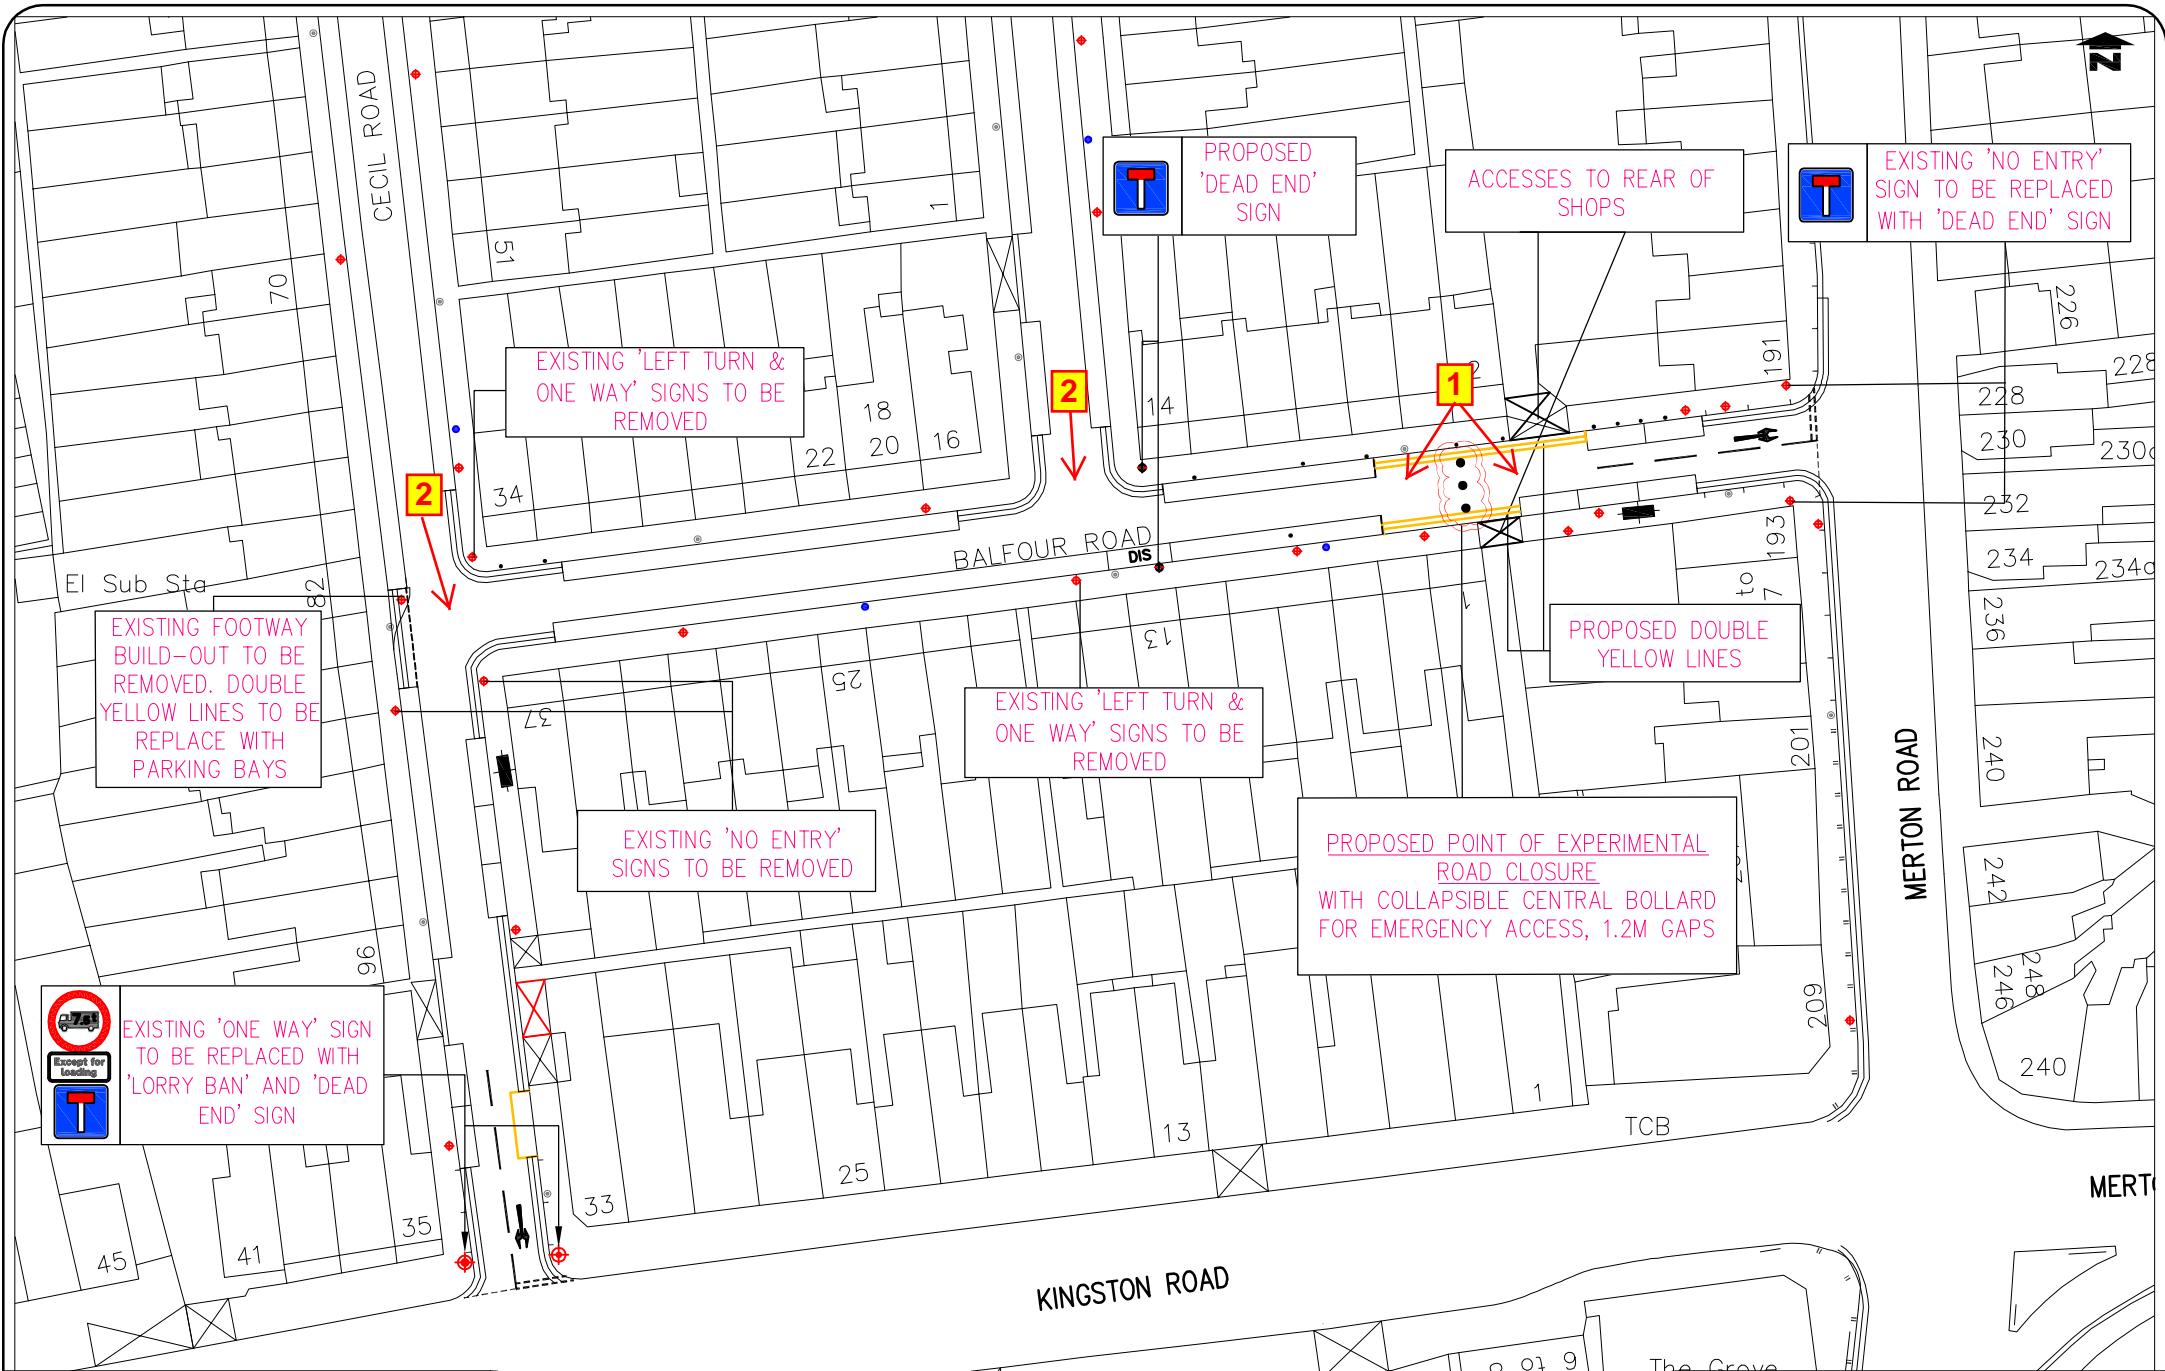
Location of Identified Problems

SUMMARY: Potential lack of sufficient turning provision.

- 2.1 The introduction of the bollards may result in there being insufficient turning provision adjacent to the bollards for a significant number of users including residents especially those parked within the parking bays adjacent to the bollards, potential HGVs/MGVs associated with the commercial premises or refuse vehicles either side of the bollards. This issue may result in injudicious turning and/or reversing manoeuvres over an excessive distance that may lead to a number of road safety issues at this location including:

SUMMARY: Lack of give way road markings.

- 2.6 At both the Balfour Road (east) and Balfour Road (west) junctions with Cecil Road there are no details provided with regard to the give-way road markings at these locations. A lack of appropriate road markings at these locations could lead to side-swipe type collisions at these locations. It is noted that give way road markings are currently provide at both junctions, albeit that they are extremely worn at the Balfour Road (east)/ Cecil Road junction.

- RECOMMENDATION**
- 2.4 Ensure suitable turning facilities are provided for vehicles to safely turn either side of the bollards.
- 2.5 It is noted that double yellow lines are provided in advance of the bollards which allows for increased width for turning vehicles, however vehicle swept path analysis should be

undertaken using the largest vehicle size anticipated to use Balfour Road to ensure the layout is satisfactory with regard to the problem raised.

- 2.7 Ensure give-way road markings are provided at both the Balfour Road (east) and Balfour Road (west) junctions with Cecil Road.
