Existing Building Conditions

Summary Overview
of
Condition Appraisal
of
High Path Estate, London SW19
for
PRP Architects

Condition Appraisal
of
Hudson Court, May Court and Marsh Court
Tower Blocks – Archetype 1
at
High Path Estate, London SW19
for
PRP Architects

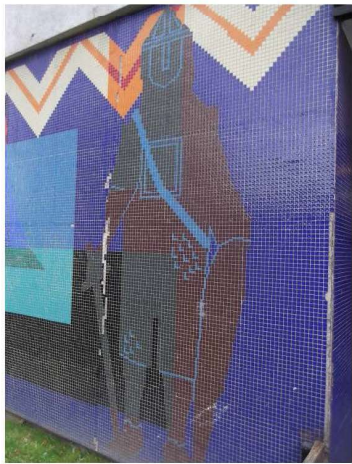
Photograph 3 – Each block has a decorative mosaic at ground floor level. These have areas of missing tile and are in need of repair.

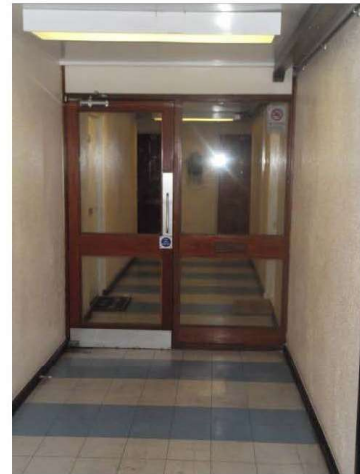
Photograph 4 – Typical internal common parts corridor. Fire doors are in need of overhaul and repair. Door closers need adjustment to close quietly and not require undue force to open doors.

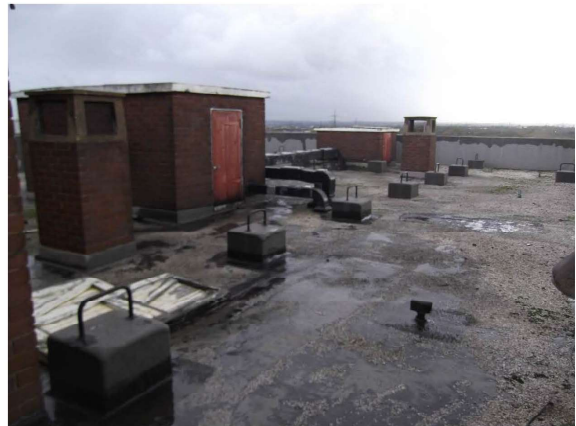
- 3.1.3 The anticipated component life for asphalt roofs is about 65 years assuming they receive regular repair and maintenance. As such the roof coverings to these blocks are likely to require replacing in the next 10 years. New coverings will also be required to meet current standard for thermal insulation.

Photograph 8 – View of main roof over May House. This is likely to be the original roof covering applied when the roof was constructed in the 1950s and 60s. The levels of insulation provided in this roof will be low when compared to today's standards

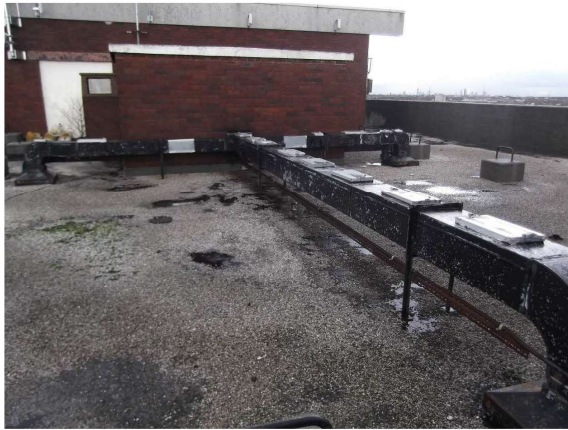
Photograph 9 – Roof over May Court. Asphalt is in fair condition for its age.

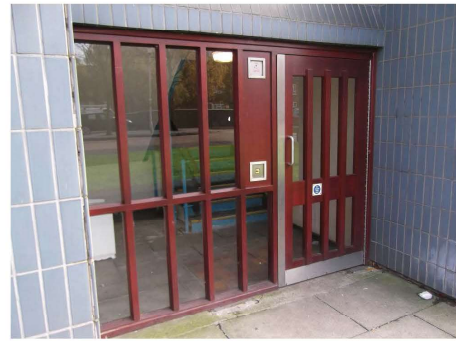
Photograph 10 – View of the ground floor fire escape from communal staircase. These screens would appear to be have been renewed within the last 10 years and are in good condition

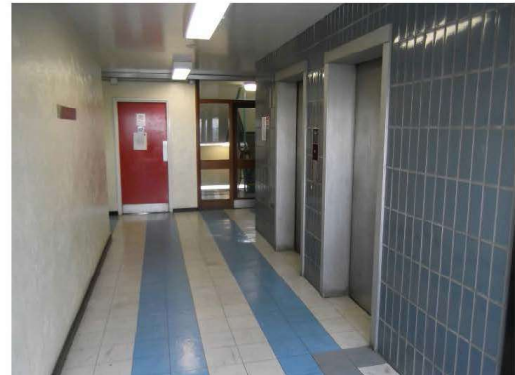
Photograph 12 – Typical upper floor lift lobby. Floor finishes on some levels have been damaged by flooding and are in need of replacement.

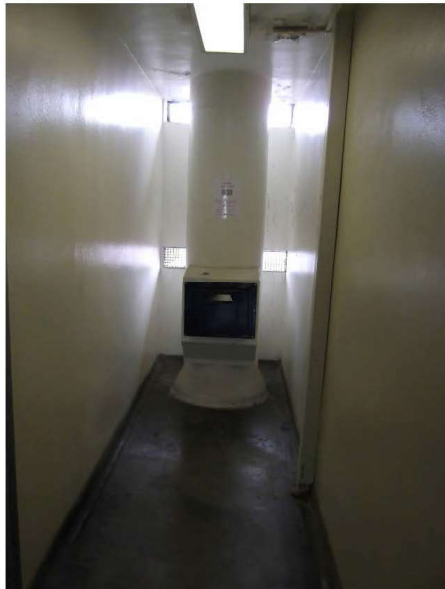
Photograph 15 – Typical view of refuse chute provided at each floor level. This arrangement does not allow for separation of recyclable materials at source

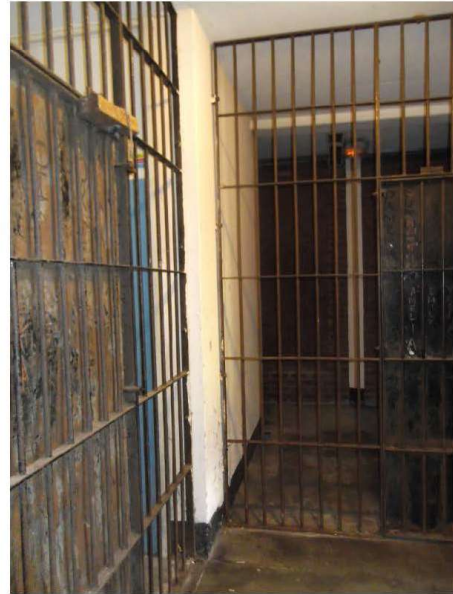
Photograph 24 – Security to tenants store areas. A review of the use of these areas may be required to establish if alternative use could be made of parts of these areas.
