Condition Appraisal
of
Beckett Close, Gilbert Close and Priory Close
Flat Blocks – Archetype 2
at
High Path Estate, London SW19
for
PRP Architects

Purpose of Issue:	Information
Date:	20 November 2014
Job No:	P178

Condition Appraisal
of
Ryder House, Ramsey House and Eleanor House
Flat Blocks – Archetype 3
at
High Path Estate, London SW19
for
PRP Architects

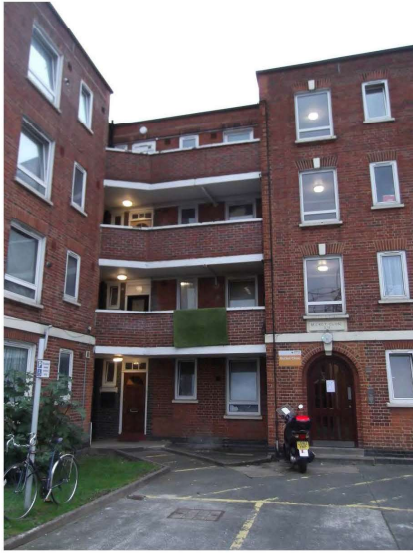
Photograph 1 – View of North communal entrance door and access balcony arrangement to Becket Close.

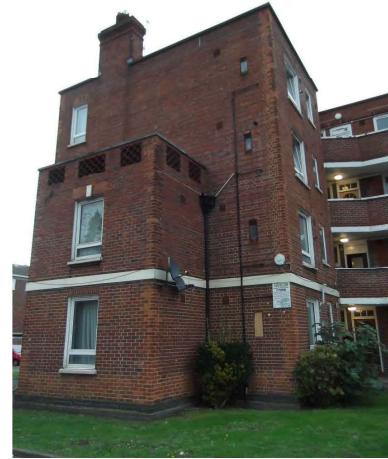
Photograph 2 – North end of Becket Close showing terraced roof area at second floor level.

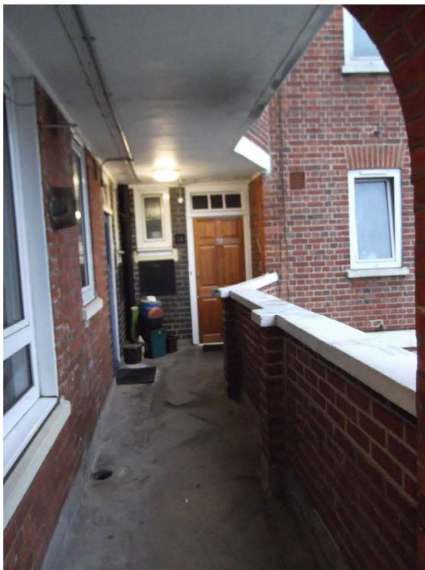
Photograph 3 - Deck access balcony to Becket Close

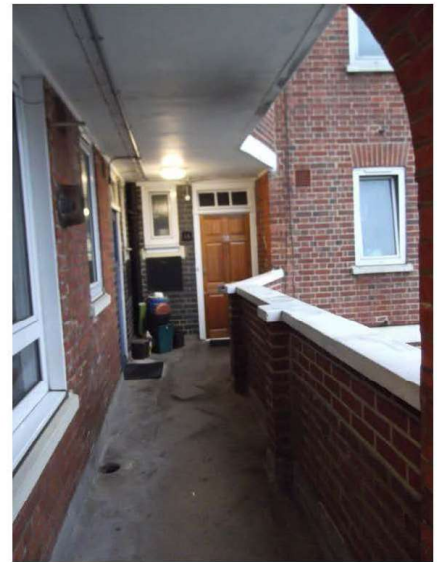
weathered in asphalt laid to falls to balcony gullies and cast iron rainwater down pipes. Asphalt is generally in good condition with some localised repairs being required.

Photograph 4 – Typical communal access balcony with asphalt weathering and brick balustrading

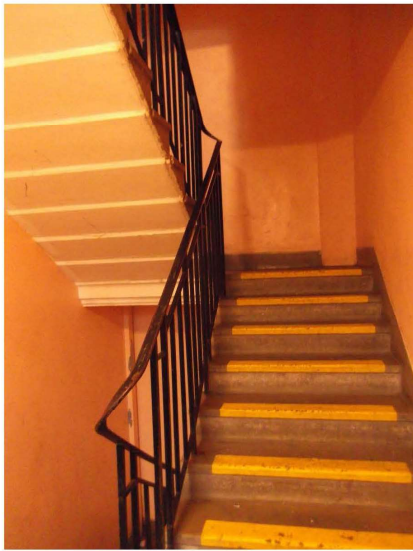
Photograph 5 – Internal communal staircase, concrete stair structure and painted metal balustrading

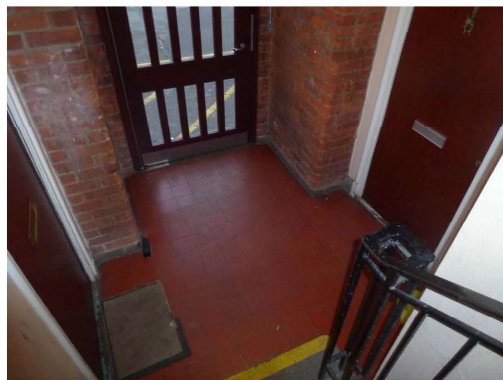
Photograph 7 – Typical communal entrance floor finishes

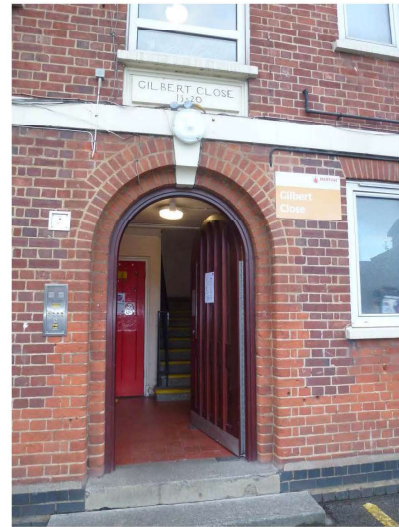
Photograph 6 – Typical entrance to communal staircase - Gilbert Close block. Doors appear to have been installed in the last 10 years. There is no level access to ground floor flats.

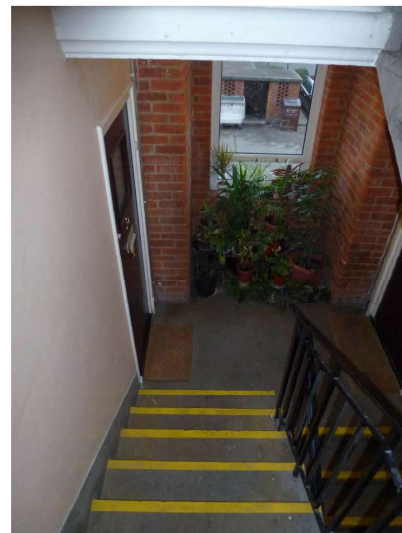
Photograph 8 – typical view of communal stairs finishes

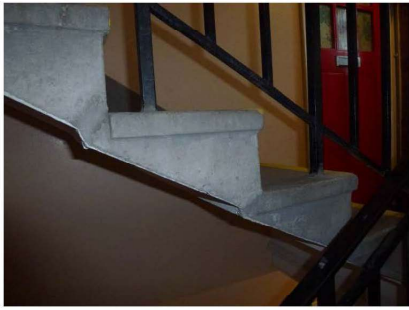
Photograph 9 – Communal staircase. Concrete stair detail

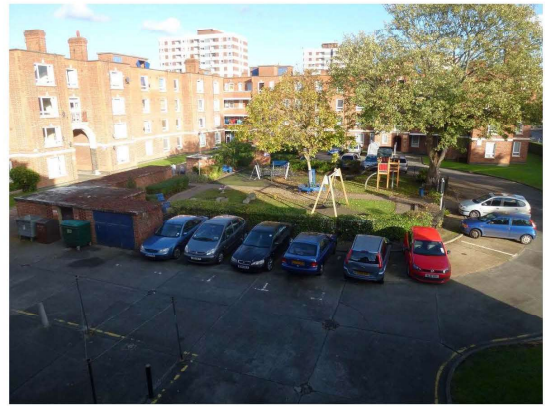
Photograph 10 – Priory Close block with the children's play area in the centre and car parking

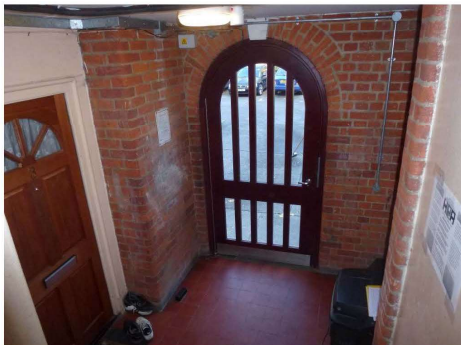
- 3.5.5 The communal stairs are constructed of concrete. Landings are finished in a granolithic topping and are in good condition for their age. The ground floor entrance lobby floors are finished in quarry tiles which appear to have been installed in the last 10 years.

Photograph 11 – Typical view of entrance lobby with hardwood and glass entrance door and quarry tile floor finish.

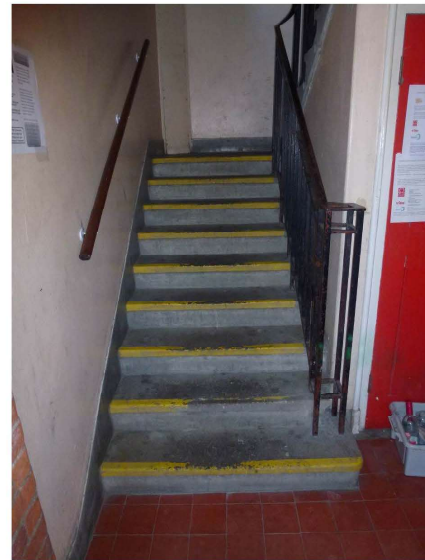
Photograph 12 – Typical view of communal stair access with services cupboard to the right of the staircase

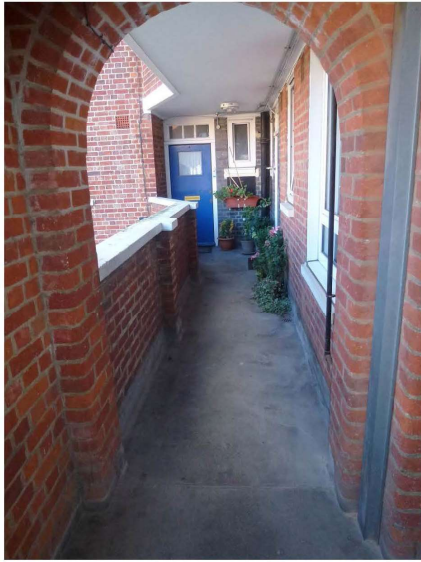
Photograph 13 – Typical upper level access balcony to flats showing asphalt weathering and brick balustrading

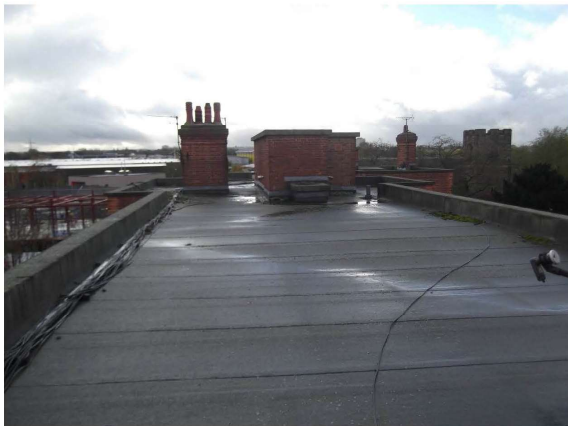
- 3.1.10 Roof coverings are in serviceable condition commensurate with their age and specification.

Photograph 14 – These blocks have been re roofed in the last 10 to 15 years with a High Performance felt roof system

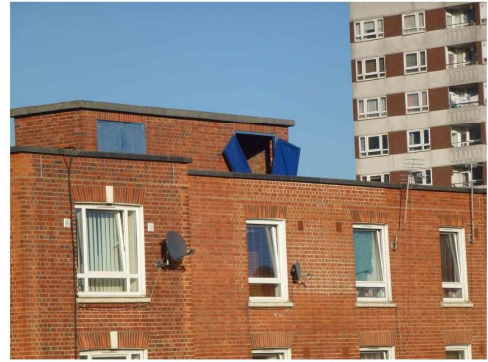
- 3.1.6 There are a number of roof top cold water tank rooms on each of the roofs. These are generally brick built structures with felt covered flat roofs over. Many of the painted softwood doors to these areas have been damaged by the wind and require urgent repair or replacement to make them safe and reduce the risk of frost damage to plumbing in these areas.

Photograph 14 – Roof top tank rooms on all three blocks. Doors have been left insecure and damaged by wind action. These should be rehung and made secure to avoid flying debris hazard and to avoid risk of frost damage to tanks and plumbing.

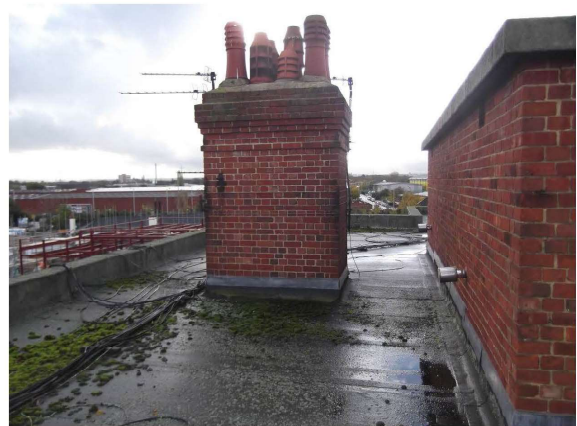
- 3.1.7 Chimney stacks to these roofs are of brick construction with mortar flaunching and a collection of various pot types. Some of the chimneys appear to be still in use. All stacks are in need of overhaul and repair.

Photograph 15 – Typical view of chimney stack over Priory Close block. Some repairs to brickwork, pots and flaunching are required

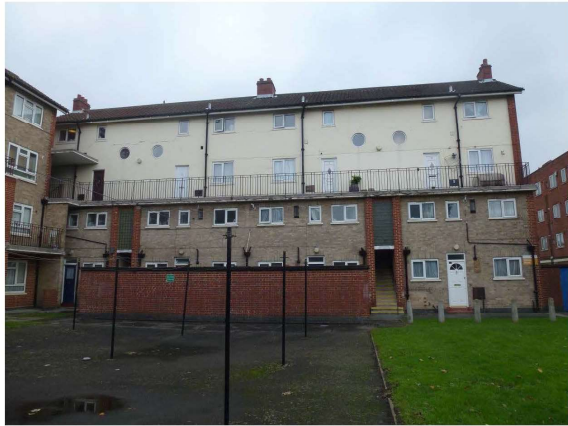
Photograph 1 – Eleanor House –Upper floor maisonettes and access balcony. Ground floor entrances to flat units

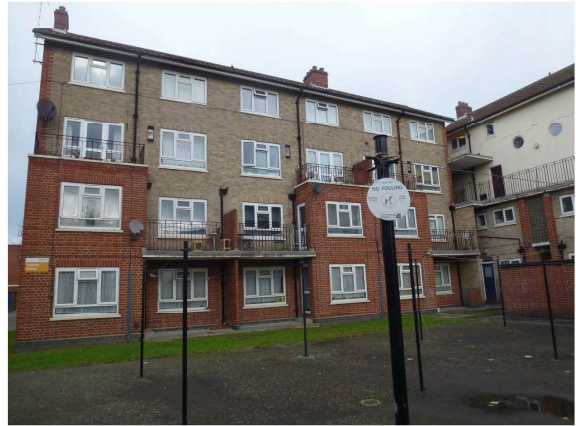
Photograph 2 – Eleanor House – Private balconies

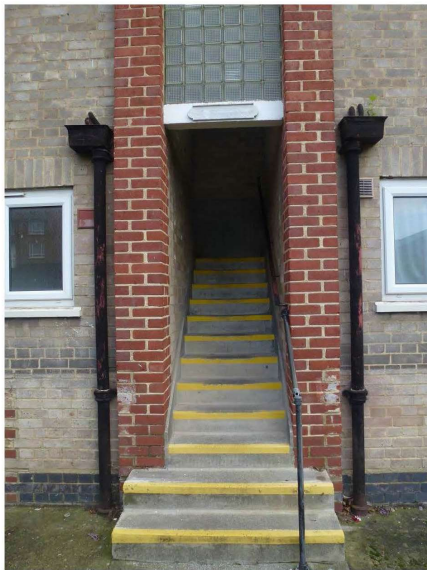
Photograph 3 – Eleanor House – entrance staircase to first floor flats

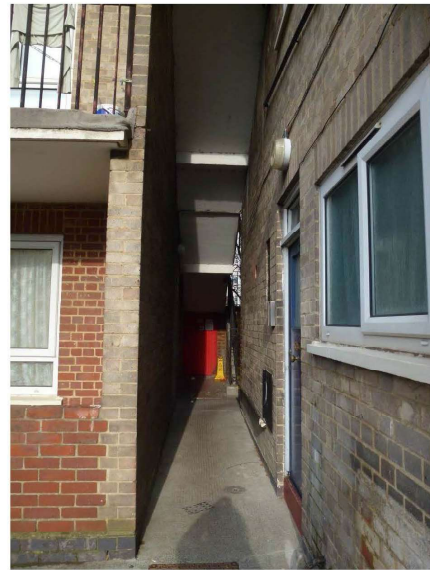
Photograph 4 – Eleanor House – passage to external communal staircase.

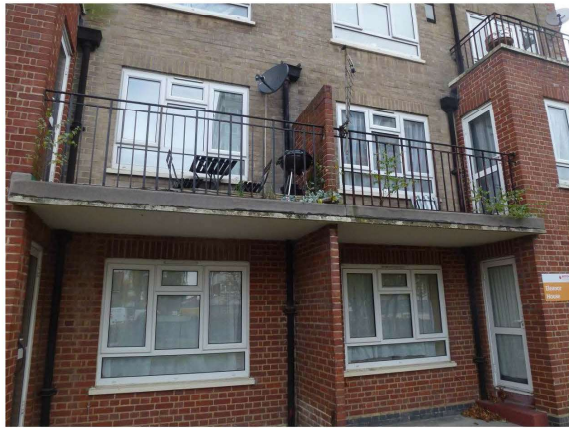
Photograph 5 – Eleanor House – private balconies

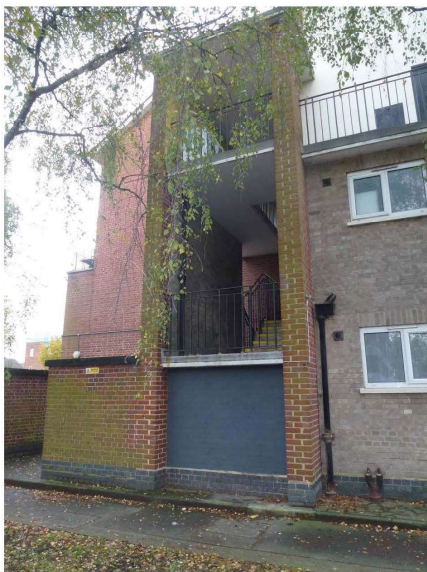
Photograph 7 – Eleanor House – External communal staircase

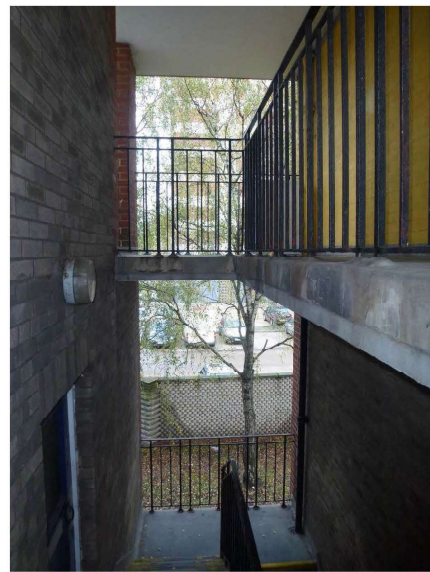
Photograph 8 – Eleanor House – External communal staircase

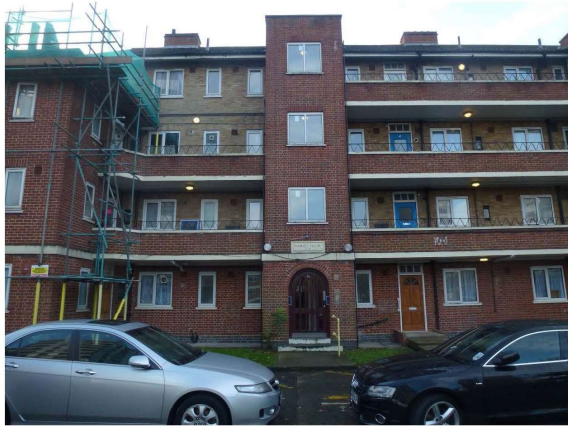
Photograph 9 – Ramsey House – Typical entrance and access balcony elevation.

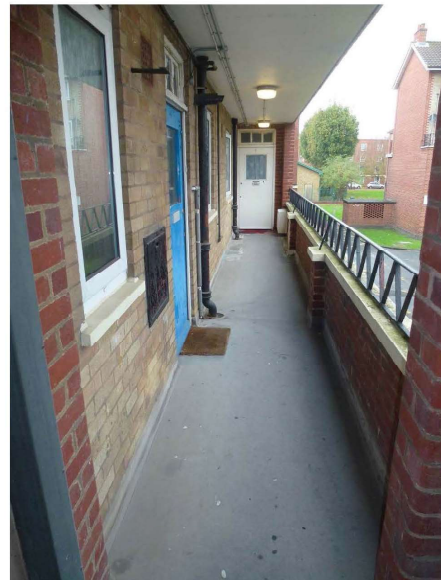
Photograph 12 – Ramsey House - Access Balcony. Note balustrade has gaps greater than 100 mm

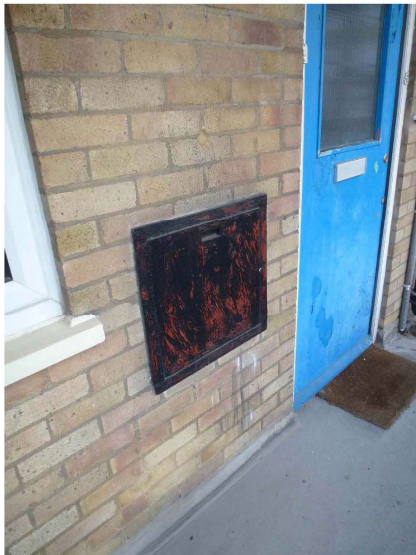
Photograph 13 – Redundant coal holes

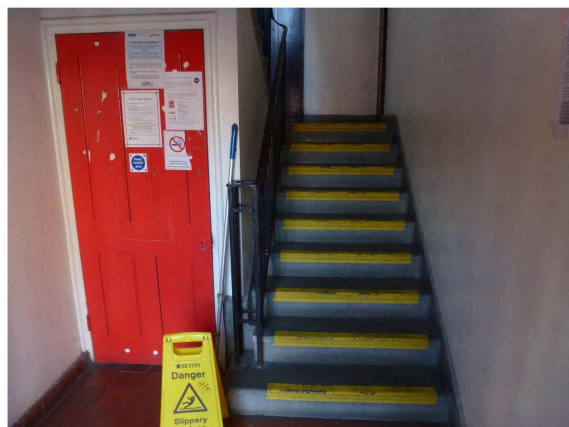
Photograph 16 - Typical stair finishes

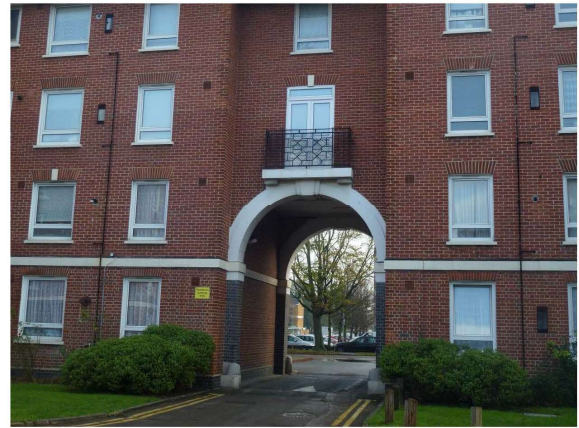
Photograph 15 - Ryder House - passageway
