Condition Appraisal  
of  
De Burgh House, 1 to 18 Hilborough Close, Merton Place,  
Norfolk House - Flat Blocks - Archetype 5  
at  
High Path Estate, London SW19  
for  
PRP Architects

Purpose of Issue: **Draft** for Information  
Date: 16 November 2014  
Job No: P178

Condition Appraisal  
of  
Mychell House, Tanner House  
Flat blocks Archetype 6  
at  
High Path Estate, London SW19  
for  
PRP Architects

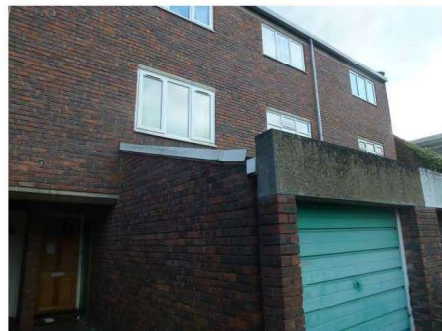
Photograph 2 – Typical view of garage projection, pitched roof and gutter behind the concrete parapet – note missing rainwater down pipe

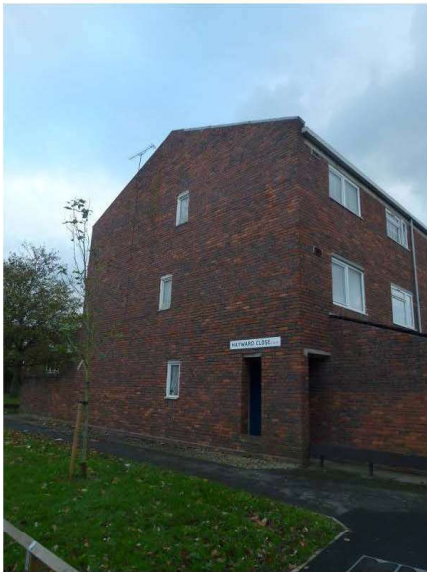
Photograph 7 – Gable end. Note missing sections of raised gable coping system and previous repairs

- 7.1.7 A number of 'wants of repair' and potential for improvement were noted during the survey. These include:
- Repairs to reinstate copings to head of raised gable walls

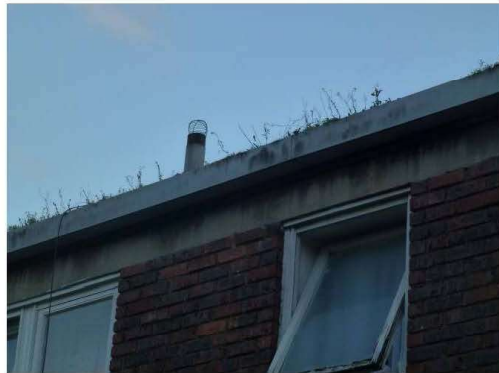
Photograph 13 – Eaves detail. Gutters need routine maintenance

- Gutter cleaning and maintenance
  - Repairs to private garden fencing
  - Concrete repairs to lintels
- 7.1.8 Budget provisions in relation to the above items and for future maintenance and repairs will need to be prepared based on further investigations, design and specification.

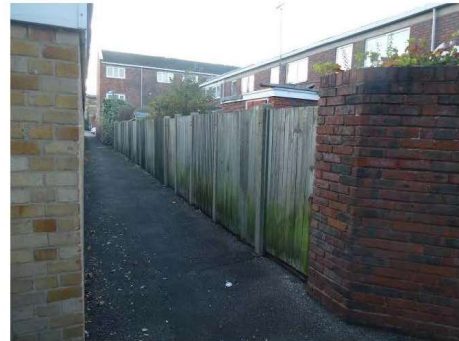
Photograph 14 – view of rear garden fences

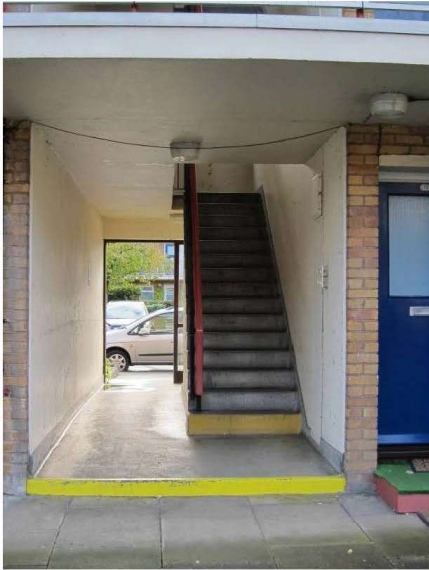
Photograph 9 – Hilborough Close Typical communal staircase. Note doors to entrance have been removed on front elevation. No doors fitted to rear.

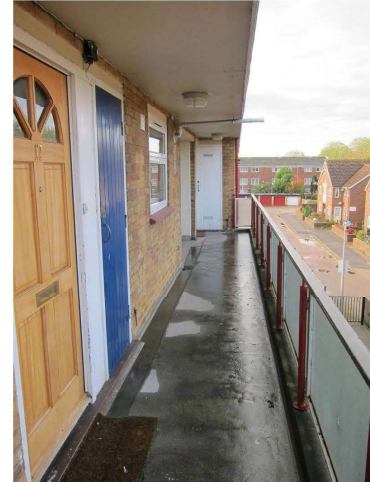
- 3.4.1 Deck access balconies have been provided for access to upper floor level flats. These are of reinforced concrete construction and are extensions of the suspend floor structures. Cracking was apparent on the underside of the balconies and rainwater penetration has been prevalent for a considerable number of years. Please refer to the structural engineers for further details of this problem.

- 3.4.2 The top of the balcony slabs has been weathered in asphalt laid to falls to balcony gullies and cast iron rainwater down pipes. Asphalt has cracked due to movements in the balcony structure and is in need of repair.

- 3.4.3 The edge protection to the access balconies is provided by painted steel balustrades and glazed panel balustrades. The balustrade steels embedded into concrete balcony slabs are corroding. These and associated asphalt details require attention.

Photograph 11 – Hilborough Close Access Balcony

- Concrete and asphalt repairs to deck access balconies
  - Concrete and asphalt repairs to private balconies
  - Repairs to all external balcony balustrades

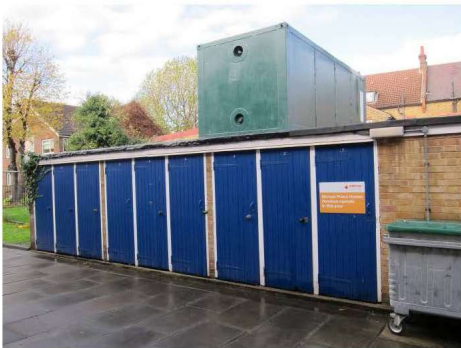
Photograph 12 – Hilborough Close Typical view external tenant stores – note roof covering in poor condition

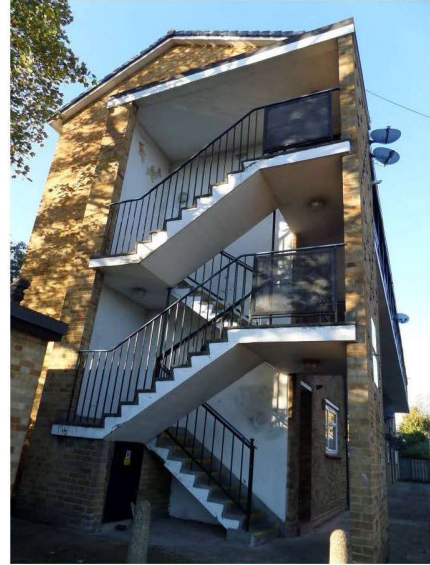
- 3.4.7 The Merton Place second floor level access balcony is reached via an external staircase located at the South end of the block. This is of concrete and brickwork construction. Stairs and landings are constructed of concrete and are finished in granolithic finish with painted concrete strings and soffits. This staircase is in poor condition and in need of urgent repair.

Photograph 15 – Merton Place -External access stairs. Note concrete repairs are required

- 7.1.6 A number of 'wants of repair' and potential for improvement were noted during the survey. These include:
- Concrete repairs to Merton Place external staircase

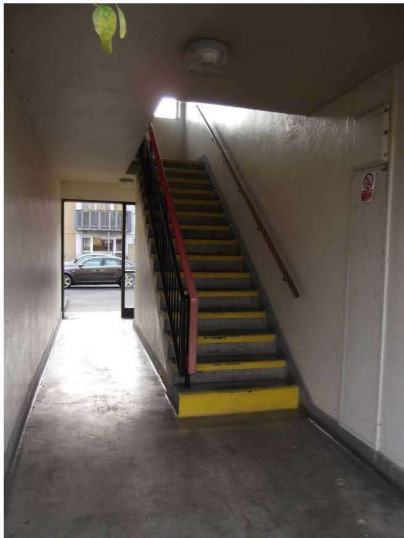
Photograph 18 – Norfolk House -Communal entrance and stair. Note missing doors

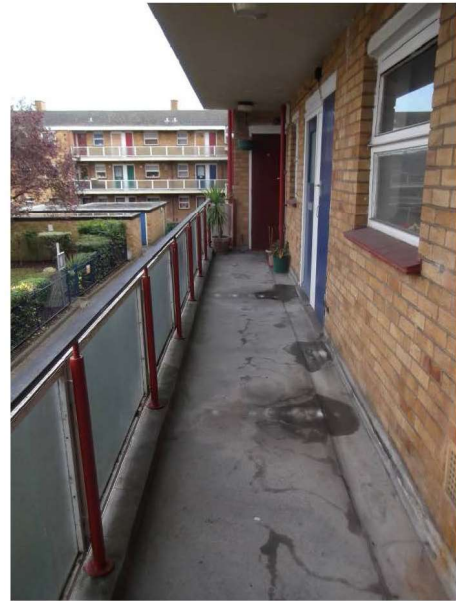
Photograph 18 – Norfolk House – Typical access balcony
