Photograph 4 – Mychell House - Tenant stores

Photograph 5 – Tanner House – Elevation

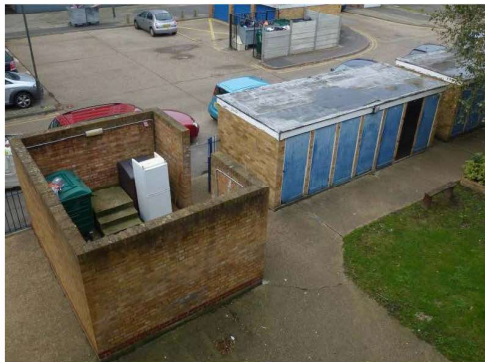
Photograph 11 –refuse area and external stores

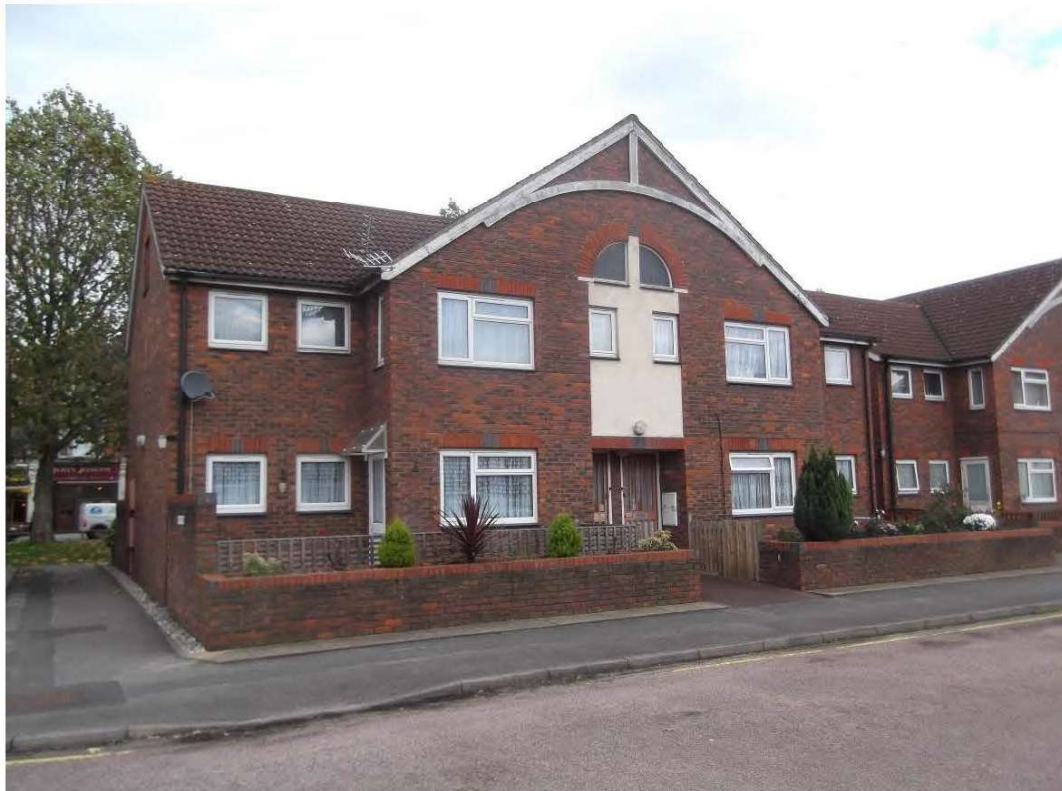
Purpose of Issue: **Draft for Information**  
Date: 16 November 2014  
Job No: P178

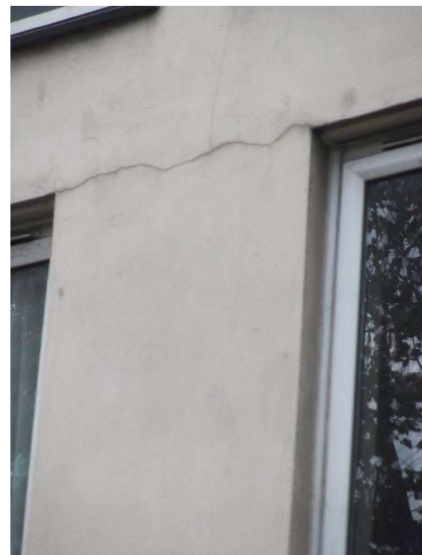
Photograph 4 – typical view of cracking in render

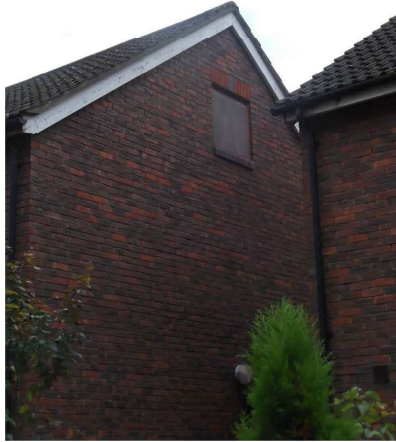
Photograph 5 – View of typical gable. Access hatches to roof voids are in poor condition and in need of replacement

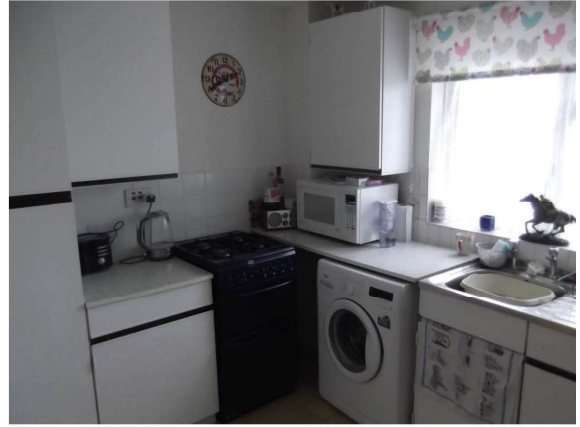
Photograph 6 – Kitchen to flat 6

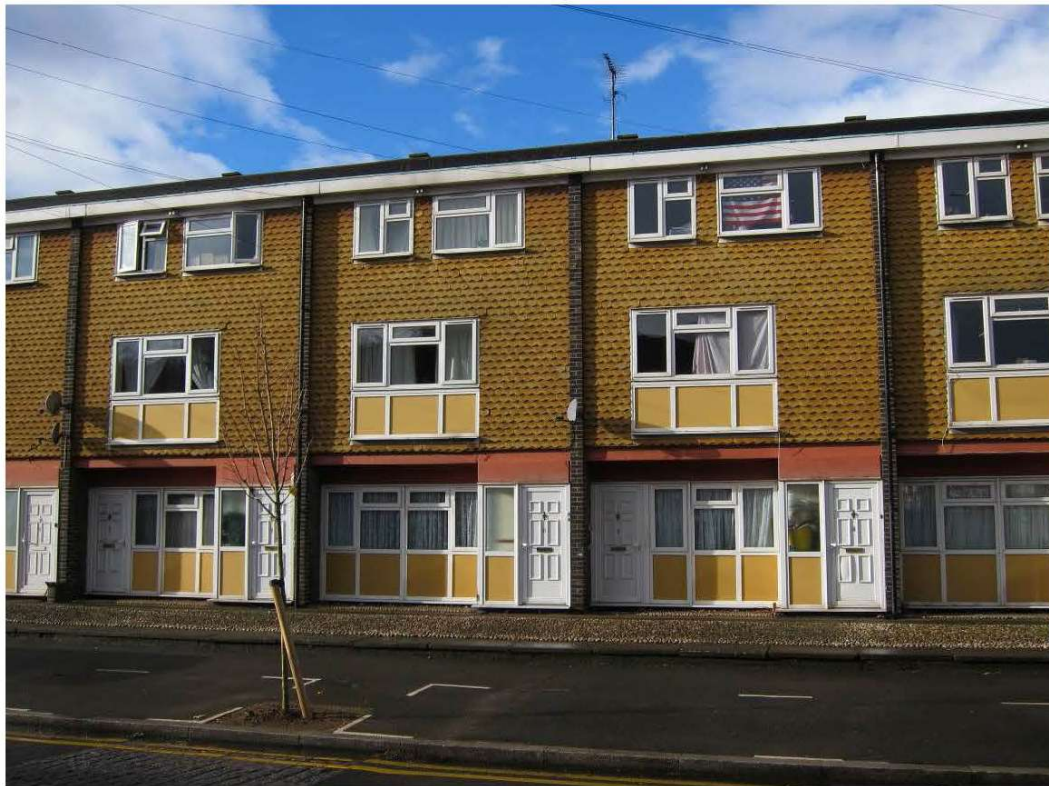
Purpose of Issue: **Draft** for Information  
Date: 22 November 2014  
Job No: P178

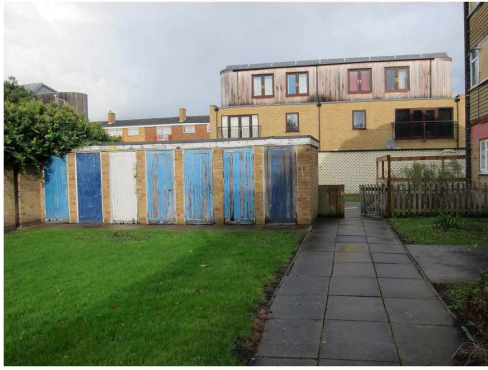
Photograph 4 – Tenants stores and communal garden to rear of block. Stores are generally in a poor state of repair

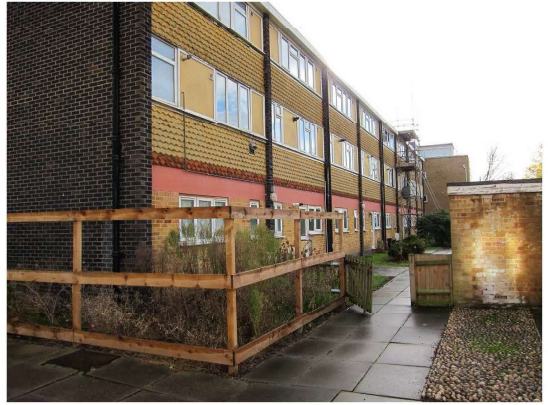
Photograph 5 – view of rear elevation with part completed timber boundary fence in foreground

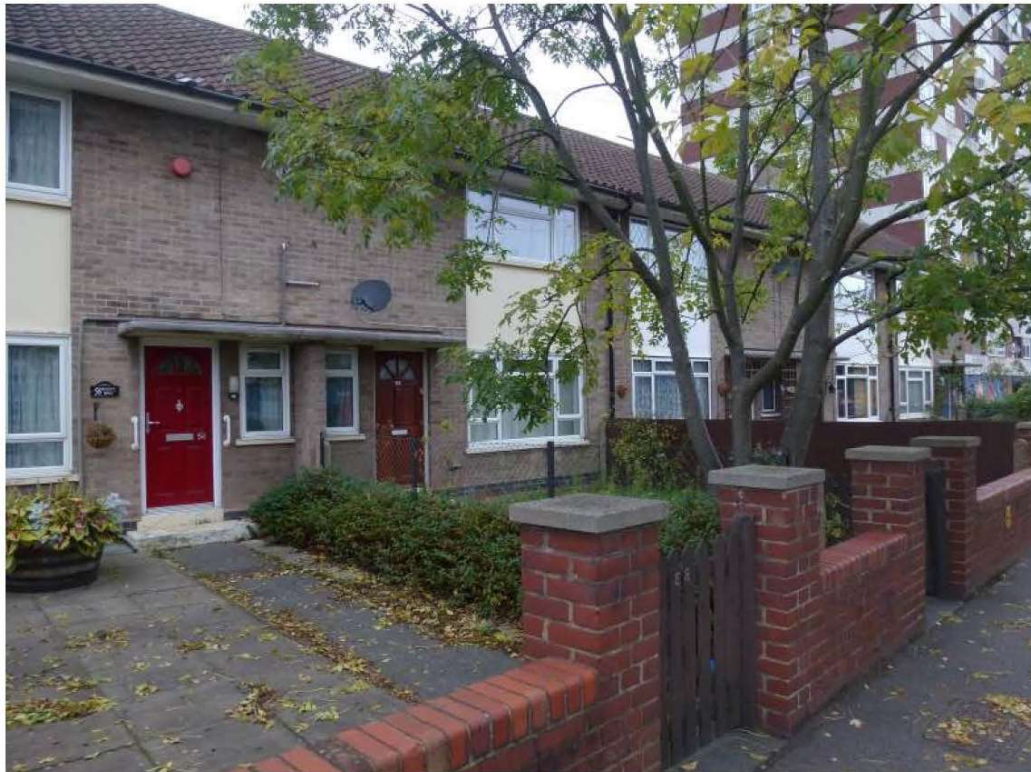
Purpose of Issue: **Draft for Information**  
Date: 22 November 2014  
Job No: P178

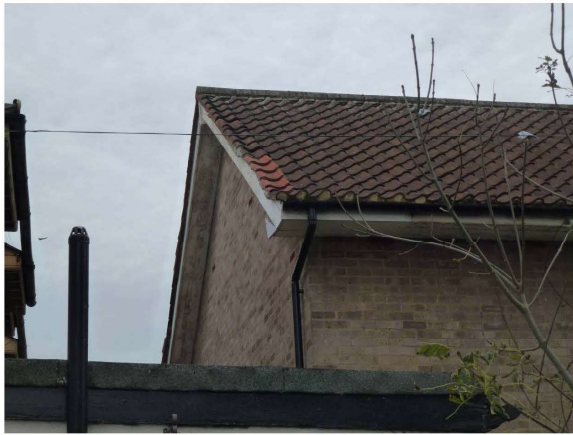
Photograph 5 – view of gable - Painted barge boards, soffit boards and fascia's all in need of repair

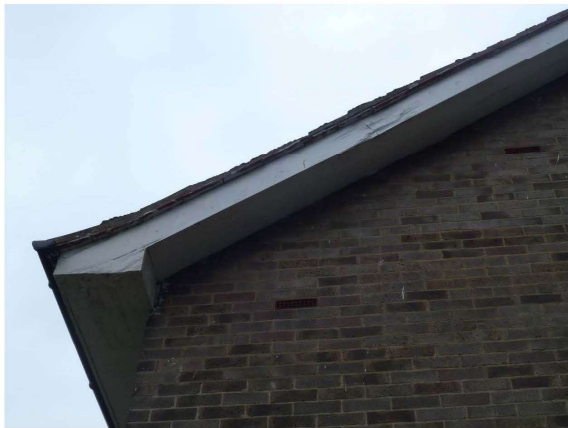
Photograph 6 - Rot in high level joinery.

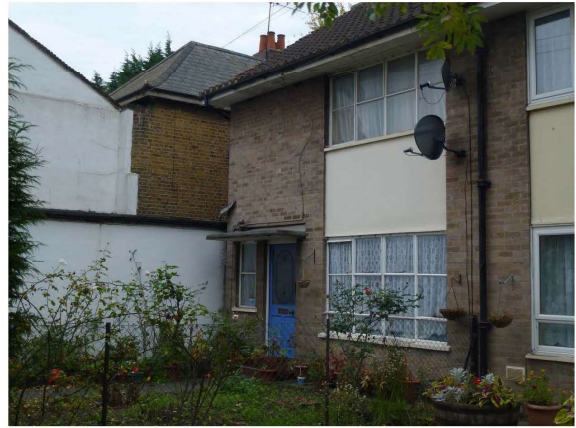
Photograph 5 – No. 60 Pincott Road – Front elevation with original Crittall type window configurations
