Structural Assessment Report of Ravensbury Grove
Flats
Ravensbury Estate Regeneration
For HTA Design LLP

Scheme No: 11264

Ravensbury Estate
Regeneration

14th October 2014

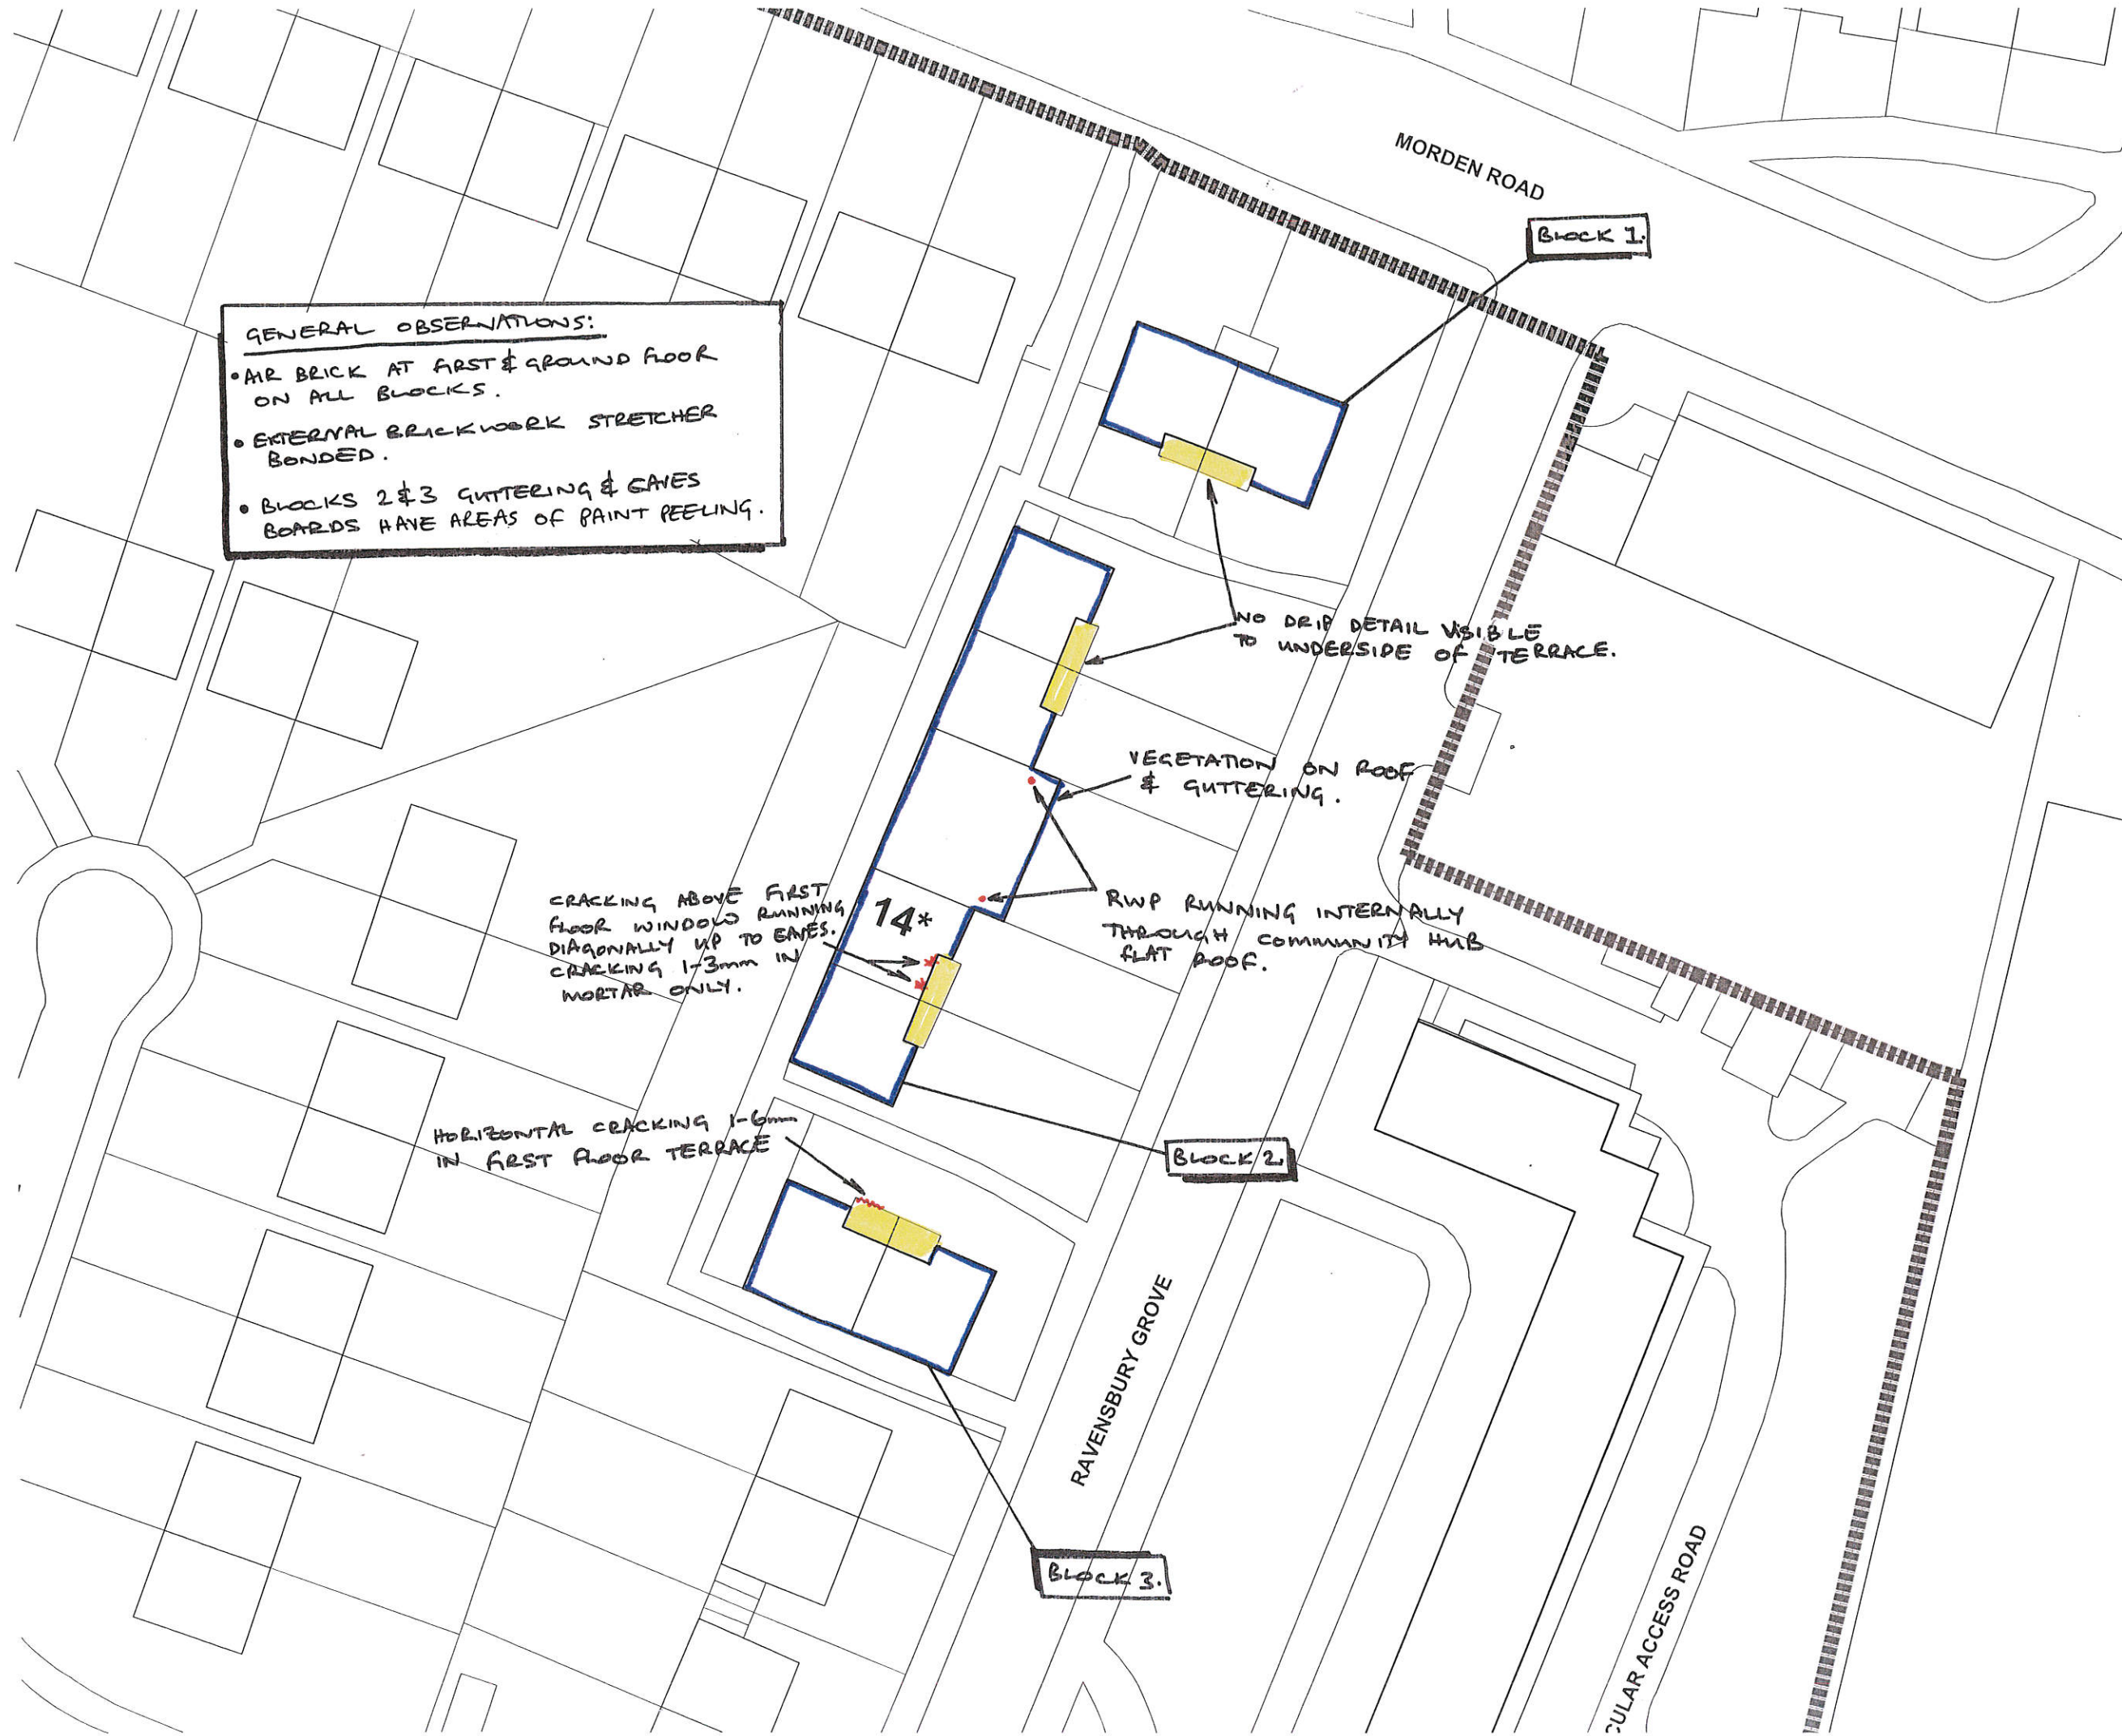
TITLE: Summary of External Observations to Ravensbury Grove Flats - Sht1
PROJECT: Ravensbury Estate
SCALE: 1:500@A1 DATE: 10/14 DRAWN: TP CHK'D:
JOB NO. DRG NO. REV.
11264 SK05

CRACKING ABOVE FIRST FLOOR WINDOWS RUNNING DIAGONALLY UP TO EAVES. CRACKING 1-3mm IN MORTAR ONLY.

HORIZONTAL CRACKING 1-6mm IN FIRST FLOOR TERRACE

NO DRIP DETAIL VISIBLE TO UNDERSIDE OF TERRACE.

VEGETATION ON ROOF & GUTTERING.

RWP RUNNING INTERNALLY THROUGH COMMUNITY HUB FLAT ROOF.

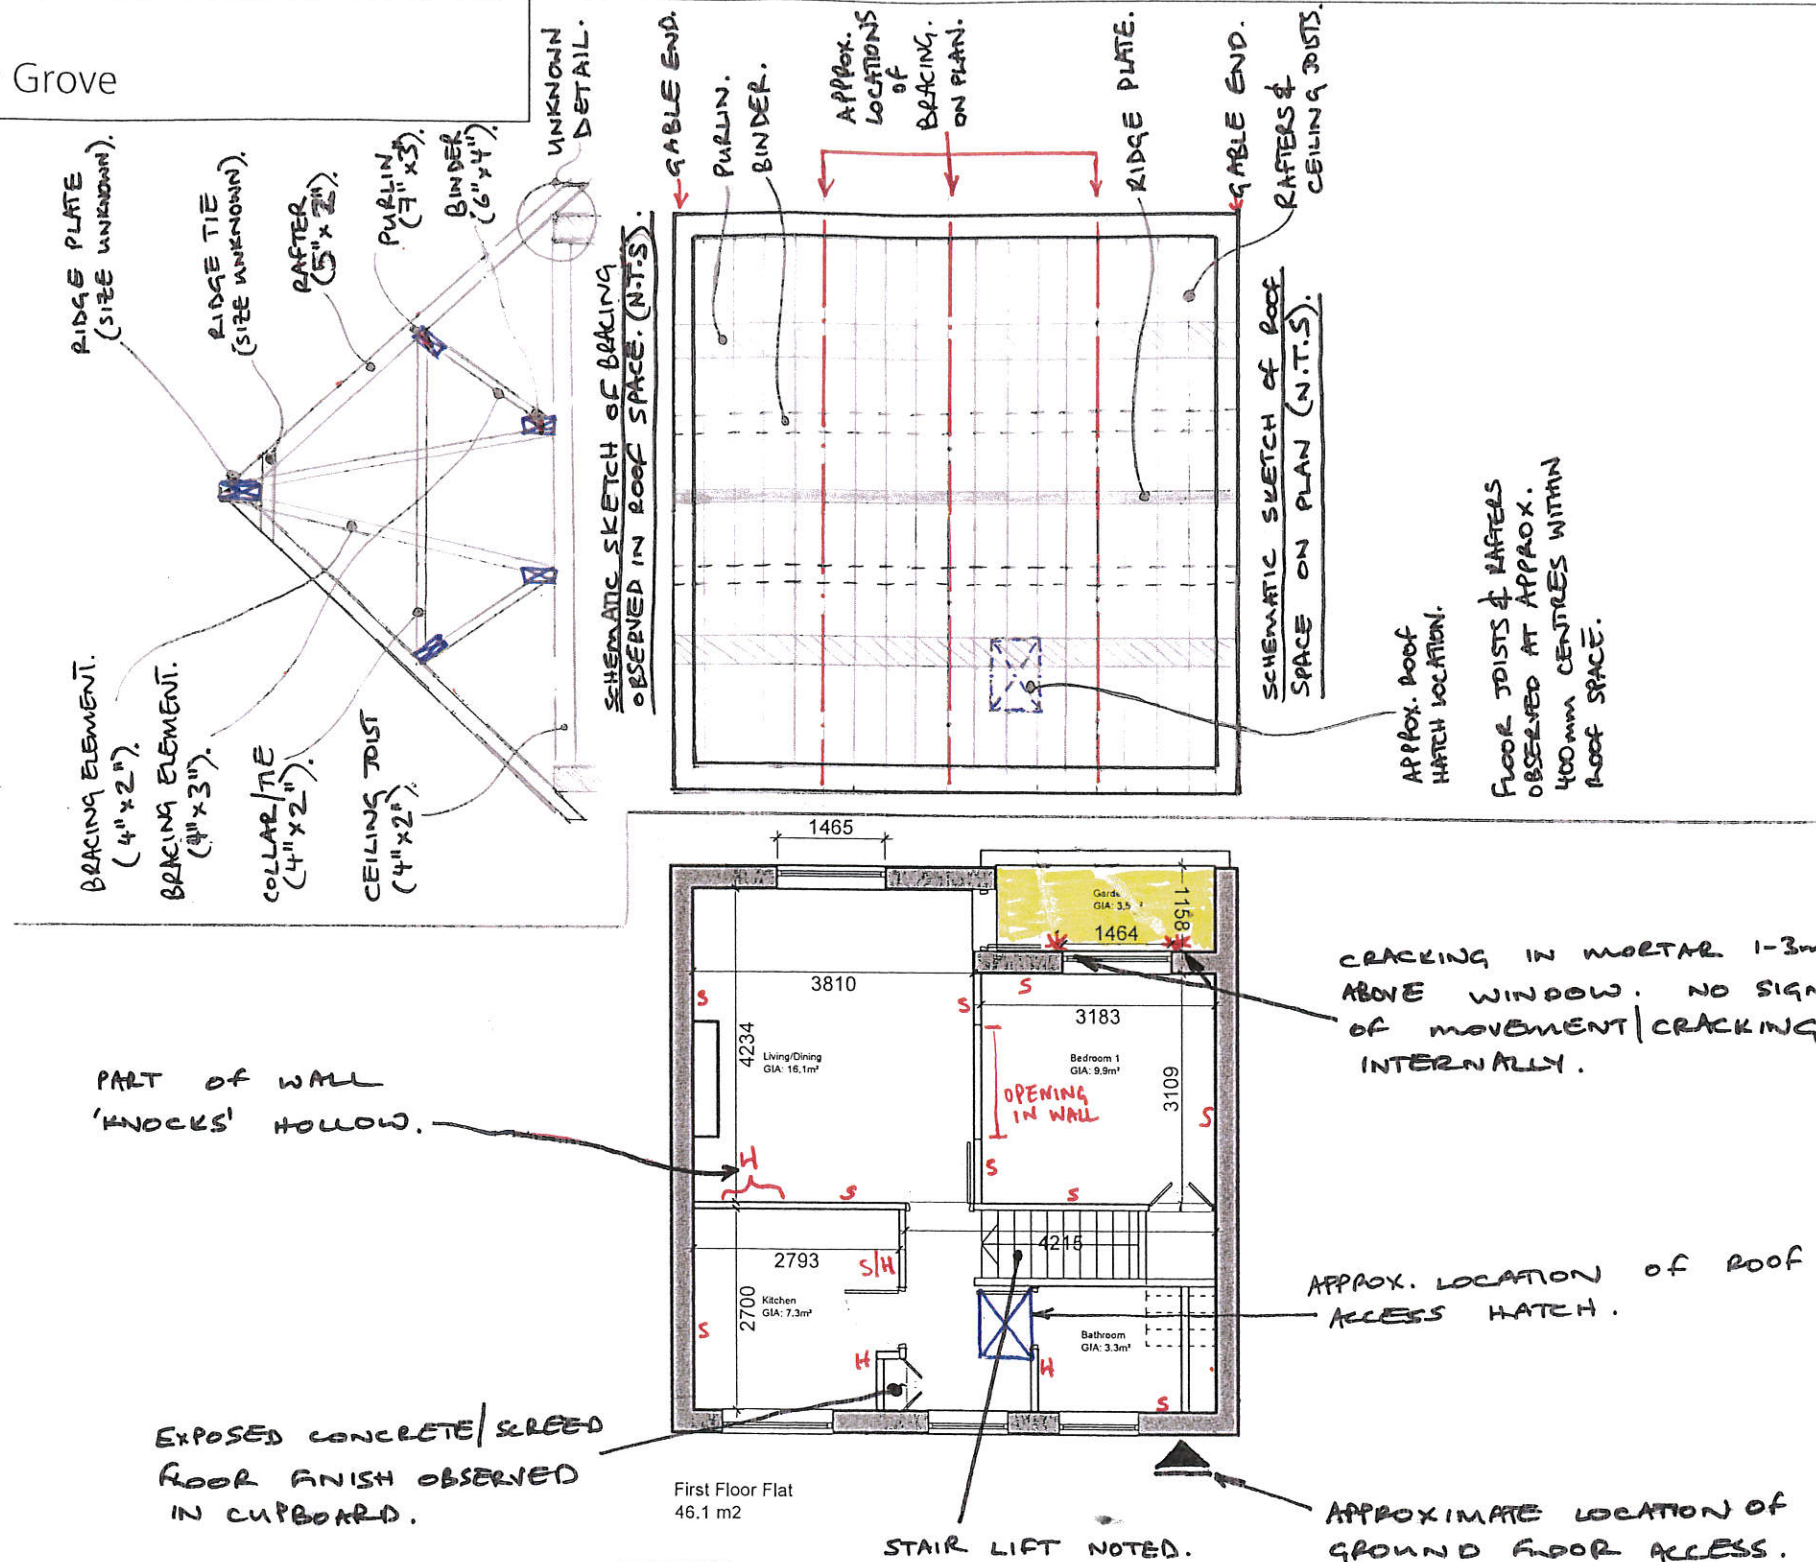
FILE: INTERNAL OBSERVATIONS TO 14 RAVENSBURY GROVE.
 PROJECT: RAVENSBURY ESTATE.
 SCALE: N.T.S. DATE: 10/14 DRAWN: TP CHK'D:
 JOB NO. 11264 DRG NO. SK 07 REV.

FLOORS FEEL SOLID
 ALL ROOMS & TERRACE.

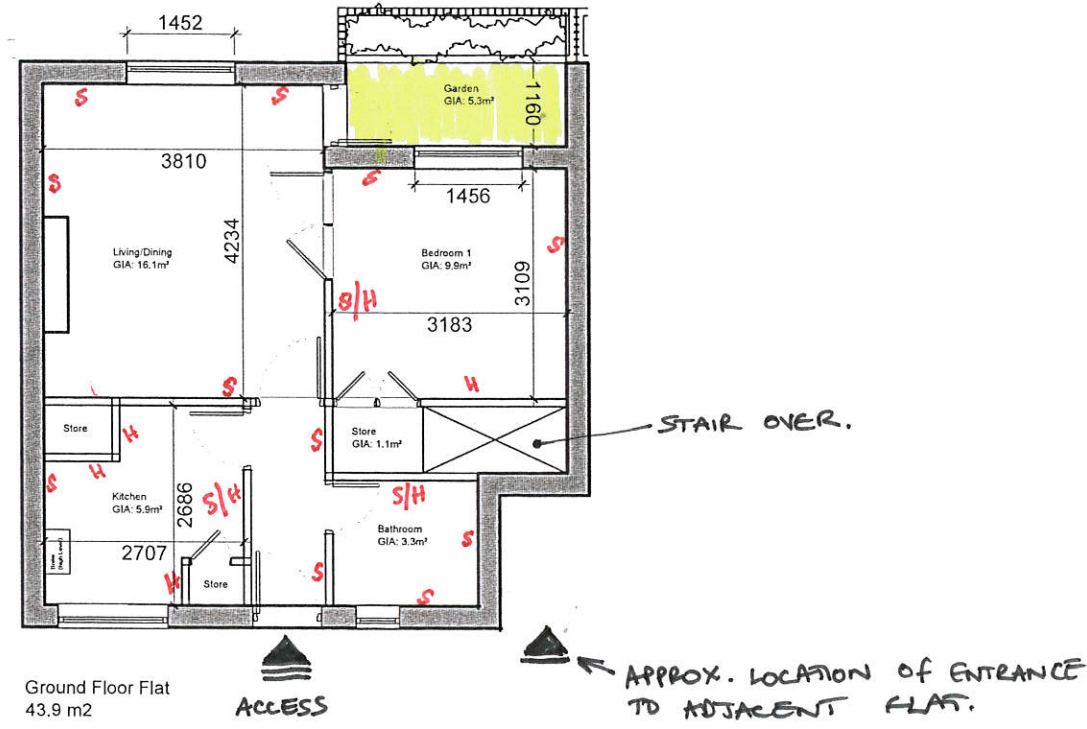
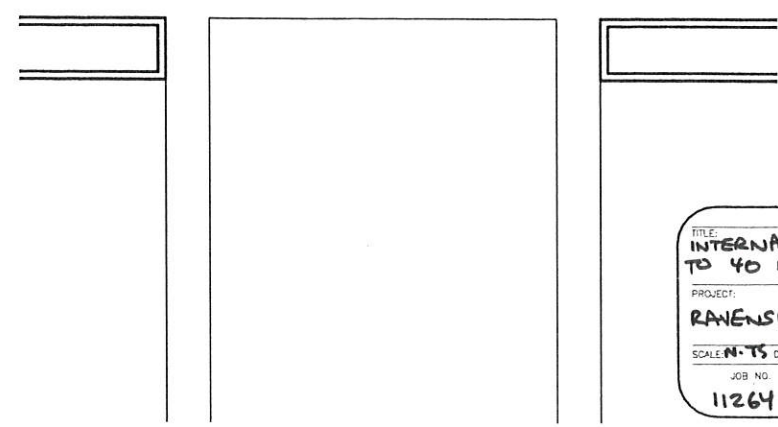
FILE: INTERNAL OBSERVATIONS TO 40 RAVENSBURY GROVE.
 PROJECT: RAVENSBURY ESTATE
 SCALE: N.T.S. DATE: 10/14 DRAWN: TP CHK'D:
 JOB NO. 11264 DRG NO. SK 08 REV.

NO ADVERSE SIGNS OF DAMAGE/ DETERIORATION INTERNALLY.

FLOOR FEELS SOLID IN ALL ROOMS.

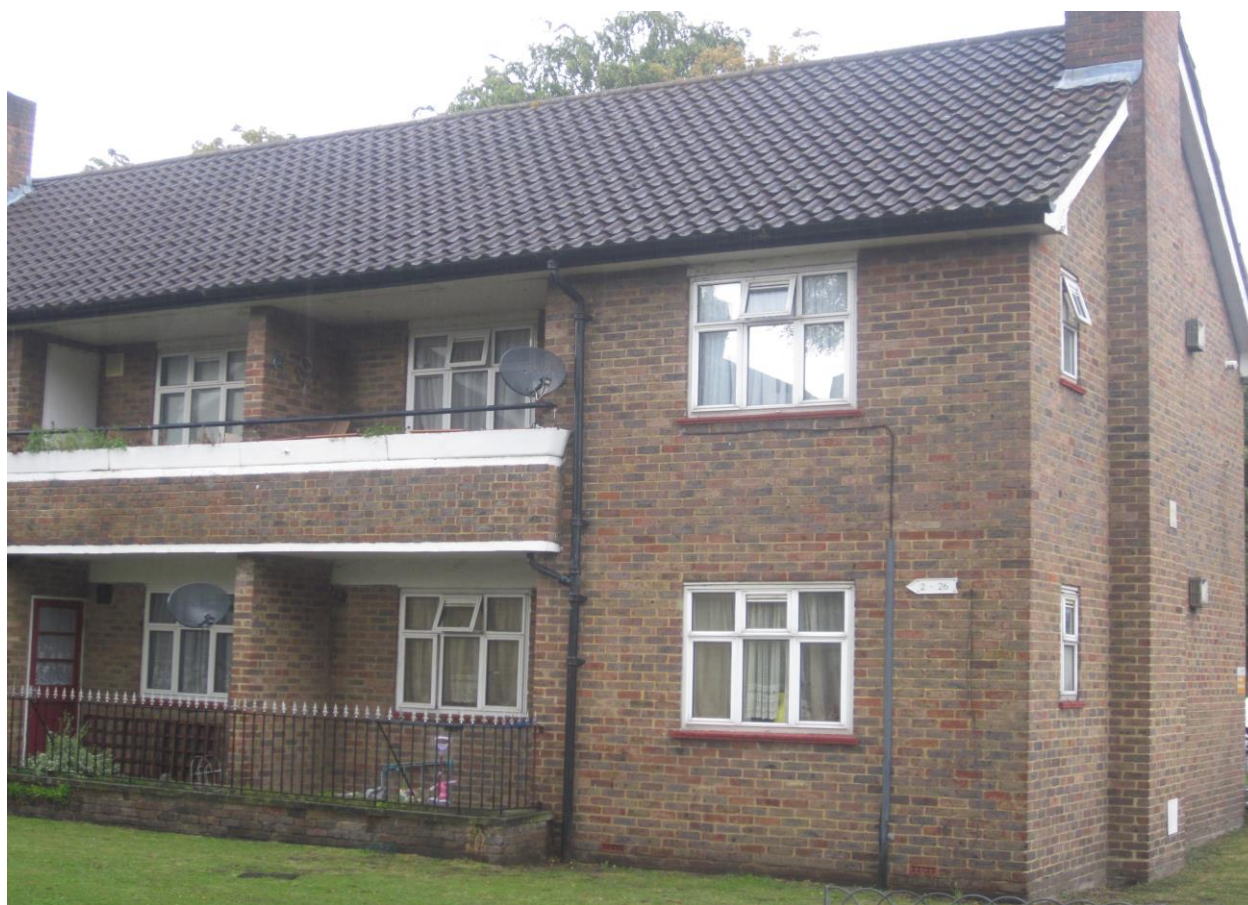
Photograph C1 – 171-177 Morden Road

- 3.1 The five buildings forming the Ravensbury Grove flats appear to be of similar construction. They are all two storey brick faced buildings, with tiled pitched roofs. Where observed, the dwellings are arranged as single storey ground floor flats with single storey first floor flats over. Each of the plots have their own private balcony/terrace area on the front elevations at ground and first floor level respectively. (See photograph C1).

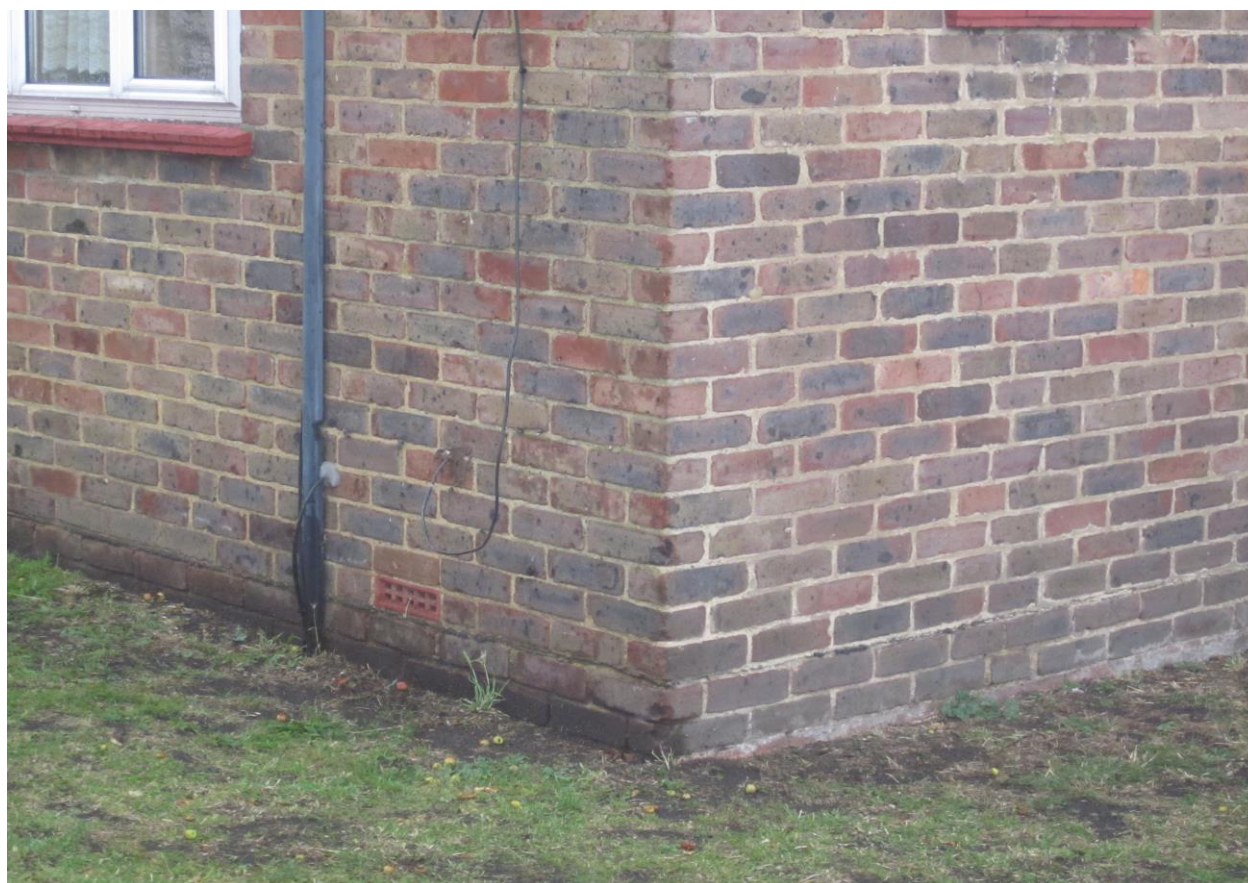
- 3.5 The external brickworks walls are stretcher bonded and appear to be of cavity wall construction. Air bricks in the elevations at both ground and first floor levels support this view. Party walls between properties also appear solid.

Photograph C2 –Ravensbury Grove Flat's Block- Air Brick at Ground Level

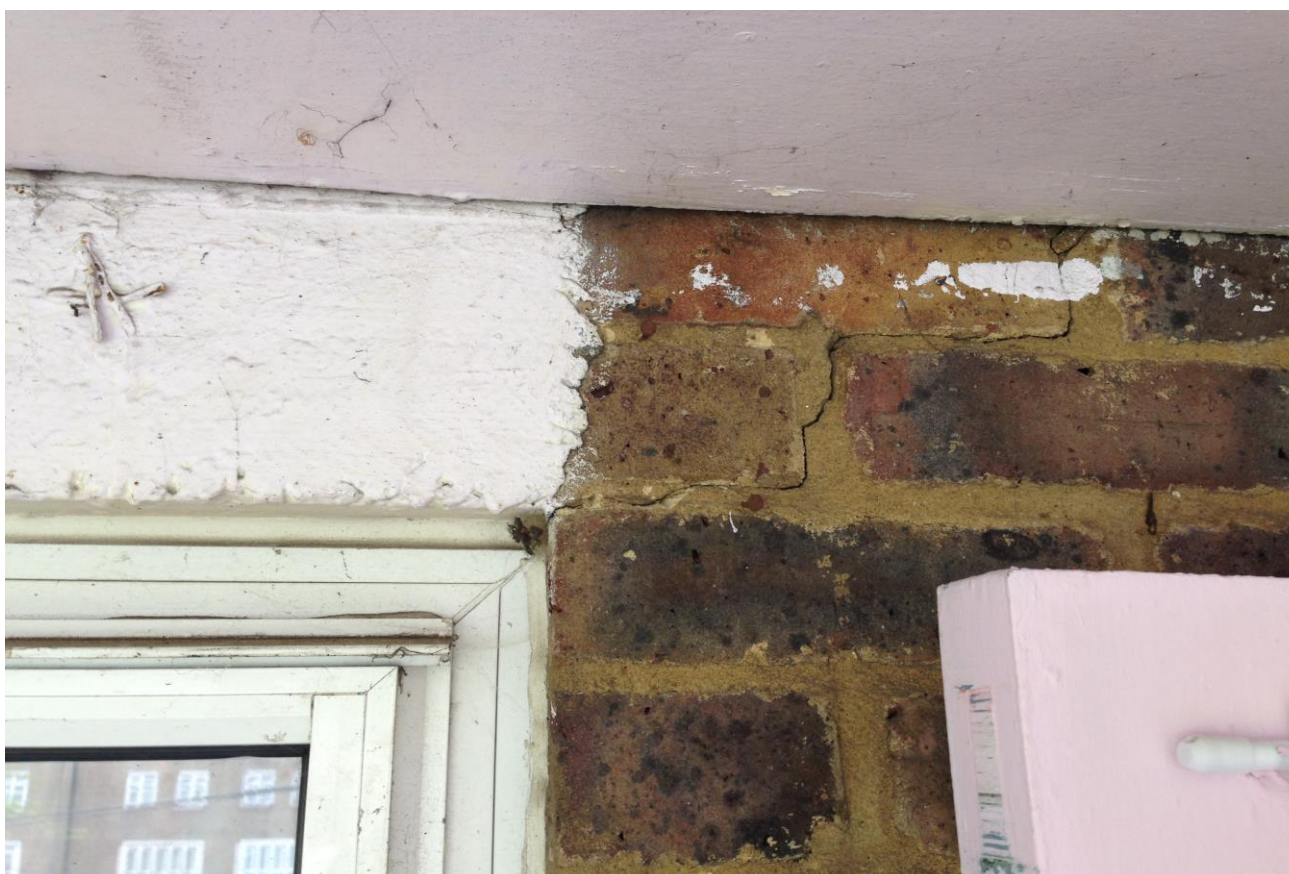
- iv. Cracking was observed externally in the mortar joints above the terrace window of 14 Ravensbury Grove within flat Block 2. These vary between 1mm and 3mm in width and appear not to be recent. (See photographs C4 and C5). No cracking or signs of movement were evident internally.

- 5.5 The cracking seen at the window head on 14 Ravensbury Grove may be suggestive of very slight thermal movement along the length of the building. The movement is not significant structurally and the opened up joints should be made good.

Photograph C4 – 1-3mm Crack in Mortar Above Window on 14 Ravensbury Grove External Terrace

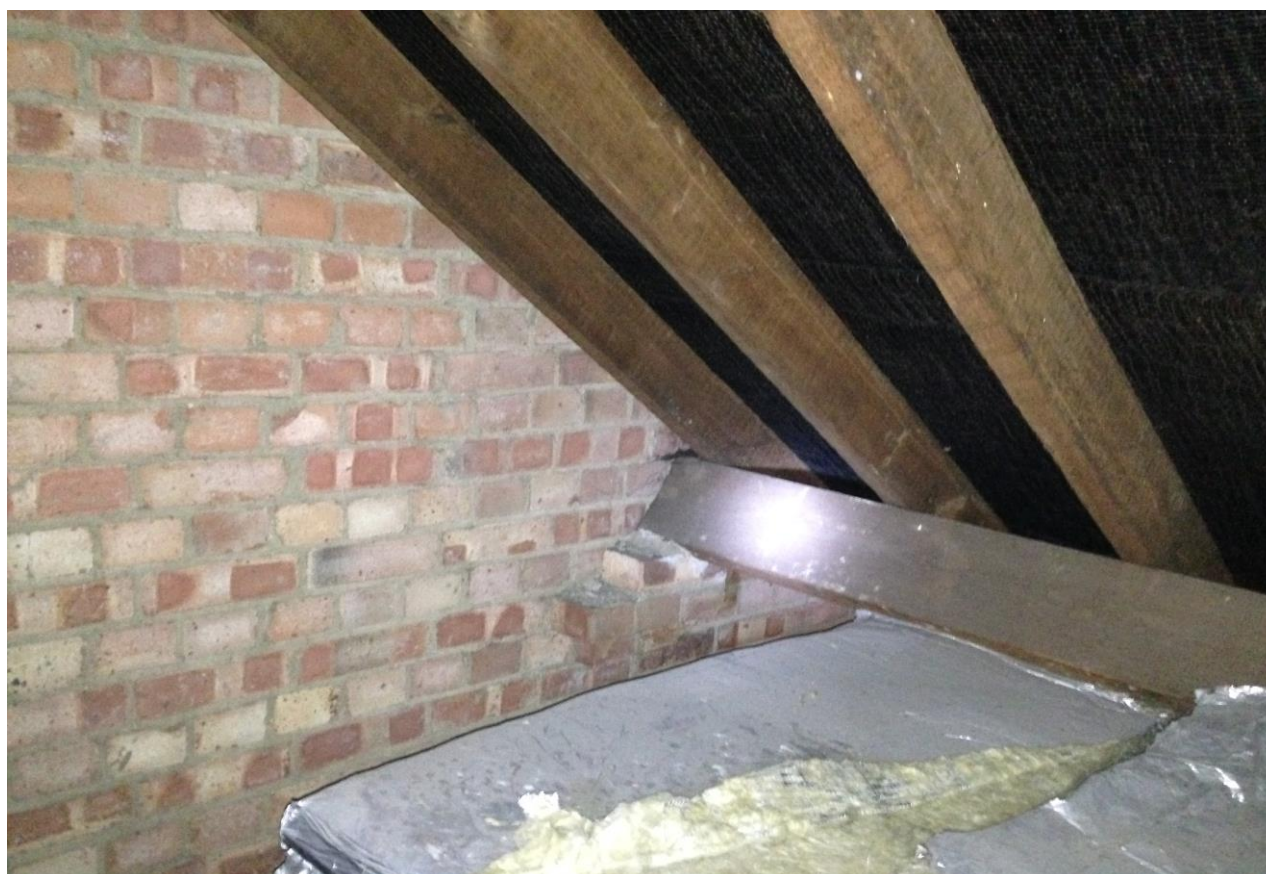
- 3.10 The main roofs are all pitched and gable ended. The roof above 14 Ravensbury Grove was carpentered, consisting of rafters extending down from a ridge plate to the front and rear external walls. Timber purlins provide additional support to the rafters and are supported by the masonry gable ends. There are also timber braces to provide stability to the roof structure. Sketch no. 11264/S07 and photographs C6 to C10 illustrate the timber roof arrangement.

Photograph C6 – Purlin Support on Masonry Gable

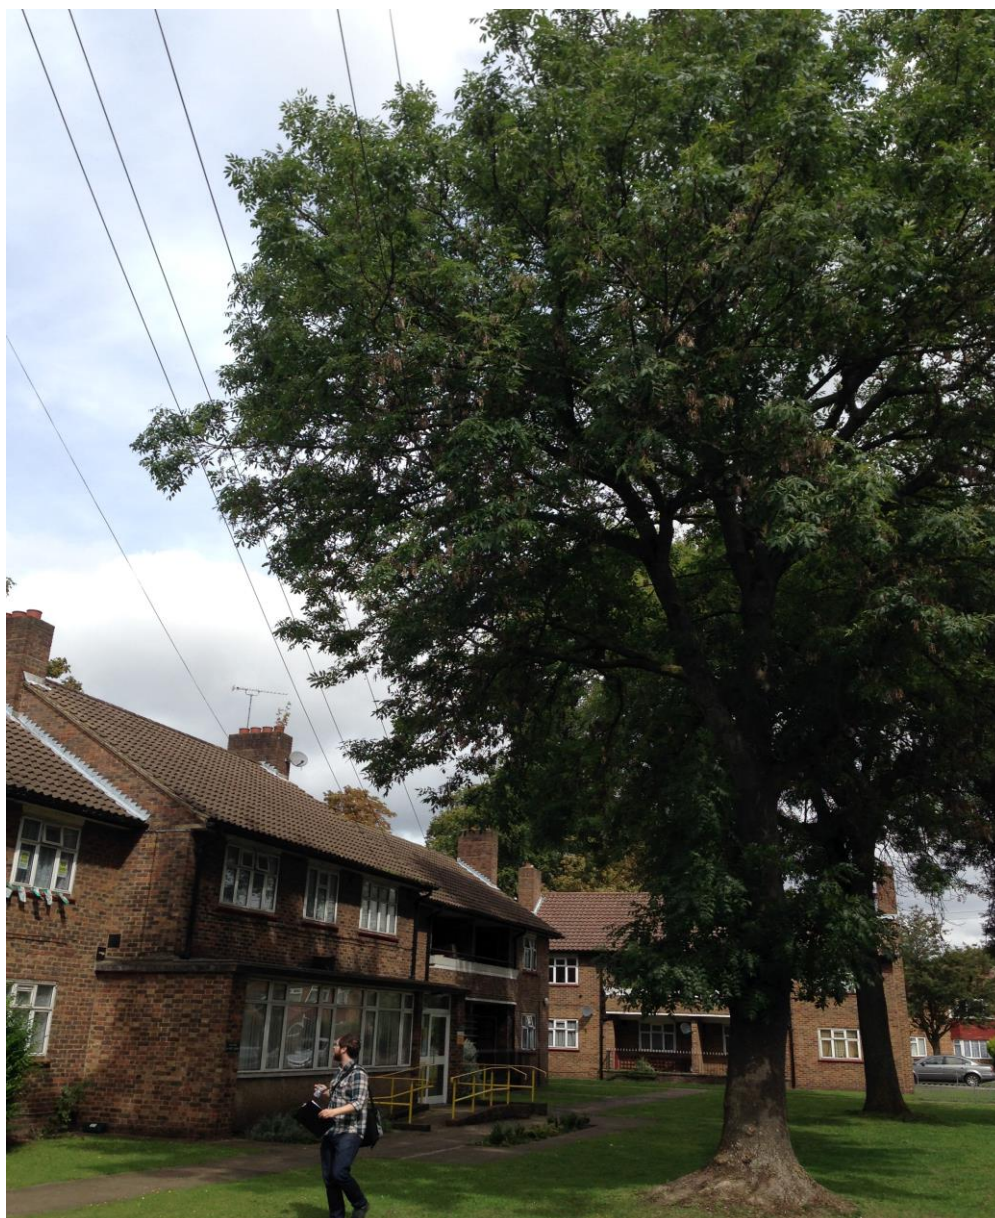
Photograph C11 – 2-18 Ravensbury Grove and Community Hall

- 3.2 The flat blocks are generally occupied as residential dwellings with the exception of Block 2 (2-18 Ravensbury Grove) which also houses the Estate's Community Hall. The Community Hall is single storey and projects externally from the main line of the building on the front elevation. The projected section has a flat roof which appears to have a felt finish. Rainwater pipes pass through though the flat roof and run internally within the Community Hall. Photograph C11 illustrates the Community Hall flat roof.

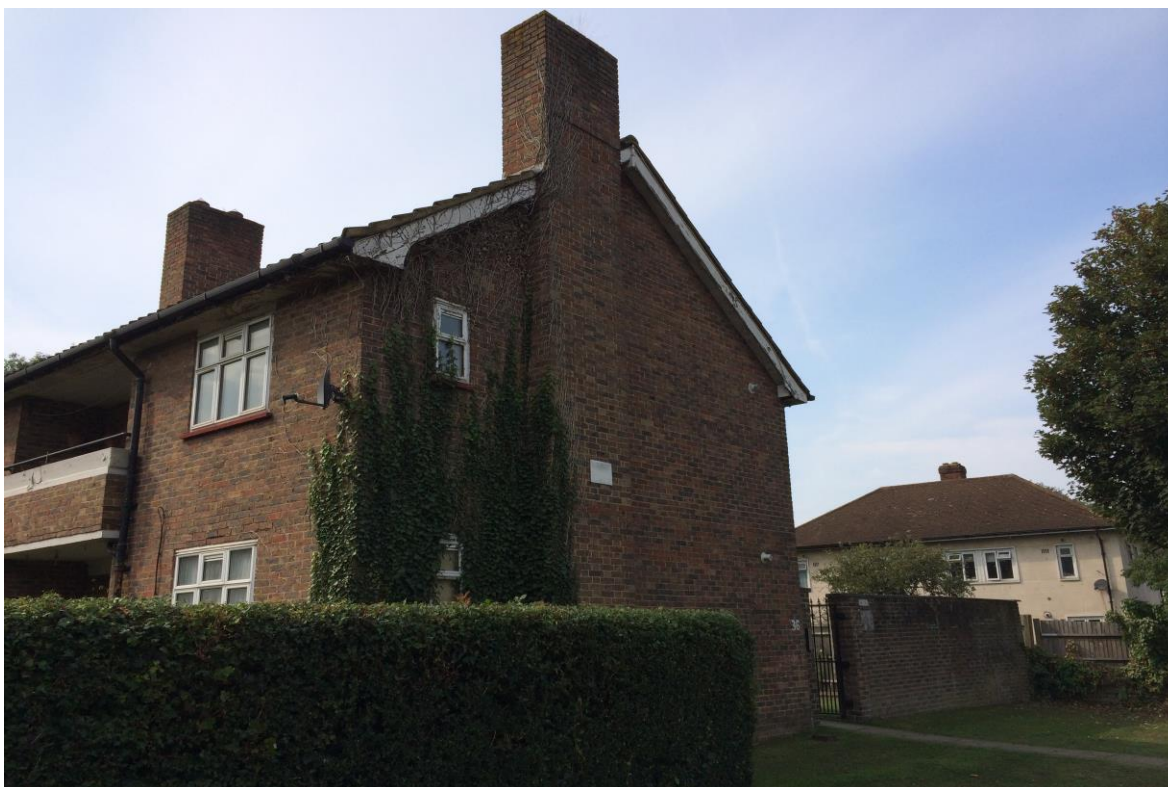
- 4.2 The following observations were made externally:
- i. The guttering and eaves boards of Blocks 2 to 5 have paint peeling in some locations.
 - ii. Vegetation was observed on the roof and guttering of Block 2. Vegetation was also observed to the side elevation of Block 4. (See photograph C12).

- 5.3 From the observations carried out, there are a few issues which suggest water ingress may be affecting the structure locally. These relate to the eaves boarding and guttering where vegetation has been allowed to take hold. Over time, roots from vegetation will extend in to the building fabric further, encouraging water ingress to occur. It is therefore important that the guttering is cleared and any damage to the finishes made good.

Photograph C12 – Vegetation to Side of Block 4 and Peeling of Paint to Eaves Board
