MERTON SECTION 19 FLOOD RISK INVESTIGATION REPORT

PREPARED FOR LONDON BOROUGH OF MERTON

Authored by: Adam McCue
Reviewed by: Tom Whitworth
Approved by: Mike Mair
Date: Aug 2023
Version 1.3

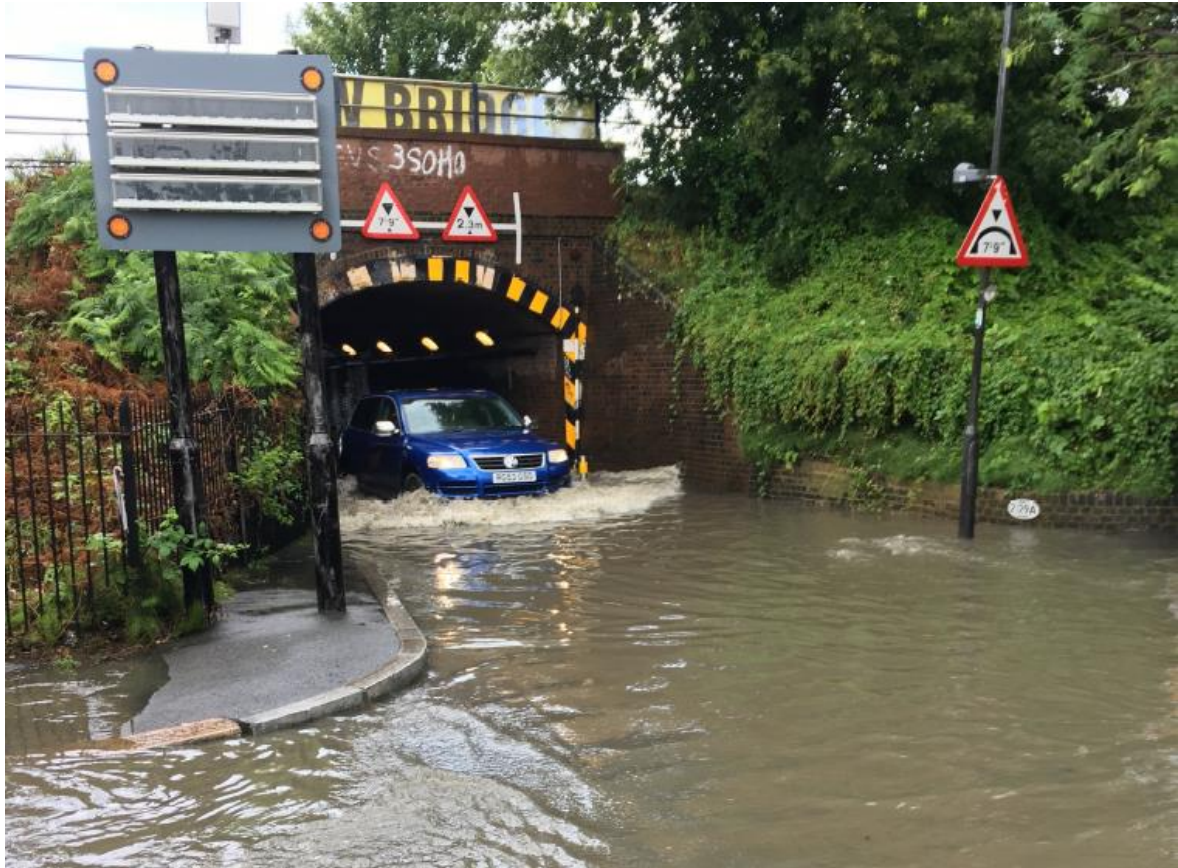
highway flooding resulted in the MPS closing access to Coombe Lane, Abbott Avenue, Worple Road, and the railway underpasses at Lower Downs Road and Approach Road (as shown in *Figure 5.2* and *Figure 5.3*), thus impacting access routes for emergency services. The most severe flooding occurred along Coombe Lane where floodwaters were deepest running parallel to the railway embankment and within the underpass, shown in *Figure 5.3*.

Figure 5.2: Flooding to the Lower Downs Road underpass on 12th July 2021 (Resident's photo submitted to Merton Council)

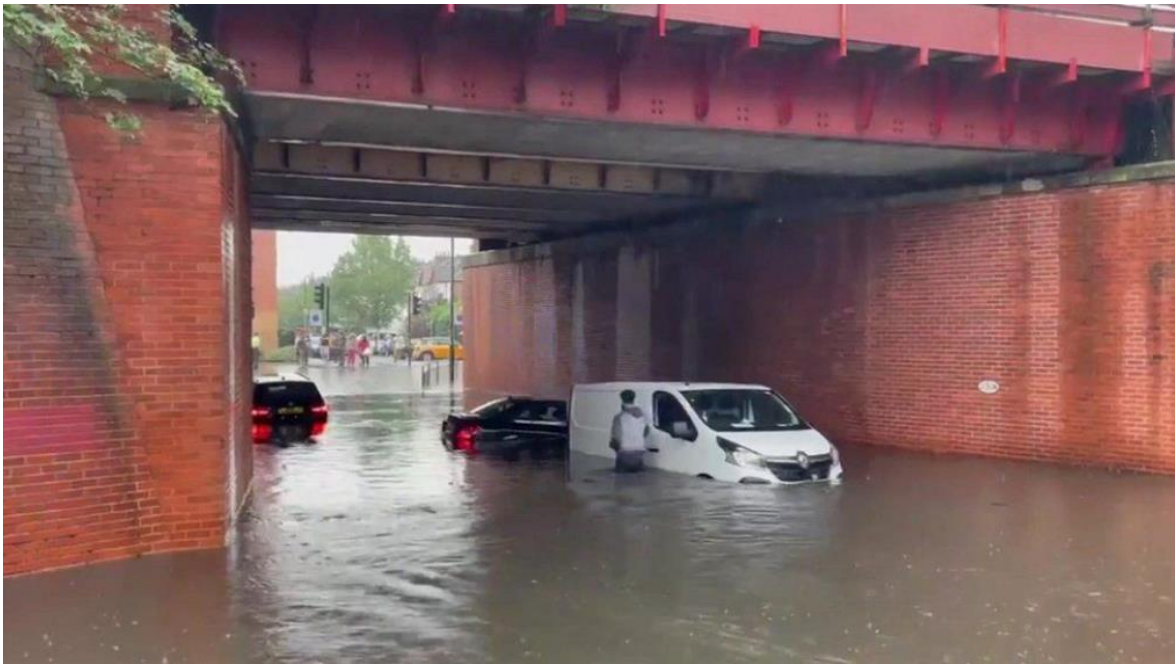
Figure 5.3: Flooding to the Approach Road underpass in Raynes Park on 12th July 2021 (Resident’s photo submitted to Merton Council)

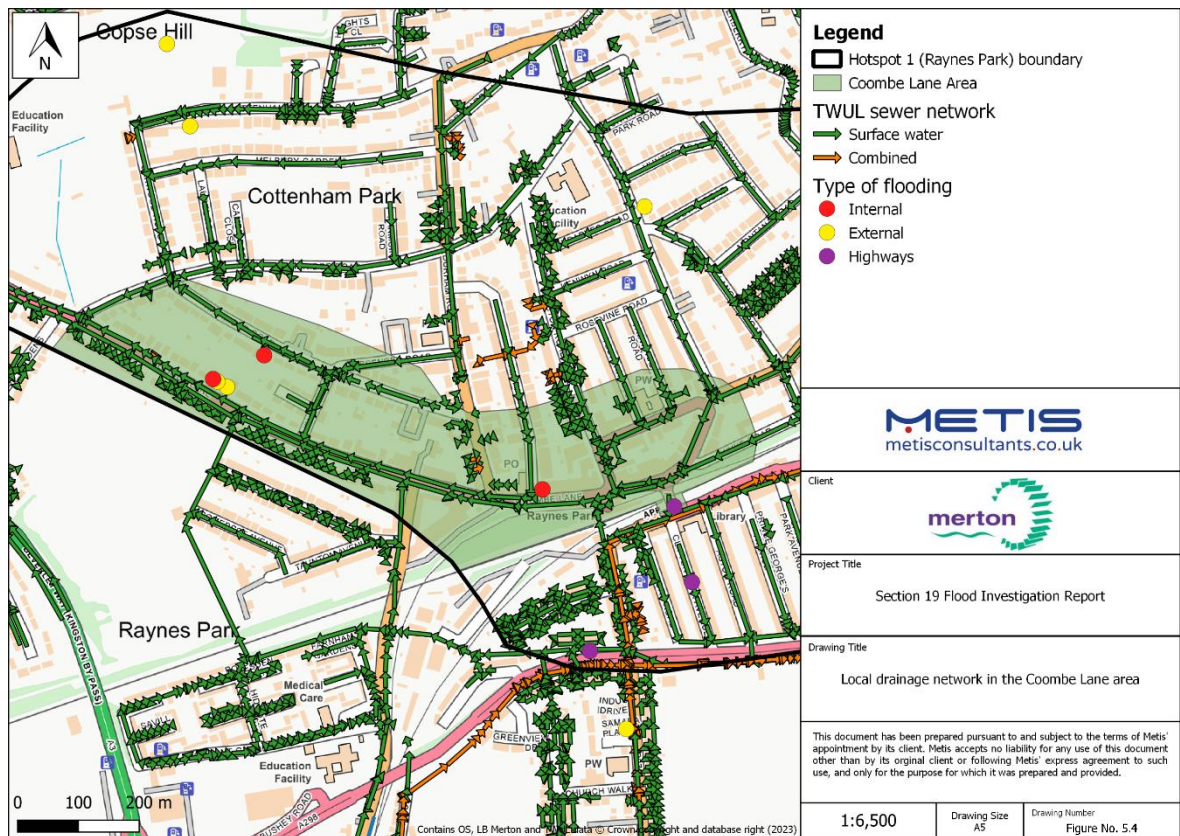
Figure 5.4: Local drainage network in the Coombe Lane area

[Map16 gully sensor data](#) provided by Merton Council show that the highway gullies in the Coombe Lane area were part of Merton Council's high-priority cleansing programme (whereby they are cleaned at least once annually and on an ad hoc basis following reports of blocked gullies at specific locations) during 2018/19 and 2019/20. Although Map16 data show that gullies along Coombe Lane had last been cleaned in June 2021 and were therefore part of the 2020/21 high-priority cleansing programme, gullies located below the railway line had most recently been cleaned in March 2020 prior to the July 2021 flood event.

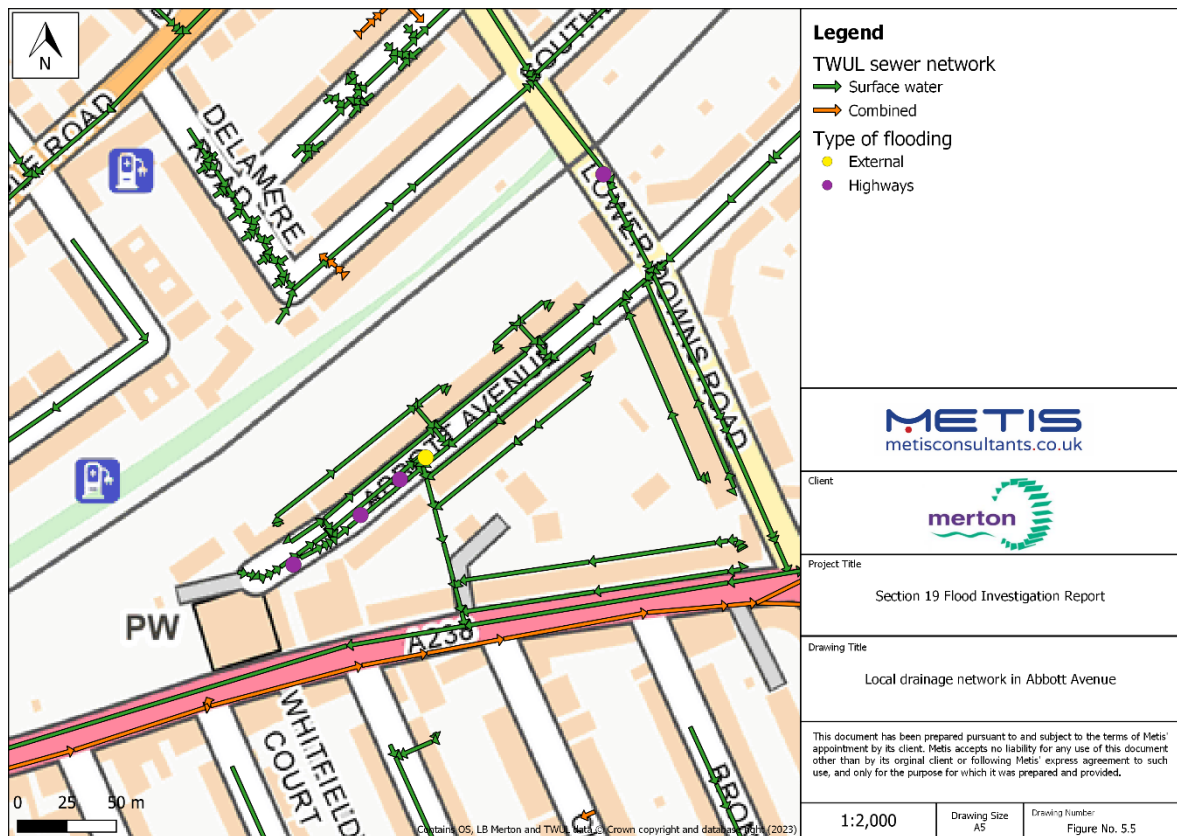
Figure 5.5: Local drainage network in Abbott Avenue

As stated in Merton Council’s previous Section 19 report, the highway gullies in Abbott Avenue were added to Merton Council’s high-priority cleansing programme after the 2016 flooding incident for 2016/17 and 2017/18. [Map16 gully sensor data](#) provided by Merton Council show that these gullies continued to be part of LB Merton’s high-priority cleansing programme during 2018/2019 and 2019/20. This means that they are cleaned at least once annually and on an ad hoc basis following reports of blocked gullies. However, Map16 data also show that prior to the flooding incident, gullies in Abbott Avenue had not been cleaned since March 2020. This indicates that they may not have been included in the 2020/21 high-priority cleansing programme, although it is possible that they were included but had not yet been cleaned prior to the July 2021 flood event.

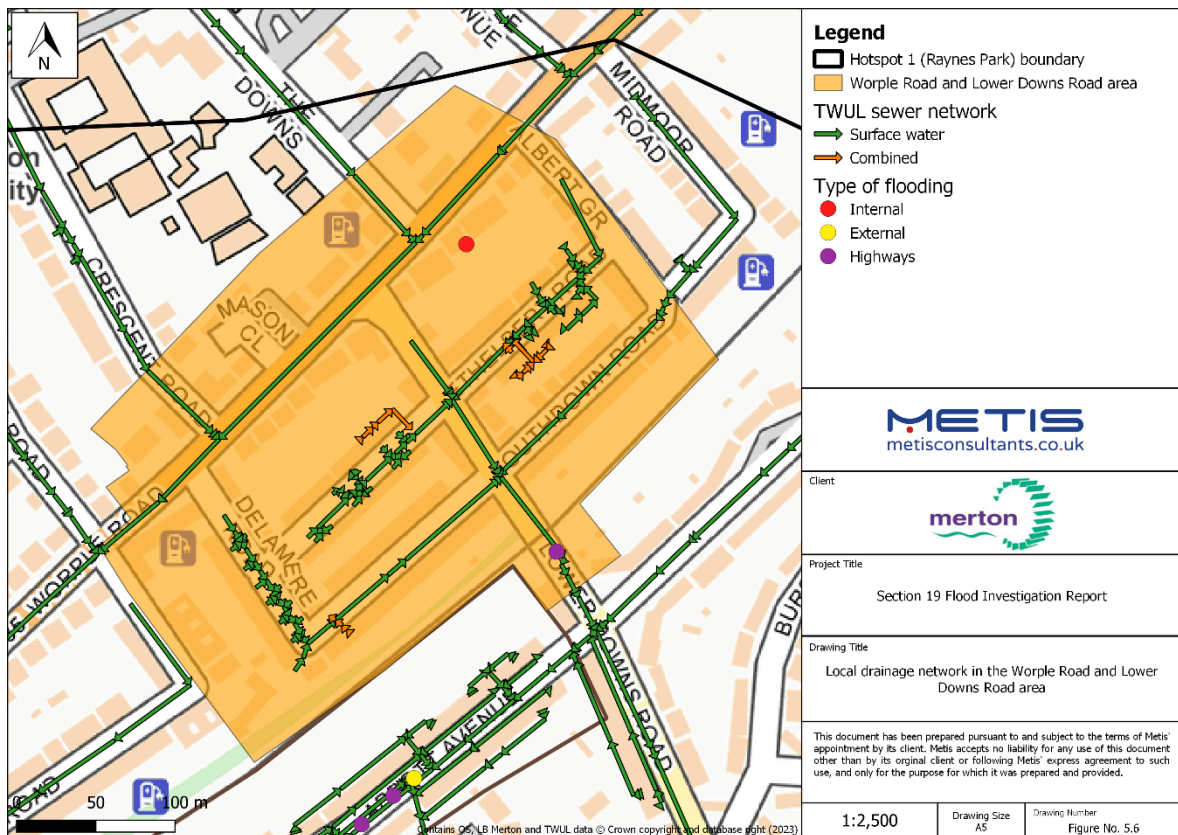
Figure 5.6: Local drainage network in the Worple Road and Lower Downs Road area

programme during 2018/19 and 2019/20, the last time that these gullies were routinely cleaned prior to the July 2021 flooding was in March 2020.

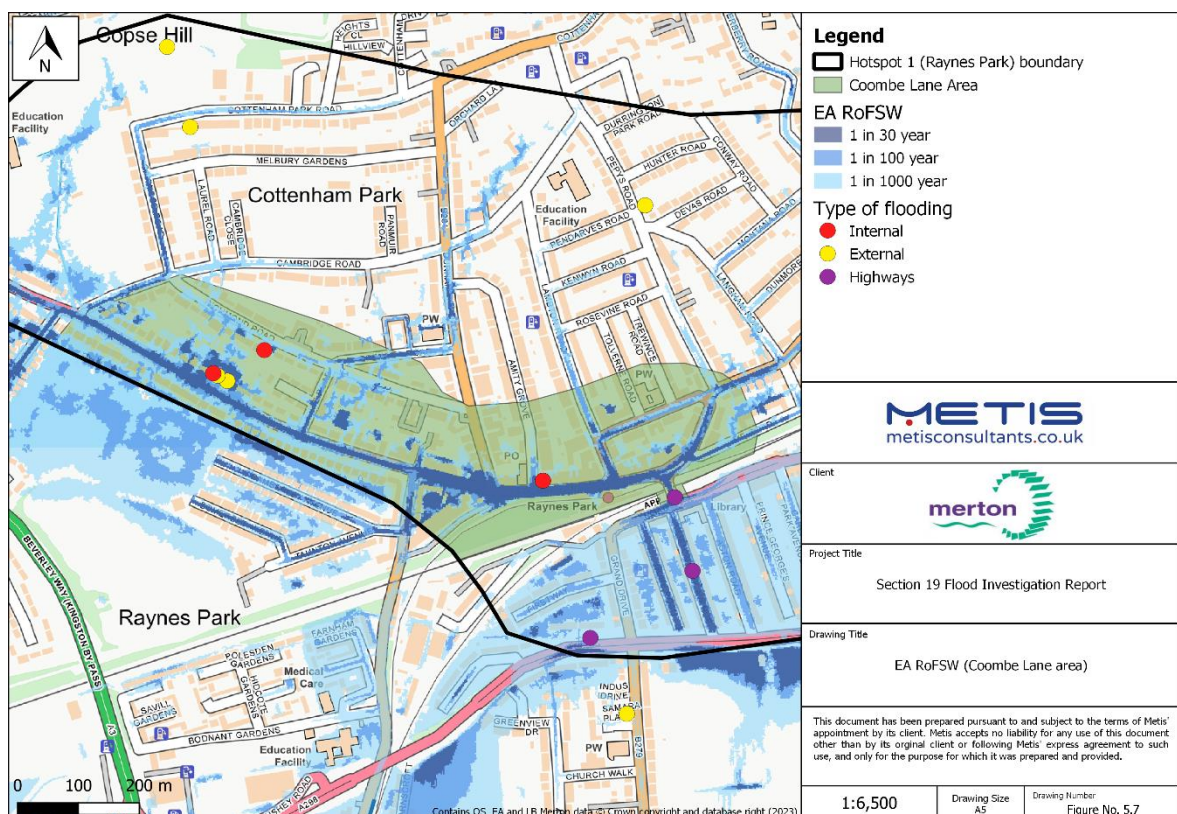
Figure 5.7: EA RoFSW (Coombe Lane area)

There is a high risk of surface water flooding to around 450m of Coombe Lane in central Raynes Park, to the railway underpass near Raynes Park Railway Station, and to parts of adjacent roads, namely Lambton Road, Worple Road and Pepys Road. Most roads adjacent to this section of Coombe Lane in central Raynes Park are at a medium risk of surface water flooding, including Lambton Road, Pepys Road, Wyke Road, and Avenue Road.

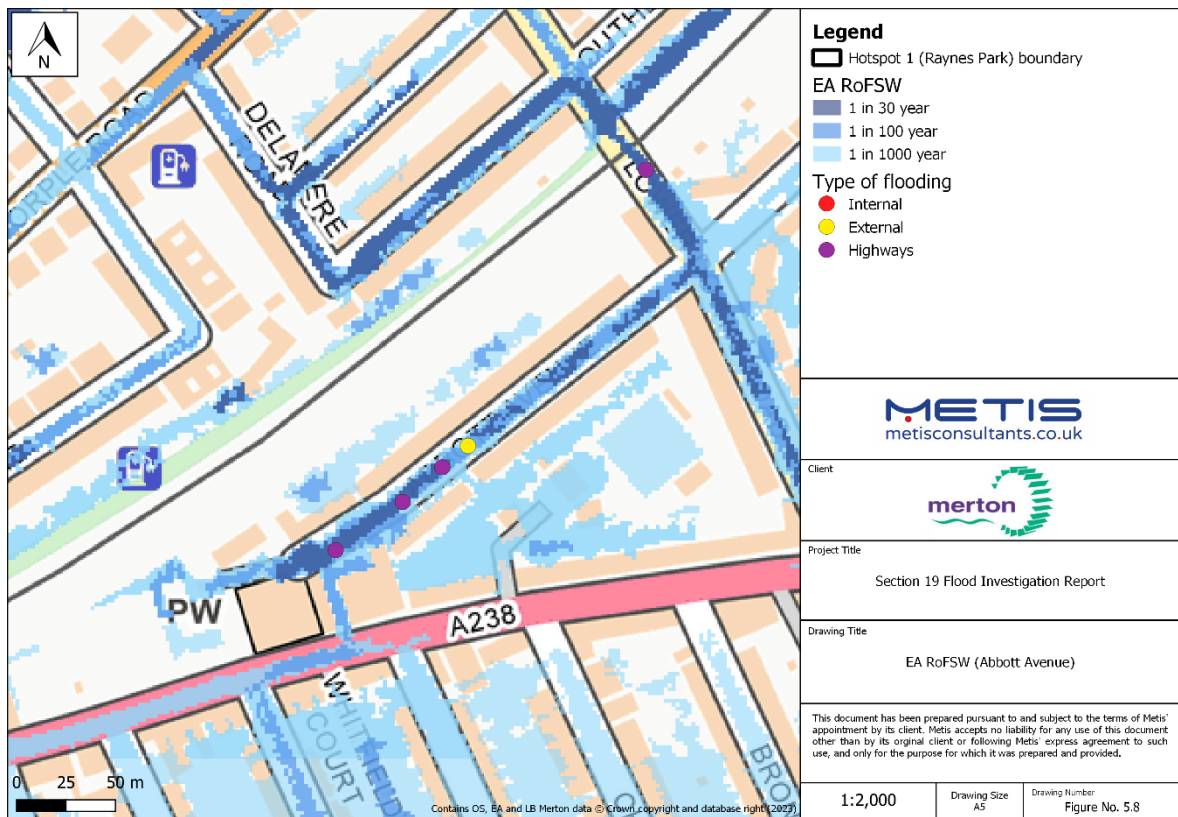
Figure 5.8: EA RoFSW (Abbott Avenue)

Around Abbott Avenue, surface water flood risk is high on Lower Downs Road and the western end of Abbott Avenue, whilst surface water flood risk is medium to the southern side of Abbott Avenue.

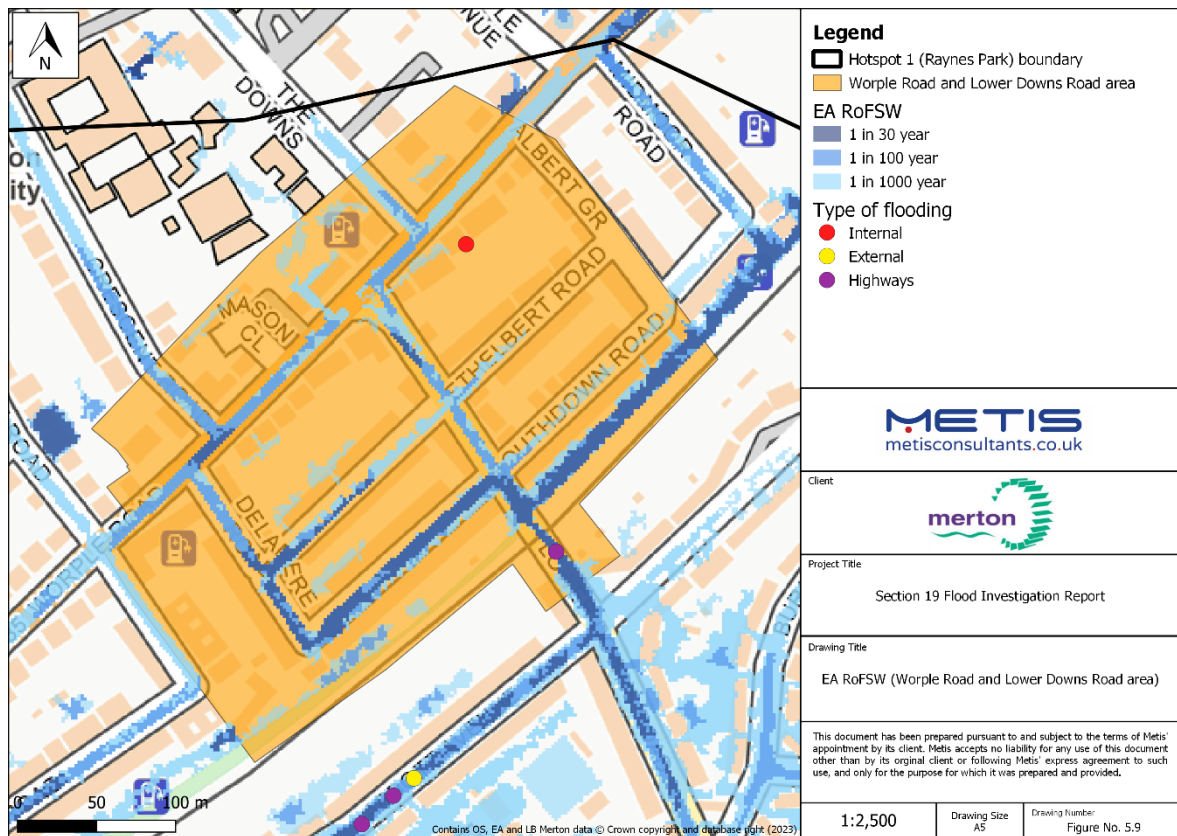
Figure 5.9: EA RoFSW (Worple Road and Lower Downs Road)

Most of Lower Downs Road is at a high risk of surface water flooding, particularly around the local low point at the railway underpass. Surface water flood risk is also high to Southdown Road, situated immediately adjacent to Lower Downs Road near the railway underpass. The remainder of Lower Downs Road is at a medium risk of surface water flooding, alongside parts of Worple Road. Nevertheless, properties are generally not at medium or high risk of surface water flooding.

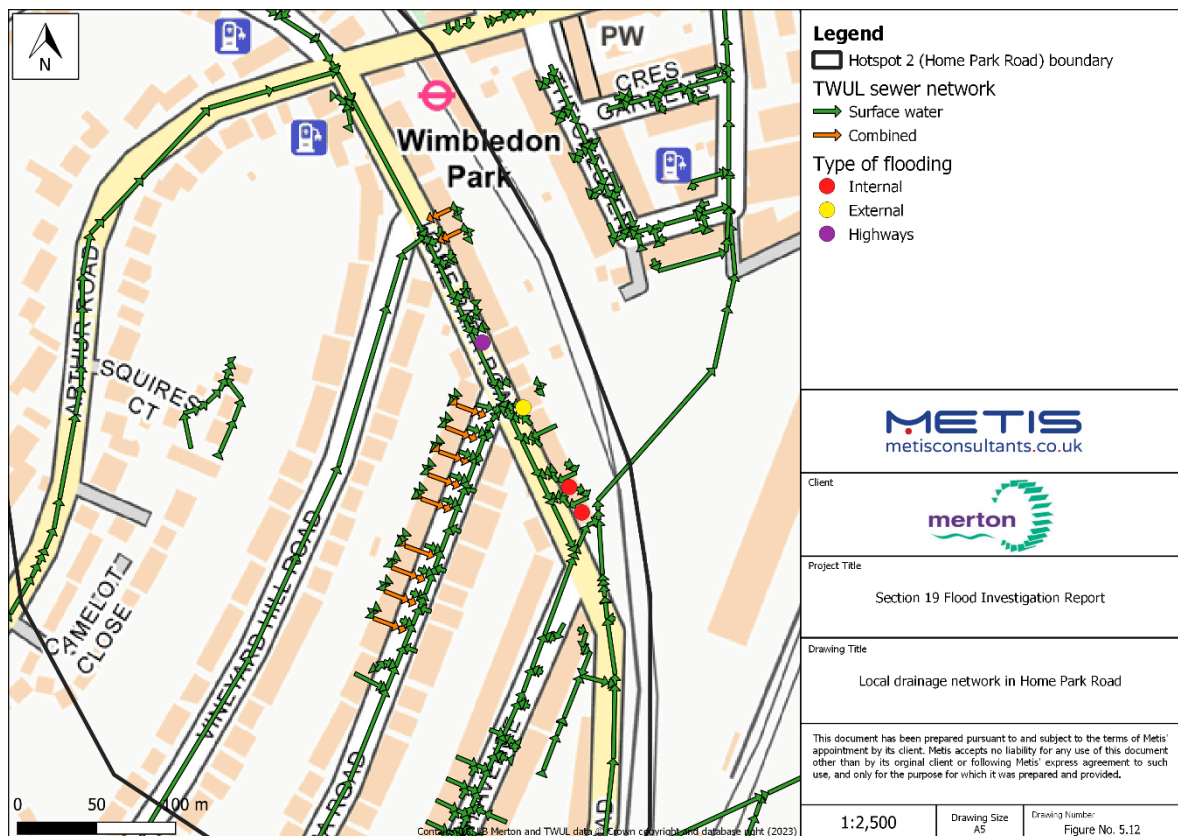
Figure 5.12: Local drainage network in Home Park Road

Figure 5.12 shows the local TWUL sewer network at the primary affected location within this hotspot using a TWUL dataset. A 300mm diameter surface water sewer pipe flows along Home Park Road in a north-west to south-east direction towards the eastern end of Home Park Road. This pipe increases in diameter to 380mm upon convergence with the 305mm diameter surface water pipe that flows in a south-west to north-east direction from Vineyard Hill Road. The surface water sewer network in this location also includes the 305mm diameter pipes from Dora Road and Kenilworth Avenue flowing in a south-west to north-east direction that also converge onto the 380mm diameter pipe on the eastern end of Home Park Road. A 305mm diameter surface water pipe flows in a south to north direction from Strathearn Road and converges onto the 380mm diameter surface water pipe at the eastern-most extremity of Home Park Road. This 380mm diameter surface water sewer pipe then carries flows away from Home Park Road in a north-east direction underneath the railway track situated immediately behind the properties.

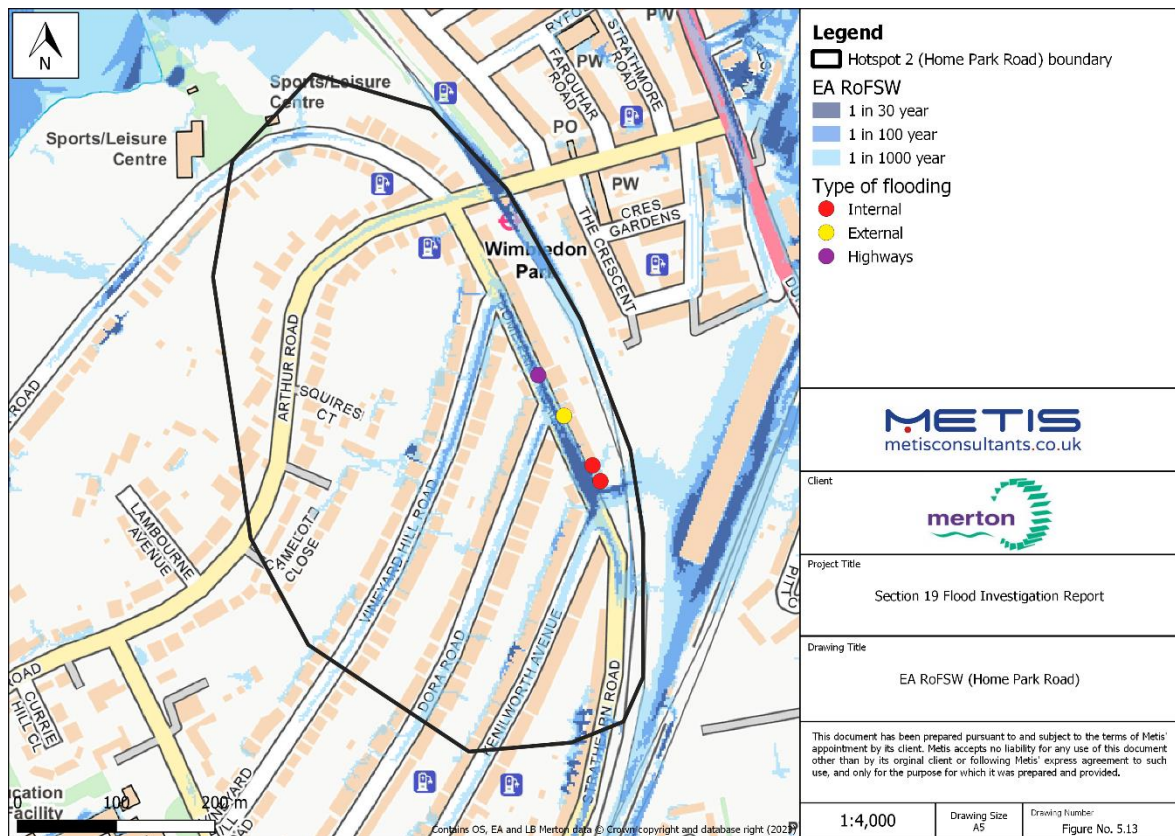
Figure 5.13: EA RoFSW (Home Park Road)

Figure 5.13 shows the [EA RoFSW map](#) for this hotspot. According to this dataset, approximately 100m of Home Park Road is at a high risk of surface water flooding, from its junction with Kenilworth Avenue to its junction with Vineyard Hill Road. Although this is primarily limited to the road itself, this high risk of surface water flooding extends into the boundaries of some properties. A larger part of this location is at a medium risk of surface water flooding, with estimated flood extent extending onto some adjacent roads.

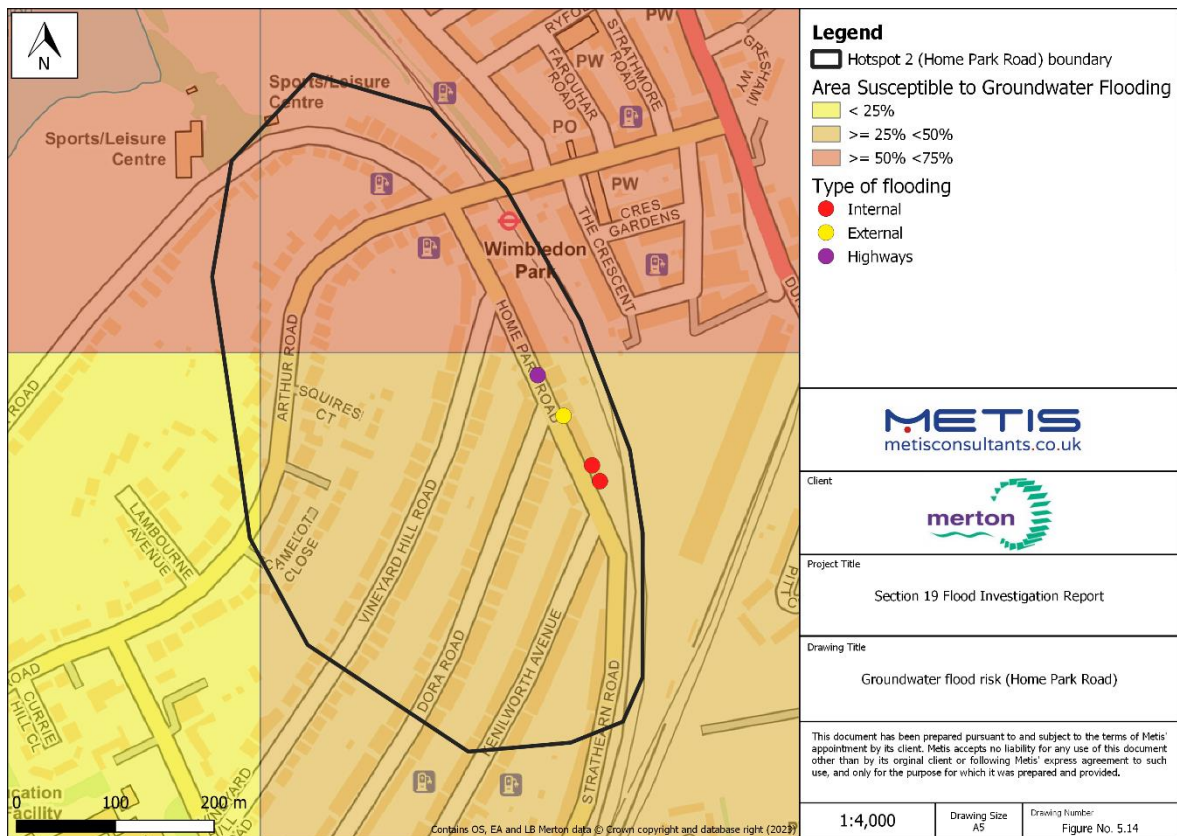
Figure 5.14: Groundwater flood risk (Home Park Road)

The EA'S AStGWF dataset that uses a 1km² grid to show the proportion of each grid square that is susceptible to groundwater flooding emerging shows that groundwater flood risk in this hotspot is split into three areas of approximately equal size. *Fig 5.12* shows that the areas situated within the northern third of this hotspot are most susceptible to groundwater flooding, being located where $\geq 50\% < 75\%$ of land is susceptible to groundwater flood emergence. Areas situated within the south-eastern third of this hotspot are located where $\geq 25\% < 50\%$ of land is susceptible to groundwater flood emergence, whilst this figure is lowest for the hotspot's south-eastern third at $< 25\%$. *Figure 5.14* shows the EA AStGWF map for this hotspot. Despite part of this hotspot being located within an area where much of the land is relatively highly susceptible to groundwater flooding, there is no indication that groundwater played a role in the flooding that occurred to this location during this flood incident.

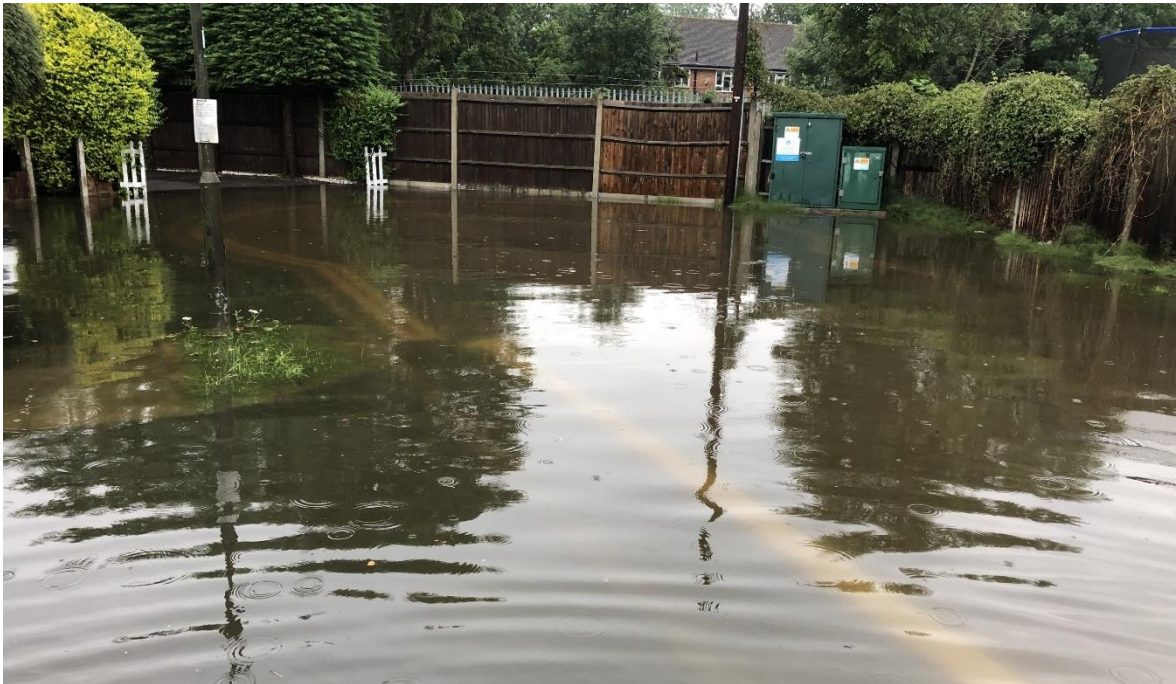
Flood reports to Merton Council indicate that flooding within this hotspot resulted in internal flooding to two residential properties on Marina Avenue and one residential property within the pavilion inside Sir Joseph Hood Memorial Park, which is Merton Council-owned land. Flooding to external areas of properties also occurred within this hotspot, whilst *Figure 6.2* shows the extensive highway flooding to approximately 30m of the road and 65m of the footway in Marina Avenue during this event. Much of the Sir Joseph Hood Memorial Playing Fields also experienced flooding, particularly in areas situated closer to the river line to the west. The TWUL SFHD indicates that one

Figure 6.2: Flooding to Marina Avenue on 25th July 2021 (Resident’s photo submitted to Merton Council)

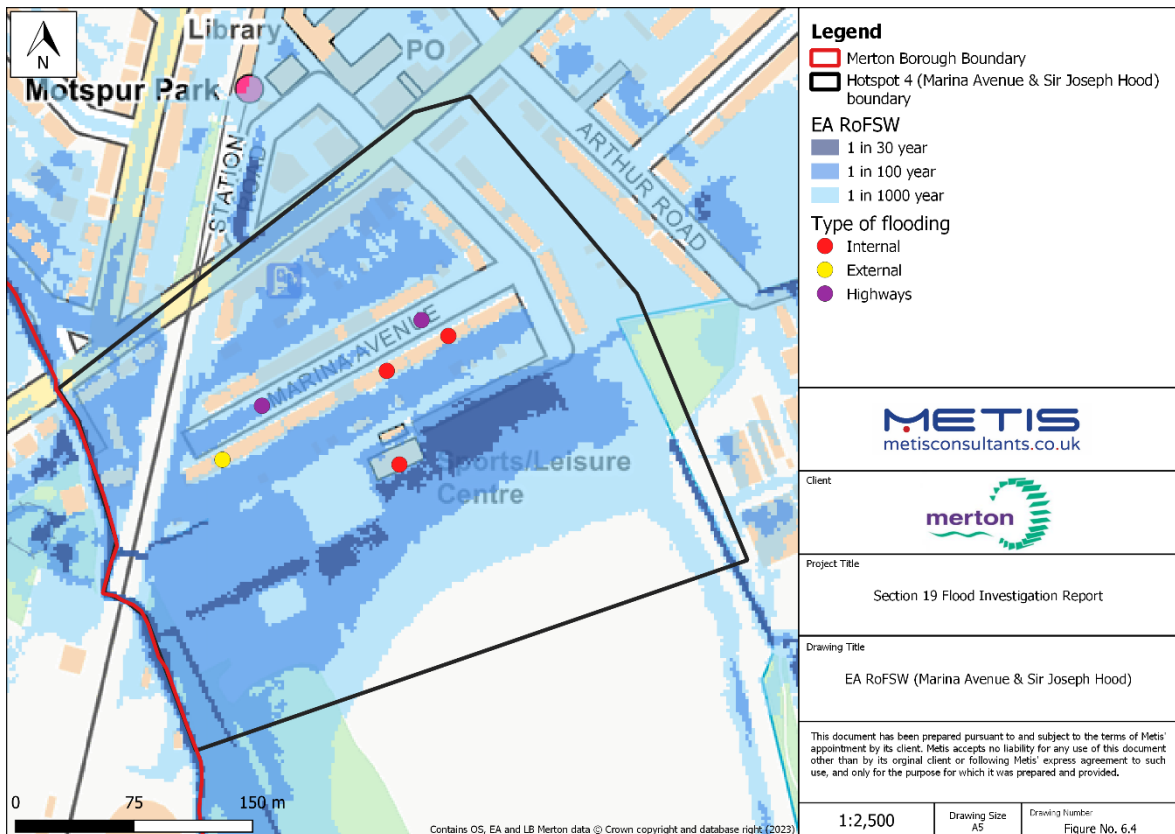
Figure 6.4: EA RoFSW (Marina Avenue & Sir Joseph Hood)

area. Figure 6.4 shows the EA RoFSW for this hotspot, with much of the area immediately adjacent to the pavilion within Sir Joseph Hood Memorial Park being at high risk of experiencing surface water flooding. The western half of Marina Avenue and the rear external areas of properties throughout the entire street are at a medium risk of surface water flooding, as is much of the northern portion of Sir Joseph Hood Memorial Park. Although internal areas of properties in this hotspot are not at a medium or high risk of experiencing surface water flooding, they are in immediate proximity to these medium-high risk areas.

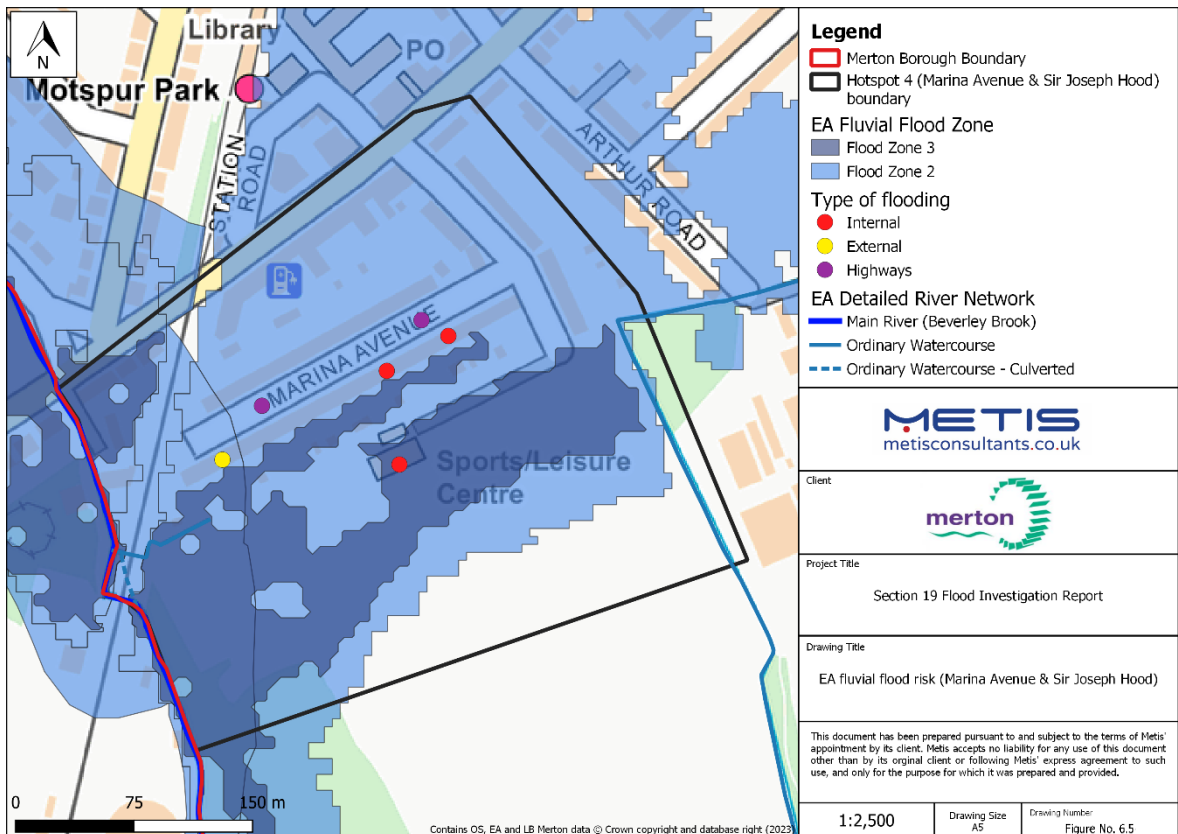
Figure 6.5: EA fluvial flood risk (Marina Avenue & Sir Joseph Hood)

Avenue. As demonstrated in *Figure 6.5*, much of this hotspot is located within Flood Zone 2 and Flood Zone 3 according to the EA’s online [Flood Map for Planning](#), and is thus at a medium-high risk of experiencing fluvial flooding. The property within the Sir Joseph Hood area alongside the rear external areas of residential properties along the south side of Marina Avenue are located in Flood Zone 3 and are thus subject to a high fluvial flood risk, whilst Marina Avenue itself and all of its properties are located within Flood Zone 2. The EA issued a fluvial flood warning at the Beverley Brook in West Barnes at approximately 15:00, and Merton Council have confirmed that fluvial flooding occurred within this hotspot during the flood event on 25th July 2021.

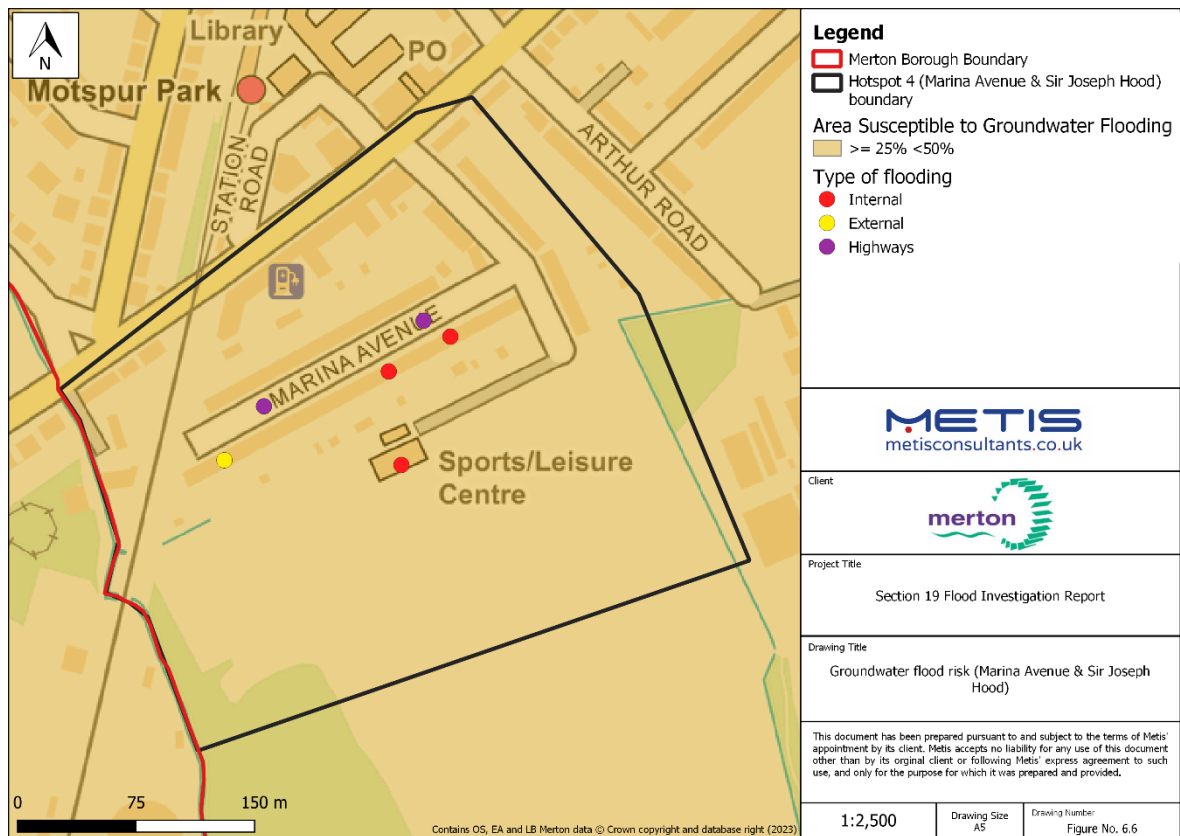
Figure 6.6: Groundwater flood risk (Marina Avenue & Sir Joseph Hood)

The EA’s AStGWF dataset shows that much of the land within this hotspot is susceptible to the emergence of groundwater flooding. Specifically, this hotspot is located wholly within an area where $\geq 50\% < 75\%$ of land is susceptible to groundwater flood emergence, depicted in *Figure 6.6*. However, there were no reports of groundwater flooding within this hotspot and so groundwater flooding is unlikely to have contributed to the flood incident in this location.
