SECTION 19
FLOOD RISK INVESTIGATION REPORT

PREPARED FOR THE LONDON BOROUGH OF MERTON

Created by Darragh Creegan, George
Tzelepis and Mike Mair
Approved by Michael Arthur
Date June 2019
Version 1.3

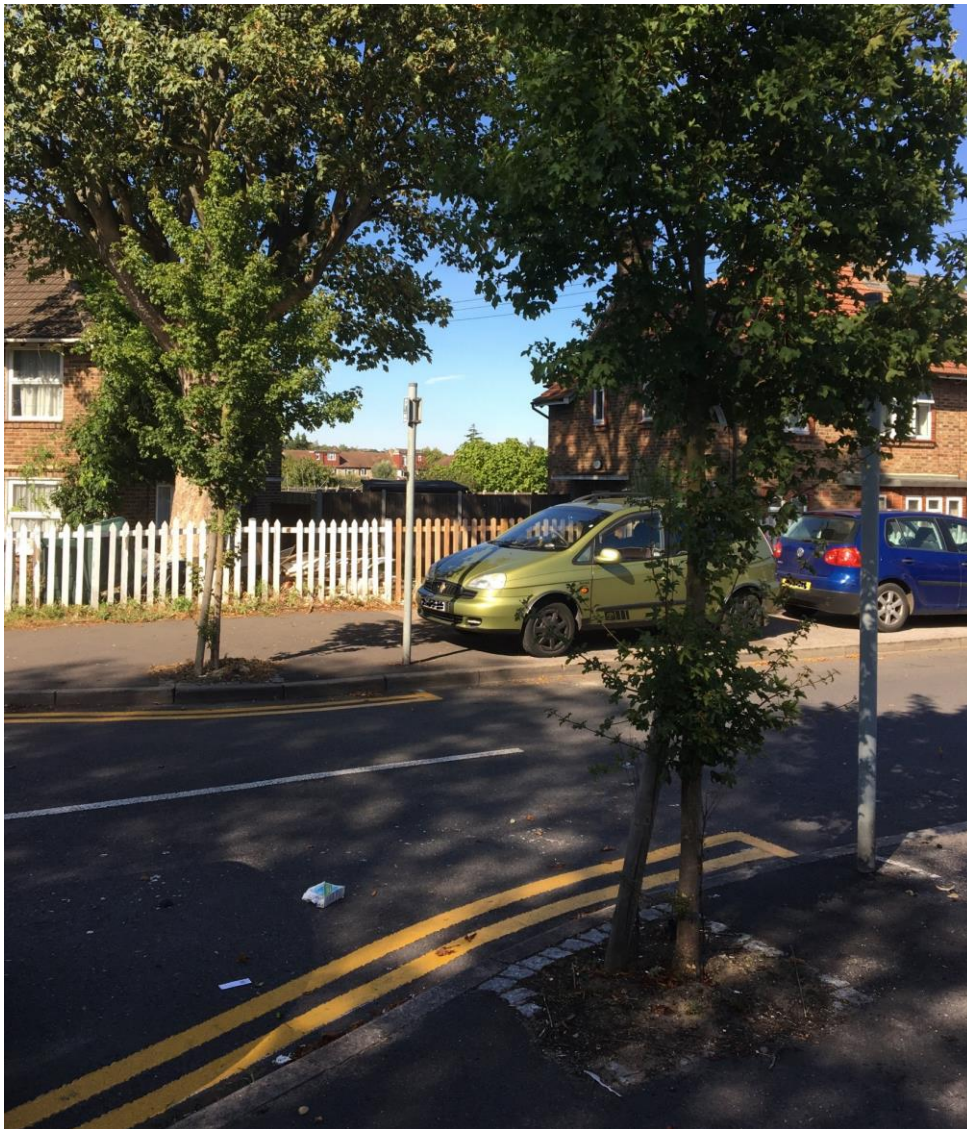
Figure 4.3: New tree pits close to the junction

Flooding was mainly caused by the 750 mm surface water sewer which was running full before the junction of Martin Way with Whatley Avenue. The local foul sewer network was also running full. Additional flow backed up, causing flooding in the adjacent gullies and consequently at the properties at low level locations near the junction of Martin Way and Whatley Avenue. Had there been some non-return valves in the local sewers, this could have decreased the flooding experienced. The topography of the location confirms that runoff from Cannon Hill Common and Joseph Hood Recreation Ground slopes down to Whatley Avenue affecting the local drainage network. This pipe discharges into the 2000 by 1524 mm trunk main which also receives multiple flows from the north and south. Other reasons include possible foul sewer misconnections adjacent to the junction, with gullies discharging into the foul sewer. Misconnections can also result from landowner lateral drains from private land discharging into the public sewer network. Weeds are also growing at the edges of

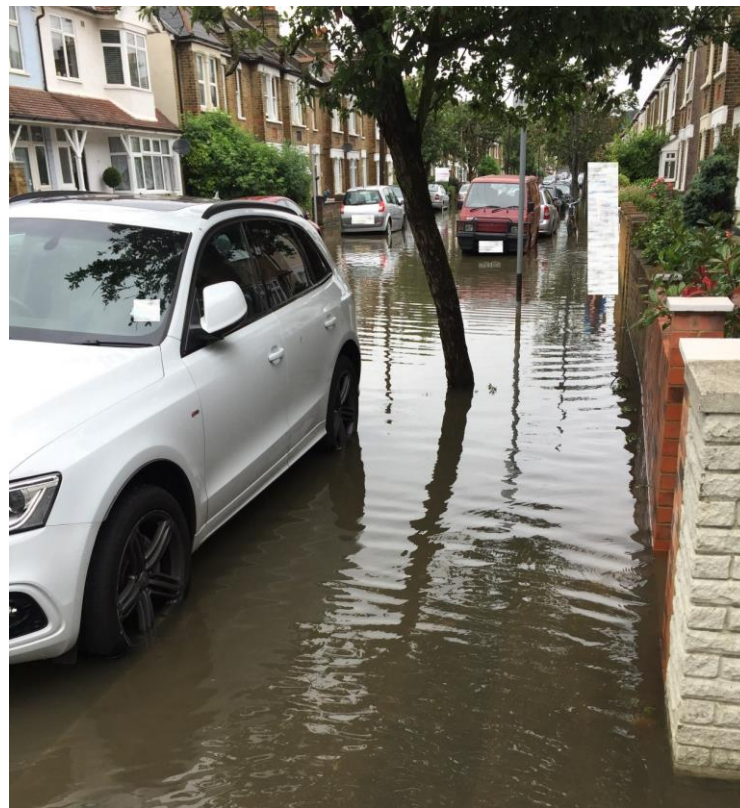
Figure 5.1: Extent of the flooding in Dupont Road

Flooding started on the 22nd June 2016, however the area was worst affected on the 23rd, starting at approximately 09:00 BST. The total duration of the incident lasted about 36 hours and resulted in the internal flooding of approximately ten properties. The maximum depth of the flooding is understood to have been between 300 and 450 mm. The measurements from the nearest rain gauge station (Mitcham Station), during the June 2016 rainfall event, can be found in *Appendix A*. *Figure 5.1* shows the extent of the flooding in Dupont Road. When compared with the other eight locations where flooding reached Merton’s Section 19 threshold, the location received the joint third highest amount of rainfall during the night of the 22nd and 23rd June 2016 but had the joint second lowest rainfall intensity over a five minute duration (see *Appendix B*). TWUL sewer rainfall records estimated the incident as being a 1 in 24 year return period.

Flooding was caused by the blockage of the surface water sewer in the junction of Dupont Road and Dorien Road, which then flows across Bushey Road. The main reasons of the flooding are the blocked 225 mm sewer which runs through Dupont Road and its connection via three 90 degree turns into the 2000 by 1524 mm main trunk sewer on Bushey Road. The trunk sewer also acts as a hydraulic throttle to any flow attempting to enter from the Apostles area roads. Due to the blockage, the water was backing up and flooding at the low point of Dupont Road. This blockage was not identified by TWUL during their site visit on the 22nd June due to a focus on the initial Dupont Road survey work. The blockage was subsequently cleared resolved by Merton on the 23rd June through the use of a jetting tanker. Additionally, there was highway ponding in Bushey Road at the junction of Grand Drive, suggesting a potential network capacity issue or hydraulic overload. The topography of Dupont Road led to the internal flooding of the properties which were at a lower level.

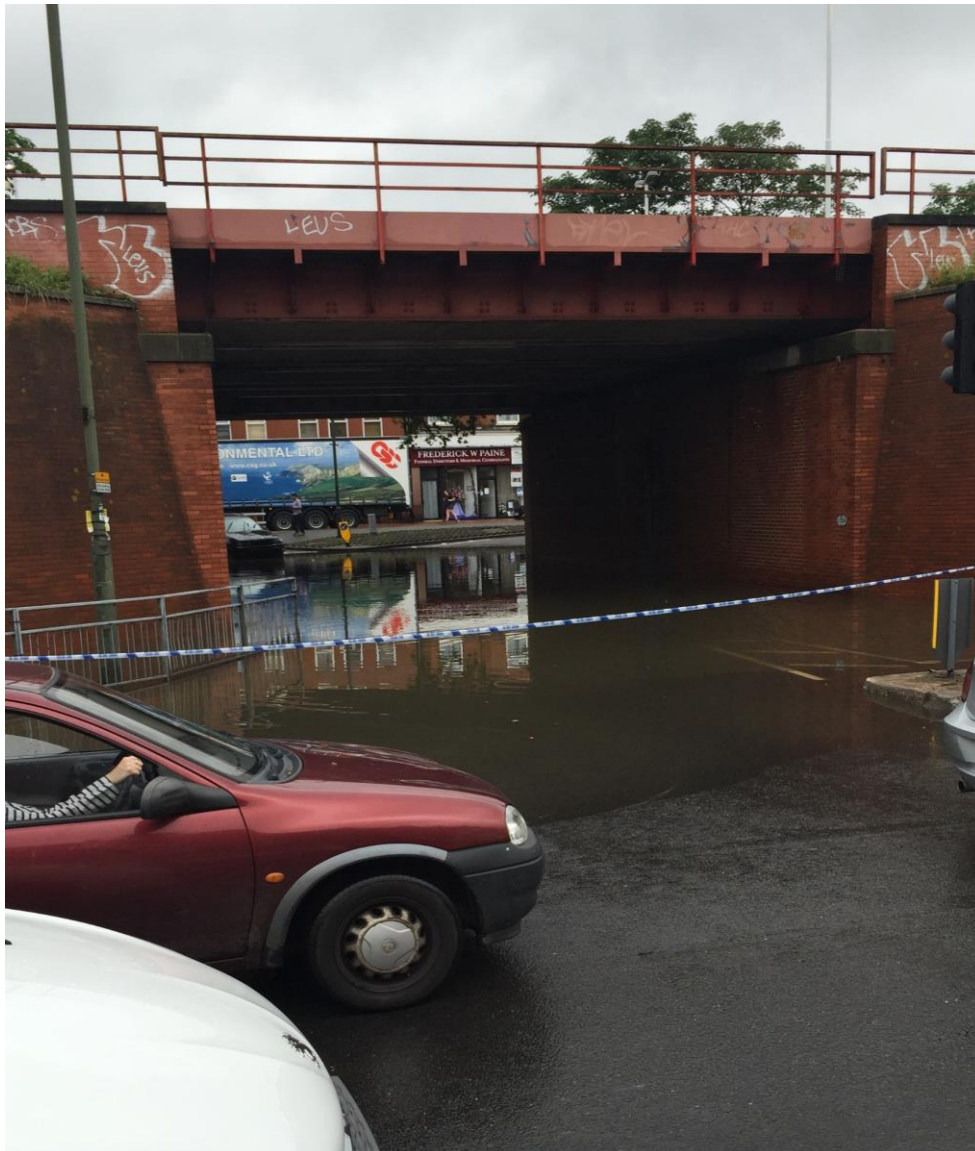
Figure 6.1: Extent of the flooding below Raynes Park railway bridge

Flooding started at approximately 09:00 BST on the morning of 23rd June 2016 and lasted for approximately 12 hours. The result was the internal flooding of approximately four commercial properties and the Metropolitan Police highway closure of Raynes Park railway bridge underpass. The depth of the flooding is understood to have been between 600 mm and 1000 mm. The measurements from the nearest rain gauge station (Hogsmill Station), during the June 2016 rainfall event, can be found in *Appendix A*. *Figure 6.1* shows the extent of the flooding beneath Raynes Park railway bridge. When compared with the other eight locations where flooding reached Merton's Section 19 threshold, the location received the highest amount of rainfall during the night of the 22nd and 23rd June 2016 but had the lowest rainfall intensity over a five minute duration (see *Appendix B*). TWUL sewer rainfall records estimated the incident as being a 1 in 24 year return period.

The flooding in all three incidents are believed to result from similar issues, predominantly the number of sewers flowing southwards down to Coombe Lane and the local area’s topography. The road slopes down underneath Raynes Park railway bridge, creating a man-made low spot, and takes the flows from Coombe Lane, Pepys Road and Langham Road. A large proportion of surface water runoff is also received from the higher ground, in and around Cottenham Park and Copse Hill. It should also be noted that, during the three incidents, the local sewer network received significant amounts of rainfall which probably exceeded its designed capacity.

- TWUL and Merton should investigate condition and operation of the pumps underneath Raynes Park railway bridge, and incorporate into surface water and sewer flood modelling.

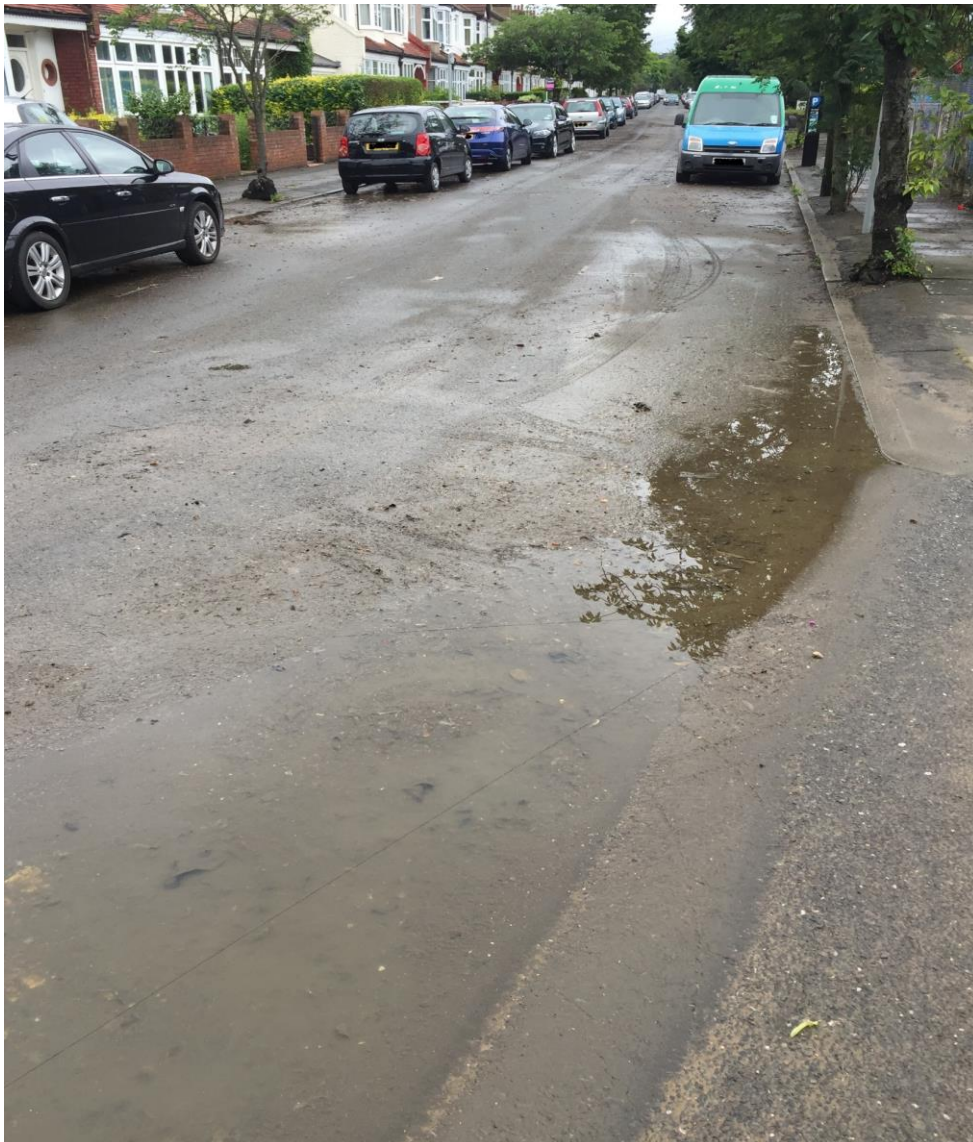
Figure 7.1: Extent of the flooding in Abbott Avenue post-June 2016 incident

There is limited available information regarding when the flooding incident started, how long it lasted, or its depth or its extent. It is understood that a manhole surcharged, causing internal flooding in some properties, mainly affecting those at the western end of Abbott Avenue adjacent to the pumping station, including the internal flooding of Dundonald Church. The measurements from the nearest rain gauge station (Mitcham Station), during the June 2016 rainfall event, can be found in *Appendix A*. *Figure 7.1* shows the post-flooding situation in Abbott Avenue, taken approximately one week later. The effects of foul flooding, including part of its extent, can be seen in this image. When compared with the other eight locations where flooding reached Merton’s Section 19 threshold, the location received the joint third highest amount of rainfall during the night of the 22nd and 23rd June 2016 but had the joint second lowest rainfall intensity over a five minute duration (see *Appendix B*). TWUL sewer rainfall records estimated the incident as being a 1 in 24 year return period.

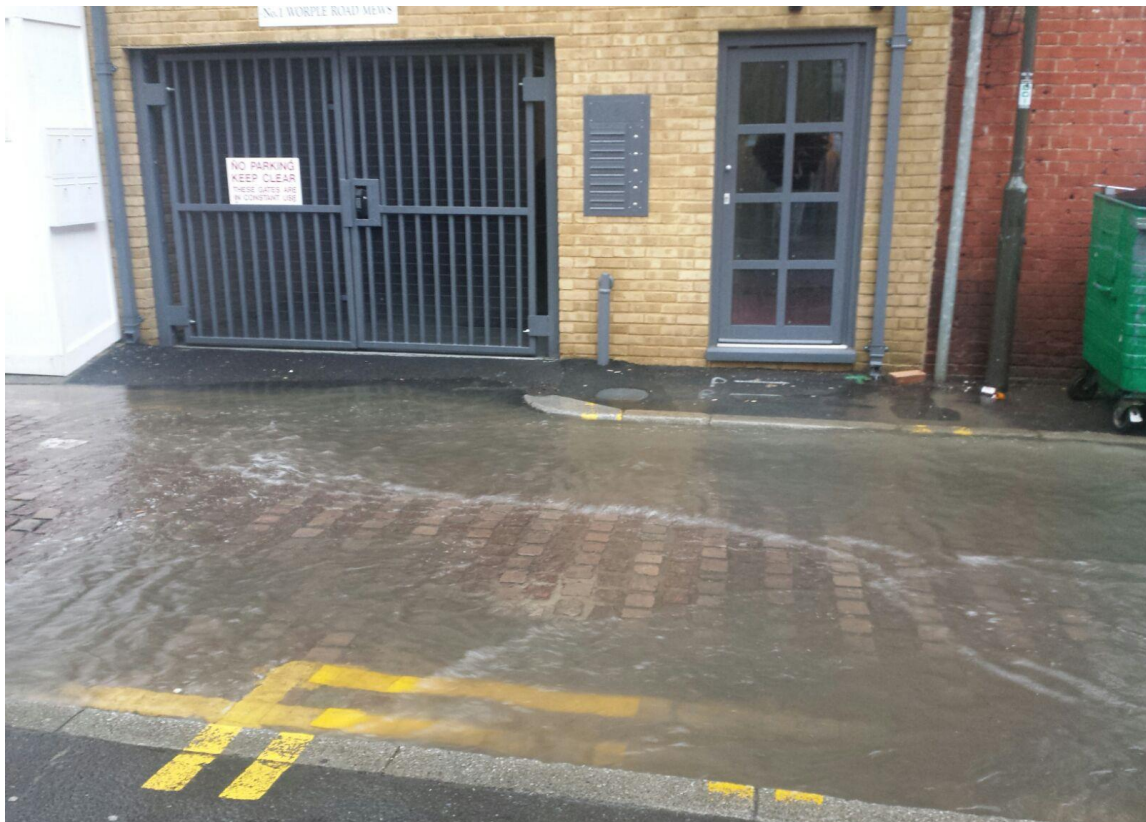
Figure 8.1: Flooding of Worple Hill Mews on 23rd June 2016

Flooding started at approximately 09:00 BST on the morning of 23rd June 2016 and lasted about 12 hours. The result was flooding of the highway and some basements on Worple Road. Runoff entered into the basements of some of The Pavement retail units through basement skylights on the footway. *Figure 8.1* shows the flooding extended onto Worple Road Mews. Two residential properties were affected internally. When compared with the other eight locations where flooding reached Merton's Section 19 threshold, the location received the fourth lowest amount of rainfall during the night of the 22nd and 23rd June 2016, but had the third highest rainfall intensity over a five minute duration (see *Appendix B*). TWUL sewer rainfall records estimated the incident as being a 1 in 21 year return period.

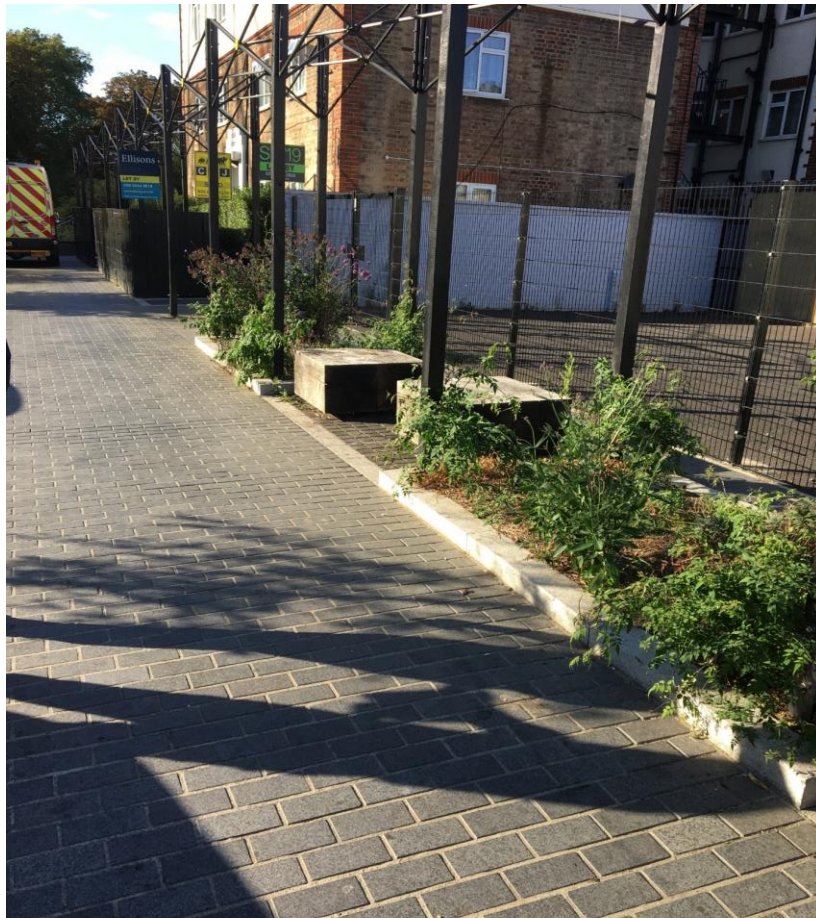
Figure 13.1: New rain gardens on Baltic Close

Public realm improvement works have been completed on Baltic Close including a joint scheme between Merton and TfL where SuDS features were installed. This included rain gardens, permeable surfacing and linear drainage on Baltic Close (see *Figure 13.1*) and a swale at the entrance of Wandle Park. This swale acts as an overflow from the raingardens and the permeable wooden cobbles in Baltic Close into the main sewer network. TfL has also undertaken highway works on High Street Colliers Wood, changing the levels of the carriageway between Baltic Close and Colliers Wood London Underground station. TWUL confirmed that they attended twice on site after the incident, checking a private sewer on 26th June 2016, which was found to be running clear, and checking a public sewer on 27th July 2016, which was running at high capacity, but no blockages were found in either sewer.
