# Asbestos Re-inspection Report (with Priority Assessments)

## **Garfield Primary School London, SW19 8SB**

Job Number: B12126/1  
Issue Date: 15/01/2021  
Issue No: 1

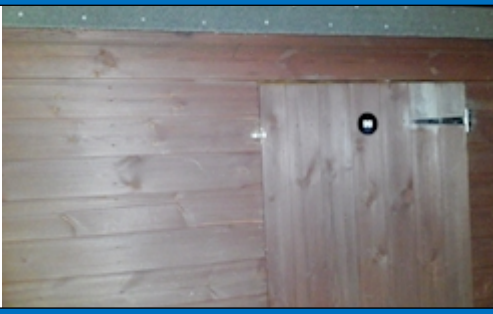
<b>Building</b>	Garfield Primary School			<b>Floor</b>	0		
<b>Location Description</b>	0/001 Block D: Shed						
<b>Item</b>	Timber Ceiling, Timber Walls, Timber Floor

<b>Level of Identification (ID)</b>	Inspected Area (IA)	<b>Sample No.</b>					
<b>Material</b>		<b>Extent</b>					
<b>Accessibility</b>							
<b>Identification</b>							
<b>Material Assessment</b>							
<b>Product Type</b>		<b>Condition</b>		<b>Surface Treatment</b>		<b>Asbestos Type</b>	
<b>Priority Assessment (for more detail see Section 4.0)</b>							
<b>Occupant Activity</b>		<b>Disturbance</b>		<b>Human Exposure</b>		<b>Maintenance Activity</b>	
<b>Scoring Summary</b>							
<b>Material Score</b>		<b>Priority Score</b>		<b>Total Risk</b>		<b>Risk Priority</b>	
<b>Recommended Action</b>	<b>No Recommendation Required</b>						
<b>Further Information</b>	No Suspect Materials

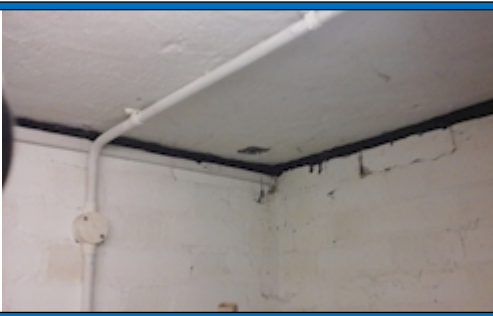
<b>Building</b>	Garfield Primary School			<b>Floor</b>	0		
<b>Location Description</b>	0/001 Block E: Sewage Pump						
<b>Item</b>	Cement Shuttering

<b>Level of Identification (ID)</b>	Strongly Presumed (SP)	<b>Sample No.</b>					
<b>Material</b>	Cement Product	<b>Extent</b>	12 lm				
<b>Accessibility</b>	Occasionally likely to be disturbed						
<b>Identification</b>	Amosite						
<b>Material Assessment</b>							
<b>Product Type</b>	1	<b>Condition</b>	1	<b>Surface Treatment</b>	1	<b>Asbestos Type</b>	2
<b>Priority Assessment (for more detail see Section 4.0)</b>							
<b>Occupant Activity</b>	0	<b>Disturbance</b>	1	<b>Human Exposure</b>	0	<b>Maintenance Activity</b>	0
<b>Scoring Summary</b>							
<b>Material Score</b>	5	<b>Priority Score</b>	1	<b>Total Risk</b>	6	<b>Risk Priority</b>	<b>VERY LOW</b>
<b>Recommended Action</b>	<b>Manage and Re-inspect</b>						
<b>Further Information</b>	Cement Shuttering to Roof. Previously Identified as Amosite. Sample GS020910/60, Report J14071 by Noble Health and Safety Limited.

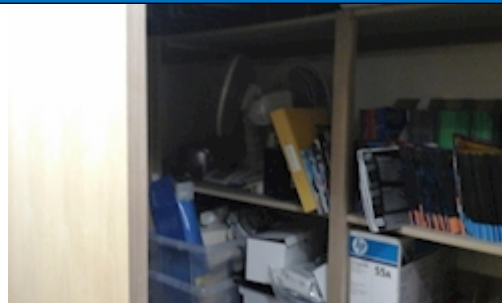
<b>Building</b>	Garfield Primary School			<b>Floor</b>	0			
<b>Location Description</b>	0/007a Block A: Cupboard							
<b>Item</b>	Plasterboard Ceiling, Brick Walls, Carpet to Concrete floor

<b>Level of Identification (ID)</b>	Inspected Area (IA)	<b>Sample No.</b>						
<b>Material</b>		<b>Extent</b>						
<b>Accessibility</b>								
<b>Identification</b>								
<b>Material Assessment</b>								
<b>Product Type</b>		<b>Condition</b>		<b>Surface Treatment</b>		<b>Asbestos Type</b>		
<b>Priority Assessment (for more detail see Section 4.0)</b>								
<b>Occupant Activity</b>		<b>Disturbance</b>		<b>Human Exposure</b>		<b>Maintenance Activity</b>		
<b>Scoring Summary</b>								
<b>Material Score</b>		<b>Priority Score</b>		<b>Total Risk</b>		<b>Risk Priority</b>		
<b>Recommended Action</b>	<b>No Recommendation Required</b>							
<b>Further Information</b>	No Suspect Materials

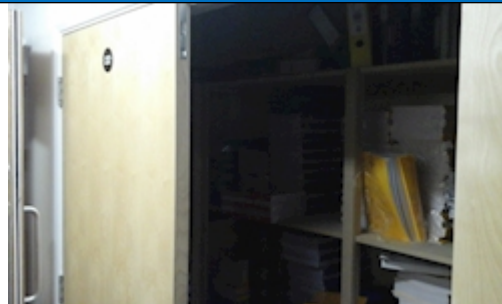
<b>Building</b>	Garfield Primary School			<b>Floor</b>	0			
<b>Location Description</b>	0/007b Block A: Cupboard							
<b>Item</b>	Plasterboard Ceiling, Brick Walls, Carpet to Concrete Floor

<b>Level of Identification (ID)</b>	Inspected Area (IA)	<b>Sample No.</b>						
<b>Material</b>		<b>Extent</b>						
<b>Accessibility</b>								
<b>Identification</b>								
<b>Material Assessment</b>								
<b>Product Type</b>		<b>Condition</b>		<b>Surface Treatment</b>		<b>Asbestos Type</b>		
<b>Priority Assessment (for more detail see Section 4.0)</b>								
<b>Occupant Activity</b>		<b>Disturbance</b>		<b>Human Exposure</b>		<b>Maintenance Activity</b>		
<b>Scoring Summary</b>								
<b>Material Score</b>		<b>Priority Score</b>		<b>Total Risk</b>		<b>Risk Priority</b>		
<b>Recommended Action</b>	<b>No Recommendation Required</b>							
<b>Further Information</b>	No Suspect Materials

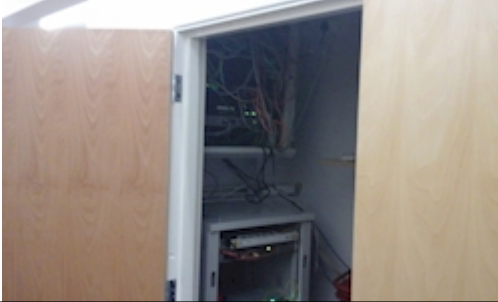
<b>Building</b>	Garfield Primary School			<b>Floor</b>	0					
<b>Location Description</b>	0/013 Block A: Electric Cupboard									
<b>Item</b>	Plasterboard Ceiling, Brick Walls, Carpet to Concrete Floor, Modern Electrics

<b>Level of Identification (ID)</b>	Inspected Area (IA)	<b>Sample No.</b>								
<b>Material</b>			<b>Extent</b>							
<b>Accessibility</b>										
<b>Identification</b>										
<b>Material Assessment</b>										
<b>Product Type</b>		<b>Condition</b>		<b>Surface Treatment</b>		<b>Asbestos Type</b>				
<b>Priority Assessment (for more detail see Section 4.0)</b>										
<b>Occupant Activity</b>		<b>Disturbance</b>		<b>Human Exposure</b>		<b>Maintenance Activity</b>				
<b>Scoring Summary</b>										
<b>Material Score</b>		<b>Priority Score</b>		<b>Total Risk</b>		<b>Risk Priority</b>				
<b>Recommended Action</b>	<b>No Recommendation Required</b>									
<b>Further Information</b>	No Suspect Materials

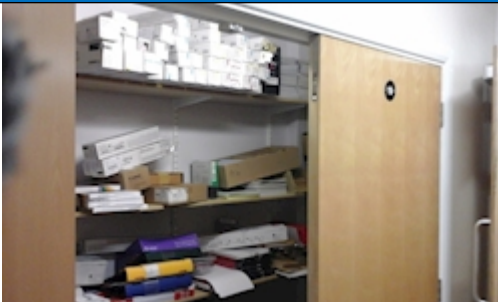
<b>Building</b>	Garfield Primary School			<b>Floor</b>	0					
<b>Location Description</b>	0/016 Block A: Cupboard									
<b>Item</b>	Plasterboard Ceiling, Brick Walls, Carpet to Concrete Floor

<b>Level of Identification (ID)</b>	Inspected Area (IA)	<b>Sample No.</b>								
<b>Material</b>			<b>Extent</b>							
<b>Accessibility</b>										
<b>Identification</b>										
<b>Material Assessment</b>										
<b>Product Type</b>		<b>Condition</b>		<b>Surface Treatment</b>		<b>Asbestos Type</b>				
<b>Priority Assessment (for more detail see Section 4.0)</b>										
<b>Occupant Activity</b>		<b>Disturbance</b>		<b>Human Exposure</b>		<b>Maintenance Activity</b>				
<b>Scoring Summary</b>										
<b>Material Score</b>		<b>Priority Score</b>		<b>Total Risk</b>		<b>Risk Priority</b>				
<b>Recommended Action</b>	<b>No Recommendation Required</b>									
<b>Further Information</b>	No Suspect Materials

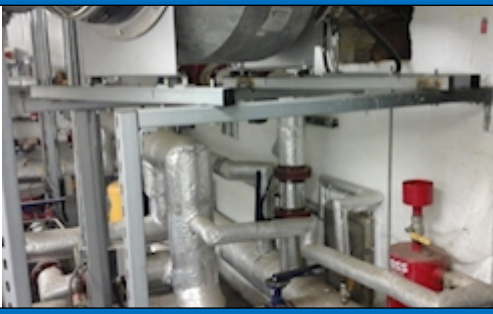
<b>Building</b>	Garfield Primary School			<b>Floor</b>	0		
<b>Location Description</b>	0/024 Block A: Boiler Room						
<b>Item</b>	Thermal Insulation Residue to Walls

<b>Level of Identification (ID)</b>	Strongly Presumed (SP)	<b>Sample No.</b>					
<b>Material</b>	Hard Set Thermal Insulation	<b>Extent</b>	50 m <sup>2</sup>				
<b>Accessibility</b>	Occasionally likely to be disturbed						
<b>Identification</b>	Crocidolite						
<b>Material Assessment</b>							
<b>Product Type</b>	3	<b>Condition</b>	1	<b>Surface Treatment</b>	1	<b>Asbestos Type</b>	3
<b>Priority Assessment (for more detail see Section 4.0)</b>							
<b>Occupant Activity</b>	1	<b>Disturbance</b>	1	<b>Human Exposure</b>	1	<b>Maintenance Activity</b>	2
<b>Scoring Summary</b>							
<b>Material Score</b>	8	<b>Priority Score</b>	5	<b>Total Risk</b>	13	<b>Risk Priority</b>	<b>MEDIUM</b>
<b>Recommended Action</b>	<b>Manage and Re-inspect</b>

<b>Further Information</b>	Previously noted in Life Environmental Services Report B-71596

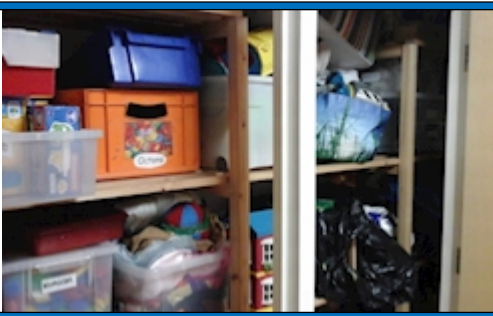
<b>Building</b>	Garfield Primary School			<b>Floor</b>	0		
<b>Location Description</b>	0/039 Block A: Store 01						
<b>Item</b>	Plasterboard Ceiling, Brick Walls, Carpet to Concrete Floor

<b>Level of Identification (ID)</b>	Inspected Area (IA)	<b>Sample No.</b>					
<b>Material</b>		<b>Extent</b>					
<b>Accessibility</b>							
<b>Identification</b>							
<b>Material Assessment</b>							
<b>Product Type</b>		<b>Condition</b>		<b>Surface Treatment</b>		<b>Asbestos Type</b>	
<b>Priority Assessment (for more detail see Section 4.0)</b>							
<b>Occupant Activity</b>		<b>Disturbance</b>		<b>Human Exposure</b>		<b>Maintenance Activity</b>	
<b>Scoring Summary</b>							
<b>Material Score</b>		<b>Priority Score</b>		<b>Total Risk</b>		<b>Risk Priority</b>	
<b>Recommended Action</b>	<b>No Recommendation Required</b>						
<b>Further Information</b>	No Suspect Materials

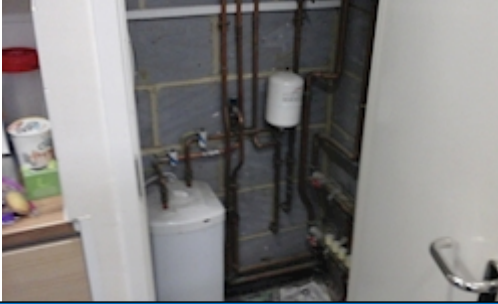
<b>Building</b>	Garfield Primary School			<b>Floor</b>	0		
<b>Location Description</b>	0/054 Block A: Store 02						
<b>Item</b>	Plasterboard Ceiling, Brick Walls, Concrete Floor, Metal Pipework

<b>Level of Identification (ID)</b>	Inspected Area (IA)	<b>Sample No.</b>					
<b>Material</b>		<b>Extent</b>					
<b>Accessibility</b>							
<b>Identification</b>							
<b>Material Assessment</b>							
<b>Product Type</b>		<b>Condition</b>		<b>Surface Treatment</b>		<b>Asbestos Type</b>	
<b>Priority Assessment (for more detail see Section 4.0)</b>							
<b>Occupant Activity</b>		<b>Disturbance</b>		<b>Human Exposure</b>		<b>Maintenance Activity</b>	
<b>Scoring Summary</b>							
<b>Material Score</b>		<b>Priority Score</b>		<b>Total Risk</b>		<b>Risk Priority</b>	
<b>Recommended Action</b>	<b>No Recommendation Required</b>						
<b>Further Information</b>	No Suspect Materials

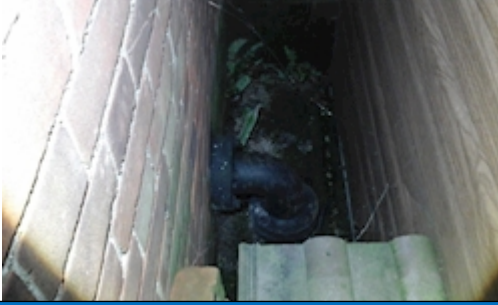
<b>Building</b>	Garfield Primary School			<b>Floor</b>	Ext		
<b>Location Description</b>	Ext Block A: External						
<b>Item</b>	Gaskets to Pipework Flanges

<b>Level of Identification (ID)</b>	Presumed (P)	<b>Sample No.</b>					
<b>Material</b>	Gaskets	<b>Extent</b>	1 No.				
<b>Accessibility</b>	Usually inaccessible or unlikely to be disturbed						
<b>Identification</b>	Chrysotile						
<b>Material Assessment</b>							
<b>Product Type</b>	2	<b>Condition</b>	1	<b>Surface Treatment</b>	1	<b>Asbestos Type</b>	1
<b>Priority Assessment (for more detail see Section 4.0)</b>							
<b>Occupant Activity</b>	0	<b>Disturbance</b>	0	<b>Human Exposure</b>	0	<b>Maintenance Activity</b>	0
<b>Scoring Summary</b>							
<b>Material Score</b>	5	<b>Priority Score</b>	0	<b>Total Risk</b>	5	<b>Risk Priority</b>	<b>VERY LOW</b>
<b>Recommended Action</b>	<b>Not sampled – Sample Required</b>						
<b>Further Information</b>	Presumed as unable to access for sampling

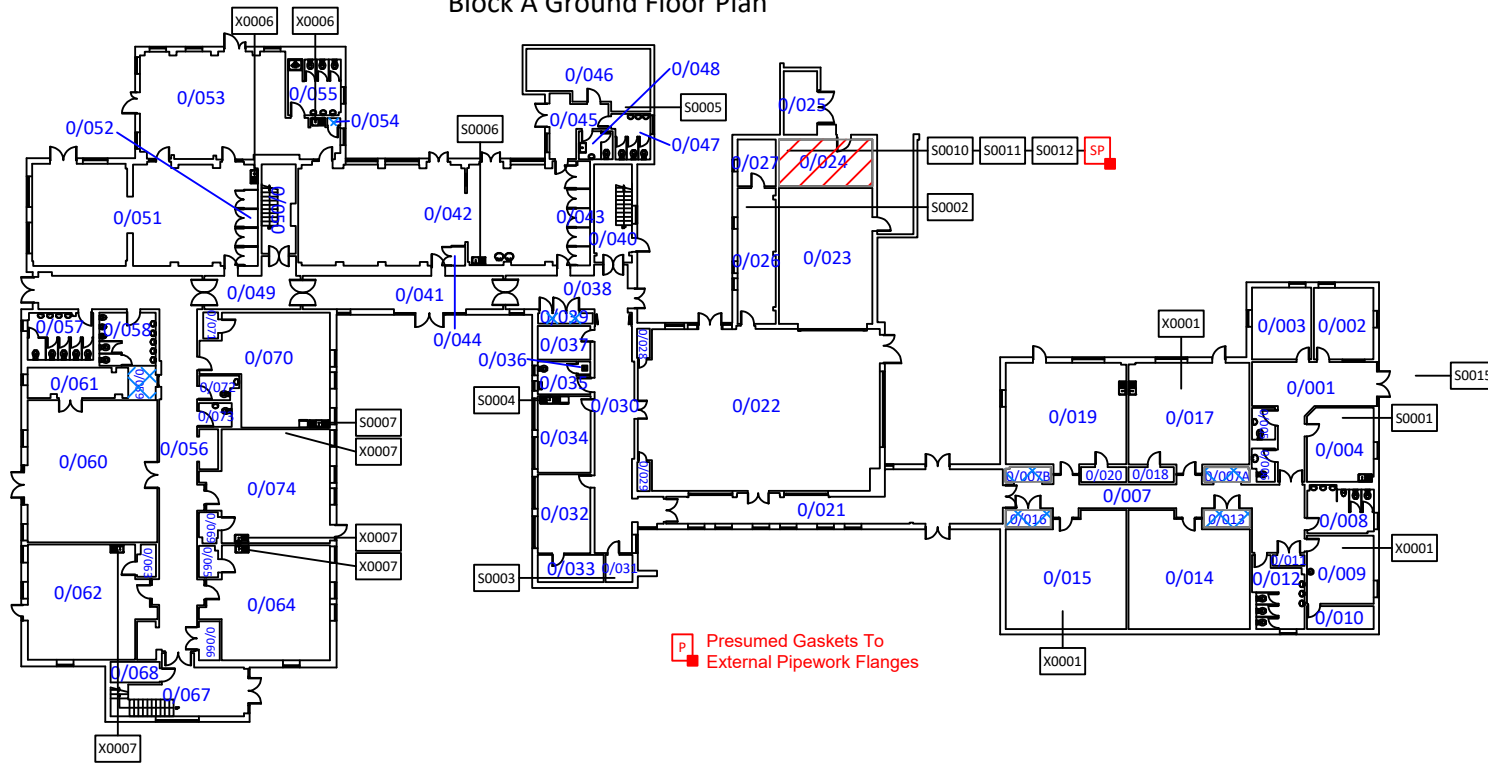
### Block A Ground Floor Plan

**P** Presumed Gaskets To  
**■** External Pipework Flanges
