Asbestos Reinspection Report (with Priority Assessments)

**Joseph Hood Primary
Whatley Avenue,
London,
SW20 9NS**

**Project Number: B-90007
Issue Date: 26th March 2020
Issue No: 1**

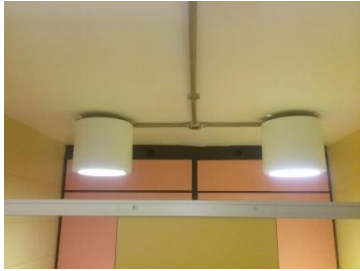
Surveyor		Charles Bayly		Room/Area		0/004 - Girls Wc

Survey Date		14 February 2020		Level of Identification		Strongly Presumed (SP)			
Building		Joseph Hood Primary		Sample No		SPDTJ251010/15			
Floor		Ground Floor		Item		Cement Flue Pipe Above Extractor

Item Accessibility		Difficult		Amount		2Lm			
A - Product Type:		B - Extent of Damage:		C - Surface Treatment		D - Asbestos Type		Material Ass (M.A) (A+B+C+D):	
Cement Products	1	Good Condition	0	Enclosed sprays, lagging and textiles, AIB (encapsulated), asbestos cement and unsealed decorative finishes	1	Amosite, Chrysotile	2	4	
1 = Normal Occupant Activity = (E)		1	E - Main type of activity	1	Total Priority Score (P.A.) = (1+2+3+4):		5	Total Risk Ass' Score (P.A. + M.A)	
2 = Disturbance = (F+G+H)/3		1	F - Location	2	G - Accessibility		0	H - Extent	
3 = Exposure potential = (I+J+K)/3		2	I - Number of occupants	3	J - Frequency of use		3	K - Average time in use	
4 = Maintenance activity = (L+M)/2		1	L - Type of maintenance	0	M - Frequency of maintenance		1	Recommendation: Manage & Re-inspect	
Further Information:		Visually consistent with sample number DTJ251010/15. Cement flue pipe above extractor, previously cross referenced to by Noble HSC to sample DTJ251010/15 in report J14338 Amosite and Chrysotile Presumed to remain in situ.

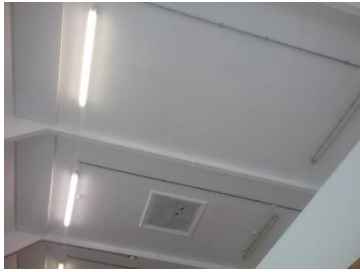
Surveyor		Charles Bayly		Room/Area		0/008 - Loft 3 Over Hall

Survey Date		14 February 2020		Level of Identification		Presumed (P)			
Building		Joseph Hood Primary		Sample No		P			
Floor		Ground Floor		Item		No Access Into Roof Void

Item Accessibility		Difficult		Amount					
A - Product Type:		B - Extent of Damage:		C - Surface Treatment		D - Asbestos Type		Material Ass (M.A) (A+B+C+D):	
Unspecified Material						Presumed Asbestos		12	
1 = Normal Occupant Activity = (E)		0	E - Main type of activity	0	Total Priority Score (P.A.) = (1+2+3+4):		0	Total Risk Ass' Score (P.A. + M.A)	
2 = Disturbance = (F+G+H)/3		0	F - Location	0	G - Accessibility		0	H - Extent	
3 = Exposure potential = (I+J+K)/3		0	I - Number of occupants	0	J - Frequency of use		0	K - Average time in use	
4 = Maintenance activity = (L+M)/2		0	L - Type of maintenance	0	M - Frequency of maintenance		0	Recommendation: No Access - Inspection Required Presumed Asbestos is scored 12 (worst case) until sampled/inspected	
Further Information:		This location was not accessed and as such should be presumed to contain asbestos until proven otherwise. No access into roof void due to height restrictions, previously presumed Noble HSC survey J14438 to contain ACM's.

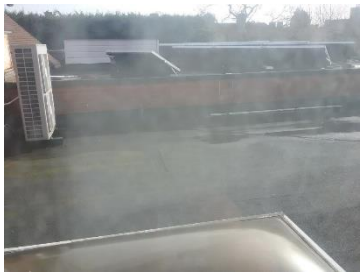
Surveyor		Charles Bayly		Room/Area		Mastic to wall on roof - External

Survey Date		14 February 2020		Level of Identification		Sampled (S)													
Building		Joseph Hood Primary		Sample No		SS0010													
Floor		External		Item		Mastic To Wall On Roof

Item Accessibility		Difficult		Amount		1Lm													
A - Product Type:		B - Extent of Damage:		C - Surface Treatment		D - Asbestos Type		Material Ass (M.A) (A+B+C+D):											
Mastics		1		Good Condition		0		Composite materials; reinforced plastics, resins, vinyl tiles, sealed decorative finishes, etc.		0		Chrysotile		1		2			
1 = Normal Occupant Activity = (E)		1		E – Main type of activity		1		Total Priority Score (P.A.) = (1+2+3+4):		2		Total Risk Ass' Score (P.A. + M.A)		4		Risk Coding		VERY LOW	
2 = Disturbance = (F+G+H)/3		0		F – Location		0		G – Accessibility		0		H – Extent		0					
3 = Exposure potential = (I+J+K)/3		0		I – Number of occupants		1		J – Frequency of use		0		K – Average time in use		0					
4 = Maintenance activity = (L+M)/2		1		L – Type of maintenance		1		M – Frequency of maintenance		1		Recommendation:							
Further Information:		Mastic on wall previously identified on Life Environmental Services survey B-68064, Found to contain Chrysotile
