# Asbestos Reinspection Report (with Priority Assessments)

**Poplar Primary School  
Poplar Road South  
Morden  
SW19 3JZ  
58550**

**Project Number: B-90703  
Issue Date: 4<sup>TH</sup> August 2020  
Issue No: 1**

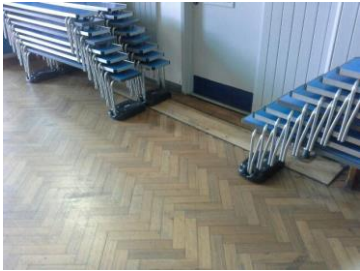
Surveyor	Richard Bowker		Room/Area	0/013 - Main Hall

Survey Date	28 July 2020		Level of Identification	Strongly Presumed (SP)													
Building	Block A		Sample No	SPSARCS/6													
Floor	Ground Floor		Item	Thermal Insulation Within Floor Duct

Item Accessibility	Medium		Amount	12Lm													
<b>A - Product Type:</b>		<b>B - Extent of Damage:</b>		<b>C - Surface Treatment</b>		<b>D - Asbestos Type</b>	<b>Material Ass (M.A) (A+B+C+D):</b>										
Thermal Insulation		3		Medium Damage		2		Unsealed AIB or textiles, Gaskets or encapsulated lagging and sprays	2		Amosite Chrysotile	2		<b>9</b>			
<b>1 = Normal Occupant Activity = (E)</b>		1		<b>E - Main type of activity</b>		1		<b>Total Priority Score (P.A.) = (1+2+3+4):</b>		6		<b>Total Risk Ass' Score (P.A. + M.A)</b>		15		<b>Risk Coding</b>	<b>MEDIUM</b>
<b>2 = Disturbance = (F+G+H)/3</b>		2		<b>F - Location</b>		2		<b>G - Accessibility</b>		1		<b>H - Extent</b>		2			
<b>3 = Exposure potential = (I+J+K)/3</b>		2		<b>I - Number of occupants</b>		3		<b>J - Frequency of use</b>		3		<b>K - Average time in use</b>		1			
<b>4 = Maintenance activity = (L+M)/2</b>		1		<b>L - Type of maintenance</b>		1		<b>M - Frequency of maintenance</b>		1		<b>Recommendation:</b>		Remove by Licensed Asbestos Contractor

<b>Further Information:</b> Thermal insulation within floor duct, previously sampled by ARCS Environmental in 2013 Survey as sample 6, found to contain Amosite and chrysotile.

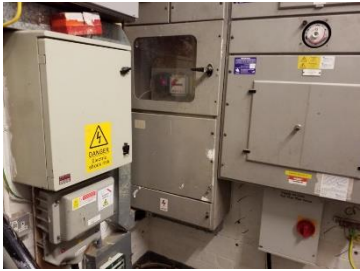
Surveyor	Richard Rayner		Room/Area	0/022 - Plant Room

Survey Date	11 March 2020		Level of Identification	Presumed (P)													
Building	Block A		Sample No	P													
Floor	Ground Floor		Item	Flashguards

Item Accessibility	Difficult		Amount	1m <sup>2</sup>													
<b>A - Product Type:</b>		<b>B - Extent of Damage:</b>		<b>C - Surface Treatment</b>		<b>D - Asbestos Type</b>	<b>Material Ass (M.A) (A+B+C+D):</b>										
Textile Rope & Yarn		2		Good Condition		0		Enclosed sprays, lagging and textiles, AIB (encapsulated), asbestos cement and unsealed decorative finishes	1		Chrysotile	1		<b>4</b>			
<b>1 = Normal Occupant Activity = (E)</b>		0		<b>E - Main type of activity</b>		0		<b>Total Priority Score (P.A.) = (1+2+3+4):</b>		0		<b>Total Risk Ass' Score (P.A. + M.A)</b>		4		<b>Risk Coding</b>	<b>VERY LOW</b>
<b>2 = Disturbance = (F+G+H)/3</b>		0		<b>F - Location</b>		0		<b>G - Accessibility</b>		0		<b>H - Extent</b>		0			
<b>3 = Exposure potential = (I+J+K)/3</b>		0		<b>I - Number of occupants</b>		0		<b>J - Frequency of use</b>		0		<b>K - Average time in use</b>		0			
<b>4 = Maintenance activity = (L+M)/2</b>		0		<b>L - Type of maintenance</b>		0		<b>M - Frequency of maintenance</b>		0		<b>Recommendation:</b>		No Access - Inspection Required

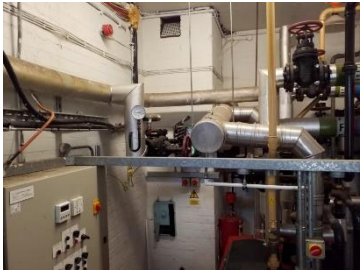
Surveyor	Richard Rayner		Room/Area	0/022 - Plant Room

Survey Date	11 March 2020		Level of Identification	Presumed (P)							
Building	Block A		Sample No	P							
Floor	Ground Floor		Item	Residue To Walls

Item Accessibility	Difficult		Amount	15m <sup>2</sup>							
<b>A - Product Type:</b>		<b>B - Extent of Damage:</b>		<b>C - Surface Treatment</b>		<b>D - Asbestos Type</b>	<b>Material Ass (M.A) (A+B+C+D):</b>				
Sprayed Coating	3	Good Condition	0	Unsealed AIB or textiles, Gaskets or encapsulated lagging and sprays	2	Crocidolite	3	<b>8</b>			
<b>1 = Normal Occupant Activity = (E)</b>		0	<b>E - Main type of activity</b>	0	<b>Total Priority Score (P.A.) = (1+2+3+4):</b>		1	<b>Total Risk Ass' Score (P.A. + M.A)</b>	9	<b>Risk Coding</b>	<b>LOW</b>
<b>2 = Disturbance = (F+G+H)/3</b>		1	<b>F - Location</b>	0	<b>G - Accessibility</b>		0	<b>H - Extent</b>	2		
<b>3 = Exposure potential = (I+J+K)/3</b>		0	<b>I - Number of occupants</b>	0	<b>J - Frequency of use</b>		0	<b>K - Average time in use</b>	0		
<b>4 = Maintenance activity = (L+M)/2</b>		0	<b>L - Type of maintenance</b>	0	<b>M - Frequency of maintenance</b>		0	<b>Recommendation:</b> No Access - Inspection Required

<b>Further Information:</b> Presumed as previously found as mentioned in previous report, Job Number B-70615, sample SGS130411/05. Room has now been painted so presume still present beneath encapsulation.

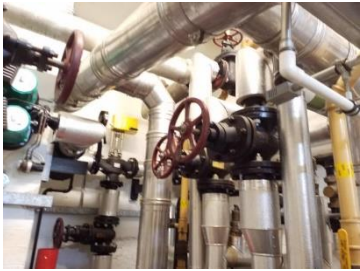
Surveyor	Richard Rayner		Room/Area	0/022 - Plant Room

Survey Date	11 March 2020		Level of Identification	Presumed (P)							
Building	Block A		Sample No	P							
Floor	Ground Floor		Item	Residue To Pipework

Item Accessibility	Difficult		Amount	15m <sup>2</sup>							
<b>A - Product Type:</b>		<b>B - Extent of Damage:</b>		<b>C - Surface Treatment</b>		<b>D - Asbestos Type</b>	<b>Material Ass (M.A) (A+B+C+D):</b>				
Sprayed Coating	3	Good Condition	0	Enclosed sprays, lagging and textiles, AIB (encapsulated), asbestos cement and unsealed decorative finishes	1	Crocidolite	3	<b>7</b>			
<b>1 = Normal Occupant Activity = (E)</b>		0	<b>E - Main type of activity</b>	0	<b>Total Priority Score (P.A.) = (1+2+3+4):</b>		1	<b>Total Risk Ass' Score (P.A. + M.A)</b>	8	<b>Risk Coding</b>	<b>VERY LOW</b>
<b>2 = Disturbance = (F+G+H)/3</b>		1	<b>F - Location</b>	0	<b>G - Accessibility</b>		0	<b>H - Extent</b>	2		
<b>3 = Exposure potential = (I+J+K)/3</b>		0	<b>I - Number of occupants</b>	0	<b>J - Frequency of use</b>		0	<b>K - Average time in use</b>	0		
<b>4 = Maintenance activity = (L+M)/2</b>		0	<b>L - Type of maintenance</b>	0	<b>M - Frequency of maintenance</b>		0	<b>Recommendation:</b> No Access - Inspection Required

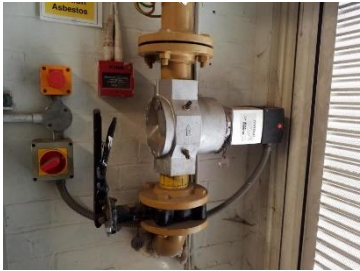
Surveyor	Richard Rayner		Room/Area	0/022 - Plant Room

Survey Date	11 March 2020		Level of Identification	Sampled (S)							
Building	Block A		Sample No	SB-86986/S0001							
Floor	Ground Floor		Item	Gasket To Gas Pipe

Item Accessibility	Difficult		Amount	3No.							
<b>A - Product Type:</b>		<b>B - Extent of Damage:</b>		<b>C - Surface Treatment</b>		<b>D - Asbestos Type</b>	<b>Material Ass (M.A) (A+B+C+D):</b>				
Gasket	2	Good Condition	0	Unsealed AIB or textiles, Gaskets or encapsulated lagging and sprays	2	Chrysotile	1	<b>5</b>			
<b>1 = Normal Occupant Activity = (E)</b>		0	<b>E - Main type of activity</b>	0	<b>Total Priority Score (P.A.) = (1+2+3+4):</b>		0	<b>Total Risk Ass' Score (P.A. + M.A)</b>	5	<b>Risk Coding</b>	<b>VERY LOW</b>
<b>2 = Disturbance = (F+G+H)/3</b>		0	<b>F - Location</b>	0	<b>G - Accessibility</b>		0	<b>H - Extent</b>	0		
<b>3 = Exposure potential = (I+J+K)/3</b>		0	<b>I - Number of occupants</b>	0	<b>J - Frequency of use</b>		0	<b>K - Average time in use</b>	0		
<b>4 = Maintenance activity = (L+M)/2</b>		0	<b>L - Type of maintenance</b>	0	<b>M - Frequency of maintenance</b>		0	<b>Recommendation:</b> Manage & Re-inspect

<b>Further Information:</b> To gas pipe. As originally samples in Life report B-86986/S001

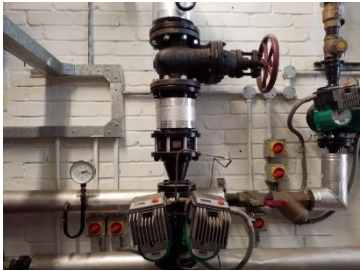
Surveyor	Richard Rayner		Room/Area	0/022 - Plant Room

Survey Date	11 March 2020		Level of Identification	Sampled (S)							
Building	Block A		Sample No	SB-86986/S0002							
Floor	Ground Floor		Item	Gasket To Pipework

Item Accessibility	Difficult		Amount	6No.							
<b>A - Product Type:</b>		<b>B - Extent of Damage:</b>		<b>C - Surface Treatment</b>		<b>D - Asbestos Type</b>	<b>Material Ass (M.A) (A+B+C+D):</b>				
Gasket	2	Good Condition	0	Unsealed AIB or textiles, Gaskets or encapsulated lagging and sprays	2	Chrysotile	1	<b>5</b>			
<b>1 = Normal Occupant Activity = (E)</b>		0	<b>E - Main type of activity</b>	0	<b>Total Priority Score (P.A.) = (1+2+3+4):</b>		0	<b>Total Risk Ass' Score (P.A. + M.A)</b>	5	<b>Risk Coding</b>	<b>VERY LOW</b>
<b>2 = Disturbance = (F+G+H)/3</b>		0	<b>F - Location</b>	0	<b>G - Accessibility</b>		0	<b>H - Extent</b>	1		
<b>3 = Exposure potential = (I+J+K)/3</b>		0	<b>I - Number of occupants</b>	0	<b>J - Frequency of use</b>		0	<b>K - Average time in use</b>	0		
<b>4 = Maintenance activity = (L+M)/2</b>		0	<b>L - Type of maintenance</b>	0	<b>M - Frequency of maintenance</b>		0	<b>Recommendation:</b> Manage & Re-inspect

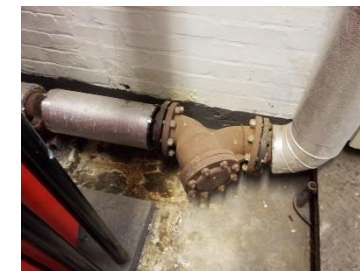
Surveyor	Richard Rayner		Room/Area	0/022 - Plant Room					
Survey Date	11 March 2020		Level of Identification	Sampled (S)					
Building	Block A		Sample No	SB-86986/S0003					
Floor	Ground Floor		Item	Gasket To Pipework

Item Accessibility	Difficult		Amount	3No.					
<b>A - Product Type:</b>		<b>B - Extent of Damage:</b>		<b>C - Surface Treatment</b>		<b>D - Asbestos Type</b>		<b>Material Ass (M.A) (A+B+C+D):</b>	
Gasket	2	Good Condition	0	Unsealed AIB or textiles, Gaskets or encapsulated lagging and sprays	2	Chrysotile	1	<b>5</b>	
<b>1 = Normal Occupant Activity = (E)</b>		0	<b>E - Main type of activity</b>	0	<b>Total Priority Score (P.A.) = (1+2+3+4):</b>		0	<b>Total Risk Ass' Score (P.A. + M.A)</b>	
<b>2 = Disturbance = (F+G+H)/3</b>		0	<b>F - Location</b>	0	<b>G - Accessibility</b>		0	<b>H - Extent</b>	
<b>3 = Exposure potential = (I+J+K)/3</b>		0	<b>I - Number of occupants</b>	0	<b>J - Frequency of use</b>		0	<b>K - Average time in use</b>	
<b>4 = Maintenance activity = (L+M)/2</b>		0	<b>L - Type of maintenance</b>	0	<b>M - Frequency of maintenance</b>		0	<b>Recommendation:</b>	
<b>Further Information:</b>		To hot water paperwork. As originally samples in Life report B-86986/S003

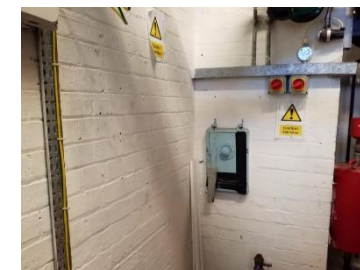
Surveyor	Richard Rayner		Room/Area	0/022 - Plant Room					
Survey Date	11 March 2020		Level of Identification	Sampled (S)					
Building	Block A		Sample No	SB-86986/S0005					
Floor	Ground Floor		Item	Residue To Walls

Item Accessibility	Difficult		Amount	15m²					
<b>A - Product Type:</b>		<b>B - Extent of Damage:</b>		<b>C - Surface Treatment</b>		<b>D - Asbestos Type</b>		<b>Material Ass (M.A) (A+B+C+D):</b>	
Sprayed Coating	3	Good Condition	0	Unsealed AIB or textiles, Gaskets or encapsulated lagging and sprays	2	Amosite	2	<b>7</b>	
<b>1 = Normal Occupant Activity = (E)</b>		0	<b>E - Main type of activity</b>	0	<b>Total Priority Score (P.A.) = (1+2+3+4):</b>		1	<b>Total Risk Ass' Score (P.A. + M.A)</b>	
<b>2 = Disturbance = (F+G+H)/3</b>		1	<b>F - Location</b>	0	<b>G - Accessibility</b>		0	<b>H - Extent</b>	
<b>3 = Exposure potential = (I+J+K)/3</b>		0	<b>I - Number of occupants</b>	0	<b>J - Frequency of use</b>		0	<b>K - Average time in use</b>	
<b>4 = Maintenance activity = (L+M)/2</b>		0	<b>L - Type of maintenance</b>	0	<b>M - Frequency of maintenance</b>		0	<b>Recommendation:</b>	
<b>Further Information:</b>		As originally samples in Life report B-86986/S005

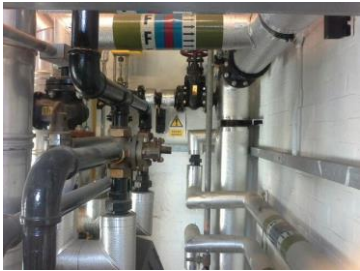
Surveyor	Richard Bowker		Room/Area	0/022 - Boiler Room

Survey Date	28 July 2020		Level of Identification	Strongly Presumed (SP)					
Building	Block A		Sample No	SPSG130411/04					
Floor	Ground Floor		Item	Insulation Residue To Walls

Item Accessibility	Difficult		Amount	20m <sup>2</sup>					
<b>A - Product Type:</b>		<b>B - Extent of Damage:</b>		<b>C - Surface Treatment</b>		<b>D - Asbestos Type</b>	<b>Material Ass (M.A) (A+B+C+D):</b>		
Thermal Insulation	3	Good Condition	0	Unsealed AIB or textiles, Gaskets or encapsulated lagging and sprays	2	Crocidolite	3	<b>8</b>	
<b>1 = Normal Occupant Activity = (E)</b>	<b>0</b>	<b>E – Main type of activity</b>	<b>0</b>	<b>Total Priority Score (P.A.) = (1+2+3+4):</b>	<b>3</b>	<b>Total Risk Ass' Score (P.A. + M.A)</b>	<b>11</b>	<b>Risk Coding</b>	<b>LOW</b>
<b>2 = Disturbance = (F+G+H)/3</b>	<b>1</b>	<b>F – Location</b>	<b>2</b>	<b>G – Accessibility</b>	<b>0</b>	<b>H – Extent</b>	<b>2</b>		
<b>3 = Exposure potential = (I+J+K)/3</b>	<b>1</b>	<b>I – Number of occupants</b>	<b>1</b>	<b>J – Frequency of use</b>	<b>3</b>	<b>K – Average time in use</b>	<b>0</b>		
<b>4 = Maintenance activity = (L+M)/2</b>	<b>1</b>	<b>L – Type of maintenance</b>	<b>1</b>	<b>M – Frequency of maintenance</b>	<b>1</b>	<b>Recommendation:</b>	<b>Manage &amp; Re-inspect</b>

<b>Further Information:</b> Thermal insulation residue to walls, previously sampled by Noble HSC as sample SG130411/04, found to contain crocidolite.

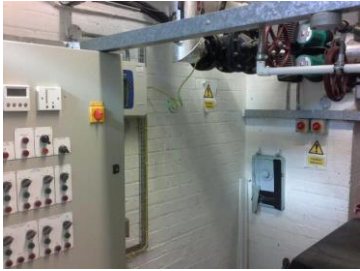
Surveyor	Richard Bowker		Room/Area	0/022 - Boiler Room

Survey Date	28 July 2020		Level of Identification	Strongly Presumed (SP)					
Building	Block A		Sample No	SPSG130411/05					
Floor	Ground Floor		Item	Insulation Residue To Walls

Item Accessibility	Difficult		Amount	20m <sup>2</sup>					
<b>A - Product Type:</b>		<b>B - Extent of Damage:</b>		<b>C - Surface Treatment</b>		<b>D - Asbestos Type</b>	<b>Material Ass (M.A) (A+B+C+D):</b>		
Thermal Insulation	3	Good Condition	0	Unsealed AIB or textiles, Gaskets or encapsulated lagging and sprays	2	Crocidolite	3	<b>8</b>	
<b>1 = Normal Occupant Activity = (E)</b>	<b>0</b>	<b>E – Main type of activity</b>	<b>0</b>	<b>Total Priority Score (P.A.) = (1+2+3+4):</b>	<b>3</b>	<b>Total Risk Ass' Score (P.A. + M.A)</b>	<b>11</b>	<b>Risk Coding</b>	<b>LOW</b>
<b>2 = Disturbance = (F+G+H)/3</b>	<b>1</b>	<b>F – Location</b>	<b>2</b>	<b>G – Accessibility</b>	<b>0</b>	<b>H – Extent</b>	<b>2</b>		
<b>3 = Exposure potential = (I+J+K)/3</b>	<b>1</b>	<b>I – Number of occupants</b>	<b>1</b>	<b>J – Frequency of use</b>	<b>3</b>	<b>K – Average time in use</b>	<b>0</b>		
<b>4 = Maintenance activity = (L+M)/2</b>	<b>1</b>	<b>L – Type of maintenance</b>	<b>1</b>	<b>M – Frequency of maintenance</b>	<b>1</b>	<b>Recommendation:</b>	<b>Manage &amp; Re-inspect</b>

<b>Further Information:</b> Thermal insulation residue to walls, previously sampled by Noble HSC as sample SG130411/05, found to contain crocidolite.

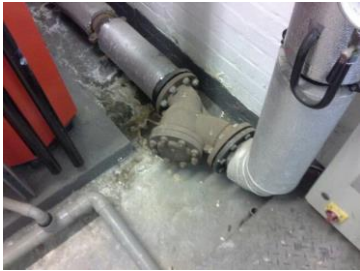
Surveyor	Richard Bowker		Room/Area	0/022 - Boiler Room

Survey Date	28 July 2020		Level of Identification	Strongly Presumed (SP)							
Building	Block A		Sample No	SPSG130411/13							
Floor	Ground Floor		Item	Gasket To Pipework

Item Accessibility	Difficult		Amount	1No.							
<b>A - Product Type:</b>		<b>B - Extent of Damage:</b>		<b>C - Surface Treatment</b>		<b>D - Asbestos Type</b>	<b>Material Ass (M.A) (A+B+C+D):</b>				
Gasket	2	Good Condition	0	Unsealed AIB or textiles, Gaskets or encapsulated lagging and sprays	2	Chrysotile	1	<b>5</b>			
<b>1 = Normal Occupant Activity = (E)</b>		0	<b>E - Main type of activity</b>	0	<b>Total Priority Score (P.A.) = (1+2+3+4):</b>		3	<b>Total Risk Ass' Score (P.A. + M.A)</b>	8	<b>Risk Coding</b>	<b>VERY LOW</b>
<b>2 = Disturbance = (F+G+H)/3</b>		1	<b>F - Location</b>	2	<b>G - Accessibility</b>		0	<b>H - Extent</b>	0		
<b>3 = Exposure potential = (I+J+K)/3</b>		1	<b>I - Number of occupants</b>	1	<b>J - Frequency of use</b>		3	<b>K - Average time in use</b>	0		
<b>4 = Maintenance activity = (L+M)/2</b>		1	<b>L - Type of maintenance</b>	1	<b>M - Frequency of maintenance</b>		1	<b>Recommendation:</b> Manage & Re-inspect

<b>Further Information:</b> Gasket to pipework, previously sampled by Noble HSC as sample SG130411/13, found to contain chrysotile. Also sampled by Life Environmental Services in report B-86986 as sample 0003.

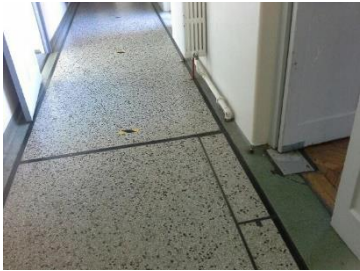
Surveyor	Richard Bowker		Room/Area	0/039 - Corridor

Survey Date	28 July 2020		Level of Identification	Strongly Presumed (SP)							
Building	Block A		Sample No	SPSARCS/5							
Floor	Ground Floor		Item	Thermal Insulation Within Floor Duct

Item Accessibility	Medium		Amount	12Lm							
<b>A - Product Type:</b>		<b>B - Extent of Damage:</b>		<b>C - Surface Treatment</b>		<b>D - Asbestos Type</b>	<b>Material Ass (M.A) (A+B+C+D):</b>				
Thermal Insulation	3	Medium Damage	2	Unsealed AIB or textiles, Gaskets or encapsulated lagging and sprays	2	Amosite Chrysotile	2	<b>9</b>			
<b>1 = Normal Occupant Activity = (E)</b>		0	<b>E - Main type of activity</b>	0	<b>Total Priority Score (P.A.) = (1+2+3+4):</b>		5	<b>Total Risk Ass' Score (P.A. + M.A)</b>	14	<b>Risk Coding</b>	<b>MEDIUM</b>
<b>2 = Disturbance = (F+G+H)/3</b>		2	<b>F - Location</b>	2	<b>G - Accessibility</b>		1	<b>H - Extent</b>	2		
<b>3 = Exposure potential = (I+J+K)/3</b>		2	<b>I - Number of occupants</b>	3	<b>J - Frequency of use</b>		3	<b>K - Average time in use</b>	0		
<b>4 = Maintenance activity = (L+M)/2</b>		1	<b>L - Type of maintenance</b>	1	<b>M - Frequency of maintenance</b>		1	<b>Recommendation:</b> Remove by Licensed Asbestos Contractor

<b>Further Information:</b> Thermal insulation within floor duct, previously sampled by ARCS Environmental in 2013 Survey as sample 5, found to contain Amosite and chrysotile.

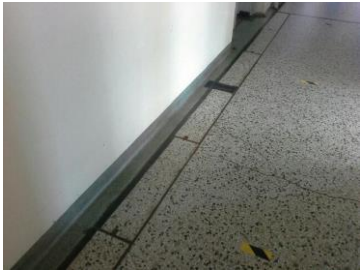
Surveyor		Richard Bowker		Room/Area		0/039A - Corridor

Survey Date		28 July 2020		Level of Identification		Strongly Presumed (SP)							
Building		Block A		Sample No		SPSARCS/5							
Floor		Ground Floor		Item		Thermal Insulation Within Floor Duct

Item Accessibility		Medium		Amount		12Lm							
<b>A - Product Type:</b>		<b>B - Extent of Damage:</b>		<b>C - Surface Treatment</b>		<b>D - Asbestos Type</b>		<b>Material Ass (M.A) (A+B+C+D):</b>					
Thermal Insulation	3	Medium Damage	2	Unsealed AIB or textiles, Gaskets or encapsulated lagging and sprays	2	Amosite Chrysotile	2	<b>9</b>					
<b>1 = Normal Occupant Activity = (E)</b>		1	<b>E – Main type of activity</b>		1	<b>Total Priority Score (P.A.) = (1+2+3+4):</b>		6	<b>Total Risk Ass' Score (P.A. + M.A)</b>		15	<b>Risk Coding</b>	<b>MEDIUM</b>
<b>2 = Disturbance = (F+G+H)/3</b>		2	<b>F – Location</b>		2	<b>G – Accessibility</b>		1	<b>H – Extent</b>		2		
<b>3 = Exposure potential = (I+J+K)/3</b>		2	<b>I – Number of occupants</b>		3	<b>J – Frequency of use</b>		3	<b>K – Average time in use</b>		0		
<b>4 = Maintenance activity = (L+M)/2</b>		1	<b>L – Type of maintenance</b>		1	<b>M – Frequency of maintenance</b>		1	<b>Recommendation:</b> Remove by Licensed Asbestos Contractor

<b>Further Information:</b> Thermal insulation within floor duct, previously cross referenced by ARCS Environmental in 2013 Survey to sample 5, found to contain Amosite and chrysotile.

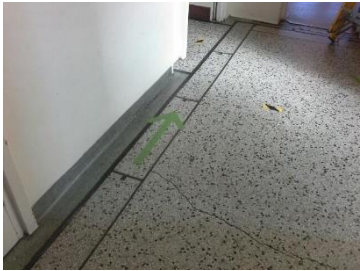
Surveyor		Richard Bowker		Room/Area		0/039B - Corridor

Survey Date		28 July 2020		Level of Identification		Strongly Presumed (SP)							
Building		Block A		Sample No		SPSARCS/5							
Floor		Ground Floor		Item		Thermal Insulation Within Floor Duct

Item Accessibility		Medium		Amount		12Lm							
<b>A - Product Type:</b>		<b>B - Extent of Damage:</b>		<b>C - Surface Treatment</b>		<b>D - Asbestos Type</b>		<b>Material Ass (M.A) (A+B+C+D):</b>					
Thermal Insulation	3	Medium Damage	2	Unsealed AIB or textiles, Gaskets or encapsulated lagging and sprays	2	Amosite Chrysotile	2	<b>9</b>					
<b>1 = Normal Occupant Activity = (E)</b>		1	<b>E – Main type of activity</b>		1	<b>Total Priority Score (P.A.) = (1+2+3+4):</b>		6	<b>Total Risk Ass' Score (P.A. + M.A)</b>		15	<b>Risk Coding</b>	<b>MEDIUM</b>
<b>2 = Disturbance = (F+G+H)/3</b>		2	<b>F – Location</b>		2	<b>G – Accessibility</b>		1	<b>H – Extent</b>		2		
<b>3 = Exposure potential = (I+J+K)/3</b>		2	<b>I – Number of occupants</b>		3	<b>J – Frequency of use</b>		3	<b>K – Average time in use</b>		0		
<b>4 = Maintenance activity = (L+M)/2</b>		1	<b>L – Type of maintenance</b>		1	<b>M – Frequency of maintenance</b>		1	<b>Recommendation:</b> Remove by Licensed Asbestos Contractor

<b>Further Information:</b> Thermal insulation within floor duct, previously cross referenced by ARCS Environmental in 2013 Survey to sample 5, found to contain Amosite and chrysotile.

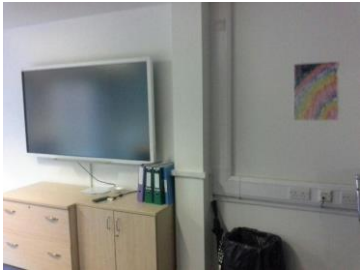
Surveyor		Richard Bowker		Room/Area		0/093 - Heads Office

Survey Date		28 July 2020		Level of Identification		Presumed (P)							
Building		Block A		Sample No		P							
Floor		Ground Floor		Item		Sealed Boxing

Item Accessibility		Medium		Amount		5Lm							
<b>A - Product Type:</b>		<b>B - Extent of Damage:</b>		<b>C - Surface Treatment</b>		<b>D - Asbestos Type</b>		<b>Material Ass (M.A) (A+B+C+D):</b>					
Thermal Insulation	3	Good Condition	0	Unsealed AIB or textiles, Gaskets or encapsulated lagging and sprays	2	Crocidolite	3	<b>8</b>					
<b>1 = Normal Occupant Activity = (E)</b>		1	<b>E - Main type of activity</b>		1	<b>Total Priority Score (P.A.) = (1+2+3+4):</b>		5	<b>Total Risk Ass' Score (P.A. + M.A)</b>		13	<b>Risk Coding</b>	<b>LOW</b>
<b>2 = Disturbance = (F+G+H)/3</b>		1	<b>F - Location</b>		2	<b>G - Accessibility</b>		1	<b>H - Extent</b>		1		
<b>3 = Exposure potential = (I+J+K)/3</b>		2	<b>I - Number of occupants</b>		1	<b>J - Frequency of use</b>		3	<b>K - Average time in use</b>		2		
<b>4 = Maintenance activity = (L+M)/2</b>		1	<b>L - Type of maintenance</b>		1	<b>M - Frequency of maintenance</b>		1	<b>Recommendation:</b> No Access - Inspection Required

<b>Further Information:</b> Presumed ACM thermal insulation within sealed boxing, previously presumed to contain crocidolite until accessed.

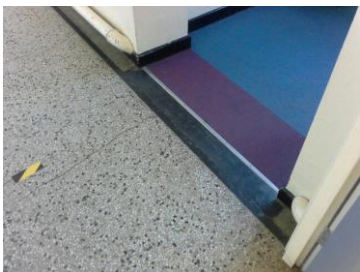
Surveyor		Richard Bowker		Room/Area		1/006 - Corridor

Survey Date		28 July 2020		Level of Identification		Strongly Presumed (SP)							
Building		Block A		Sample No		SPSARCS/5							
Floor		1st Floor		Item		Thermal Insulation Within Floor Duct

Item Accessibility		Medium		Amount		12Lm							
<b>A - Product Type:</b>		<b>B - Extent of Damage:</b>		<b>C - Surface Treatment</b>		<b>D - Asbestos Type</b>		<b>Material Ass (M.A) (A+B+C+D):</b>					
Thermal Insulation	3	Medium Damage	2	Unsealed AIB or textiles, Gaskets or encapsulated lagging and sprays	2	Amosite Chrysotile	2	<b>9</b>					
<b>1 = Normal Occupant Activity = (E)</b>		1	<b>E - Main type of activity</b>		1	<b>Total Priority Score (P.A.) = (1+2+3+4):</b>		6	<b>Total Risk Ass' Score (P.A. + M.A)</b>		15	<b>Risk Coding</b>	<b>MEDIUM</b>
<b>2 = Disturbance = (F+G+H)/3</b>		2	<b>F - Location</b>		2	<b>G - Accessibility</b>		1	<b>H - Extent</b>		2		
<b>3 = Exposure potential = (I+J+K)/3</b>		2	<b>I - Number of occupants</b>		3	<b>J - Frequency of use</b>		3	<b>K - Average time in use</b>		0		
<b>4 = Maintenance activity = (L+M)/2</b>		1	<b>L - Type of maintenance</b>		1	<b>M - Frequency of maintenance</b>		1	<b>Recommendation:</b> Remove by Licensed Asbestos Contractor

<b>Further Information:</b> Thermal insulation within floor duct, previously cross referenced by ARCS Environmental in 2013 Survey to sample 5, found to contain Amosite and chrysotile.

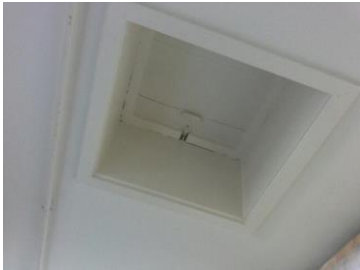
Surveyor	Richard Bowker		Room/Area	2/001 - Roof Void - Loft

Survey Date	28 July 2020		Level of Identification	Presumed (P)					
Building	Block A		Sample No	P					
Floor	2nd Floor		Item	No Access Into Loft Space

Item Accessibility			Amount						
<b>A - Product Type:</b>		<b>B - Extent of Damage:</b>		<b>C - Surface Treatment</b>		<b>D - Asbestos Type</b>	<b>Material Ass (M.A) (A+B+C+D):</b>		
Unspecified Material						Presumed Asbestos	<b>12</b>		
<b>1 = Normal Occupant Activity = (E)</b>	<b>0</b>	<b>E - Main type of activity</b>	<b>0</b>	<b>Total Priority Score (P.A.) = (1+2+3+4):</b>	<b>0</b>	<b>Total Risk Ass' Score (P.A. + M.A)</b>	<b>12</b>	<b>Risk Coding</b>	
<b>2 = Disturbance = (F+G+H)/3</b>	<b>0</b>	<b>F - Location</b>		<b>G - Accessibility</b>		<b>H - Extent</b>			
<b>3 = Exposure potential = (I+J+K)/3</b>	<b>0</b>	<b>I - Number of occupants</b>		<b>J - Frequency of use</b>		<b>K - Average time in use</b>			
<b>4 = Maintenance activity = (L+M)/2</b>	<b>0</b>	<b>L - Type of maintenance</b>		<b>M - Frequency of maintenance</b>		<b>Recommendation:</b> No Access - Inspection Required Presumed Asbestos is scored 12 (worst case) until sampled/inspected

<b>Further Information:</b> This location was not accessed and as such should be presumed to contain asbestos until proven otherwise. No access into loft space, previously presumed to contain ACM's until accessed. Located above Corridor 1/005.

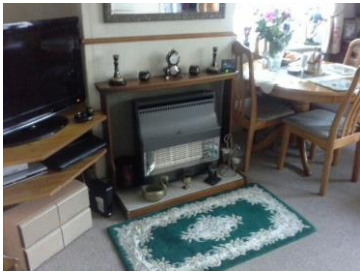
Surveyor	Richard Bowker		Room/Area	0/004 - Lounge

Survey Date	28 July 2020		Level of Identification	Presumed (P)							
Building	Caretaker's House		Sample No	P							
Floor	Ground Floor		Item	Board Behind Fireplace

Item Accessibility	Difficult		Amount	1m <sup>2</sup>							
<b>A - Product Type:</b>		<b>B - Extent of Damage:</b>		<b>C - Surface Treatment</b>		<b>D - Asbestos Type</b>	<b>Material Ass (M.A) (A+B+C+D):</b>				
Insulating Board		2		Good Condition		0	Unsealed AIB or textiles, Gaskets or encapsulated lagging and sprays	2	Amosite	2	<b>6</b>
<b>1 = Normal Occupant Activity = (E)</b>	<b>1</b>	<b>E - Main type of activity</b>	<b>1</b>	<b>Total Priority Score (P.A.) = (1+2+3+4):</b>	<b>5</b>	<b>Total Risk Ass' Score (P.A. + M.A)</b>	<b>11</b>	<b>Risk Coding</b>	<b>LOW</b>		
<b>2 = Disturbance = (F+G+H)/3</b>	<b>1</b>	<b>F - Location</b>	<b>2</b>	<b>G - Accessibility</b>	<b>0</b>	<b>H - Extent</b>			<b>0</b>		
<b>3 = Exposure potential = (I+J+K)/3</b>	<b>2</b>	<b>I - Number of occupants</b>	<b>1</b>	<b>J - Frequency of use</b>	<b>3</b>	<b>K - Average time in use</b>			<b>2</b>		
<b>4 = Maintenance activity = (L+M)/2</b>	<b>1</b>	<b>L - Type of maintenance</b>	<b>1</b>	<b>M - Frequency of maintenance</b>	<b>1</b>	<b>Recommendation:</b> No Access - Inspection Required

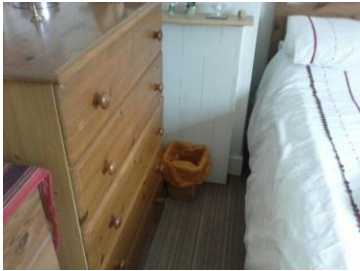
Surveyor		Richard Bowker		Room/Area		1/004 - Bedroom

Survey Date		28 July 2020		Level of Identification		Presumed (P)													
Building		Caretaker's House		Sample No		P													
Floor		1st Floor		Item		Board Behind Fireplace

Item Accessibility		Difficult		Amount		1m <sup>2</sup>													
<b>A - Product Type:</b>		<b>B - Extent of Damage:</b>		<b>C - Surface Treatment</b>		<b>D - Asbestos Type</b>		<b>Material Ass (M.A) (A+B+C+D):</b>											
Insulating Board		2		Good Condition		0		Unsealed AIB or textiles, Gaskets or encapsulated lagging and sprays		2		Amosite		2		6			
<b>1 = Normal Occupant Activity = (E)</b>		1		<b>E - Main type of activity</b>		1		<b>Total Priority Score (P.A.) = (1+2+3+4):</b>		5		<b>Total Risk Ass' Score (P.A. + M.A)</b>		11		<b>Risk Coding</b>		LOW	
<b>2 = Disturbance = (F+G+H)/3</b>		1		<b>F - Location</b>		2		<b>G - Accessibility</b>		0		<b>H - Extent</b>		0					
<b>3 = Exposure potential = (I+J+K)/3</b>		2		<b>I - Number of occupants</b>		1		<b>J - Frequency of use</b>		3		<b>K - Average time in use</b>		3					
<b>4 = Maintenance activity = (L+M)/2</b>		1		<b>L - Type of maintenance</b>		1		<b>M - Frequency of maintenance</b>		1		<b>Recommendation:</b> No Access - Inspection Required

<b>Further Information:</b> Presumed ACM Insulation board panel behind fireplace, previously presumed by Noble HSC to contain Amosite until sampled.

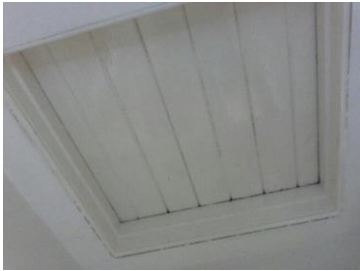
Surveyor		Richard Bowker		Room/Area		2/001 - Roof Void - Loft

Survey Date		28 July 2020		Level of Identification		Presumed (P)													
Building		Caretaker's House		Sample No		P													
Floor		2nd Floor		Item		No Access Into Loft Space

Item Accessibility				Amount															
<b>A - Product Type:</b>		<b>B - Extent of Damage:</b>		<b>C - Surface Treatment</b>		<b>D - Asbestos Type</b>		<b>Material Ass (M.A) (A+B+C+D):</b>											
Unspecified Material								Presumed Asbestos				12							
<b>1 = Normal Occupant Activity = (E)</b>		0		<b>E - Main type of activity</b>		0		<b>Total Priority Score (P.A.) = (1+2+3+4):</b>		0		<b>Total Risk Ass' Score (P.A. + M.A)</b>		12		<b>Risk Coding</b>			
<b>2 = Disturbance = (F+G+H)/3</b>		0		<b>F - Location</b>				<b>G - Accessibility</b>				<b>H - Extent</b>							
<b>3 = Exposure potential = (I+J+K)/3</b>		0		<b>I - Number of occupants</b>				<b>J - Frequency of use</b>				<b>K - Average time in use</b>							
<b>4 = Maintenance activity = (L+M)/2</b>		0		<b>L - Type of maintenance</b>				<b>M - Frequency of maintenance</b>				<b>Recommendation:</b> No Access - Inspection Required Presumed Asbestos is scored 12 (worst case) until sampled/inspected
