Wimbledon Park Lake

Site Investigation Report

**Report Ref:
A112771 V1**

Project: Wimbledon Lake
Client: London Borough of Merton
Job Number: A112771
File Origin: \\londondc02\100SJS\Projects\A110000\A112771 Wimbledon Lake\Report\WYG Ground Investigation Report Wimbledon Lake_FINALv2.docx

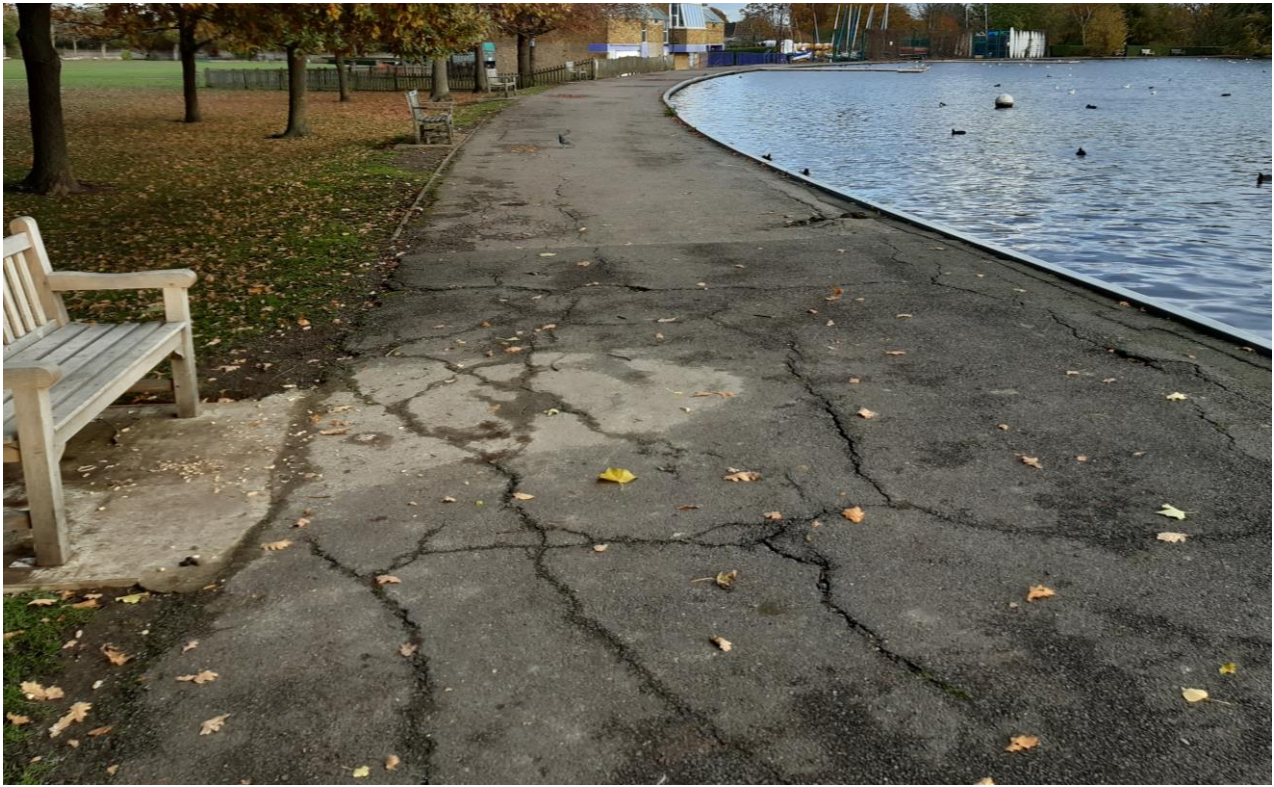
- Up to 15mm aperture, 0.3 to 3.0m long cracks running parallel to the lake perimeter, most notably in the area surrounding the mature trees in the central east area of the site and the north part of the site, close to the entrance to the athletics track enclosure. These cracks are suggestive of either minor slope movements and / or shrinkage / settlement of the underlying soils (Photo 09, Appendix C);
- undulations associated with the root balls in the central east area if the site (Photo 10, Appendix C);
- damage / breaching of the asphalt from emerging roots in the central east area (Photo 11, Appendix C);
- Bulging of the sheet pile around trees in the central east area of the site (Photo 12, Appendix C).

Plate 9 View east showing cracks in asphalt in the north area of the site

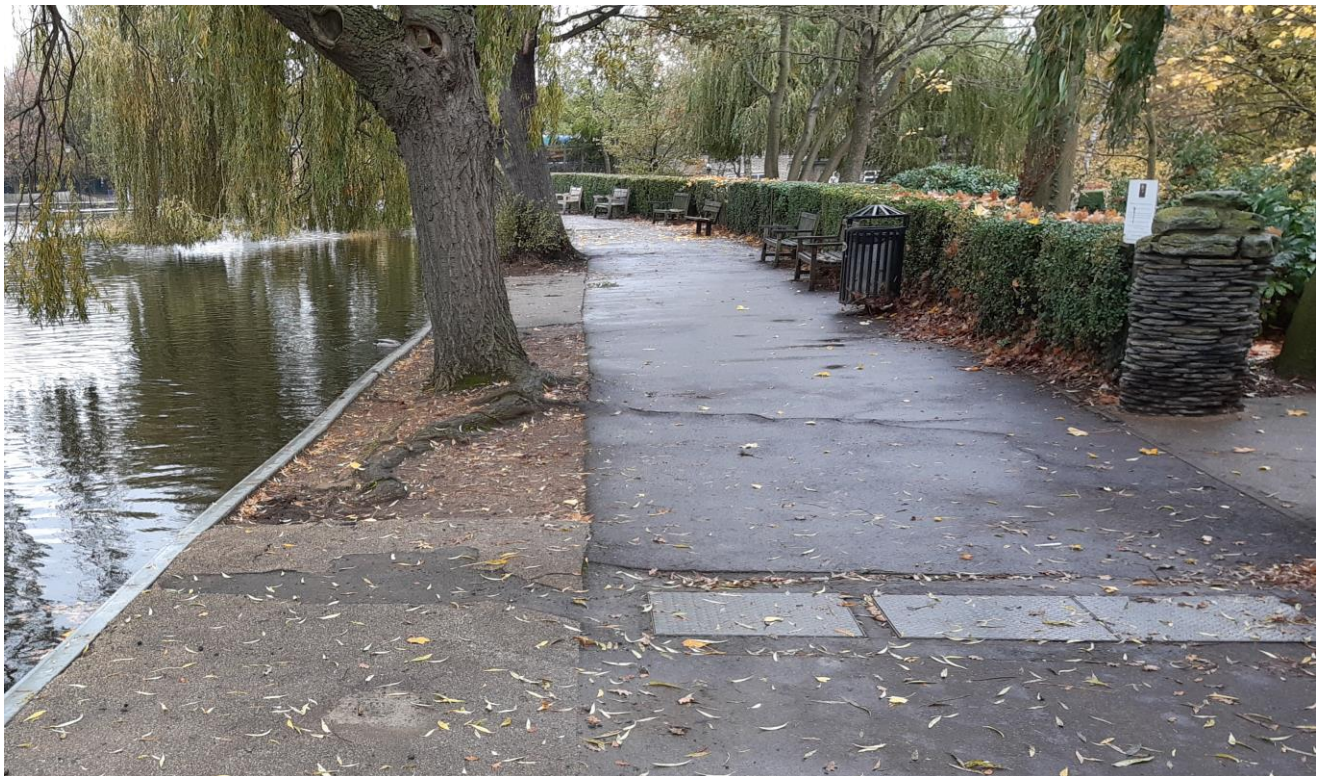
Plate 10 Undulations in the asphalt due to root balls in the central east area of the site

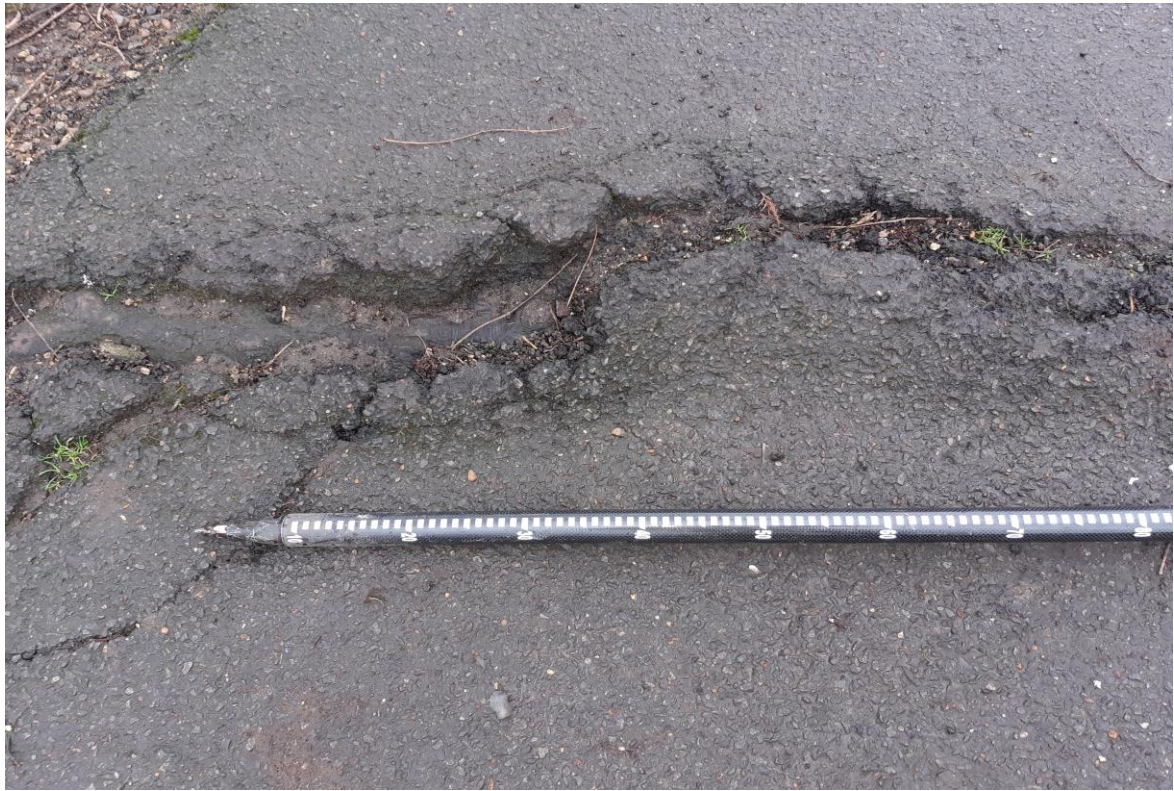
Plate 11 Damage to the asphalt due to root breaching in the central east area of the site

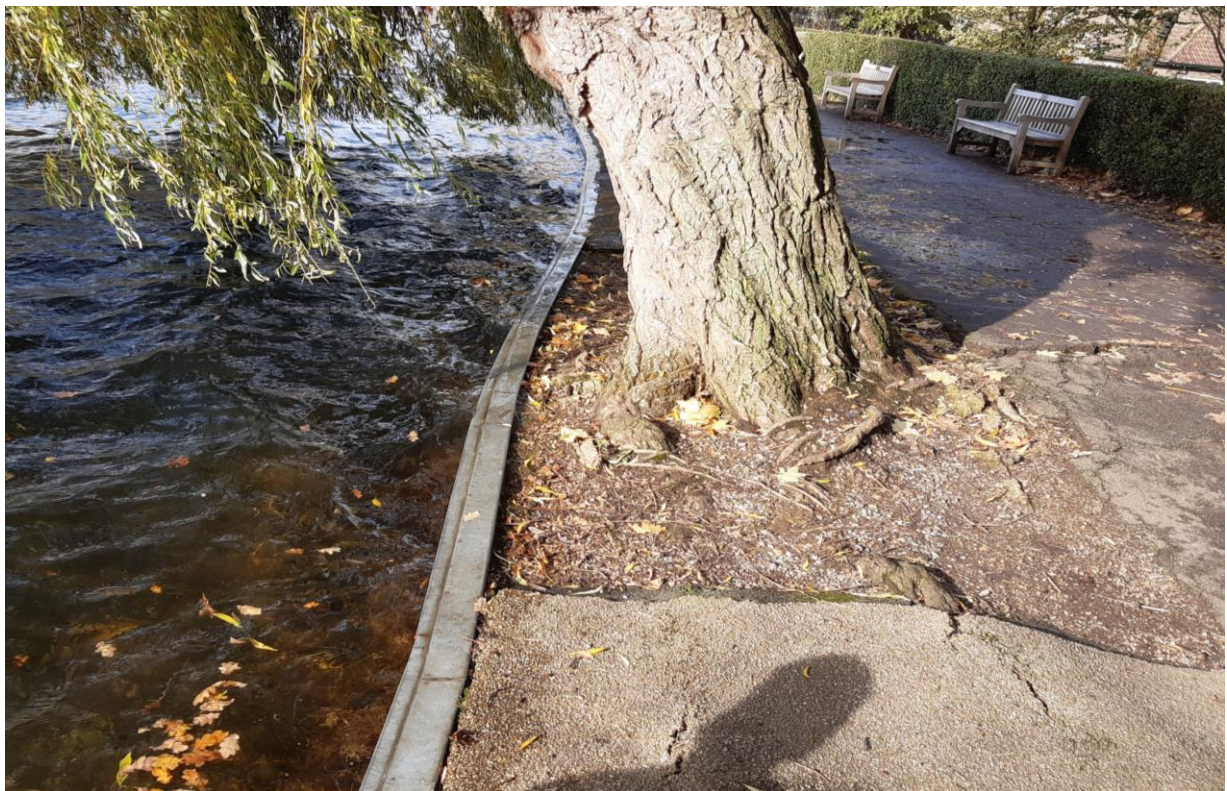
Plate 12 Bulging of the sheet pile due to trees in the central east area of the site

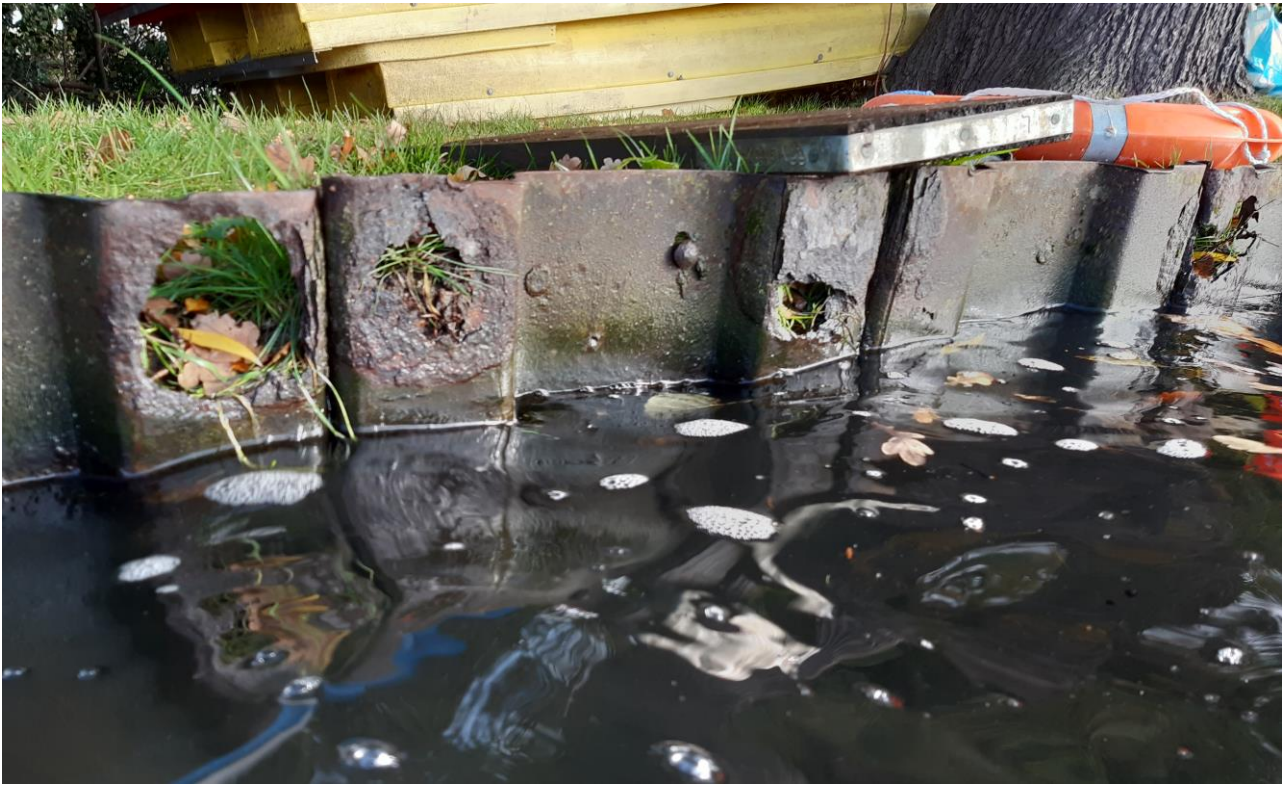
Plate 23 Organic growth and minor defects on sheet pile on fishing bank

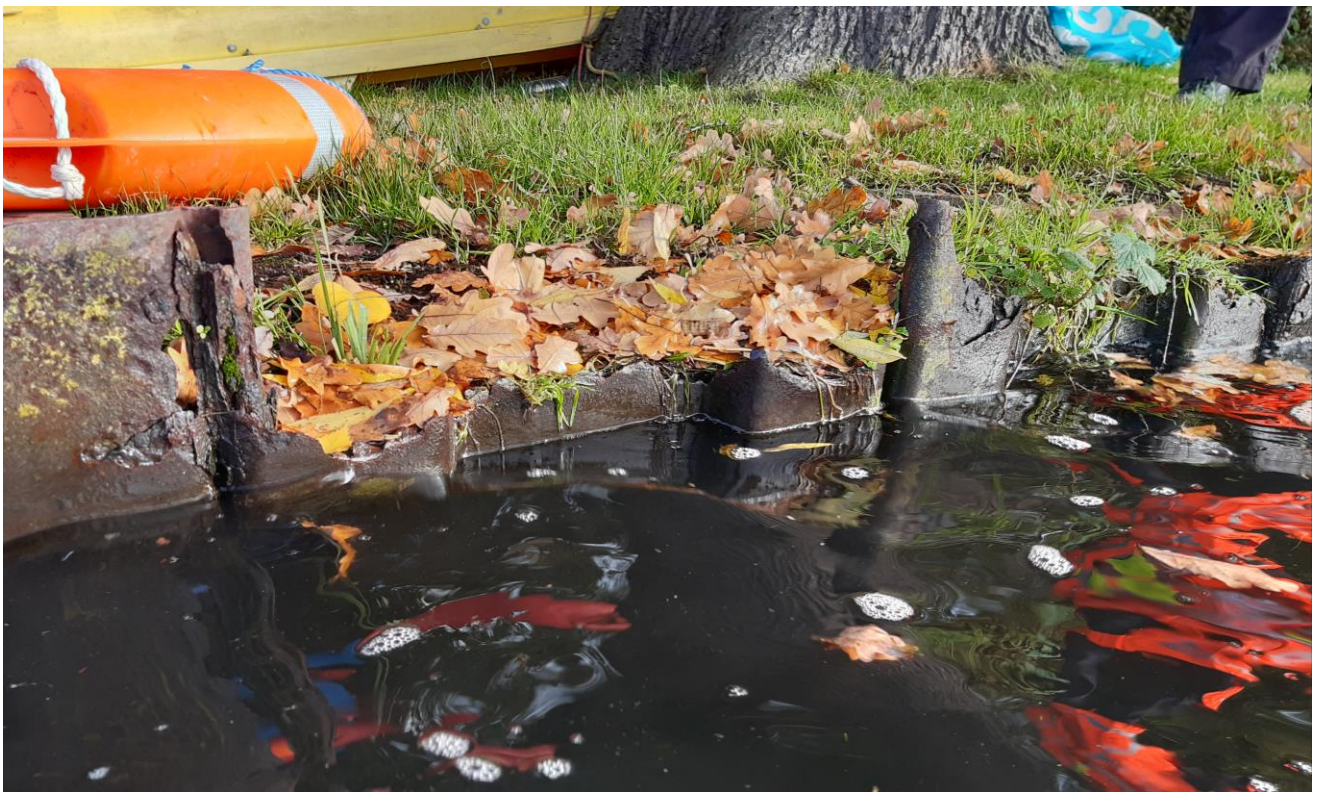
Plate 24 Degredation of the sheet pile on fishing bank

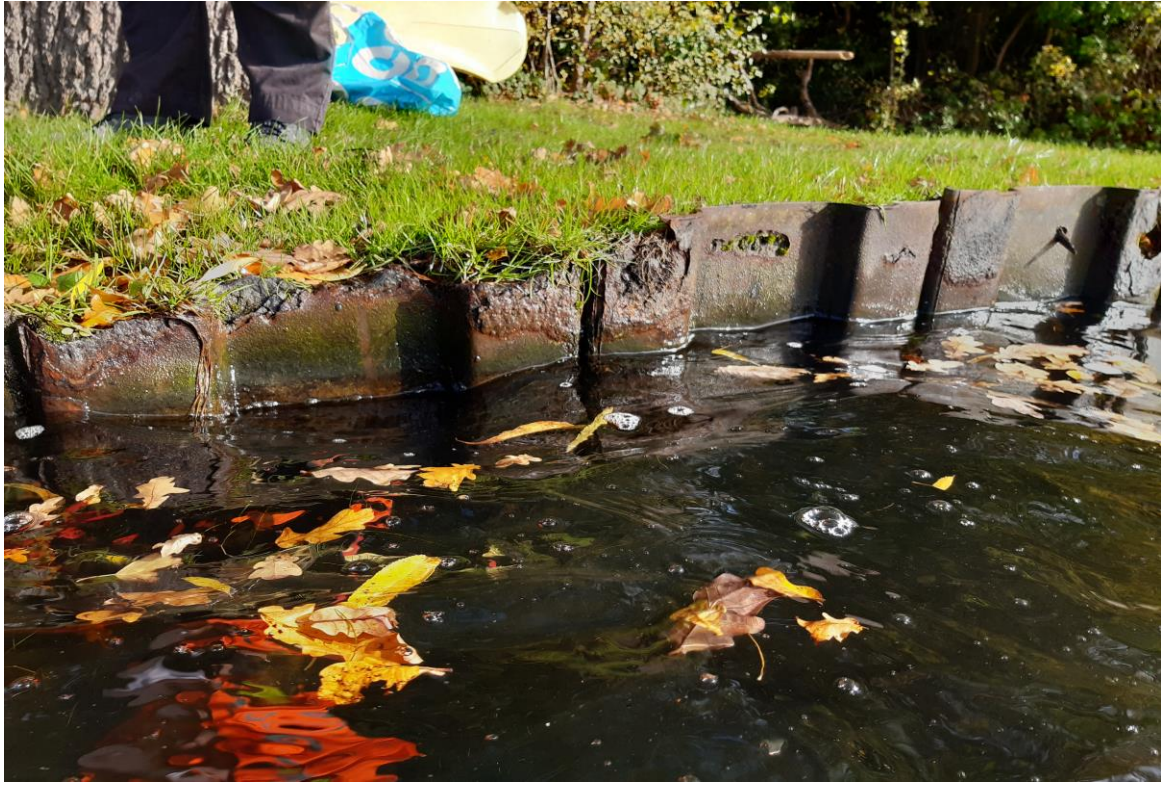
Plate 25 Evidence of corrosion on sheet pile at fishing bank

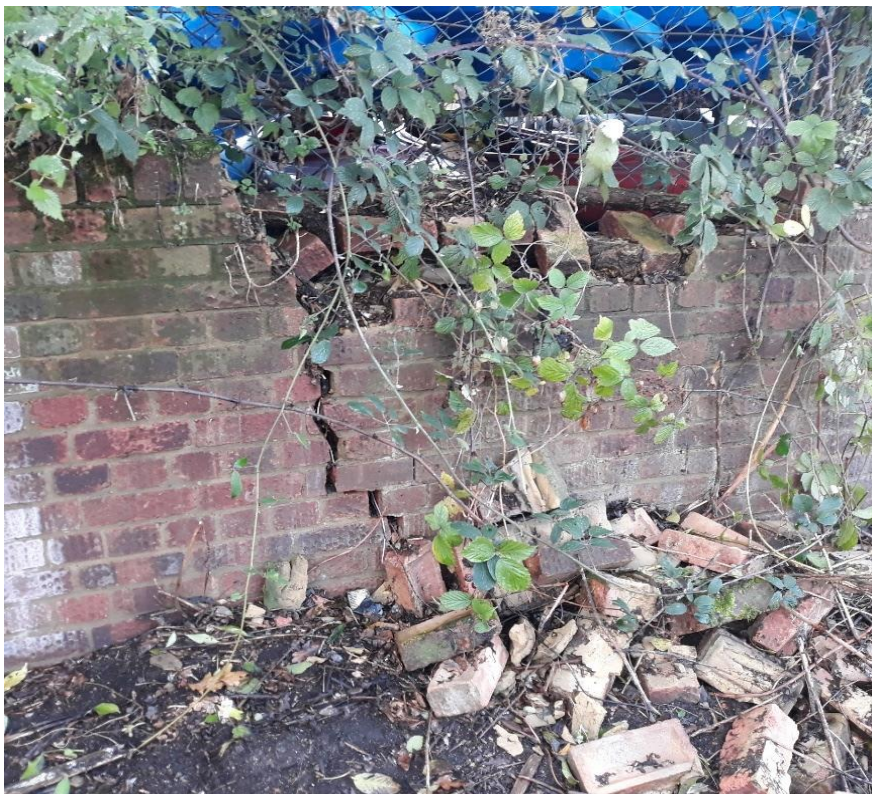
Plate 26 Structural Crack running the full visible height of the brickwork retaining wall

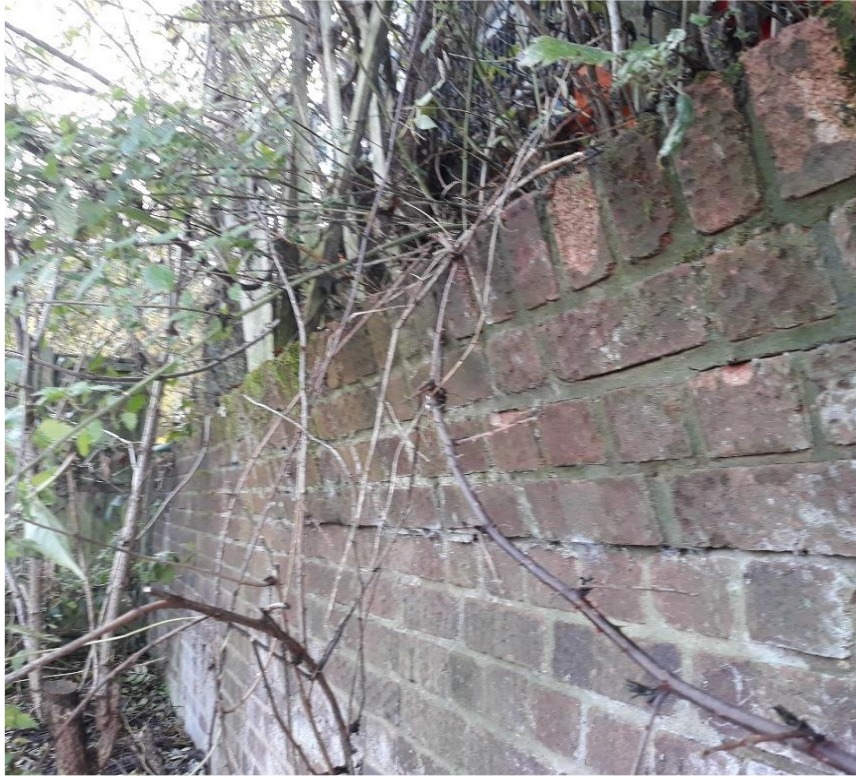
Plate 27

Top section of brickwork retaining wall rotated about a failure plain along a mortar joint

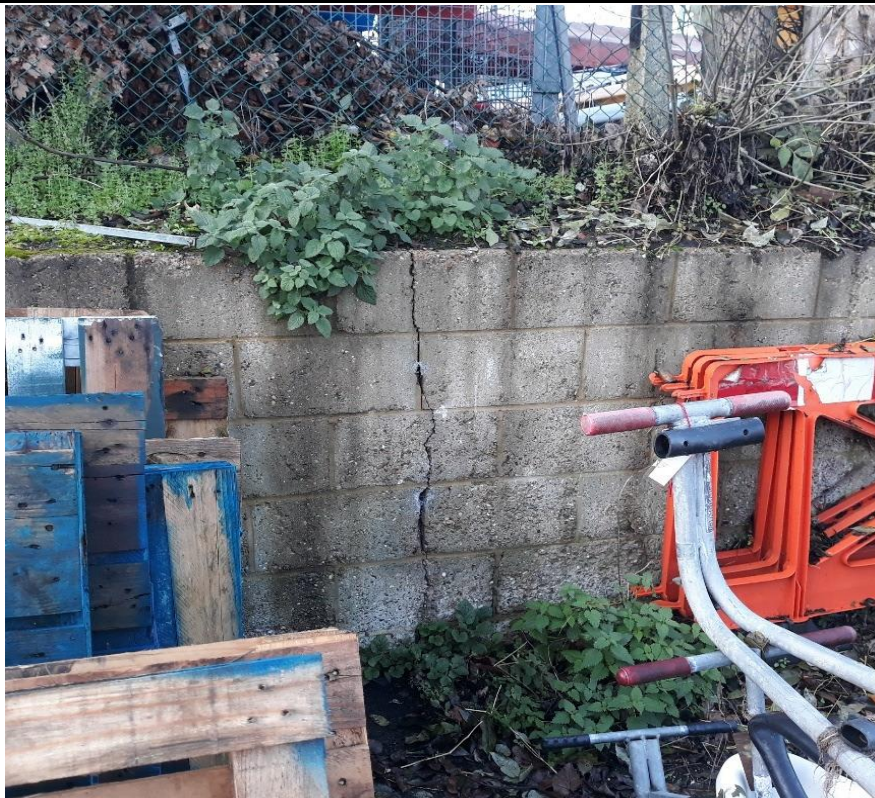
Plate 28

Structural crack running the full height of the blockwork wall

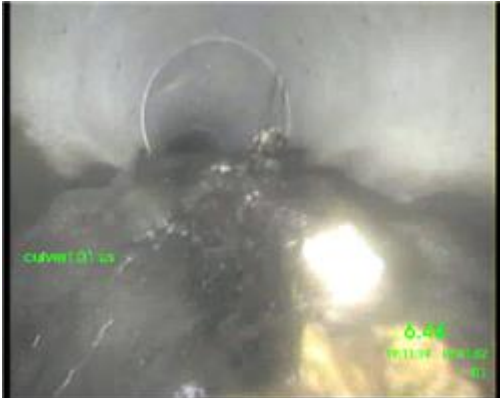
06.4m	0:00:00	RM	S1	Roots mass 6.4m - 7.7m: 20% cross-sectional area loss - Severity 4	Image Provided - Ref: 0_1

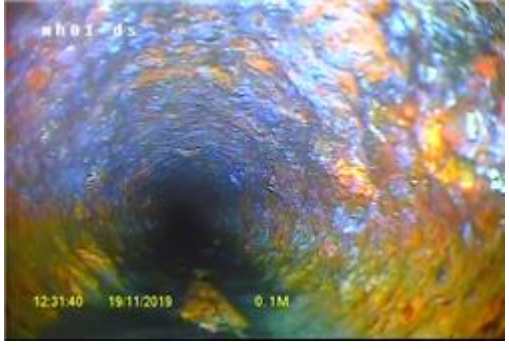
00.0m	0:00:00	DEZ	S1	Other 0m - 3m from 12 o'clock to 12 o'clock: 10% cross-sectional area loss - Severity 2 Rust/Corrosion	Image Provided - Ref: 3_1

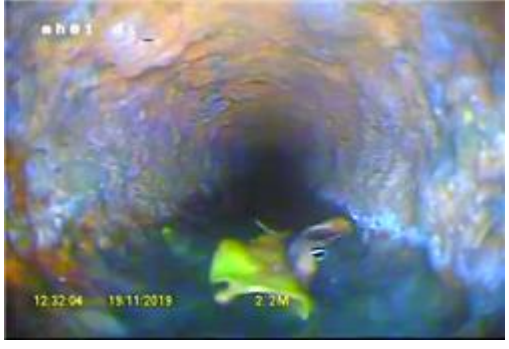
02.2m	0:00:23	DES		Settled deposits fine: 5% cross-sectional area loss - Severity 2 Settled Leaves	Image Provided - Ref: 3_2

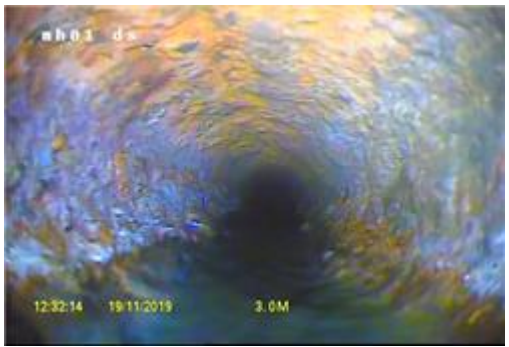
03.0m	0:00:00	DEZ	F1	Other Defect End from 12 o'clock to 12 o'clock: 10% cross-sectional area loss - Severity 2 Rust/Corrosion	
03.0m	0:00:34	DEZ	S2	Other 3m - 4m from 12 o'clock to 12 o'clock: 20% cross-sectional area loss - Severity 2 Rust/Corrosion	Image Provided - Ref: 3_3

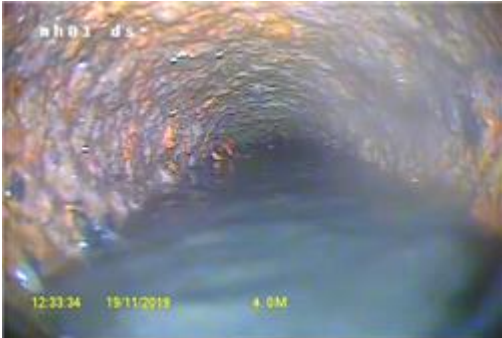
04.1m		SA		Survey abandoned Survey Abandoned - Unable to Push Camera Further Due to Rust/Corrosion Reduces Pipe Circumference.	Image Provided - Ref: 3_9999

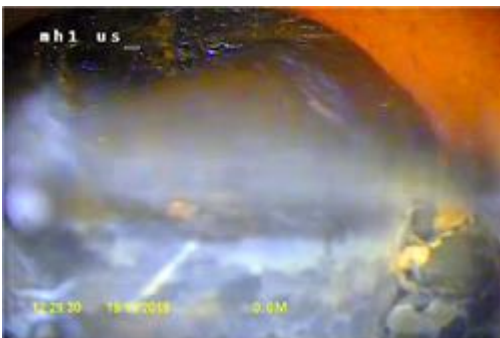
00.1m		SA		Survey abandoned Survey Abandoned - Unable to Pass Blockage	Image Provided - Ref: 4_9999

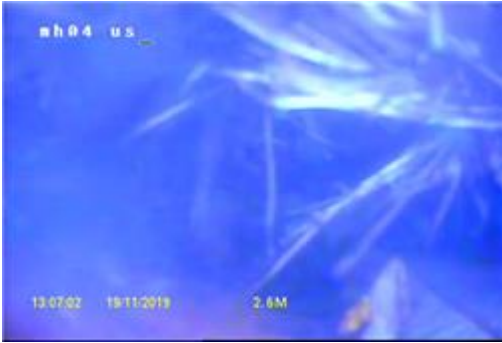
02.1m		SA		Survey abandoned Survey Abandoned - Unable to Pass Vegetation/Debris	Image Provided - Ref: 7_9999

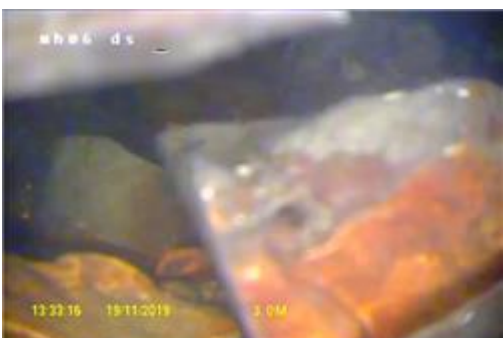
03.0m		SA		Survey abandoned Survey Abandoned - Unable to Pass Debris Under Water Level	Image Provided - Ref: 9_9999

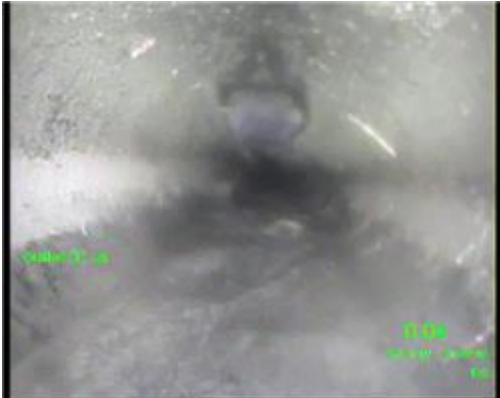
00.0m	0:00:00	D	S1	Deformed drain/sewer 0m - 1.8m: 20% Cross sectional area loss - Severity 5	Image Provided - Ref: 10_1

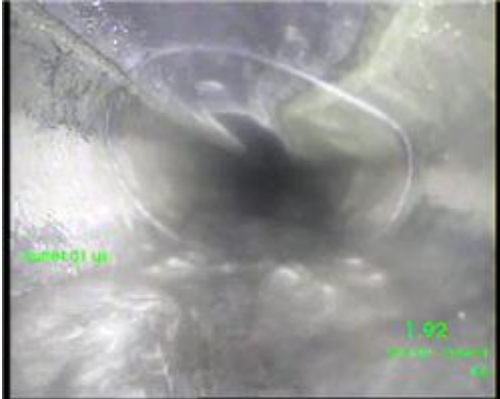
01.8m	0:00:00	D	F1	Deformed drain/sewer Defect End: 20% Cross sectional area loss - Severity 5	
01.9m	0:00:17	D		Deformed drain/sewer: 40% Cross sectional area loss - Severity 5	Image Provided - Ref: 10_2
