**An Asbestos Refurbishment/Demolition Survey (MA and PA) to the specific areas
of
1 Rutter Gardens
Mitcham
Surrey
CR4 4DS**

Survey Carried Out On:	15 September 2014	 
Commissioned By:	Kadija Goujane Circle Housing Group c/o Merton Priory Homes Southern Region Hub CR	
Date:	19 September 2014	
Our Reference:	J019940	
Surveyed By:	Joe Nason

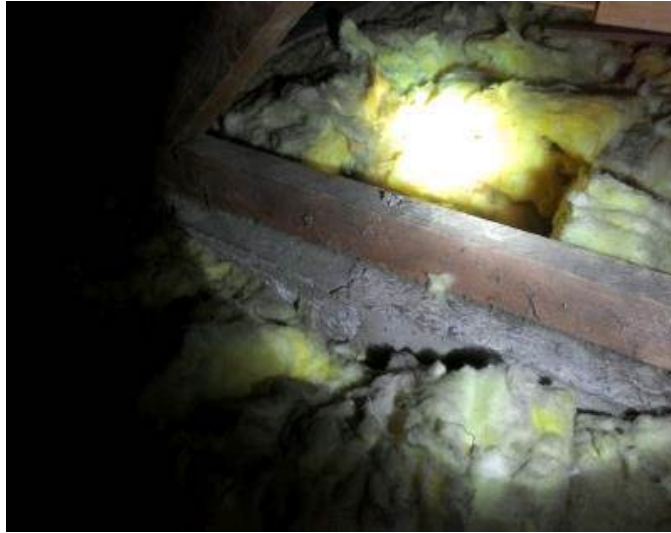
Building: N/A	Floor Level: Roof Void	Room Name: (001) Loft
Component: Concrete forming T section beams

Sample Reference	Asbestos Type	Material	Surface Treatment Score	
AB000875 (Sample 1)	No Asbestos Detected			
Extent of damage	Material Assessment**	Accessibility	Extent/amount	Location
Occupant Activity	No. of Occupants	Frequency of Use	Average Time Area is in Use	
Type of Maintenance		Frequency of Maintenance	Priority Assessment	
Recommendations				
Who	What		When	
-	No further action required		-	
Further Recommendations: None				
General Notes:				
Only areas likely to be disturbed during the proposed structural survey, or suspect materials in close proximity to those areas likely to be disturbed were inspected.				
This scope was determined following on site discussions with the structural engineer on a similar property and from notes on pans provided by the structural engineer.				
Mmmf loft insulation, no lose fill present beneath

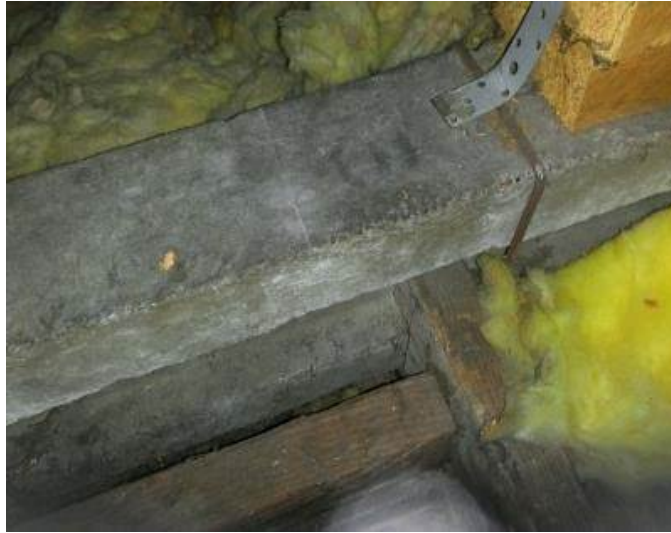
Building: N/A	Floor Level: Roof Void	Room Name: (001) Loft
Component: Concrete forming I section beams

Sample Reference	Asbestos Type	Material	Surface Treatment Score	
AB000876 (Sample 2)	No Asbestos Detected			
Extent of damage	Material Assessment**	Accessibility	Extent/amount	Location
Occupant Activity	No. of Occupants	Frequency of Use	Average Time Area is in Use	
Type of Maintenance		Frequency of Maintenance	Priority Assessment	
Recommendations				
Who	What		When	
-	No further action required		-	
Further Recommendations: None				
General Notes:				
Only areas likely to be disturbed during the proposed structural survey, or suspect materials in close proximity to those areas likely to be disturbed were inspected.				
This scope was determined following on site discussions with the structural engineer on a similar property and from notes on pans provided by the structural engineer.				
Mmmf loft insulation, no lose fill present beneath

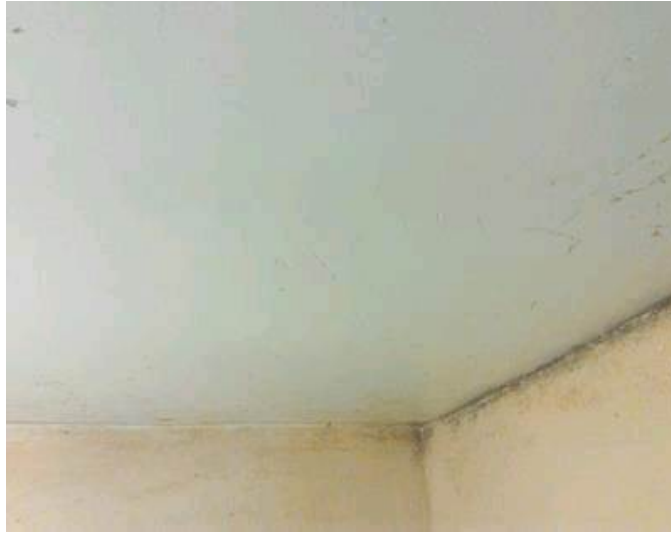
Building: N/A	Floor Level: First	Room Name: (002) All Areas
Component: Typical ceiling plaster

Sample Reference	Asbestos Type	Material	Surface Treatment Score	
AB000877 (Sample 3)	No Asbestos Detected			
Extent of damage	Material Assessment**	Accessibility	Extent/amount	Location
Occupant Activity	No. of Occupants	Frequency of Use	Average Time Area is in Use	
Type of Maintenance		Frequency of Maintenance	Priority Assessment	
Recommendations				
Who	What	When

-	No further action required	-		
Further Recommendations: None				
General Notes:				
Only areas likely to be disturbed during the proposed structural survey inspected.				
All wall and ceiling plasters were considered generic throughout the first floor areas and the samples are therefore typical throughout these areas, excluding bedroom 1 and bathroom ceilings as these have a textured coating finish. Other walls and ceilings have various textured papers not considered suspect.				
No practicable means of access beneath floor boards to inspect concrete beams - heavy furnishings and fitted carpets block access.

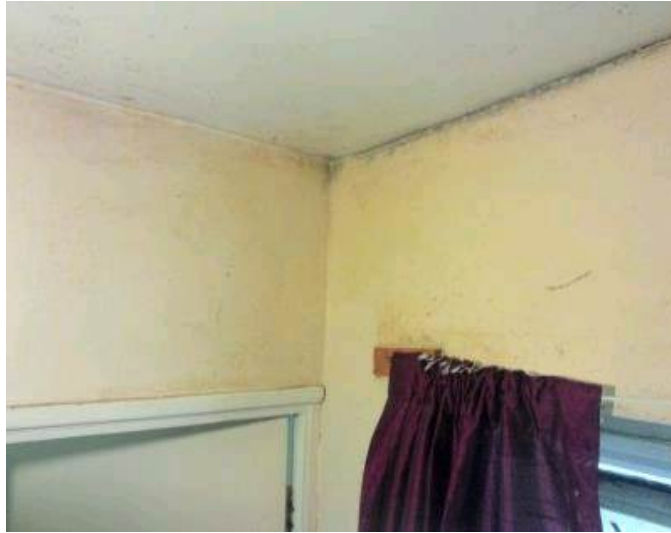
Building: N/A	Floor Level: First	Room Name: (002) All Areas
Component: Typical structural/external wall plaster

Sample Reference	Asbestos Type	Material	Surface Treatment Score	
AB000878 (Sample 4)	No Asbestos Detected			
Extent of damage	Material Assessment**	Accessibility	Extent/amount	Location
Occupant Activity	No. of Occupants	Frequency of Use	Average Time Area is in Use	
Type of Maintenance		Frequency of Maintenance	Priority Assessment

Recommendations		
Who	What	When
-	No further action required	-

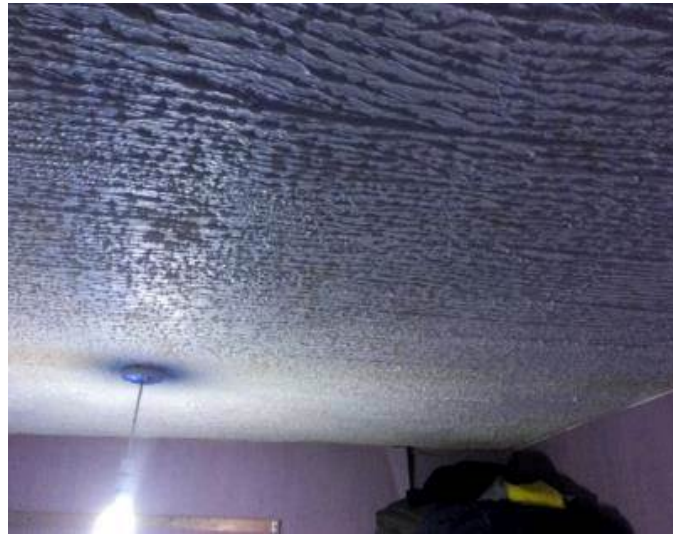
Building: N/A	Floor Level: First	Room Name: (003) Bedroom 1
Component: Textured coating to ceiling

Sample Reference	Asbestos Type	Material	Surface Treatment Score	
AB000880 (Sample 5)	No Asbestos Detected			
Extent of damage	Material Assessment**	Accessibility	Extent/amount	Location
Occupant Activity	No. of Occupants	Frequency of Use	Average Time Area is in Use	
Type of Maintenance		Frequency of Maintenance	Priority Assessment	
Recommendations				
Who	What	When		
-	No further action required	-		
Further Recommendations: None				
General Notes:				
Only areas likely to be disturbed during the proposed structural survey inspected.				
All wall and ceiling plasters were considered generic throughout the first floor areas and the samples are therefore typical throughout these areas, excluding bedroom 1 and bathroom ceilings as these have a textured coating finish. Other walls and ceilings have various textured papers not considered suspect.

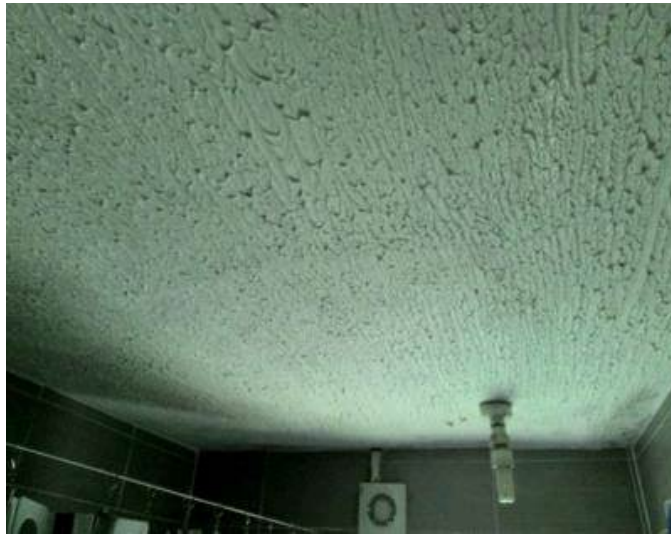
Building: N/A	Floor Level: First	Room Name: (004) Bathroom
Component: Textured coating to ceiling

Sample Reference	Asbestos Type	Material	Surface Treatment Score	
As AB000880 (Ref Sample 5)	No Asbestos Assumed			
Extent of damage	Material Assessment**	Accessibility	Extent/amount	Location
Occupant Activity	No. of Occupants	Frequency of Use	Average Time Area is in Use	
Type of Maintenance		Frequency of Maintenance	Priority Assessment	
Recommendations				
Who	What	When		
-	No further action required	-		
Further Recommendations: None				
General Notes:				
Only areas likely to be disturbed during the proposed structural survey inspected.				
All wall and ceiling plasters were considered generic throughout the first floor areas and the samples are therefore typical throughout these areas, excluding bedroom 1 and bathroom ceilings as these have a textured coating finish. Other walls and ceilings have various textured papers not considered suspect.

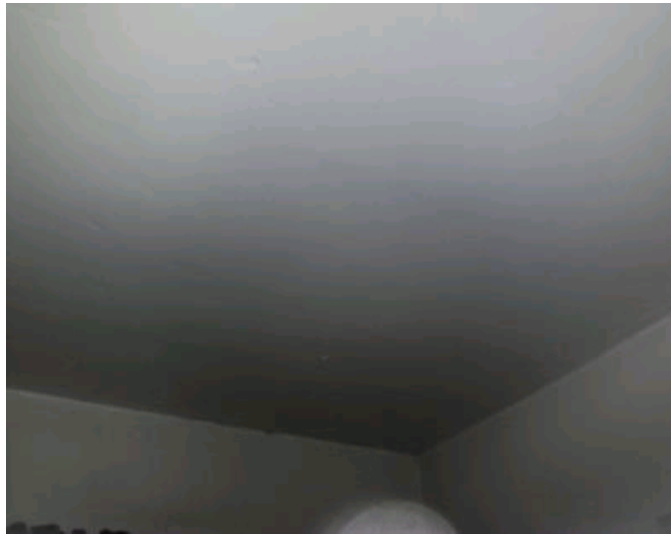
Building: N/A	Floor Level: Ground	Room Name: (005) All Areas
Component: Typical ceiling plaster

Sample Reference	Asbestos Type	Material	Surface Treatment Score	
AB000881 (Sample 6)	No Asbestos Detected			
Extent of damage	Material Assessment**	Accessibility	Extent/amount	Location
Occupant Activity	No. of Occupants	Frequency of Use	Average Time Area is in Use	
Type of Maintenance		Frequency of Maintenance	Priority Assessment	
Recommendations				
Who	What		When	
-	No further action required		-	
Further Recommendations: None				
General Notes:				
Only areas likely to be disturbed during the proposed structural survey inspected.				
All wall and ceiling plasters were considered generic throughout the ground floor areas and the samples are therefore typical throughout these areas, excluding lounge and dining room ceilings as these have a textured coating finish.				
Other walls and ceilings have various textured papers not considered suspect.

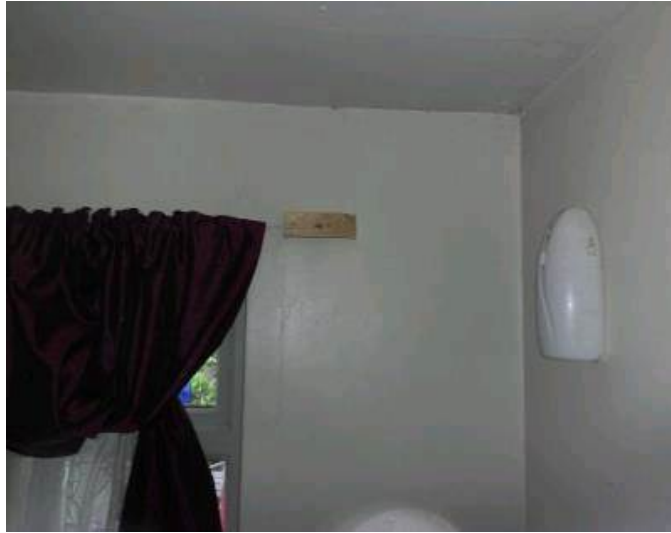
Building: N/A	Floor Level: Ground	Room Name: (005) All Areas
Component: Typical structural/external wall plaster

Sample Reference	Asbestos Type	Material	Surface Treatment Score	
AB000882 (Sample 7)	No Asbestos Detected			
Extent of damage	Material Assessment**	Accessibility	Extent/amount	Location
Occupant Activity	No. of Occupants	Frequency of Use	Average Time Area is in Use	
Type of Maintenance		Frequency of Maintenance	Priority Assessment

Recommendations		
Who	What	When
-	No further action required	-

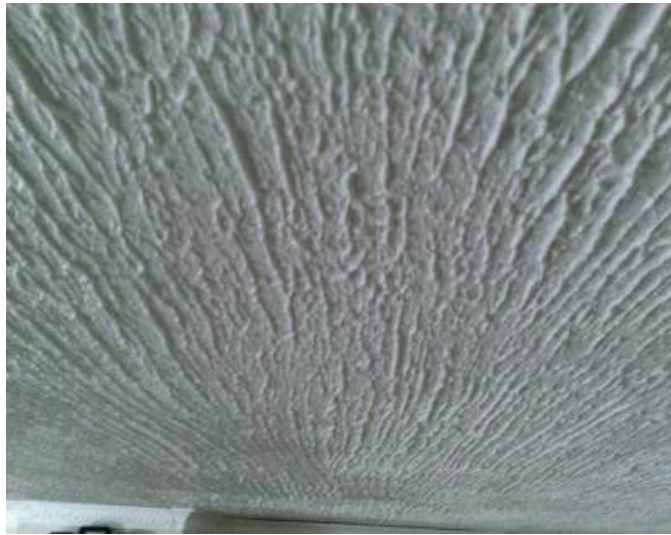
Building: N/A	Floor Level: Ground	Room Name: (006) Living Room
Component: Textured coating to ceiling

Sample Reference	Asbestos Type	Material	Surface Treatment Score	
As AB000880 (Ref Sample 5)	No Asbestos Assumed			
Extent of damage	Material Assessment**	Accessibility	Extent/amount	Location
Occupant Activity	No. of Occupants	Frequency of Use	Average Time Area is in Use	
Type of Maintenance		Frequency of Maintenance	Priority Assessment	
Recommendations				
Who	What	When		
-	No further action required	-		
Further Recommendations: None				
General Notes:				
Only areas likely to be disturbed during the proposed structural survey inspected.				
All wall and ceiling plasters were considered generic throughout the ground floor areas and the samples are therefore typical throughout these areas, excluding lounge and dining room ceilings as these have a textured coating finish. Other walls and ceilings have various textured papers not considered suspect.

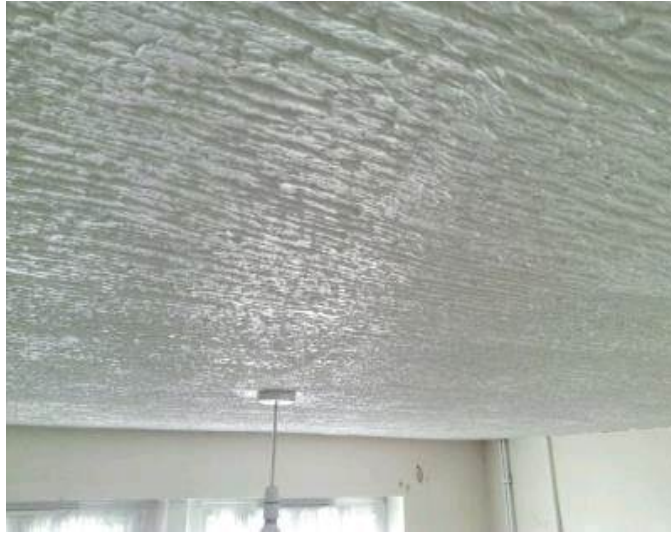
Building: N/A	Floor Level: Ground	Room Name: (007) Dining Room
Component: Textured coating to ceiling

Sample Reference	Asbestos Type	Material	Surface Treatment Score	
As AB000880 (Ref Sample 5)	No Asbestos Assumed			
Extent of damage	Material Assessment**	Accessibility	Extent/amount	Location
Occupant Activity	No. of Occupants	Frequency of Use	Average Time Area is in Use	
Type of Maintenance		Frequency of Maintenance	Priority Assessment	
Recommendations				
Who	What	When		
-	No further action required	-		
Further Recommendations: None				
General Notes:				
Only areas likely to be disturbed during the proposed structural survey inspected.				
All wall and ceiling plasters were considered generic throughout the Ground floor areas and the samples are therefore typical throughout these areas, excluding lounge and dining room ceilings as these have a textured coating finish. Other walls and ceilings have various textured papers not considered suspect.

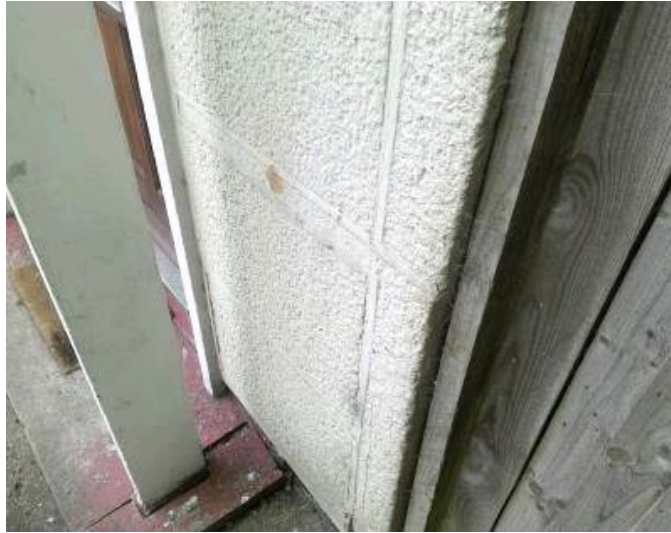
Building: N/A	Floor Level: External	Room Name: (008) External
Component: Typical pre-fabricated concrete wall panels

Sample Reference	Asbestos Type	Material	Surface Treatment Score	
AB000883 (Sample 8)	No Asbestos Detected			
Extent of damage	Material Assessment**	Accessibility	Extent/amount	Location
Occupant Activity	No. of Occupants	Frequency of Use	Average Time Area is in Use	
Type of Maintenance		Frequency of Maintenance	Priority Assessment	
Recommendations				
Who	What	When

-	No further action required	-		
Further Recommendations: None				
General Notes:				
<p>Only areas likely to be disturbed during the proposed structural survey, or suspect materials in close proximity to those areas likely to be disturbed were inspected.</p> <p>This scope was determined following on site discussions with the structural engineer on a similar property and from notes on pans provided by the structural engineer.</p> <p>No access soffits - no safe means, consider the soffits to contain asbestos and avoid disturbance during structural survey works.</p> <p>Pre-fabricated external wall panels Upvc windows, concrete sills</p>

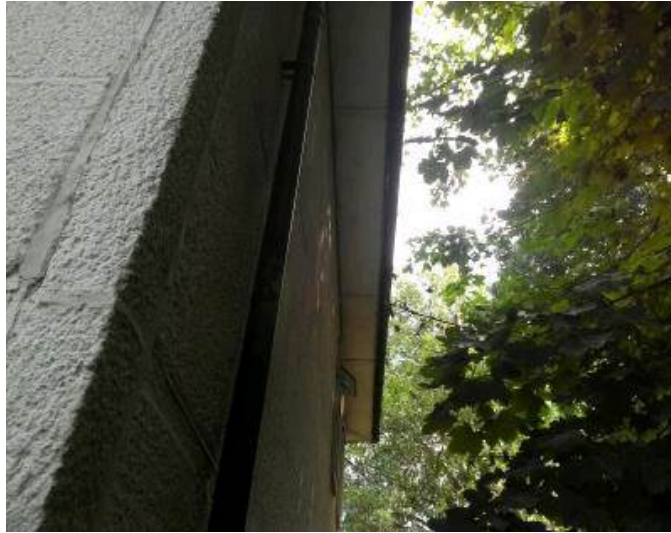
Building: N/A	Floor Level: External	Room Name: (008) External
Component: Soffit panels at roof eaves

Location	Result (asbestos type)	Action
External (008) External Soffit panels at roof eaves	Chrysotile	Remove prior to refurbishment if likely to be disturbed

Sample Reference	Asbestos Type	Material	Surface Treatment Score	
Presumed (Visual 1)	Chrysotile (1)	Cement (1)	1	
Extent of damage	Material Assessment**	Accessibility	Extent/amount	Location
Low Damage (1)	Low (4)	0	24lm (2)	0
Occupant Activity	No. of Occupants	Frequency of Use	Average Time Area is in Use	
1 (Low disturbance)	0 (None)	0 (Infrequent)	0 (<1 hour)	
Type of Maintenance		Frequency of Maintenance	Priority Assessment	
0 (Minor disturbance)		1 (<1 per year)	3	
Recommendations				
Who	What	When		
Licensed contractor	Remove	Prior to refurbishment if likely to be disturbed

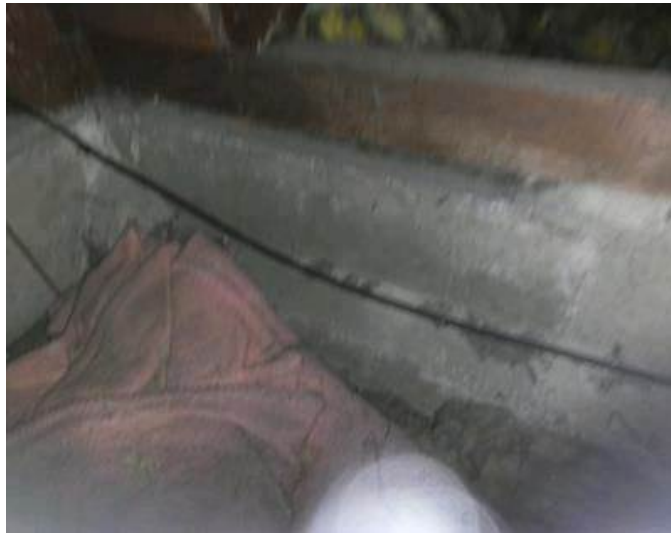
Building: N/A	Floor Level: Roof Void	Room Name: (001) Loft
Component: Concrete forming T section beams

Sample Reference	Asbestos Type	Material	Surface Treatment Score	
AB000867 (Sample 1)	No Asbestos Detected			
Extent of damage	Material Assessment**	Accessibility	Extent/amount	Location
Occupant Activity	No. of Occupants	Frequency of Use	Average Time Area is in Use	
Type of Maintenance		Frequency of Maintenance	Priority Assessment	
Recommendations				
Who	What	When		
-	No further action required	-		
Further Recommendations: None				
General Notes:				
Only areas likely to be disturbed during the proposed structural survey inspected.				
Only mmmf loft insulation present on plasterboard ceilings

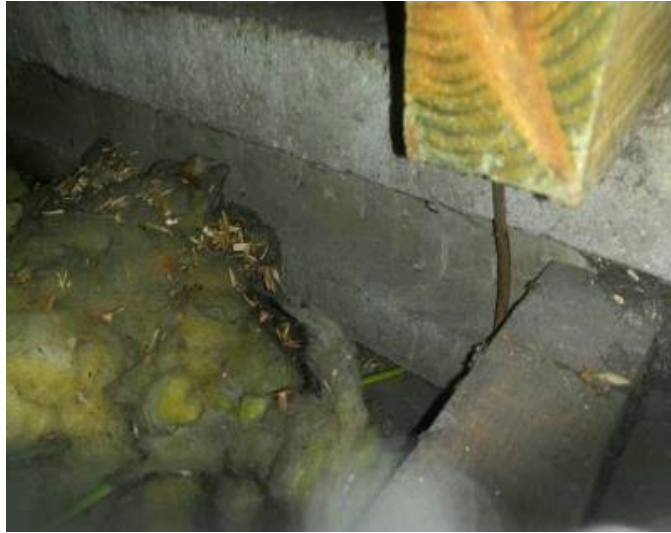
Building: N/A	Floor Level: Roof Void	Room Name: (001) Loft
Component: Concrete forming I section beams

Sample Reference	Asbestos Type	Material	Surface Treatment Score	
AB000868 (Sample 2)	No Asbestos Detected			
Extent of damage	Material Assessment**	Accessibility	Extent/amount	Location
Occupant Activity	No. of Occupants	Frequency of Use	Average Time Area is in Use	
Type of Maintenance		Frequency of Maintenance	Priority Assessment	
Recommendations				
Who	What	When		
-	No further action required	-		
Further Recommendations: None				
General Notes:				
Only areas likely to be disturbed during the proposed structural survey inspected.				
Only mmmf loft insulation present on plasterboard ceilings

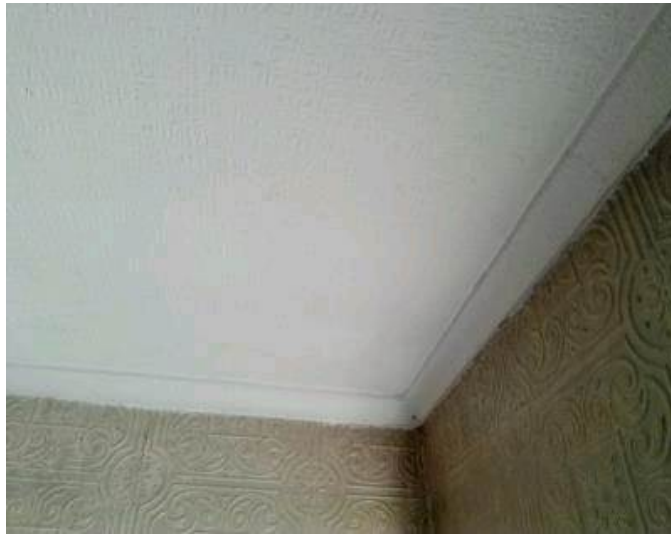
Building: N/A	Floor Level: First	Room Name: (002) All Areas
Component: Ceiling plaster throughout

Sample Reference	Asbestos Type	Material	Surface Treatment Score	
AB000869 (Sample 3)	No Asbestos Detected			
Extent of damage	Material Assessment**	Accessibility	Extent/amount	Location
Occupant Activity	No. of Occupants	Frequency of Use	Average Time Area is in Use	
Type of Maintenance		Frequency of Maintenance	Priority Assessment	
Recommendations				
Who	What	When		
-	No further action required	-		
Further Recommendations: None				
General Notes:				
Only areas likely to be disturbed during the proposed structural survey inspected.				
All wall and ceiling plasters were considered generic throughout the first floor areas and the samples are therefore typical throughout these areas excluding the bedroom 2 ceiling as this has a textured coating finish.				
Other walls and ceilings have various textured papers not considered suspect.

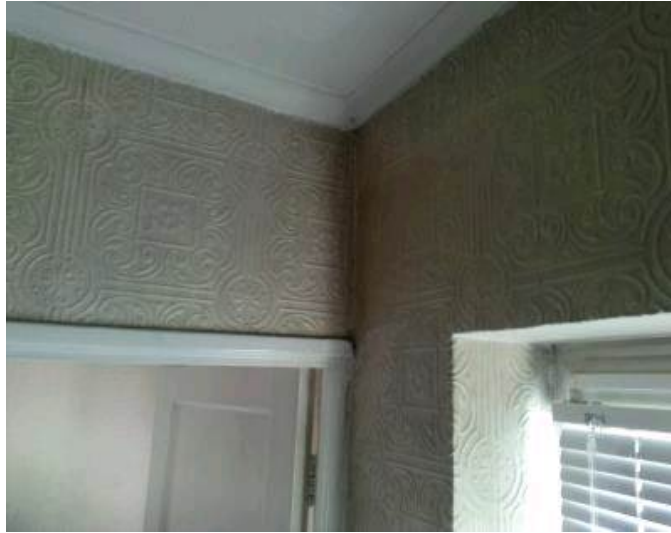
Building: N/A	Floor Level: First	Room Name: (002) All Areas
Component: Typical structural support/external wall plaster

Sample Reference	Asbestos Type	Material	Surface Treatment Score	
AB000870 (Sample 4)	No Asbestos Detected			
Extent of damage	Material Assessment**	Accessibility	Extent/amount	Location
Occupant Activity	No. of Occupants	Frequency of Use	Average Time Area is in Use	
Type of Maintenance		Frequency of Maintenance	Priority Assessment	
Recommendations				
Who	What		When	
-	No further action required		-	
Further Recommendations: None				
General Notes:				
Only areas likely to be disturbed during the proposed structural survey inspected.				
All wall and ceiling plasters were considered generic throughout the first floor areas and the samples are therefore typical throughout these areas excluding the bedroom 2 ceiling as this has a textured coating finish.				
Other walls and ceilings have various textured papers not considered suspect.

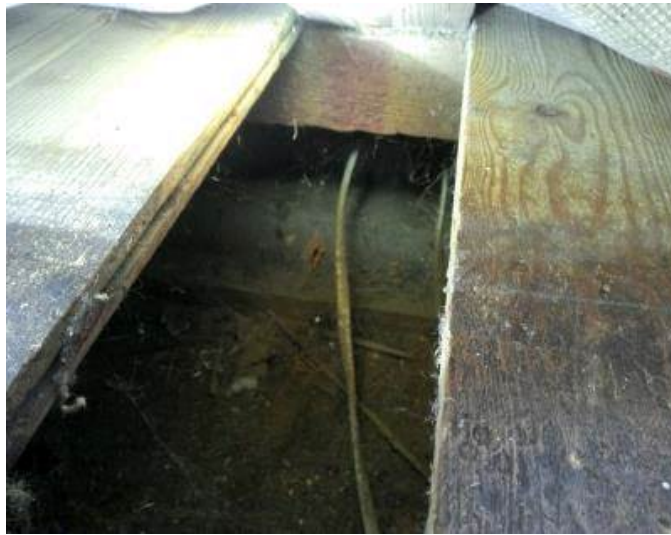
Building: N/A	Floor Level: First	Room Name: (002) All Areas
Component: Concrete forming T section beam in floor void

Sample Reference	Asbestos Type	Material	Surface Treatment Score	
AB000871 (Sample 5)	No Asbestos Detected			
Extent of damage	Material Assessment**	Accessibility	Extent/amount	Location
Occupant Activity	No. of Occupants	Frequency of Use	Average Time Area is in Use	
Type of Maintenance		Frequency of Maintenance	Priority Assessment	
Recommendations				
Who	What	When		
-	No further action required	-		
Further Recommendations: None				
General Notes:				
Only areas likely to be disturbed during the proposed structural survey inspected.				
All wall and ceiling plasters were considered generic throughout the first floor areas and the samples are therefore typical throughout these areas excluding the bedroom 2 ceiling as this has a textured coating finish.				
Other walls and ceilings have various textured papers not considered suspect.

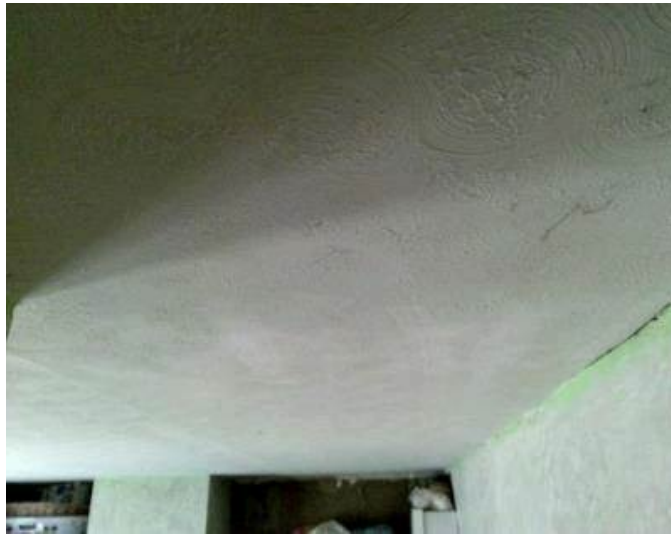
Building: N/A	Floor Level: First	Room Name: (003) Bedroom 1
Component: Textured coating to ceiling throughout

Sample Reference	Asbestos Type	Material	Surface Treatment Score	
As AB000869 (Ref Sample 3)	No Asbestos Assumed			
Extent of damage	Material Assessment**	Accessibility	Extent/amount	Location
Occupant Activity	No. of Occupants	Frequency of Use	Average Time Area is in Use	
Type of Maintenance		Frequency of Maintenance	Priority Assessment	
Recommendations				
Who	What		When	
-	No further action required		-	
Further Recommendations: None				
General Notes:				
Only areas likely to be disturbed during the proposed structural survey inspected.				
All wall and ceiling plasters were considered generic throughout the first floor areas and the samples are therefore typical throughout these areas, excluding bedroom 2 ceiling as this has a textured coating finish.				
Other walls and ceilings have various textured papers not considered suspect.

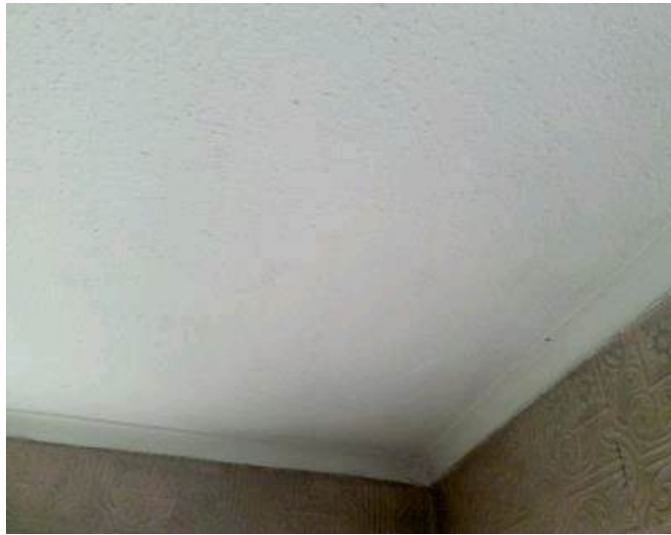
Building: N/A	Floor Level: Ground	Room Name: (004) All Areas
Component: Ceiling plaster throughout

Sample Reference	Asbestos Type	Material	Surface Treatment Score	
AB000872 (Sample 6)	No Asbestos Detected			
Extent of damage	Material Assessment**	Accessibility	Extent/amount	Location
Occupant Activity	No. of Occupants	Frequency of Use	Average Time Area is in Use	
Type of Maintenance		Frequency of Maintenance	Priority Assessment	
Recommendations				
Who	What		When	
-	No further action required		-	
Further Recommendations: None				
General Notes:				
Only areas likely to be disturbed during the proposed structural survey inspected.				
All wall and ceiling plasters were considered generic throughout the ground floor areas and the samples are therefore typical throughout these areas excluding the lobby outside the kitchen which were wood panels.				
Walls and ceilings have various textured papers not considered suspect. Sandtex type non-suspect coating present to lounge ceiling.

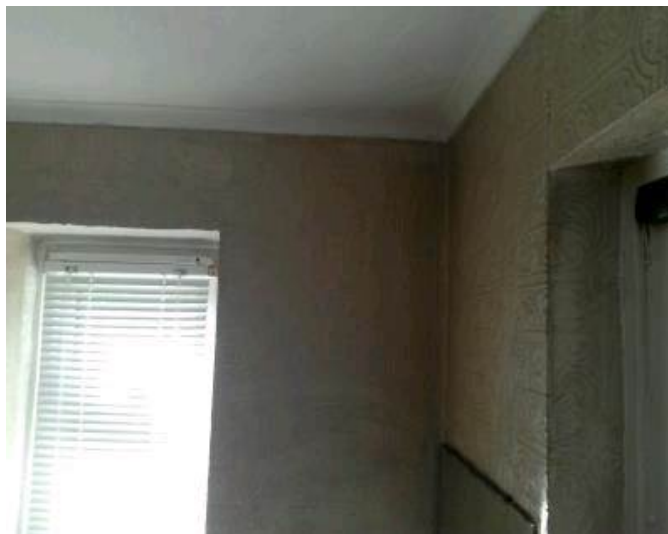
Building: N/A	Floor Level: Ground	Room Name: (004) All Areas
Component: Typical structural/external wall plaster

Sample Reference	Asbestos Type	Material	Surface Treatment Score	
AB000873 (Sample 7)	No Asbestos Detected			
Extent of damage	Material Assessment**	Accessibility	Extent/amount	Location
Occupant Activity	No. of Occupants	Frequency of Use	Average Time Area is in Use	
Type of Maintenance		Frequency of Maintenance	Priority Assessment	
Recommendations				
Who	What		When	
-	No further action required		-	
Further Recommendations: None				
General Notes:				
Only areas likely to be disturbed during the proposed structural survey inspected.				
All wall and ceiling plasters were considered generic throughout the ground floor areas and the samples are therefore typical throughout these areas excluding the lobby outside the kitchen which were wood panels.				
Walls and ceilings have various textured papers not considered suspect. Sandtex type non-suspect coating present to lounge ceiling.

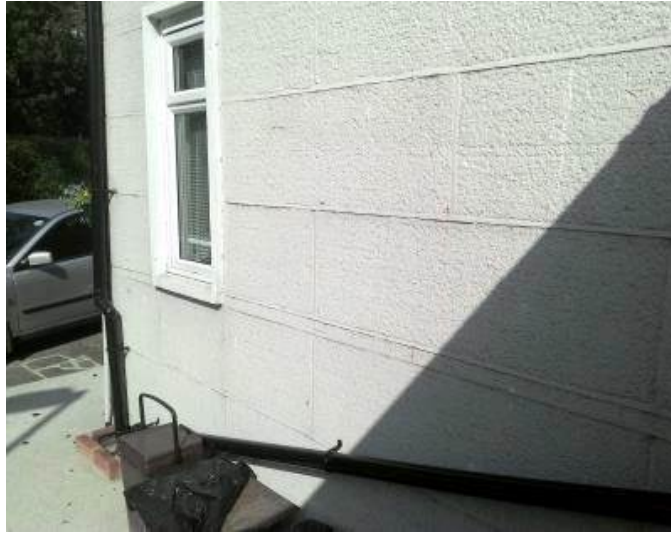
Building: N/A	Floor Level: External	Room Name: (005) External
Component: Concrete prefabricated wall panels

Sample Reference	Asbestos Type	Material	Surface Treatment Score	
AB000874 (Sample 8)	No Asbestos Detected			
Extent of damage	Material Assessment**	Accessibility	Extent/amount	Location
Occupant Activity	No. of Occupants	Frequency of Use	Average Time Area is in Use	
Type of Maintenance		Frequency of Maintenance	Priority Assessment	
Recommendations				
Who	What	When

-	No further action required	-		
Further Recommendations: None				
General Notes:				
<p>Only areas likely to be disturbed during the proposed structural survey, or suspect materials in close proximity to those areas likely to be disturbed were inspected.</p> <p>This scope was determined following on site discussions with the structural engineer on a similar property and from notes on plans provided by the structural engineer.</p> <p>No access soffits - no safe means, consider the soffits to contain asbestos and avoid disturbance during structural survey works.</p> <p>Prefabricated external wall panels Upvc windows, concrete sills</p>

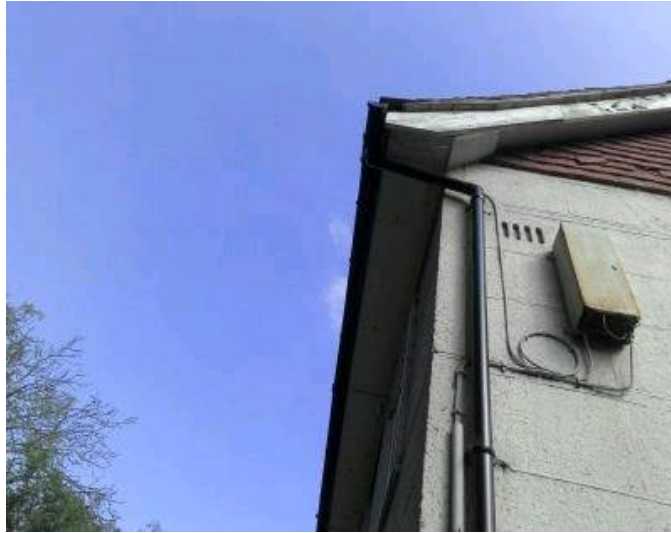
Building: N/A	Floor Level: External	Room Name: (005) External
Component: External soffit panels at roof eaves

Sample Reference	Asbestos Type	Material	Surface Treatment Score	
Presumed (Visual 1)	Chrysotile (1)	Cement (1)	2	
Extent of damage	Material Assessment**	Accessibility	Extent/amount	Location
Low Damage (1)	Low (5)	0	16lm (2)	0
Occupant Activity	No. of Occupants	Frequency of Use	Average Time Area is in Use	
0 (Rare disturbance)	0 (None)	0 (Infrequent)	0 (<1 hour)	
Type of Maintenance		Frequency of Maintenance	Priority Assessment	
1 (Low disturbance)		0 (Unlikely)	2	
Recommendations				
Who	What		When	
Licensed contractor	Remove		Prior to refurbishment if likely to be disturbed

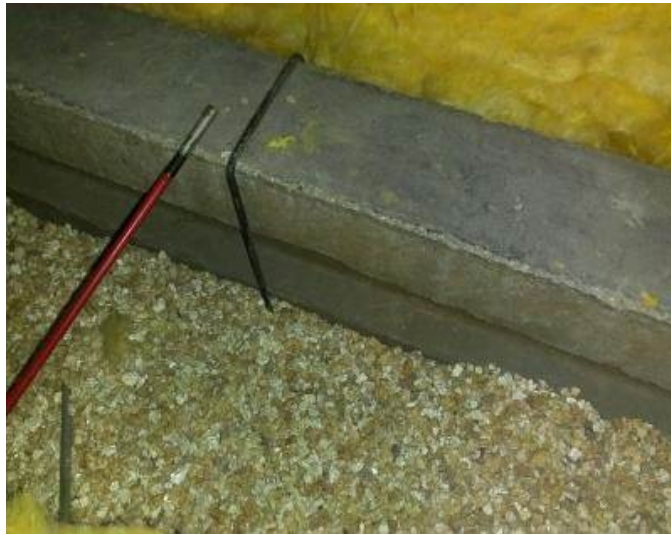
Building: N/A	Floor Level: Roof Void	Room Name: (001) Loft
Component: Concrete forming I section beams

Sample Reference	Asbestos Type	Material	Surface Treatment Score	
AB000837 (Sample 1)	No Asbestos Detected			
Extent of damage	Material Assessment**	Accessibility	Extent/amount	Location
Occupant Activity	No. of Occupants	Frequency of Use	Average Time Area is in Use	
Type of Maintenance		Frequency of Maintenance	Priority Assessment	
Recommendations				
Who	What	When		
-	No further action required	-		
Further Recommendations: None				
General Notes: R and D undertaken to specific areas likely to be affected by structural survey works only

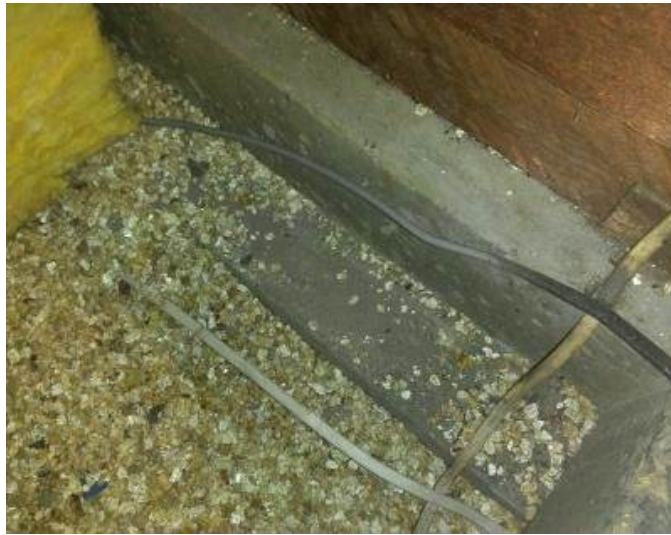
Building: N/A	Floor Level: Roof Void	Room Name: (001) Loft
Component: Concrete forming T section beams

Sample Reference	Asbestos Type	Material	Surface Treatment Score	
AB000838 (Sample 2)	No Asbestos Detected			
Extent of damage	Material Assessment**	Accessibility	Extent/amount	Location
Occupant Activity	No. of Occupants	Frequency of Use	Average Time Area is in Use	
Type of Maintenance		Frequency of Maintenance	Priority Assessment	
Recommendations				
Who	What	When		
-	No further action required	-		
Further Recommendations: None				
General Notes: R and D undertaken to specific areas likely to be affected by structural survey works only

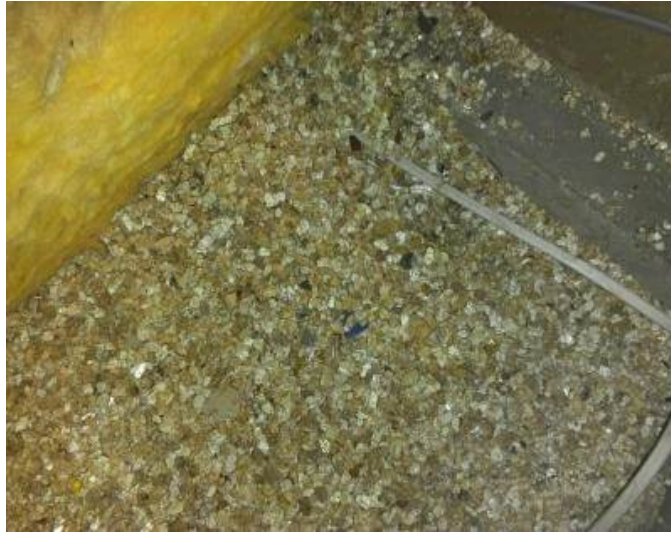
Building: N/A	Floor Level: Roof Void	Room Name: (001) Loft
Component: Loose fill insulation throughout loft

Sample Reference	Asbestos Type	Material	Surface Treatment Score	
AB000839 (Sample 3)	No Asbestos Detected			
Extent of damage	Material Assessment**	Accessibility	Extent/amount	Location
Occupant Activity	No. of Occupants	Frequency of Use	Average Time Area is in Use	
Type of Maintenance		Frequency of Maintenance	Priority Assessment	
Recommendations				
Who	What		When	
-	No further action required		-	
Further Recommendations: None				
General Notes: R and D undertaken to specific areas likely to be affected by structural survey works only

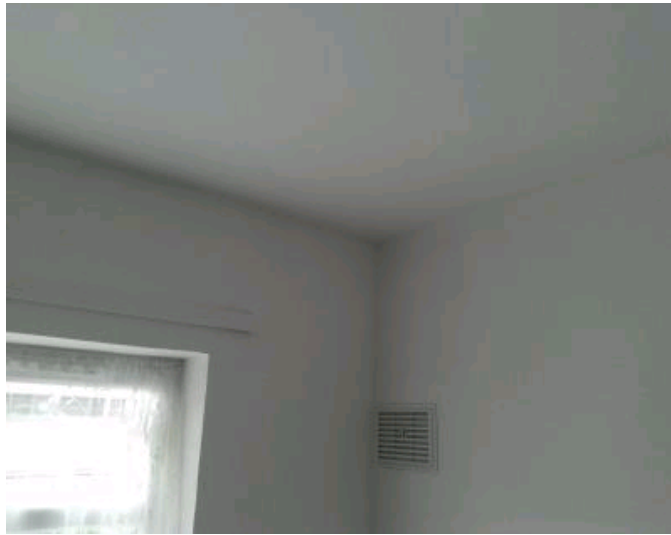
Building: N/A	Floor Level: First	Room Name: (002) All areas
Component: Typical ceiling plaster materials

Sample Reference	Asbestos Type	Material	Surface Treatment Score	
AB000840 (Sample 4)	No Asbestos Detected			
Extent of damage	Material Assessment**	Accessibility	Extent/amount	Location
Occupant Activity	No. of Occupants	Frequency of Use	Average Time Area is in Use	
Type of Maintenance		Frequency of Maintenance	Priority Assessment	
Recommendations				
Who	What		When	
-	No further action required		-	
Further Recommendations: None				
General Notes:				
Specific areas likely to be disturbed during proposed structural survey only inspected - typical sample of ceiling and wall plasters taken to enable proposed opening up.				
Other likely ACMs in close proximity to proposed opening up considered and identified where present.				
No access possible beneath wood floorboards due to ongoing occupancy, fitted carpets and heavy furnishings

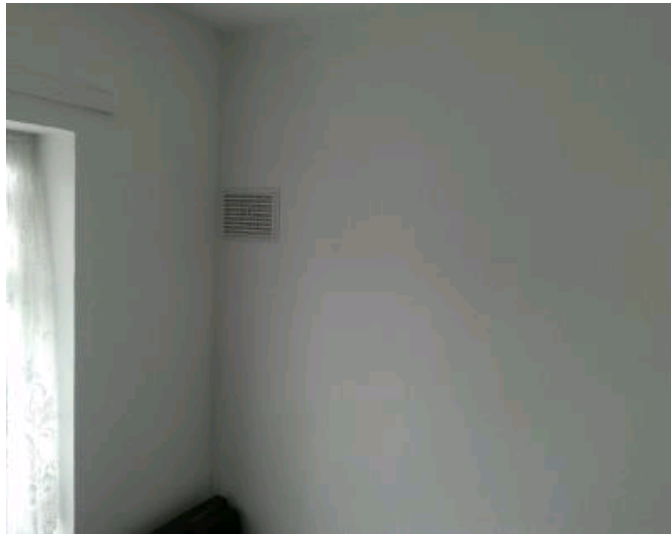
Building: N/A	Floor Level: First	Room Name: (002) All areas
Component: Typical structural/external wall plaster materials

Sample Reference	Asbestos Type	Material	Surface Treatment Score	
AB000841 (Sample 5)	No Asbestos Detected			
Extent of damage	Material Assessment**	Accessibility	Extent/amount	Location
Occupant Activity	No. of Occupants	Frequency of Use	Average Time Area is in Use	
Type of Maintenance		Frequency of Maintenance	Priority Assessment	
Recommendations				
Who	What		When	
-	No further action required		-	
Further Recommendations: None				
General Notes:				
Specific areas likely to be disturbed during proposed structural survey only inspected - typical sample of ceiling and wall plasters taken to enable proposed opening up.				
Other likely ACMs in close proximity to proposed opening up considered and identified where present.				
No access possible beneath wood floorboards due to ongoing occupancy, fitted carpets and heavy furnishings

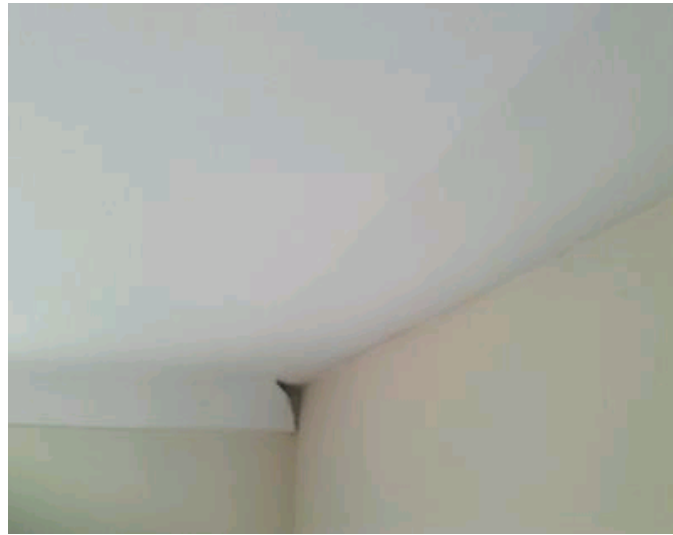
Building: N/A	Floor Level: Ground	Room Name: (003) All areas
Component: Typical ceiling plaster materials

Sample Reference	Asbestos Type	Material	Surface Treatment Score	
AB000842 (Sample 6)	No Asbestos Detected			
Extent of damage	Material Assessment**	Accessibility	Extent/amount	Location
Occupant Activity	No. of Occupants	Frequency of Use	Average Time Area is in Use	
Type of Maintenance		Frequency of Maintenance	Priority Assessment	
Recommendations				
Who	What		When	
-	No further action required		-	
Further Recommendations: None				
General Notes:				
Specific areas likely to be disturbed during proposed structural survey only inspected - typical sample of ceiling and wall plasters taken to enable proposed opening up.				
Other likely ACMs in close proximity to proposed opening up considered and identified where present.

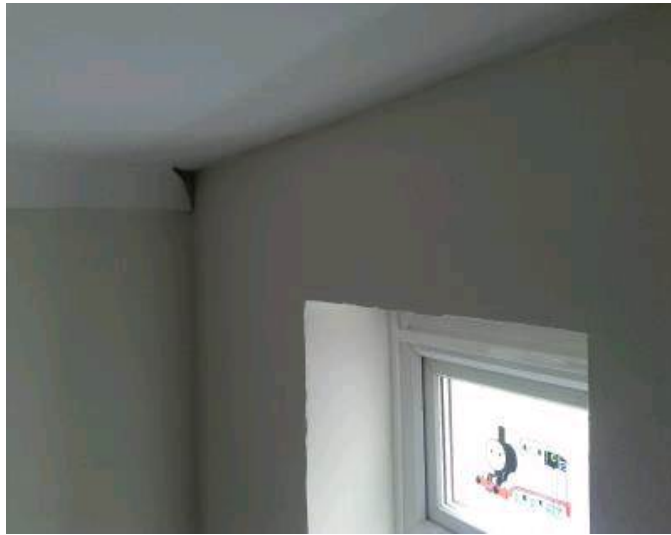
Building: N/A	Floor Level: Ground	Room Name: (003) All areas
Component: Typical structural/external wall plaster materials

Sample Reference	Asbestos Type	Material	Surface Treatment Score	
AB000843 (Sample 7)	No Asbestos Detected			
Extent of damage	Material Assessment**	Accessibility	Extent/amount	Location
Occupant Activity	No. of Occupants	Frequency of Use	Average Time Area is in Use	
Type of Maintenance		Frequency of Maintenance	Priority Assessment	
Recommendations				
Who	What		When	
-	No further action required		-	
Further Recommendations: None				
General Notes:				
Specific areas likely to be disturbed during proposed structural survey only inspected - typical sample of ceiling and wall plasters taken to enable proposed opening up.				
Other likely ACMs in close proximity to proposed opening up considered and identified where present.

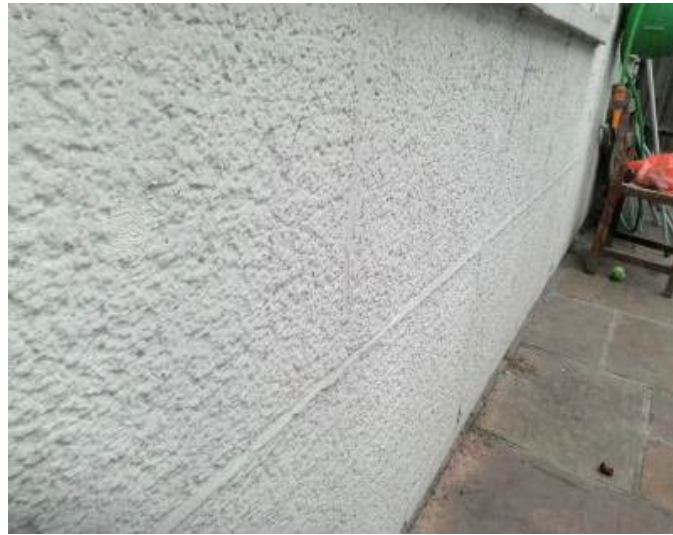
Building: N/A	Floor Level: External	Room Name: (004) External
Component: Typical external pre-cast concrete wall panels

Sample Reference	Asbestos Type	Material	Surface Treatment Score	
AB000844 (Sample 8)	No Asbestos Detected			
Extent of damage	Material Assessment**	Accessibility	Extent/amount	Location
Occupant Activity	No. of Occupants	Frequency of Use	Average Time Area is in Use	
Type of Maintenance		Frequency of Maintenance	Priority Assessment	
Recommendations				
Who	What		When	
-	No further action required		-	
Further Recommendations: None				
General Notes:				
External pre-cast wall panels only considered prior to proposed structural investigative works. No safe means of access possible to soffits at eaves - therefore care should be taken not to disturb these materials during the structural survey

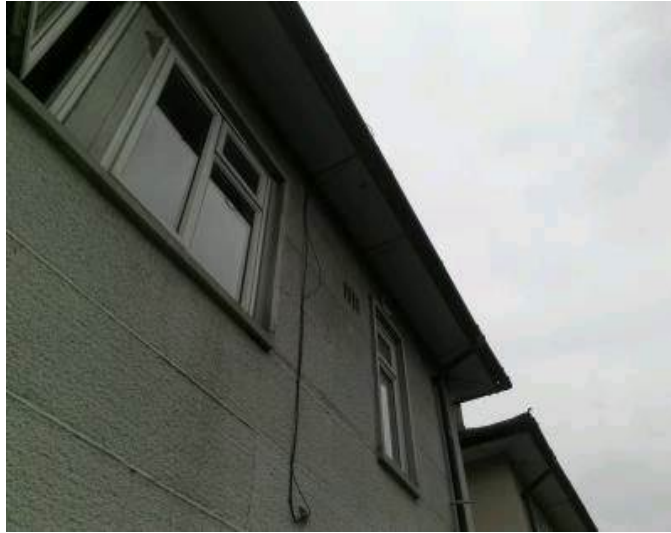
Building: N/A	Floor Level: External	Room Name: (004) External
Component: Soffit panels at eaves

Sample Reference	Asbestos Type	Material	Surface Treatment Score	
Presumed (Visual 1)	Amosite (2)	Board (2)	1	
Extent of damage	Material Assessment**	Accessibility	Extent/amount	Location
Low Damage (1)	Low (6)	0	25lm (2)	0
Occupant Activity	No. of Occupants	Frequency of Use	Average Time Area is in Use	
0 (Rare disturbance)	0 (None)	0 (Infrequent)	0 (<1 hour)	
Type of Maintenance		Frequency of Maintenance	Priority Assessment	
0 (Minor disturbance)		1 (<1 per year)	2	
Recommendations				
Who	What	When		
Licensed contractor	Remove	Prior to refurbishment if likely to be disturbed		
Further Recommendations: None				
General Notes:				
External pre-cast wall panels only considered prior to proposed structural investigative works. No safe means of access possible to soffits at eaves - therefore care should be taken not to disturb these materials during the structural survey
