STRUCTURAL ENGINEERS REPORT

EASTFIELDS ESTATE

MERTON

14942-re-001

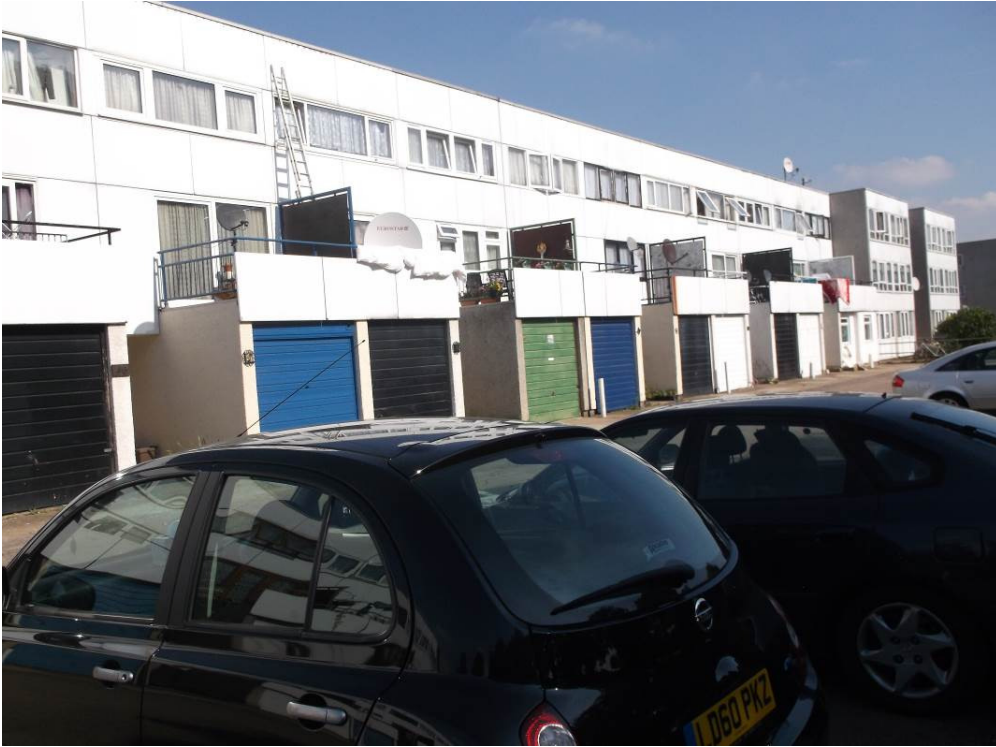
Photograph 1 – Town houses – front elevation

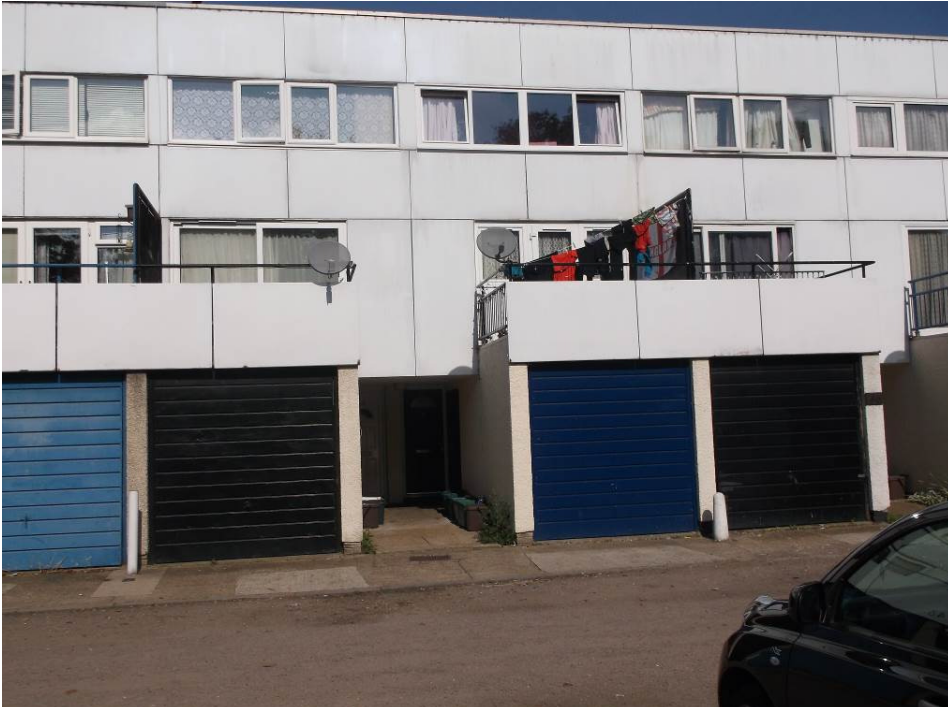
Photograph 2 – Town houses – front elevation

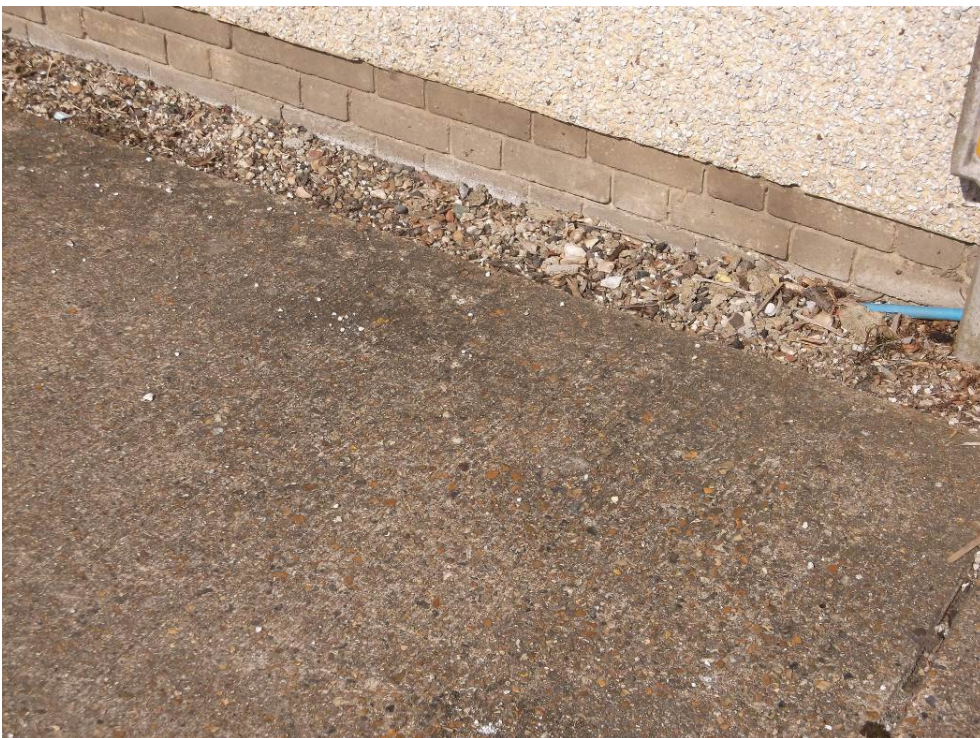
Photograph 4- Base of flank wall

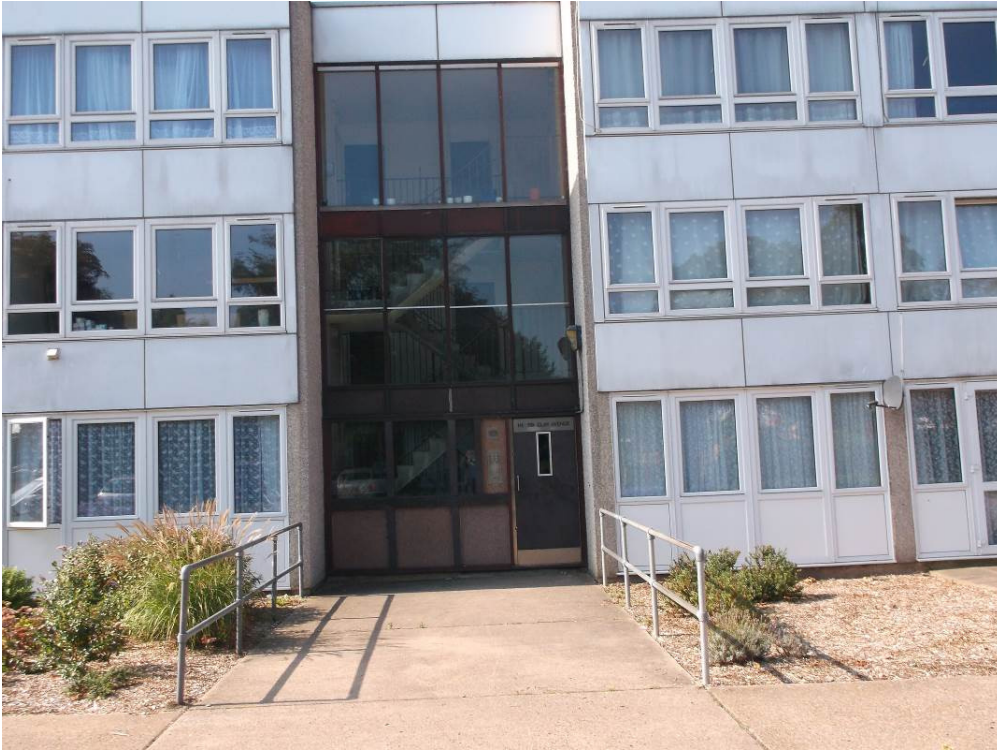
Photograph 5 – Typical block of flats

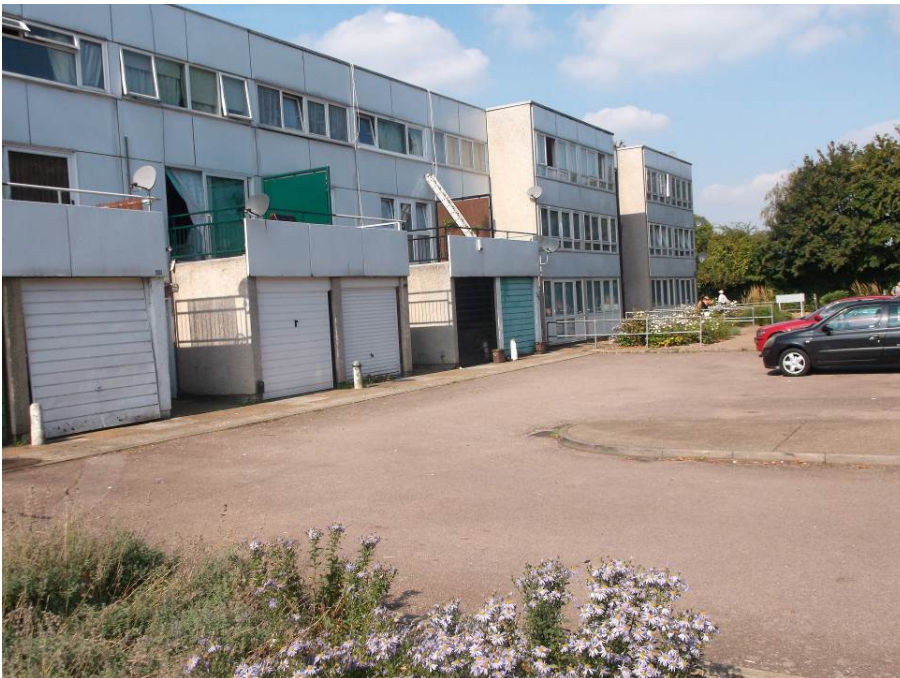
Photograph 6 – Town Houses

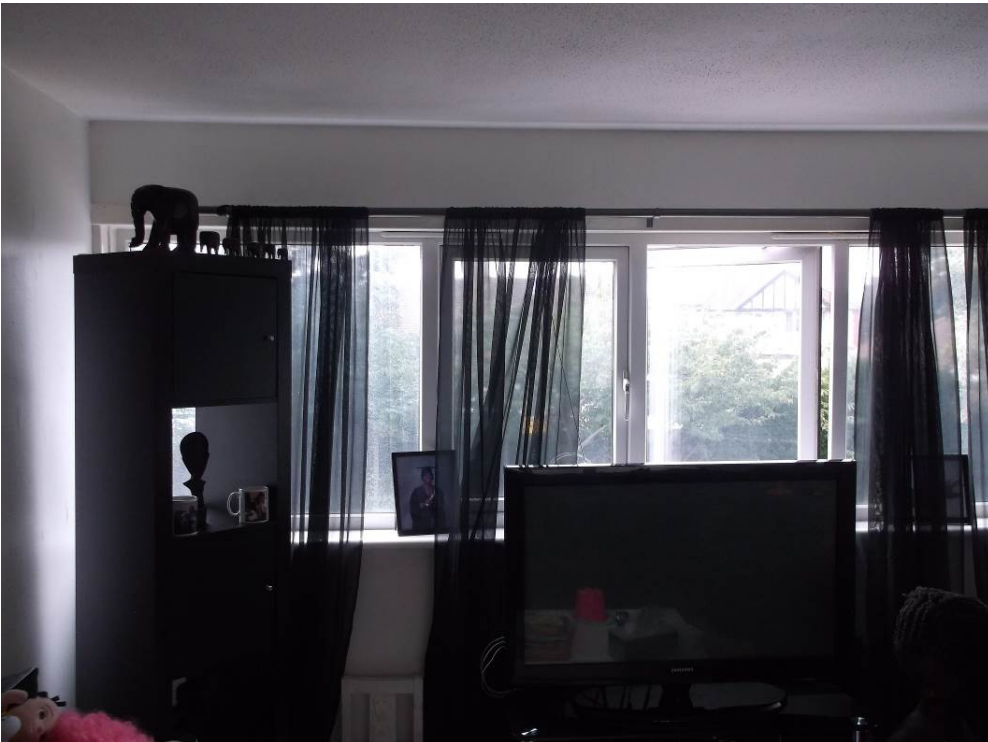
Photograph 10 – Typical internal view in flats

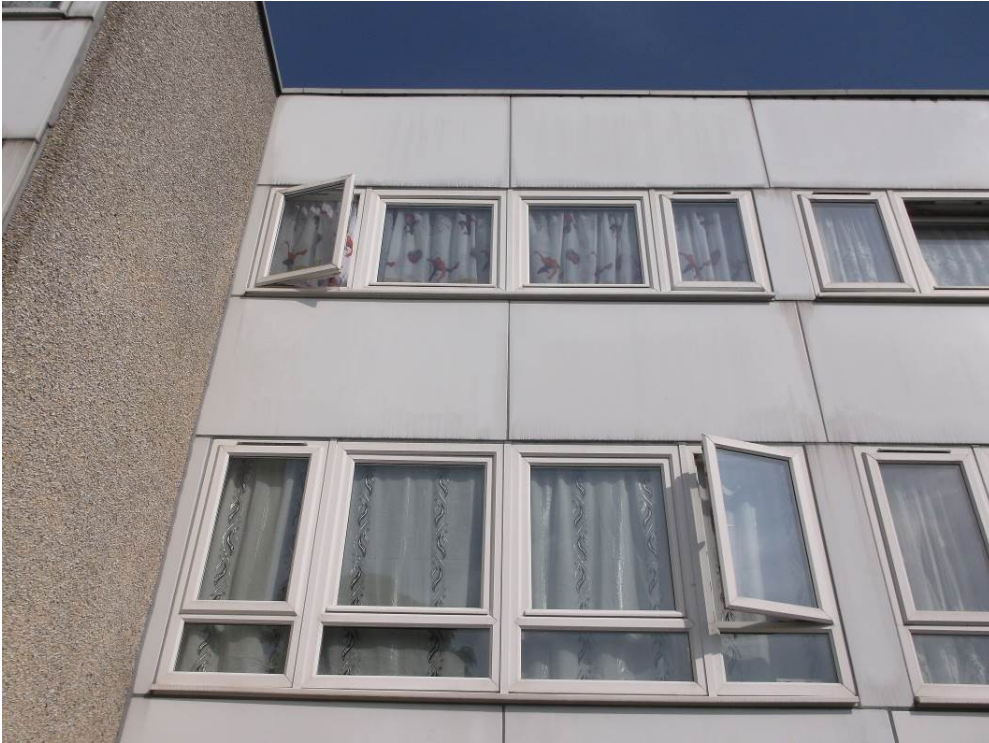
Photograph 13 – Paines Close – Rear elevation

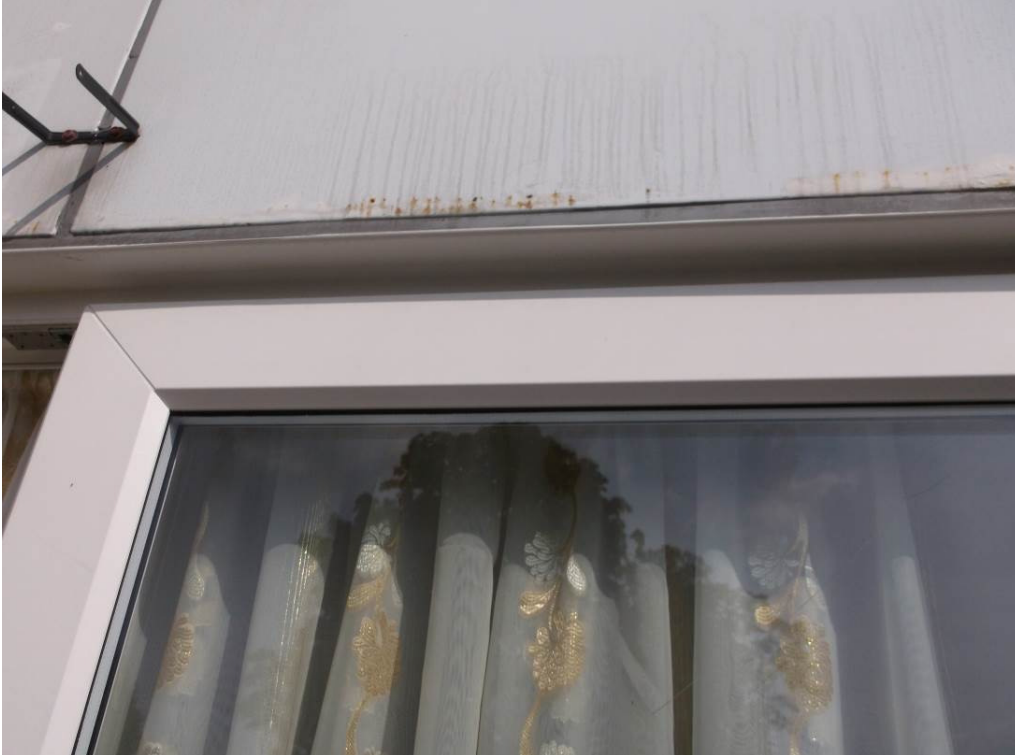
On the front and rear elevation the windows have been replaced plus there are enamelled steel panels below the window.. There is some rust staining on the tops of the panels at first floor level and some deterioration of the mastic between the panels. – Refer to the photographs.

Photograph 14 – 18 Paines Close – Cladding and windows at rear

It is recommended that the roof coverings, windows and the cladding are investigated further and a report prepared by a building surveyor to estimate how long these elements will last in serviceable condition. The report should be read in conjunction with structural report.
