Thermographic Survey Report

To Investigate
The 'Continuity of Insulation'
At
Eastfield Estate
Mitcham
Greater London
CR4 1BX

Survey Date: 05/11/14
Project No: 15081

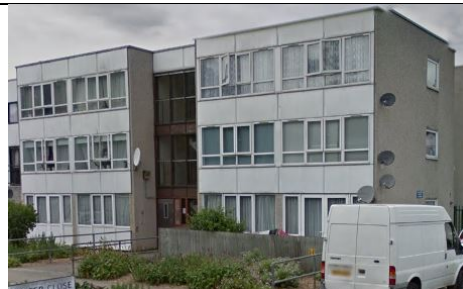
57 – 62 Clay Avenue – South Elevation

The striking change in the above image is the 2nd floor that generally appears to be 4°C and below. Logically this cannot be real and is in fact the result of reflection from the night sky. However this will not stop anomalies from being detected such as the heat loss from around some 2nd floor windows. The main anomaly is circled white and similar examples will be discussed later.

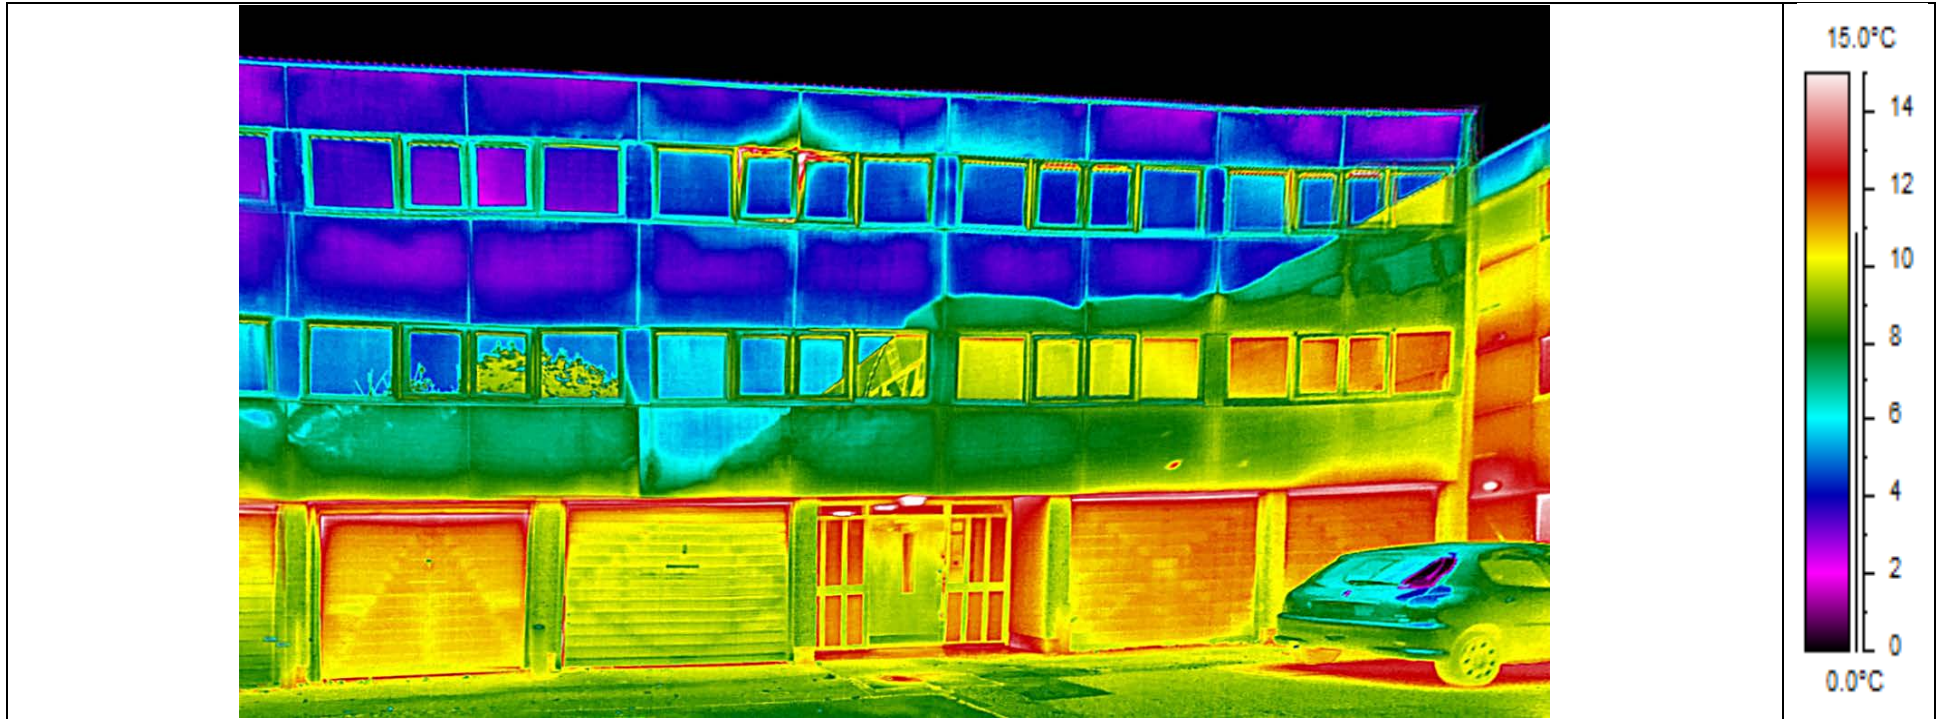
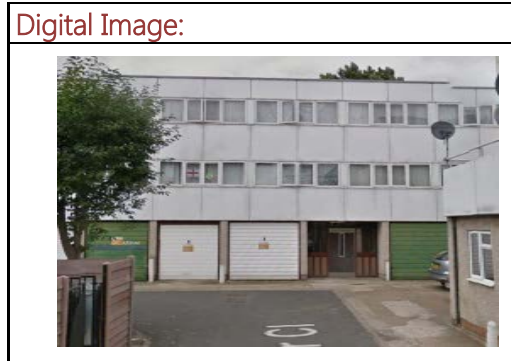
13 – 32 Potter Close – South Elevation – Right Side

Window on top floor is open and can be ignored.

In addition to the garages discussed before, the main entrance appears to be thermally weak. The door and glazing should be checked for thermal integrity together with all seals.

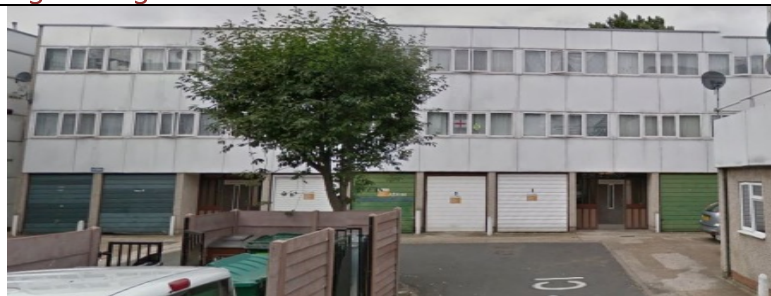
13 – 32 Potter Close – North East Corner

It is suspected that the side elevation is generally protected by the close proximity of the adjacent building thus leading to a build-up of heat. Again, an internal survey of this particular outside wall could be compared with other walls in the room to confirm if there is significant heat loss from the elevation.

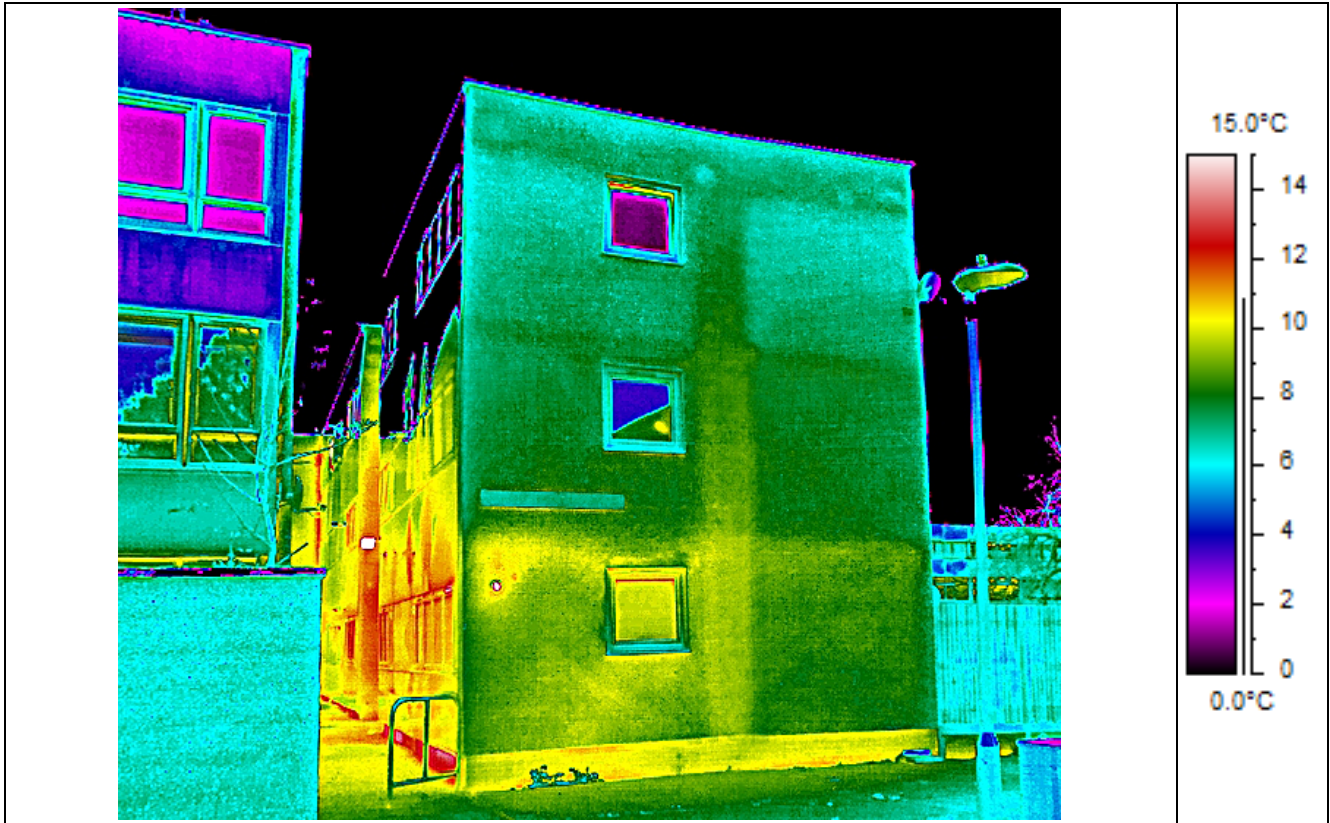
7-12 Thrupp Close – North West Corner

Some evidence of thermal bridging on the end wall.

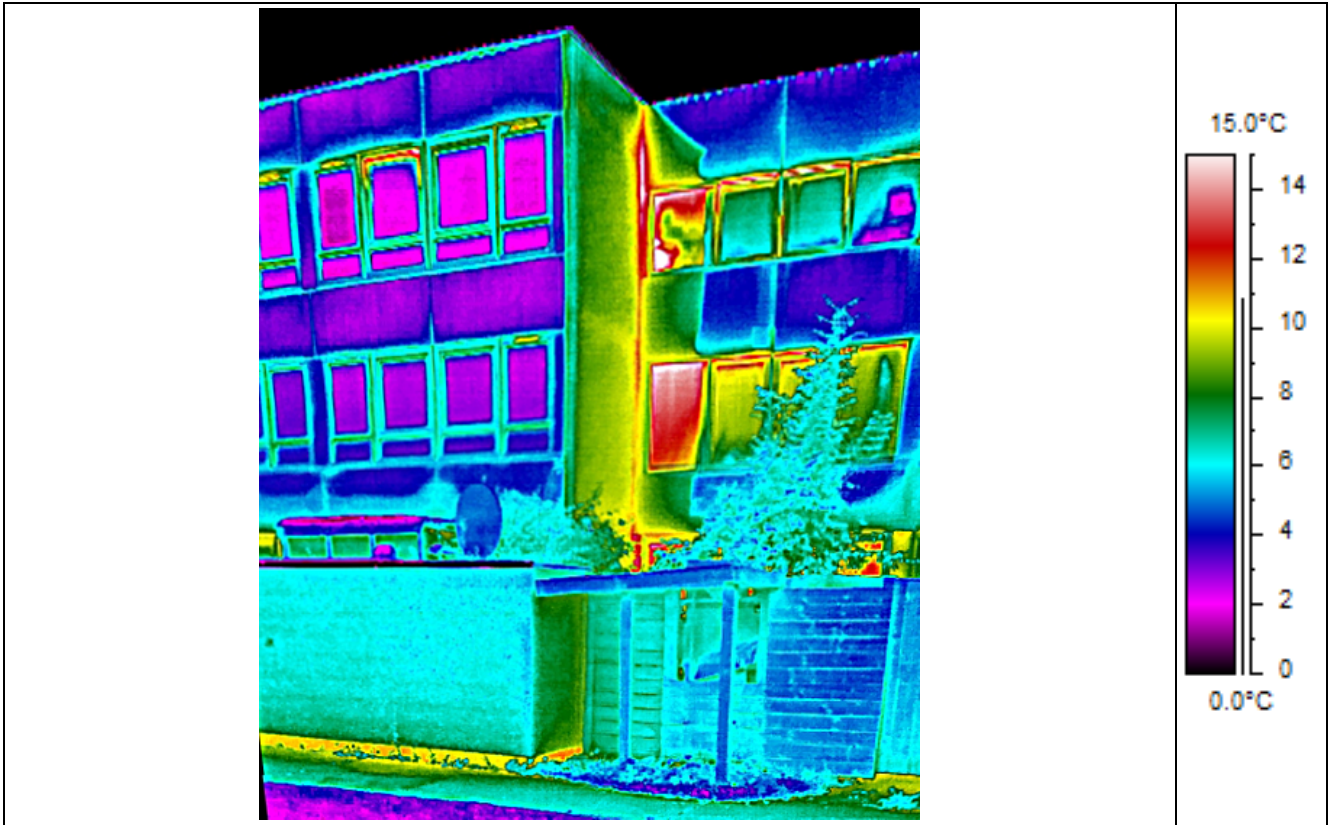
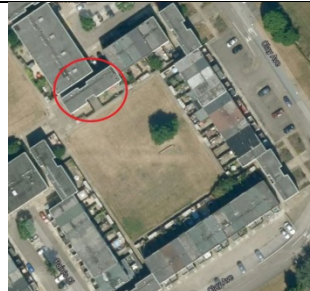
7-12 Thrupp Close – South Elevation

There is a significant anomaly at the internal corner on the 2nd floor. From the temperature it could be either air leakage or more probably missing / poor insulation. It is more than just the detail design, because the problem appears centred in just one area.

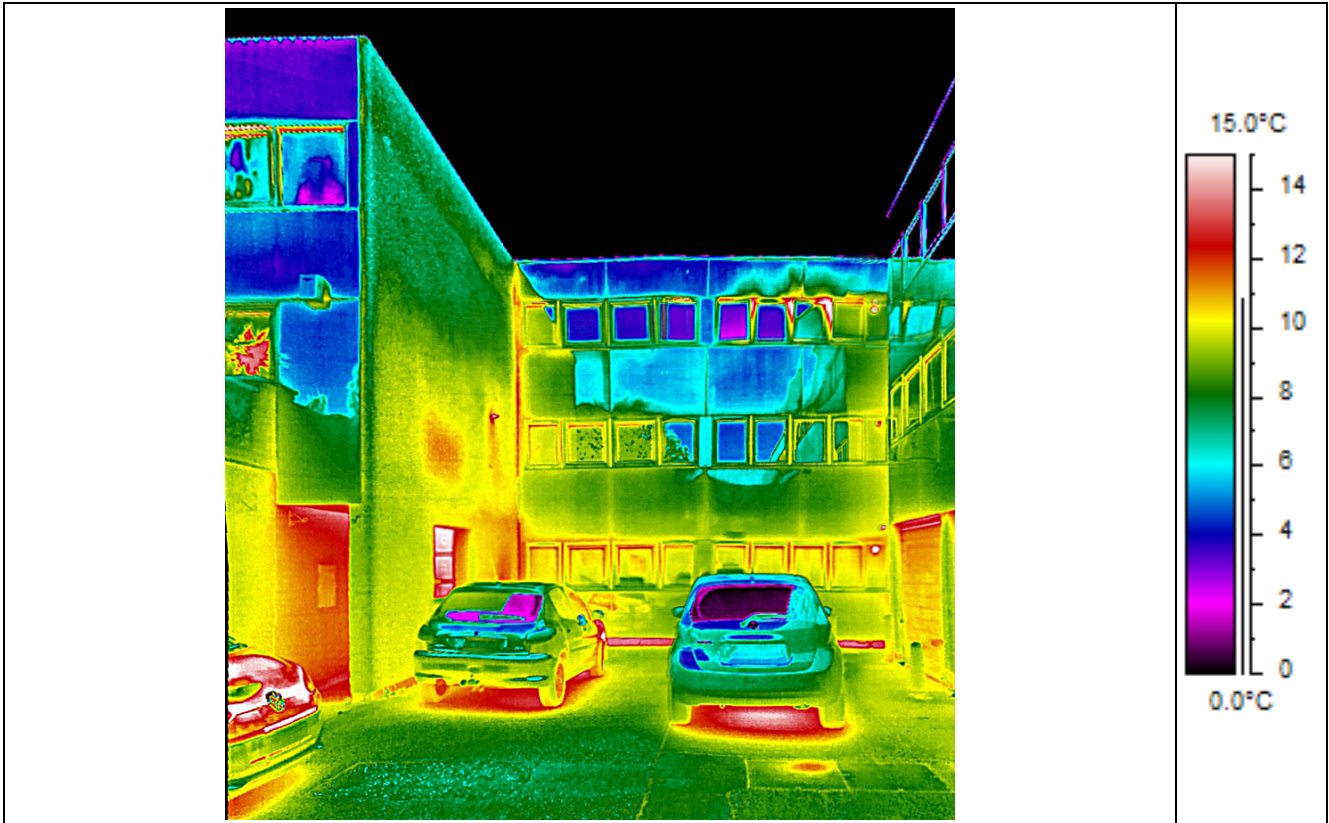
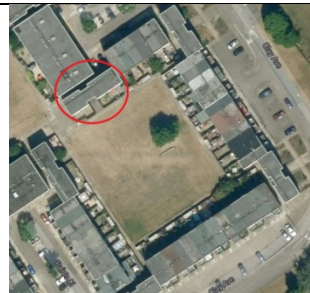
7-12 Thrupp Close – North East Join

Open Windows

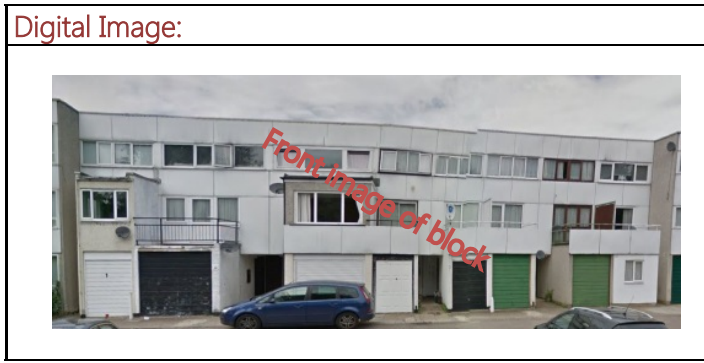
1-8 Pains Close – North Elevation

Some open or windows with poor seals.

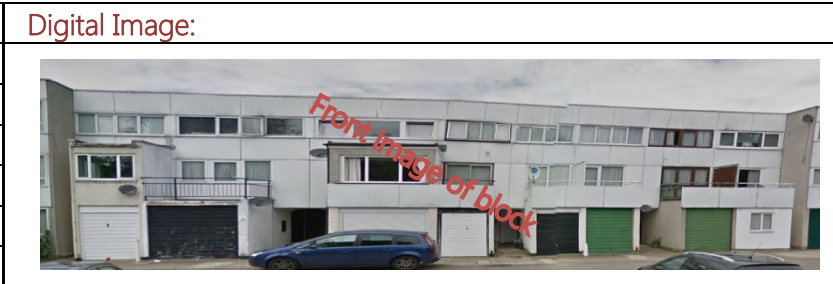
1-8 Pains Close – North Elevation – No. 4 Close Up

Comments:
 This image is fairly representative of how the ground floor elevation appears on this block.

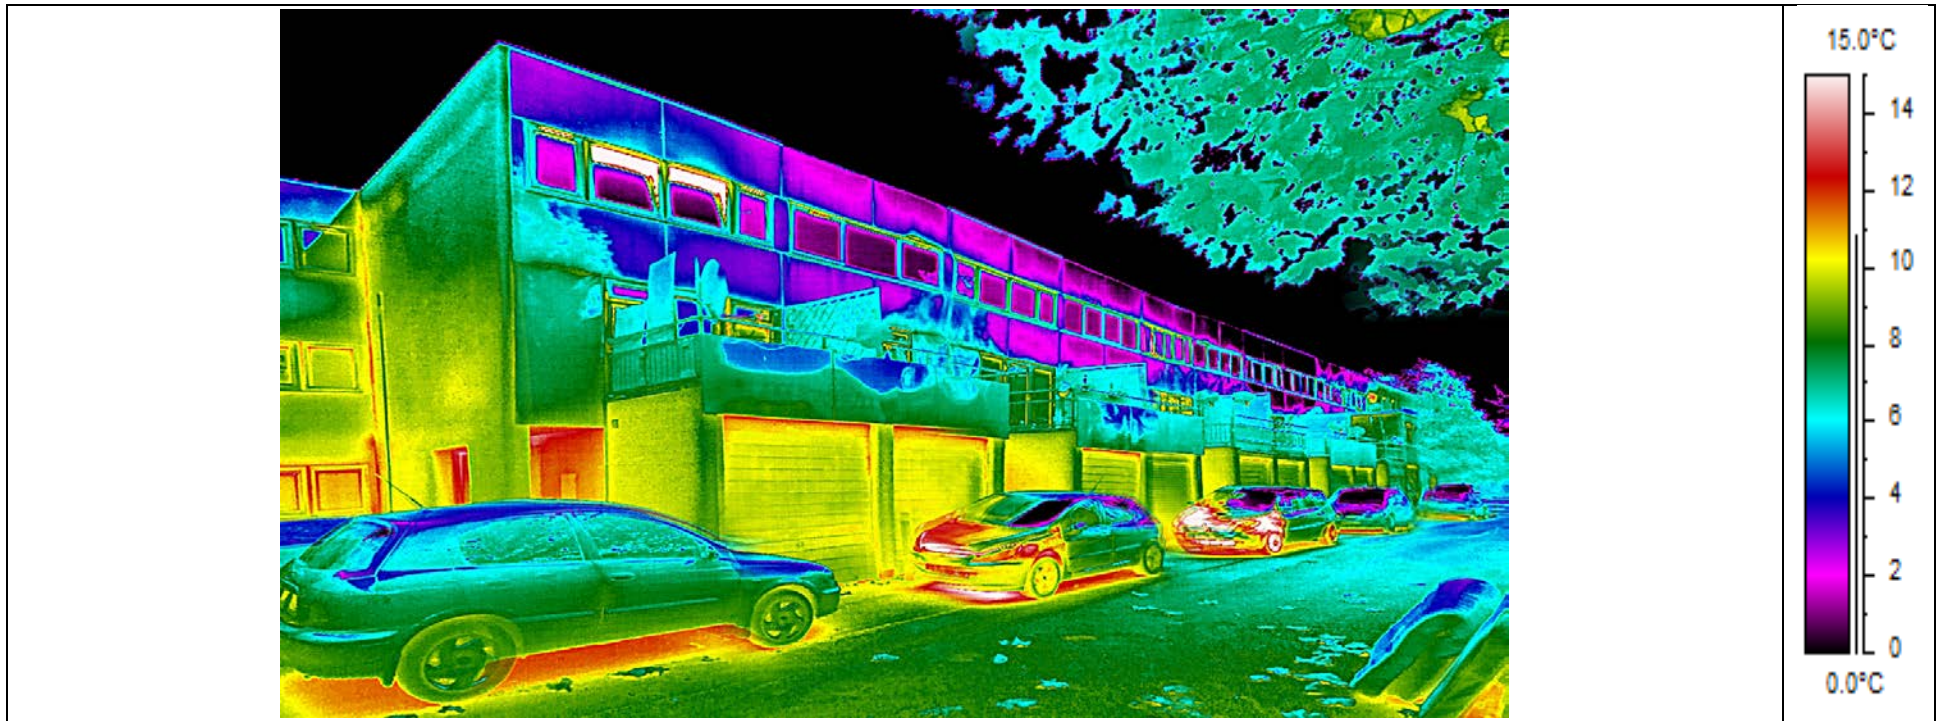
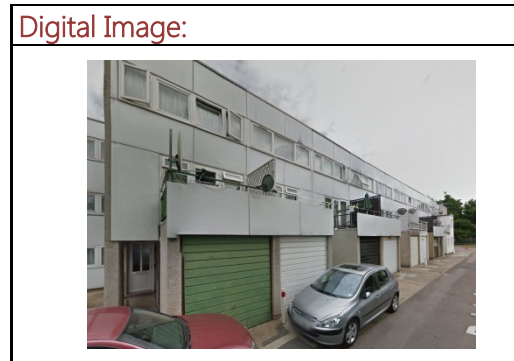
51-60 Pains Close – West Elevation – North End

Open windows on top floor.
No further comment.
