Structural Assessment Report of Orlit Houses Revision A Ravensbury Estate Regeneration For HTA Design LLP

Ravensbury Estate
Regeneration

Structural Assessment Report
of Orlit Houses

6th November 2014

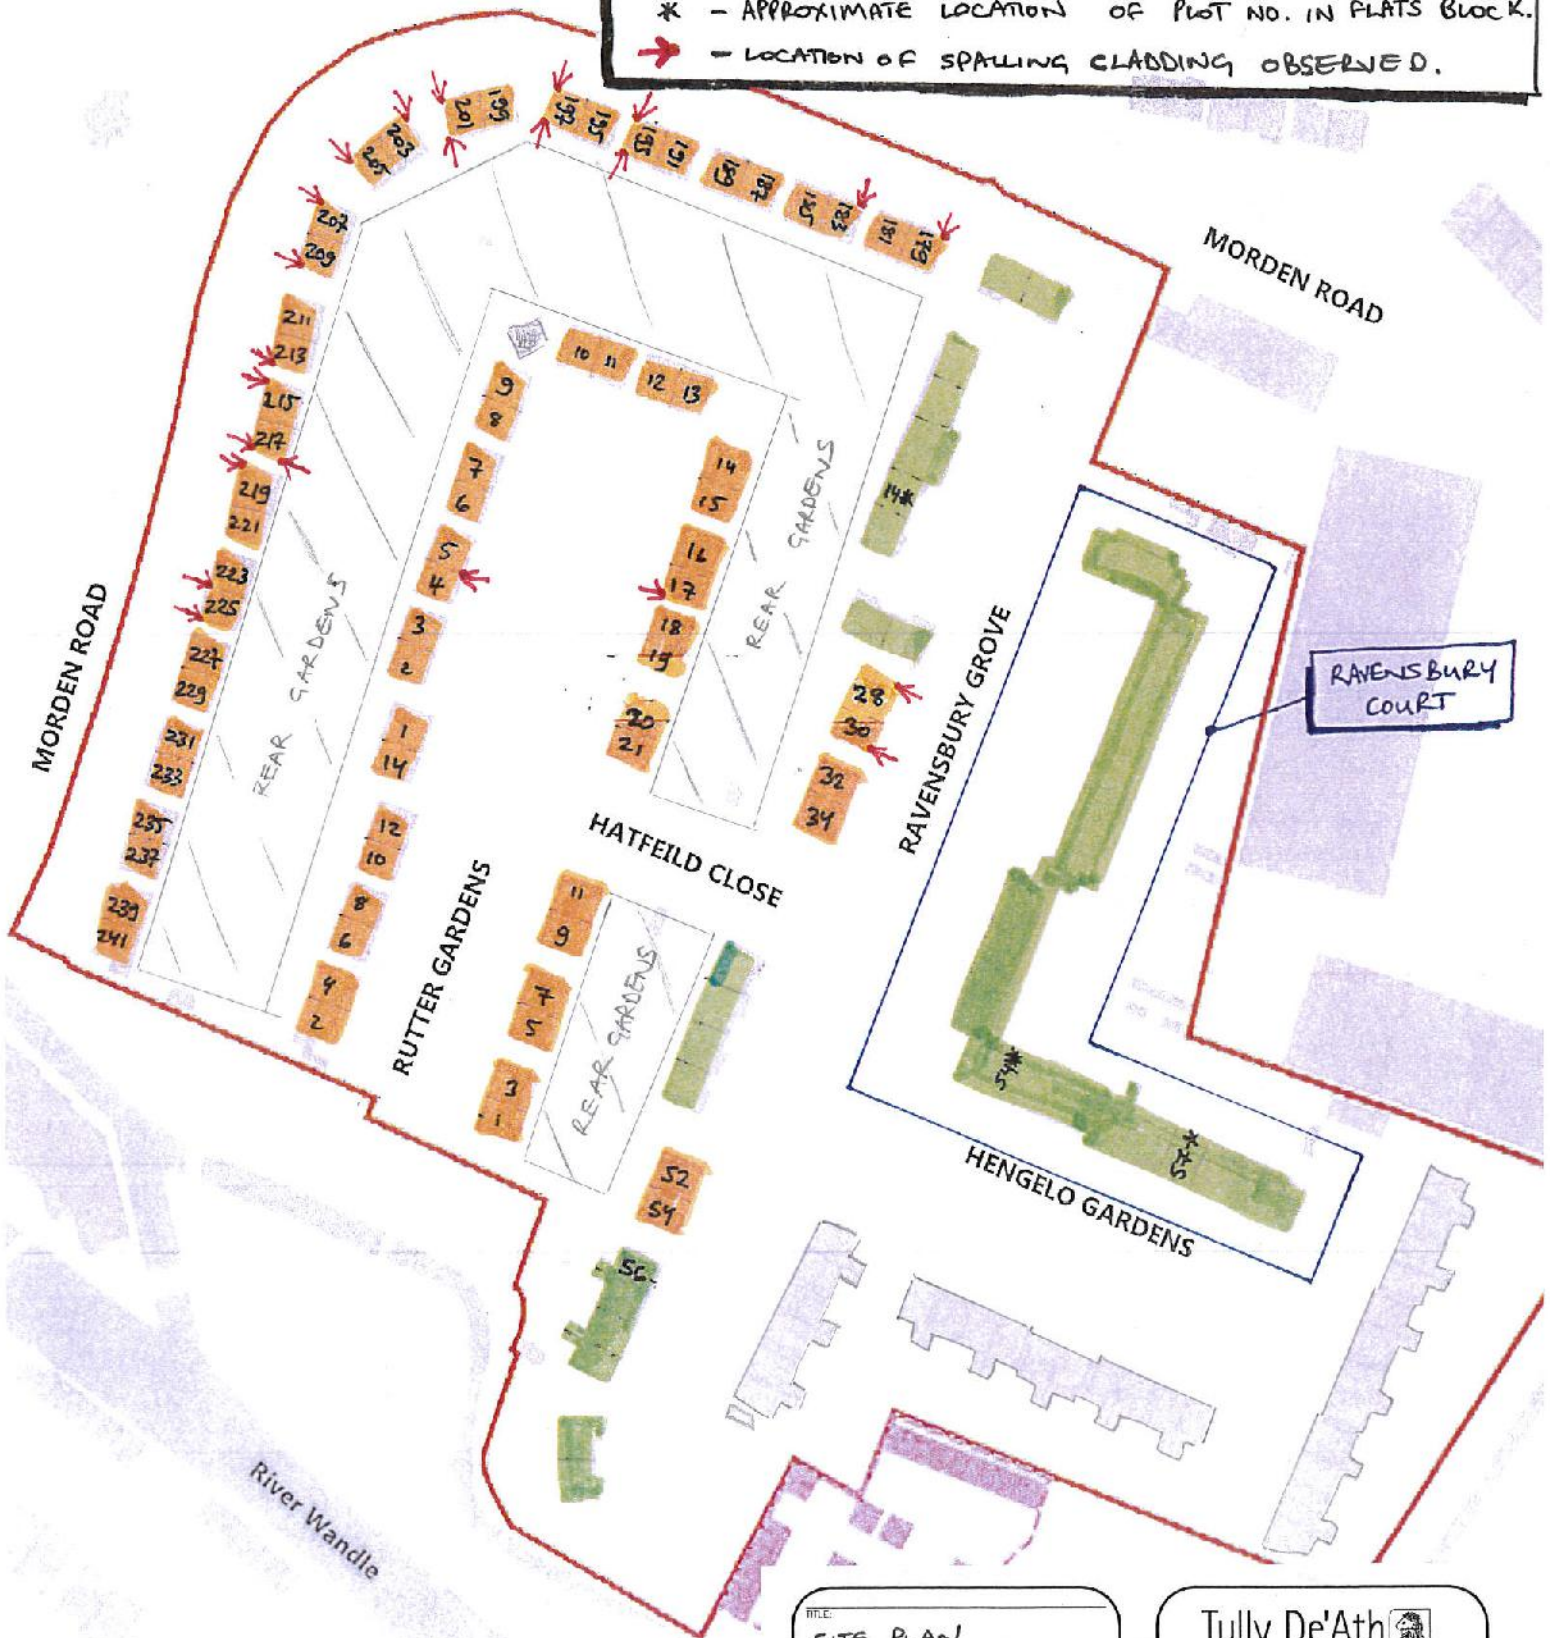
TITLE: **SITE PLAN**

- iii. These damaged areas of cladding on the corners and by the party walls tend to be more prevalent on the north and northwest facing elevations. Sketch number 11264/SK01 indicates the locations where spalling was observed.

- LOCATION OF SPALLING CLADDING OBSERVED.

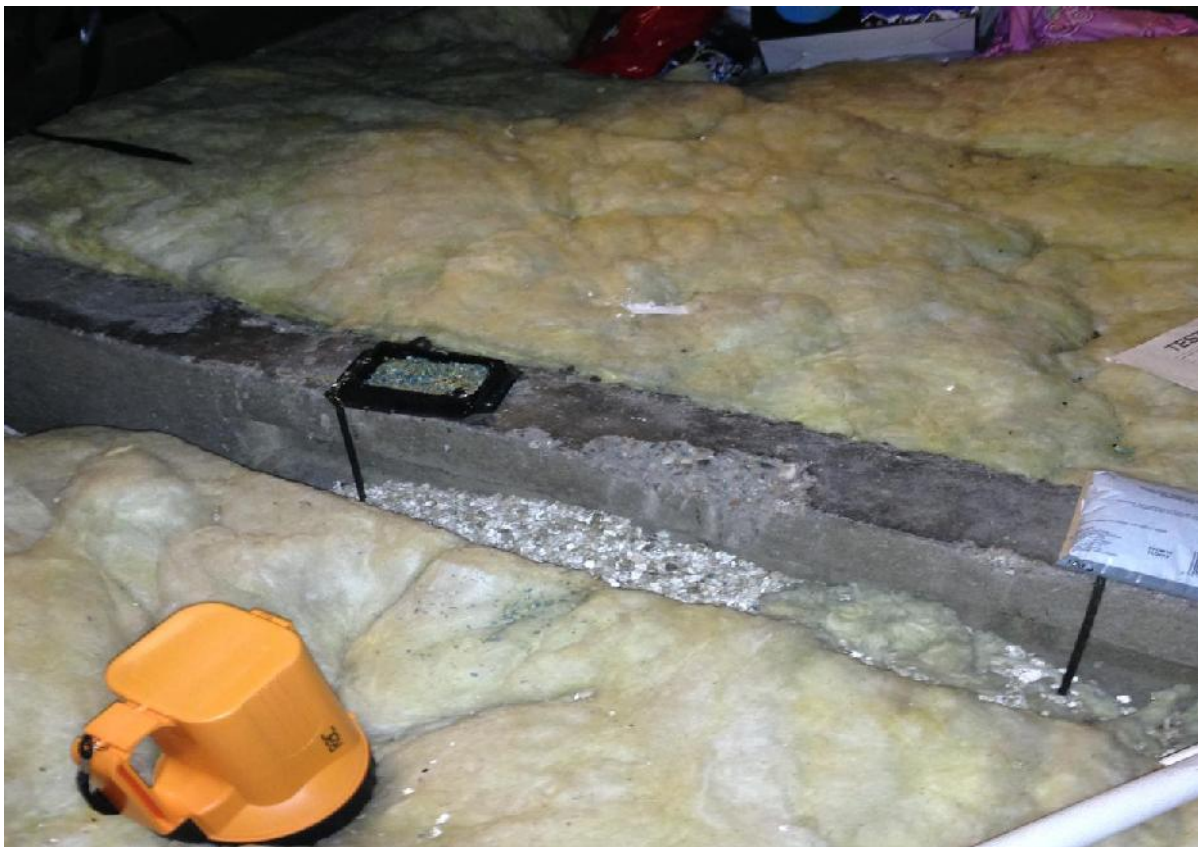
Photograph C6 – Damage to secondary beam

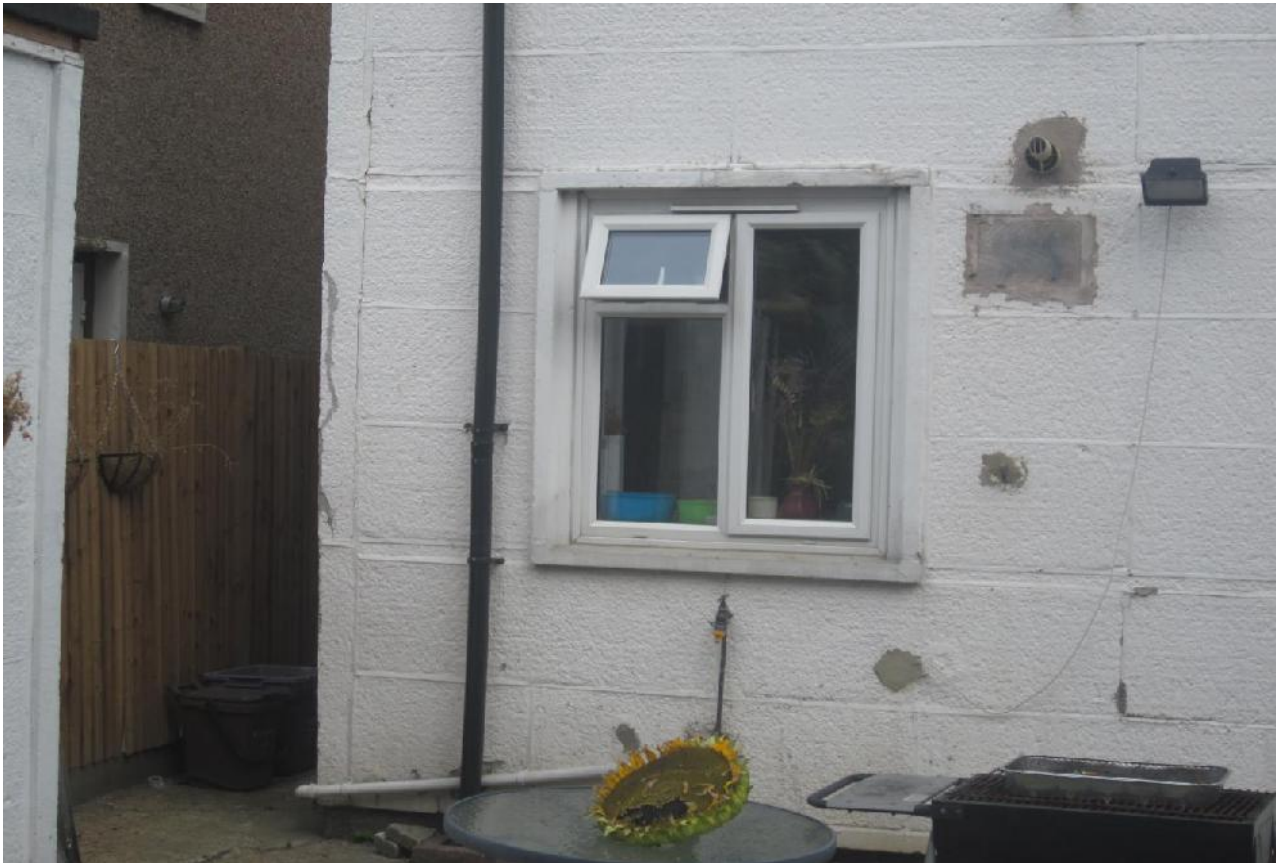
- 5.2 The following observations were made externally:
- i. Cracking has occurred to a number of the PRC corner cladding units. The cracks range from hairline up to about 10mm wide and extend vertically up the corner of the building where they occur. In a number of instances the corner cladding units show signs of patch repairs or have been replaced with new cladding panels. Refer to photographs C9, C15, C16, C17 and C30 in appendix C.

Photograph C9 – Spalled corner cladding panel and covered venting cladding panel to rear of 193 Morden Road

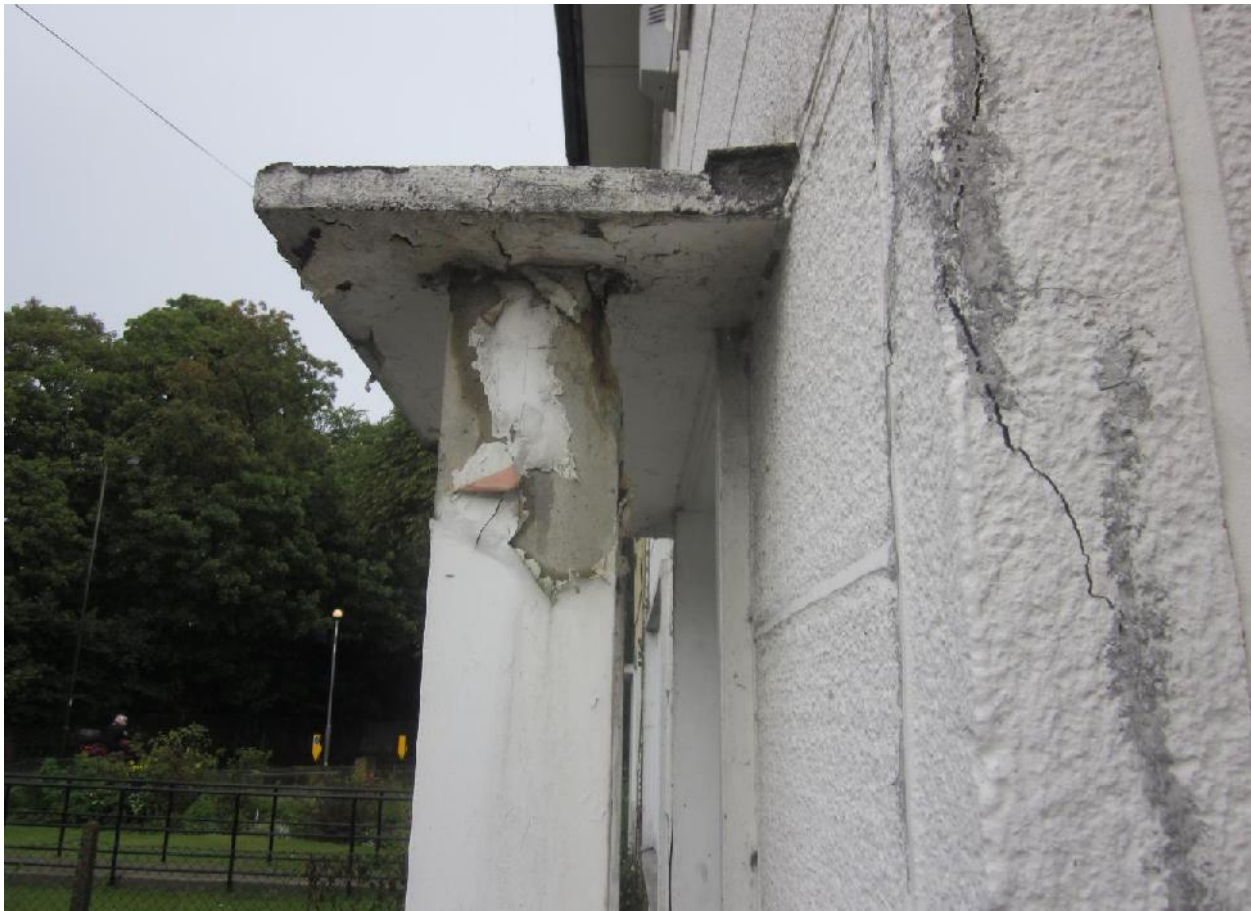
- v. Some of the external columns supporting canopies have spalled close to the upper end of these units, immediately below the soffit of the canopy roof. In some instances, the reinforcement bars within the column sections have become exposed, showing signs of corrosion. Refer to photographs C16 and C23.

Photograph C16 – Example of corner cladding and canopy support spalling

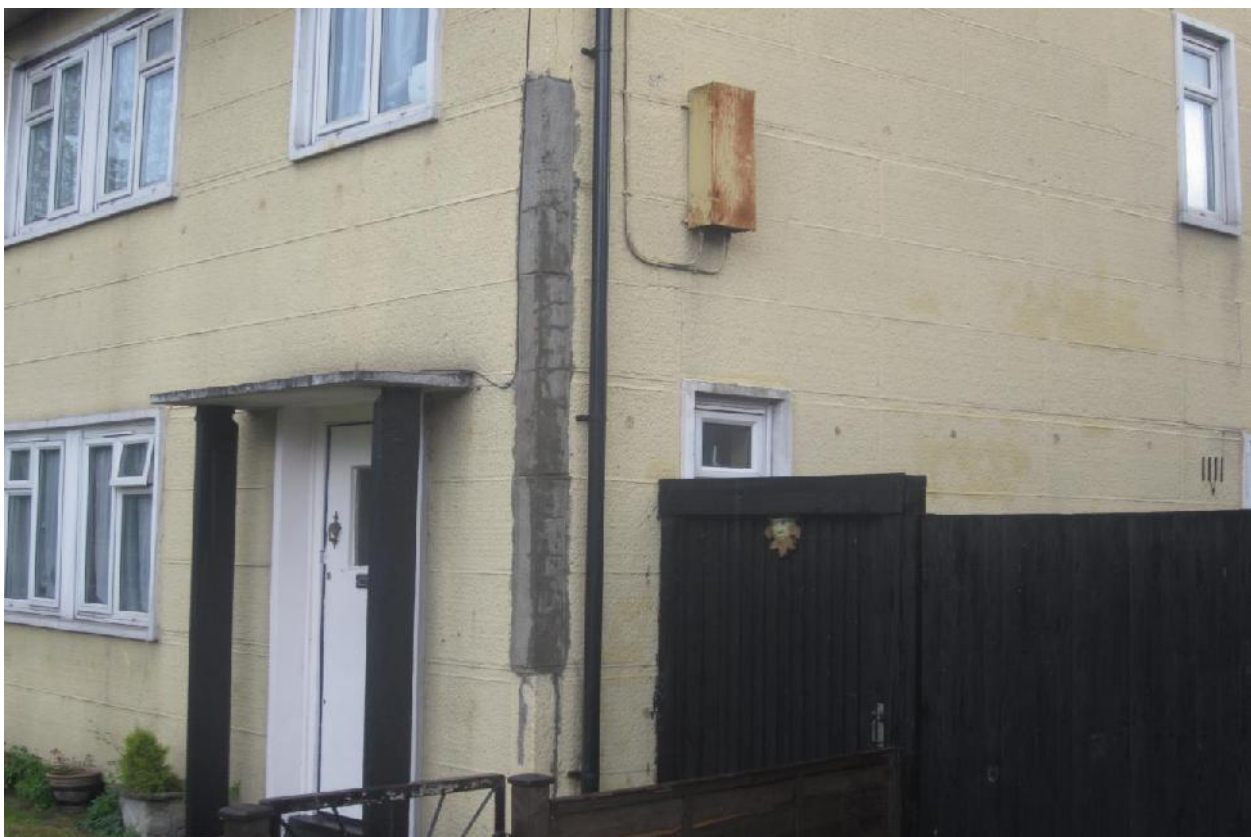
Photograph C17 – Corner cladding patch and repair

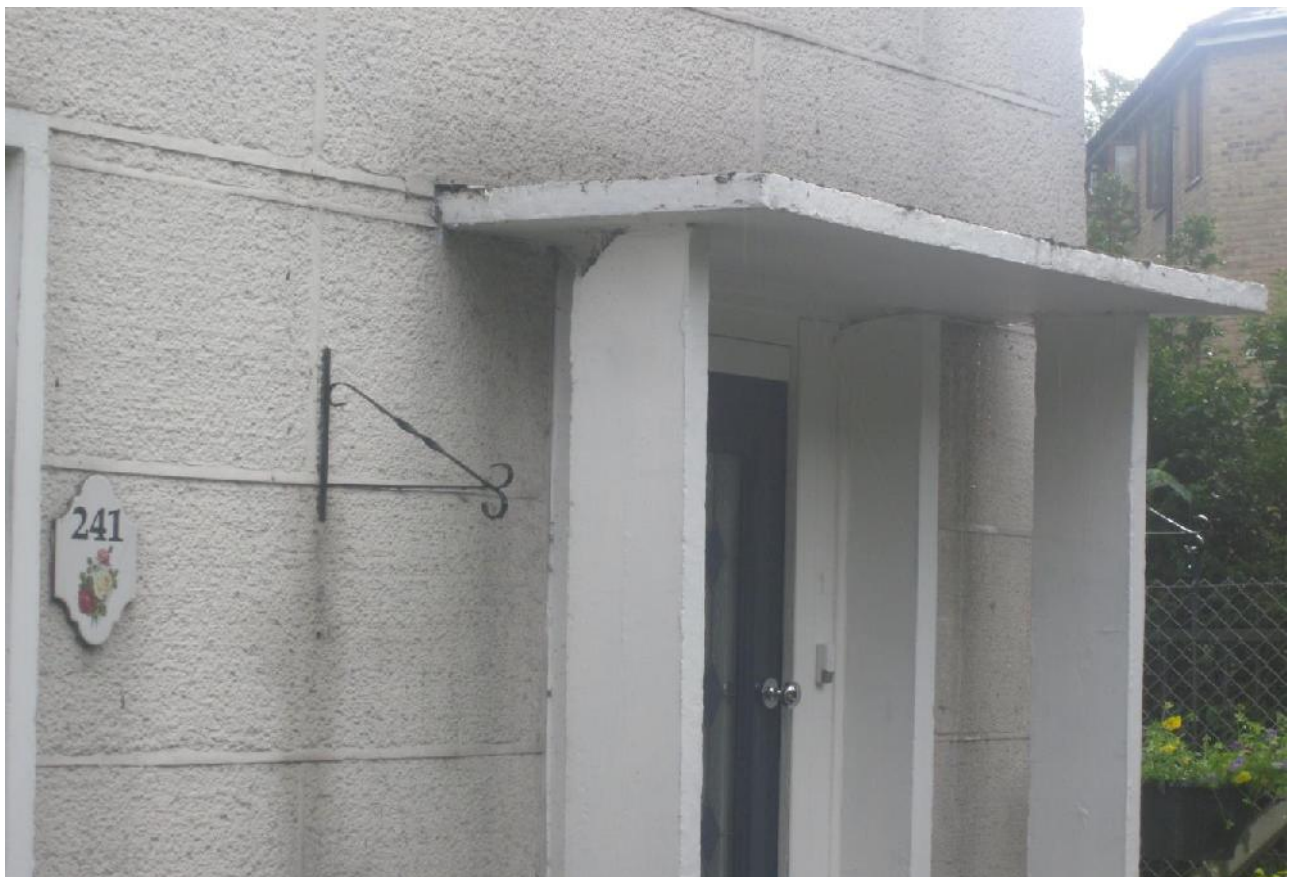
Photograph C23 – Canopy support spalling

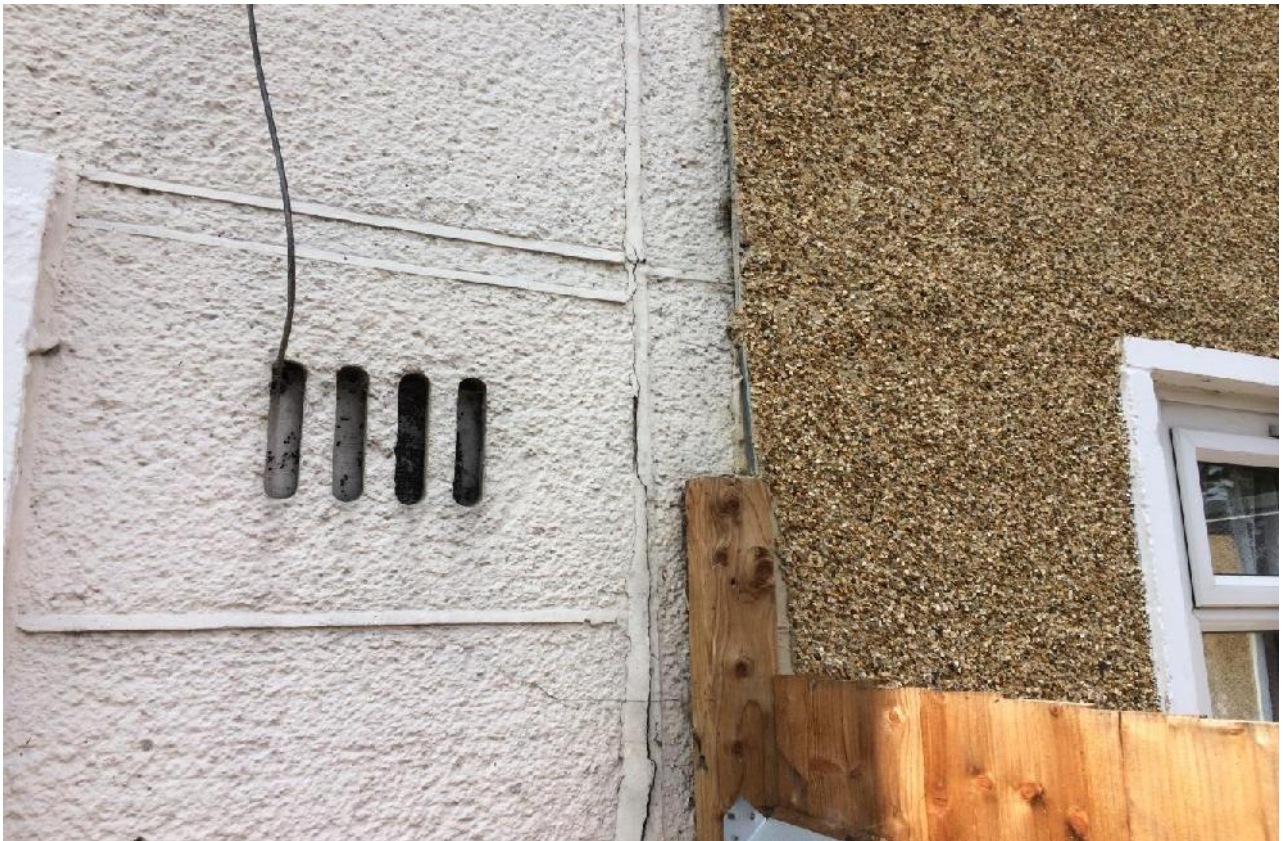
- ii. A number of party wall cladding units show signs of spalling or cracking and patch repair. The cracking observed varied between hairline to 1mm in size and ran vertically along the panels. Patch repairs were visible on some houses and tend to be to the mortar joints running vertically between the party wall and main elevation panels. See photographs C22, C27 and C31.

Photograph C31 – Painted vent in cladding and party wall cladding mortar joint cracking

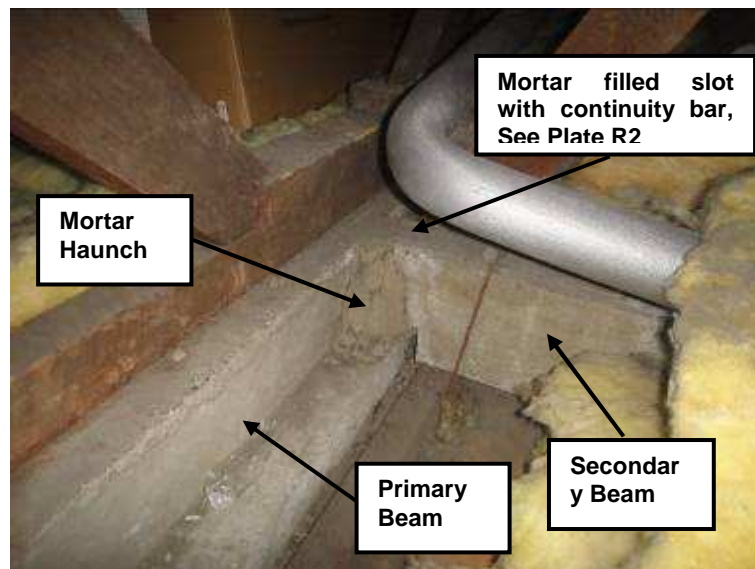
Plate R1: View of roof secondary beam bearing onto central roof primary beam over central column at No.193 Morden Road. Note mortar haunch and mortar filled slot with continuity bar

The mortar cover to the continuity bar exposed within No. 193 Morden Road and 1 Rutter Gardens exhibited cracking, elsewhere the mortar was observed to be in reasonable condition.

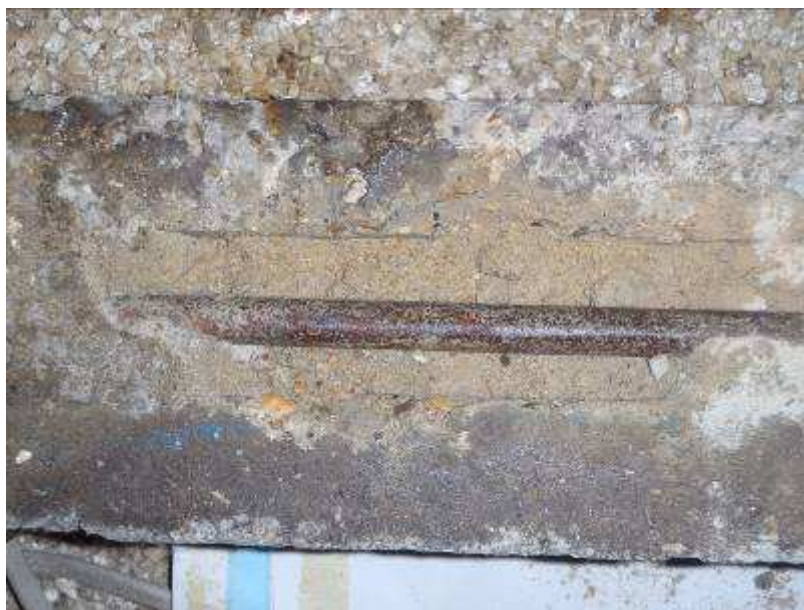
Plate R8: View of Breakout D2 to roof secondary beam continuity bar over central column at No. 20 Hatfield Close.

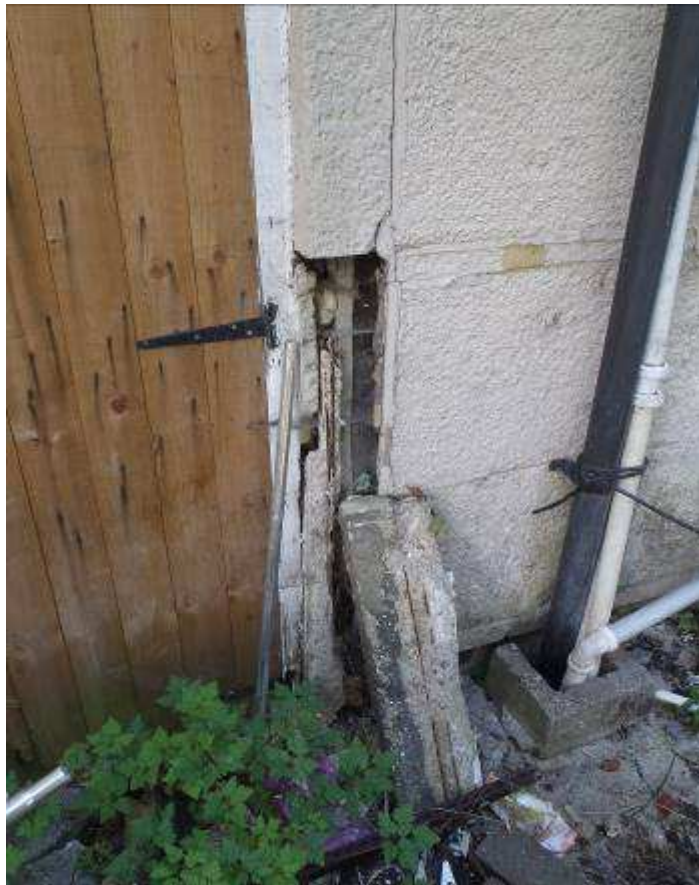
The external cladding panels were generally observed to be in reasonable condition, however, cracking and spalling of the corner panels was noted at each property, particularly at low level. There was also some cracking and spalling noted to the front porch frames.

Plate R10: View of spalled corner panel at ground floor level to No. 1 Rutter Gardens

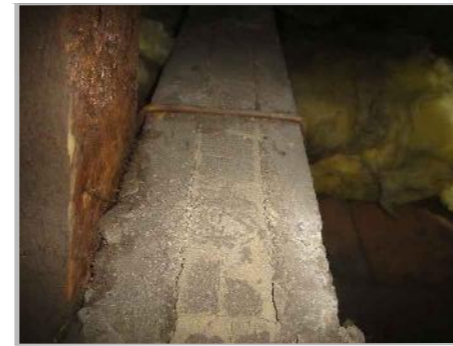
10mmØ PLAIN ROUND CONTINUITY BAR EMBEDDED WITHIN INSITU MORTAR FILLED PRE-FORMED SLOT. TOP COVER TO BAR 5mm. BAR OBSERVED TO BE IN GOOD CONDITION EXHIBITING LIGHT SURFACE CORROSION ONLY. INSITU MORTAR EXHIBITS CRACKING.

PB2a: VIEW OF INSITU MORTAR PRIOR TO BREAKOUT B/O B1

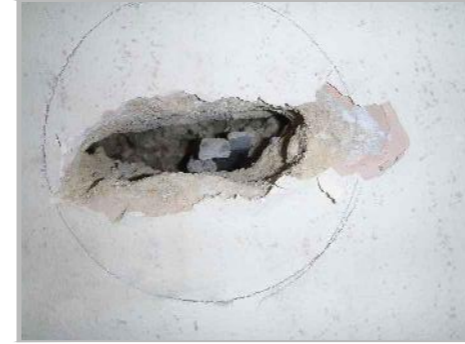
DETAILS OF B/O D6
GALVANISED STEEL WALL TIE EXPOSED AND FOUND TO BE IN GOOD CONDITION.
DEPTH OF TIE EMBEDMENT WITHIN INTERNAL BLOCKWORK SKIN: 35mm.
NOTE CAVITY FILLED WITH INSULATION.

PD8a: VIEW OF B/O D6 AND EXPOSED WALL TIE
