Structural Assessment Report of Ravensbury Grove Flats Ravensbury Estate Regeneration For HTA Design LLP

Scheme No: 11264

Ravensbury Estate
Regeneration

14th October 2014

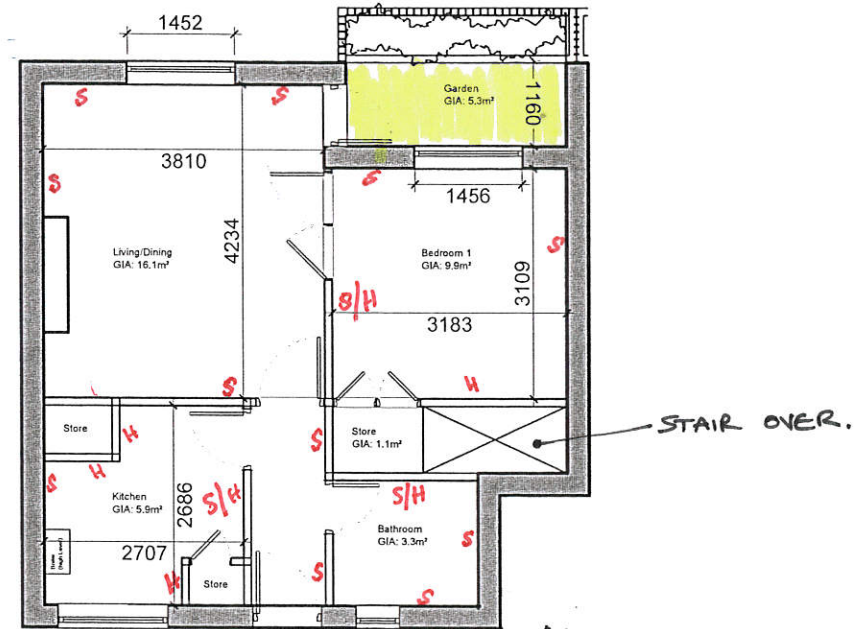
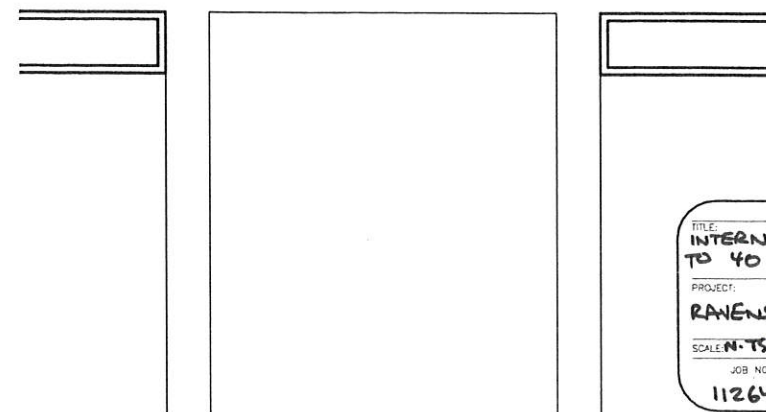
FILE: INTERNAL OBSERVATIONS TO 40 RAVENSBURY GROVE.
 PROJECT: RAVENSBURY ESTATE
 SCALE: N.T.S. DATE: 10/14 DRAWN: TP CHK'D:
 JOB NO. 11264 DRG NO. SK 08 REV.

NO ADVERSE SIGNS OF DAMAGE/ DETERIORATION INTERNALLY.

FLOOR FEELS SOLID IN ALL ROOMS.

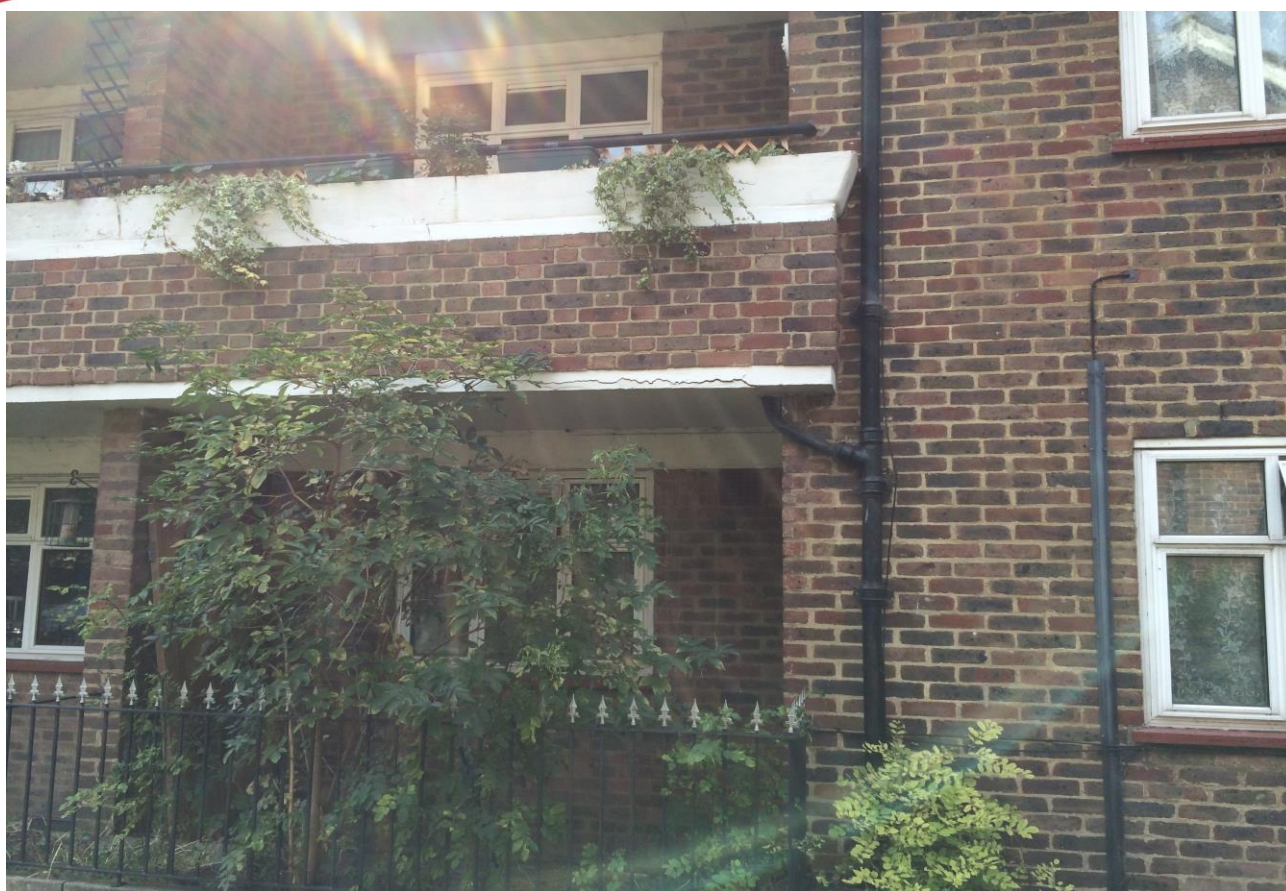
- iii. Cracking was observed in Block 3's first floor terrace. These vary from about 1mm and 6mm in width and run horizontally along the front of the terrace close to the slab soffit. The cracking does not appear recent. There is a gully that projects through the terrace slab and connects into the adjacent down pipe. It is also noted that there are no obvious drip details on the external edge of and of the terrace soffits viewed.

- 5.4 The cracking on the first floor terrace appears to be related to water ingress too. It is located on the outer edge of the terrace structure where it is vulnerable to higher concentrations of surface water after rainfall. This has partly been exacerbated by the lack of a drip detail on the soffit of the terrace structure. It appears water ingress has caused some corrosion of embedded reinforcement and this has resulted in the concrete expanding and cracking. The cracks do not appear to be structurally significant at present but concrete repairs would be necessary to prevent the cracking becoming more extensive over time.

Photograph C3 – 1-6mm Horizontal Crack in Terrace Soffit

- 6.3 There are a few examples observed to suggest that water ingress may be affecting the structure locally. If it is intended to extend the useful life of the buildings, it is important that a maintenance regime is put in place to restore affected areas and limit potential for future water ingress which could result in accelerated deterioration of the structure. Based upon observations to date, concrete repairs would be required to some of the external roof terraces.

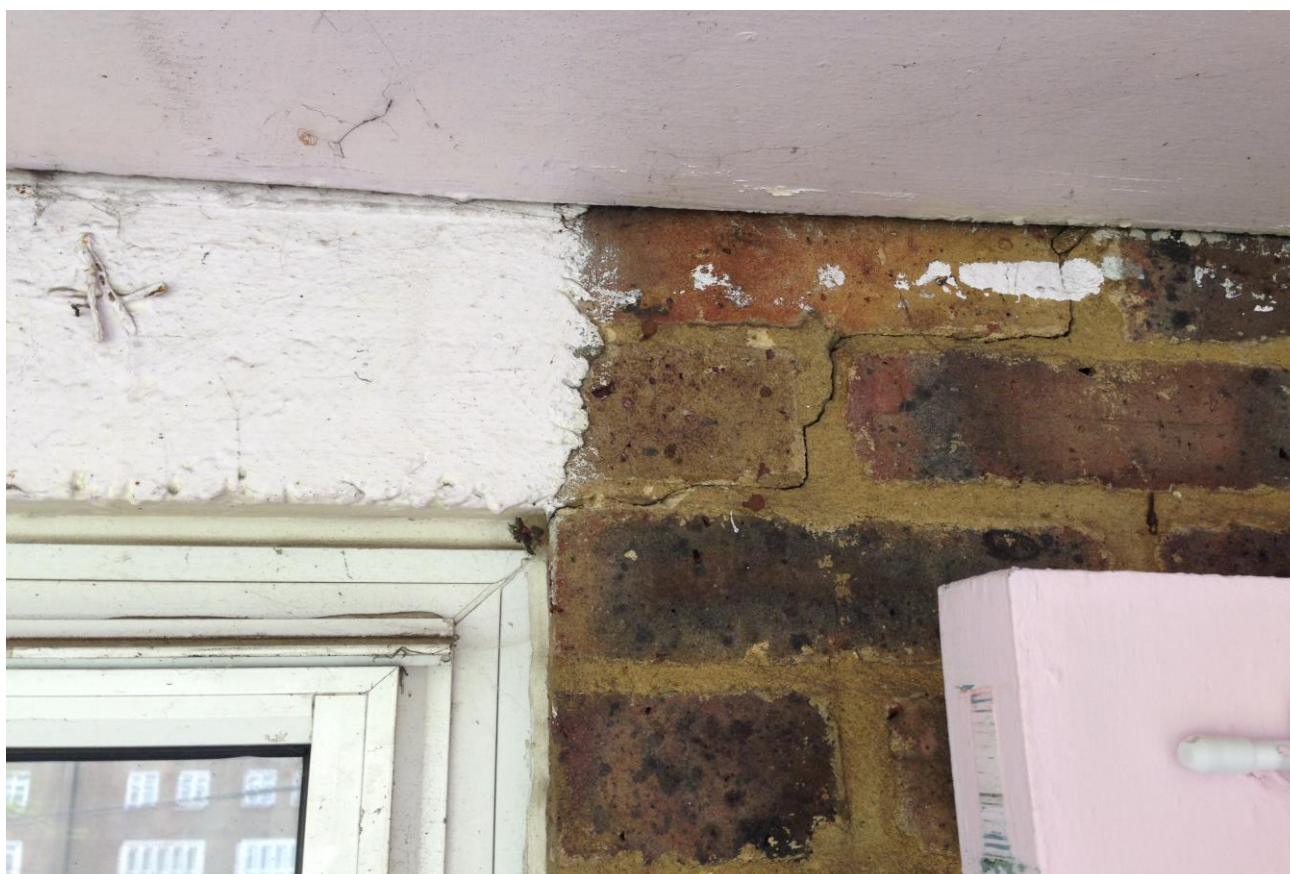
- iv. Cracking was observed externally in the mortar joints above the terrace window of 14 Ravensbury Grove within flat Block 2. These vary between 1mm and 3mm in width and appear not to be recent. (See photographs C4 and C5). No cracking or signs of movement were evident internally.

- 5.5 The cracking seen at the window head on 14 Ravensbury Grove may be suggestive of very slight thermal movement along the length of the building. The movement is not significant structurally and the opened up joints should be made good.

Photograph C4 – 1-3mm Crack in Mortar Above Window on 14 Ravensbury Grove External Terrace

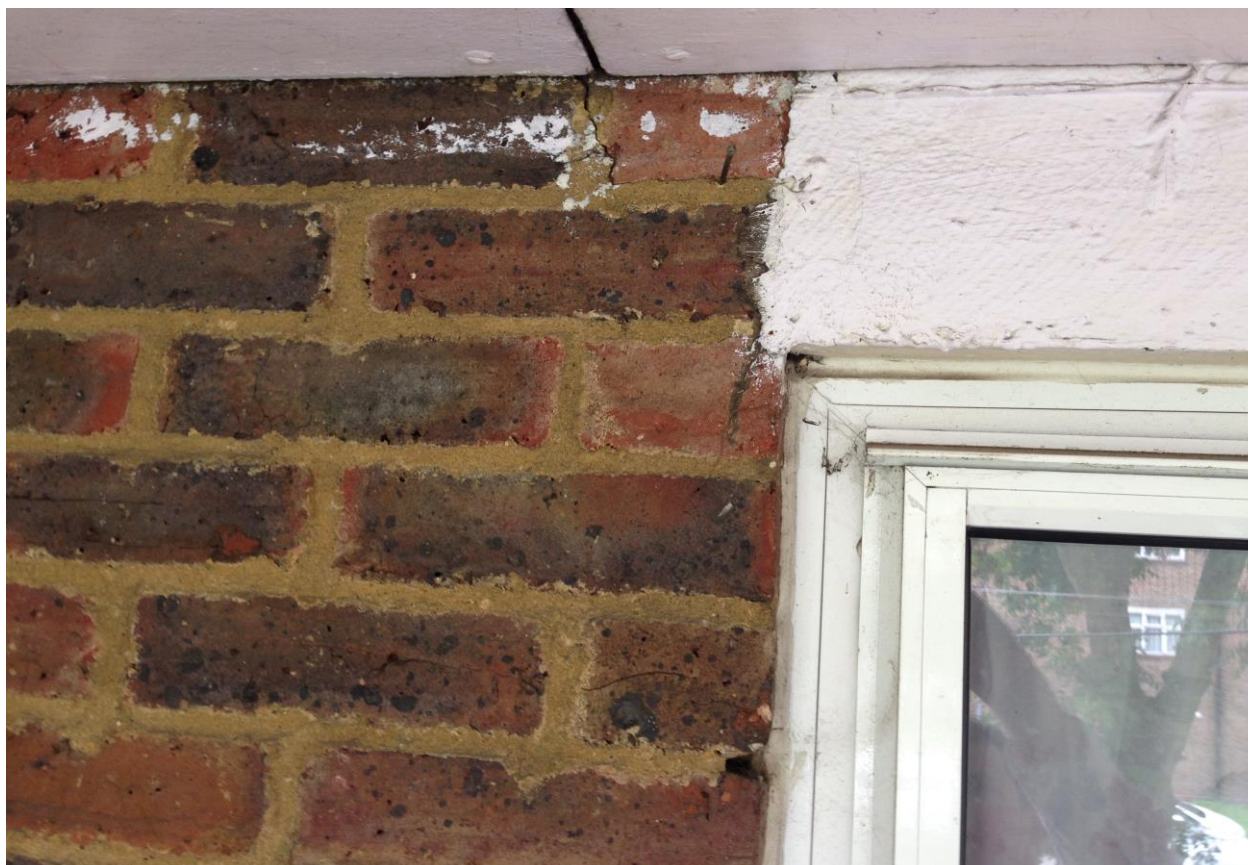
Photograph C5 – 1-3mm Crack Above Window on 14 Ravensbury Grove 's External Terrace

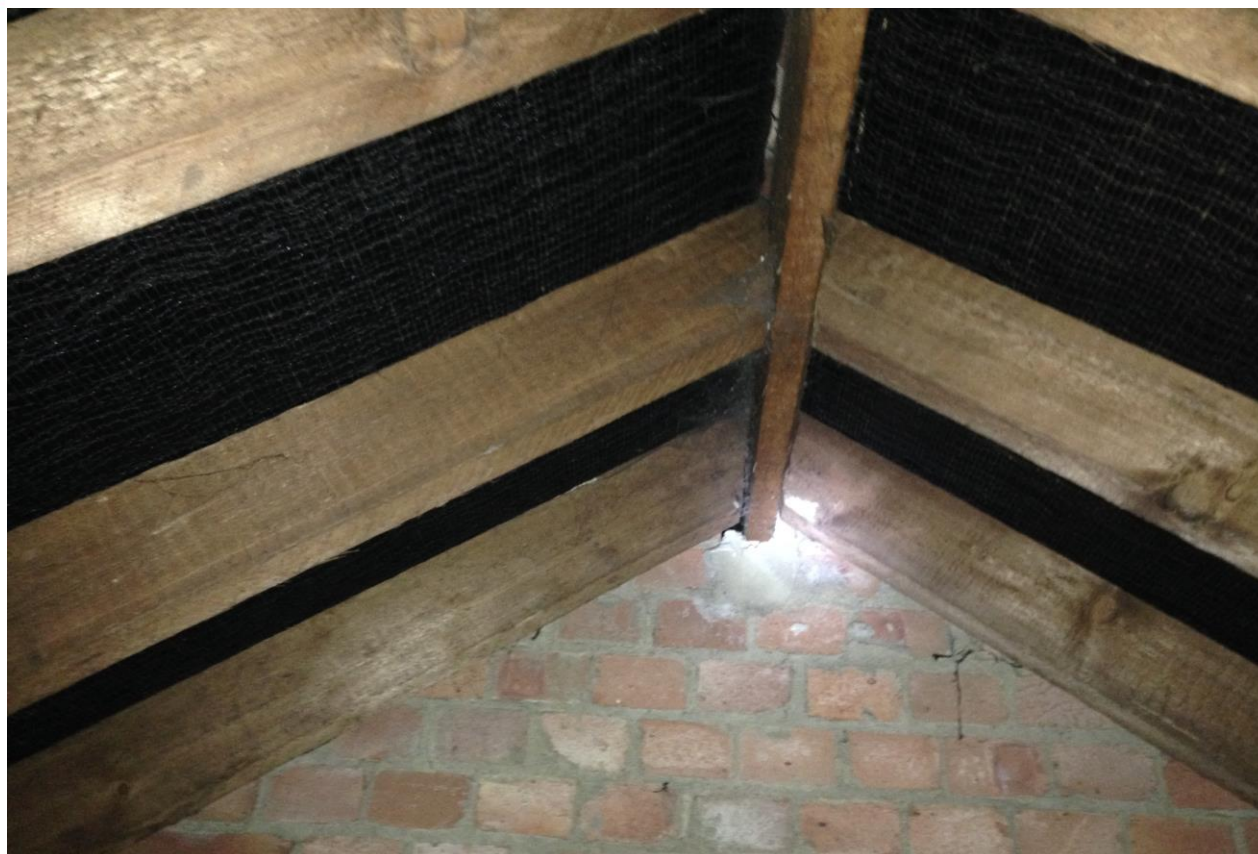
Photograph C7 - 14 Ravensbury Grove Roof Space

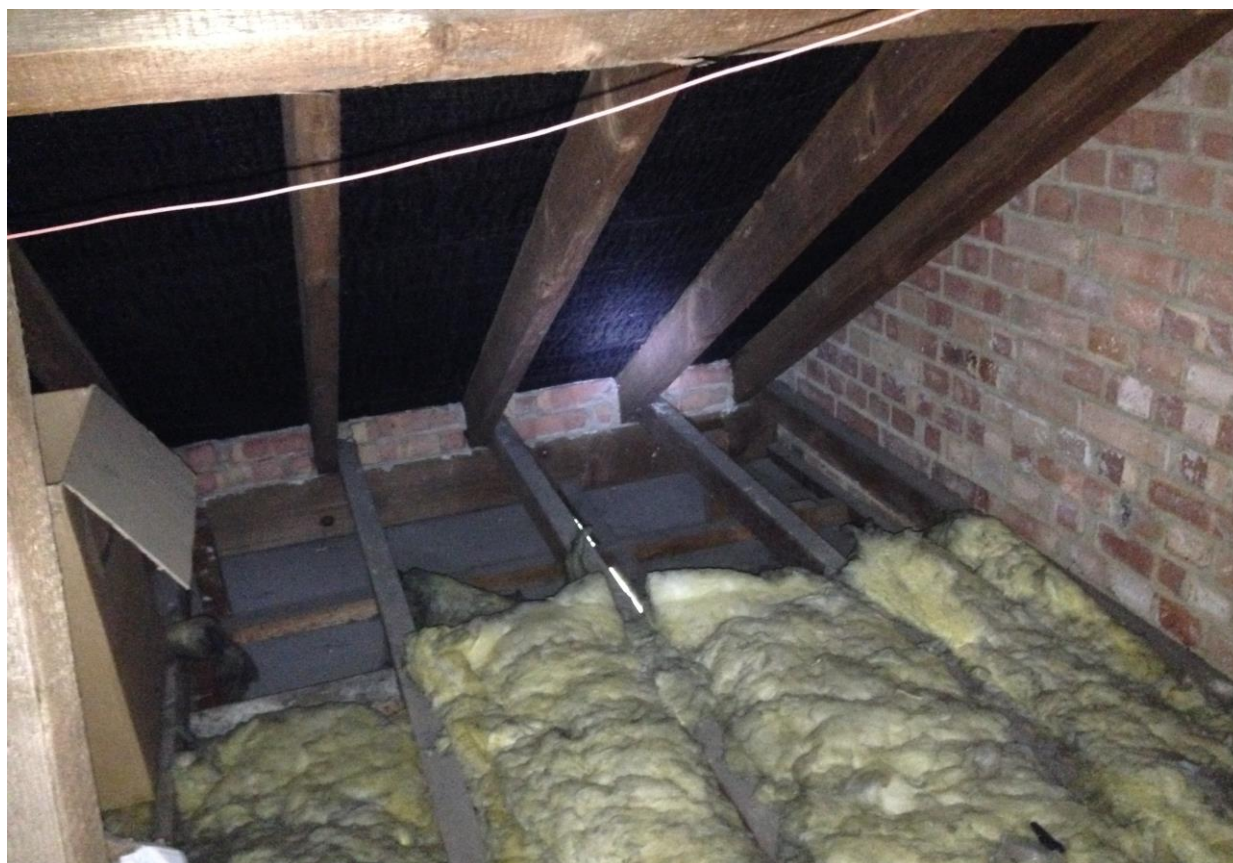
Photograph C8 - 14 Ravensbury Grove Roof Space

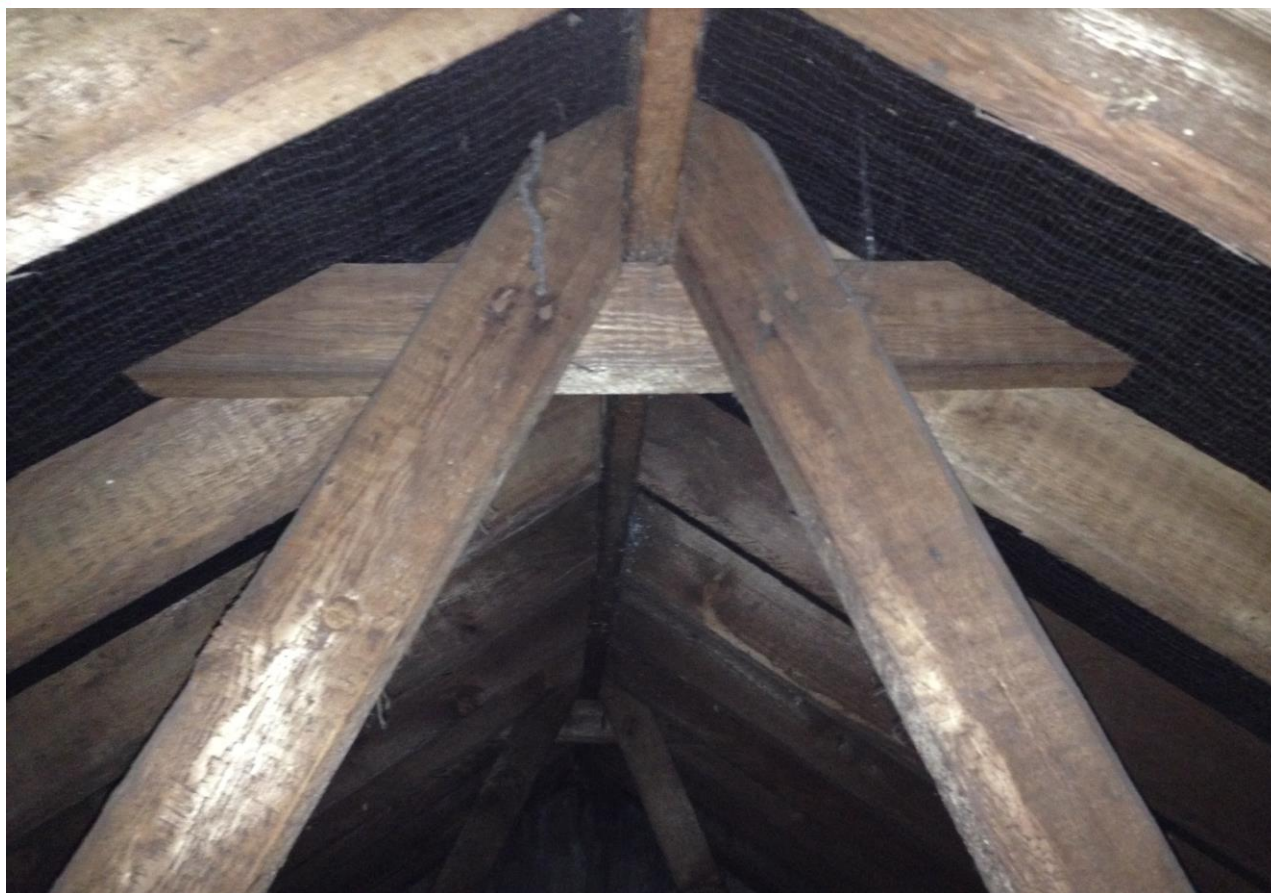
Photograph C9 – 14 Ravensbury Grove Roof Detail

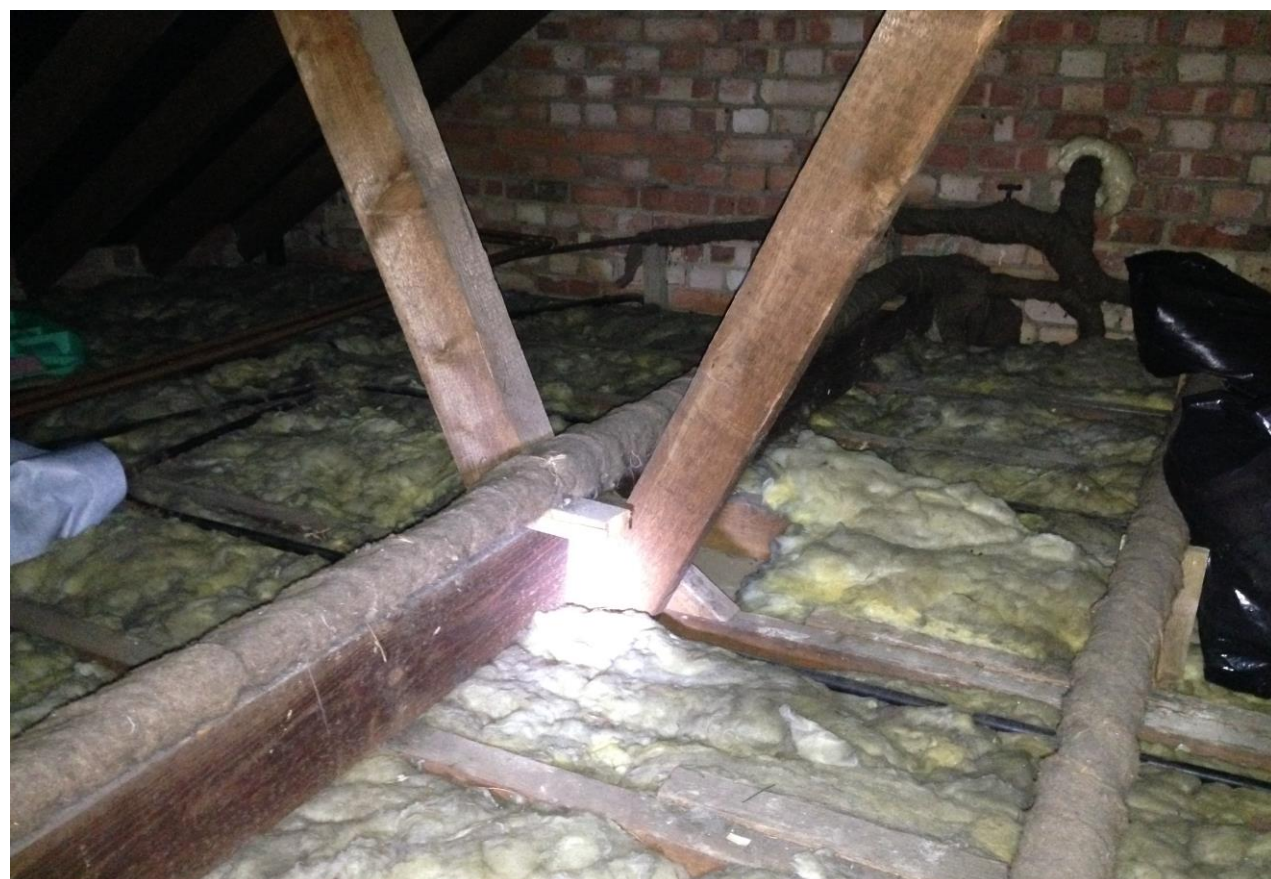
Photograph C10 – 14 Ravensbury Grove Roof Space

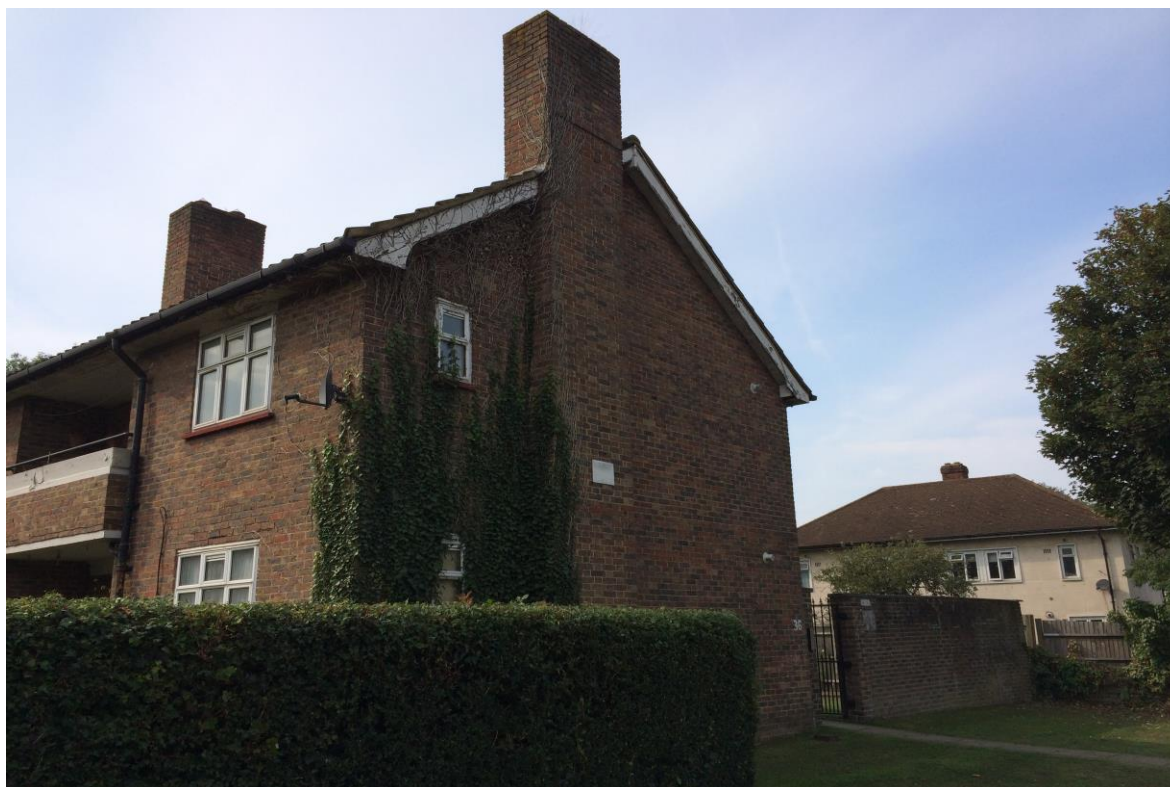
- 4.2 The following observations were made externally:
- i. The guttering and eaves boards of Blocks 2 to 5 have paint peeling in some locations.
 - ii. Vegetation was observed on the roof and guttering of Block 2. Vegetation was also observed to the side elevation of Block 4. (See photograph C12).

- 5.3 From the observations carried out, there are a few issues which suggest water ingress may be affecting the structure locally. These relate to the eaves boarding and guttering where vegetation has been allowed to take hold. Over time, roots from vegetation will extend in to the building fabric further, encouraging water ingress to occur. It is therefore important that the guttering is cleared and any damage to the finishes made good.

Photograph C12 – Vegetation to Side of Block 4 and Peeling of Paint to Eaves Board
