STRUCTURAL ENGINEERS REPORT

EASTFIELDS ESTATE

MERTON

14942-re-001

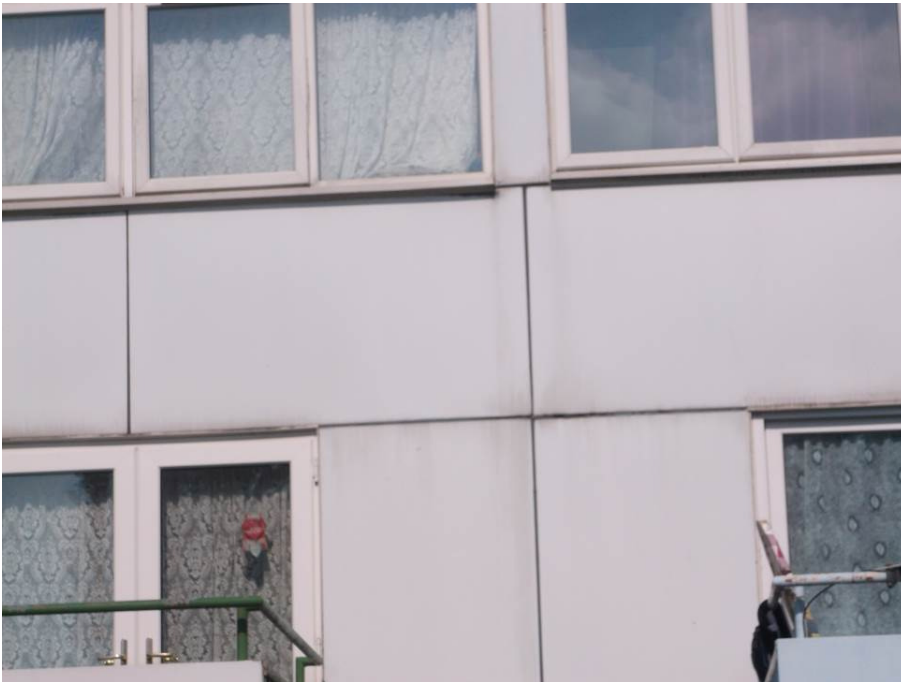
On the front and rear elevations there were signs of corrosion on the steel panels, particularly at the corners and also signs of failure of the mastic joints between the panels and the existing concrete. At this stage the jointing is satisfactory, but it is likely to have limited life.

Photograph 3 –Typical cladding to flats

It is recommended that the roof coverings, windows and the cladding are investigated further and a report prepared by a building surveyor to estimate how long these elements will last in serviceable condition. The report should be read in conjunction with structural report.

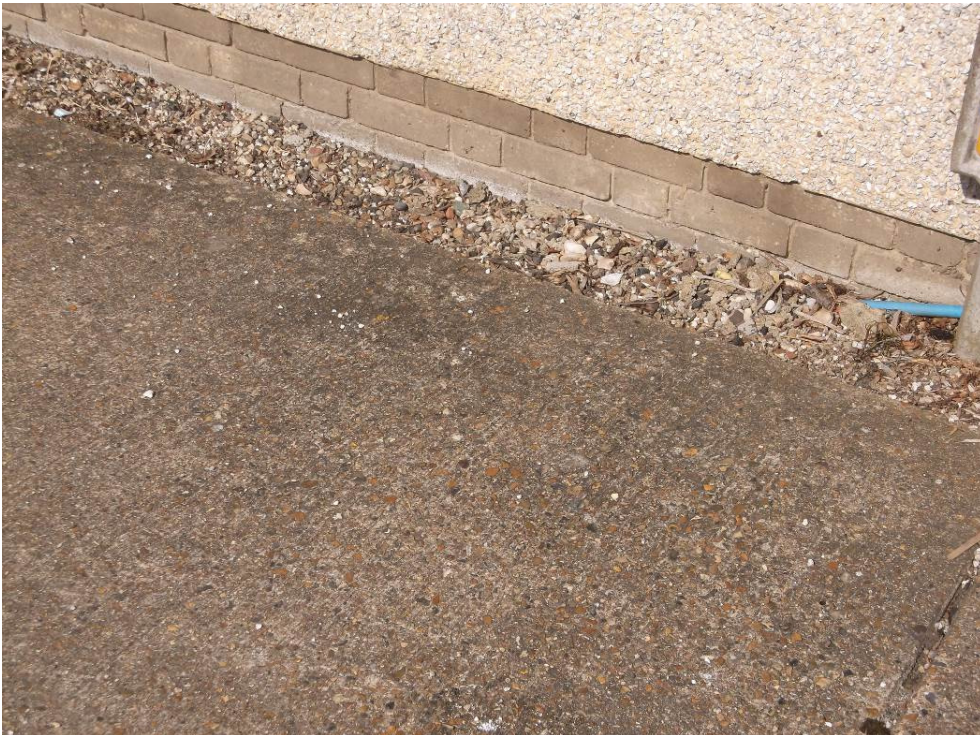
Photograph 4- Base of flank wall

Generally the pebble dash finish on the external walls is in good condition and there are no signs of any movement or cracking. The No Fines flank wall is supported on a brick plinth at ground level.

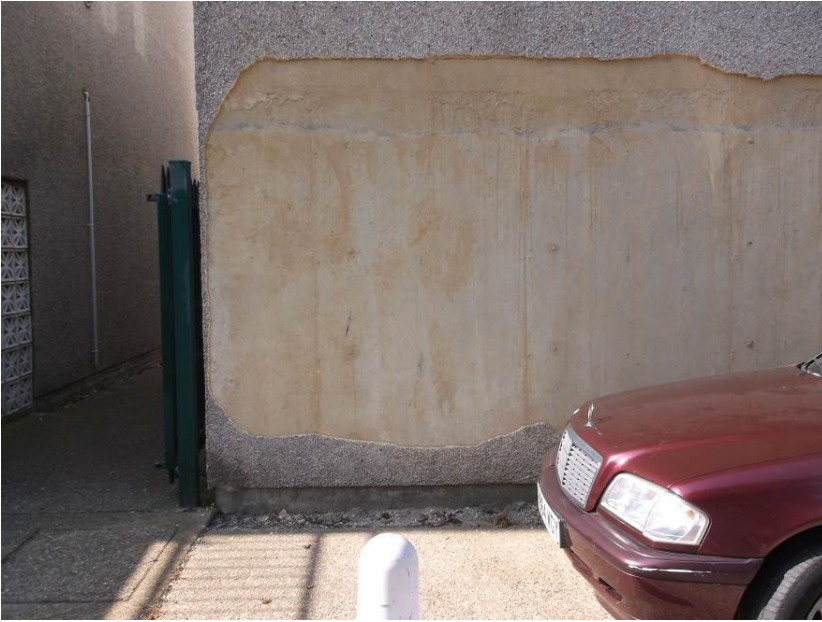
Photograph 7 – Flank wall render removed

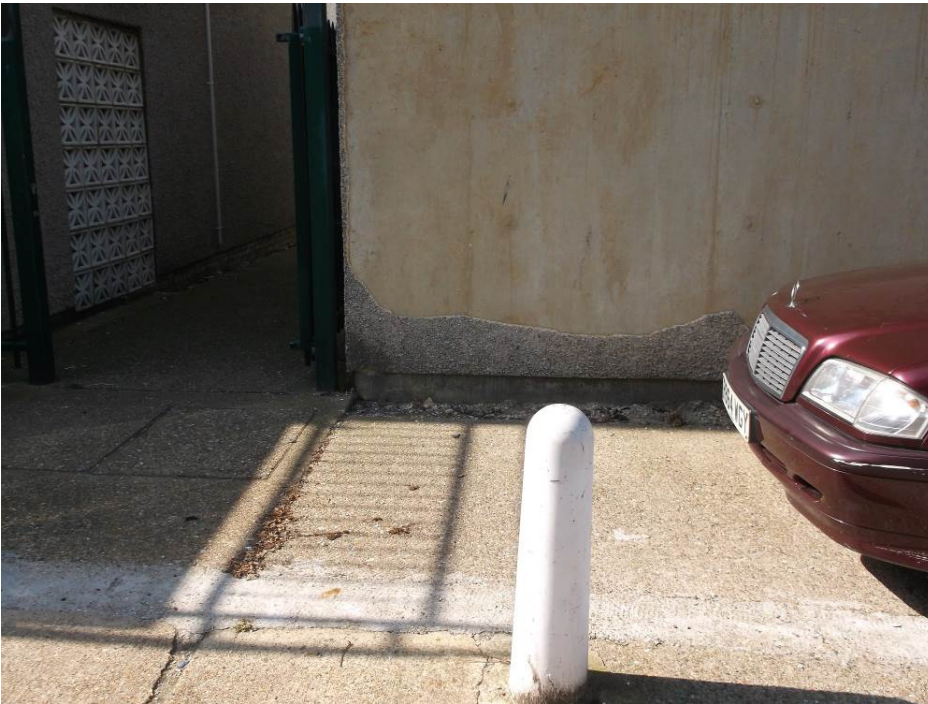
Photograph 8 – Flank wall render removed

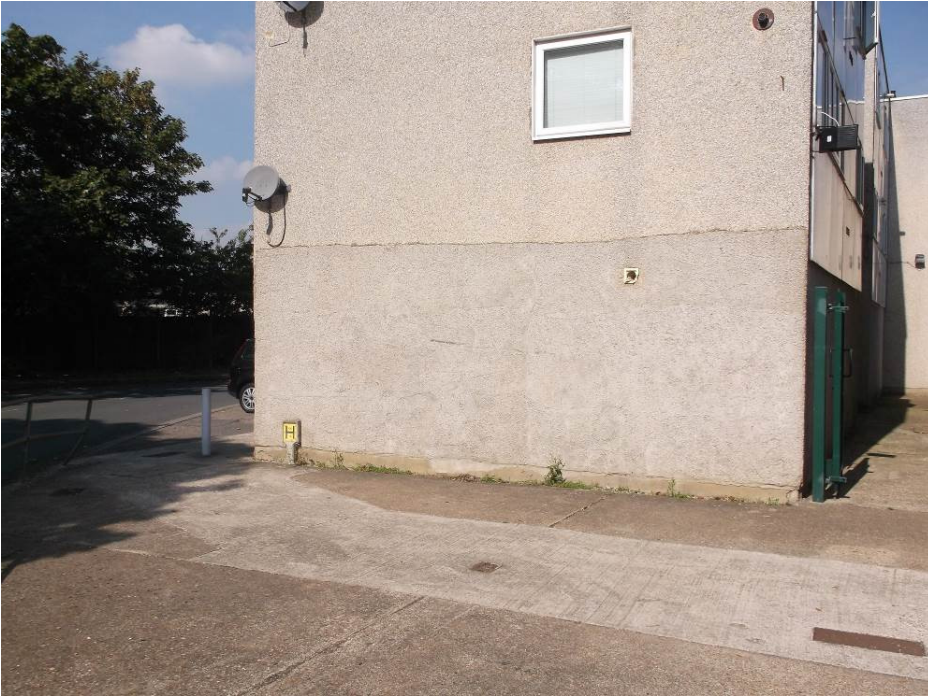
Photograph 9 – Flank wall rendered

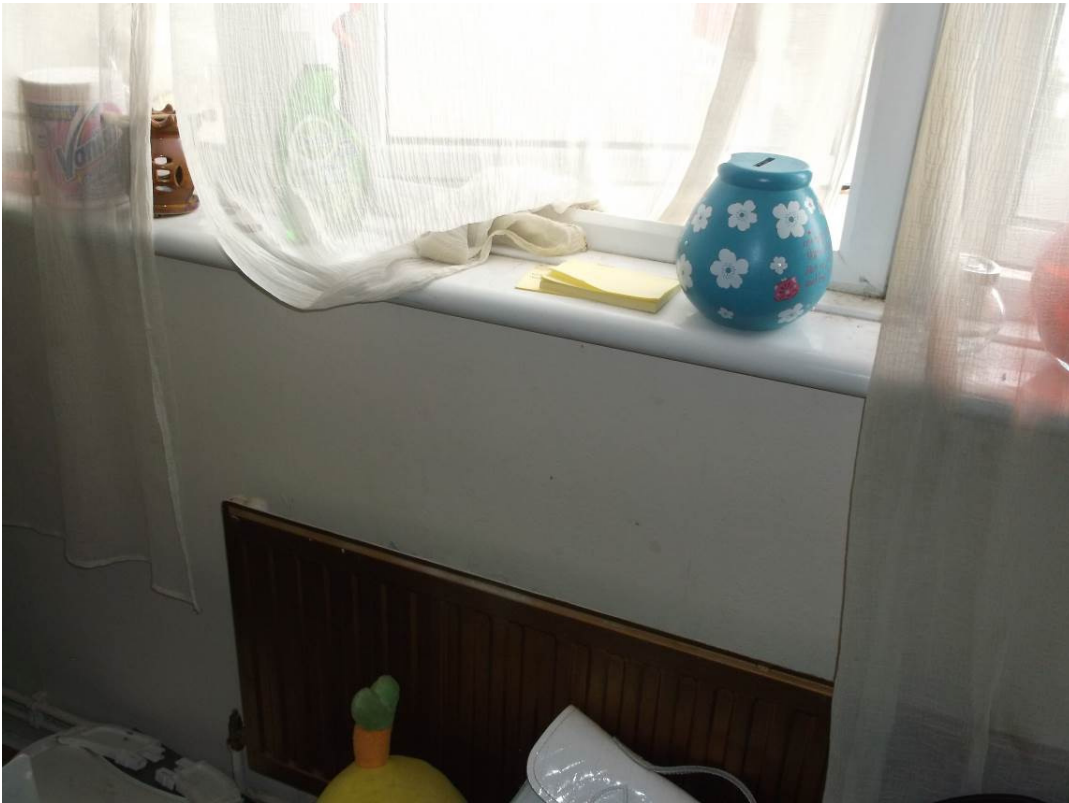
Similar comments apply to the flats as to the houses. There are more steel panels on these buildings than on the houses as they have been used at ground floor level below all the window cills.

The same comment applies on the mastic jointing which has limited life, as have the windows.

Photograph 11 – Typical panel below windows in flats

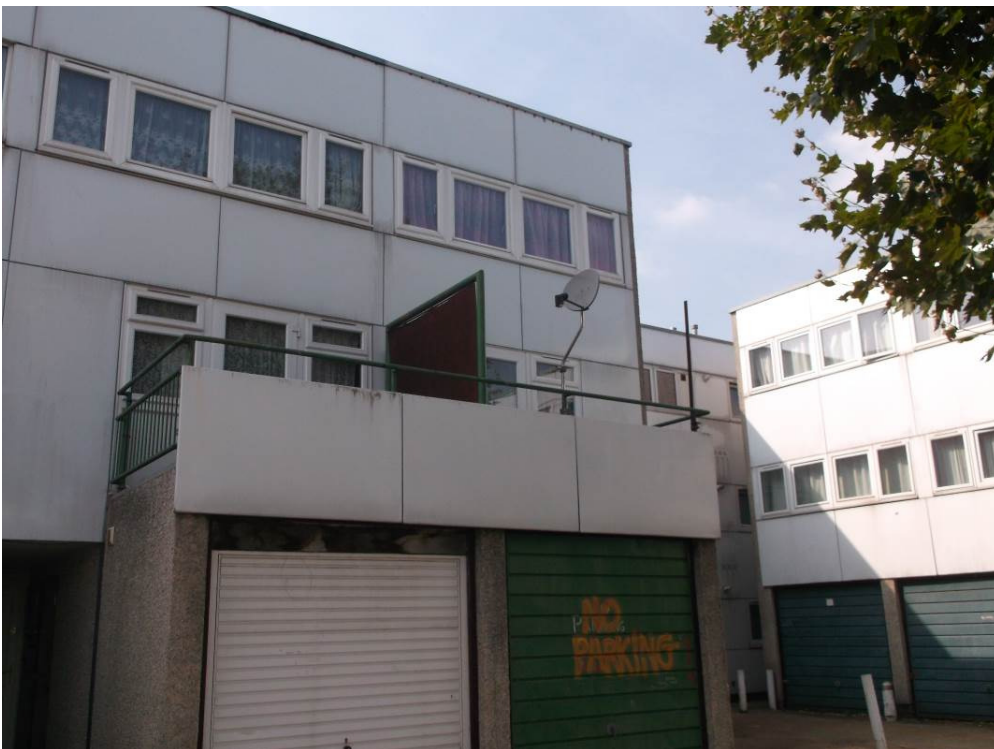
Photograph 12 – Front elevation 18 Paines Close

On the front and rear elevation the windows have been replaced plus there are enamelled steel panels below the window.. There is some rust staining on the tops of the panels at first floor level and some deterioration of the mastic between the panels. – Refer to the photographs.

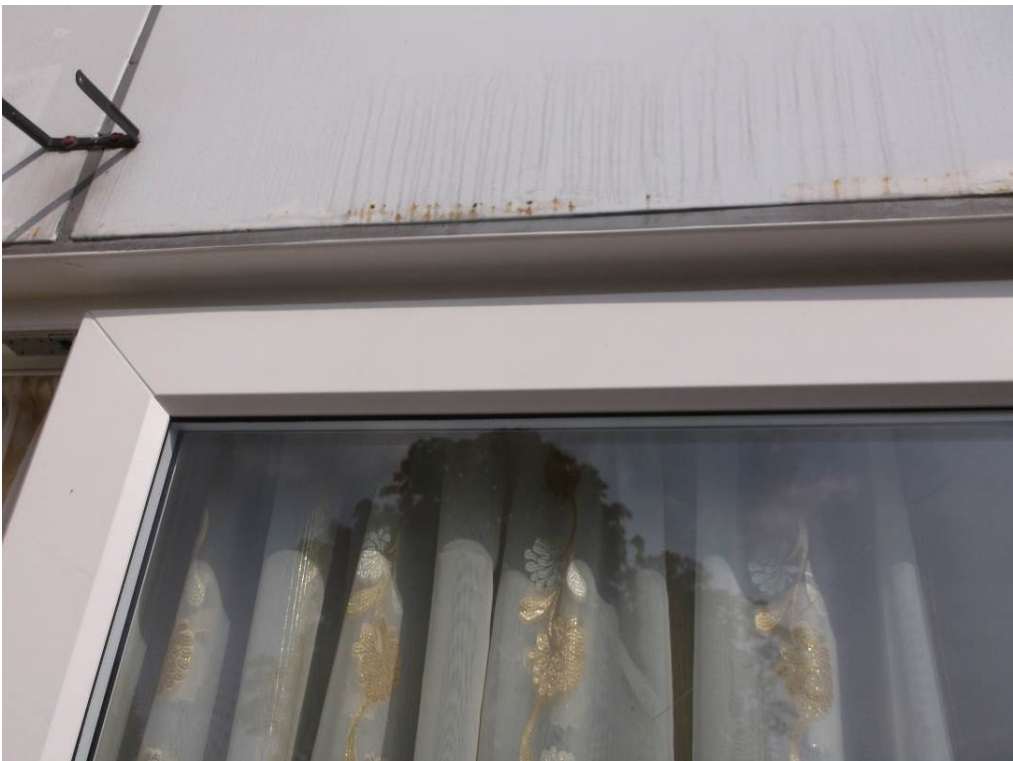
Photograph 14 – 18 Paines Close – Cladding and windows at rear
