Thermographic Survey Report

To Investigate
The 'Continuity of Insulation'

At
Eastfield Estate
Mitcham
Greater London
CR4 1BX

Survey Date: 05/11/14
Project No: 15081

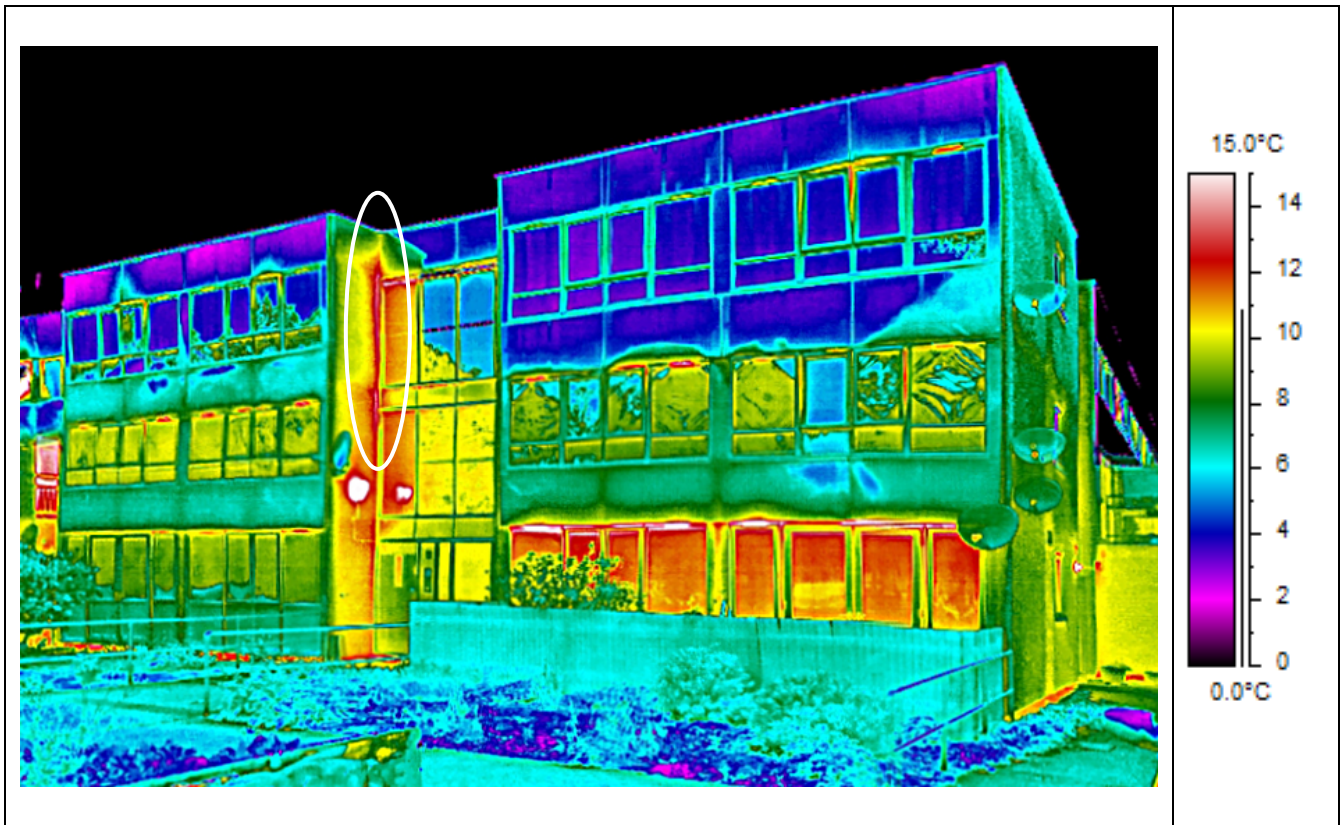
57 – 62 Clay Avenue – South Elevation

The striking change in the above image is the 2nd floor that generally appears to be 4°C and below. Logically this cannot be real and is in fact the result of reflection from the night sky. However this will not stop anomalies from being detected such as the heat loss from around some 2nd floor windows. The main anomaly is circled white and similar examples will be discussed later.

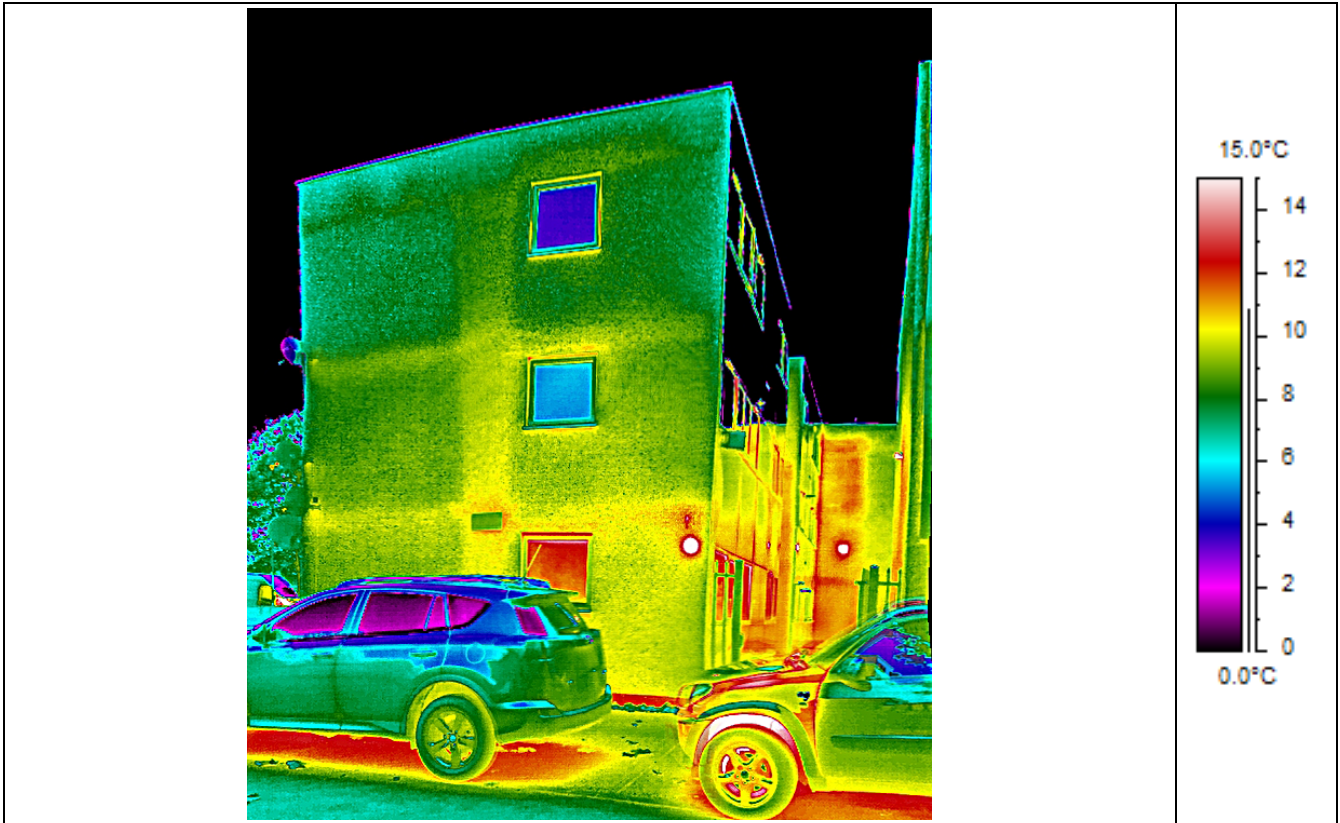
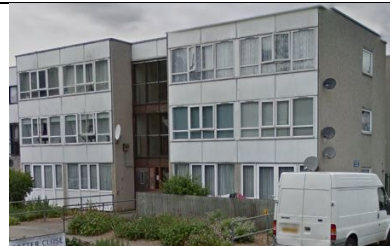
57 – 62 Clay Avenue – North East Corner

The general impression of cooling from ground to 2nd floor will be influenced from the sky and possibly buildings behind the camera. Also, without knowing the exact internal conditions only a guess can be made. However, the vertical and horizontal yellowish lines at each floor level suggest there is some thermal bridging from each floor slab.

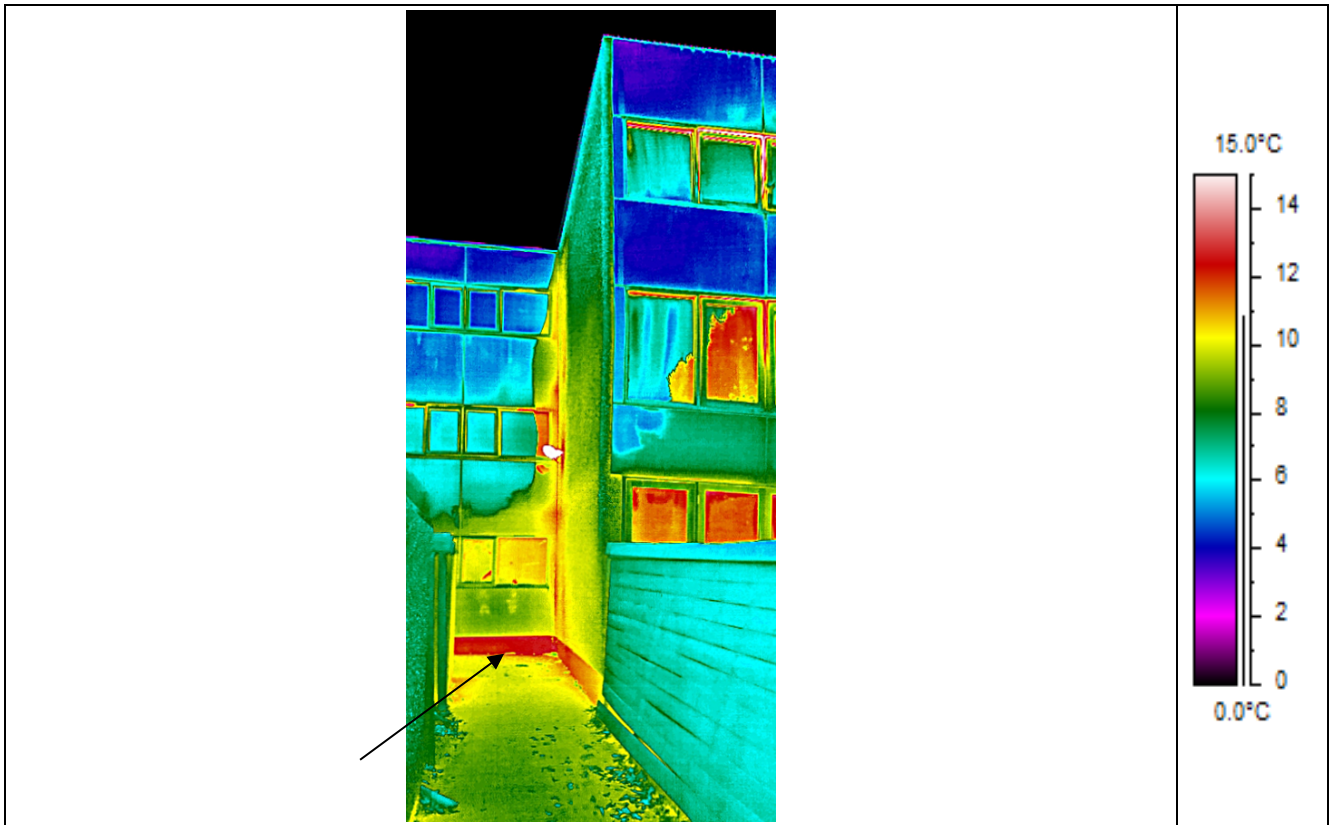
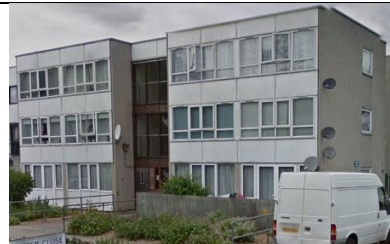
57 – 62 Clay Avenue – North East Join

The black arrow highlights a potential weak area. Firstly, it could be below the DPC in which case it is naturally damper than the elevation. Thus, it may have retained more heat from a raised capacitance. Alternatively, there could be a thermal bridge through the floor slab which may lead to a significant heat loss. Further investigation on the internal walls may help confirm the matter.

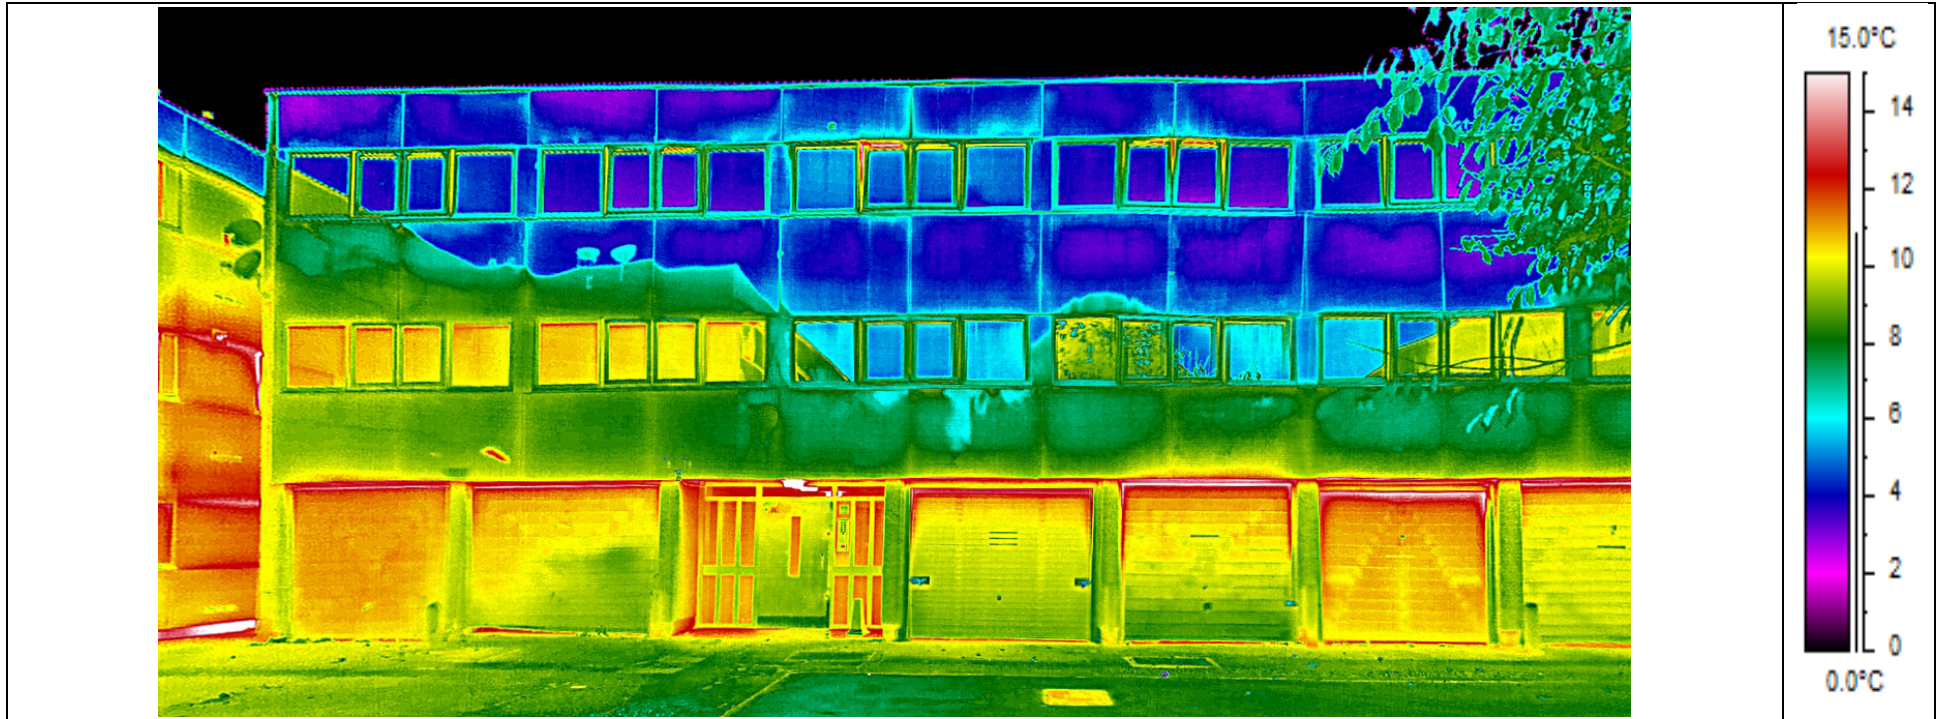
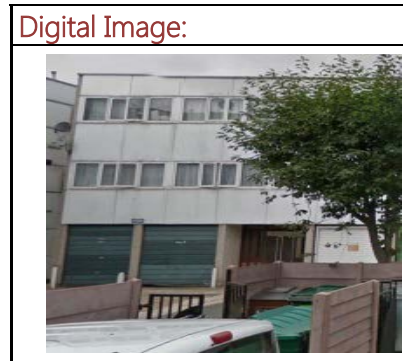
13- 32 Potter Close – South Elevation – Left Side

It is almost possible to define the reflected skyline in this image. Despite this, some marginally weaker areas to the elevation can be detected along with slightly open windows or windows with a poor seal.

However, the main point of concern are the garages. It is presumed they are unheated spaces and outside the thermal envelope and therefore should not generate any heat. This should be investigated further.

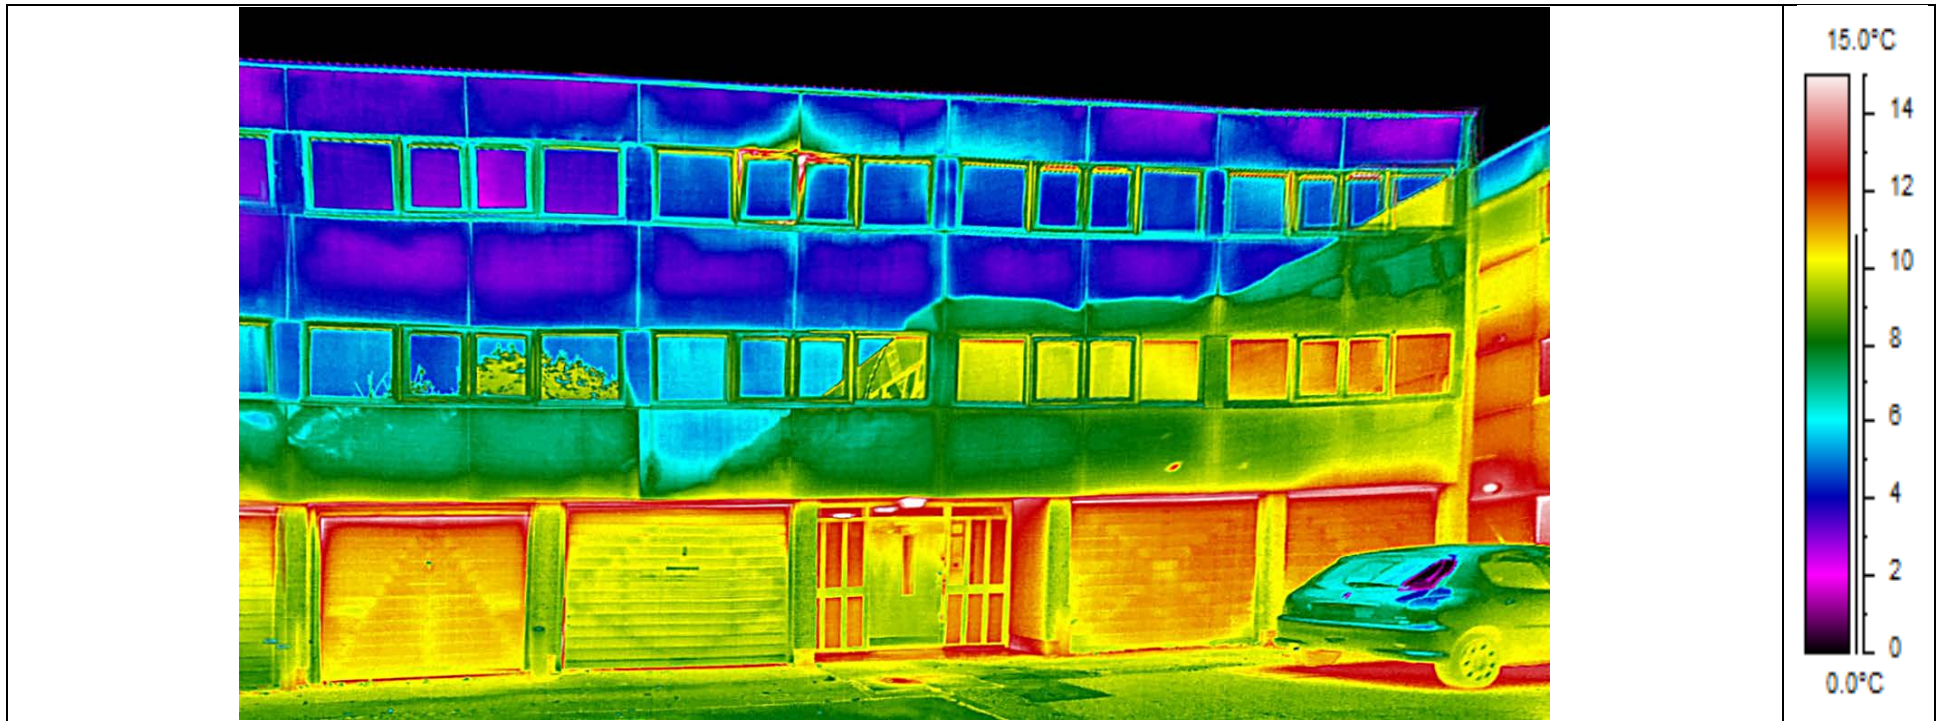
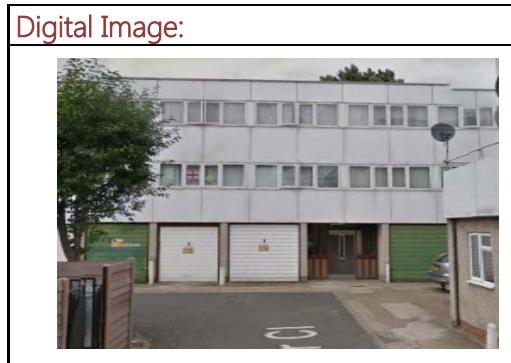
13 – 32 Potter Close – South Elevation – Right Side

Window on top floor is open and can be ignored.
 In addition to the garages discussed before, the main entrance appears to be thermally weak. The door and glazing should be checked for thermal integrity together with all seals.

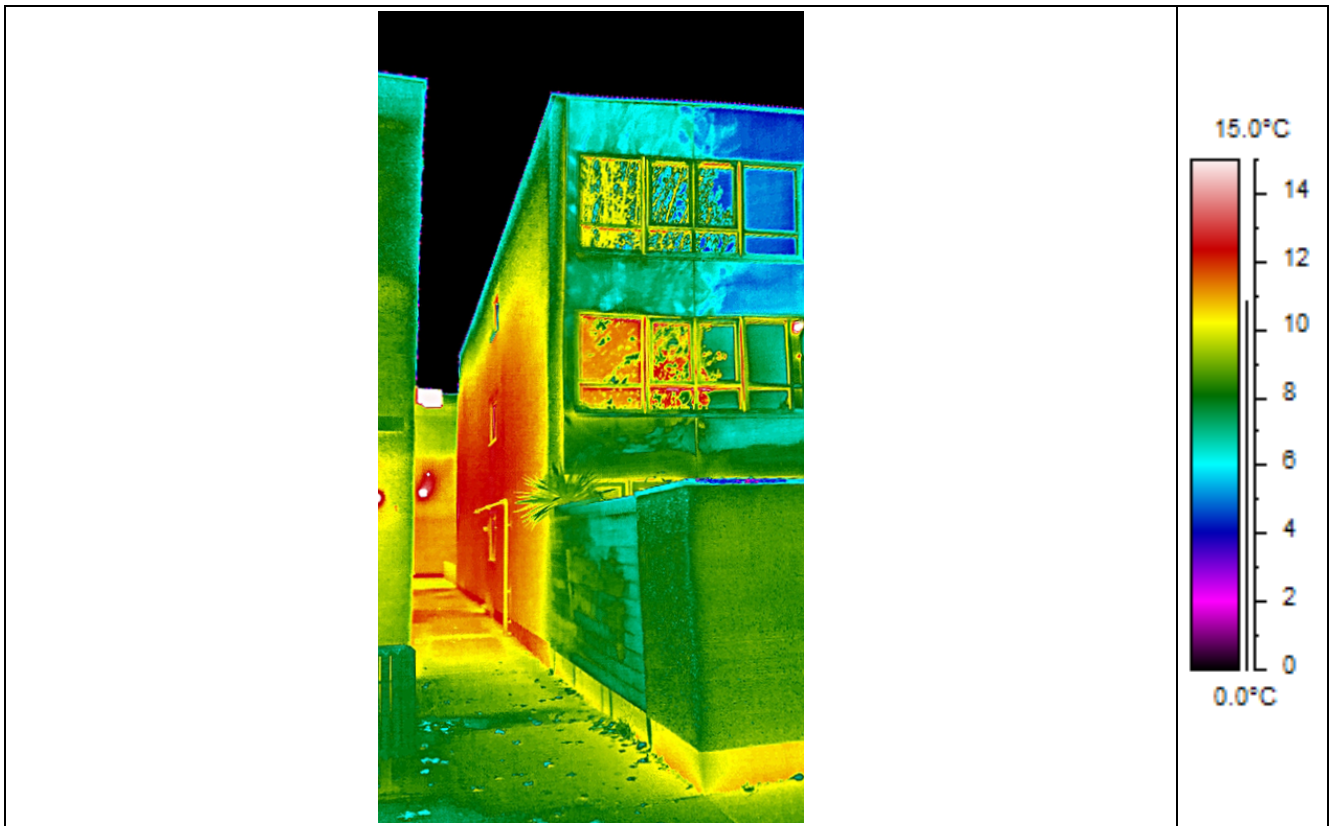
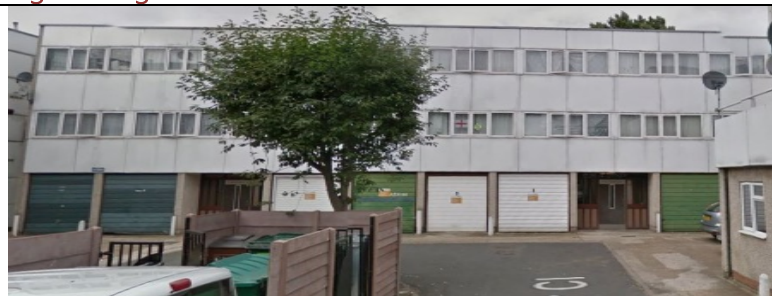
13 – 32 Potter Close – North East Corner

It is suspected that the side elevation is generally protected by the close proximity of the adjacent building thus leading to a build-up of heat. Again, an internal survey of this particular outside wall could be compared with other walls in the room to confirm if there is significant heat loss from the elevation.

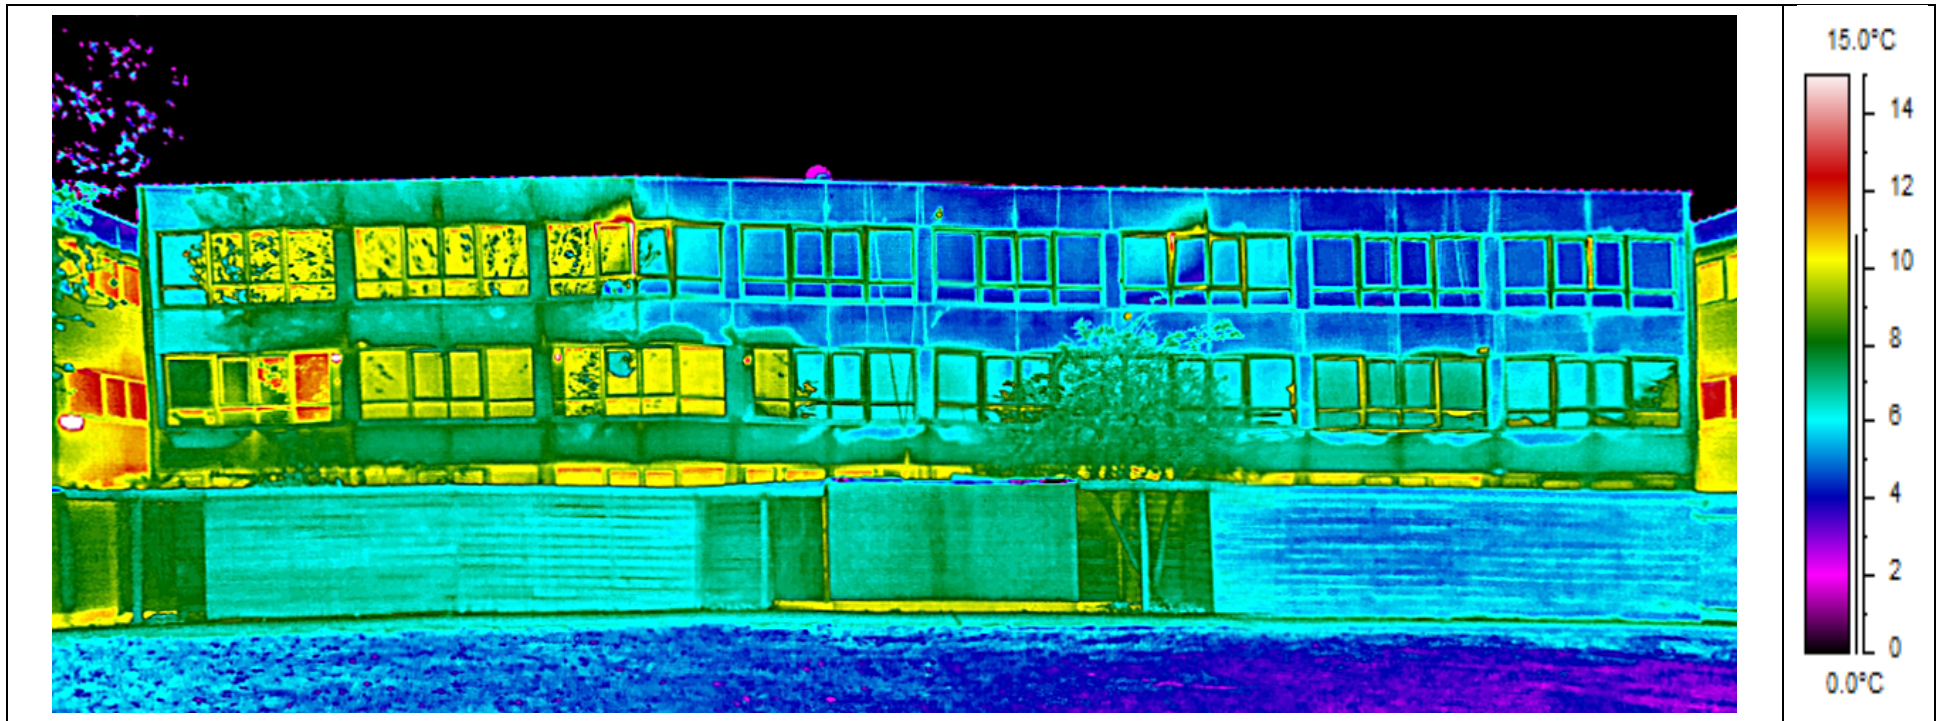
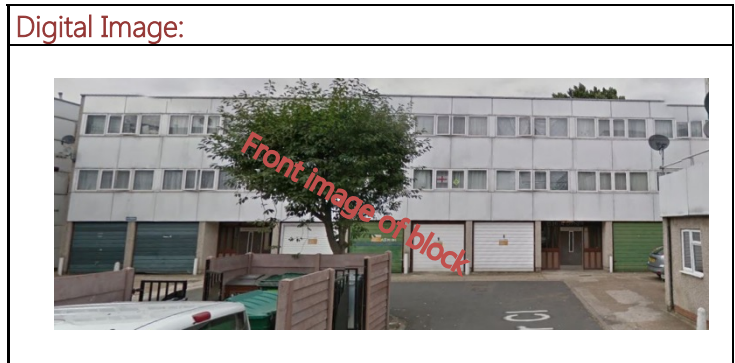
13 – 32 Potter Close – North Elevation

Windows on top floor open.
 The colour variegation to the 1st and 2nd floors are mainly due to reflection and can be ignored.

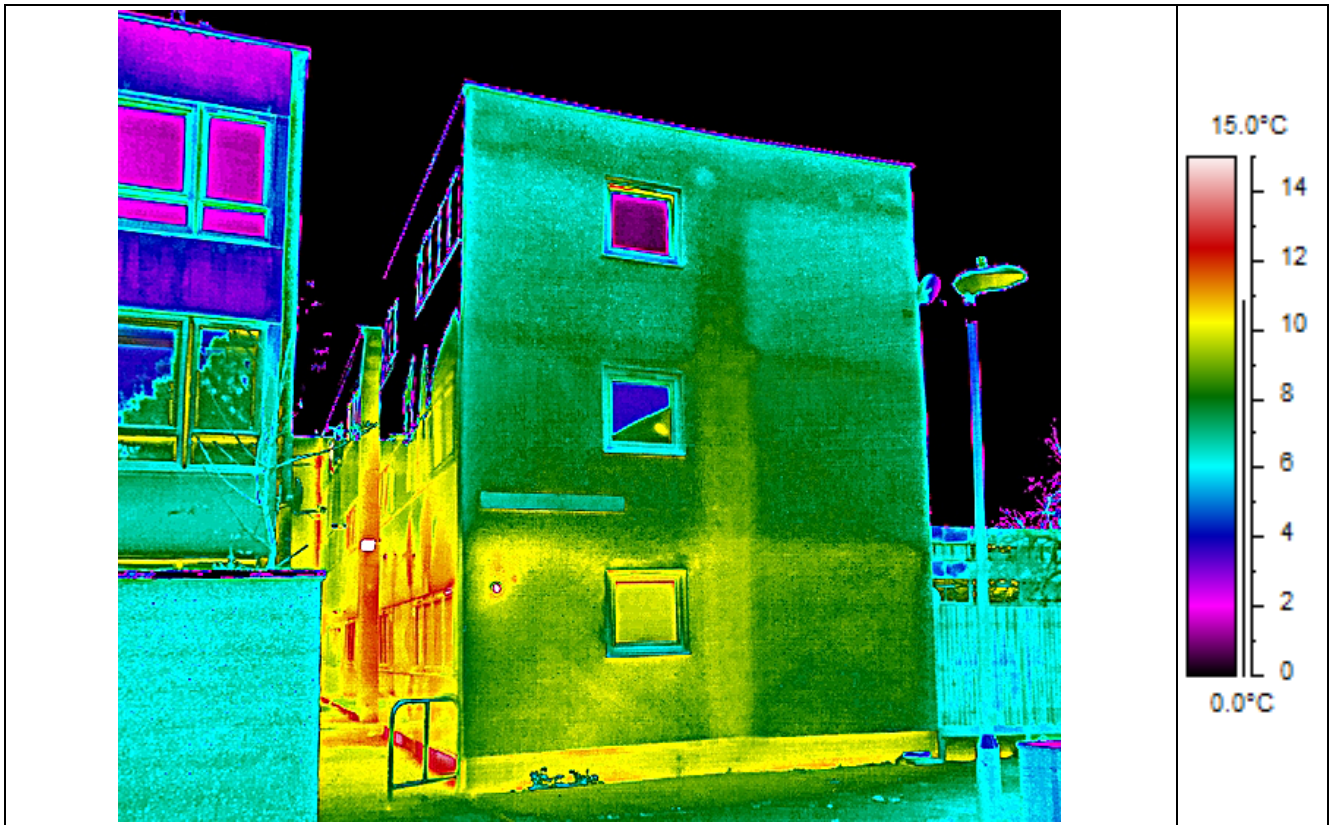
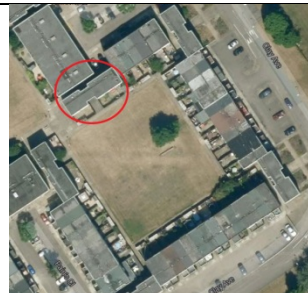
7-12 Thrupp Close – North West Corner

Some evidence of thermal bridging on the end wall.

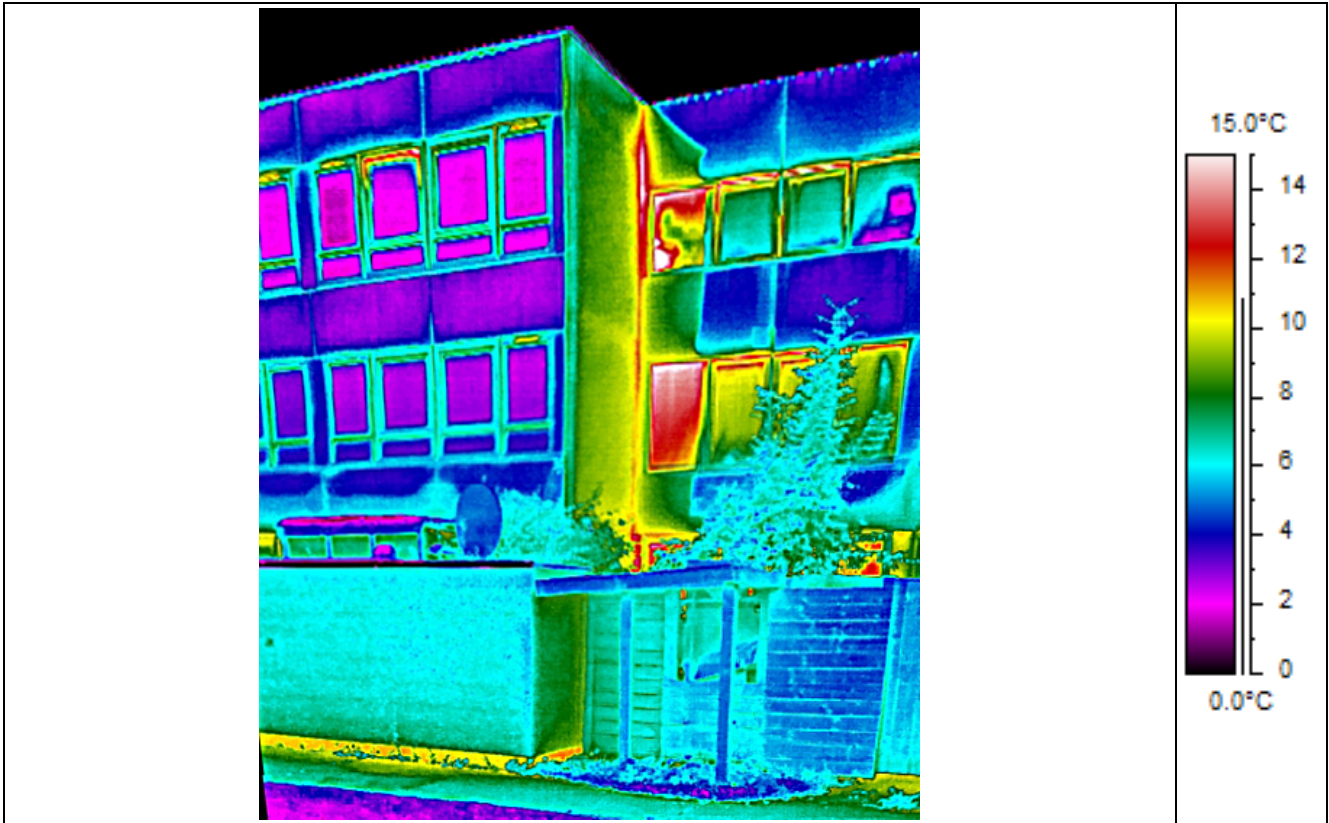
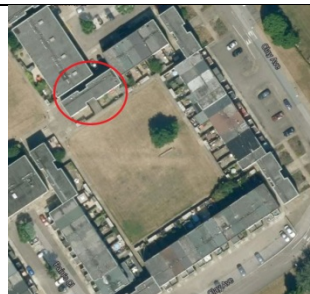
7-12 Thrupp Close – South East Join

There is a significant anomaly at the internal corner on the 2nd floor. From the temperature it could be either air leakage or more probably missing / poor insulation. It is more than just the detail design, because the problem appears centred in just one area.

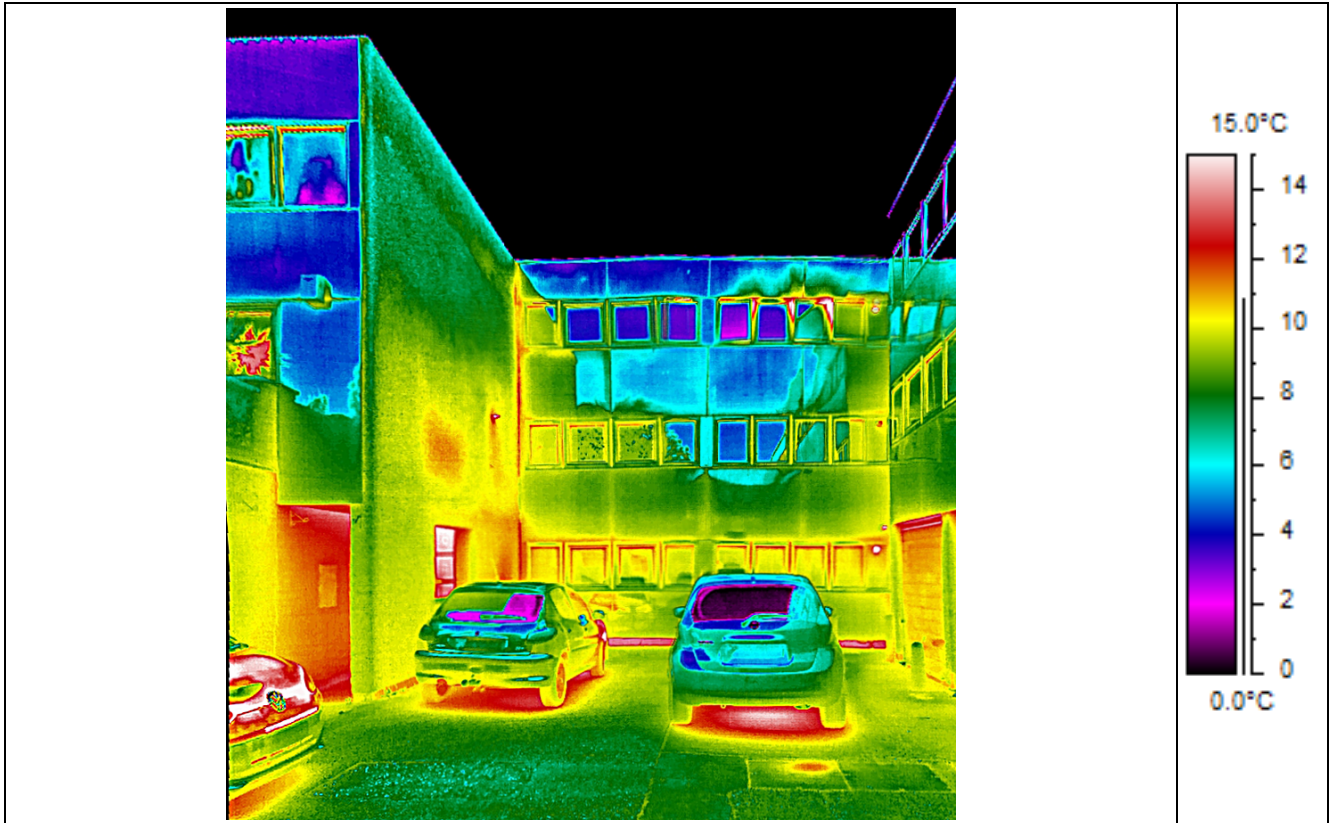
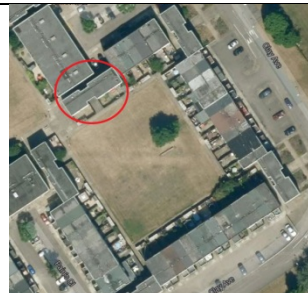
7-12 Thrupp Close – North East Join

Open Windows

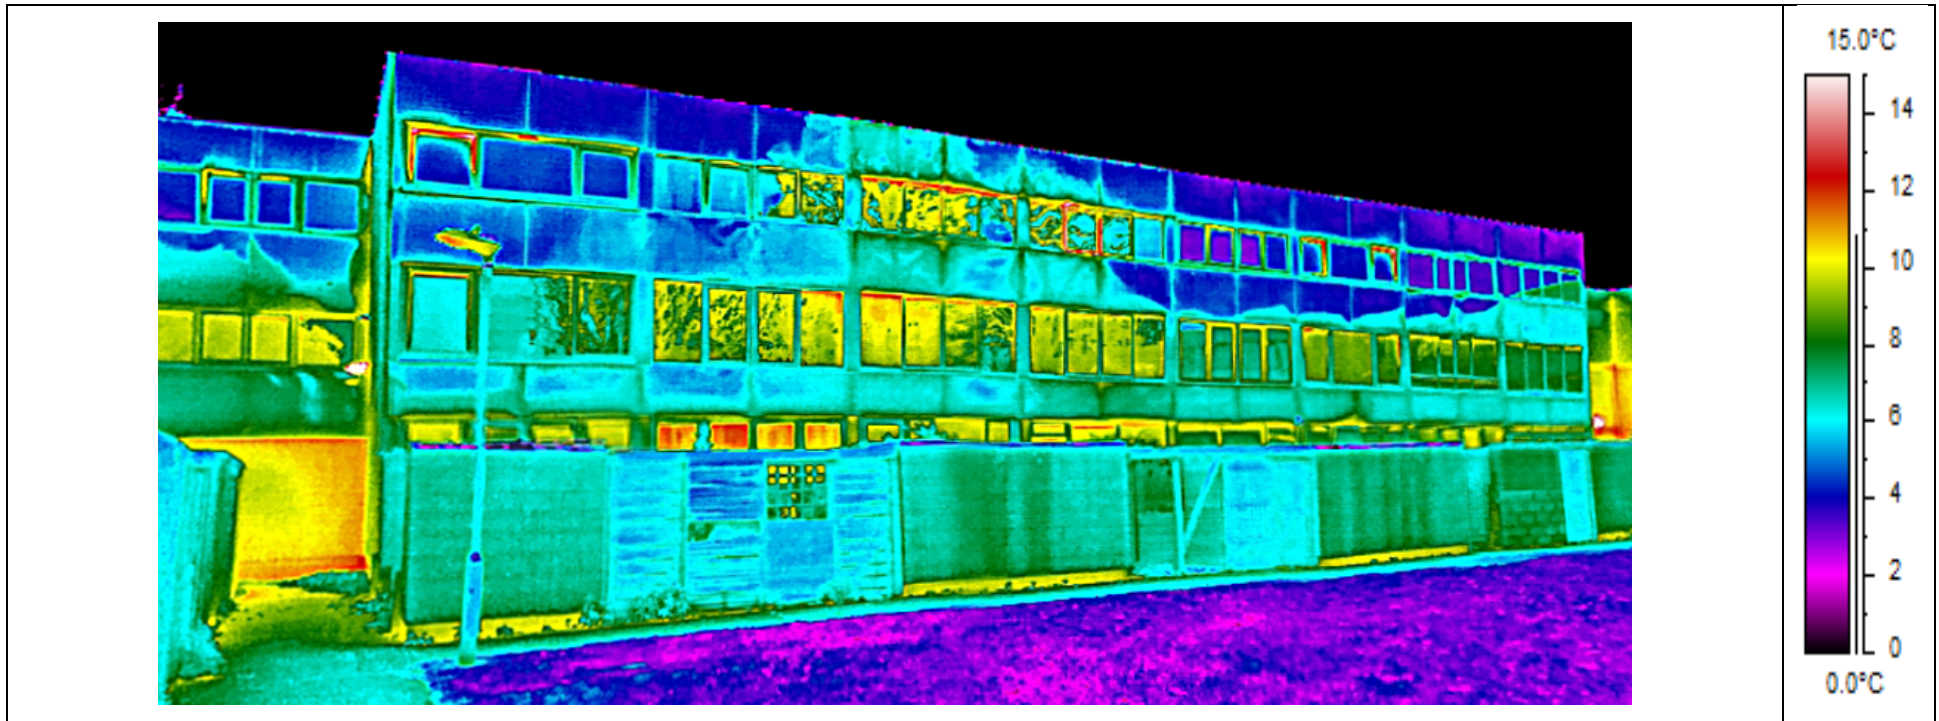
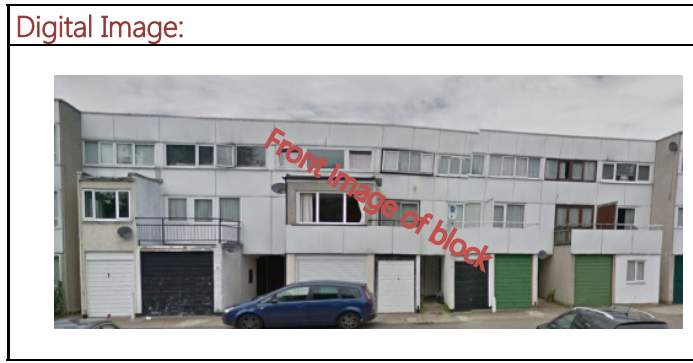
1-8 Pains Close – North Elevation

Some open or windows with poor seals.

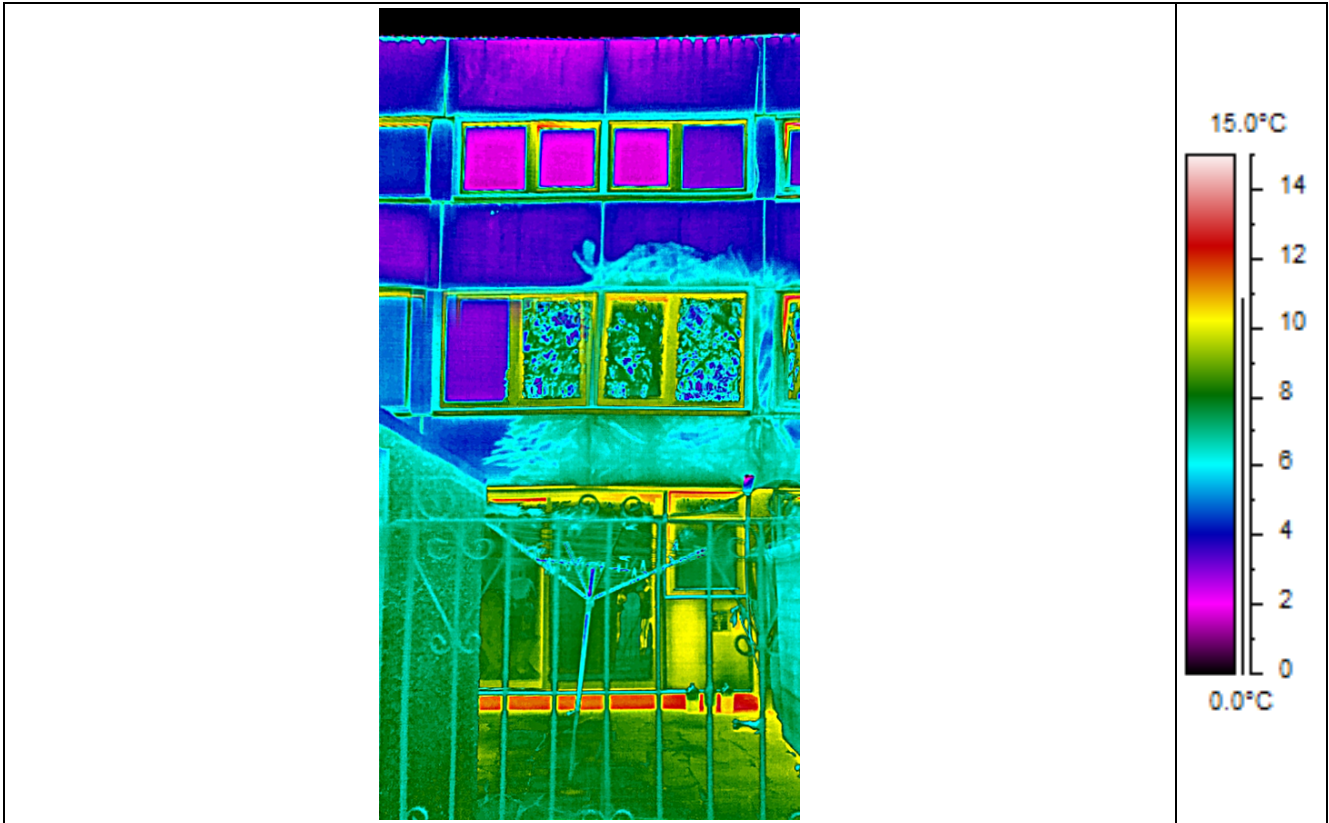
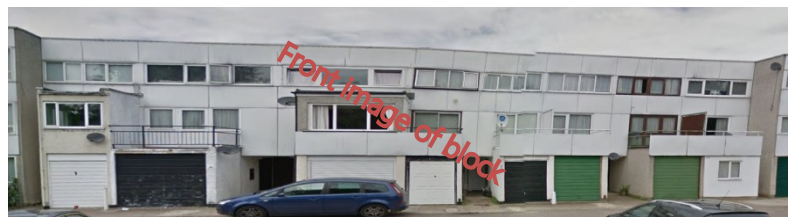
1-8 Pains Close – North Elevation – No. 4 Close Up

This image is fairly representative of how the ground floor elevation appears on this block.

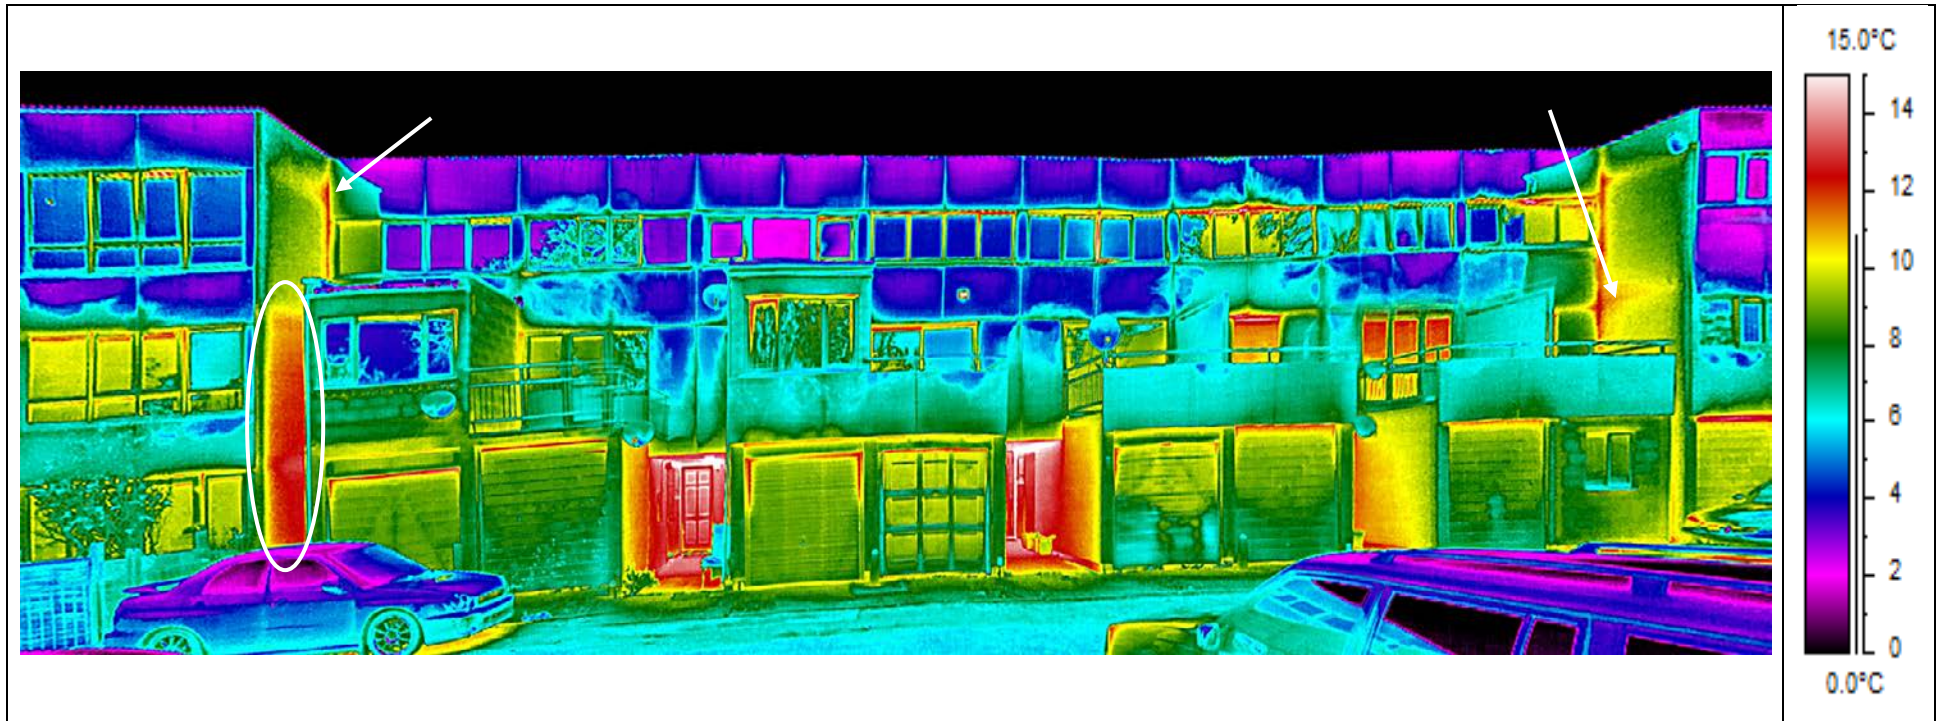
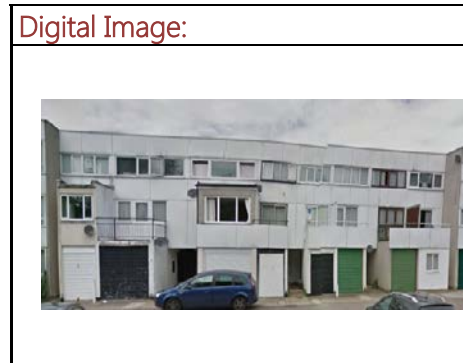
1-8 Pains Close – South Elevation

Both of these visible doorways appear to show significant heat loss over the expected level for a protected area. The white arrows indicate further similar examples of thermal bridging. The red area highlighted by the white circle should be investigated further as the main heat loss appears to have definite constraints at the 2nd floor level.

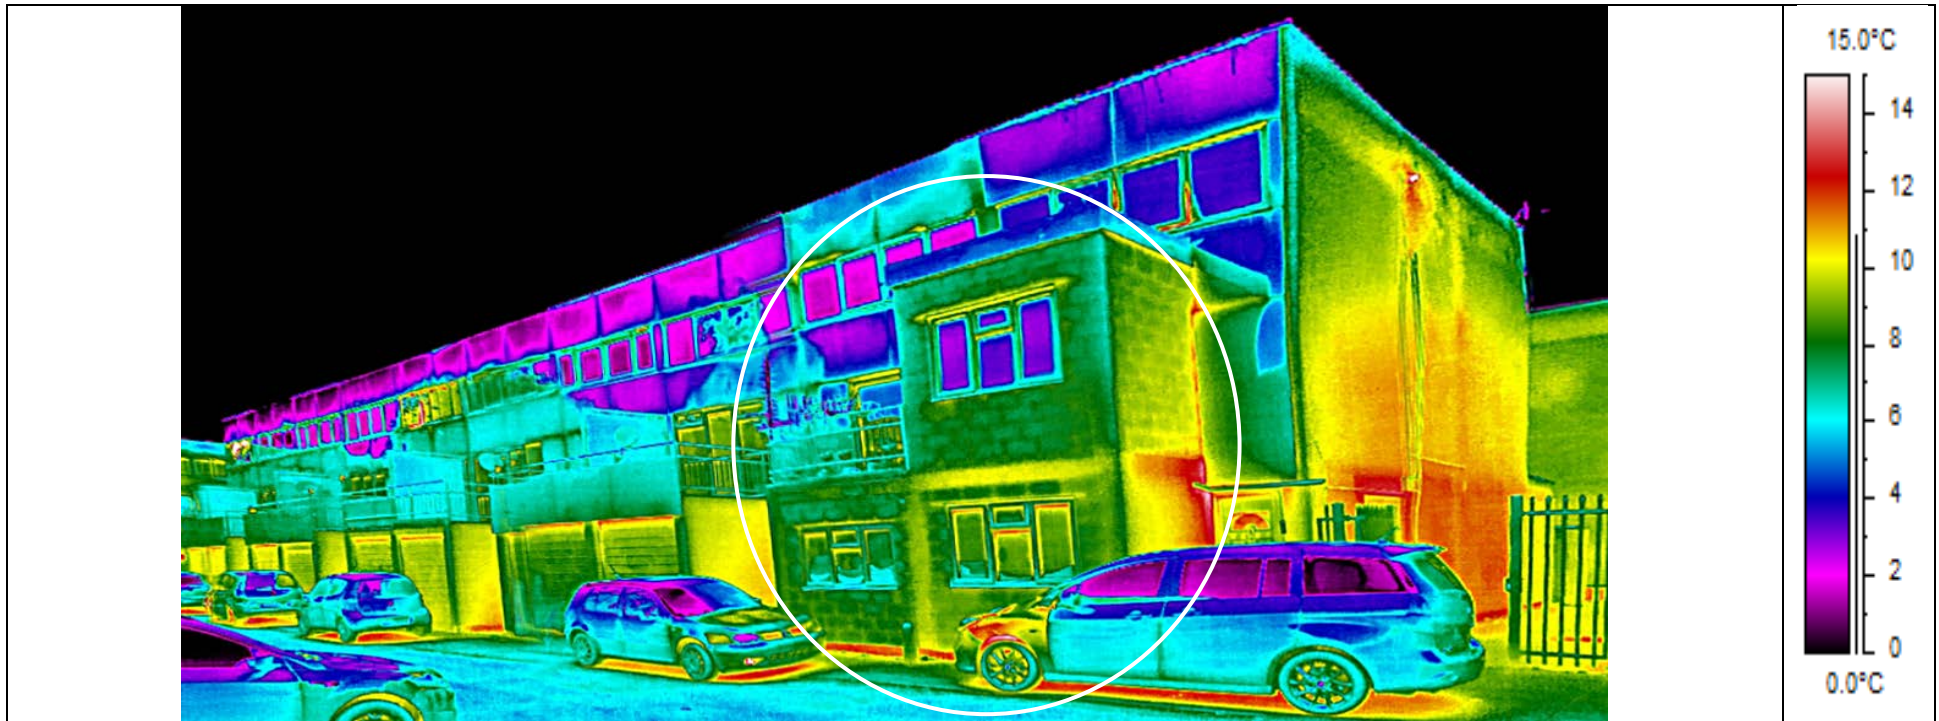
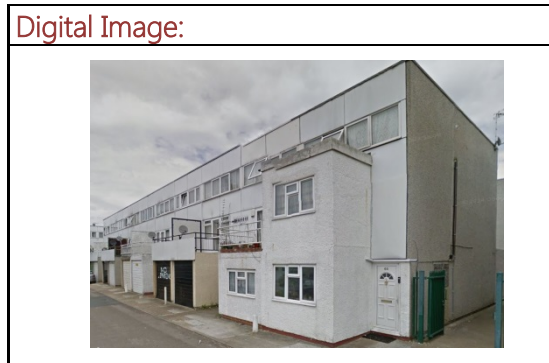
51-60 Pains Close – West Elevation - South End

The two Panels on top floor looked different visually and may have been replaced at some point. Otherwise, the garage conversions and 1st floor addition contained within the white circle show thermal bridging along the window lintels, along the ground and 1st floor slabs, together with a general weakness defined by clearly visible mortar lines around the blockwork.

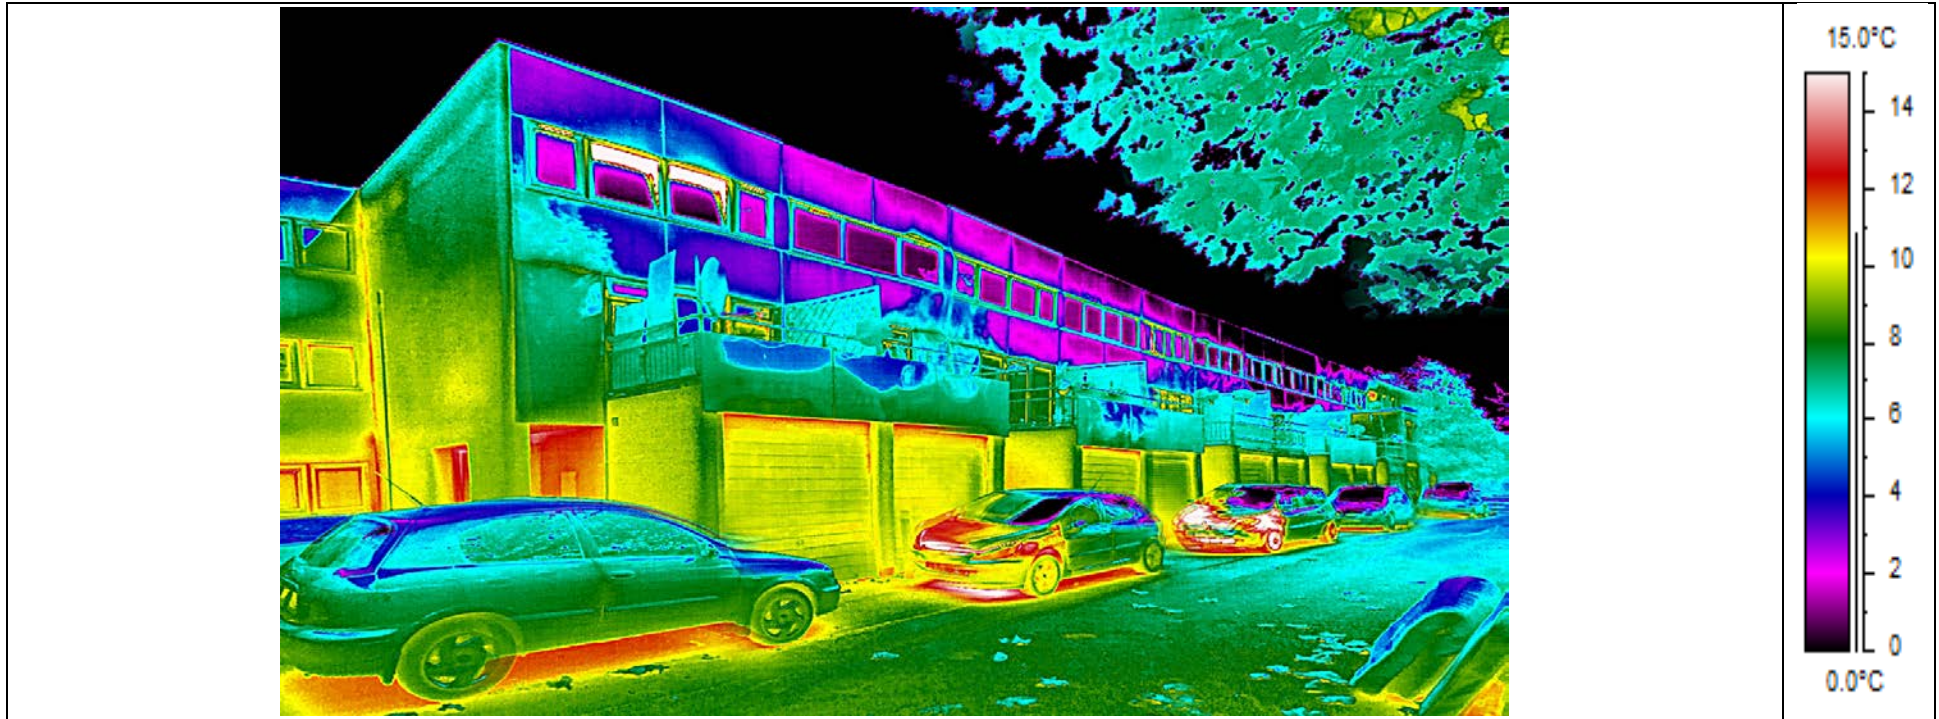
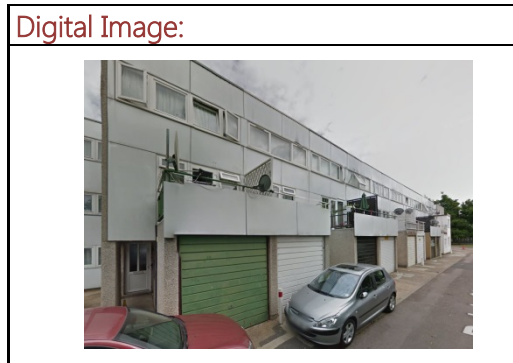
51-60 Pains Close – West Elevation – North End

Open windows on top floor.
No further comment.
