Structural Assessment Report of Orlit Houses  
Revision A  
Ravensbury Estate Regeneration  
For HTA Design LLP

Scheme No: 11264

6<sup>th</sup> November 2014

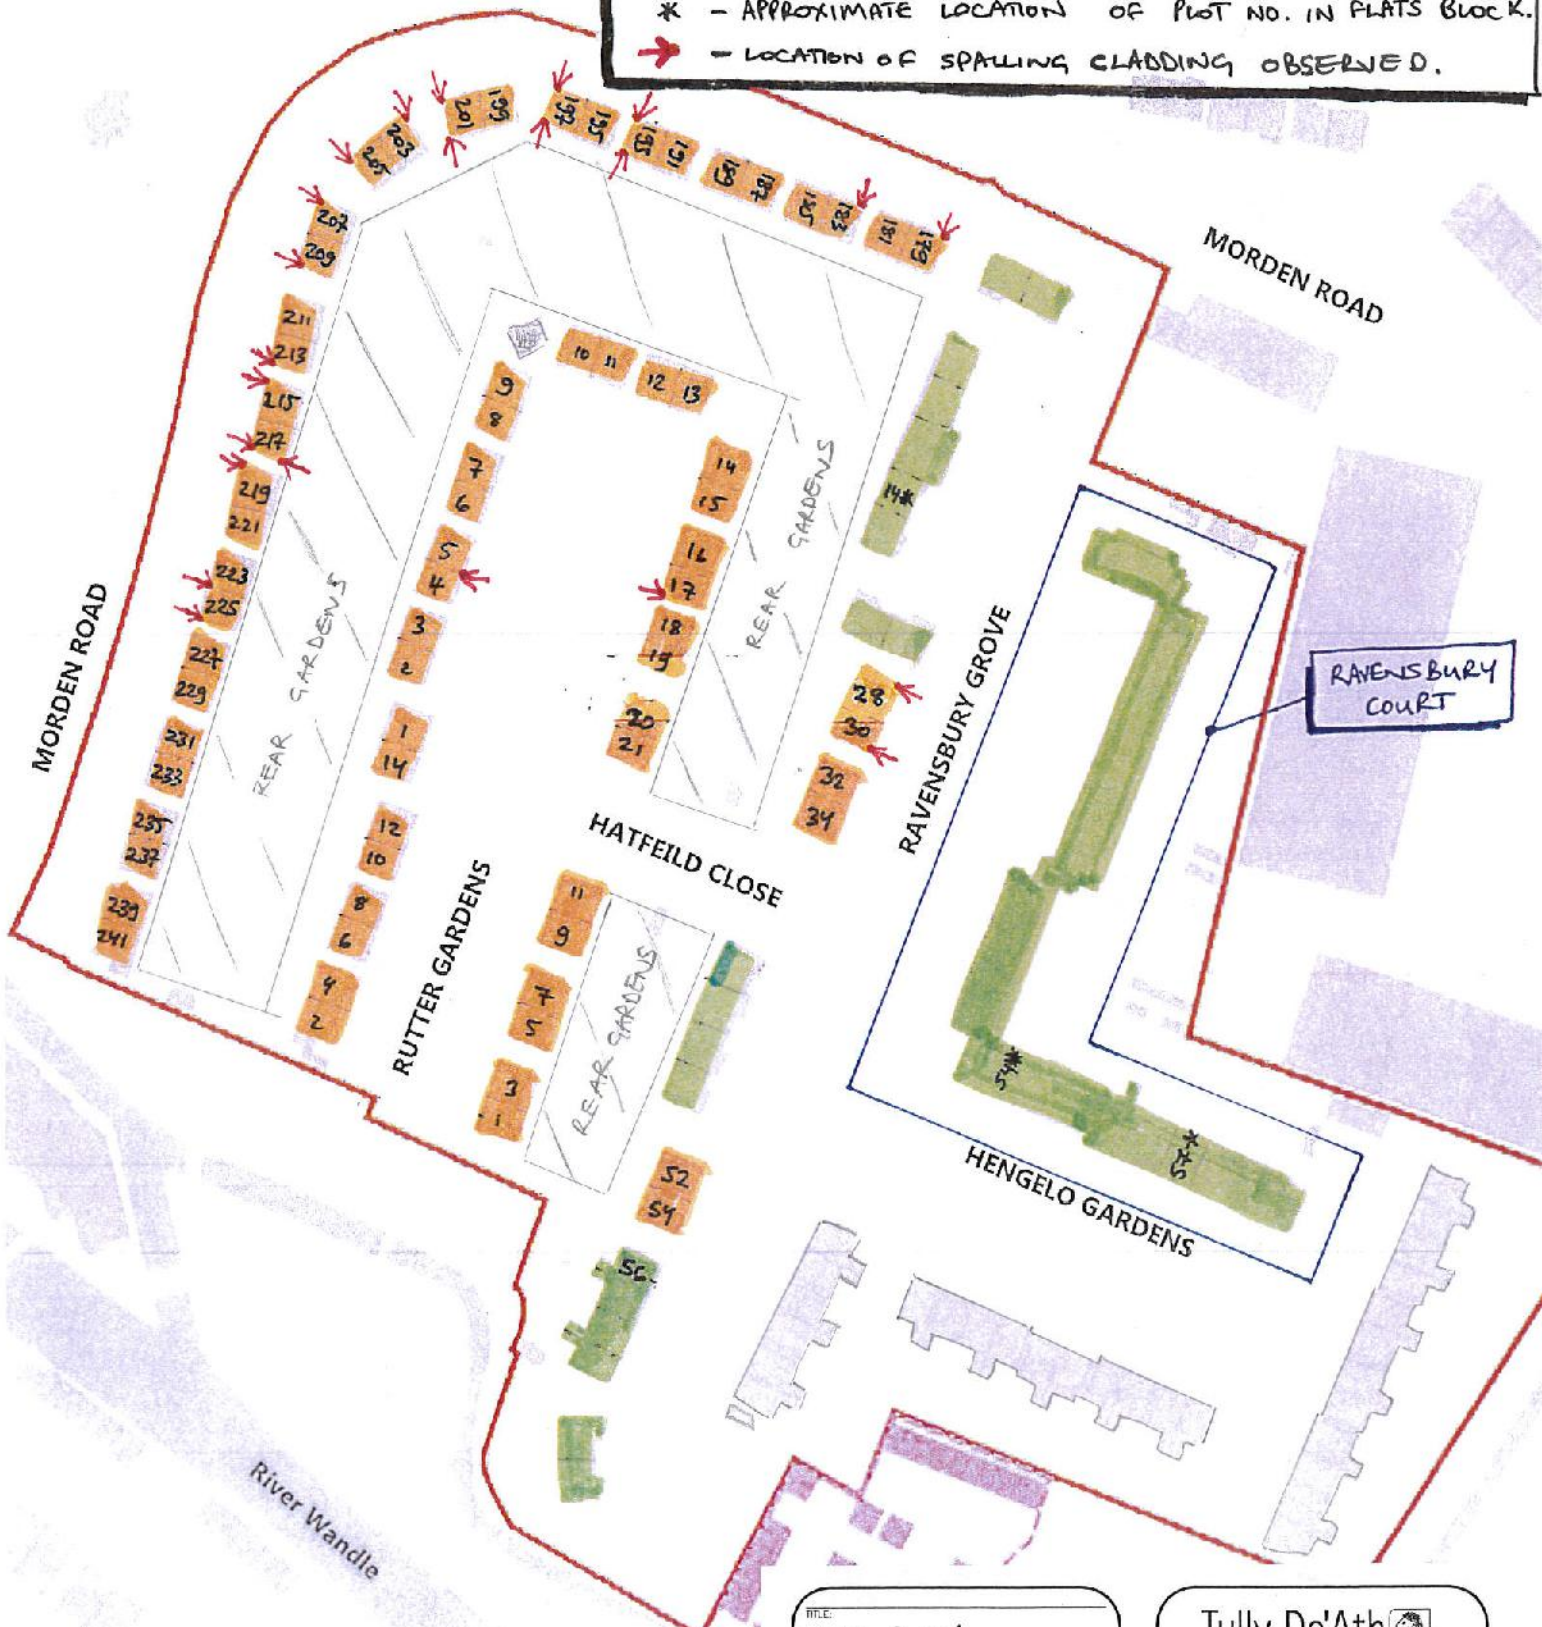
- iii. These damaged areas of cladding on the corners and by the party walls tend to be more prevalent on the north and northwest facing elevations. Sketch number 11264/SK01 indicates the locations where spalling was observed.

- LOCATION OF SPALLING CLADDING OBSERVED.

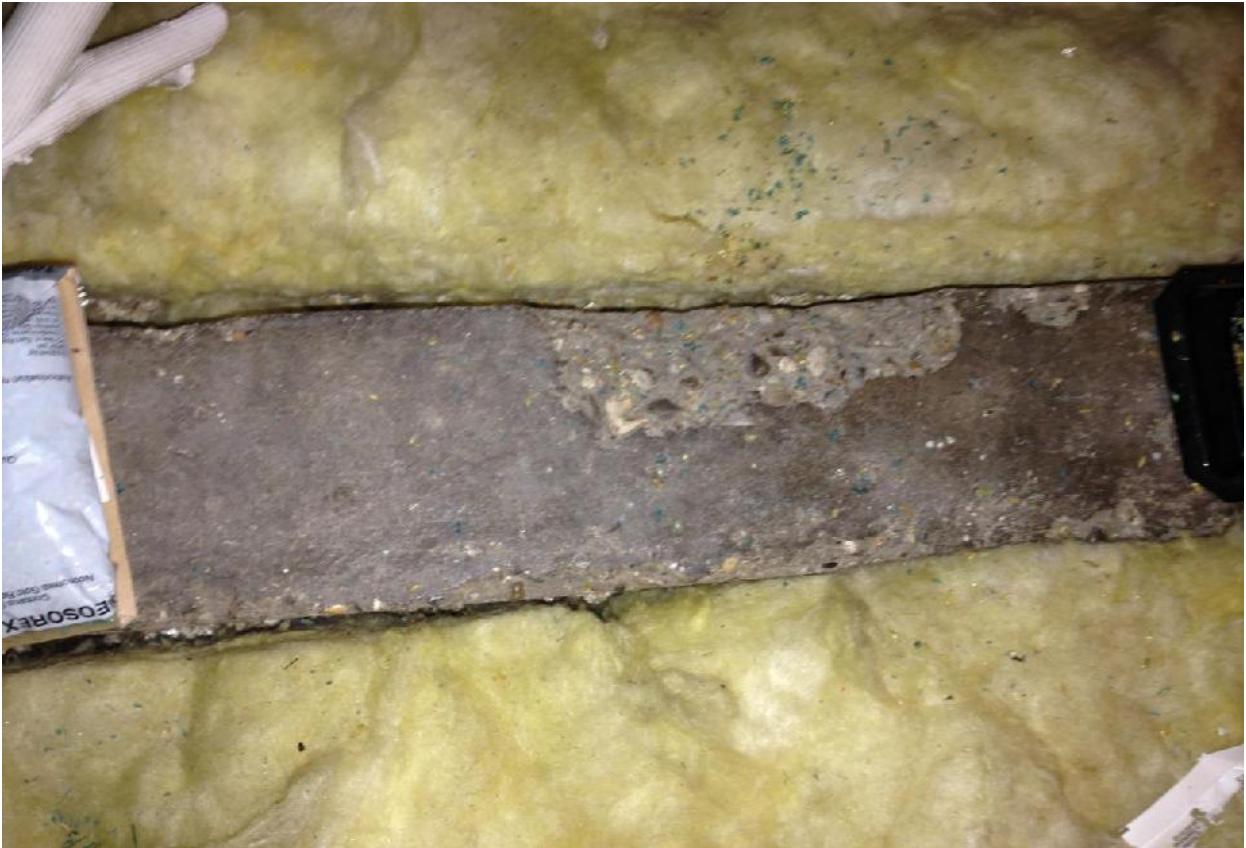
**Photograph C3 – Damage to secondary beam**

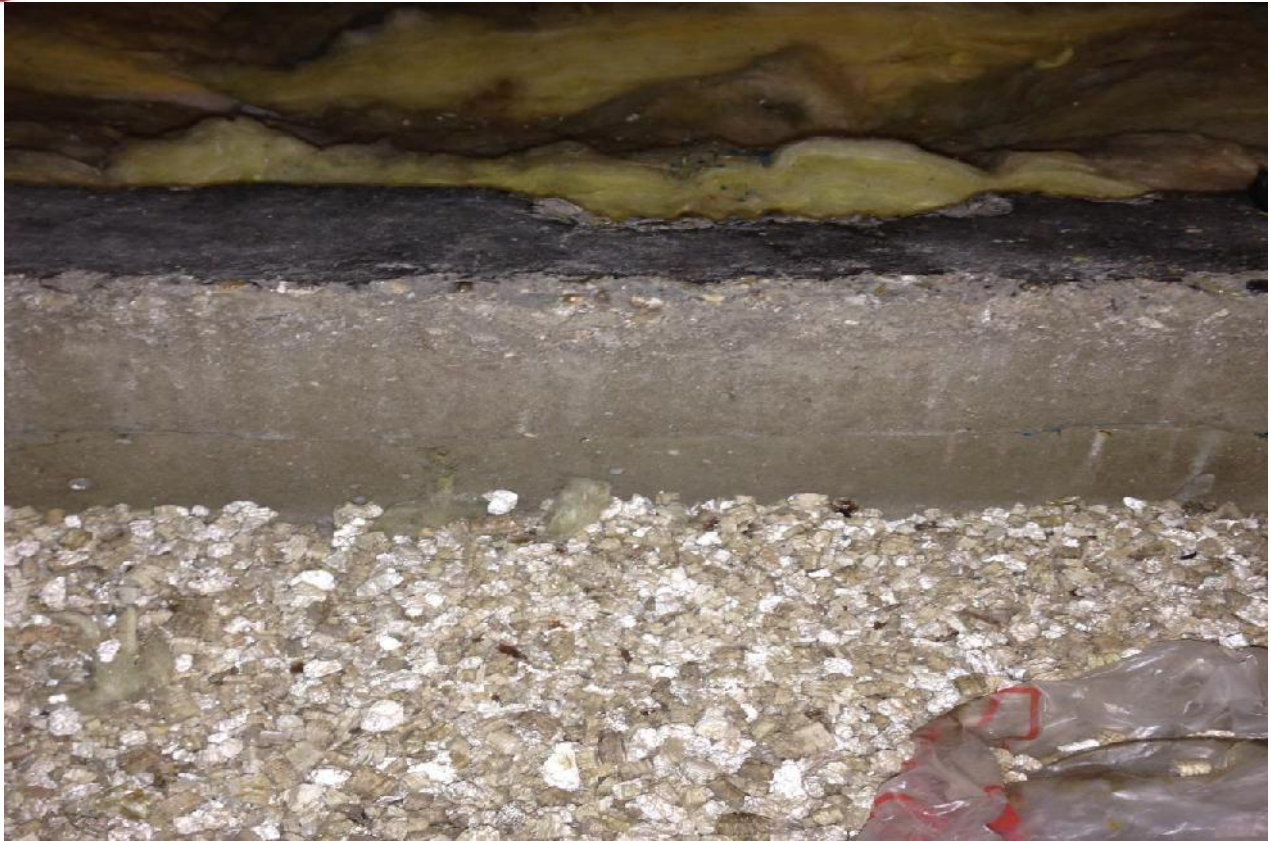
**Photograph C7 - Damage to secondary beam**

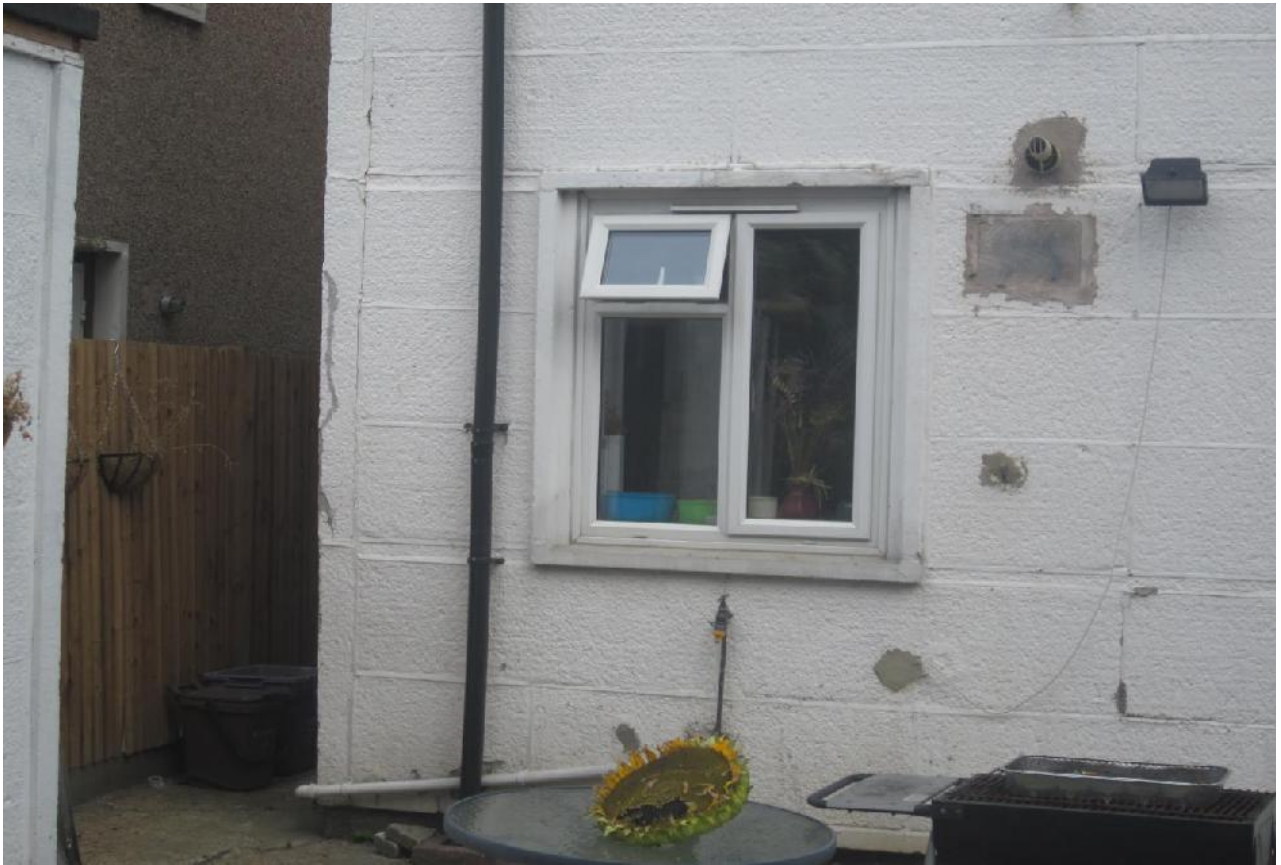
- 5.2 The following observations were made externally:
- i. Cracking has occurred to a number of the PRC corner cladding units. The cracks range from hairline up to about 10mm wide and extend vertically up the corner of the building where they occur. In a number of instances the corner cladding units show signs of patch repairs or have been replaced with new cladding panels. Refer to photographs C9, C15, C16, C17 and C30 in appendix C.

- viii. A few of the PRC window frames have cracking running longitudinally along the top horizontal members. These vary between hairline and 1mm in size. In some cases there were also small (approx. 10mm) chips to the edges of concrete elements. Photograph C9a shows an example of this.

**Photograph C9 – Spalled corner cladding panel and covered venting cladding panel to rear of 193 Morden Road**

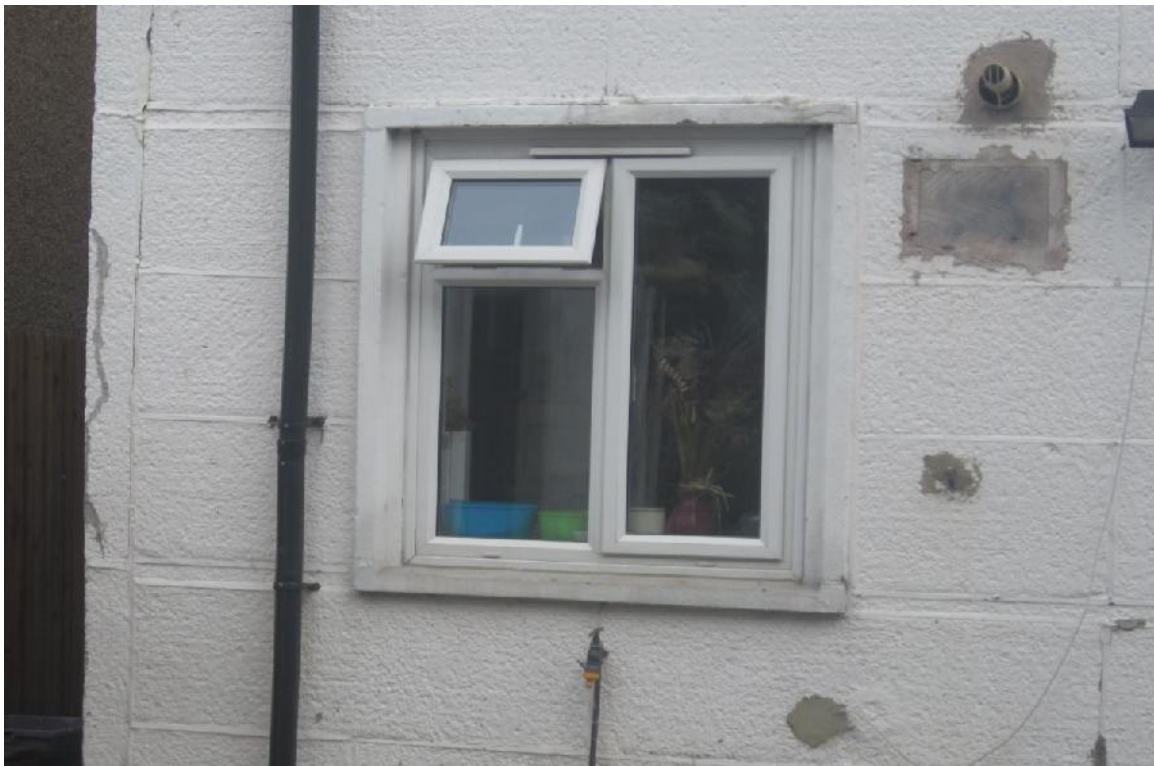
**Photograph C9a – Spalled corner cladding panel and covered venting cladding panel to rear of 193 Morden Road**

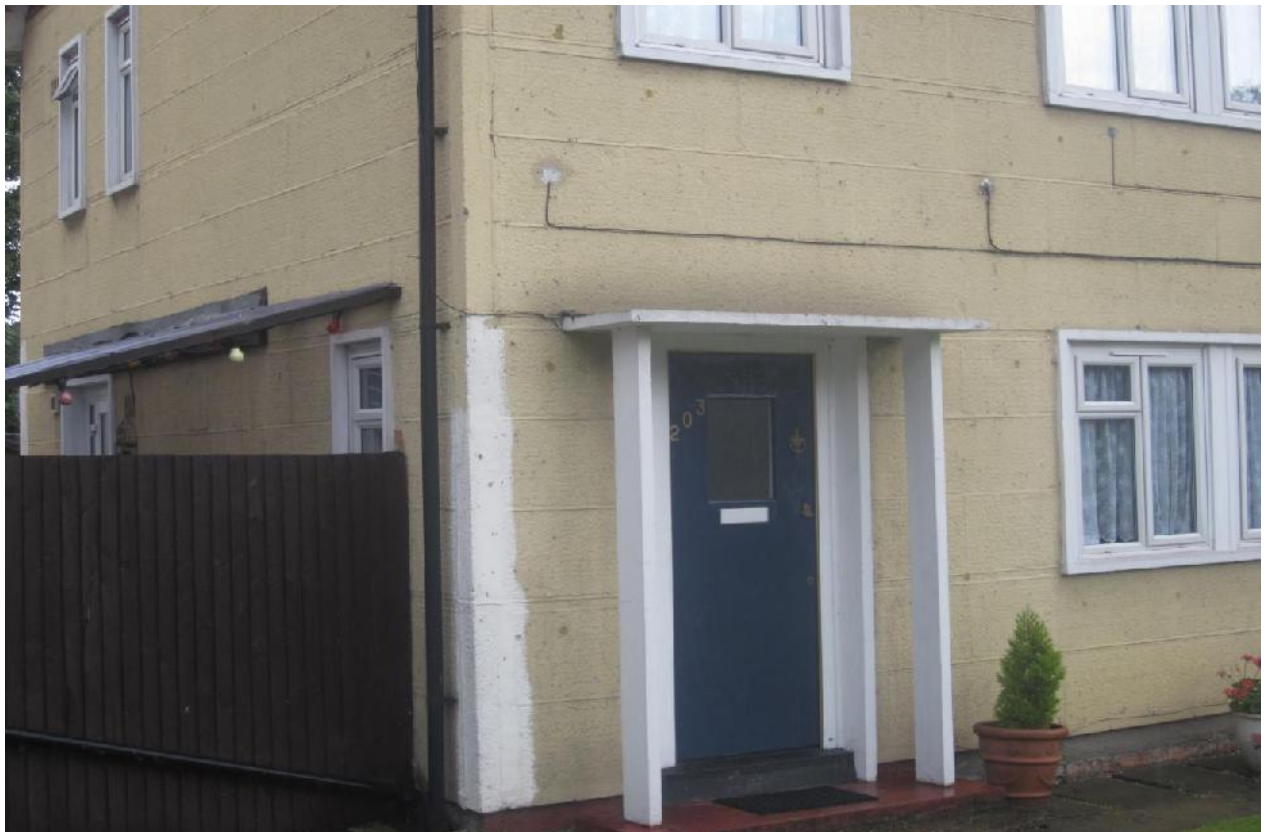
**Photograph C15 – Evidence of corner cladding repair**

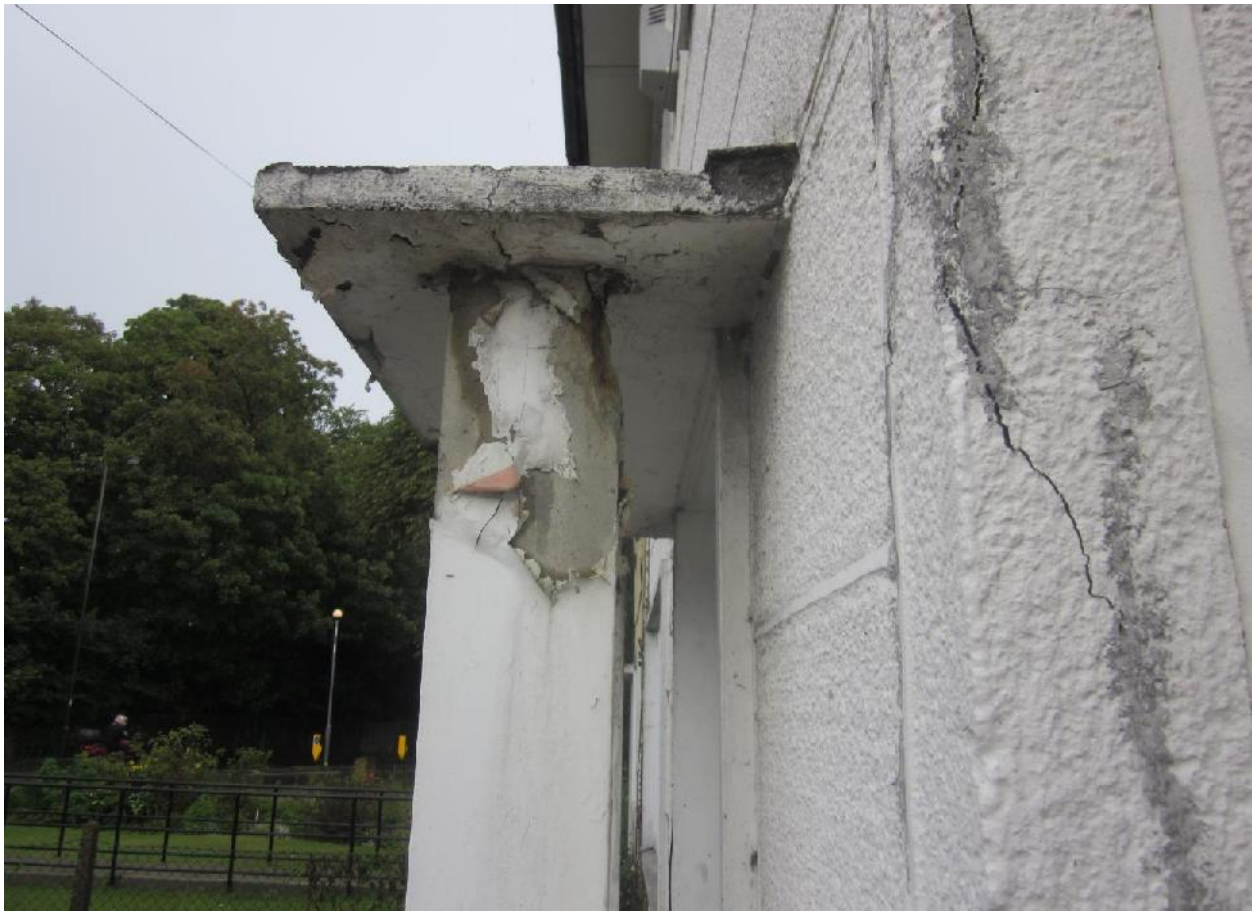
- v. Some of the external columns supporting canopies have spalled close to the upper end of these units, immediately below the soffit of the canopy roof. In some instances, the reinforcement bars within the column sections have become exposed, showing signs of corrosion. Refer to photographs C16 and C23.

**Photograph C16 – Example of corner cladding and canopy support spalling**

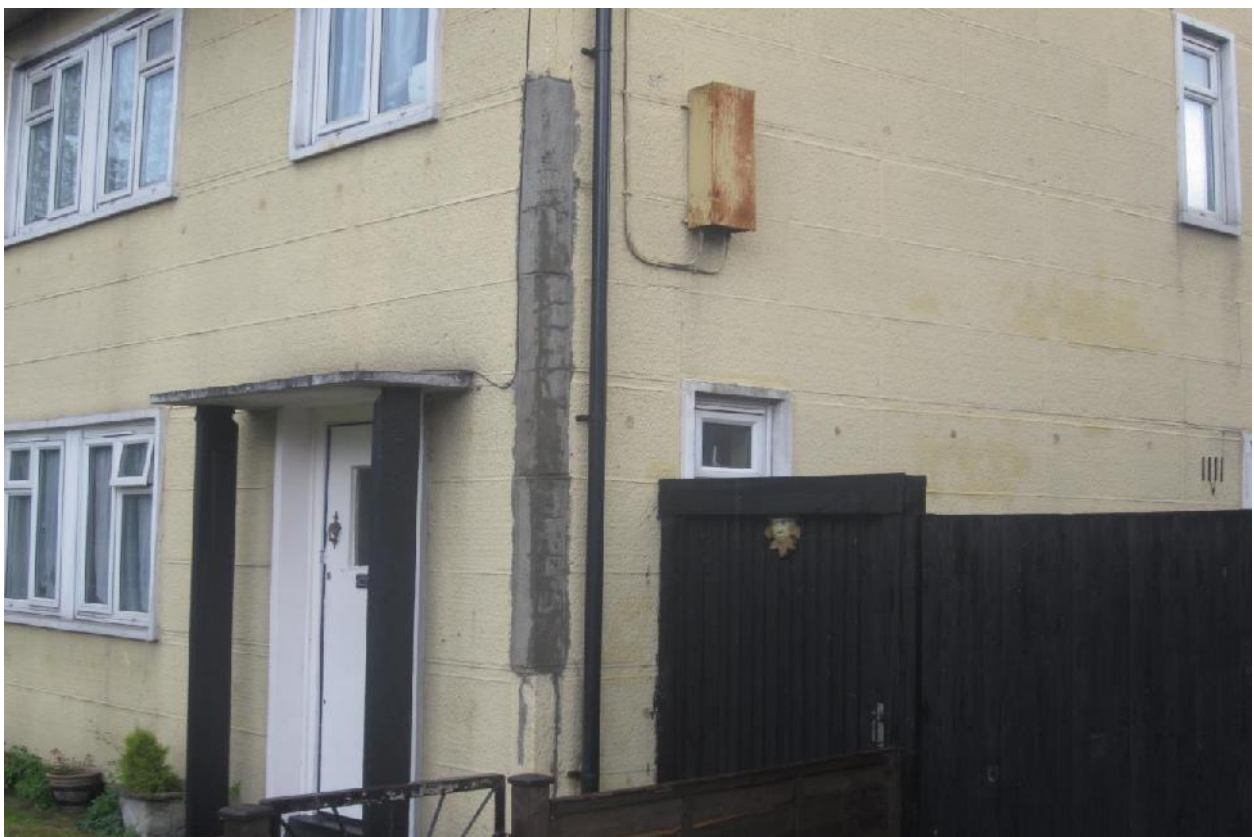
**Photograph C17 – Corner cladding patch and repair**

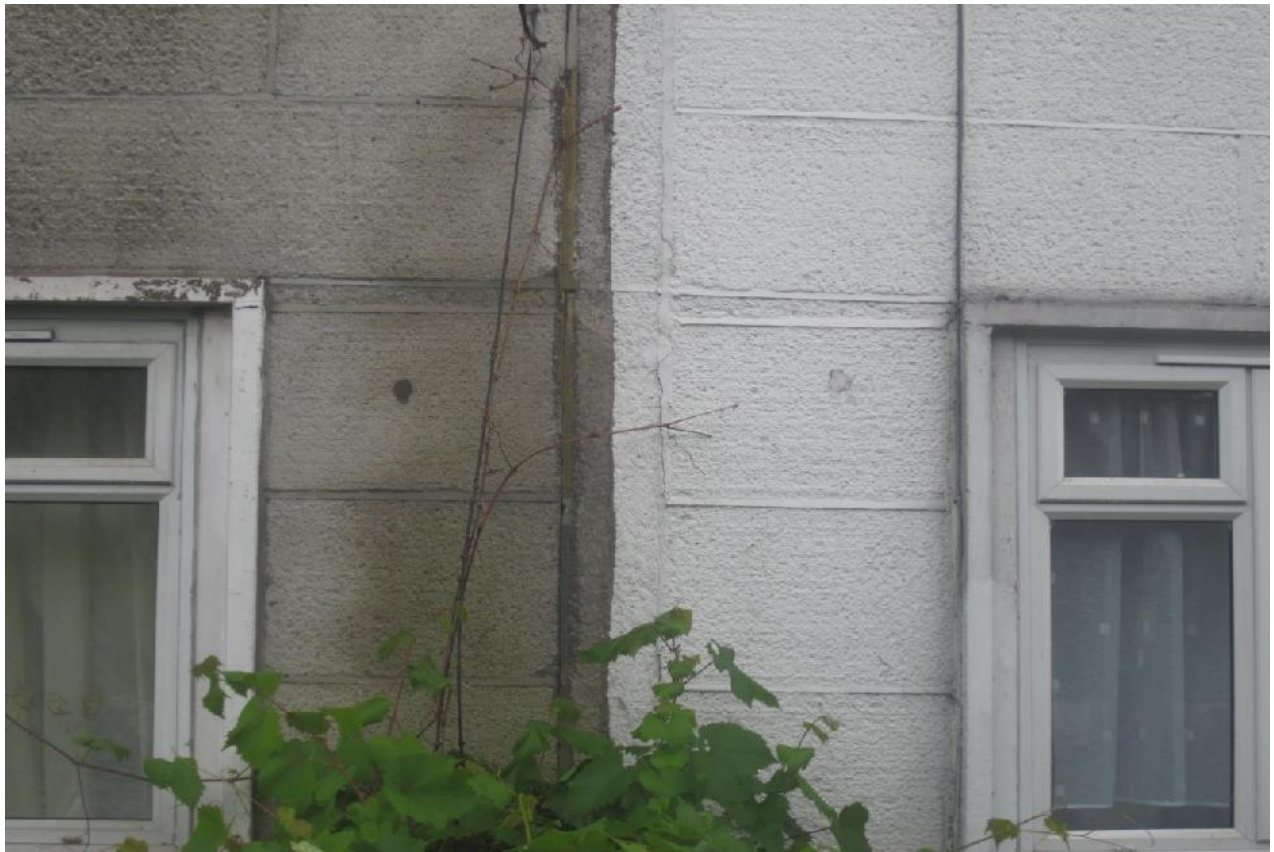
- ii. A number of party wall cladding units show signs of spalling or cracking and patch repair. The cracking observed varied between hairline to 1mm in size and ran vertically along the panels. Patch repairs were visible on some houses and tend to be to the mortar joints running vertically between the party wall and main elevation panels. See photographs C22, C27 and C31.

**Photograph C22 – Party wall cladding unit mortar repair**

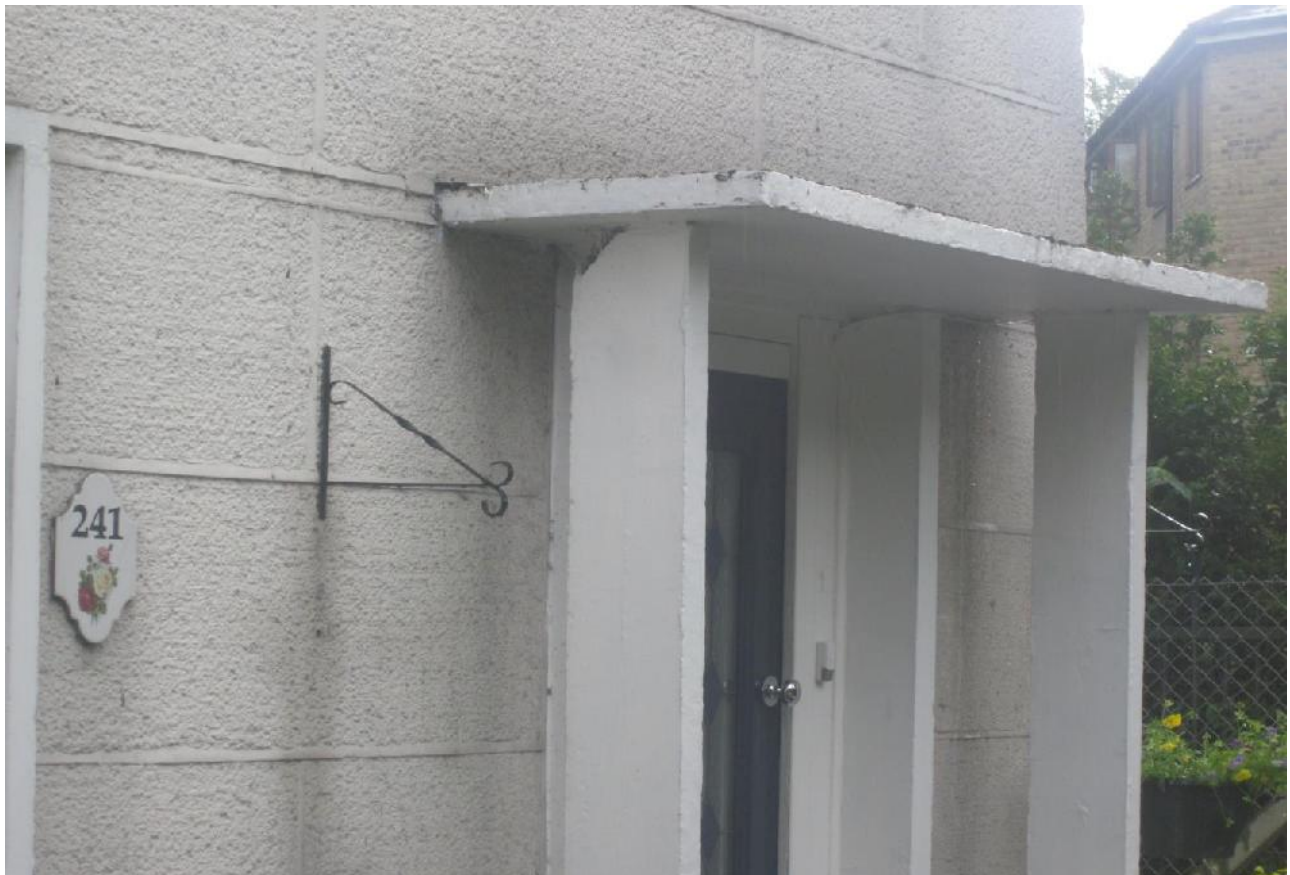
**Photograph C23 – Canopy support spalling**

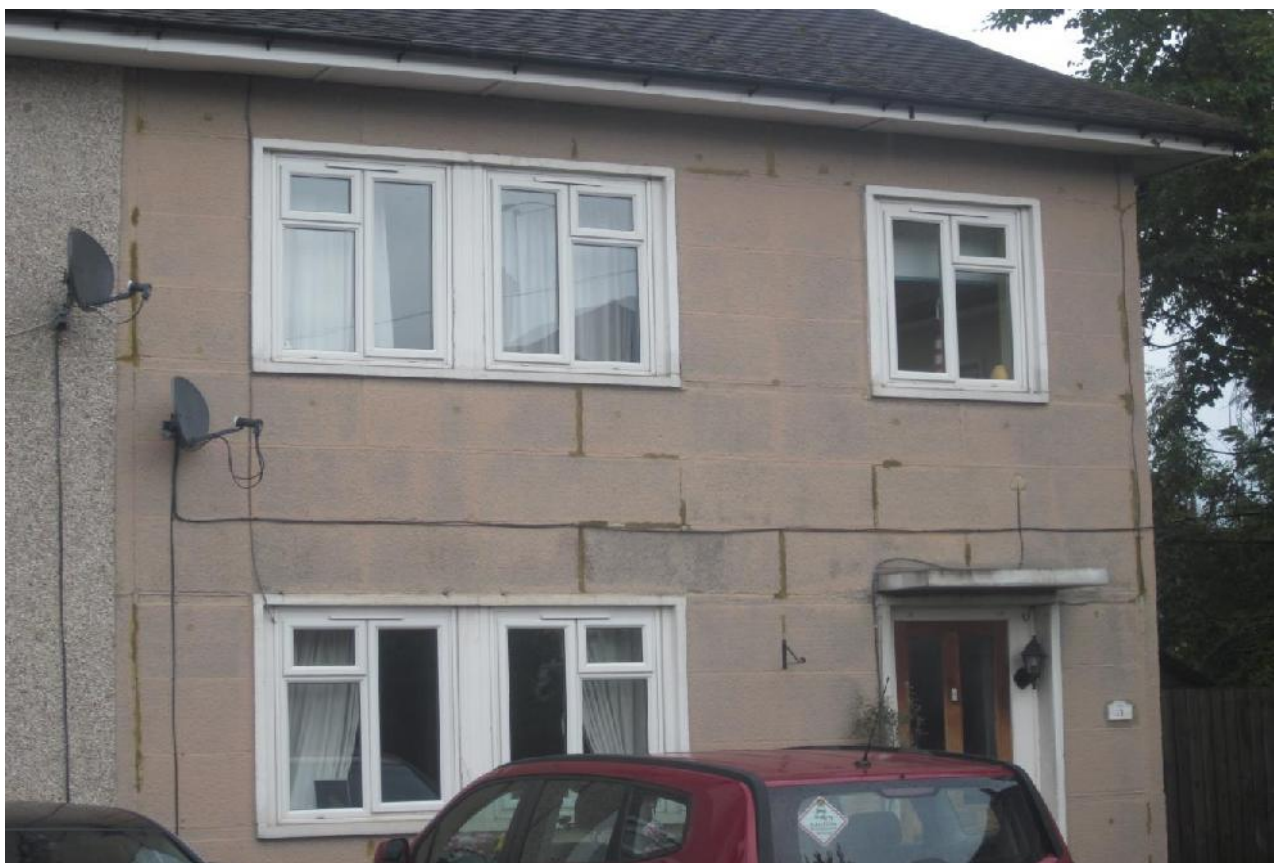
- iv. Across a number of houses, there are signs of patch repairs to the mortar between cladding panels. The table in Appendix D summarises where this was observed. The most extensive repairs were noted on the front elevation of 13 Hatfield Close (See photograph C27).

**Photograph C27 - Significant mortar repair**

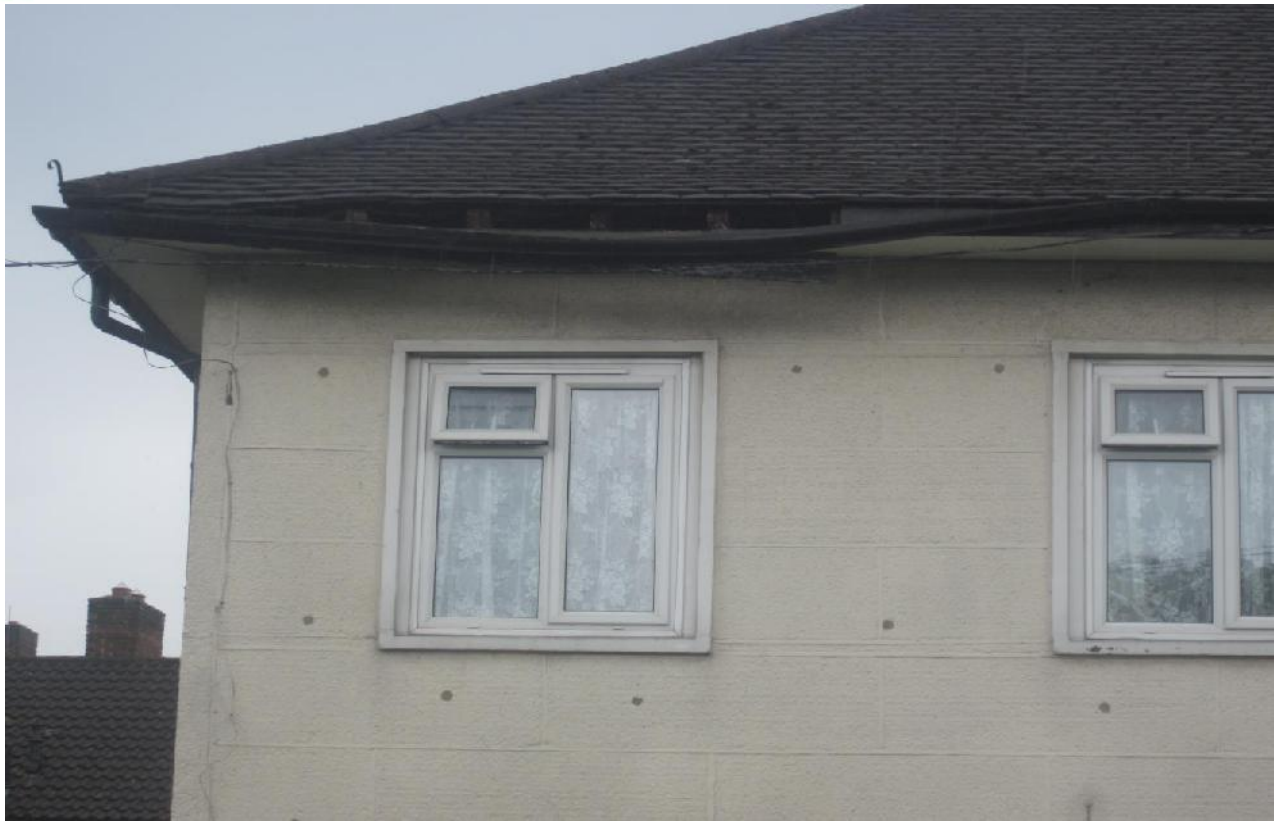
- ix. Whilst the downpipes and guttering could not be viewed up close, some of the guttering was visibly in a poor state of repair. This was particularly so at 54 Ravensbury Grove and 7

Rutter Gardens, where the eaves boarding was noticeably decayed and the rafters behind are visible. In all cases the guttering appeared to be plastic. See photographs C28 and C29.

**Photograph C28 – Damaged guttering**

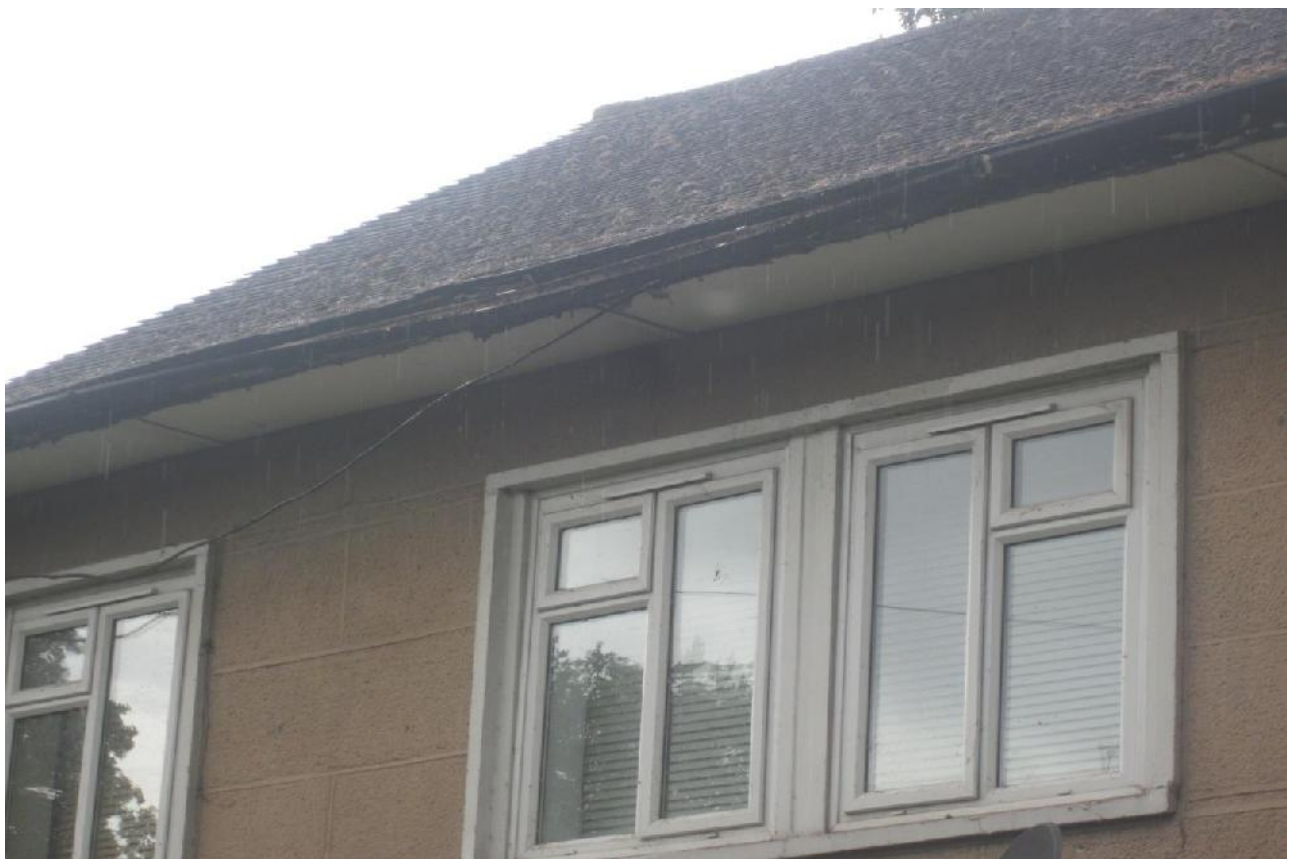
**Photograph C29 – Damaged guttering**

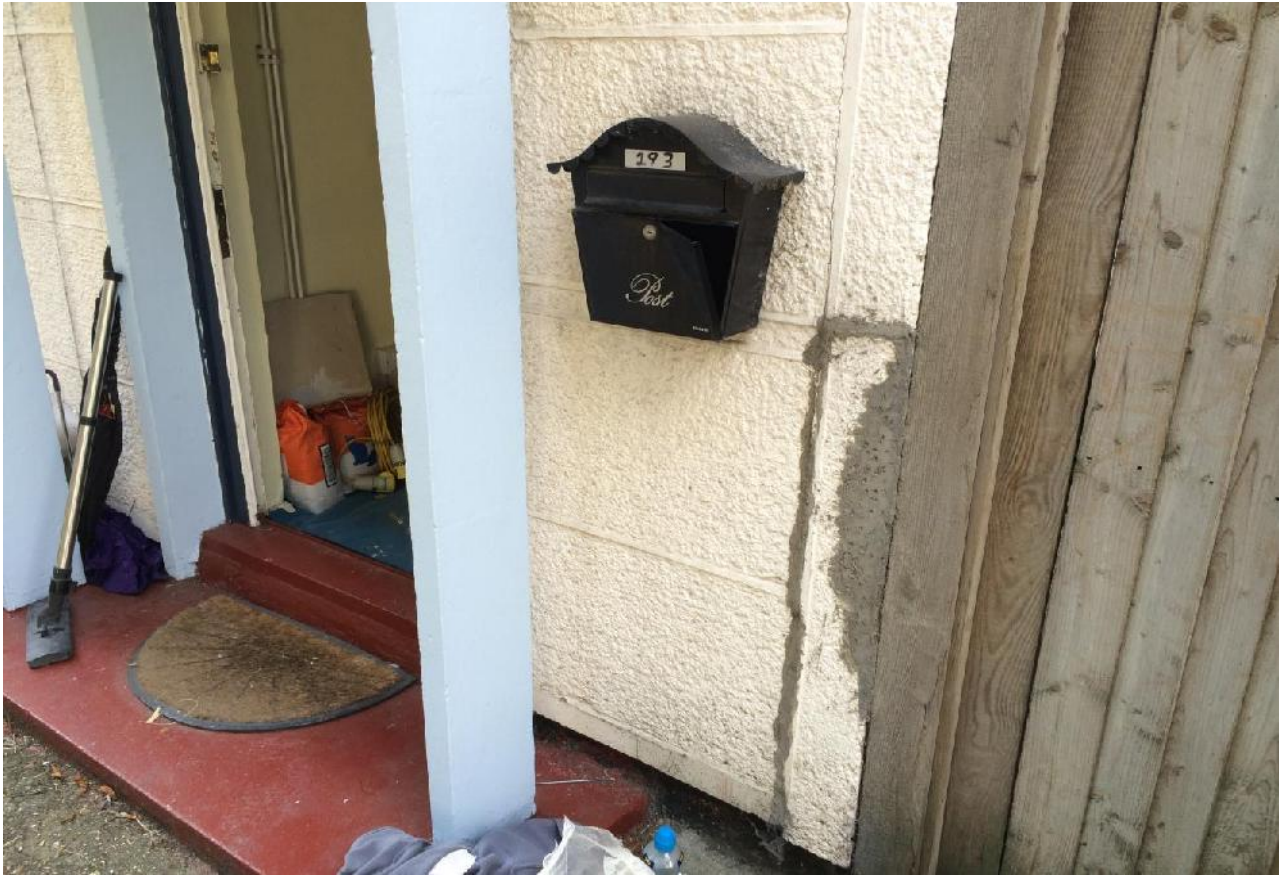
**Photograph C30 – Patch repair to corner cladding**

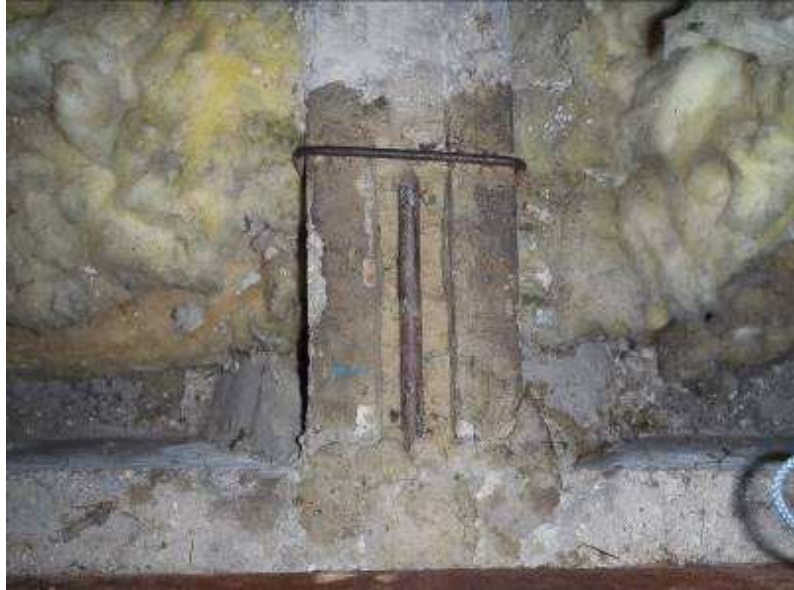
Plate R2: View of Breakout C1 to continuity bar at roof secondary beam to roof primary beam connection over central column at No. 1 Rutter Gardens.

The mortar cover to the continuity bar exposed within No. 193 Morden Road and 1 Rutter Gardens exhibited cracking, elsewhere the mortar was observed to be in reasonable condition.

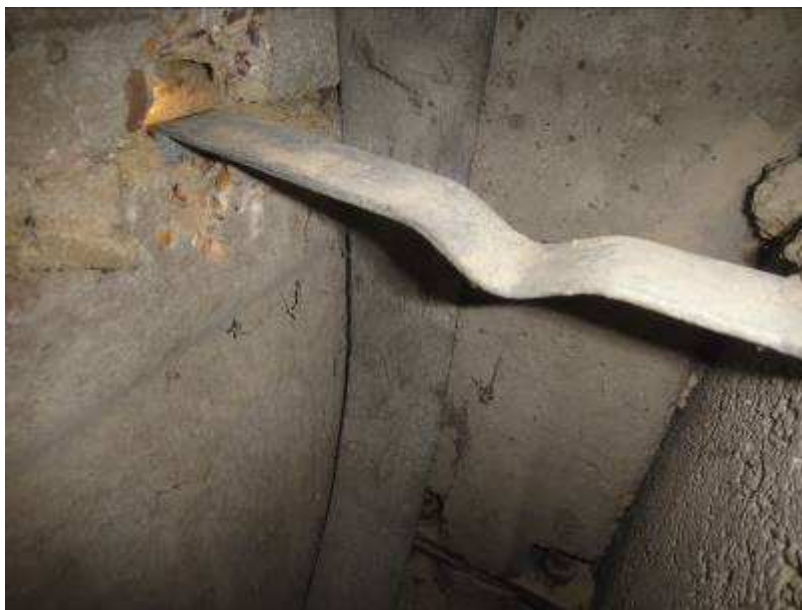
The external end of the wall ties were found to be embedded by approximately 15mm into the cladding panels at their horizontal joints and the internal ends of the ties were found to be embedded by approximately 35mm into the horizontal mortar joints of the internal blockwork skin where inspected.

Fig. R5: View of Breakout B3 to tie embedment within external cladding panel at No. 193 Morden Road.

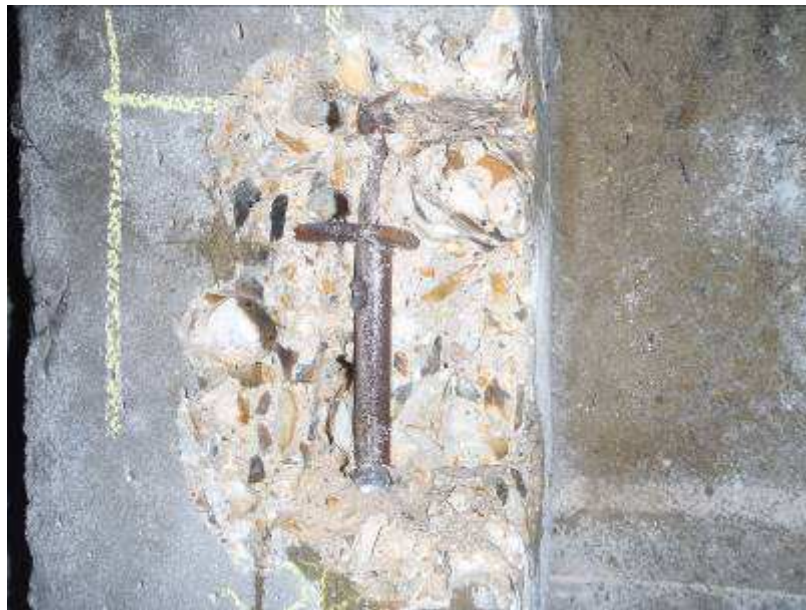
A total of eighteen localised breakouts were carried out to the various precast concrete elements forming the structures in order to size and inspect the reinforcement. The reinforcement was generally observed to be in good condition, generally exhibiting light surface corrosion only.

Plate R7: View of column Breakout A2 at No. 241 Morden Road.

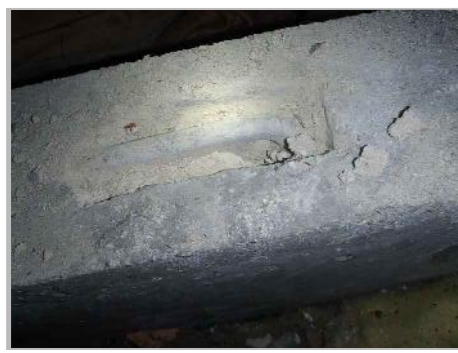
10mmØ PLAIN ROUND CONTINUITY BAR EMBEDDED WITHIN INSITU MORTAR FILLED PRE-FORMED SLOT. TOP COVER TO BAR 2mm.  
BAR OBSERVED TO BE IN GOOD CONDITION WITH LIGHT SURFACE CORROSION ONLY. INSITU MORTAR APPEARS TO BE IN REASONABLE CONDITION.

PA4a: VIEW OF B/O A5 TO CONTINUITY BAR WITHIN TOP OF SECONDARY BEAM

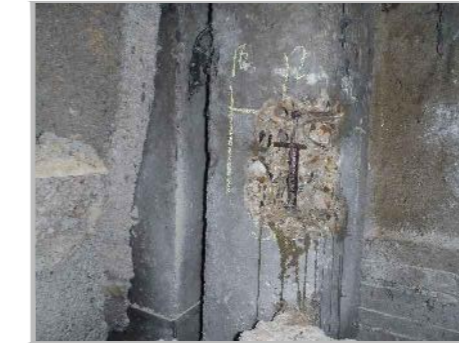
**DETAILS OF B/O A2**  
10mmØ PLAIN ROUND VERTICAL BAR AT 15mm COVER  
5mmØ PLAN ROUND HORIZONTAL LINK AT 2-3mm MINIMUM COVER  
BOTH BARS IN GOOD CONDITION EXHIBITING LIGHT SURFACE CORROSION ONLY.  
CARBONATION DEPTH: 15mm

PA8a: VIEW OF B/O A2 TO 1ST FLOOR COLUMN WITHIN CAVITY

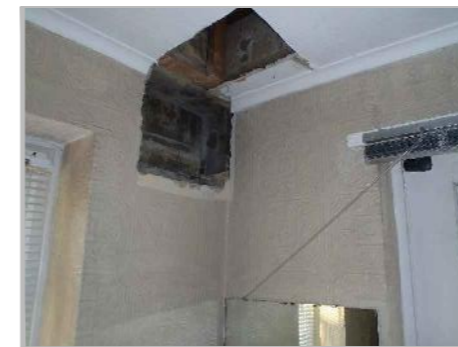
**NOTES**  
GALVANISED WALL TIES PRESENT WITHIN CAVITY IN VICINITY OF EXPOSURE EXP A1. TIES SPACED TYPICALLY AT 400mm c/c VERTICALLY AND 250-350mm c/c HORIZONTALLY. TIES OBSERVED TO BE IN GOOD CONDITION.

PA9a: GENERAL VIEW OF EXPOSURE EXP A1 IN SOUTH WESTERN CORNER OF PROPERTY

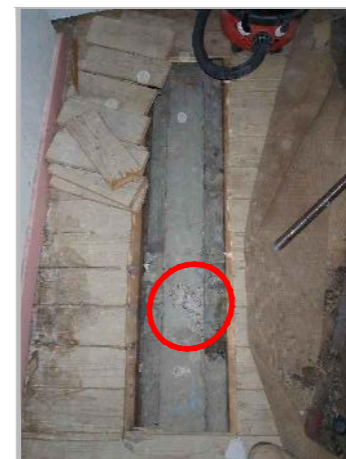
**DETAILS OF B/O 4**  
10mmØ PLAIN ROUND LONGITUDINAL BAR AT 37mm TOP COVER.  
5mmØ PLAN ROUND VERTICAL LINK AT TOP 30mm COVER.  
BOTH BARS IN GOOD CONDITION EXHIBITING LIGHT SURFACE CORROSION ONLY.  
CARBONATION DEPTH: 3-4mm

PA10a: GENERAL VIEW OF 1ST FLOOR EXPOSURE AT B/O A4

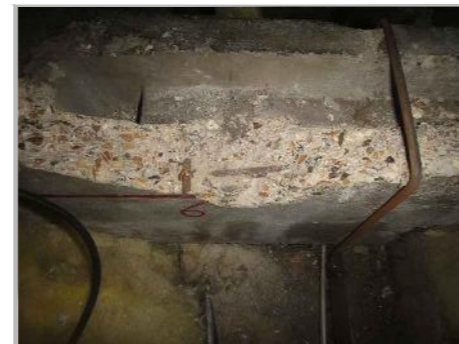
**DETAILS OF B/O B2**  
6mmØ PLAIN ROUND LONGITUDINAL BAR AT 12mm MINIMUM COVER.  
5mmØ PLAIN ROUND LINK AT 2mm MINIMUM COVER.  
BOTH BARS EXHIBIT LIGHT TO MODERATE SURFACE CORROSION.  
CARBONATION DEPTH: 2-3mm

PB4a: VIEW OF BREAKOUT B/O B2 TO TOP OF SECONDARY BEAM

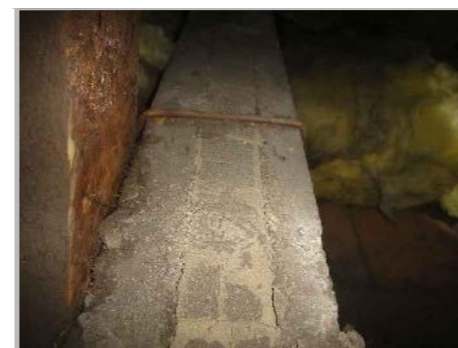
**DETAILS OF B/O B1**  
10mmØ PLAIN ROUND CONTINUITY BAR EMBEDDED WITHIN INSITU MORTAR FILLED PRE-FORMED SLOT. TOP COVER TO BAR 5mm. BAR OBSERVED TO BE IN GOOD CONDITION EXHIBITING LIGHT SURFACE CORROSION ONLY. INSITU MORTAR EXHIBITS CRACKING.

PB2a: VIEW OF INSITU MORTAR PRIOR TO BREAKOUT B/O B1

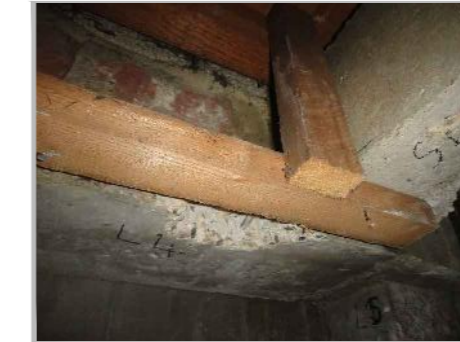
BARS EXHIBIT LIGHT TO MODERATE SURFACE CORROSION. CARBONATION DEPTH: 2-3mm

PB6a: GENERAL VIEW OF B/O B7 TO 1ST FLOOR PRIMARY BEAM

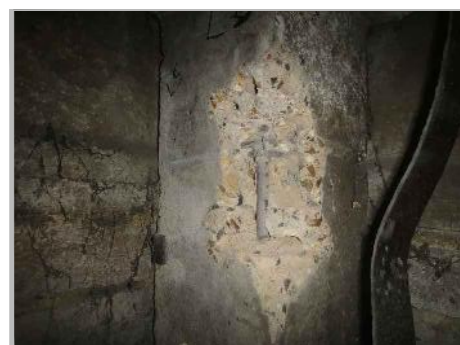
**DETAILS OF BREAKOUT**  
10mmØ PLAIN ROUND VERTICAL BAR AT 25mm MINIMUM COVER.  
5mmØ PLAIN ROUND LINK BAR AT 20mm MINIMUM COVER.  
BOTH BARS EXHIBIT LIGHT SURFACE CORROSION ONLY.  
CARBONATION DEPTH: 2-5mm

PB11a: VIEW OF B/O B5 TO GROUND FLOOR COLUMN AT LOW LEVEL

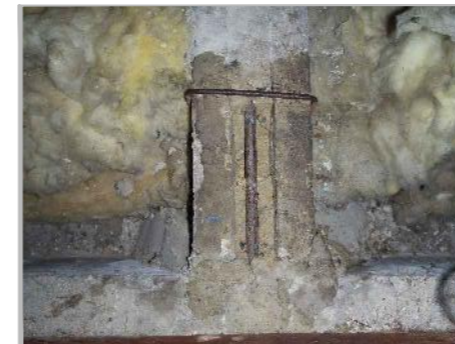
10mmØ PLAIN ROUND CONTINUITY BAR EMBEDDED WITHIN INSITU MORTAR FILLED PRE-FORMED SLOT. TOP COVER TO BAR 10mm. BAR OBSERVED TO BE IN GOOD CONDITION EXHIBITING LIGHT SURFACE CORROSION ONLY. INSITU MORTAR APPEARS TO BE IN REASONABLE CONDITION WITH THE EXCEPTION OF SOME CRACKING.

PC2a: VIEW OF B/O C1 TO TOP OF ROOF SECONDARY BEAM

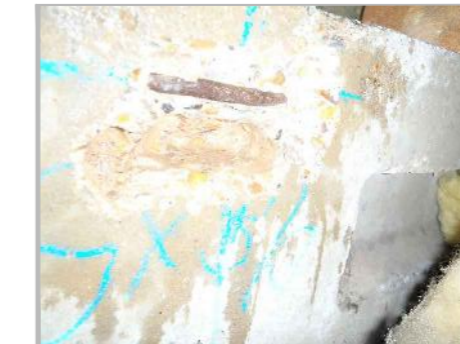
BAR OBSERVED TO BE IN GOOD CONDITION EXHIBITING LIGHT SURFACE CORROSION ONLY. CARBONATION DEPTH: 2-3mm.

PC3a: VIEW OF B/O C2 TO SECONDARY BEAM

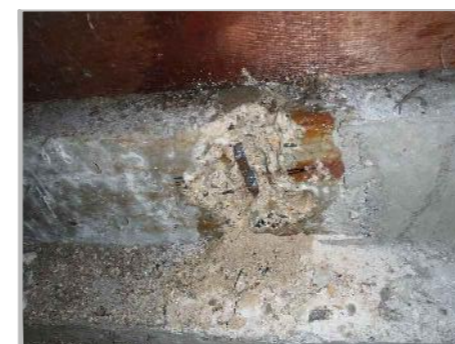
BAR IN GOOD CONDITION EXHIBITING LIGHT SURFACE CORROSION ONLY. CARBONATION DEPTH: 17mm

PC4a: VIEW OF B/O C3 TO ROOF PRIMARY BEAM

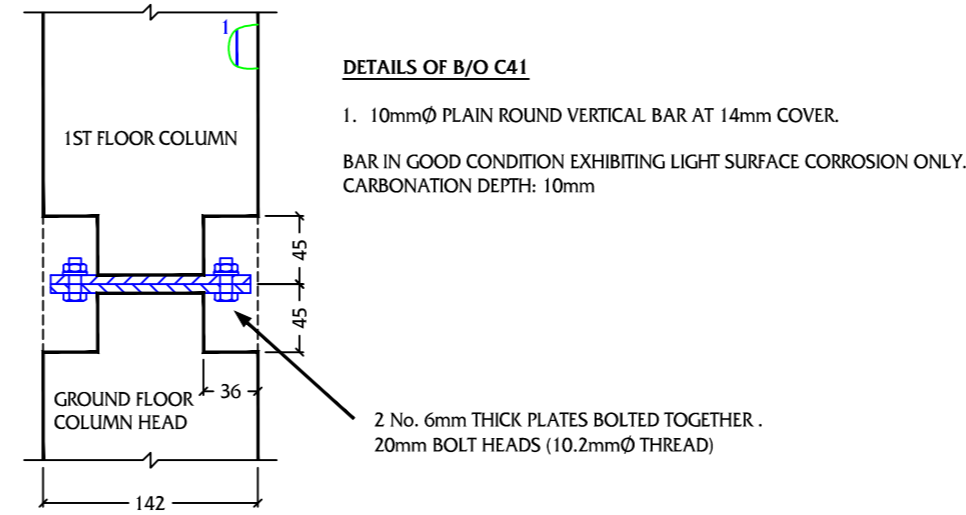
FIG.C6: DETAILS OF BREAKOUT B/O C4 TO 1ST FLOOR COLUMN AND 1ST FLOOR TO GROUND FLOOR COLUMN CONNECTION SCALE 1:5

**DETAILS OF B/O C41**  
1. 10mmØ PLAIN ROUND VERTICAL BAR AT 14mm COVER.  
BAR IN GOOD CONDITION EXHIBITING LIGHT SURFACE CORROSION ONLY. CARBONATION DEPTH: 10mm
