Free4m 0502

Bishopsford Rd Bridge, Merton

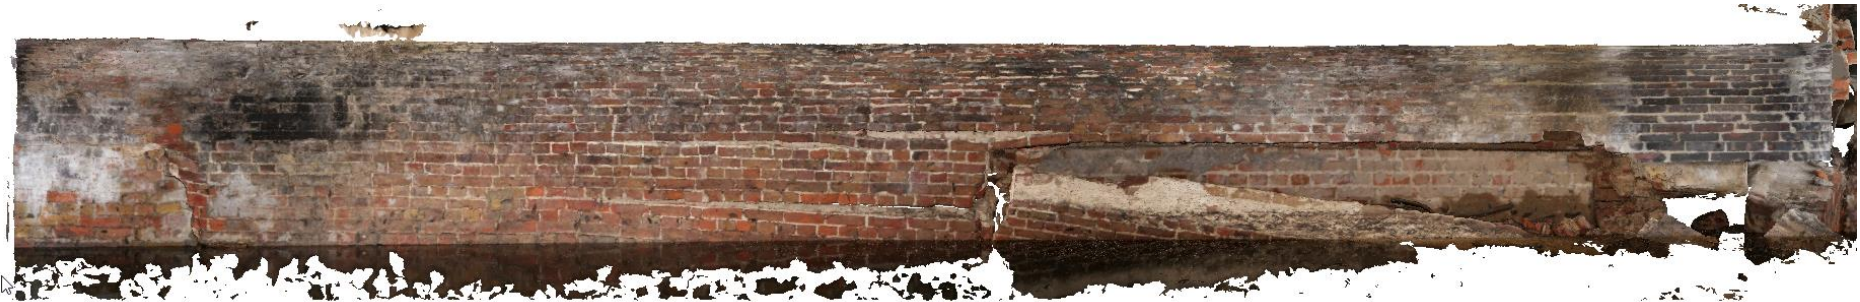
Upstream to the right. Note very different bricks at RH end marking an extension.

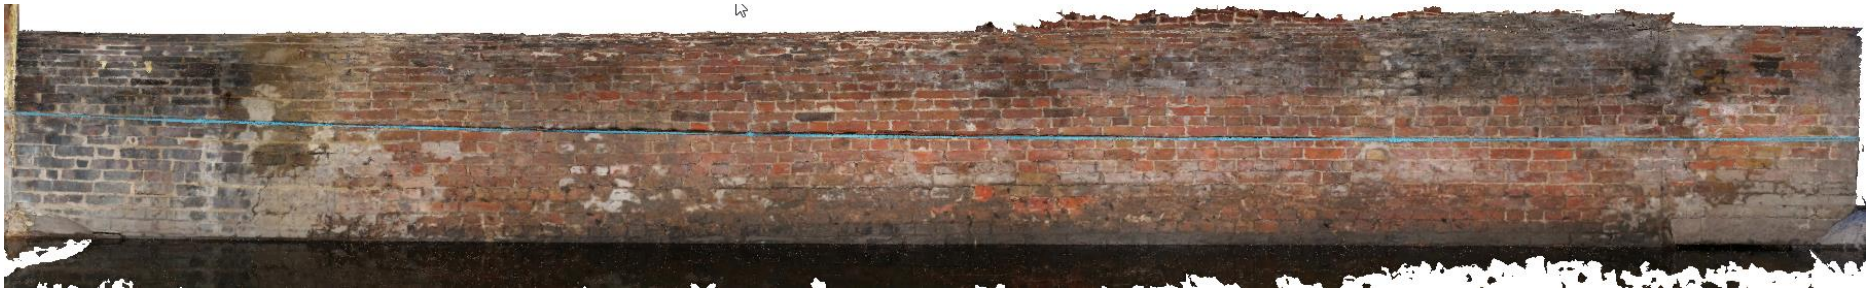
The end extensions are clearer here. At the downstream end it stands on stone.

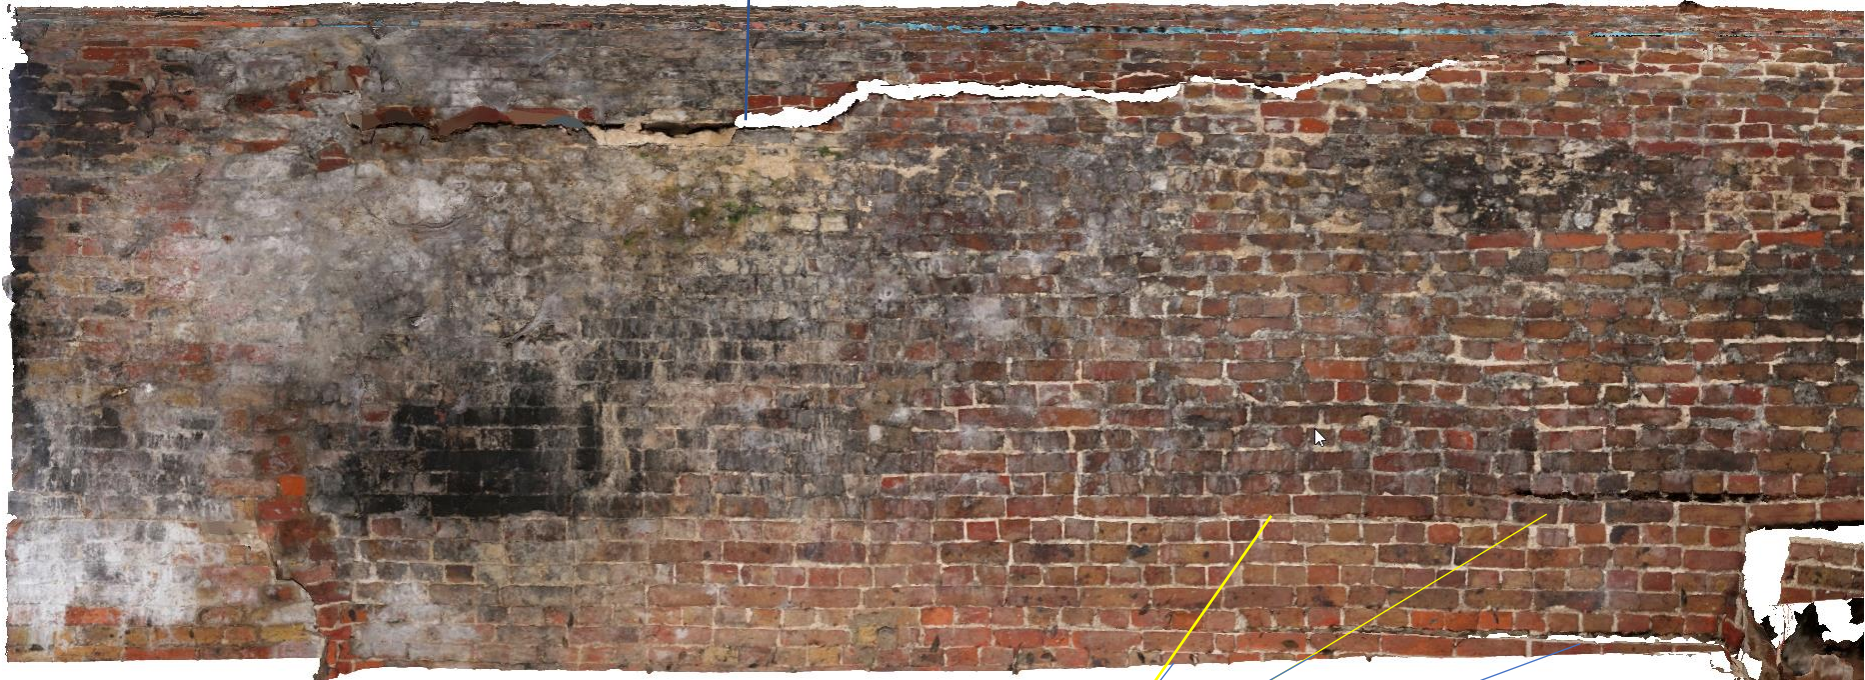
Tear in crown. White is where the camera couldn't see anything but is not clear sky.

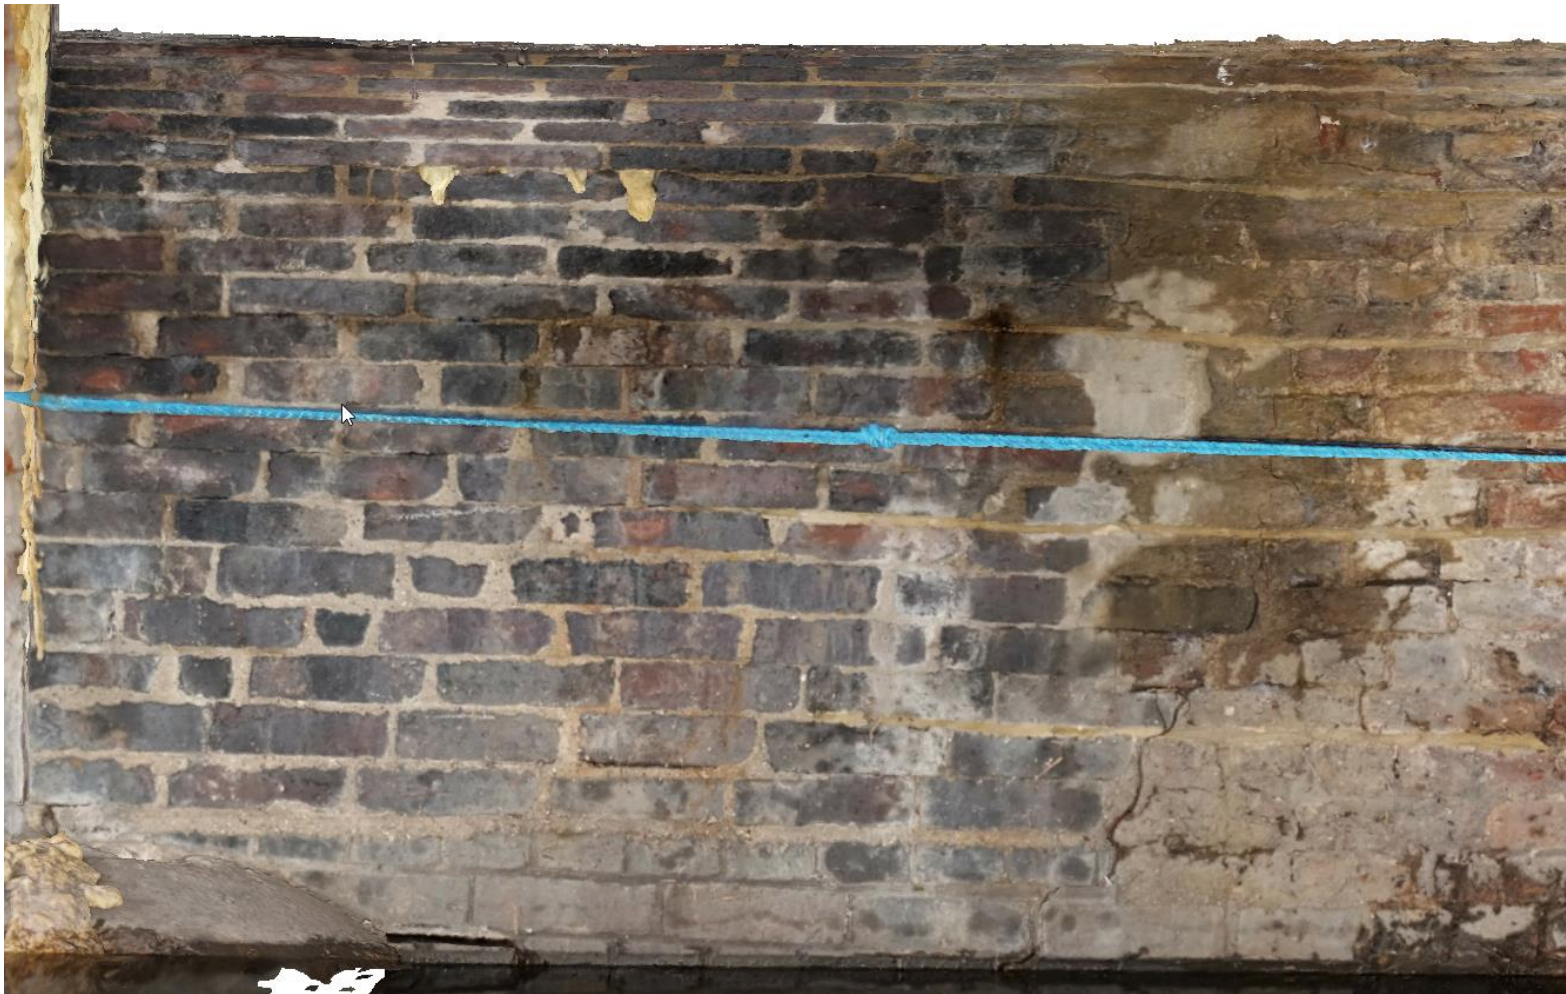
At the upstream end of the pier, the extension is tilted up to the upstream. The crack suggests that is a long standing rotation but it is unlikely to have been built that way. The tilt goes all the way to the crown.

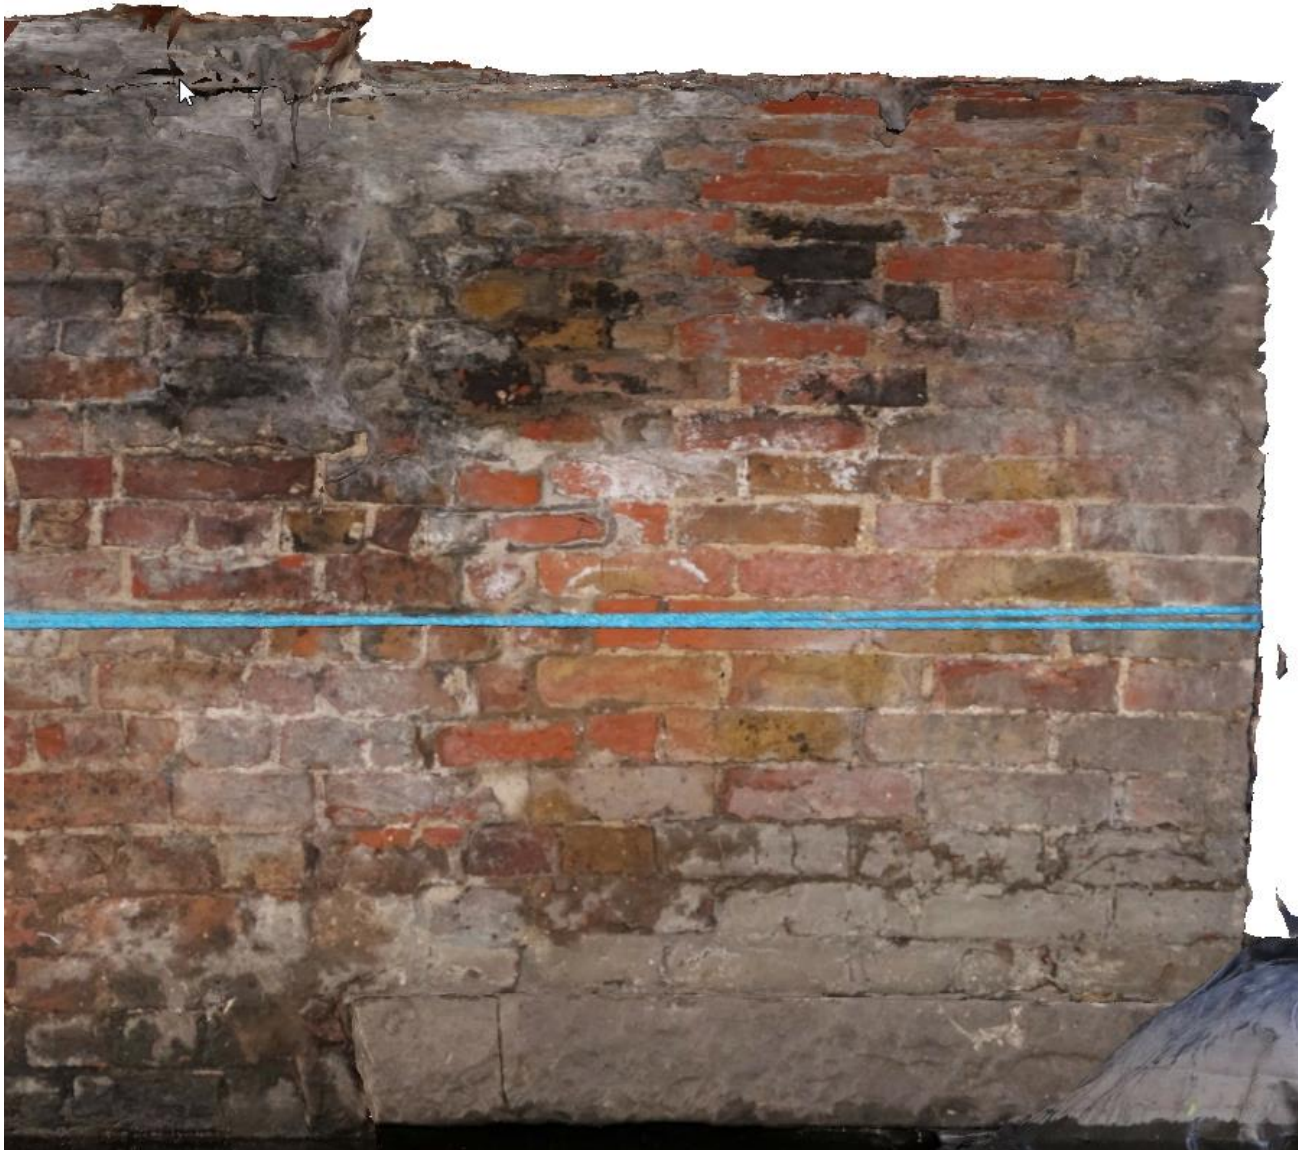
At the downstream end the new build us evidenced by:

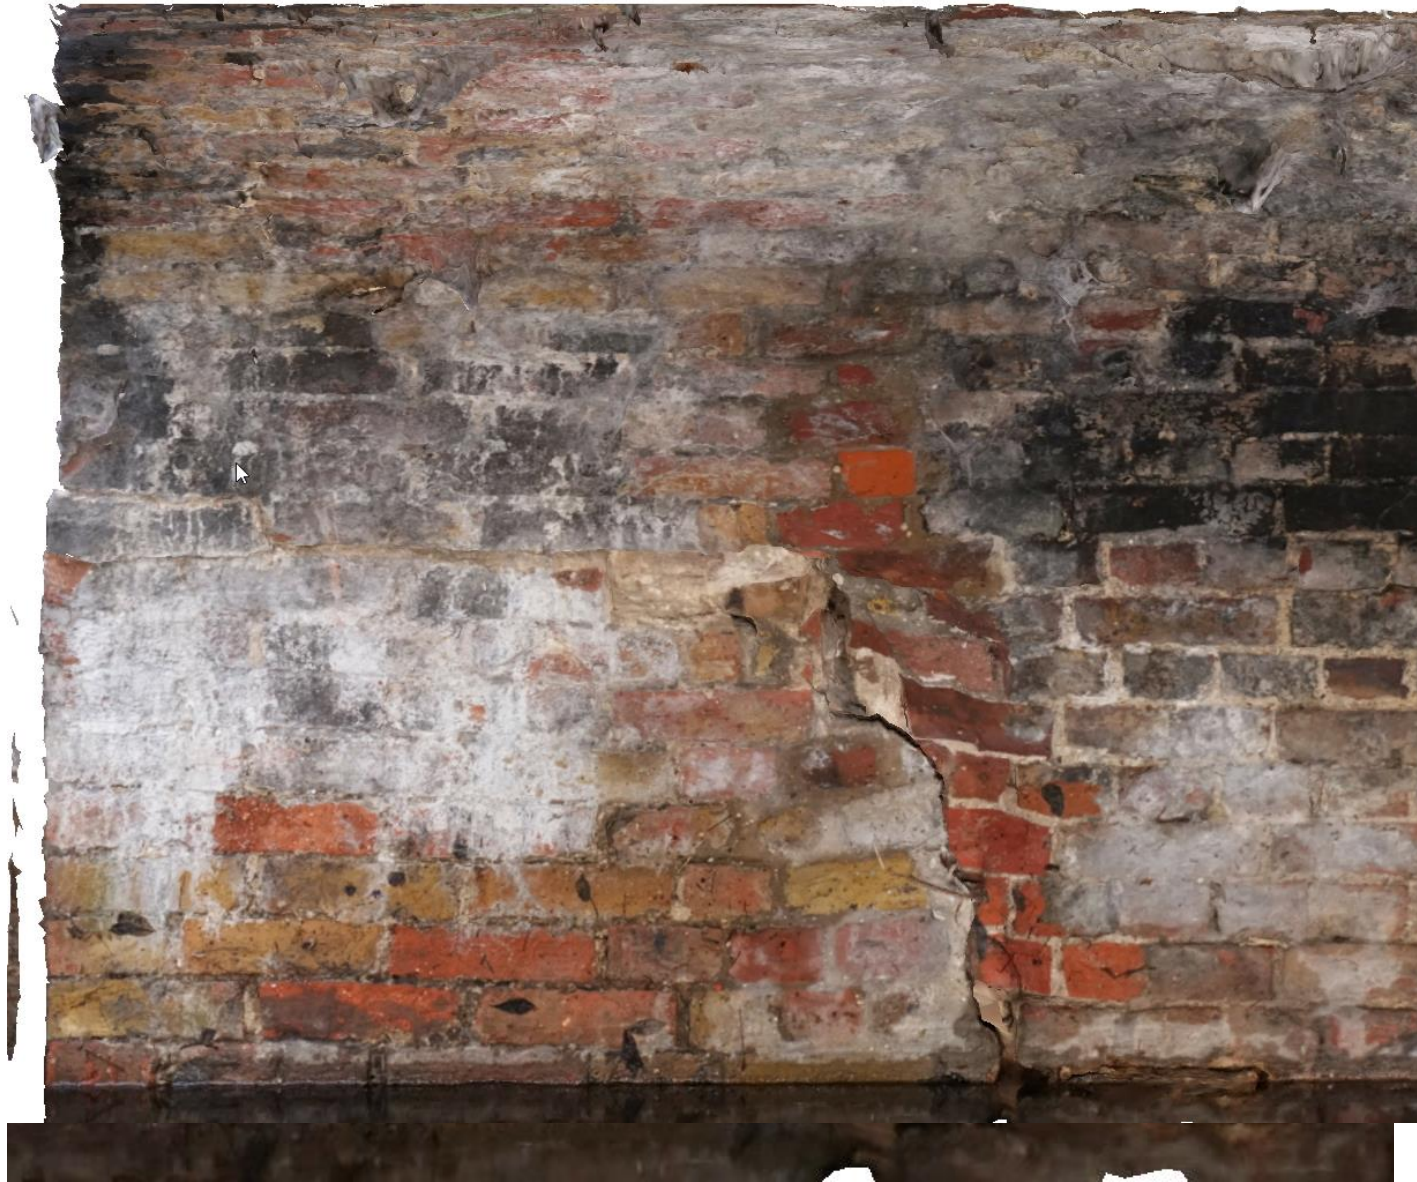
This fissure begins at the interface between old and new but seems to show a degree of bonding in.

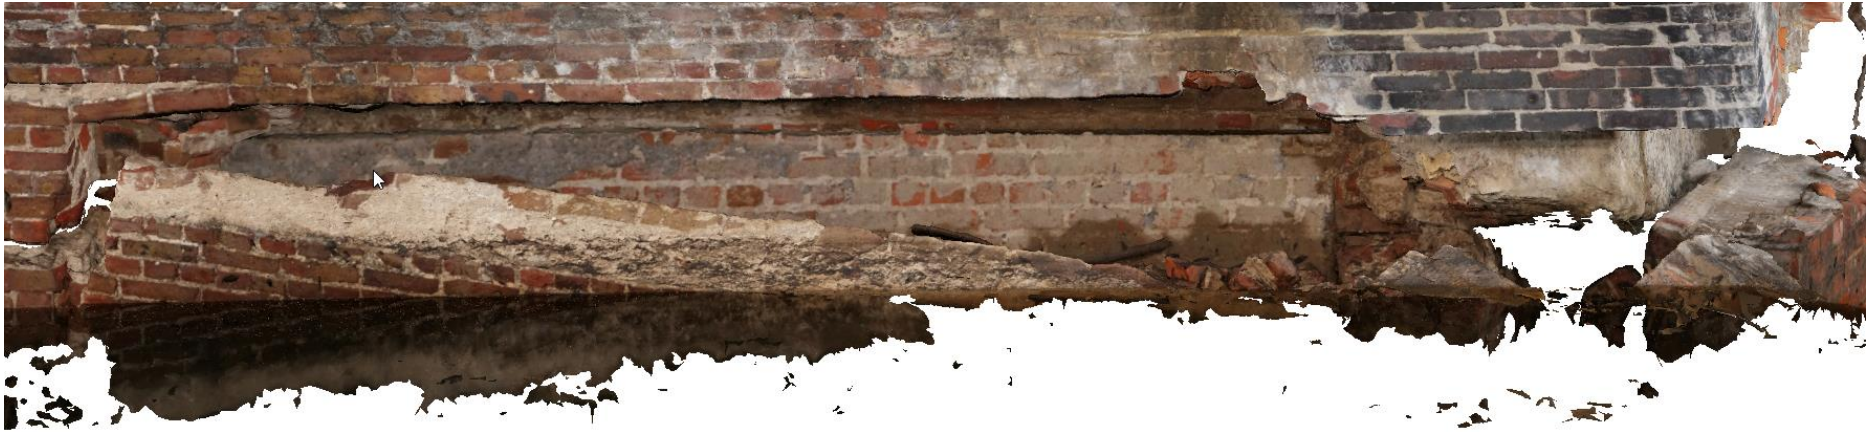
A view into the large void. The vertical wall at the back is the shell of the abutment which was then filled with rather poorer workmanship and bricks.

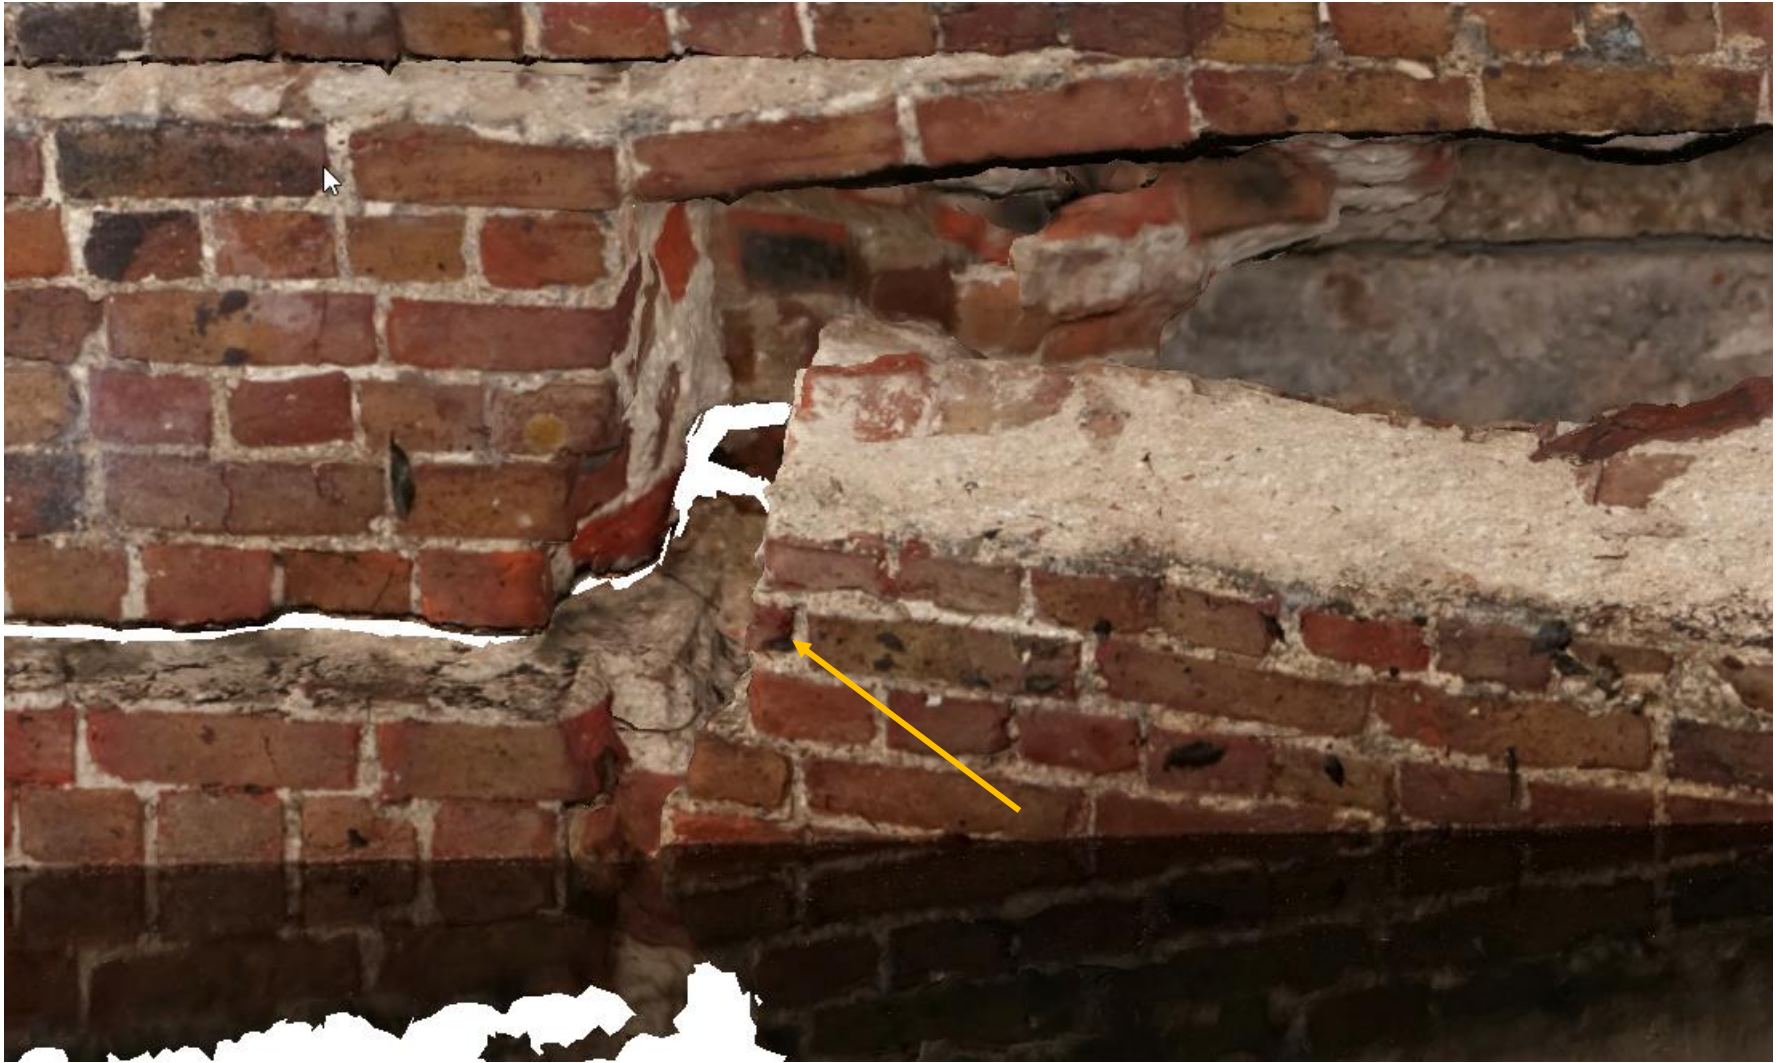
The rounded corners on the bricks confirms this is a long standing fracture. The small stub of brick arrowed would have pulled out rather than breaking in this event.

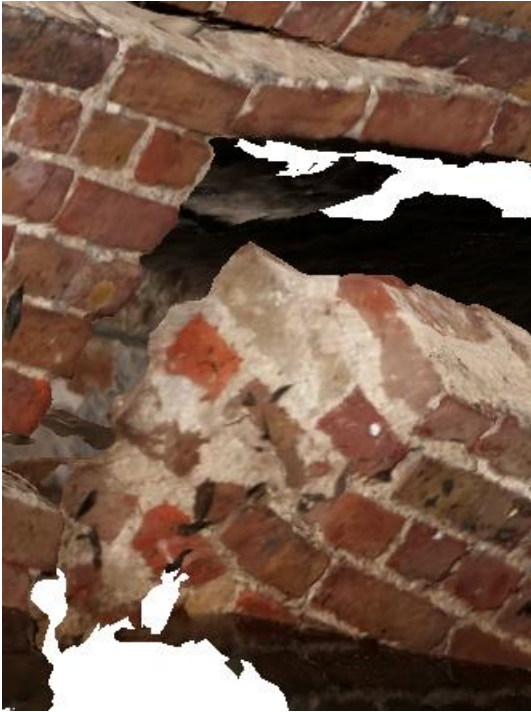
This shows that the rings are fully bonded, not snap headers.

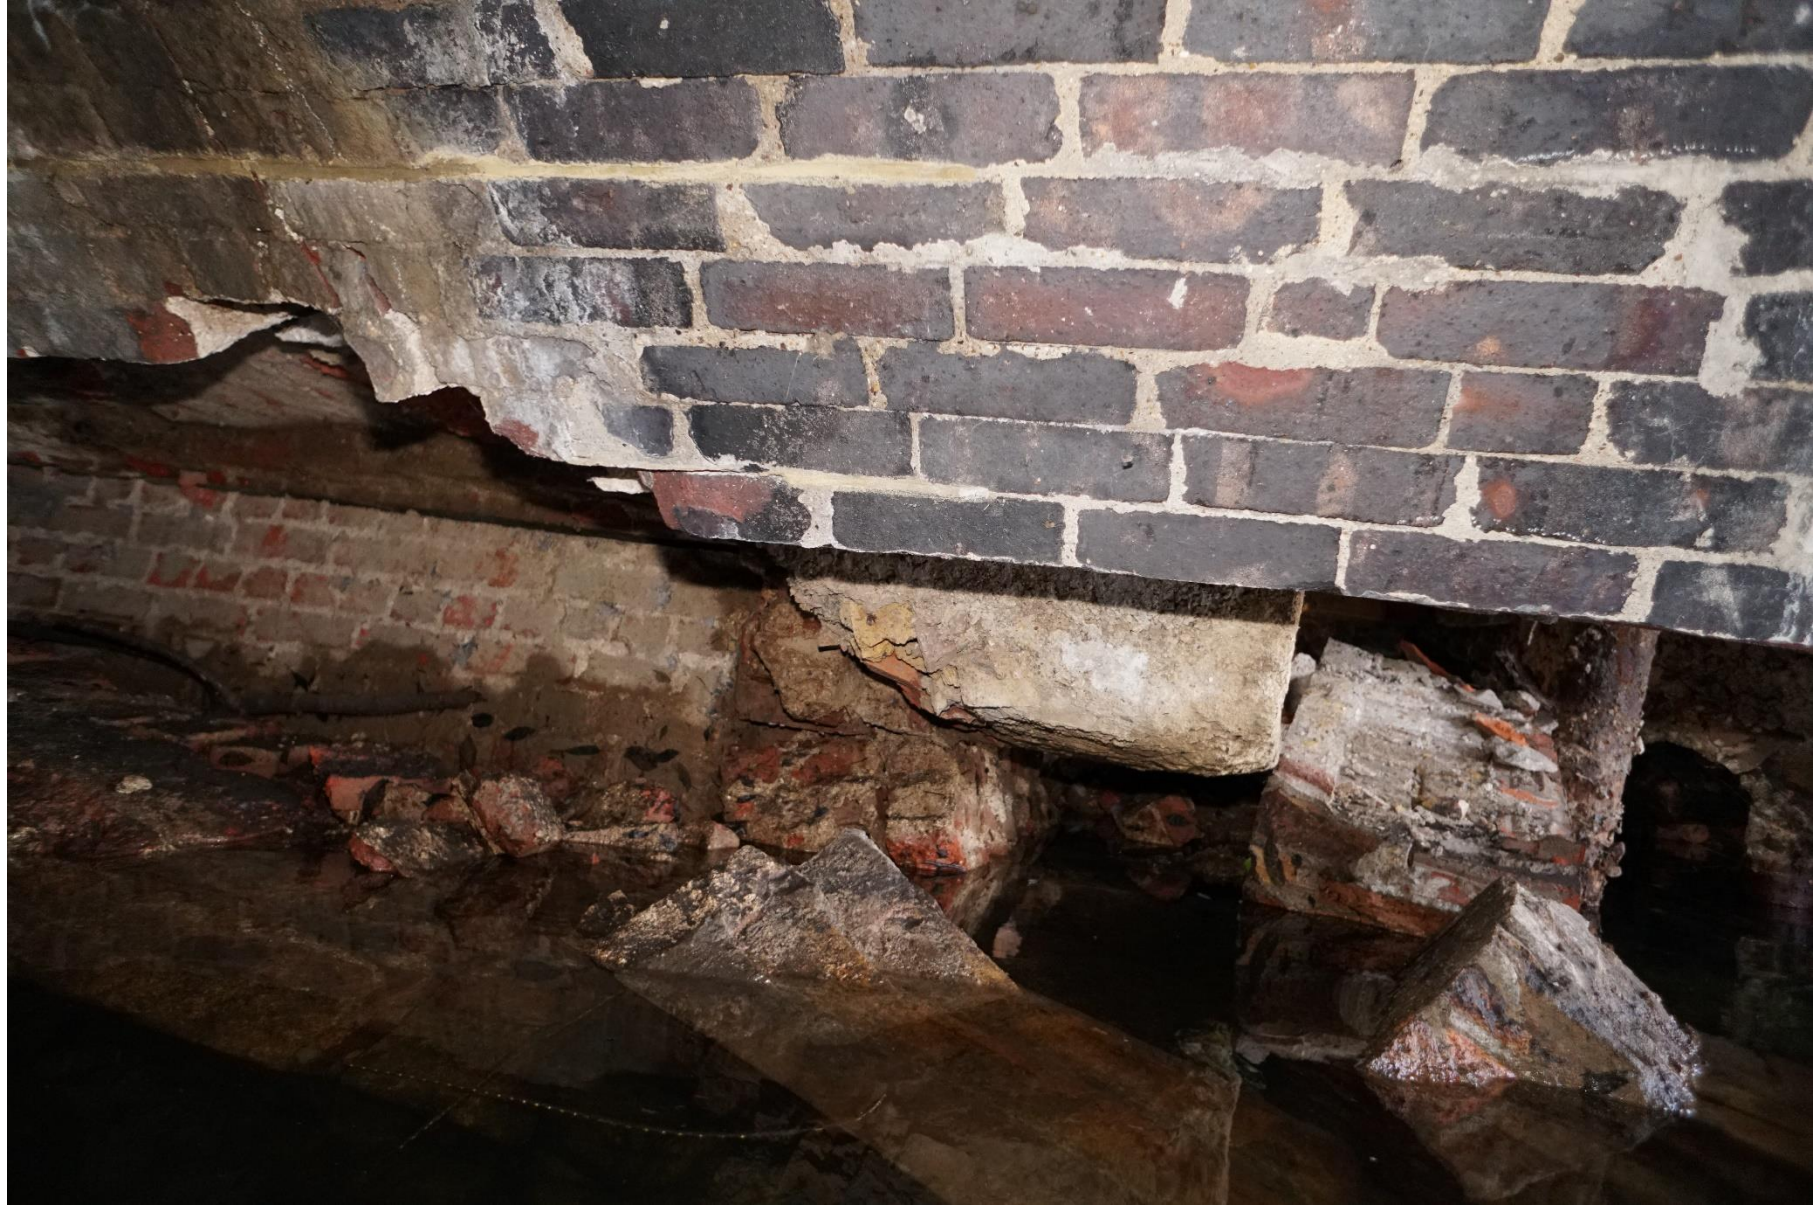
APPENDIX 2 – REPAIR OPTIONS INDICATIVE WORKS STAGES

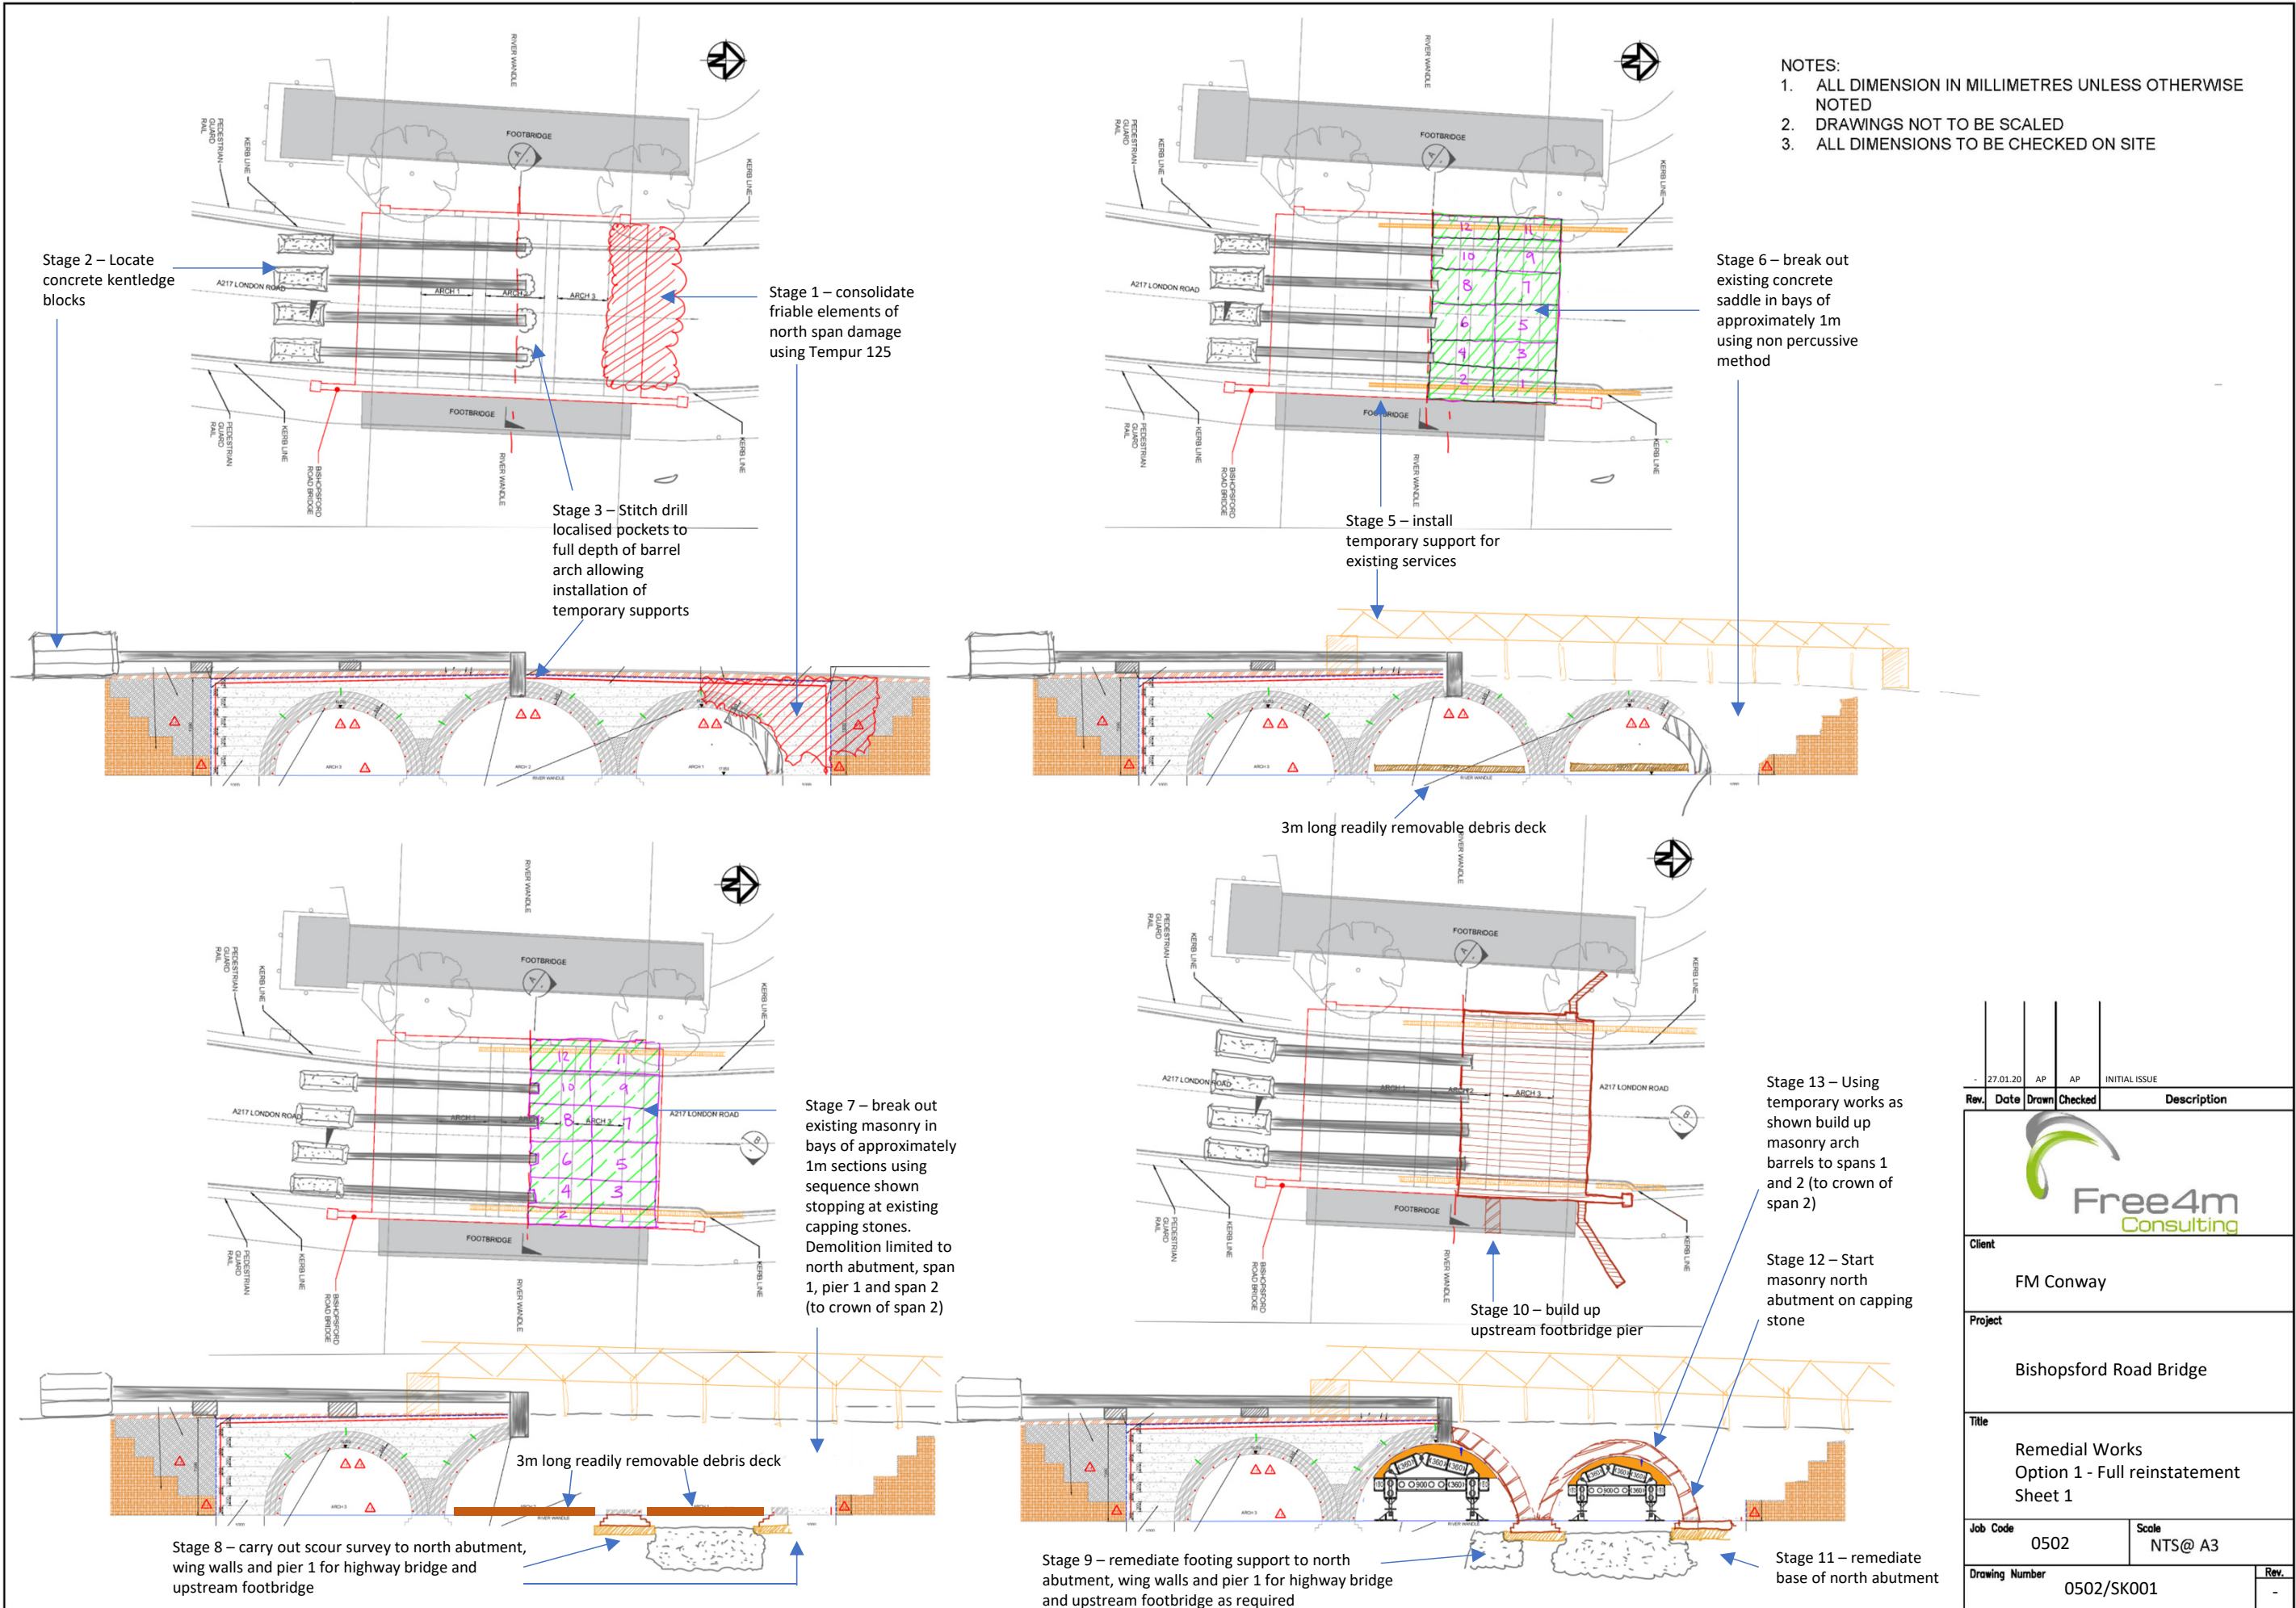
- NOTES:
1. ALL DIMENSION IN MILLIMETRES UNLESS OTHERWISE NOTED
 2. DRAWINGS NOT TO BE SCALED
 3. ALL DIMENSIONS TO BE CHECKED ON SITE

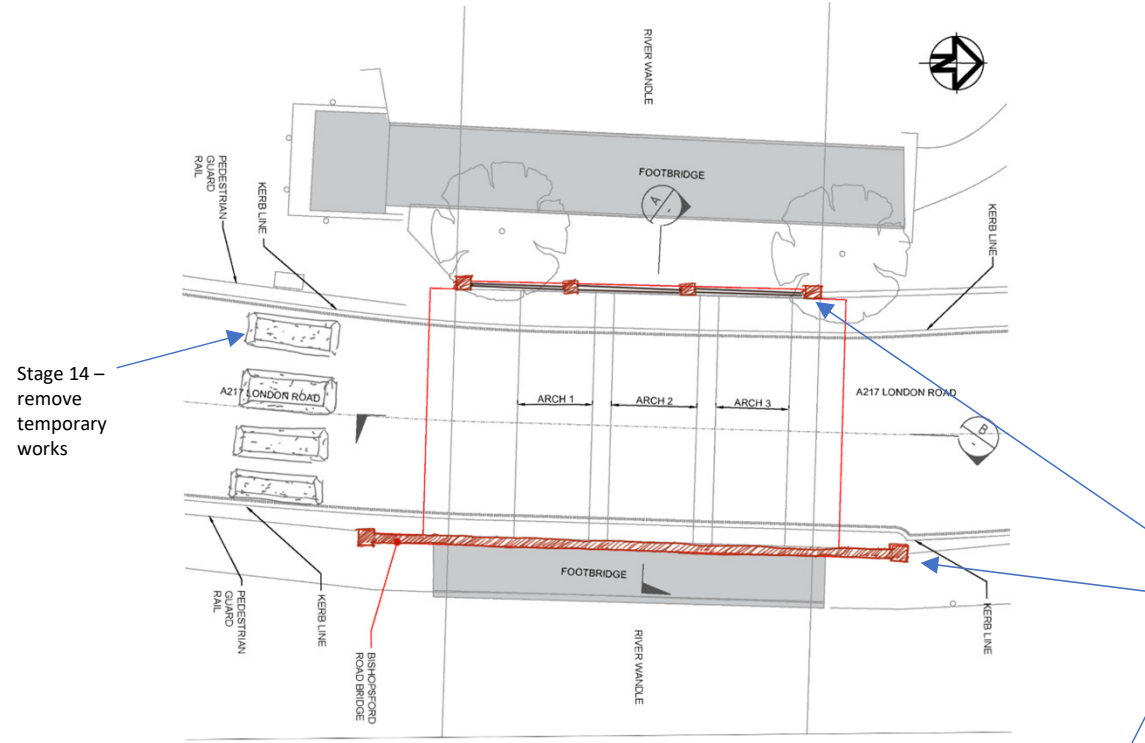
Stage 14 – remove temporary works

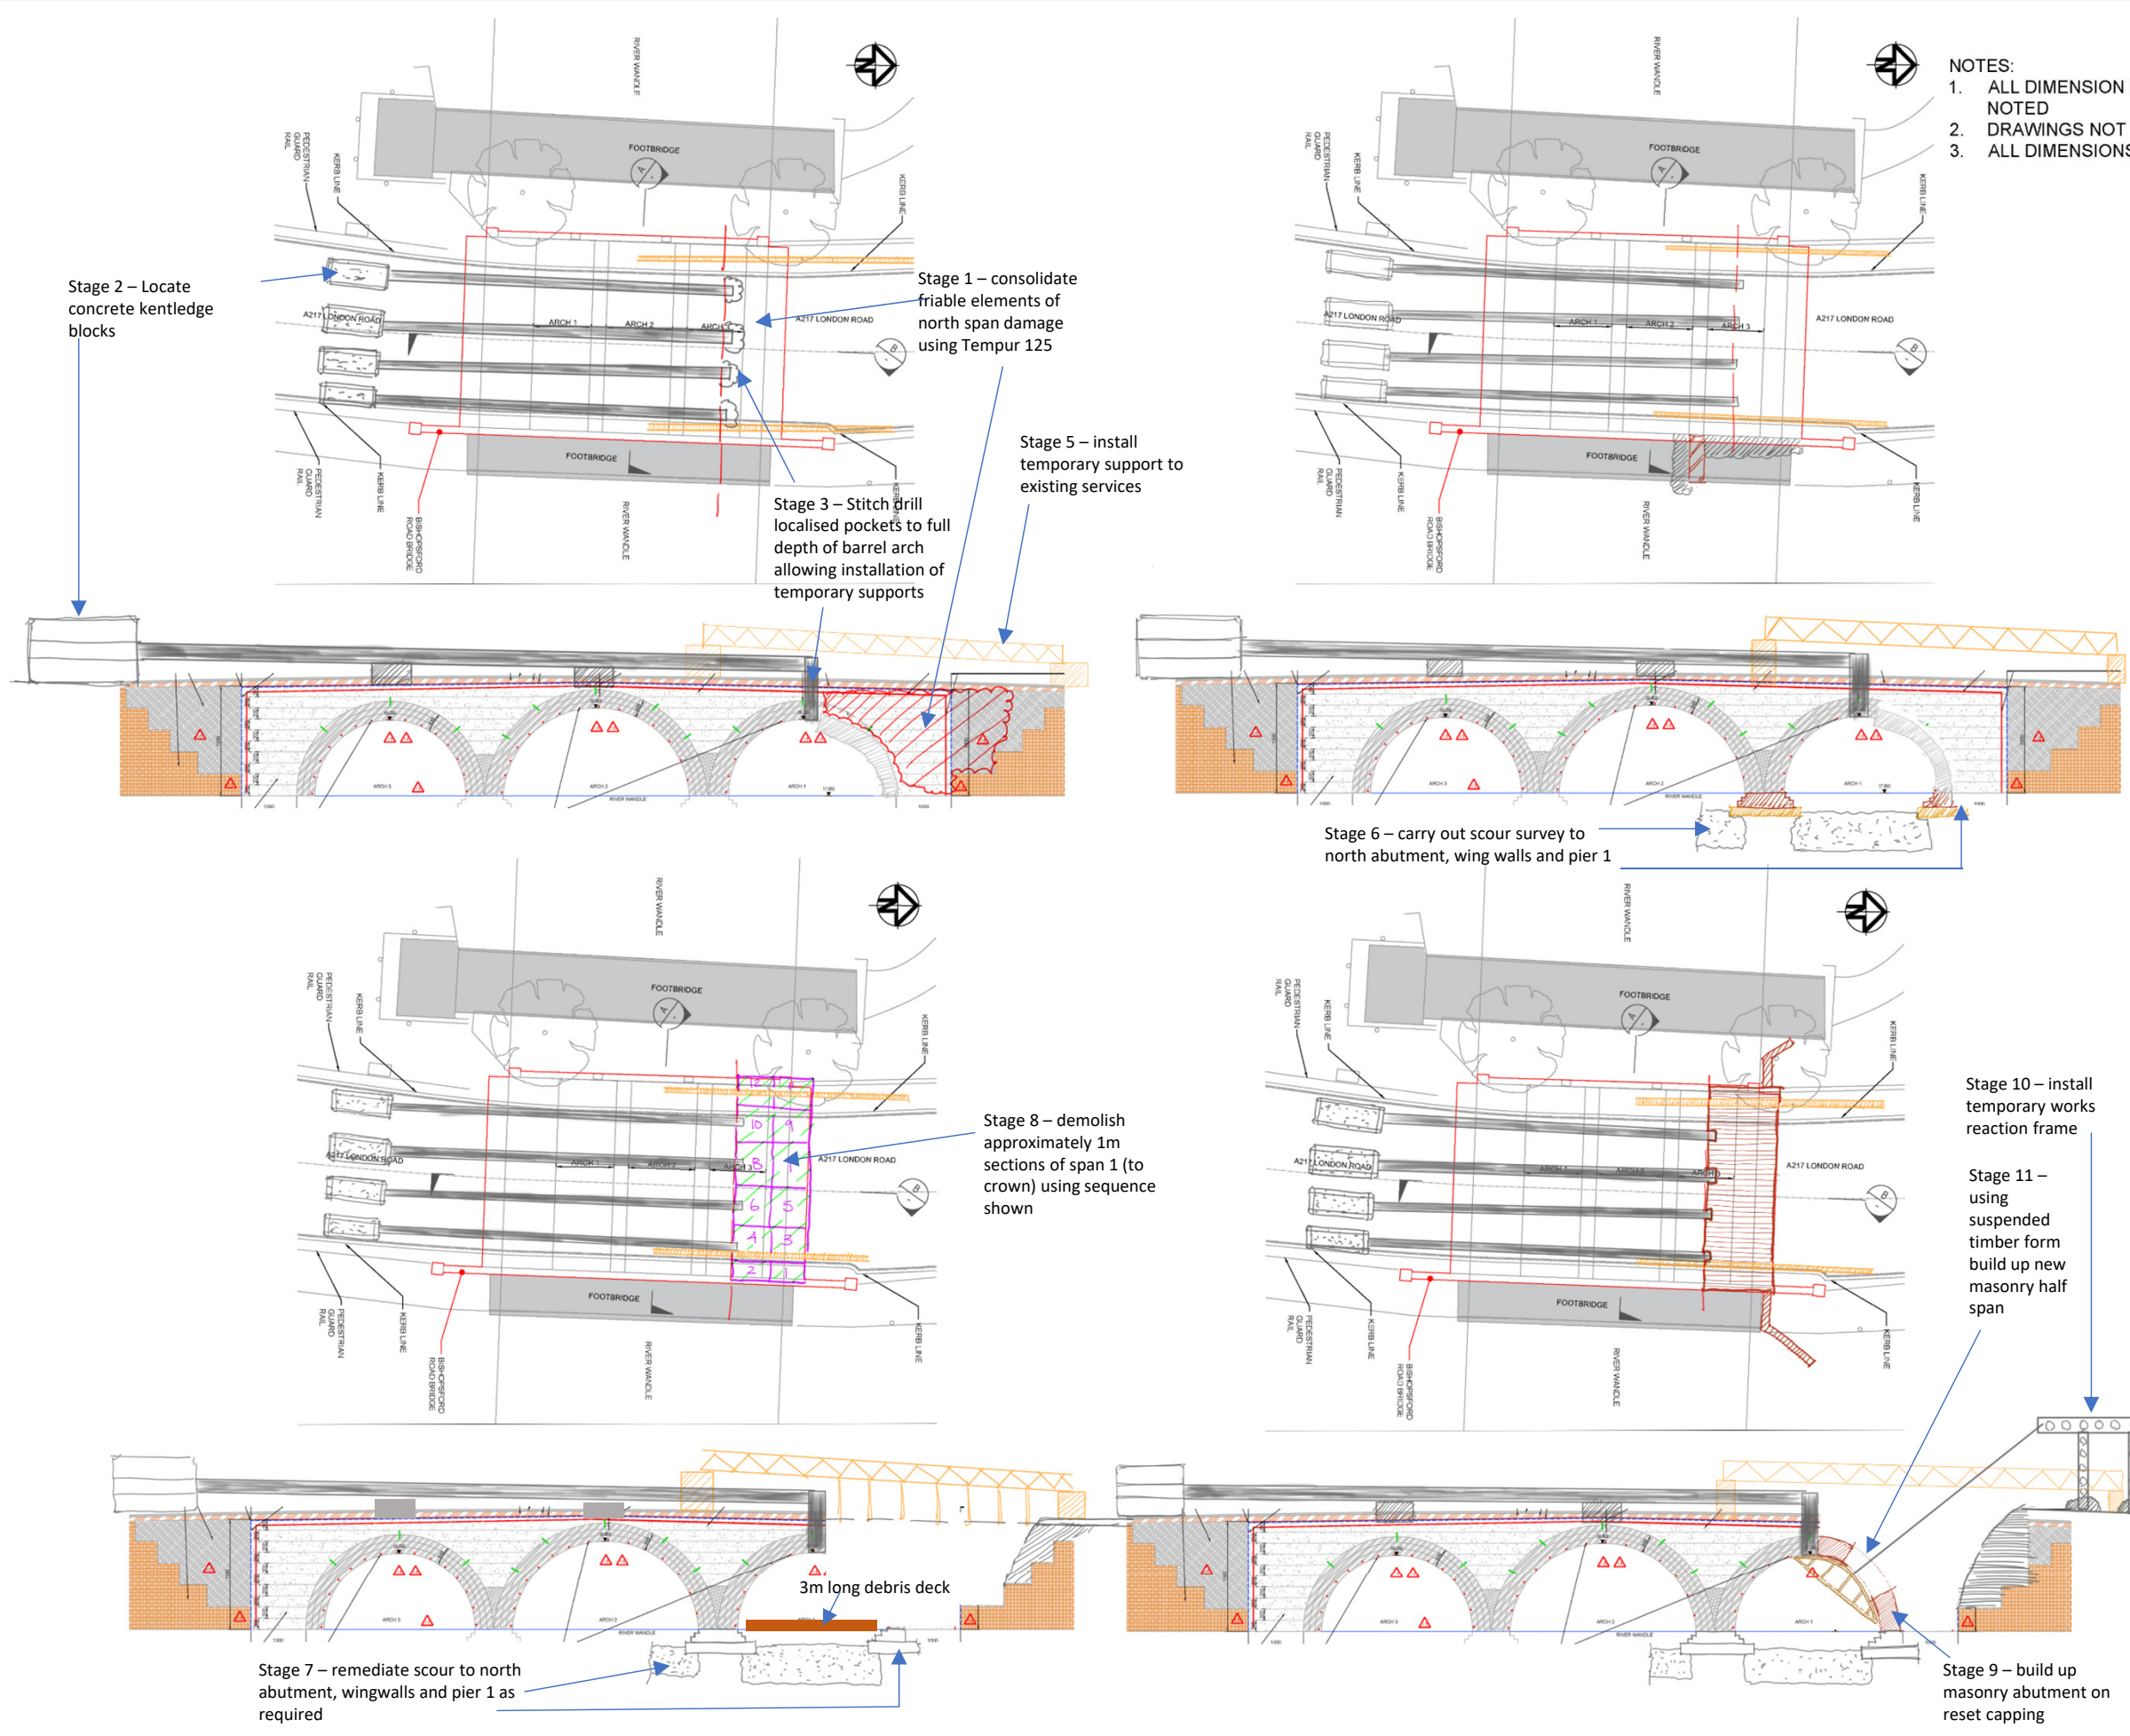
Rev.	Date	Drawn	Checked	Description
-	27.01.20	AP	AP	INITIAL ISSUE

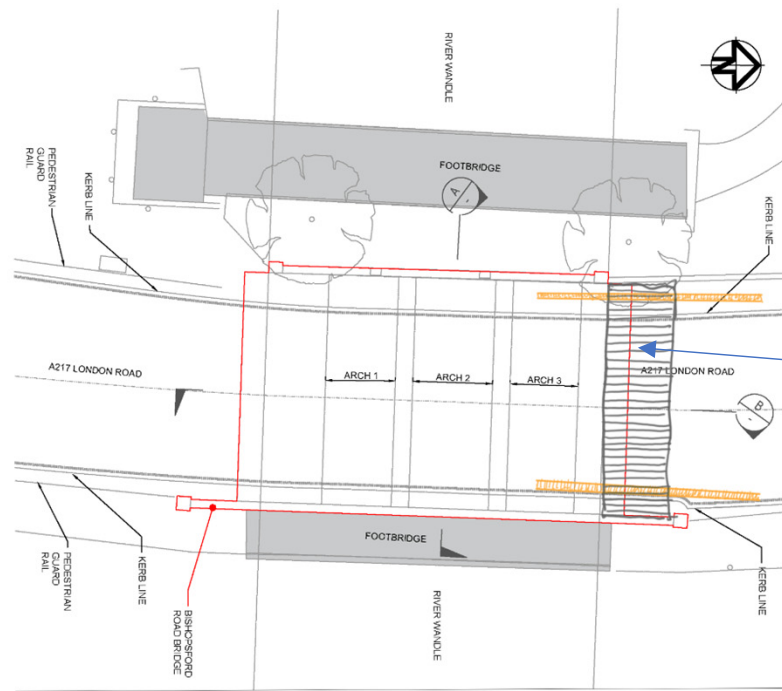
Stage 16 – backfill using concrete to form new saddle in accordance with Arcadis details
