Free4m 0502

Bishopsford Rd Bridge, Merton

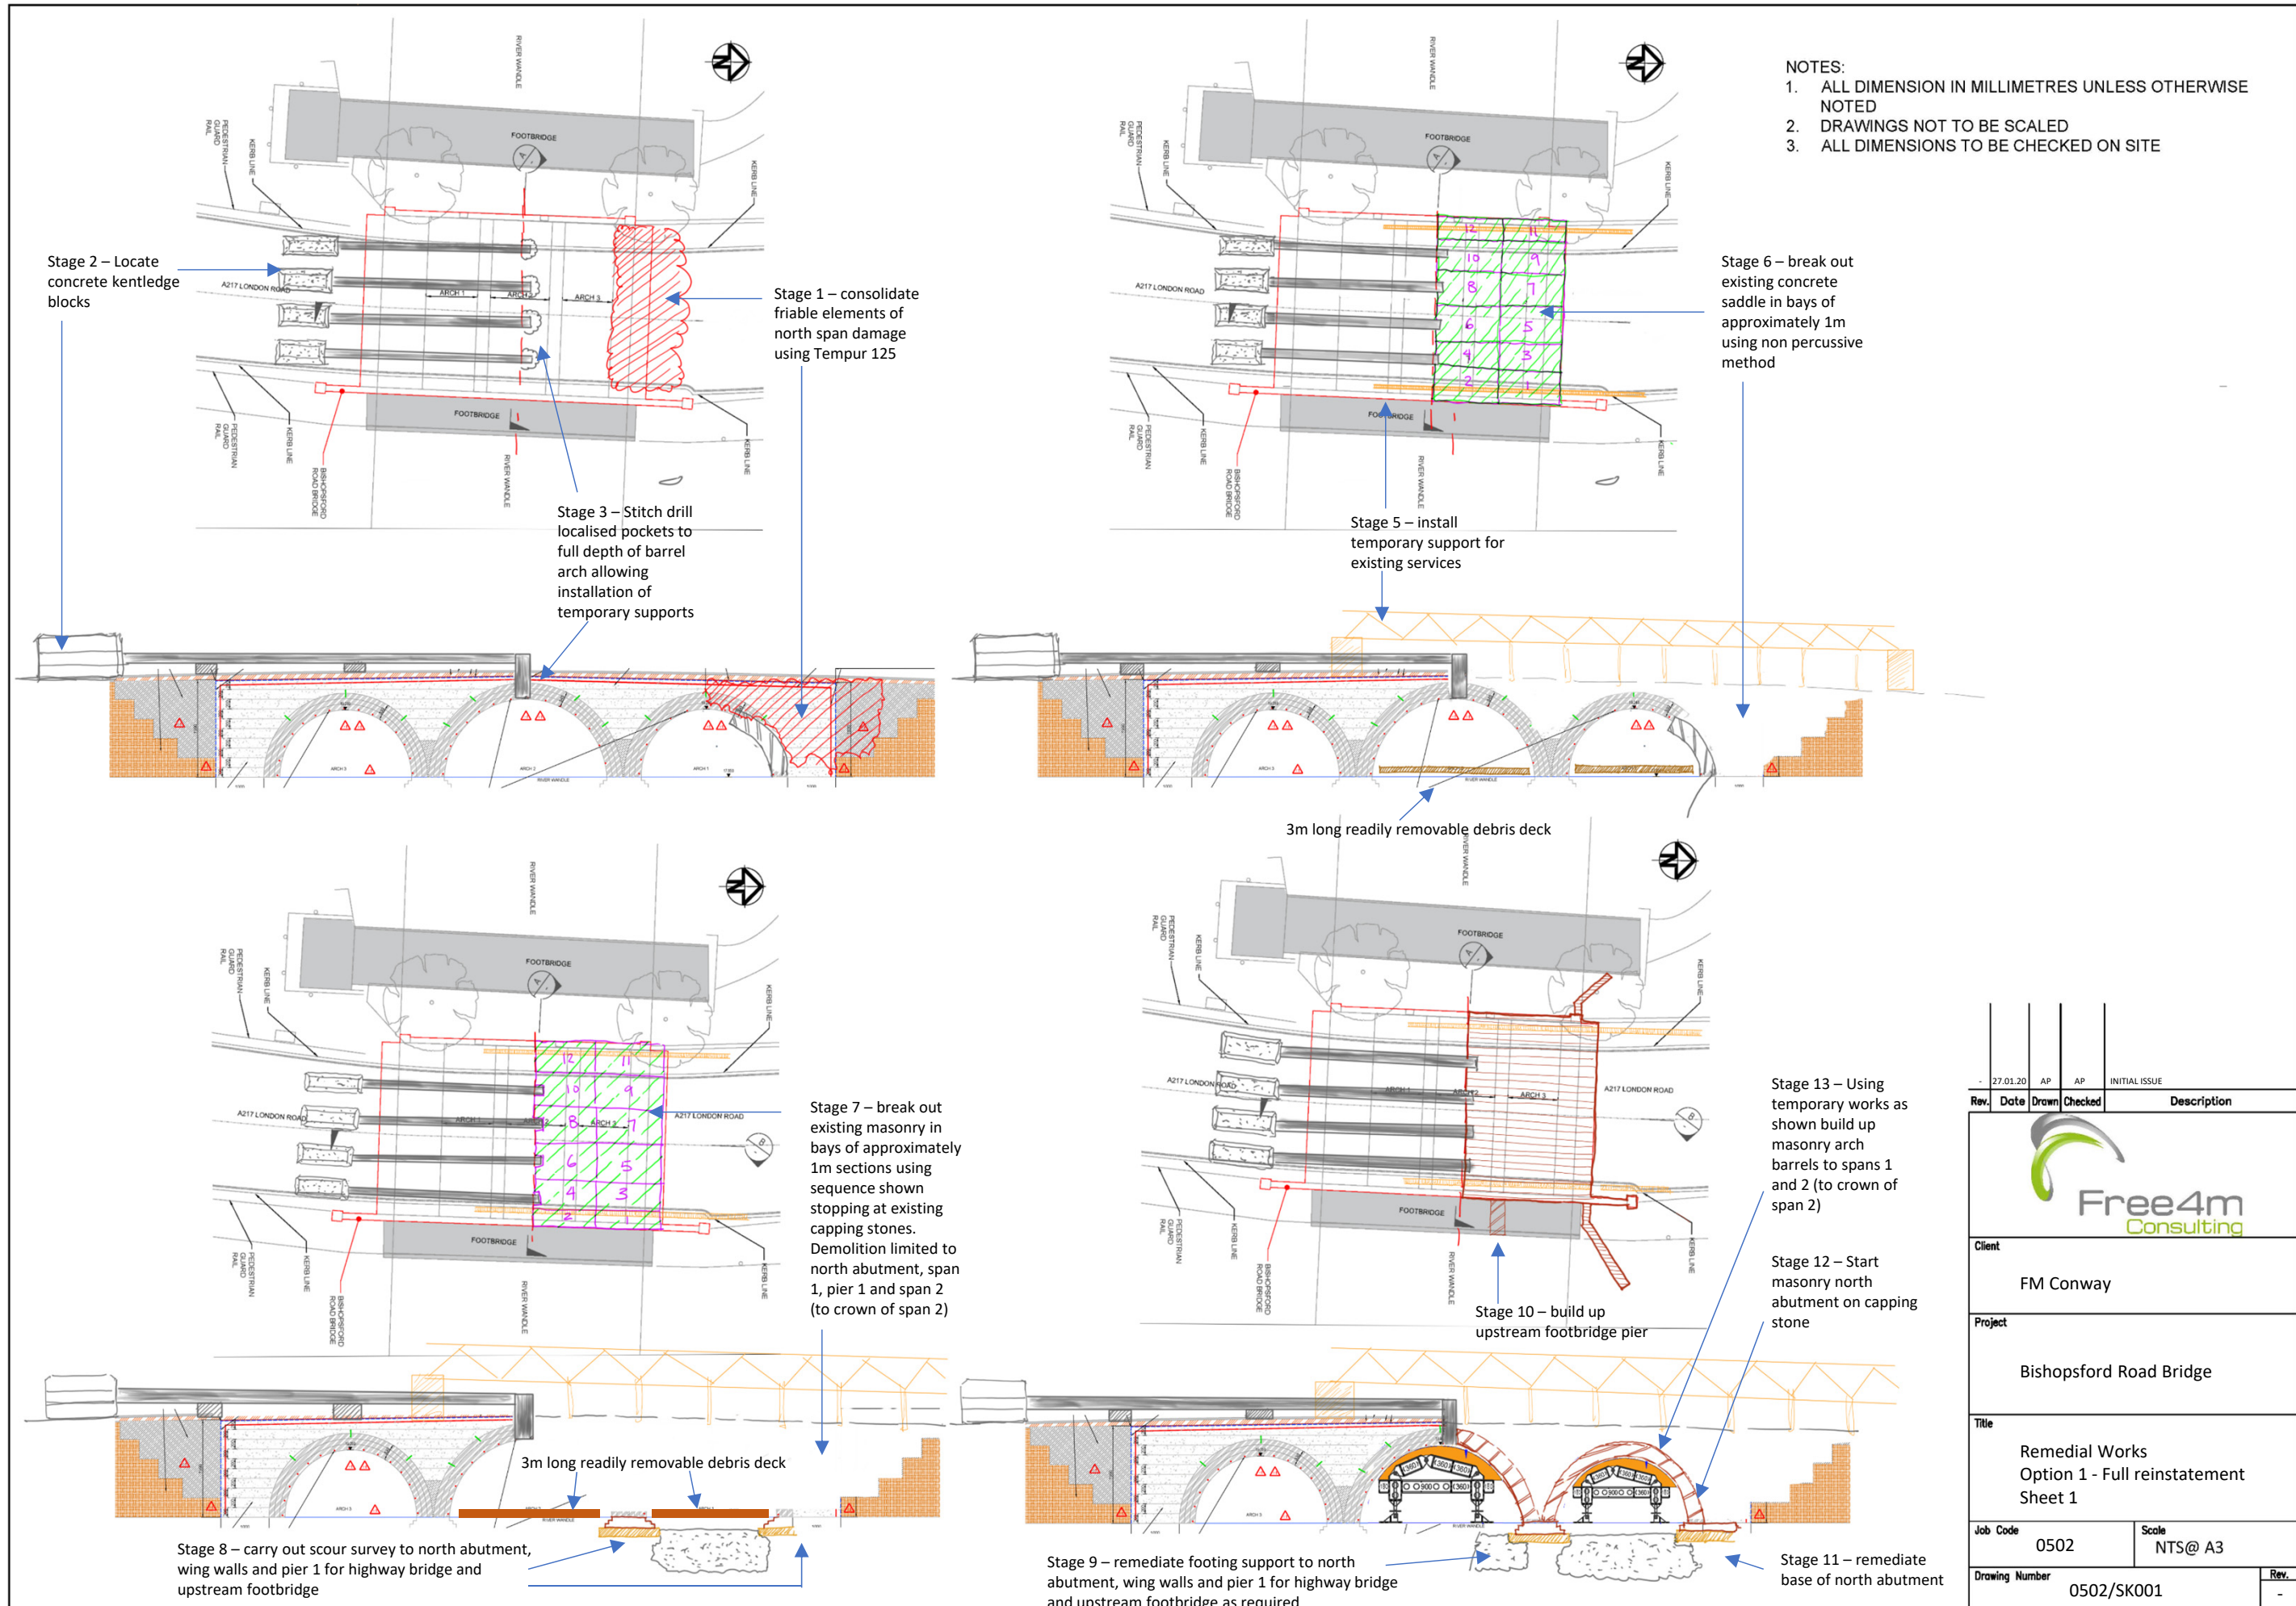
- NOTES:
1. ALL DIMENSION IN MILLIMETRES UNLESS OTHERWISE NOTED
 2. DRAWINGS NOT TO BE SCALED
 3. ALL DIMENSIONS TO BE CHECKED ON SITE

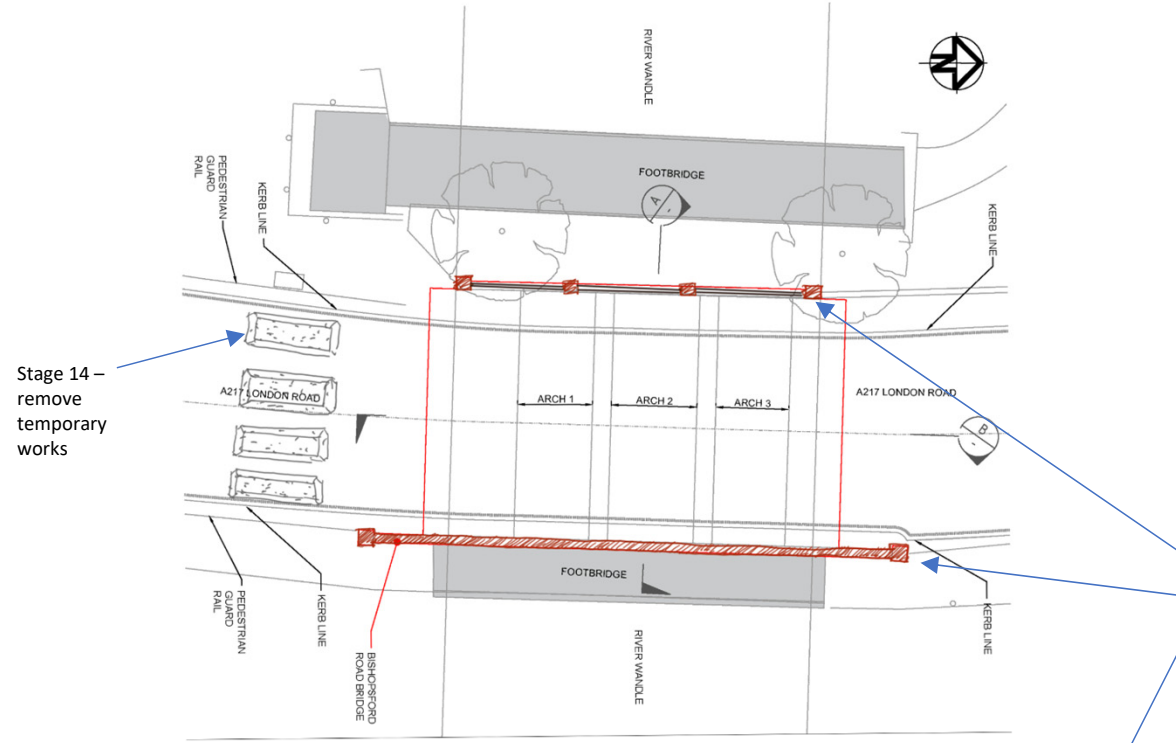
Stage 14 – remove temporary works

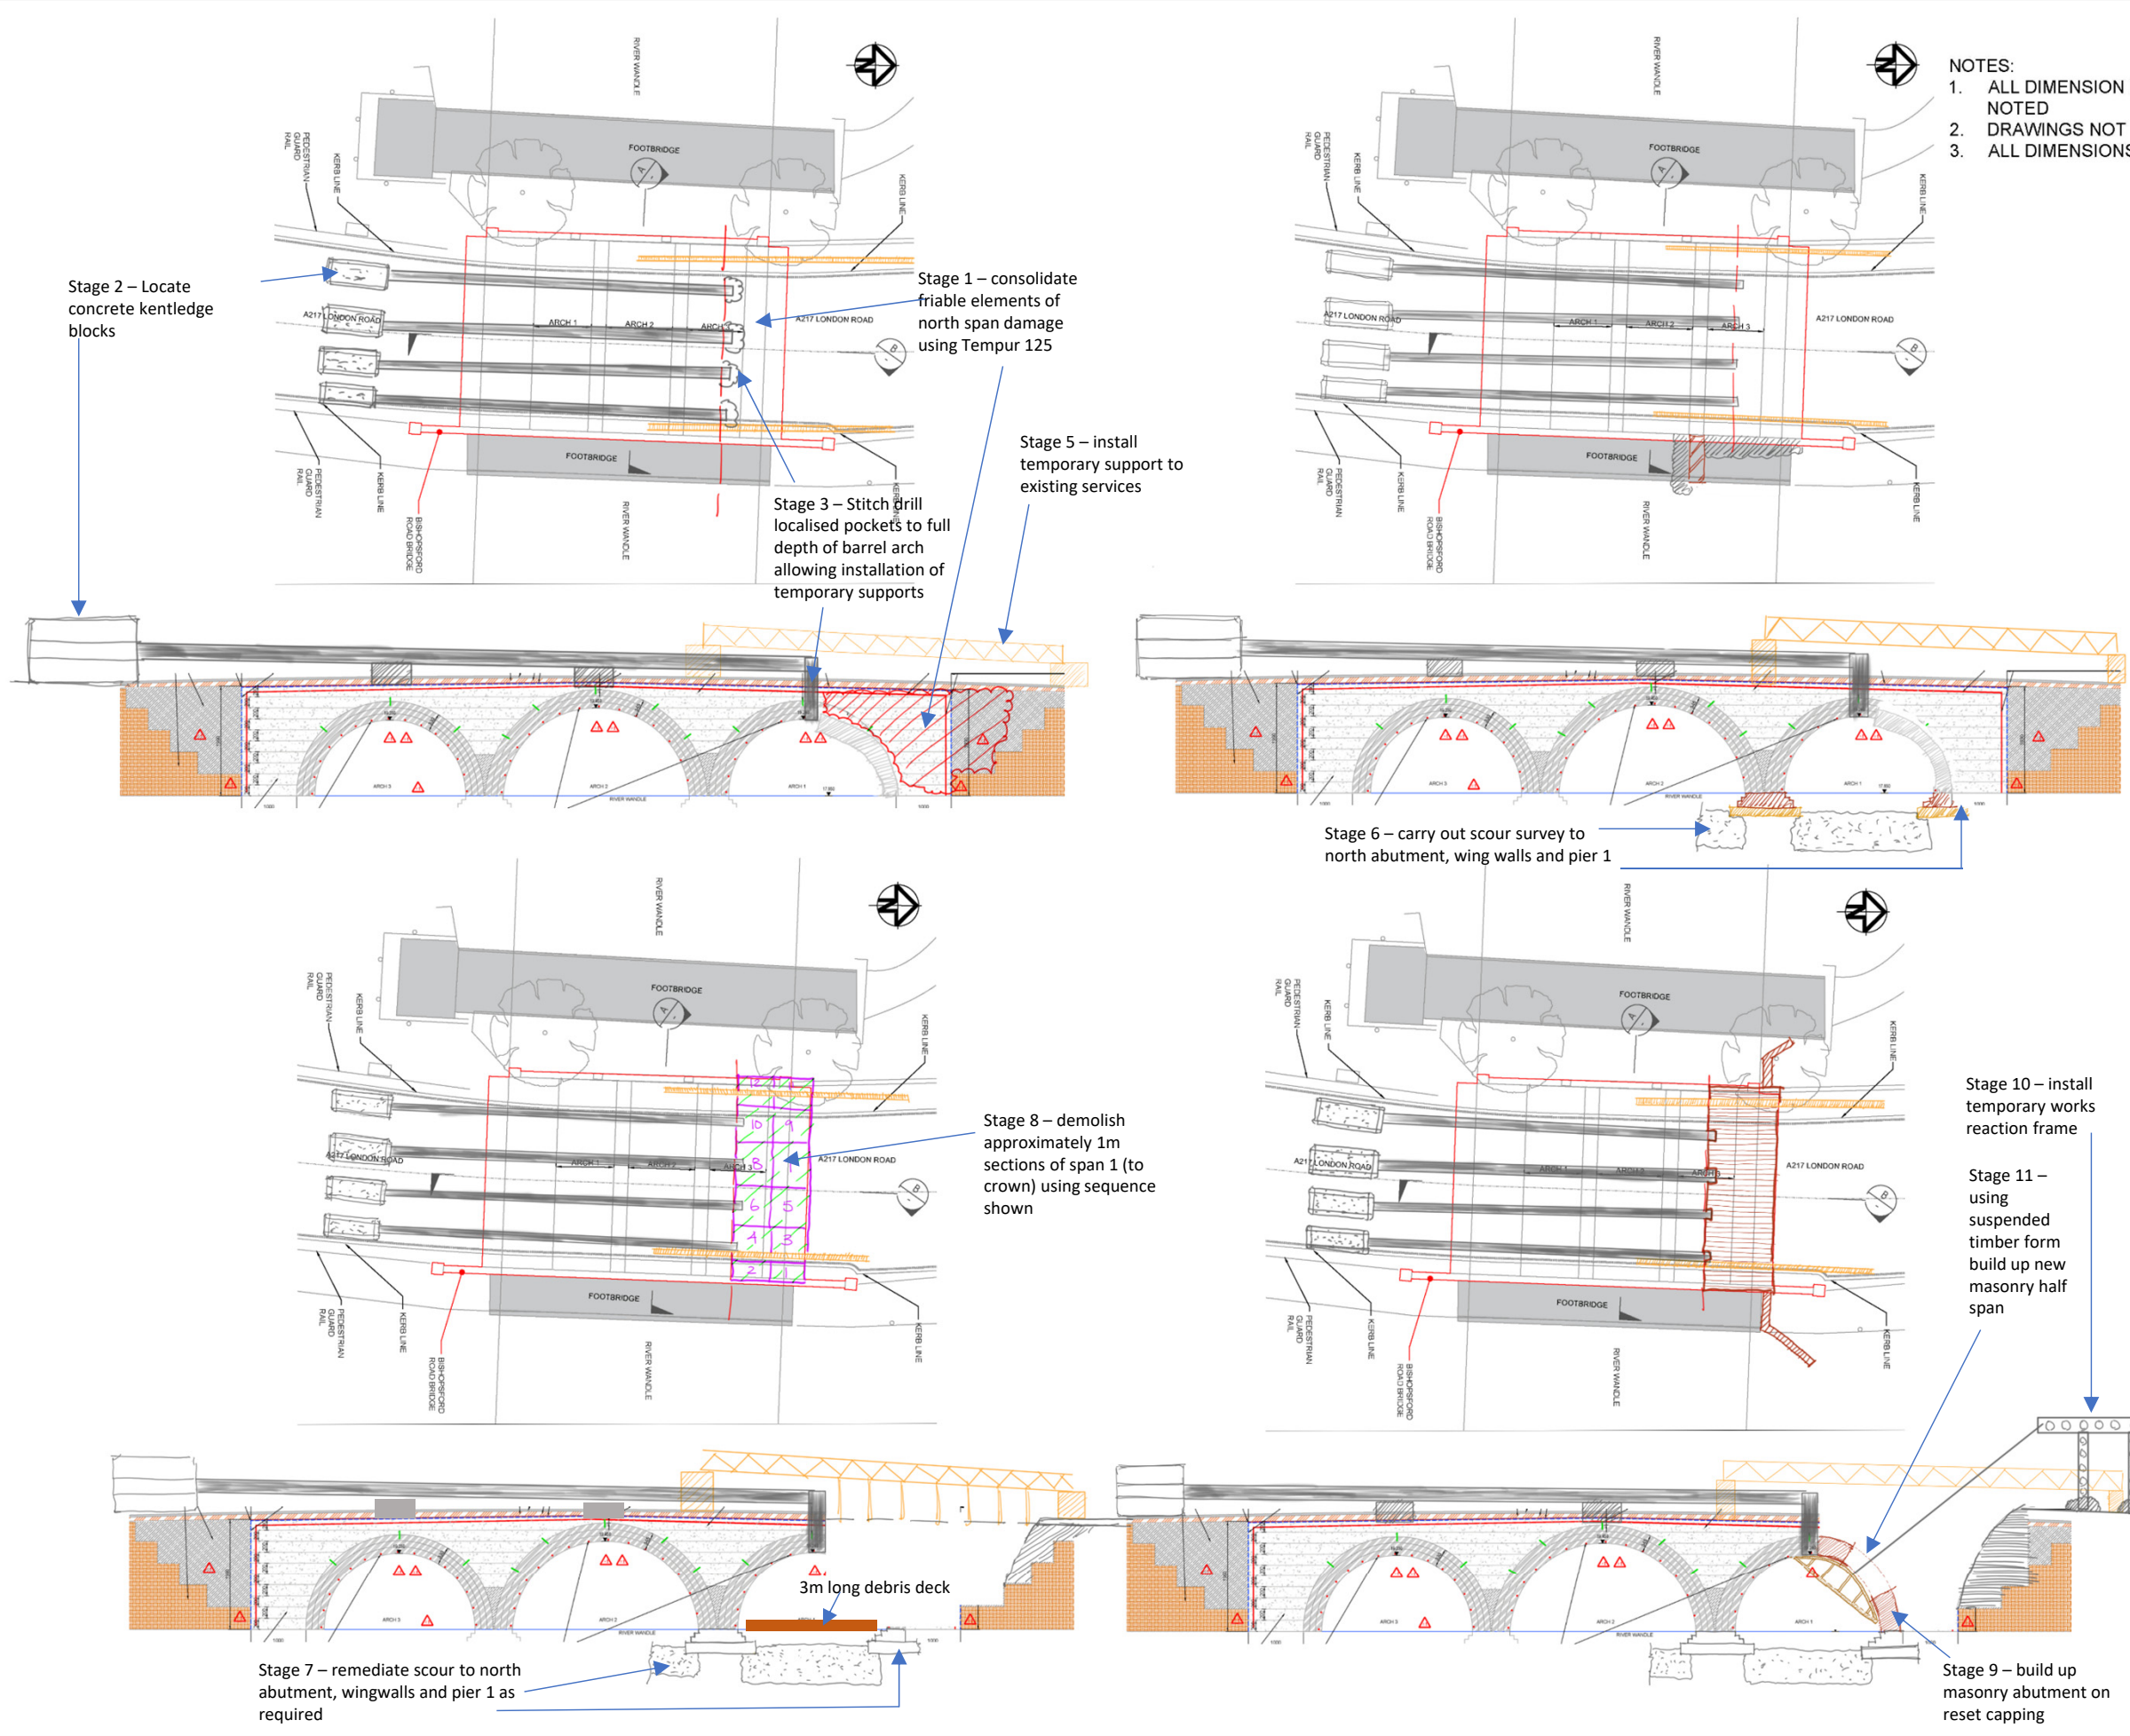
Rev.	Date	Drawn	Checked	Description
-	27.01.20	AP	AP	INITIAL ISSUE

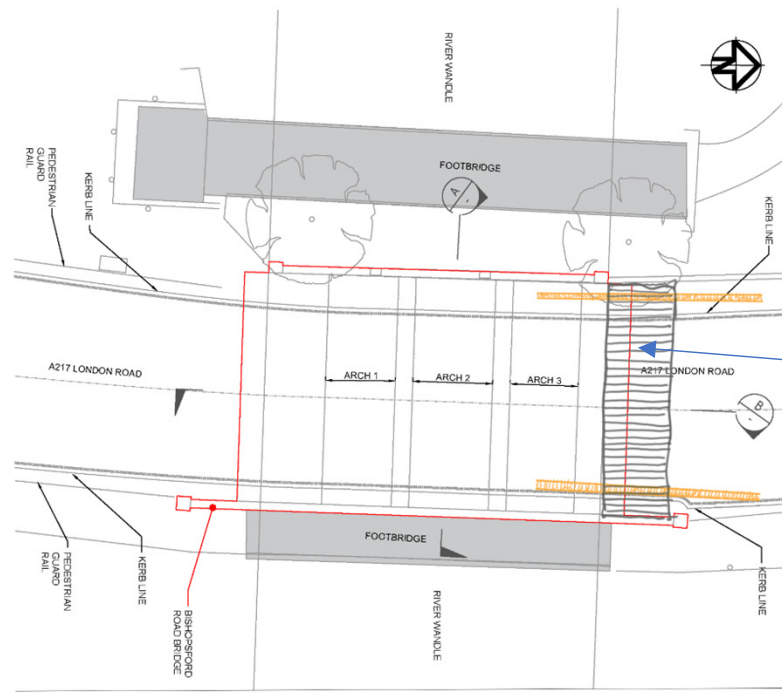
Stage 16 – backfill using concrete to form new saddle in accordance with Arcadis details
