NOS. 24, 22 AND 20 LEOPOLD ROAD. Below: Historic features which have been retained.

Level of Maintenance, Apparent Level of Prosperity, and Contribution to the Character of the Conservation Area

JUSTIFICATION FOR RETAINING THE CONSERVATION AREA

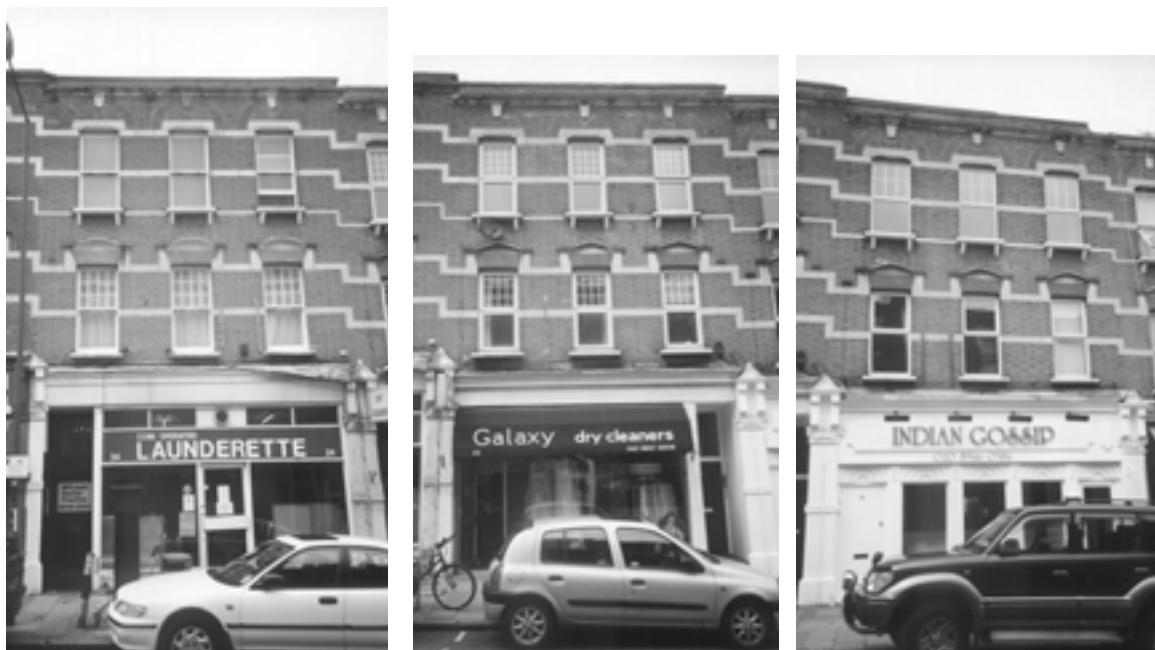
No.24: Used as a coin operated Launderette since 1963, with a modern utilitarian front. **Shop Front:** Picture windows exposing washing machines etc. to public view. Centrally placed modern shop door. **Fascia:** The original fascia has been left bare, and the shop fascia has been built into the shop front immediately above door head height; simple white lettering on a blue background. **Blind:** Remains of blind hanging from top of fascia. **Side access:** Retained; leads to dental practice. The upper floors are used as offices. **Level of maintenance:** Minimal. **Apparent level of prosperity:** Moderate. **Contribution to CA:** Negative.

No.22: A dry cleaners with a smart, modern utilitarian front. **Shop front:** large picture window revealing clothes hanging on racks. In contrast to the washing machines next door, their exposure is not detrimental to the street scene. **Blind:** Smart dark blue Dutch blind with white lettering immediately below original fascia. **Side access:** retained. **Upper floors:** Original windows replaced with modern plastic replicas. **Level of maintenance:** high. **Apparent level of prosperity:** high. **Contribution to CA:** positive.

No. 20: Used as an Indian restaurant since 1972, with an attractive modern front installed in 1990 which attempts at period character in the detailing; painted white throughout. **Shop front:** A 5-bay design, with the restaurant entrance at one end, the side entrance at the other and three windows in the centre. Ornamental 'lintels' over the doors and windows. **Fascia:** deepened to accommodate elegant raised lettering on raised panel, spot lit. **Blind:** retained. **Side access:** retained and arranged to form part of composition. **Upper floors:** Original windows replaced with modern plastic replicas. 6-light to upper half of 2nd. floor. **Level of maintenance:** high. **Apparent level of prosperity:** high. **Contribution to CA:** positive.

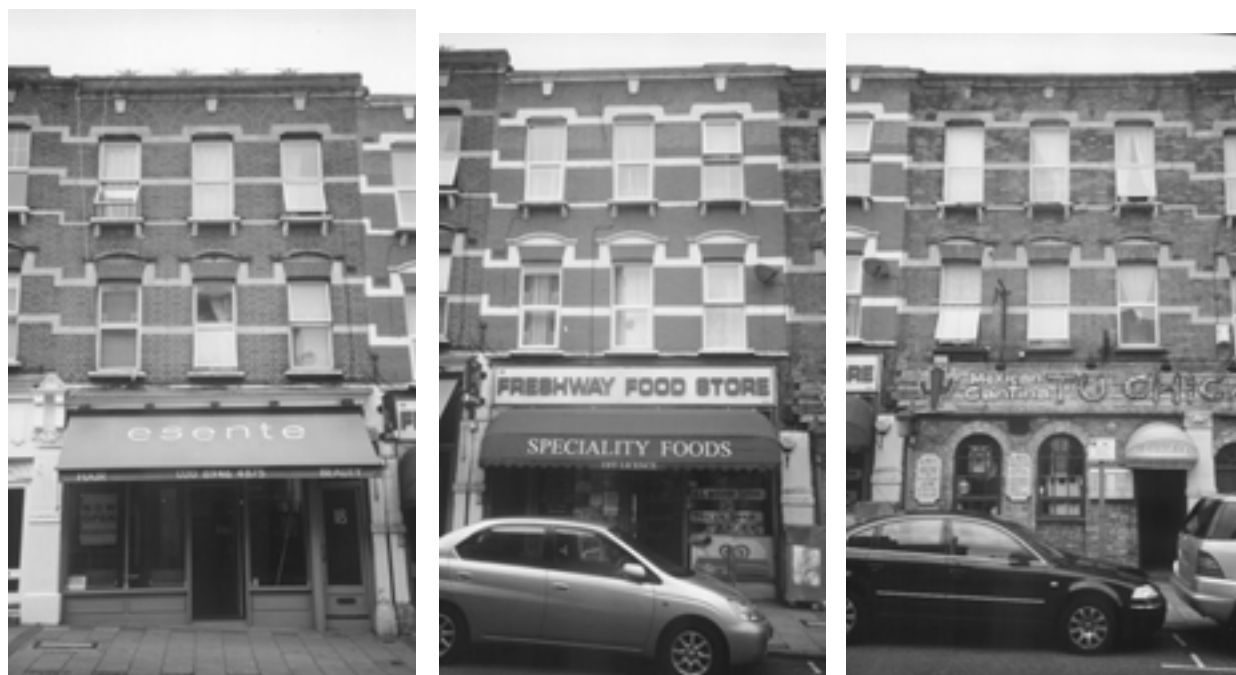
NOS. 18, 16 AND 14 LEOPOLD ROAD. Below: Historic features which have been retained.

No. 18: A hair and beauty salon extended at the rear in 1988, with an elegantly designed, modern front, painted throughout in discrete café latté. **Shop front:** Four-light front with asymmetrically placed entrance; windows separated with thin ornamental mullions; panelled stall riser. **Fascia:** hidden by blind. **Blind:** retained; coloured to match shop front, with elegant white lettering. **Side entrance:** retained, designed and coloured to match the shop front. **Upper floors:** Original windows replaced by modern top hung replicas. **Level of maintenance:** high. **Apparent level of prosperity:** high. **Contribution to CA:** positive.

No. 16: Used as a grocers since at least 1964, now a speciality food supplies store and off-licence with a modern, utilitarian, garish front installed in 1986. **Shopfront:** Picture windows in bright red frames, used as advertising hoardings; covered in notices and 'special offers'; centrally placed doorway. **Fascia:** Modern, large harsh red lettering on white background. **Blind:** modern Dutch blind, bright red with white lettering. **Side entrance:** modern, red painted frame. **Upper floors:** brickwork painted dark pink with string courses and lintels picked out in white; original windows replaced with modern top hung casements. **Level of maintenance:** Moderate. **Apparent level of prosperity:** moderate. **Contribution to CA:** Strongly negative, mainly because of treatment to brickwork of upper floors.

No. 14: (with No. 12): Used as a licensed Mexican cantina and coffee bar since 1982 which apparently attempts to create a Mexican 'Wide West' impression, which is a totally unsuitable treatment to a sensitively designed period property. **Shop front:** replaced with two round-arched windows and a doorway in bright blue frames surrounded by multi-coloured yellow brickwork. Menus and other notices in panels between the windows. Pilasters painted yellow and corbels removed. **Fascia:** replaced with rough-hewn horizontal boarding soiled to look weather-beaten. Lettering which may be intended to look as though it is made out of cacti; with a sketch of a cactus at one end. **Blind:** removed. Bright yellow 'Dutch' blind over doorway. **Side entrance:** removed. **Upper floors:** Original windows replaced by modern top-hung casements. A hanging sign has been installed at first floor level. **Level of maintenance:** moderate. **Apparent level of prosperity:** moderate. **Contribution to CA:** Seriously detrimental.

- Owners should be encouraged to replace such lost historic features as fascias, blinds, entrances to upper floors and first and second floor windows. The owners of Nos. 10 and 16 should be encouraged to remove the paintwork from brick facades, and no further painting or other defacing of the upper floors should be permitted. A scheme of grant aid, possibly funded from S.106 Agreements, should be considered to ensure that any repairs are sympathetic with the original character and materials.

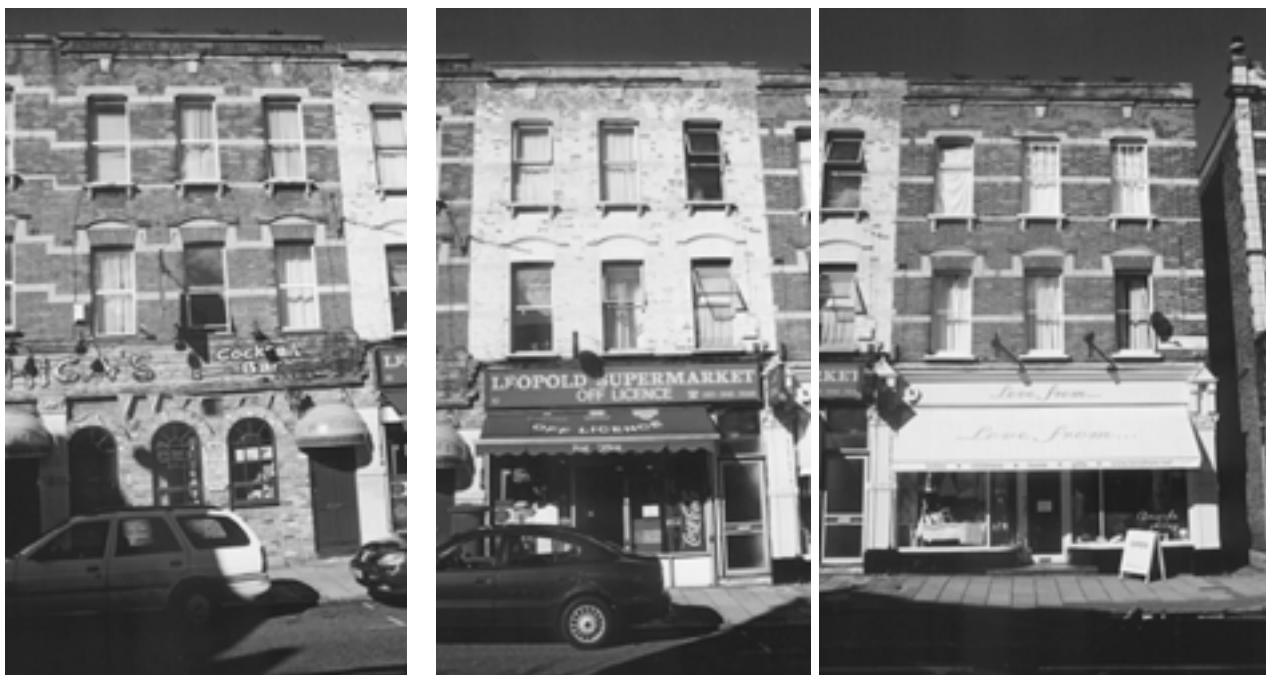
NOS. 12, 10 AND 8. LEOPOLD ROAD. Below: historic features which have been retained.

No. 12 (with No. 14): A continuation of No. 14, with the same character. The only difference is that the **side access** has been retained, there is yellow bunting hanging from the bottom of the fascia, and there is another hanging sign at first floor level. The overall treatment continues to be seriously detrimental to the character of the Conservation Area.

No. 10: A supermarket, off-licence and post office with a modern with a utilitarian front installed in 1984. **Shop front:** Modern metal framed picture windows with white painted stall risers, the entrance being placed centrally. The windows are used as advertisement hoardings, cluttered with adverts and notices. **Fascia:** replaced with deeper modern fascia in green with large yellow lettering. Hanging sign at fascia level. **Blind:** Traditional blind under fascia, in dark green with white lettering. **Side access:** retained, modern metal framed door. **Upper floors:** Brickwork painted white, much of which has peeled off. The original windows have been replaced with modern top hung replicas. **Level of maintenance:** poor, particularly upper floors. **Apparent level of prosperity:** poor. **Contribution to CA:** negative.

No. 8: A decorous candy-coloured gift shop designed to appeal to the feminine shopper. **Shop front:** A pair of symmetrically arranged picture windows with low black stall risers, each side of curved glazing and a central recessed door, the narrow frames, pilasters and corbels painted pale pink. **Fascia:** Painted pale pink to match, with red script lettering. **Blind:** Traditional blind below fascia in white with pink script lettering. **Side entry:** Down alleyway. **Upper floors:** Original sashes retained, except for top left window, which is modern top hung casement. **Level of maintenance:** high. **Apparent level of prosperity:** high. **Contribution to CA:** positive.

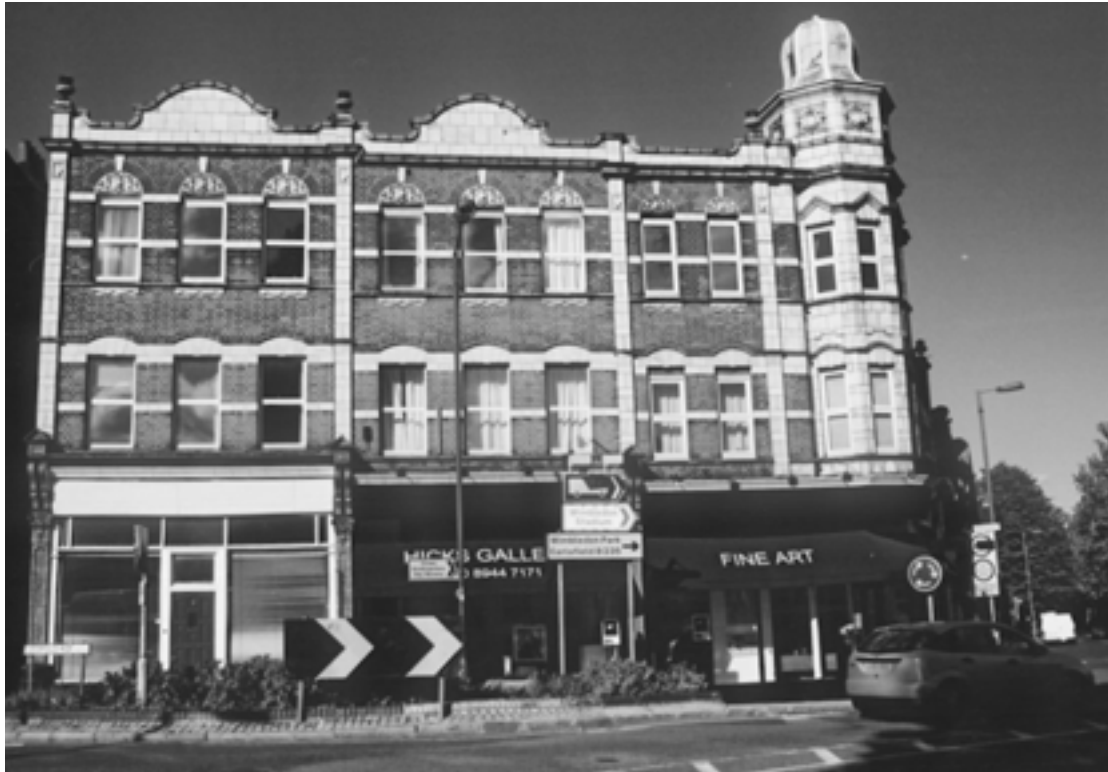
NOS. 6 , 4 AND 2 LEOPOLD ROAD. Below: historic features which have been retained.

The north side of Leopold Road and the south end of Strathearn Road from the east.

No. 6: An anonymous, utilitarian front; the ground floor may be used as offices. **Shop front:** modern white painted frames, centrally placed black painted panelled door, picture windows with horizontal blinds to maintain privacy, **Fascia:** blank, painted white. **Blind:** None. **Side access:** In alleyway. **Upper floors:** Original windows have been replaced by modern replicas. **Level of maintenance:** high. **Apparent level of prosperity:** high. **Contribution to CA:** Negative because lack of street presence.

Nos. 4 and 2: An art gallery with a modern high-tech minimalist front. **Shop front:** Picture windows and low stall riser painted block. The entrance is at No. 2 and No. 4 extends round the corner into Strathearn Road, with another entrance on the corner. **Fascia:** Black, no lettering. **Blind:** Below fascia, square section, black with white sans serif lettering. **Side access:** retained, modern door. **Upper floors:** Original windows retained. **Level of maintenance:** high. **Apparent level of prosperity:** high. **Contribution to CA:** positive.

The facades are more elaborate than the rest of those in the Conservation Area and are locally listed. They were built in 1908 and because of their position facing on to the busy road junction at the eastern end of the Conservation Area, they form a visual stop to the view northwards along Alexander Road.

Nos. 4 and 6: Nos. 4 and 6 each have three Georgian proportioned sash windows on each floor with brick piers of similar width to the windows. The red brickwork is decorated by pale terracotta string courses at the heads and central sash levels of the windows. The continuous plain terracotta stringcourse and lintels to the first floor windows have curved tops protected by ornamental brick corbels, and the elaborately decorated terracotta semi-circular panels over the second floor windows are surrounded by semi-circular brick arches and terracotta keystones. The second floor windows also have elaborate terracotta cills. The coping below each of the elaborate terracotta parapets is straight and that above is curved at the centre. The party walls are picked out with terracotta pilasters topped by ornamental urns.

No. 2: The façade to No. 2 is similar to those of 4 and 6 except that it incorporates a prominent octagonal tower which acts as an elaborate corner feature at the junction of Leopold and Strathearn Roads. The features of the main façade are slightly narrower to accommodate the tower and are separated from it by an additional pilaster. The tower continues the window proportions of the rest of the façade but is clad entirely in terracotta with copings over the second floor windows and ornate panels beneath a copper cupola. A single three-storey bay continues around the corner, and adjoining the three-storey section is a two-storey wing of similar design with a pair of blue painted doors below a semi-circular terracotta arch and a pair of particularly narrow first floor windows. The change from three to two storey's features a pair of ornamental scrolls in terracotta.

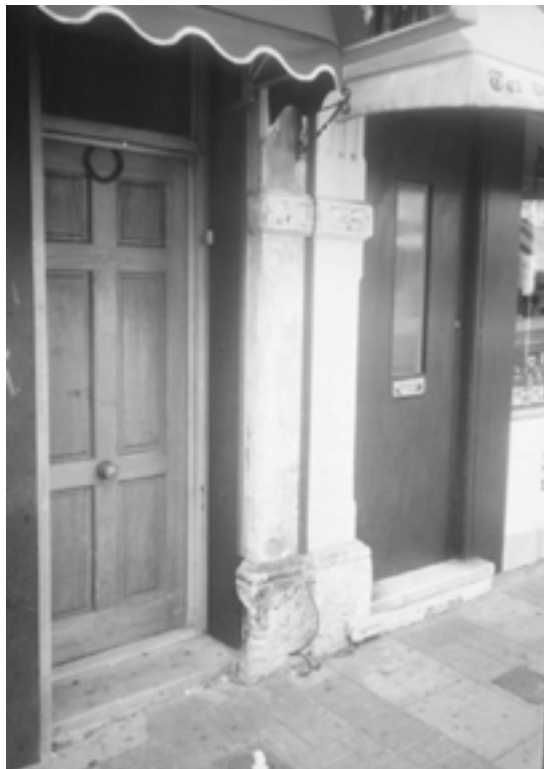
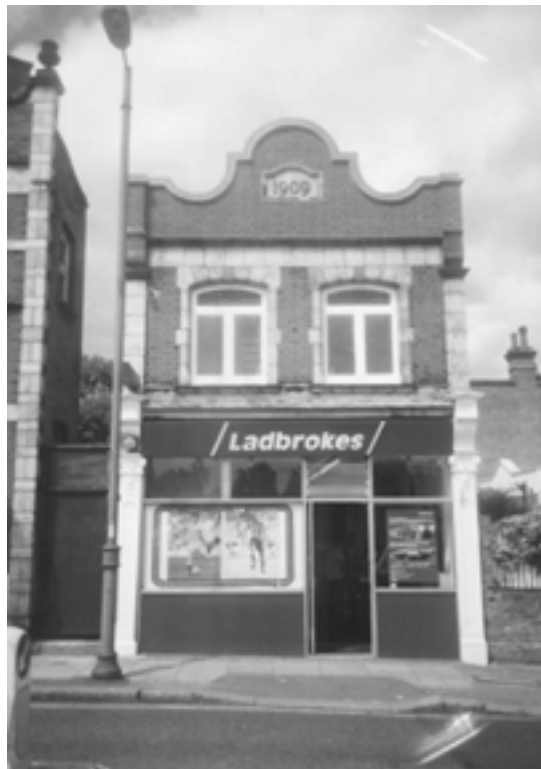
No.1a Strathearn Road: No. 1a is a detached two-storey building separated from No. 2 Leopold Road by a rear service access way. It continues many of the features of Nos. 2 to 6 Leopold Road, and the façade is topped by a scrolled parapet with '1909' in the centre. The ground floor is occupied by a turf accountant, the shop front being modern and utilitarian, with a central door, red panelled stall risers, and window posters.

Below: Left, typically inappropriate examples of modern doors providing access to the upper floors; and right, the façade to No. 1a Strathearn Road.

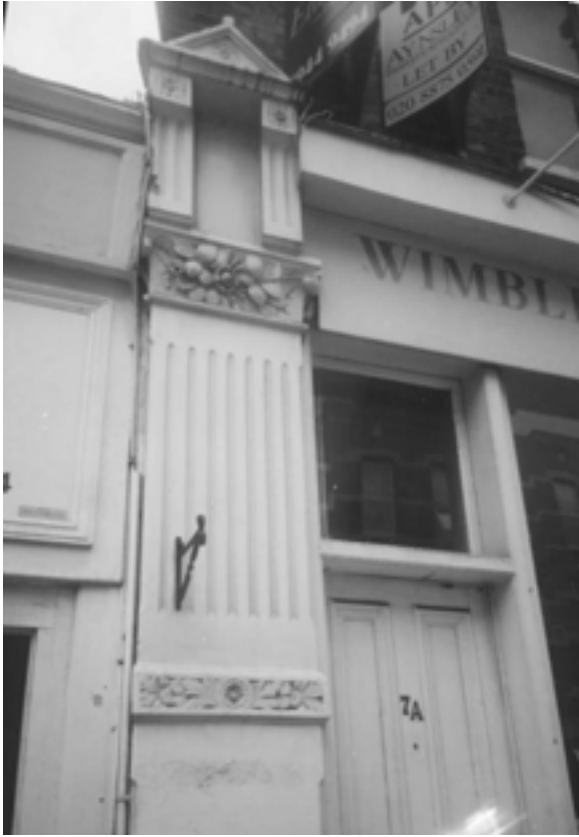
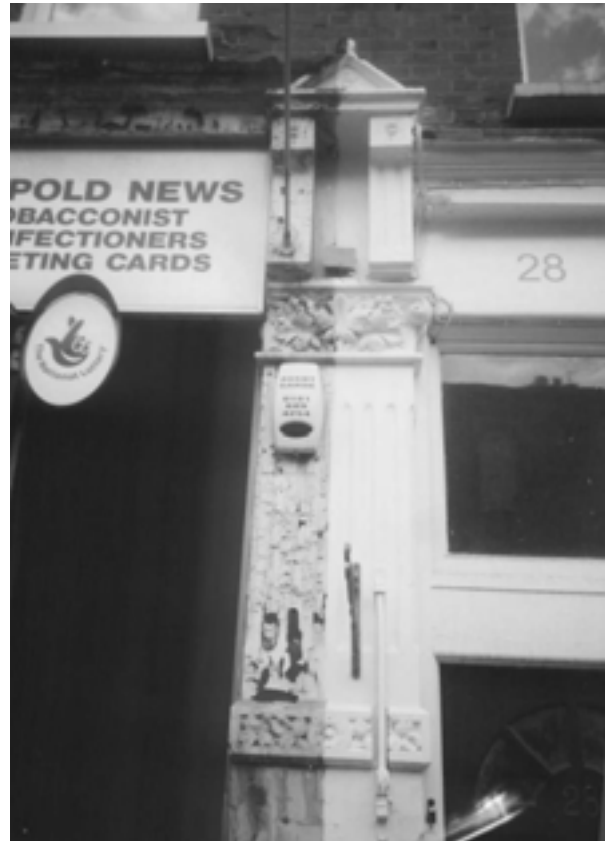
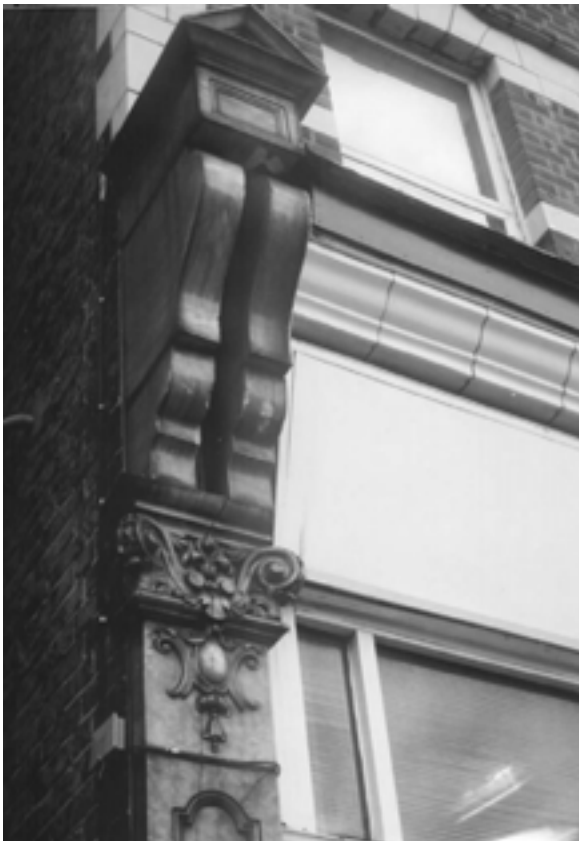
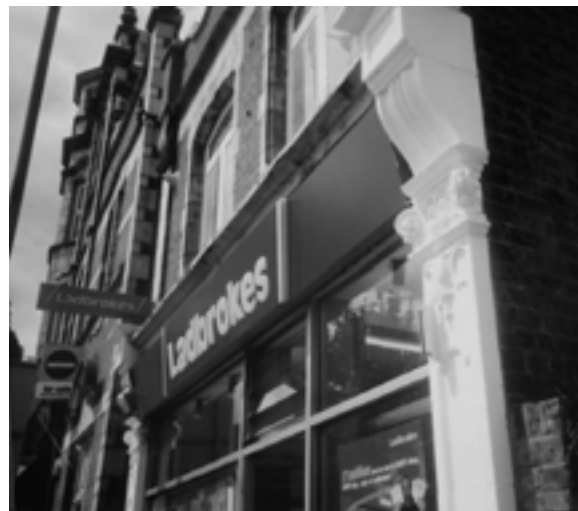
Typical examples of the ornamental pilasters and corbels between the shop fronts: Top left, a carefully restored example between Nos. 5 and 7; top right contrasting badly and well maintained examples between Nos 28 and 30; bottom left, an example of the ornate terracotta decoration to shop Nos. 2 to 6; and bottom right, the recently restored corbels and capitals to No.1a Strathearn Rd.

- It is important that, as time progresses, the further removal of those few historic features that remain, such as pilasters and corbels between the shops and some of the upper floor windows, should be prevented by means of an Article 4 Direction.

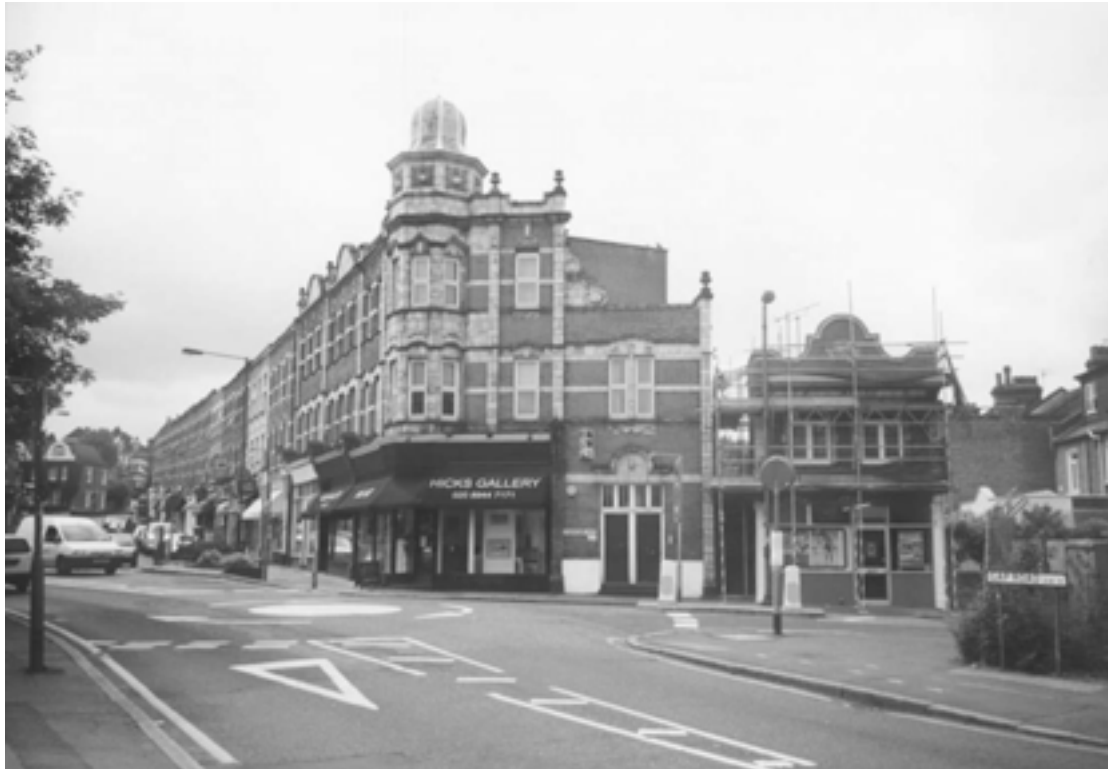
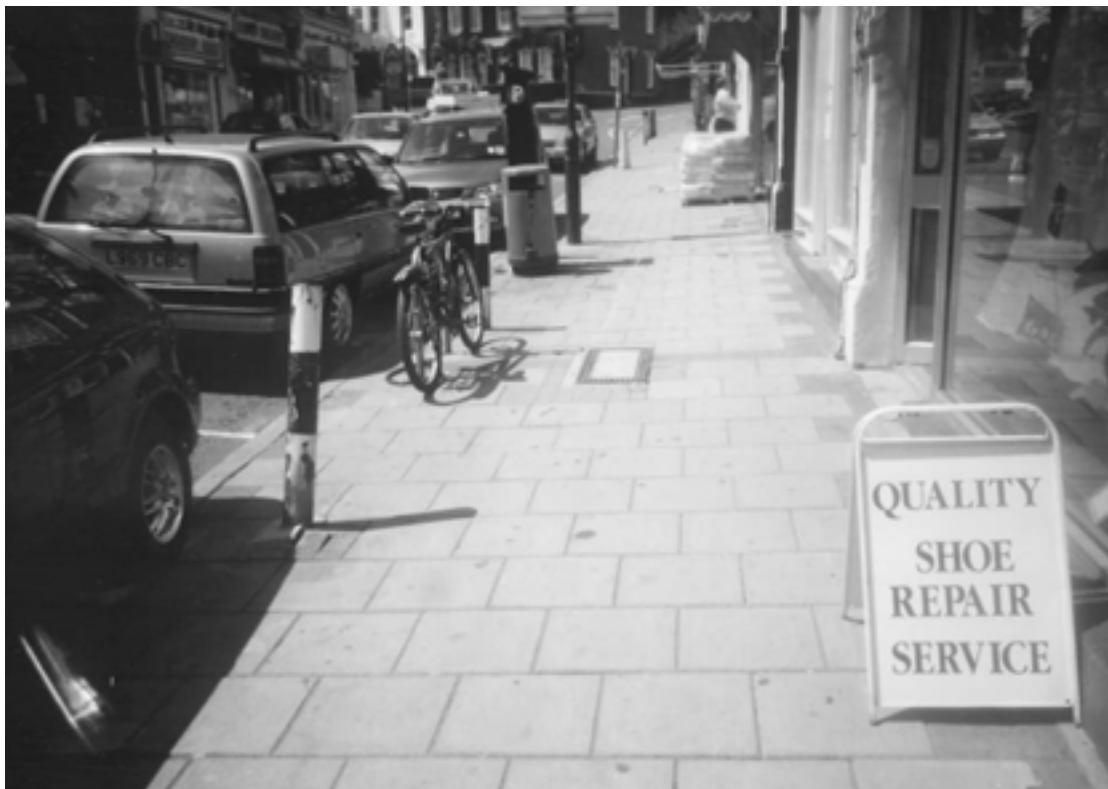
Above: the western end of the northern parade adjoining the junction of Leopold, Strathearn and Alexandra Roads, seen from Gap Road. Below: a view of the pavement on the northern side of Leopold Road, showing the typical clutter of street furniture.

- A Street Audit should be undertaken to assess the extent and quality of street furniture, and an enhancement scheme, based on the Council's emerging Street Design Guide, be produced to rationalise street furniture and minimise clutter.

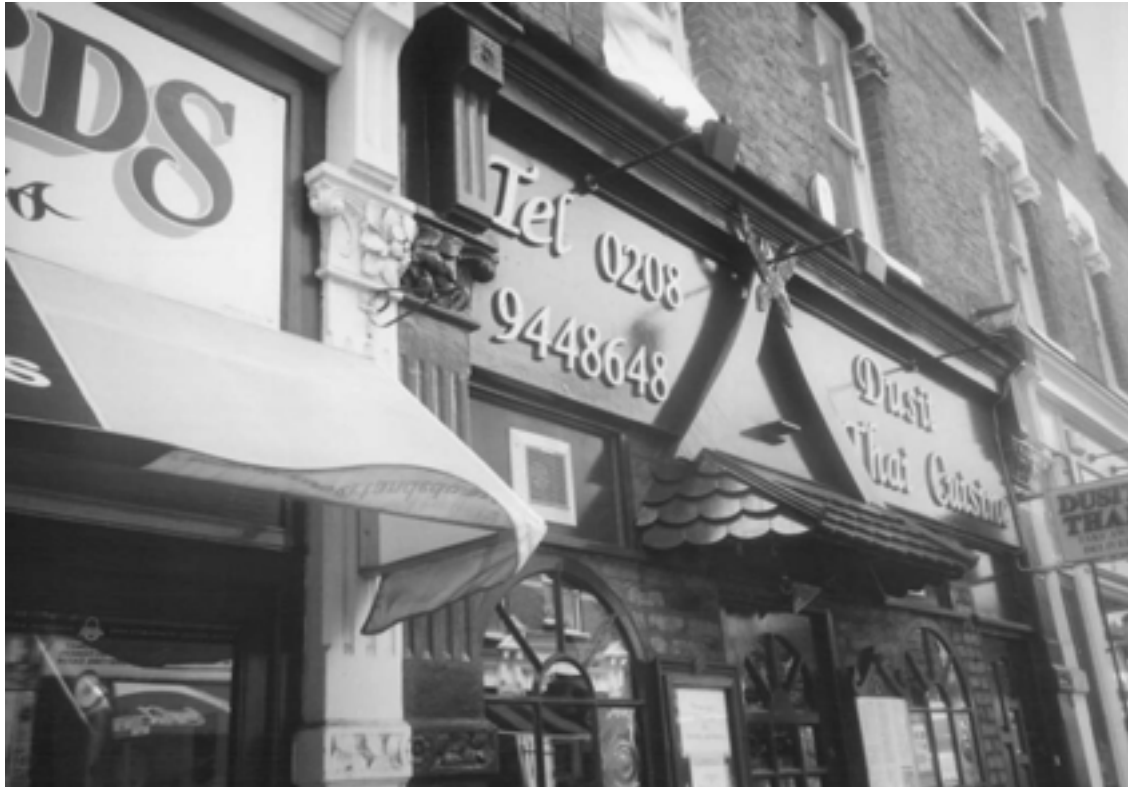
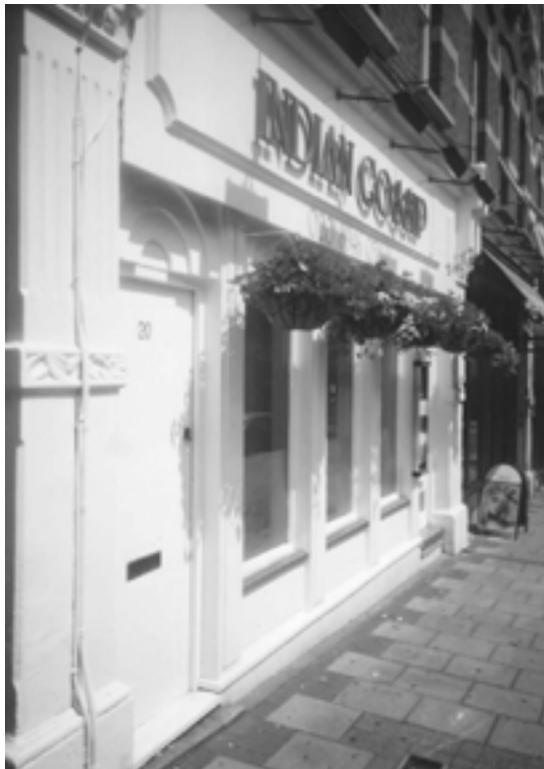
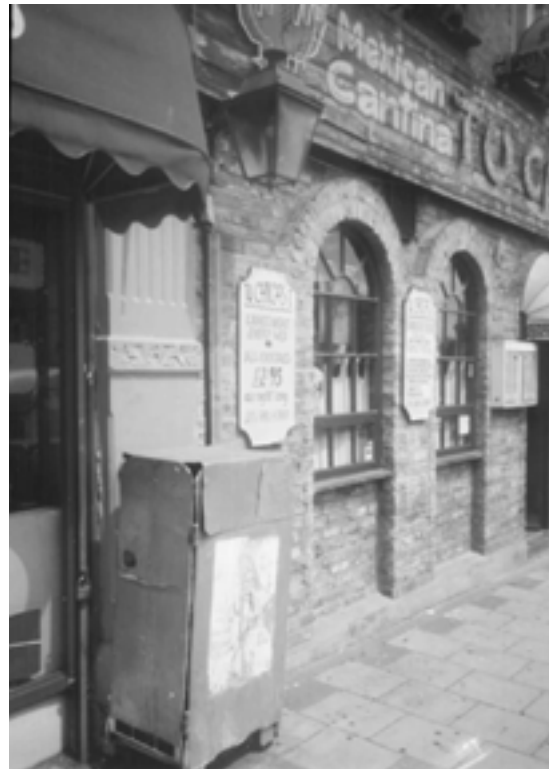
The facades of three of the 'ethnic' restaurants: above, the idiosyncratic façade to the Thai restaurant at No. 21; below left, the elegant façade to the Indian restaurant at No. 20; and below right, the considerably less elegant façade to the Mexican 'cantina' at Nos. 12 and 14.

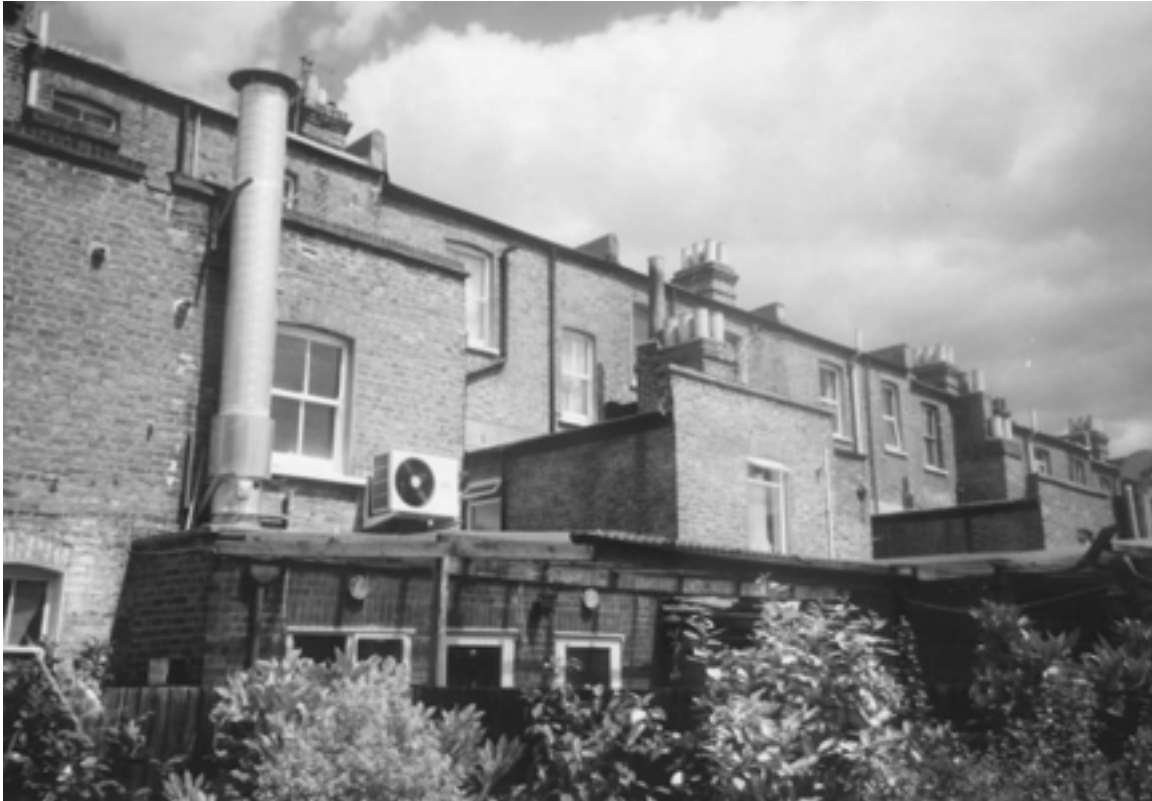
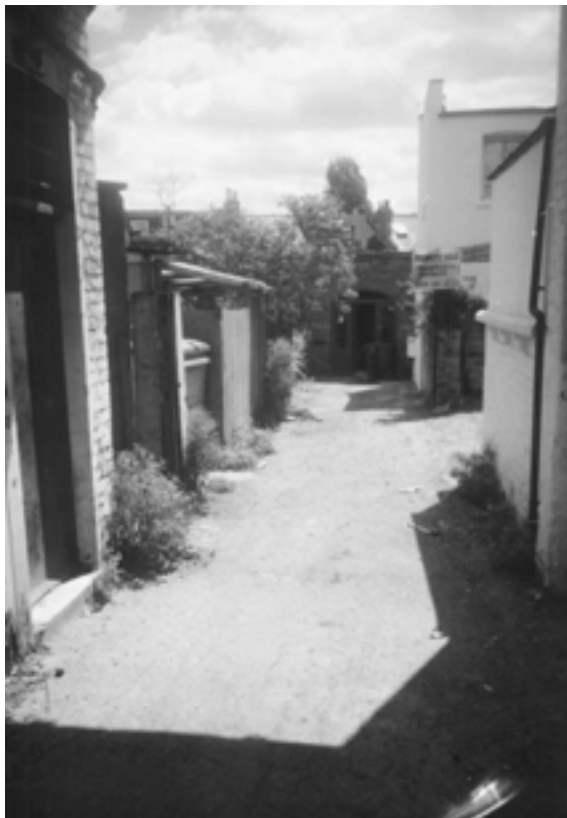
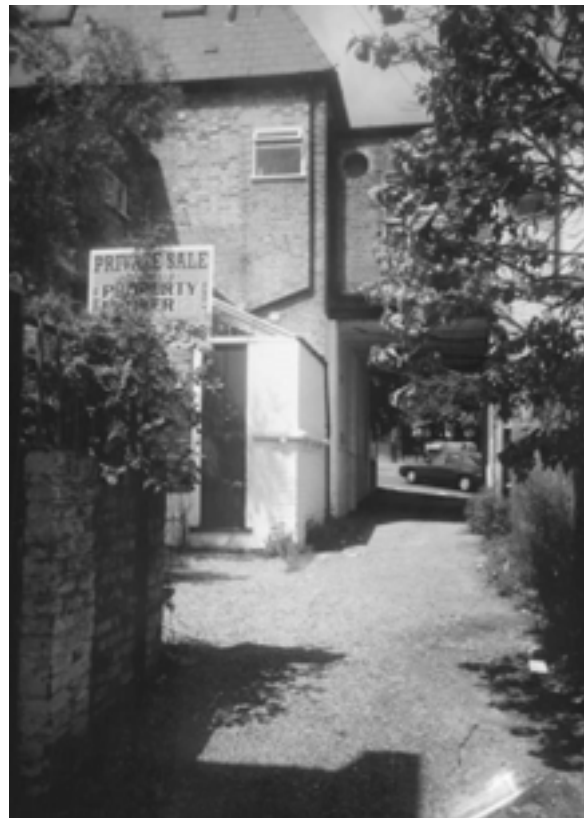
The rear of the properties on the south side of Leopold Road: above, the rear extensions; below left, the rear yard at the western end from the entrance passageway with 'The Mews' to the right; and below right, looking back to the passageway and the rear No. 1 Woodside.

- The rear extensions should also be inspected to check for any potential improvement of the character of the rear yards. The design guide could include advice on future rear extensions.

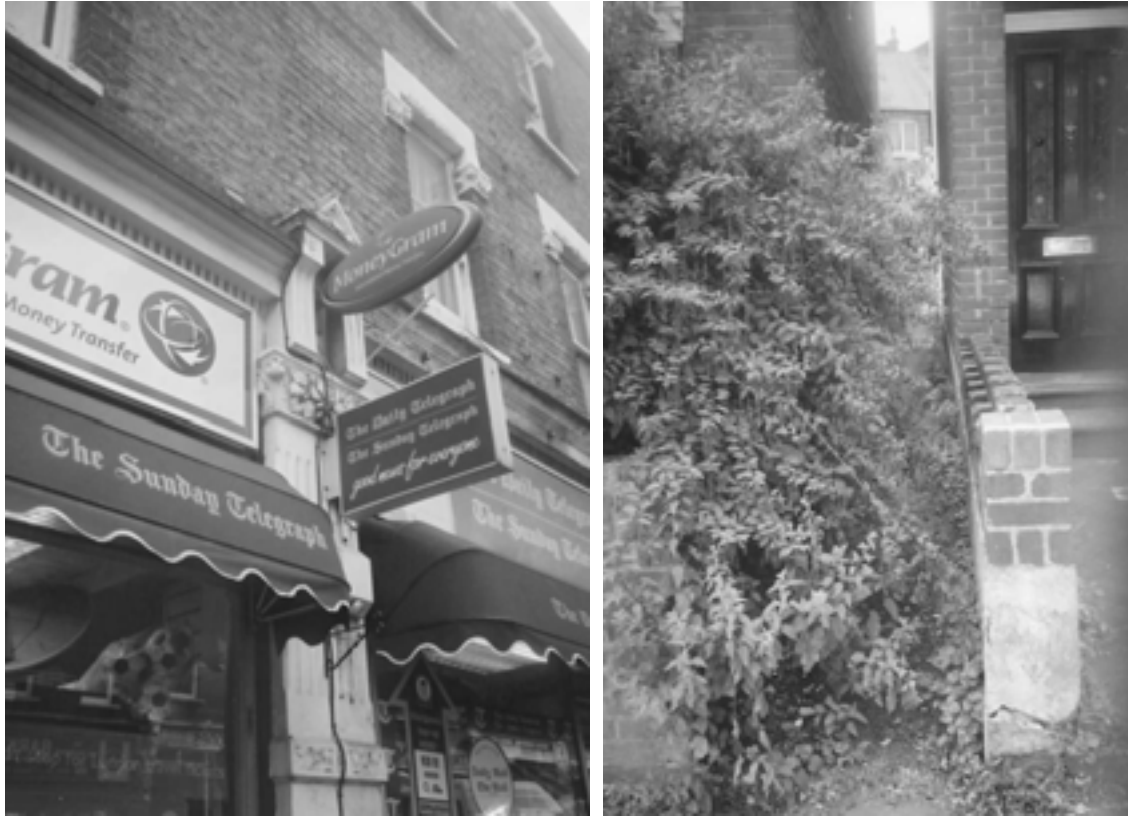
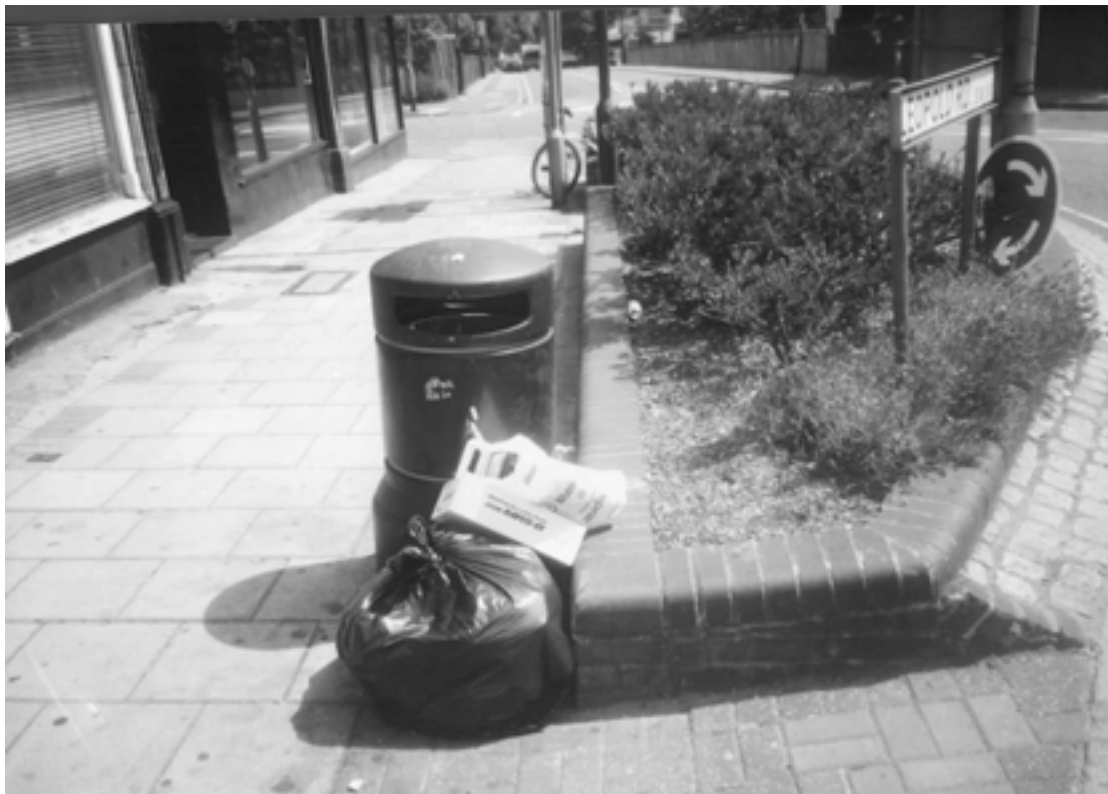
Three typical examples of features which detract from the character of the Conservation Area and which would need to be considered in any enhancement scheme: top left, a typical clutter of discordant signage and shop fittings; top right, the less than inviting access the space at the rear of the north parade; and bottom, unattractive streetscape.

- Only suitably designed shop fronts should be approved which either reflect the period character of the buildings or are of high quality modern design, are appropriate and consisted in scale and proportion along the length of the parade, and result in greater harmony. The production of a shop front design guide would assist shopkeepers to apply for suitable replacements.
