Wimbledon Chase Character Assessment

CHARACTER APPRAISAL WIMBLEDON CHASE CONSERVATION AREA.

**Wimbledon Chase Conservation Area
Plan 1
(Plan No DLU/2112)**

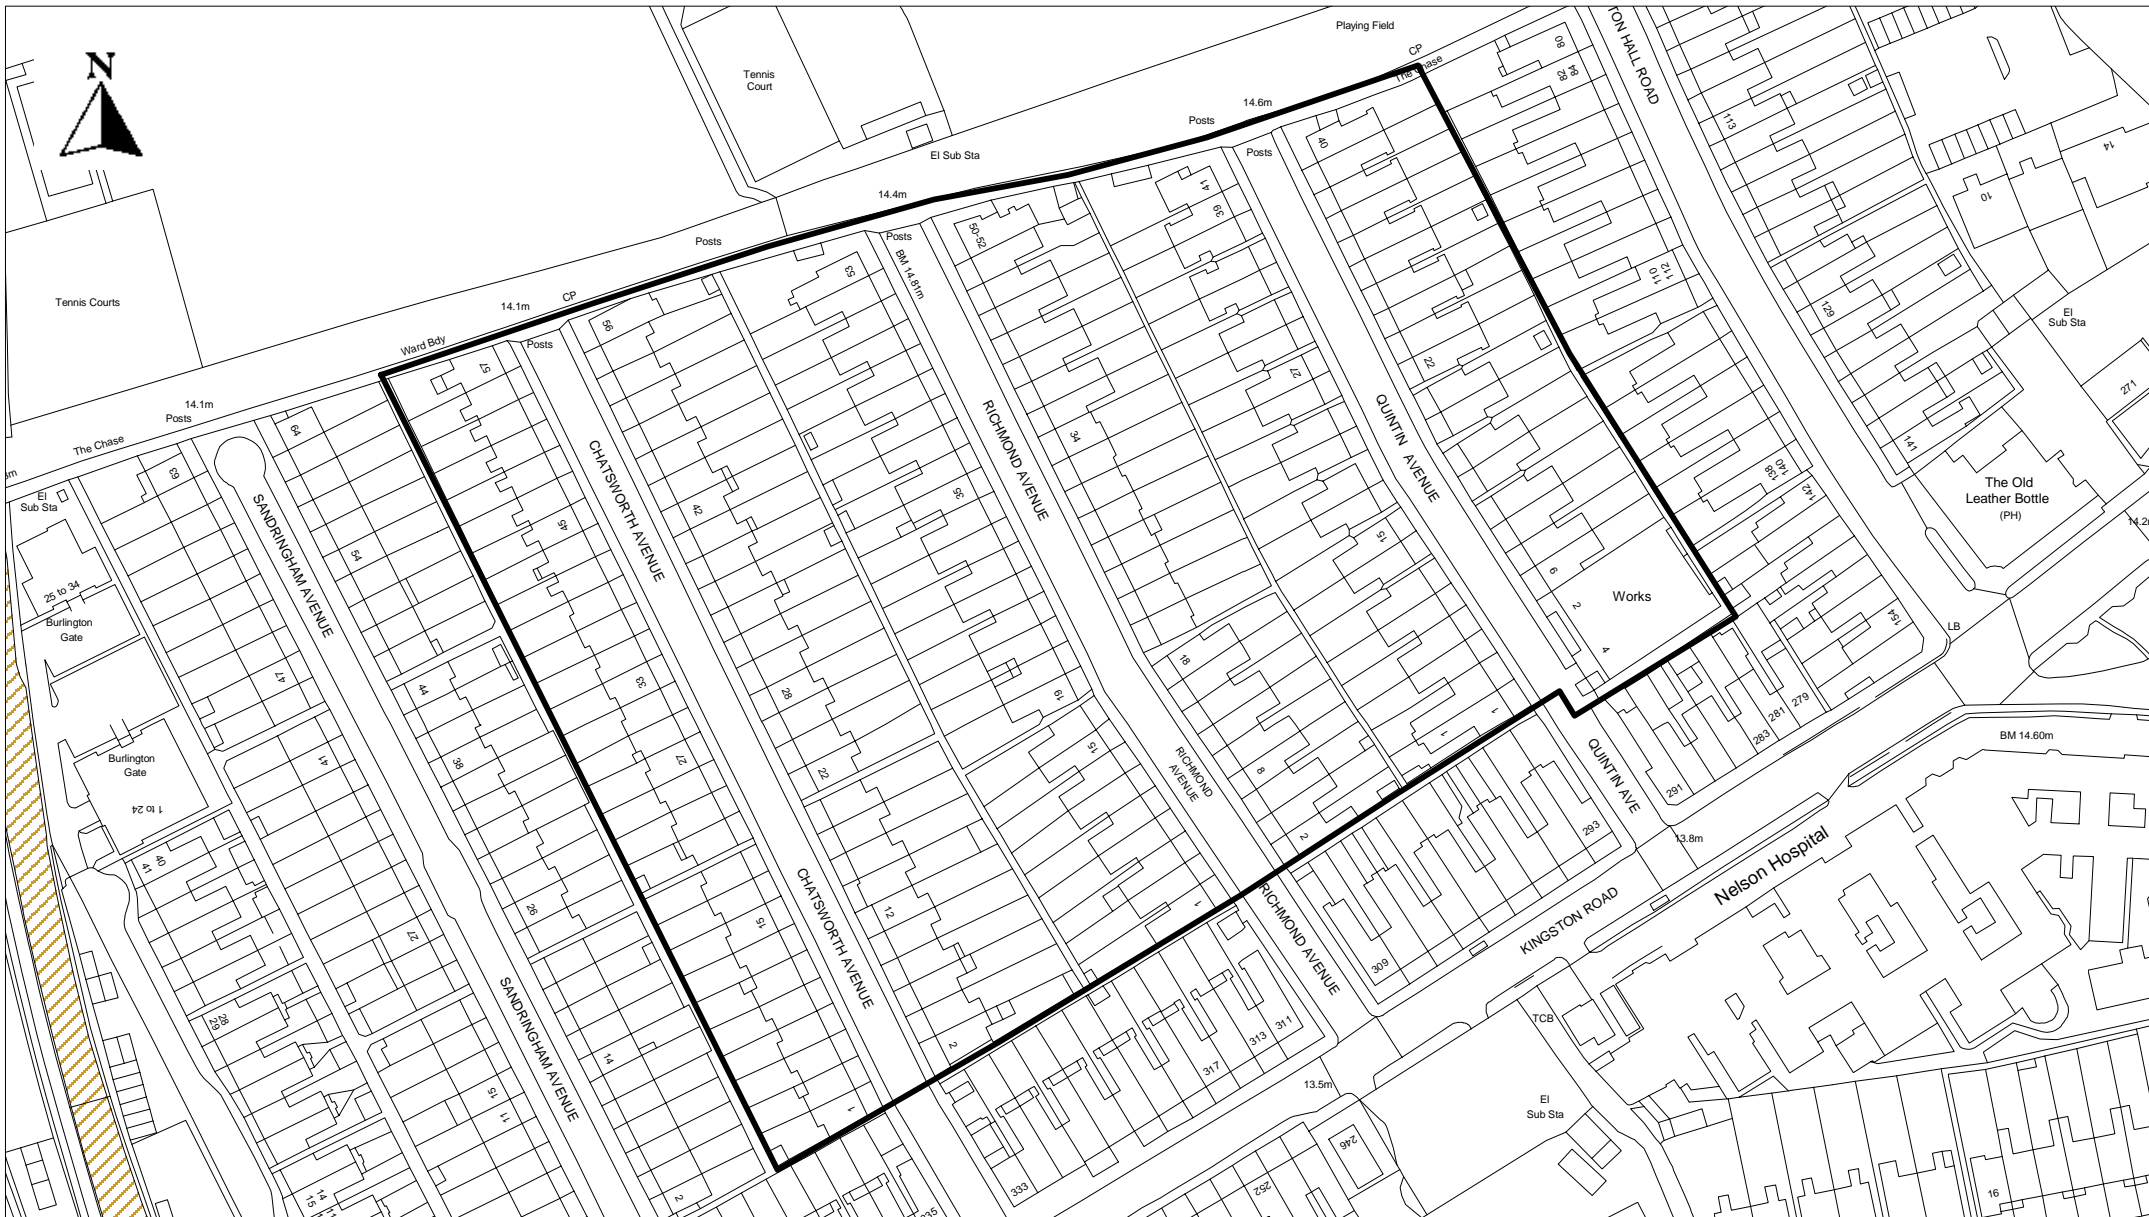
The Conservation Area comprises 3.26 hectares. It is situated approximately 1 km to the south of Wimbledon Town Centre. It lies to the north of Kingston Rd, and to the south of the open space known as Wimbledon Chase. To the east lies Merton Hall Rd, and to the west the residential cul-de-sac Sandringham Ave.

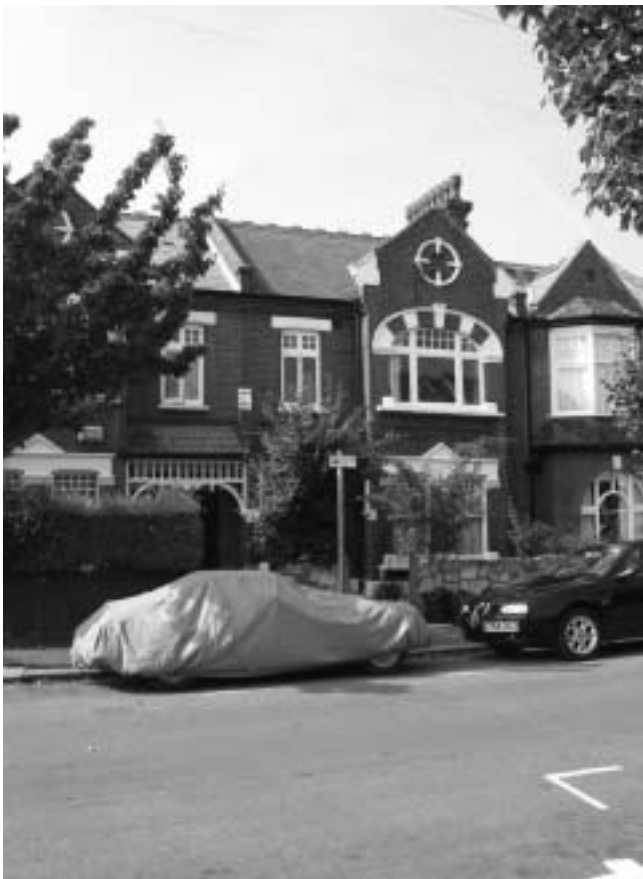
Building Type A

Type A (1/3 Quintin Ave). This is a symmetrical pair of 2 storey properties, having the general appearance of a pair of houses, but which accommodates 4 flats. The design of this building has a close relationship to that of other flats in the adjacent Merton Hall Rd Conservation Area. The building has excellent brick and stone detailing (including moulded bricks and good quality gauged bricks) at the wide arch over the 1st floor windows. Above this there is a gable which contained a roundel feature in stone. The recessed porch uses well detailed timberwork.

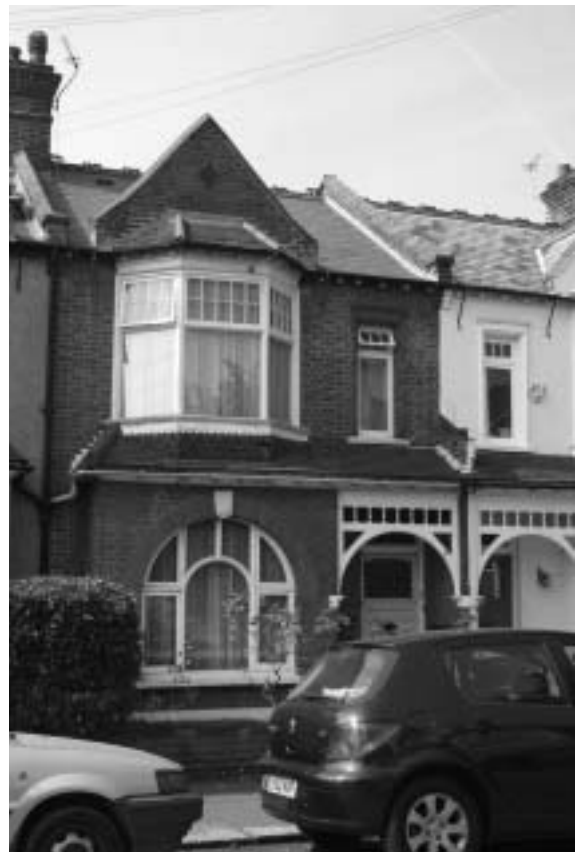
Building Type B

Type B (5-11 odds, Quintin Ave). This is a short run of terraced houses with a square bay at ground level and angled bay at first floor level. There is a fine wide semi circular arch to the ground floor bay window, with good quality gauged bricks. There is a recessed porch with well detailed timberwork. The window above has a moulded brick architrave.

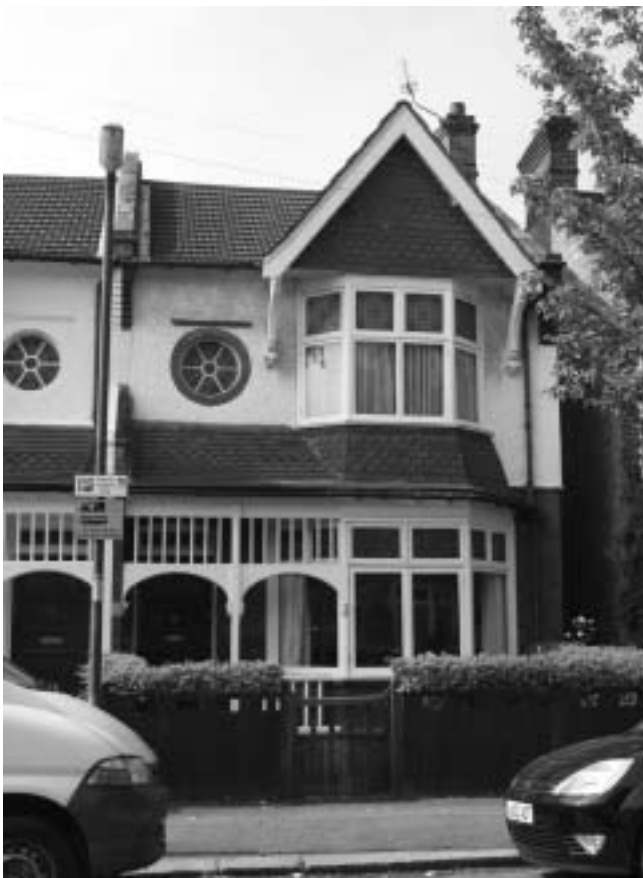
Building Type C

Type C (13/15, 33/35, 37/39, 6-12 odds, 14/16, 18/20, 26/28, and 34/36 Quintin Ave). This type comprises semi detached houses. The projecting bay is angled, larger in plan at ground floor than at first floor level. The gable above is supported on timber brackets. The recessed porches have good quality timber detailing, and above there is a roundel window with radiating glazing bars.

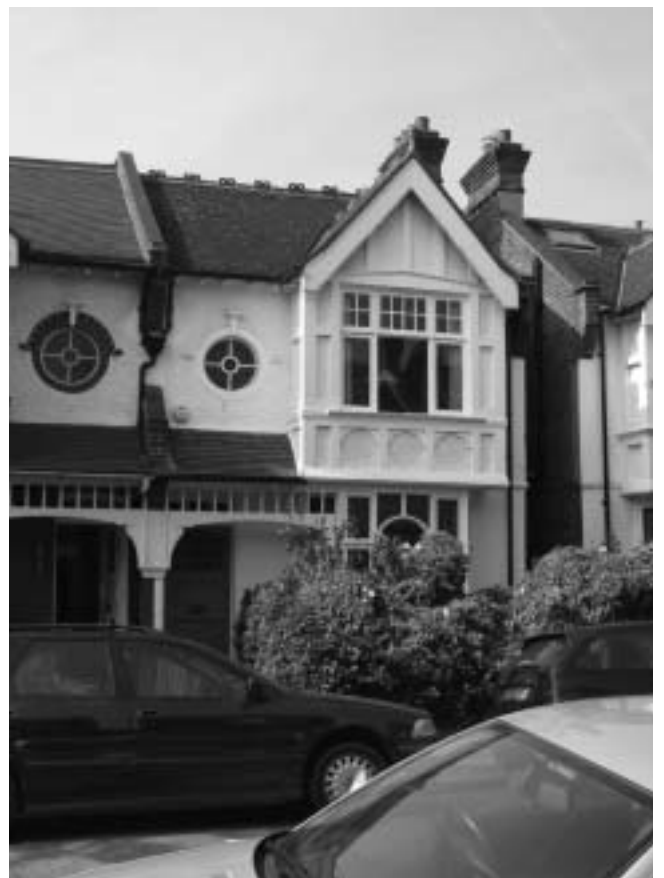
Building Type D

Type D (17/19, 21/23, 25/27, 29/31, 22/24, 30/32 and 38/40 Quintin Ave). This type is in many ways similar to type C, but the projecting bay

is square shaped, the upper level being wider than the lower one. Timber frame detailing is used on the bay.

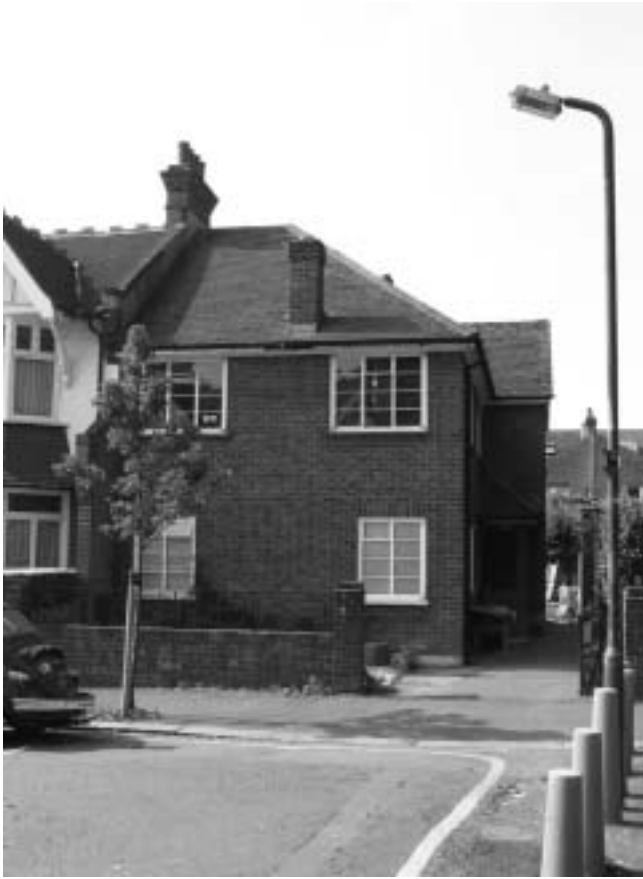
Building Type E

Type E (41 Quintin Ave). This is a later building probably dating from the 1950's replacing what would once have been a house contemporary to the others in the road, but which seems likely to have been lost to wartime bomb damage. It is attached to 37/39 Quintin Ave, making a short terrace. It has a hipped roof at the northern end covered with plain tiles. The walls are wholly built of plain brick. The windows are metal framed "Crittall" type.

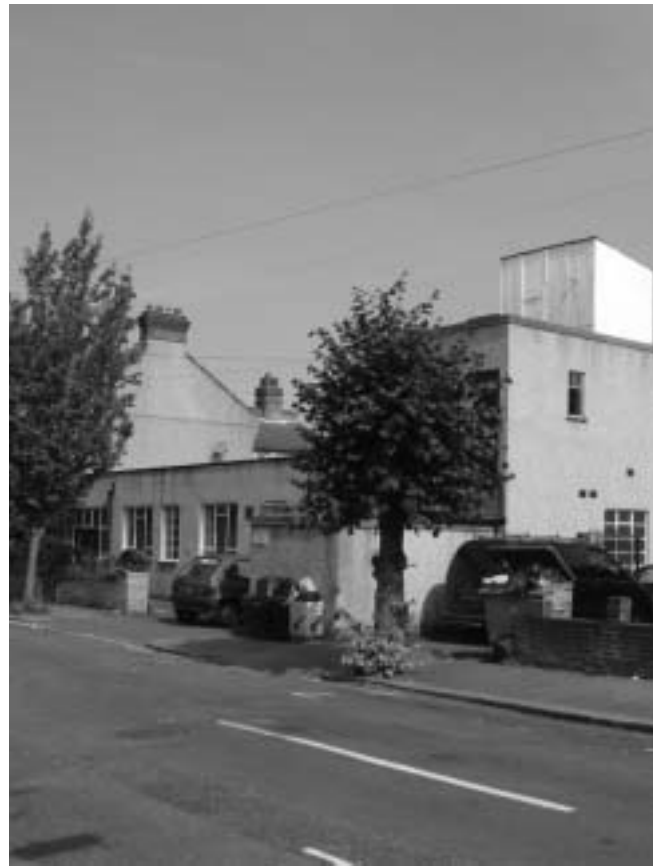
Building Type F

Type F (2/4 Quintin Ave). This is an ugly, largely single storey, industrial building, but with a 2 storey element at one end. Its character is entirely alien to that of the other buildings in the Conservation Area, and it detracts markedly from the character/appearance of the Conservation Area. Its elevations are of pebbledash, it has a flat roof at the front, with pitched roofs behind. The windows are metal framed. It is thought to date from about 1920.

- Redeveloping the site at 2/4 Quinton Ave with a new building more in keeping with the character of the area
- Replacing the “chalk stick” bollards with more appropriate vehicle control measures
- Replacing 100 mm yellow lines with 50 mm yellow lines
- Preparation of Article 4 Directions to protect detailing on the houses within the Conservation Area, including replacement of front doors, front windows, and alterations to porches, including the enclosure of open fronted porches.
- Consider possible Tree Preservation Orders for the major trees either within the Conservation Area boundary, or outside it, where they contribute to views from the Conservation Area.

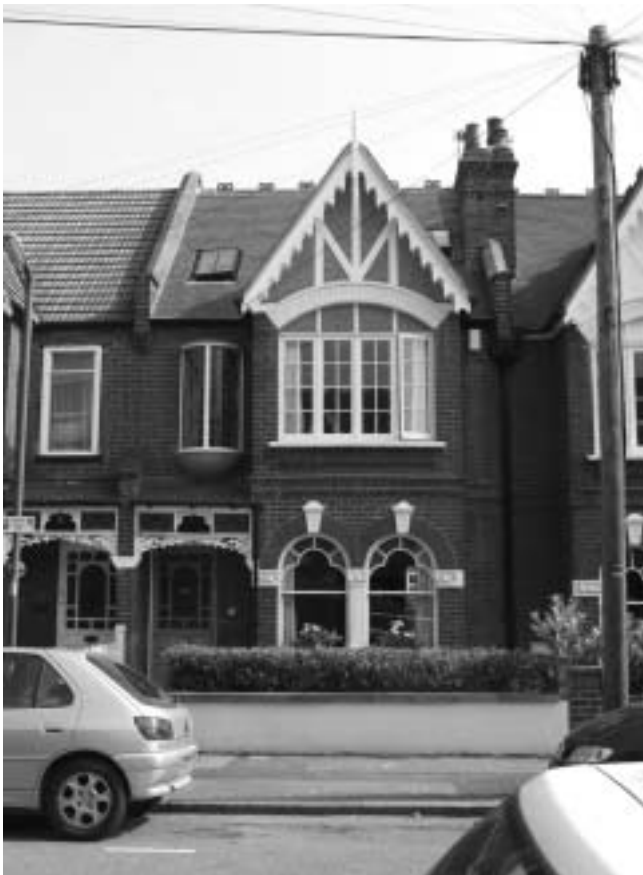
Building Type G

Type G (1-17 odds, 19-53 odds, 6-18 evens, and 36-50 evens, Richmond Ave). These are terraces of highly distinctive design. At ground floor level there are pairs of round headed windows in the front bays. These windows have ornate keystones with a leaf motif, and similar decorative stone detail to the capitals at the base of the window arches. Fluted pilasters divide the pair of windows. The sash window glazing within them has a part radial design to the glazing bars, and they have part leaded glass. The upper part of the bays have casement windows with "Georgian" style glazing bars. Above these windows there is a shallow segmental arch of moulded brick (painted). Above the arch, within the gable there are timber frame details, infilled with pebbledash panels. The gable itself has highly distinctive timber bargeboarding using an "icicle" design. The panelled front doors are well detailed (good examples are at nos. 19, 21 and 27), with art nouveau leaded and coloured glass. Porches are similarly extravagantly detailed with fretwork-cut timber panels, and leaded and coloured glass panels. The porches at 6-18 (evens) Richmond Ave are more variable in design. Above the porches there are highly unusual half-cylinder shaped oriel windows also with leaded and coloured glass. Unfortunately over time some houses have lost some of this detailing. The building materials are red brick to both ground and first floors, in some cases this has unfortunately been painted over. The roofs are of tiles, and ornate ridge tiles are evident, though in some cases these are missing.

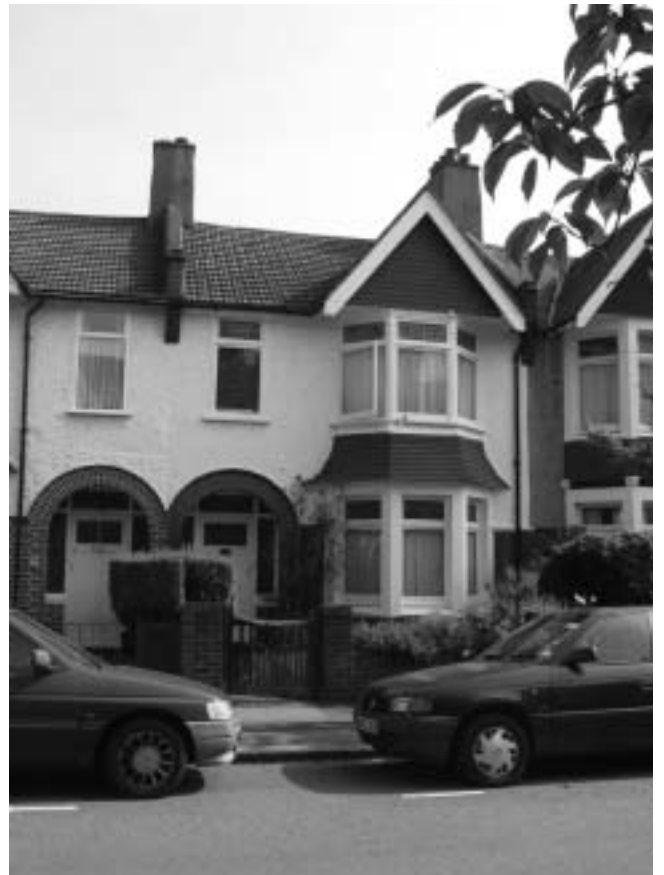
Building Type H

Type H (20/22, and 32/34 Richmond Ave). These are relatively plain pairs of houses that form part of a larger terrace. The angled bays are larger at ground floor than at first floor level. A semi circular arch is used at the recessed porch.

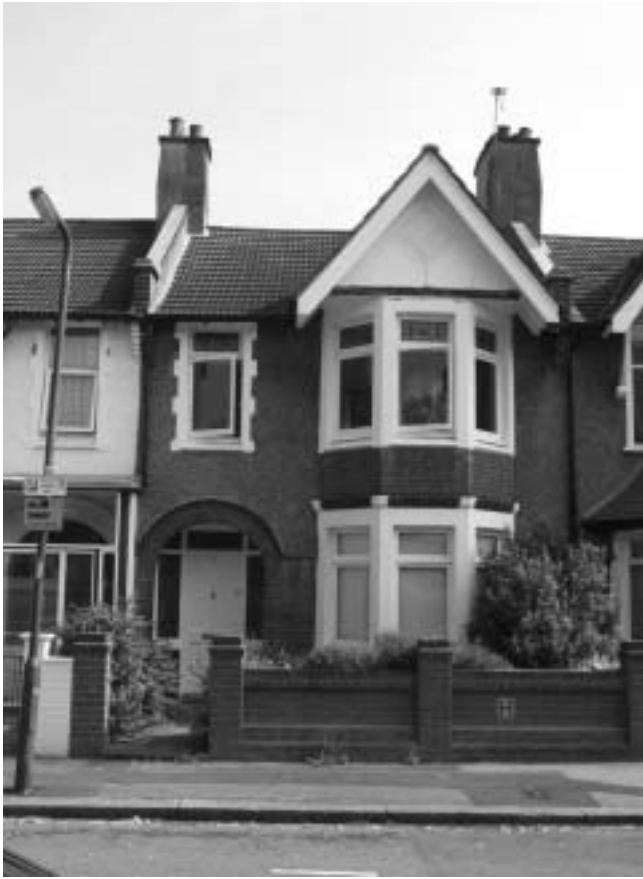
Building Type I

Type I (24-30 evens, Richmond Ave). These houses sit within a larger terrace. Their design is quite similar to type I, but the bay is the same

size at ground and first floor levels. Moulded bricks are used above the ground floor bay windows.

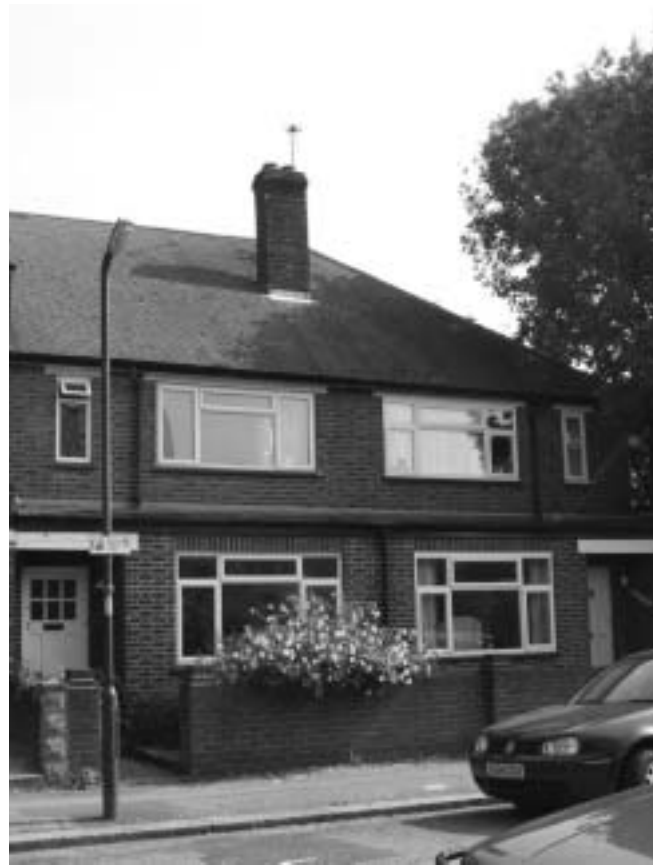
Building Type J

Type J (2/4 Richmond Ave). This is a later building containing a pair of houses, which probably dates from the 1950's. It replaces houses destroyed as a result of the crash of a Junkers bomber in September 1940. It is physically attached to terrace at 6-18 Richmond Ave. The ground floor projects slightly further forward relative to the 1st floor, and has a flat roof over. The building has a pitched roof, hipped at the southern end, and covered with plain tiles. The walls are wholly built of plain brick. The windows are the replacement UPVC type.

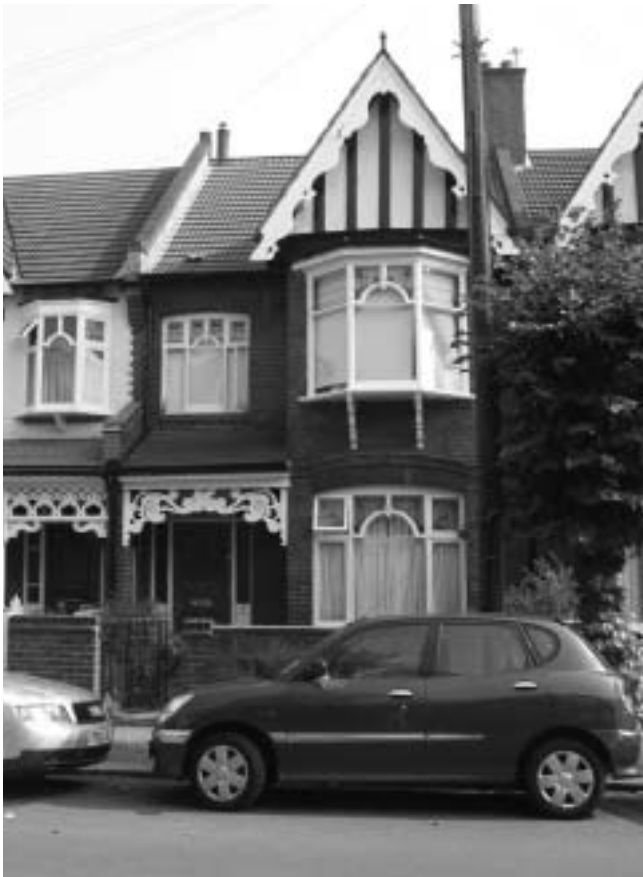
Building Type K

Type K (14/16 Chatsworth Ave). This pair of houses sit within a larger terrace. There are projecting square bays, in which the upper, angled window projects forward, supported on two timber brackets. The lower window has a shallow segmental arch above, in moulded brick. There is ornate timber bargeboarding to the gable above with timber frame detailing within the gable. The recessed porch has very ornate timber detailing.

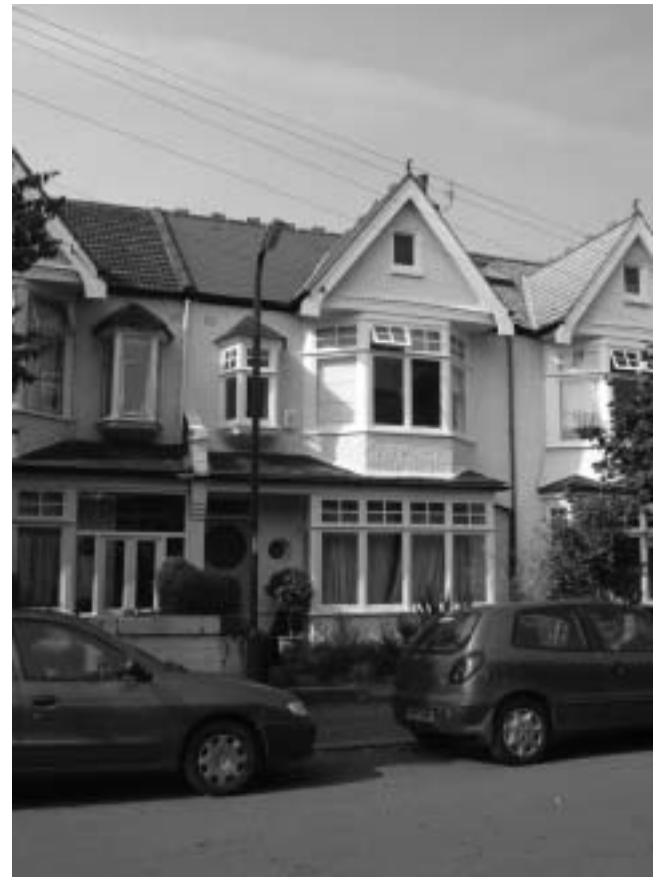
Building Type L

Type L (41-57 (odds) Chatsworth Ave). These terraced houses have wide square bays at ground floor level, with smaller angled bays above. The gable above the bay projects forward over the angled bay window below. There is an oriel window above the recessed porch.

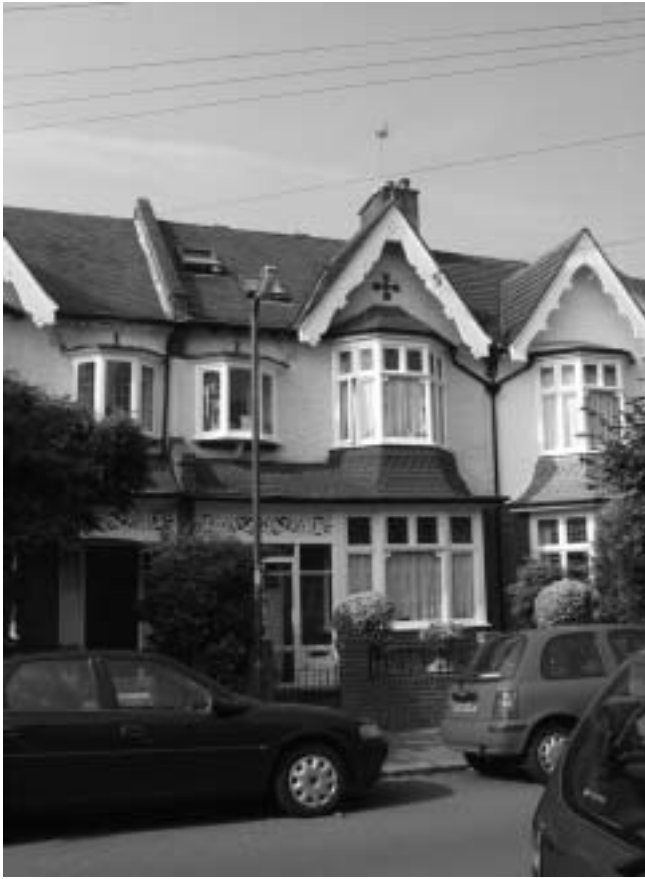
Building Type M

Type M (2-12, 18-56, and 1-39 Chatsworth Ave). These houses are terraced, some with a square bay at ground floor level and some with an angled bay. Above this the first floor has a smaller angled bay window, and above that a gable with an ornate bargeboard. The recessed porch has very ornate timberwork detail, and there is an oriel window above.
