Eastfields Estate, Mitcham
Visual Impact Study
October 2016

Eastfields Estate, Mitcham

Visual Impact Study

October 2016

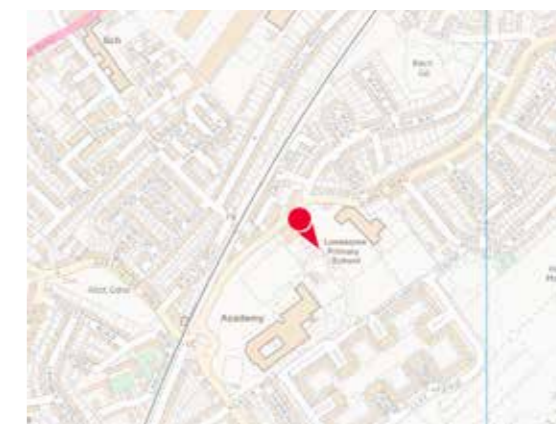
Existing

14. This viewpoint is located at the north of the footpath that runs between the Lonesome Primary School and the Acacia Children's Centre and faces south towards the estate. The main aspect of this image is the footpath and the railings either side – red to the left and green to the right. The tree foliage above the footpath completes the framing of this view. The estate is not visible from this viewpoint.

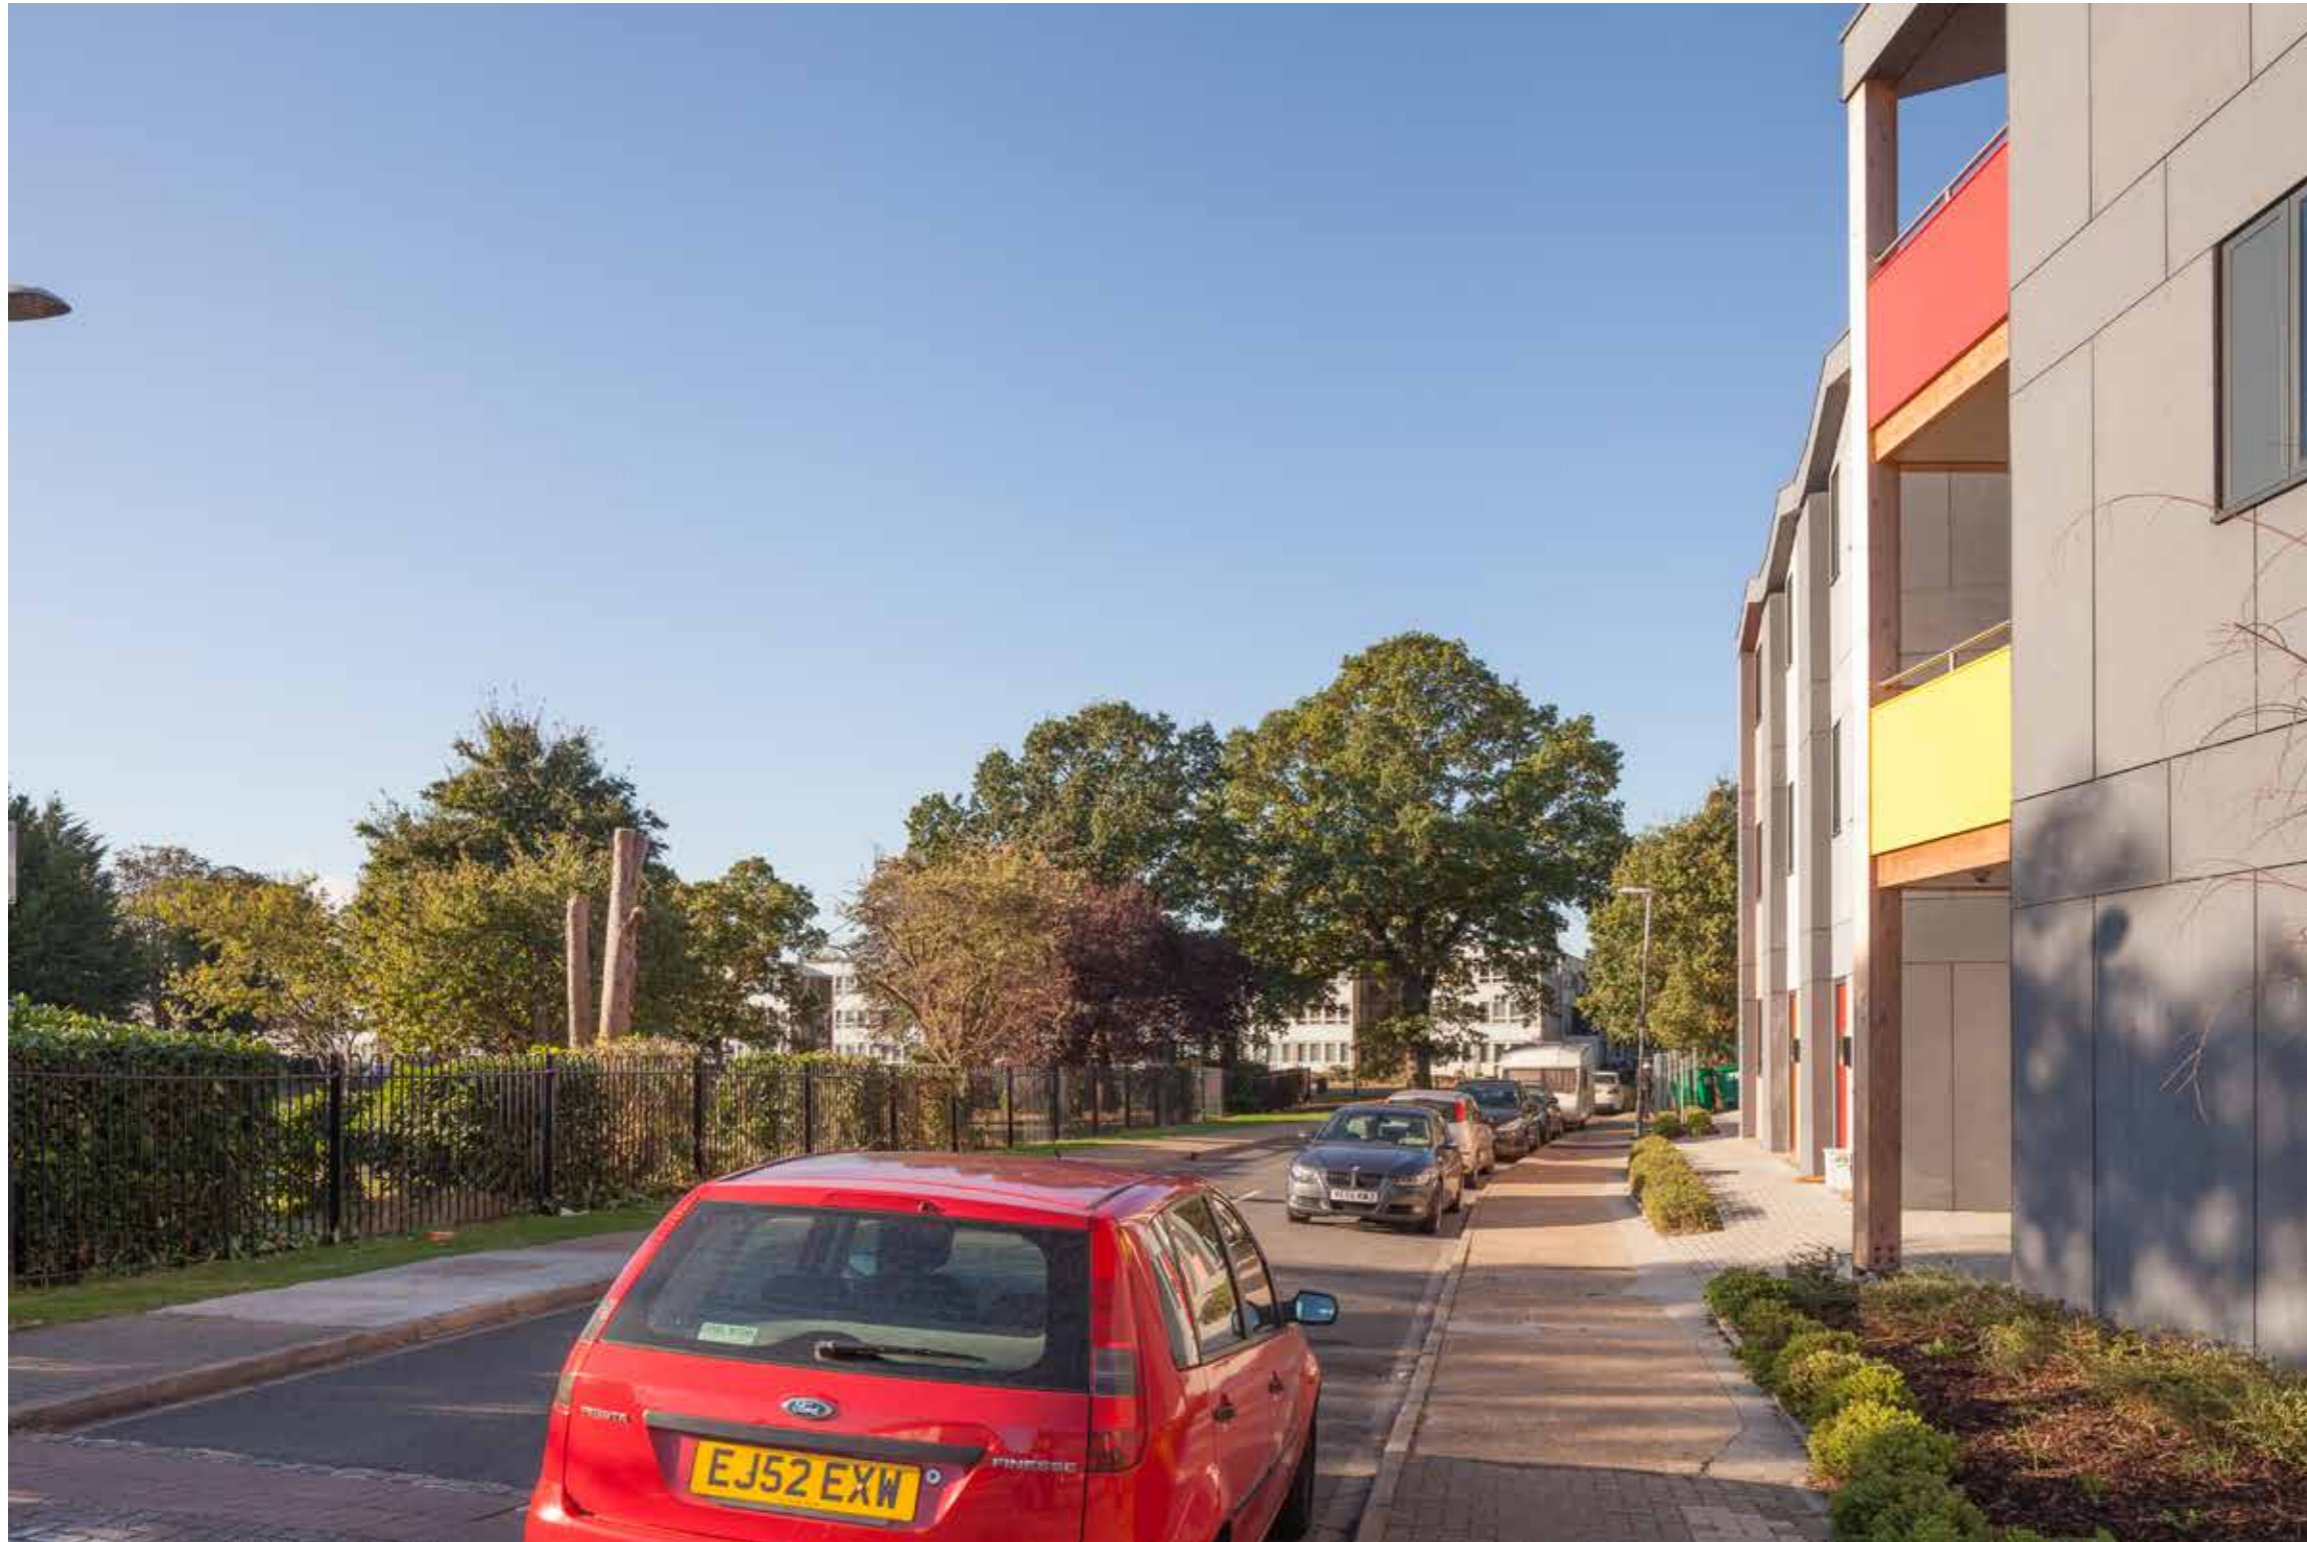
15. This viewpoint is located to the north of the estate, on the corner of Mulholland Close and Woodstock Way, facing back towards the estate. The main characteristic of this image are the trees and landscaping in the park. The new Rogers Stirk Harbour development is also seen on the right of the image, which due to its architecture and colours, attracts the viewers' attention. The existing estate can be seen in the background, beyond the trees.

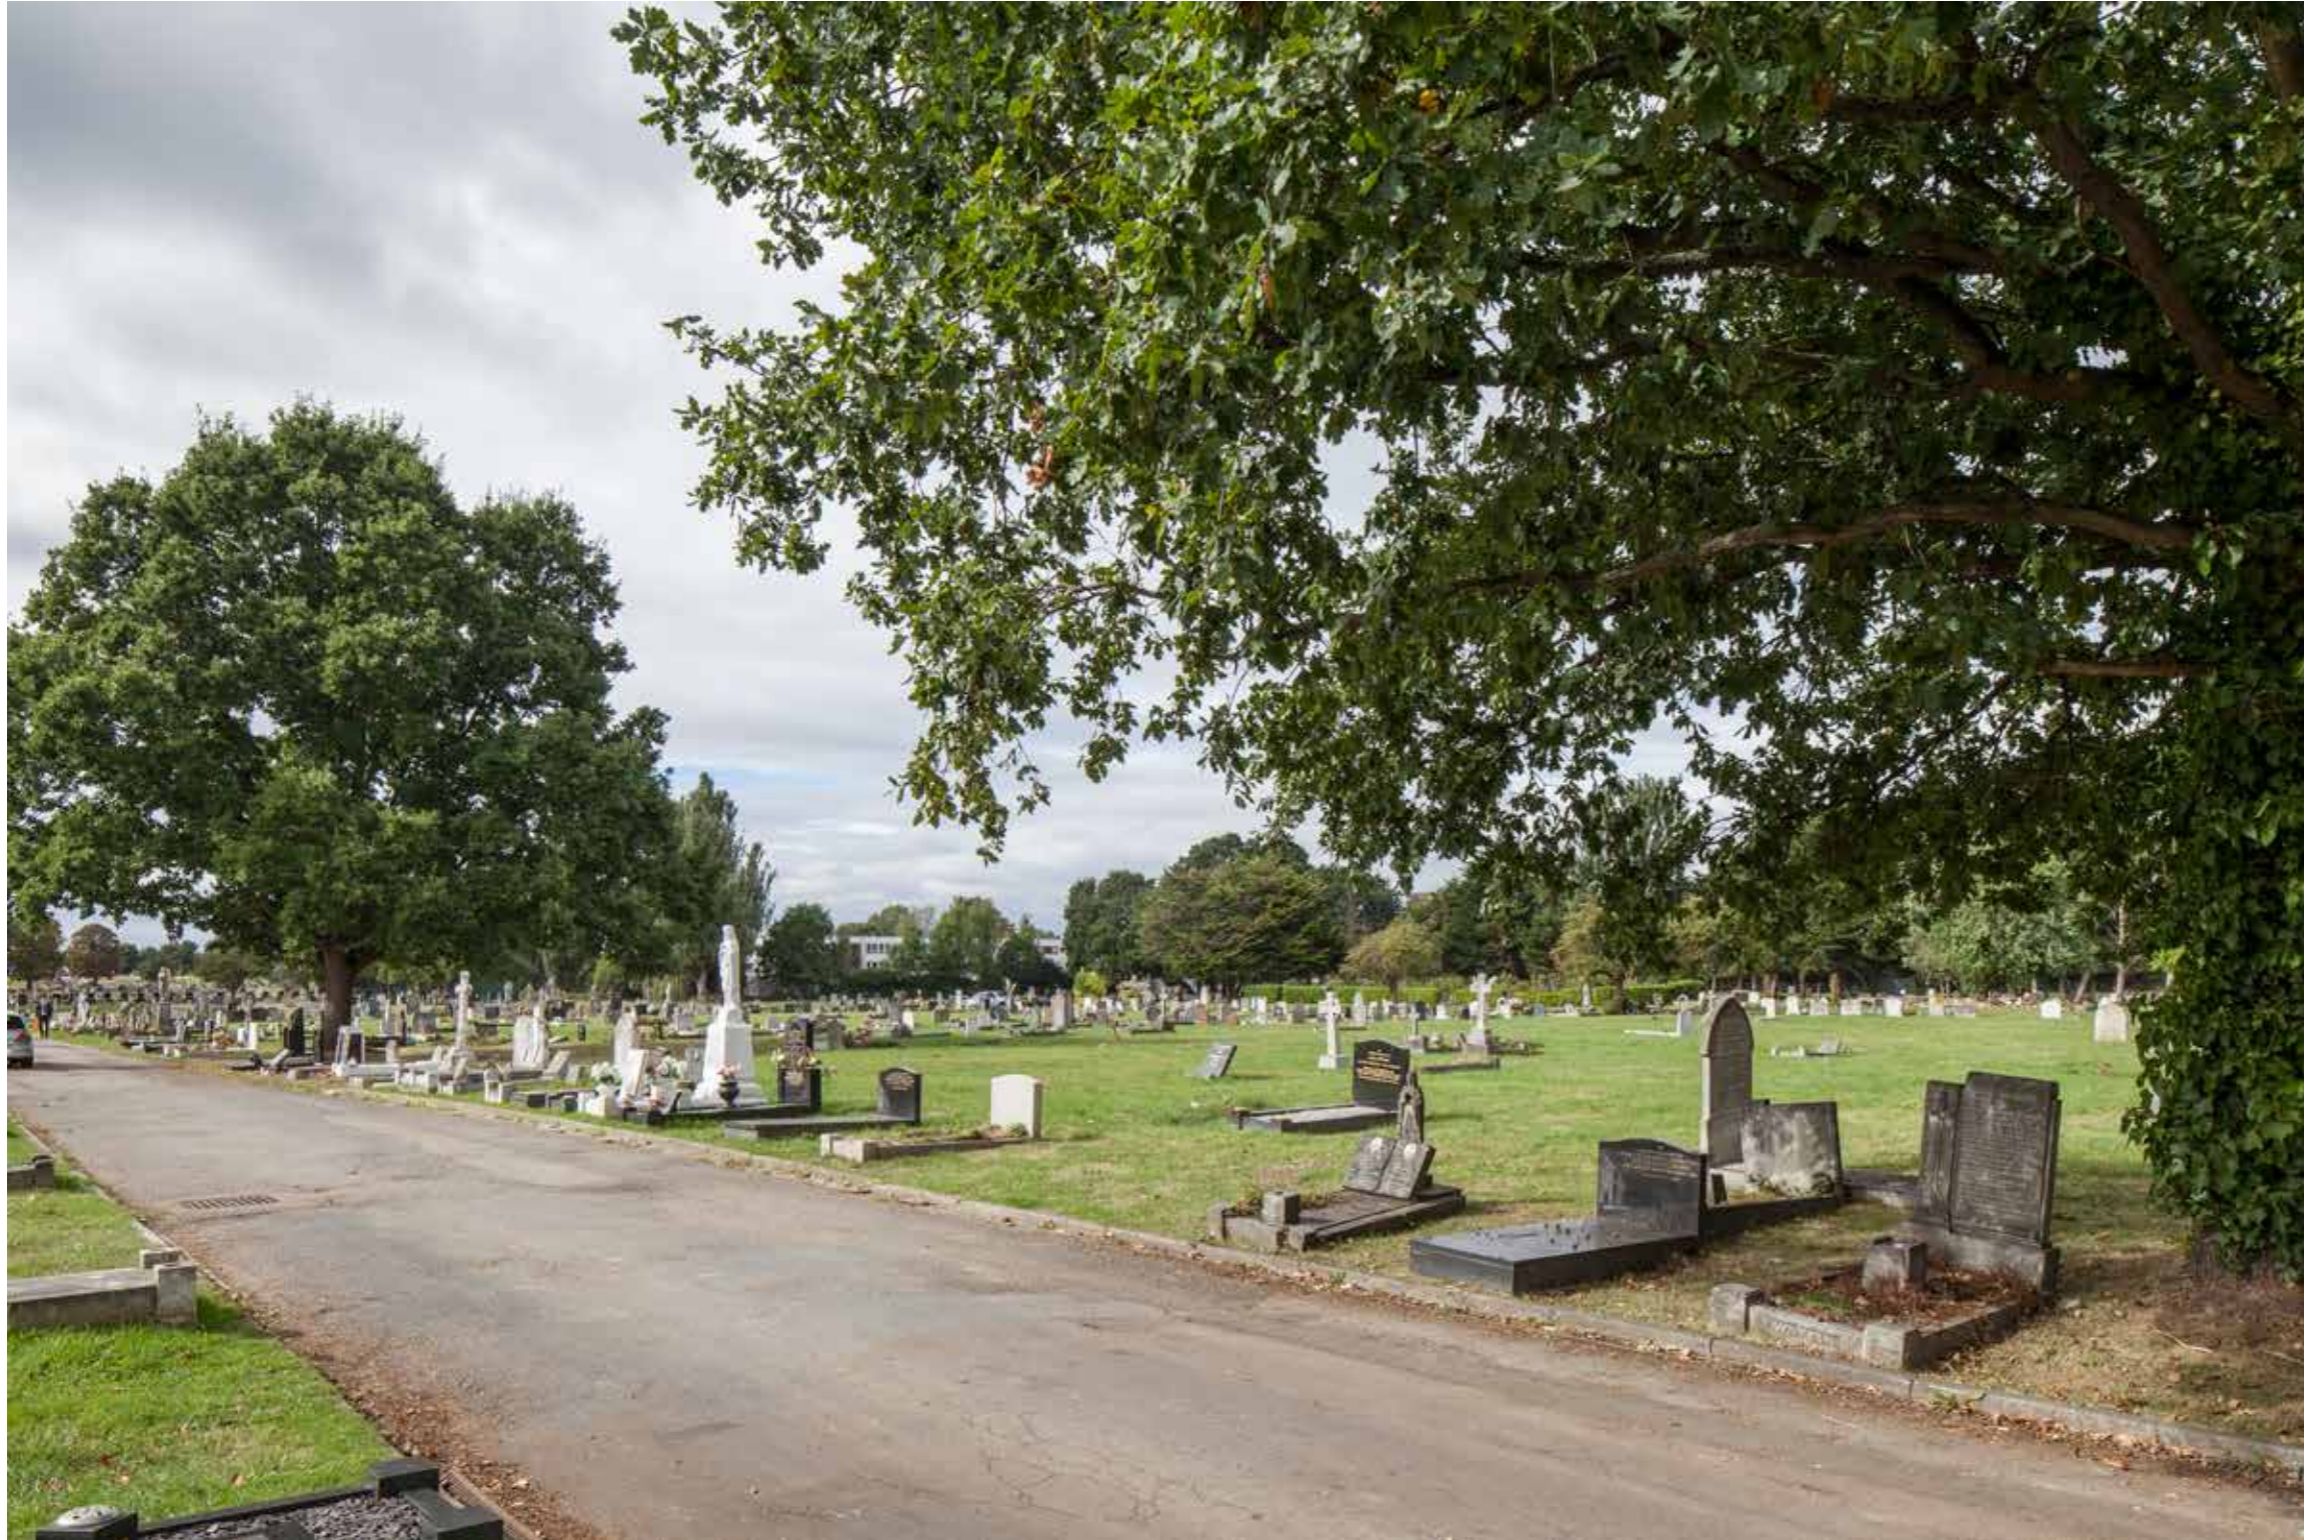
Existing

16. This viewpoint is located to the east of the estate, close to the crematorium building. The main aspect of this image is the cemetery itself, along with the associated trees and landscaping. The Eastfields Estate buildings are partially visible through the trees, in the background.

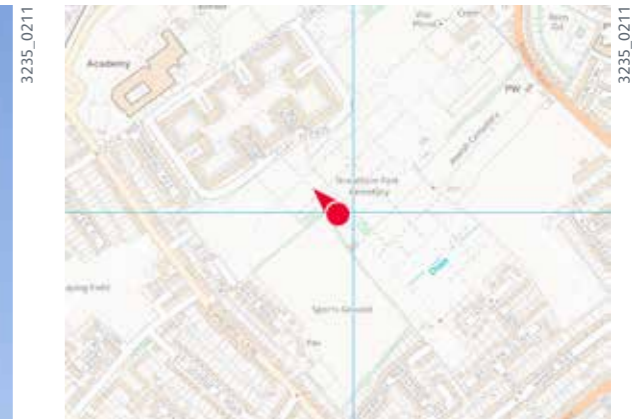
17. This image was taken from within the cemetery, south of the estate, looking north towards the estate. The predominant aspect of this image is the cemetery and its associated hard and soft landscaping and tombstones. Eastfields Estate is barely visible in the background, through the trees.

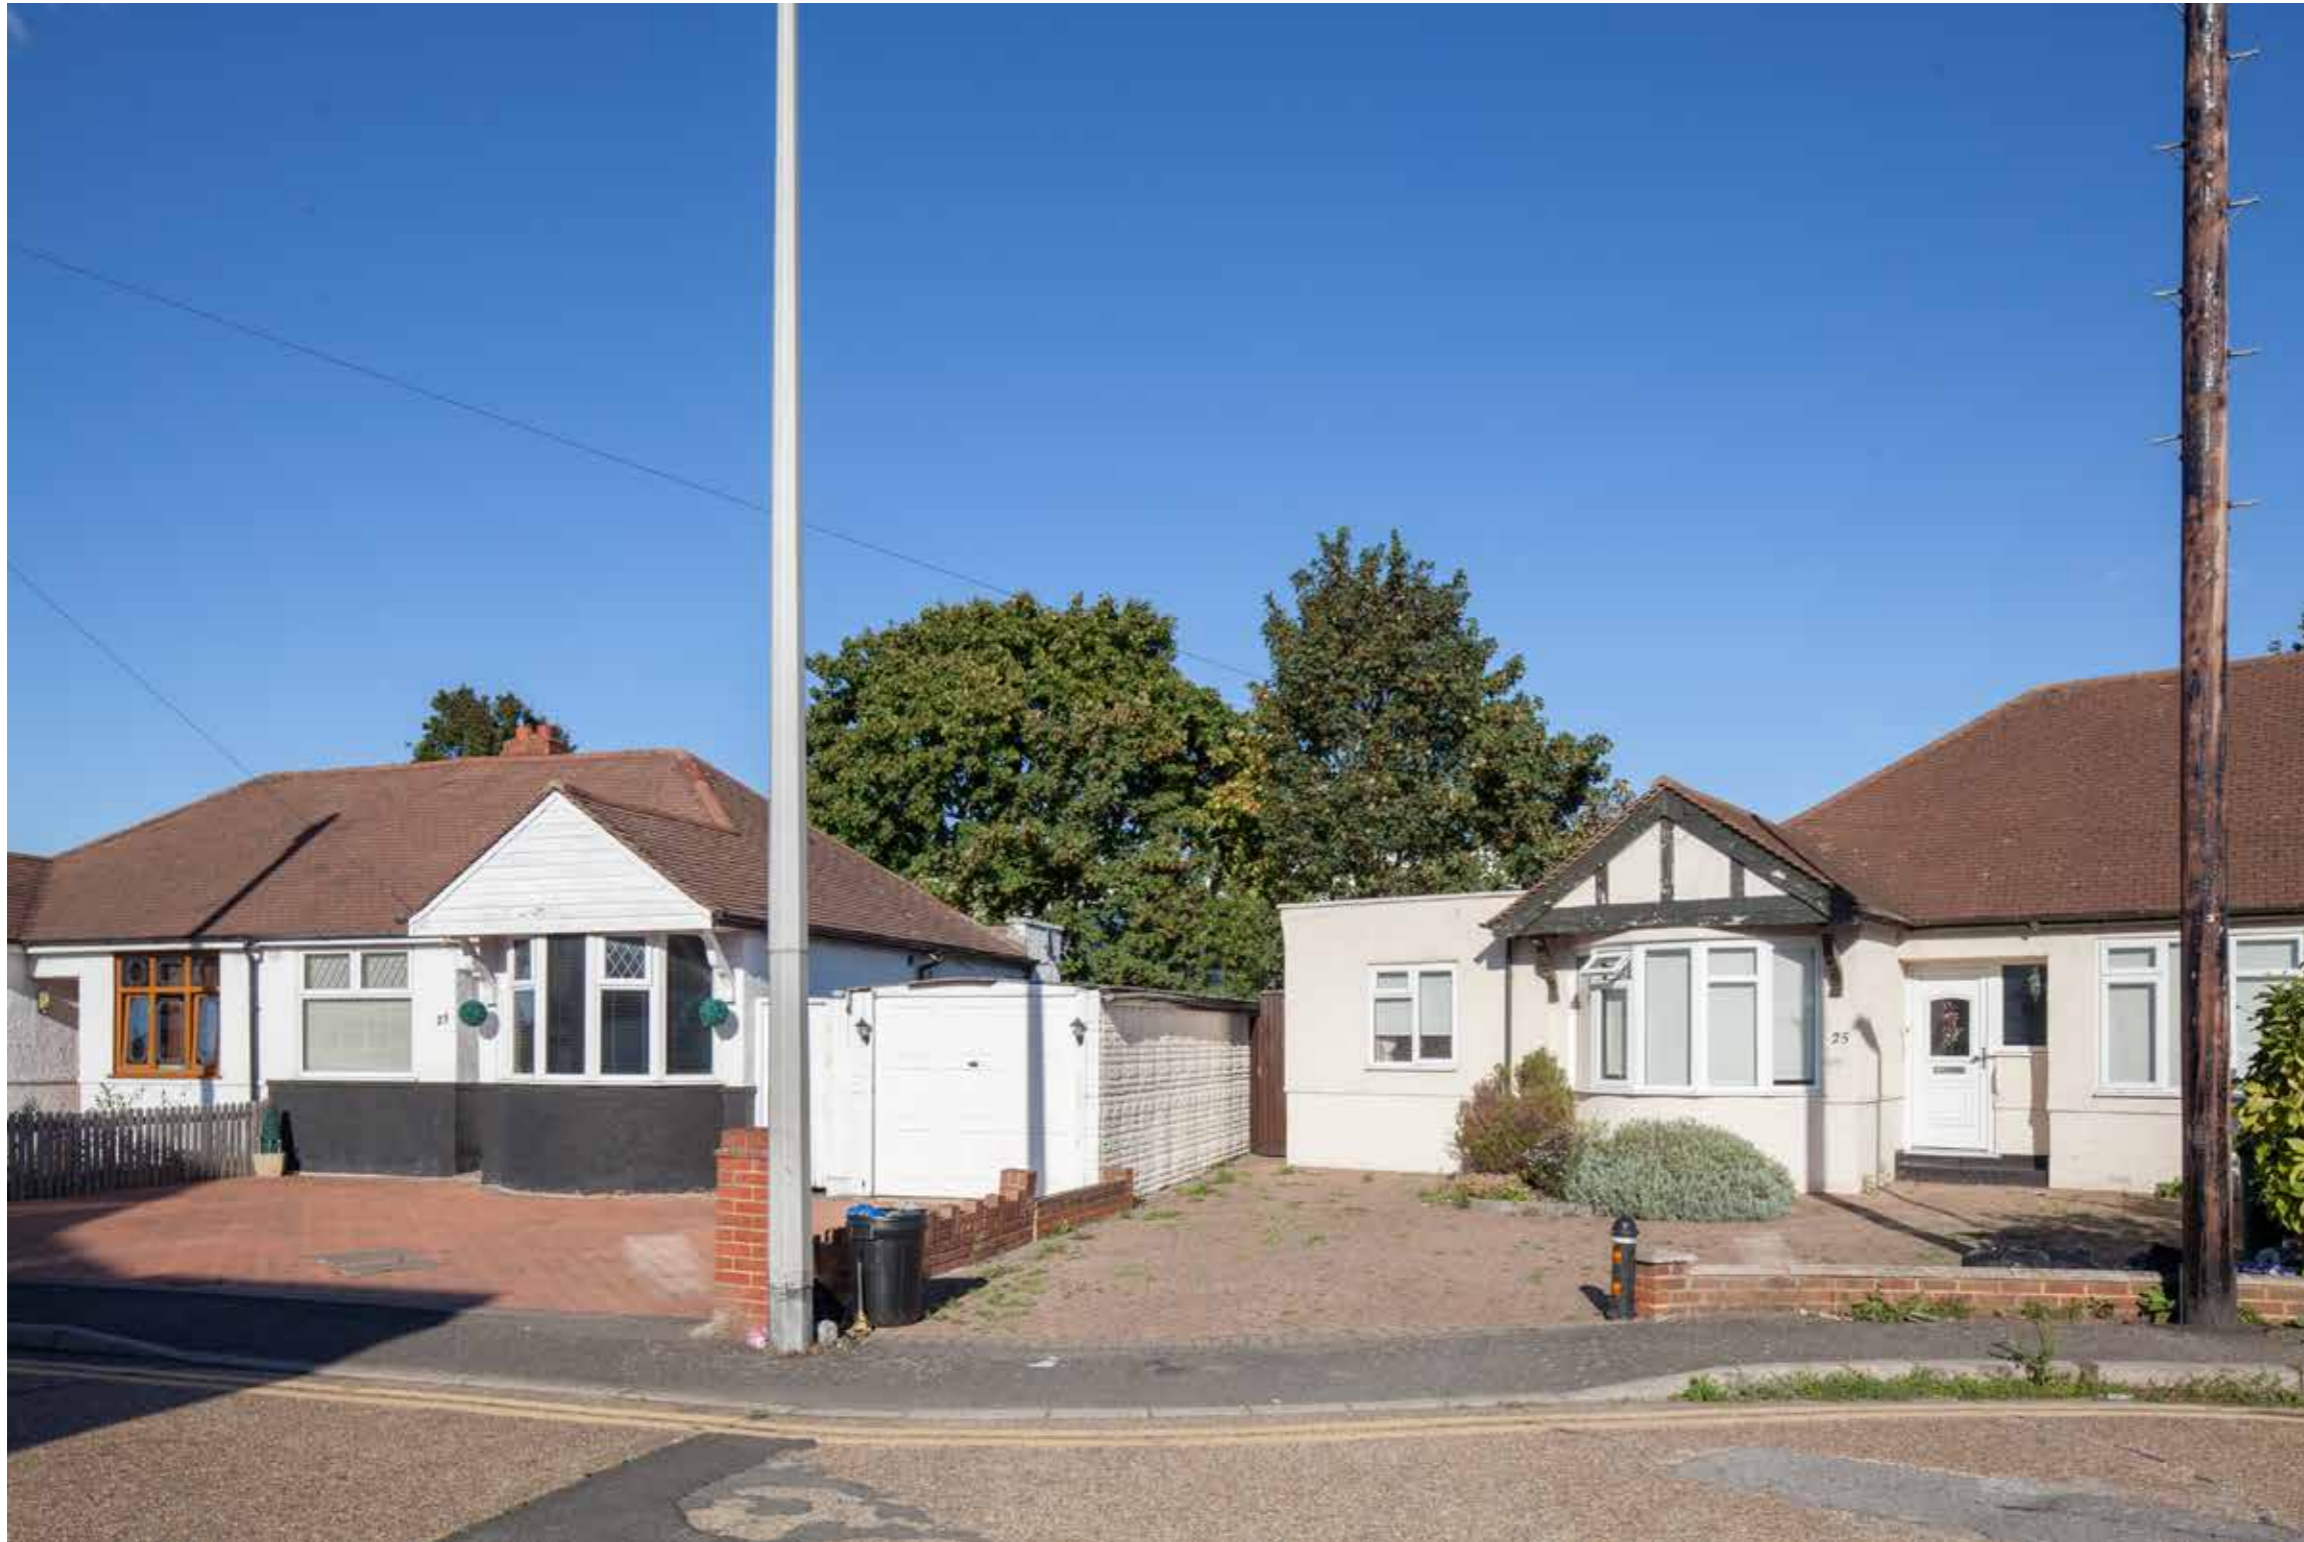
3235_0201

18. This viewpoint is located to the west of the Eastfields Estate, along Hammond Avenue. The focal point of this image are the bungalow houses and the hard landscaping in front of them. Behind the bungalows one can see the foliage of some fairly mature trees. The estate can barely be seen behind them, when the trees are in leaf.

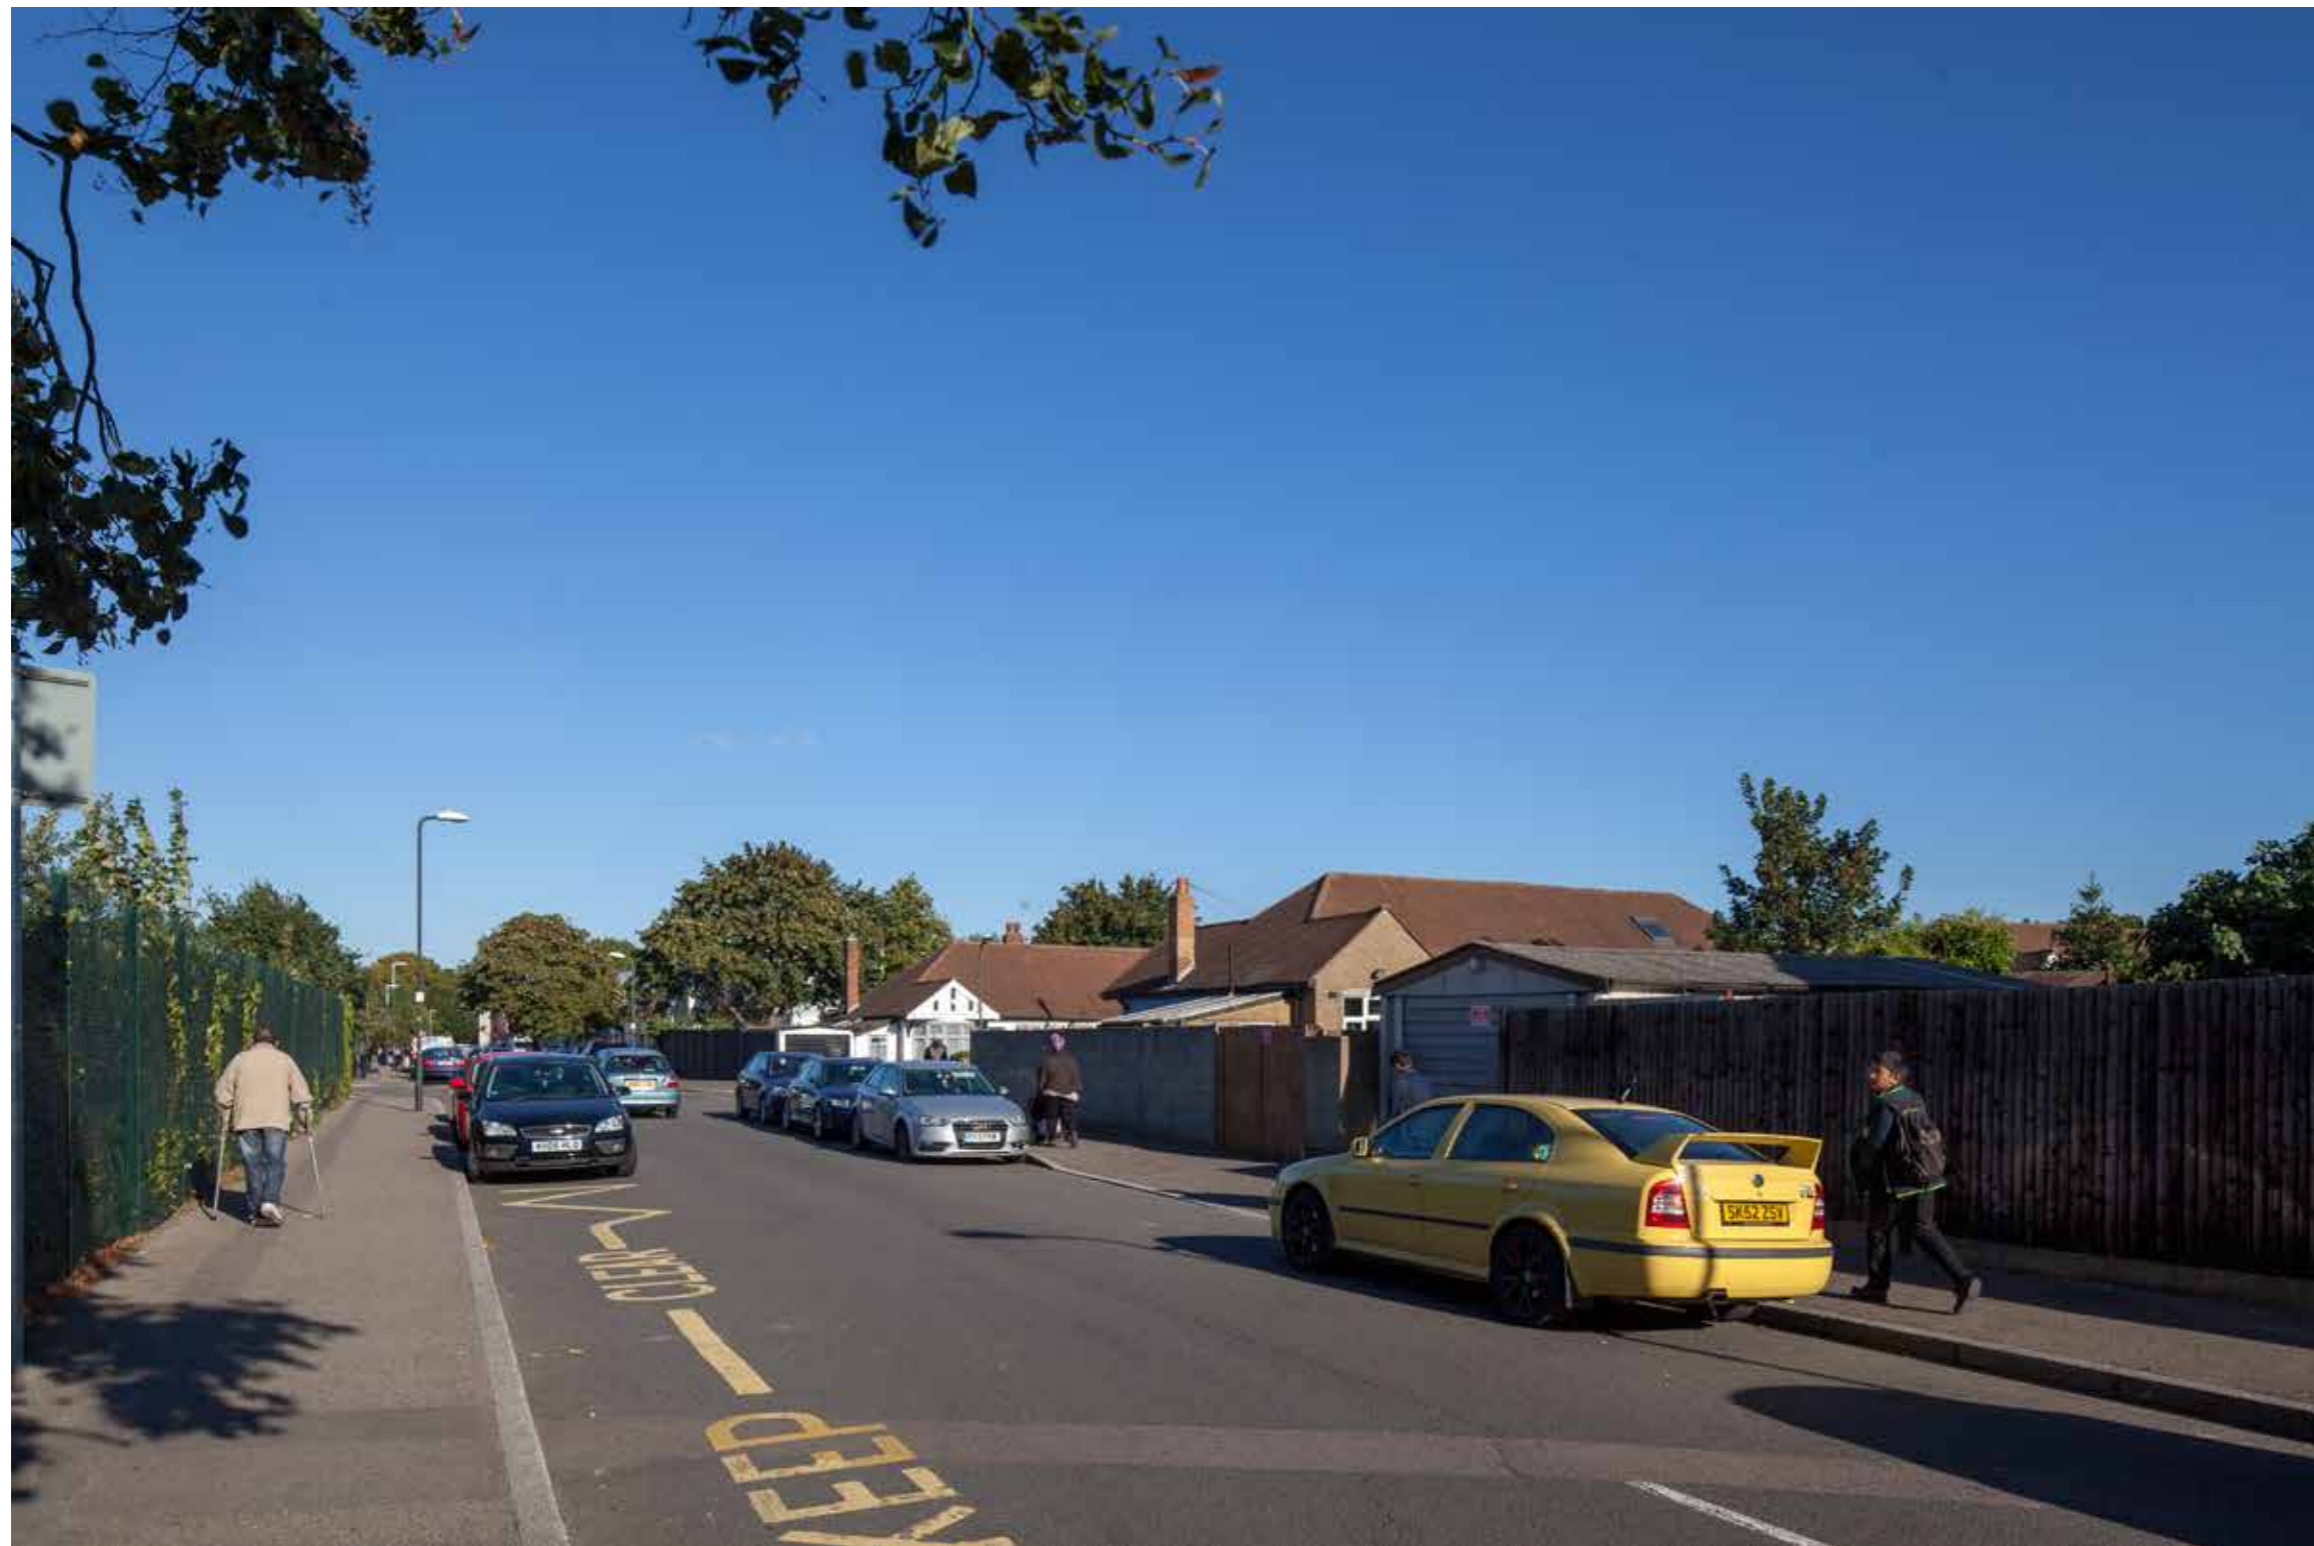
3235_0161

19. This viewpoint is located to the west of the estate, near the corner with Tamworth Lane, facing northeast towards the estate. What is noticeable in this view is the lack of street frontages along both sides of the street, due to the garden walls and edges of the houses on one side and the school fence on the other. Eastfields Estate is barely visible in the background of the image, behind the bungalows and trees.

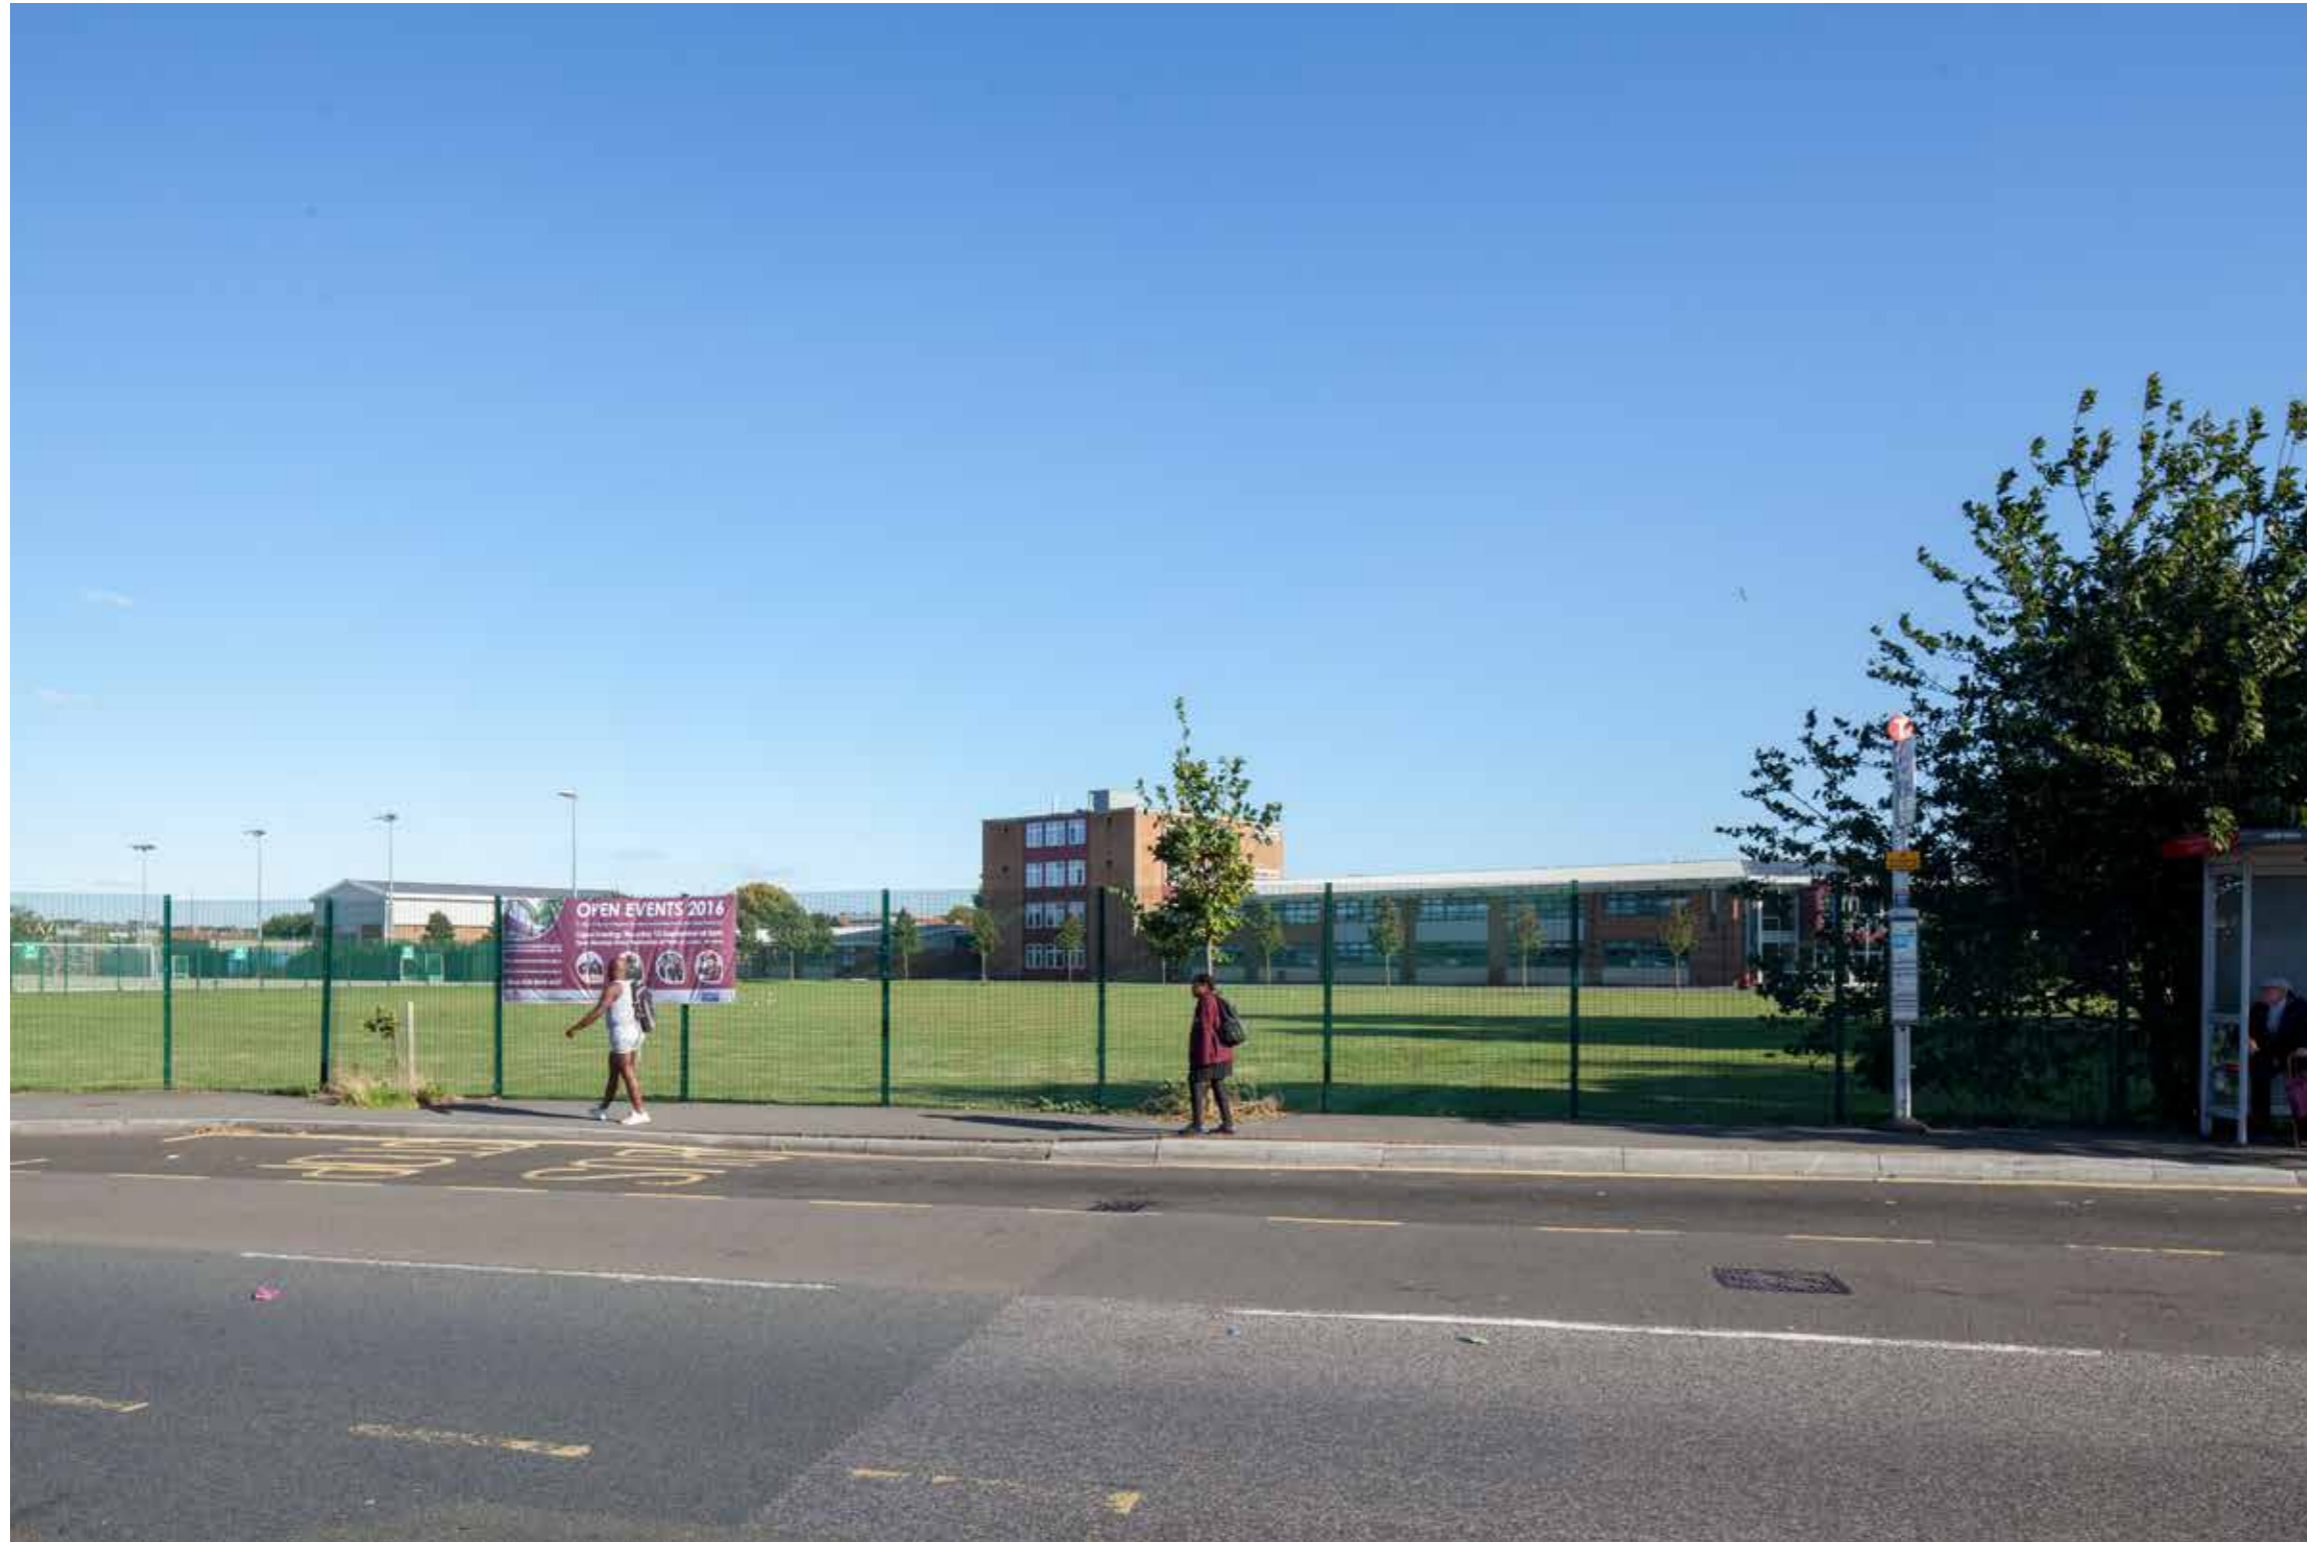
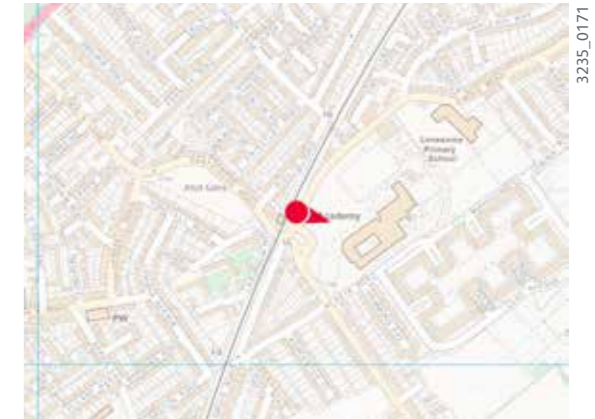
3235_0171

- 20. Grove Road. This image was taken from Grove Road, to the north of the estate, near the Mitcham Eastfields station, looking southeast towards the location of the estate. One can see the buildings of the St Marks Church of England Academy, along with the playing fields in the foreground. The estate is not visible or perceived from this location.
