Ravensbury Estate, Morden
Visual Impact Study
October 2016

Ravensbury Estate, Morden

Visual Impact Study

October 2016

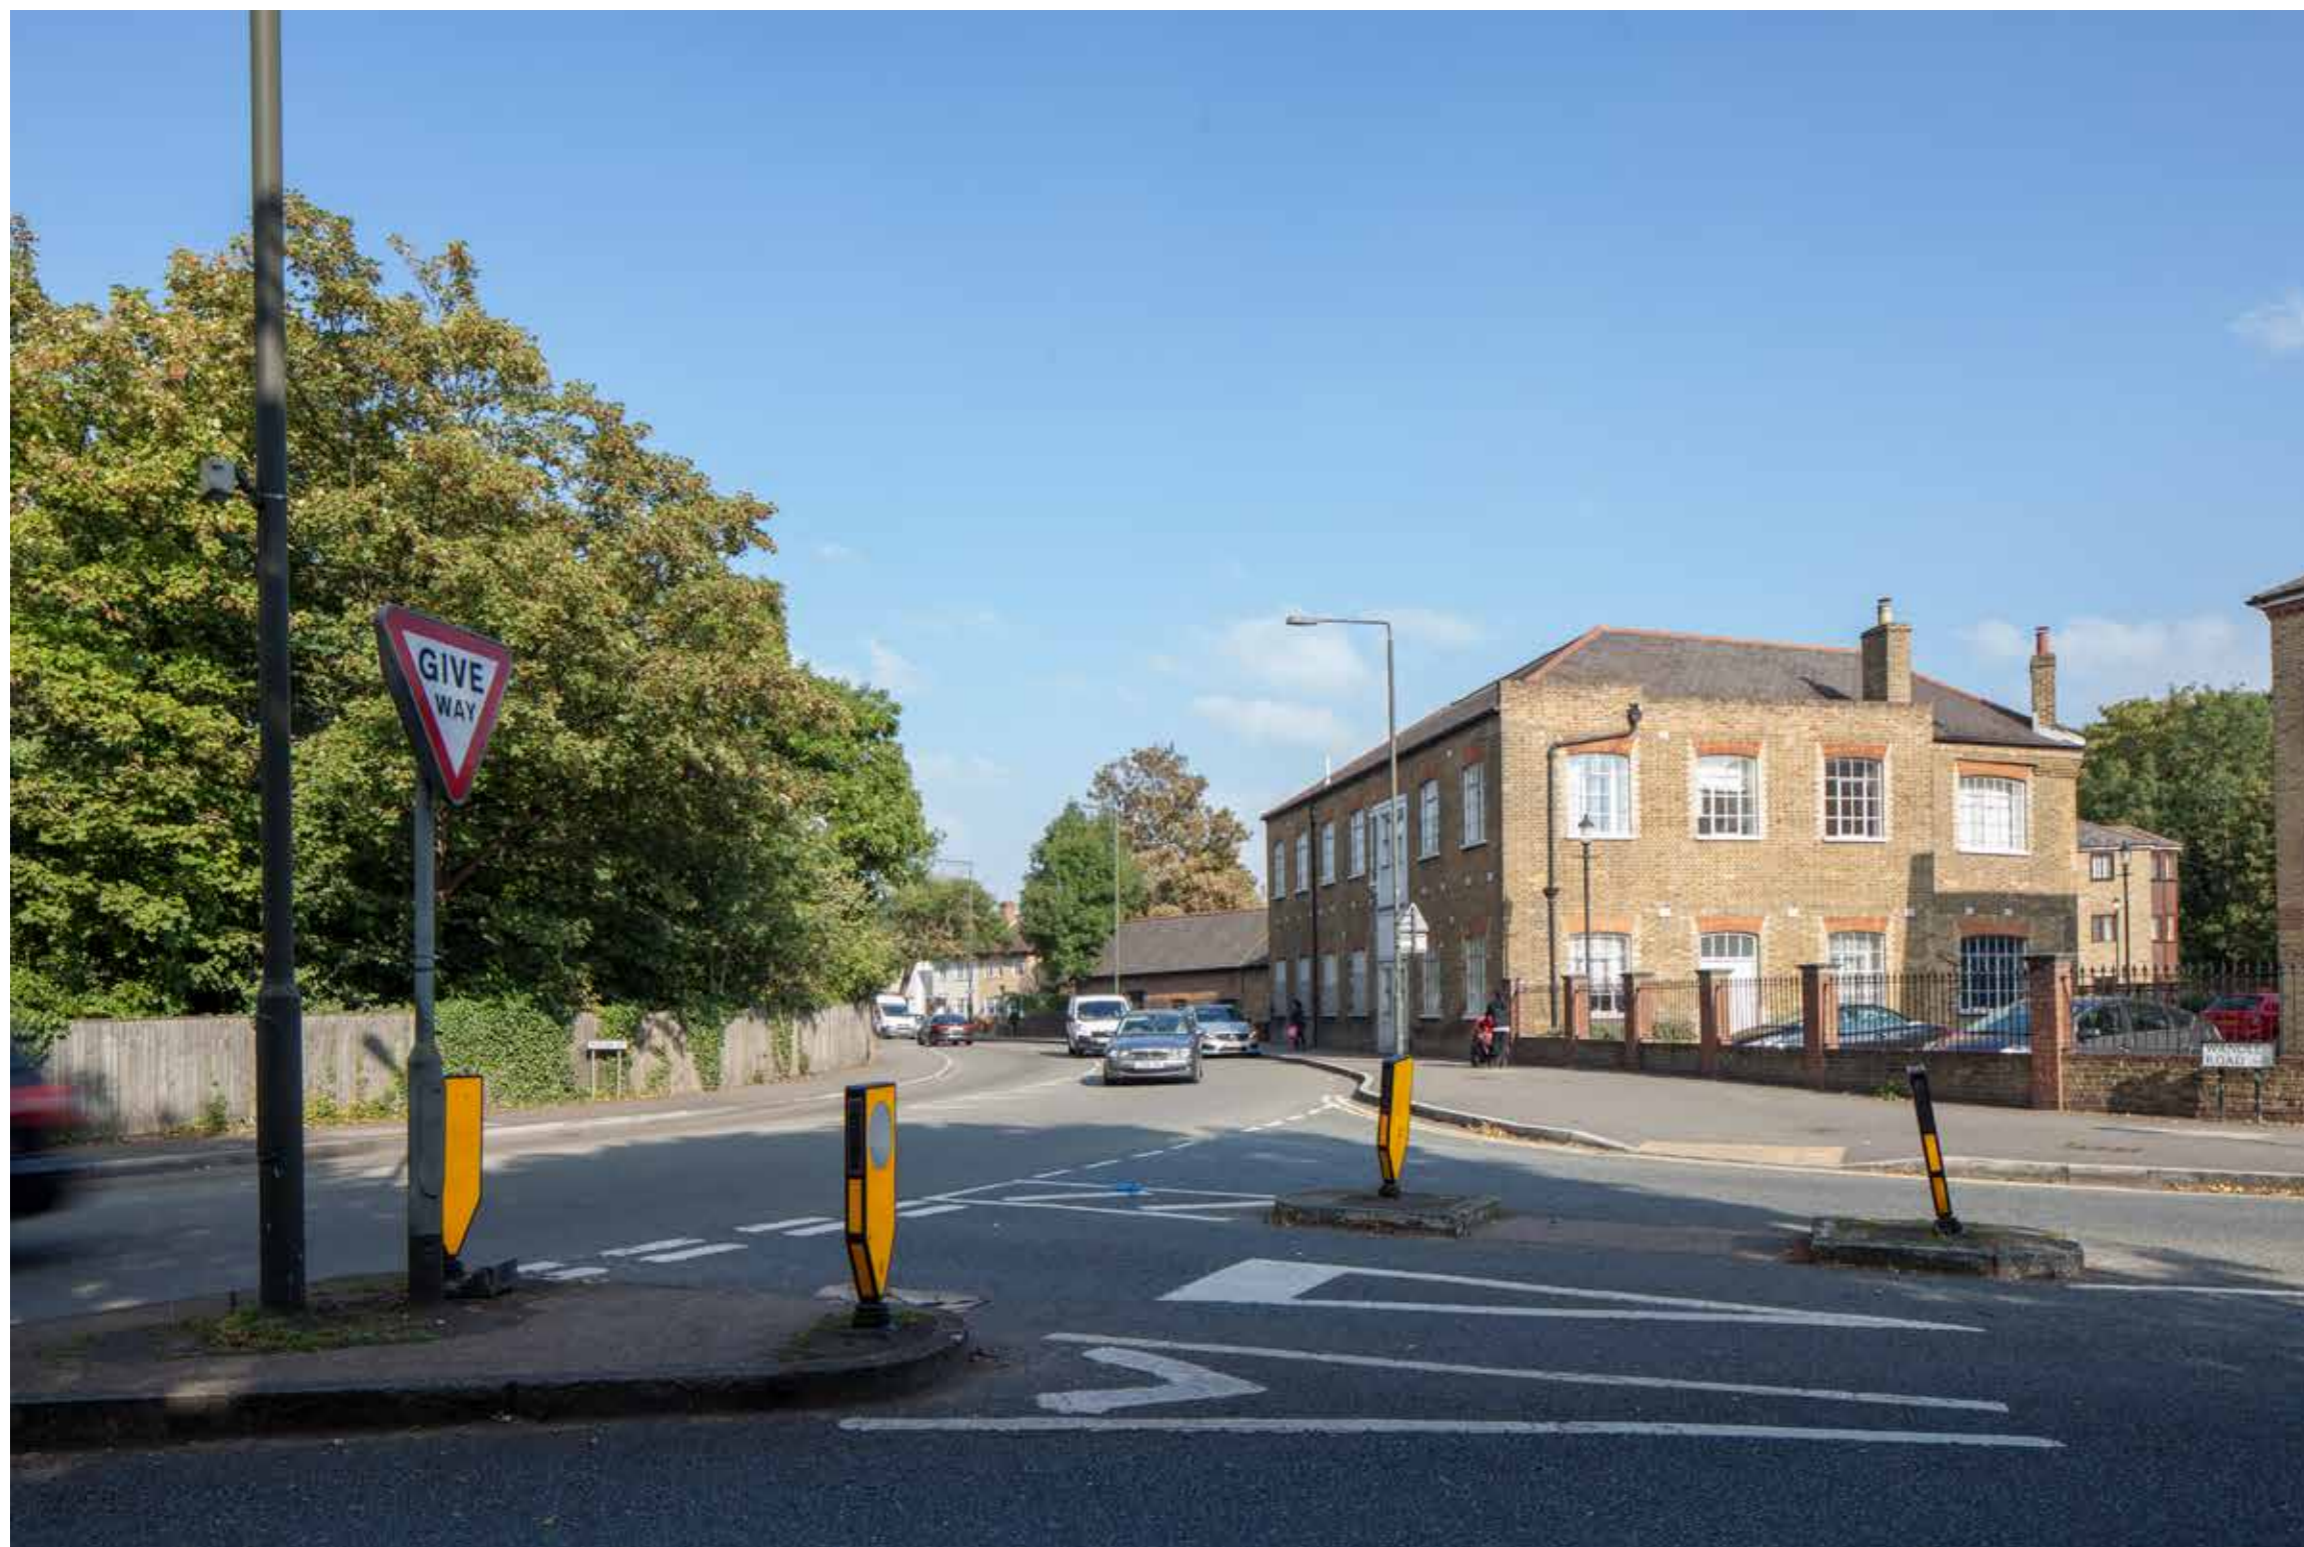
Existing

13. Viewpoint 1 is located on the junction of Wandle Road with Morden Road, on the south-western corner, looking northeast, towards the estate. The grade II listed Ravensbury Mill is the focal point of this image, with the road and the trees from Morden Hall Park making up much of the rest of the view. A few houses of the existing estate can be seen in the background, at the centre of the image.

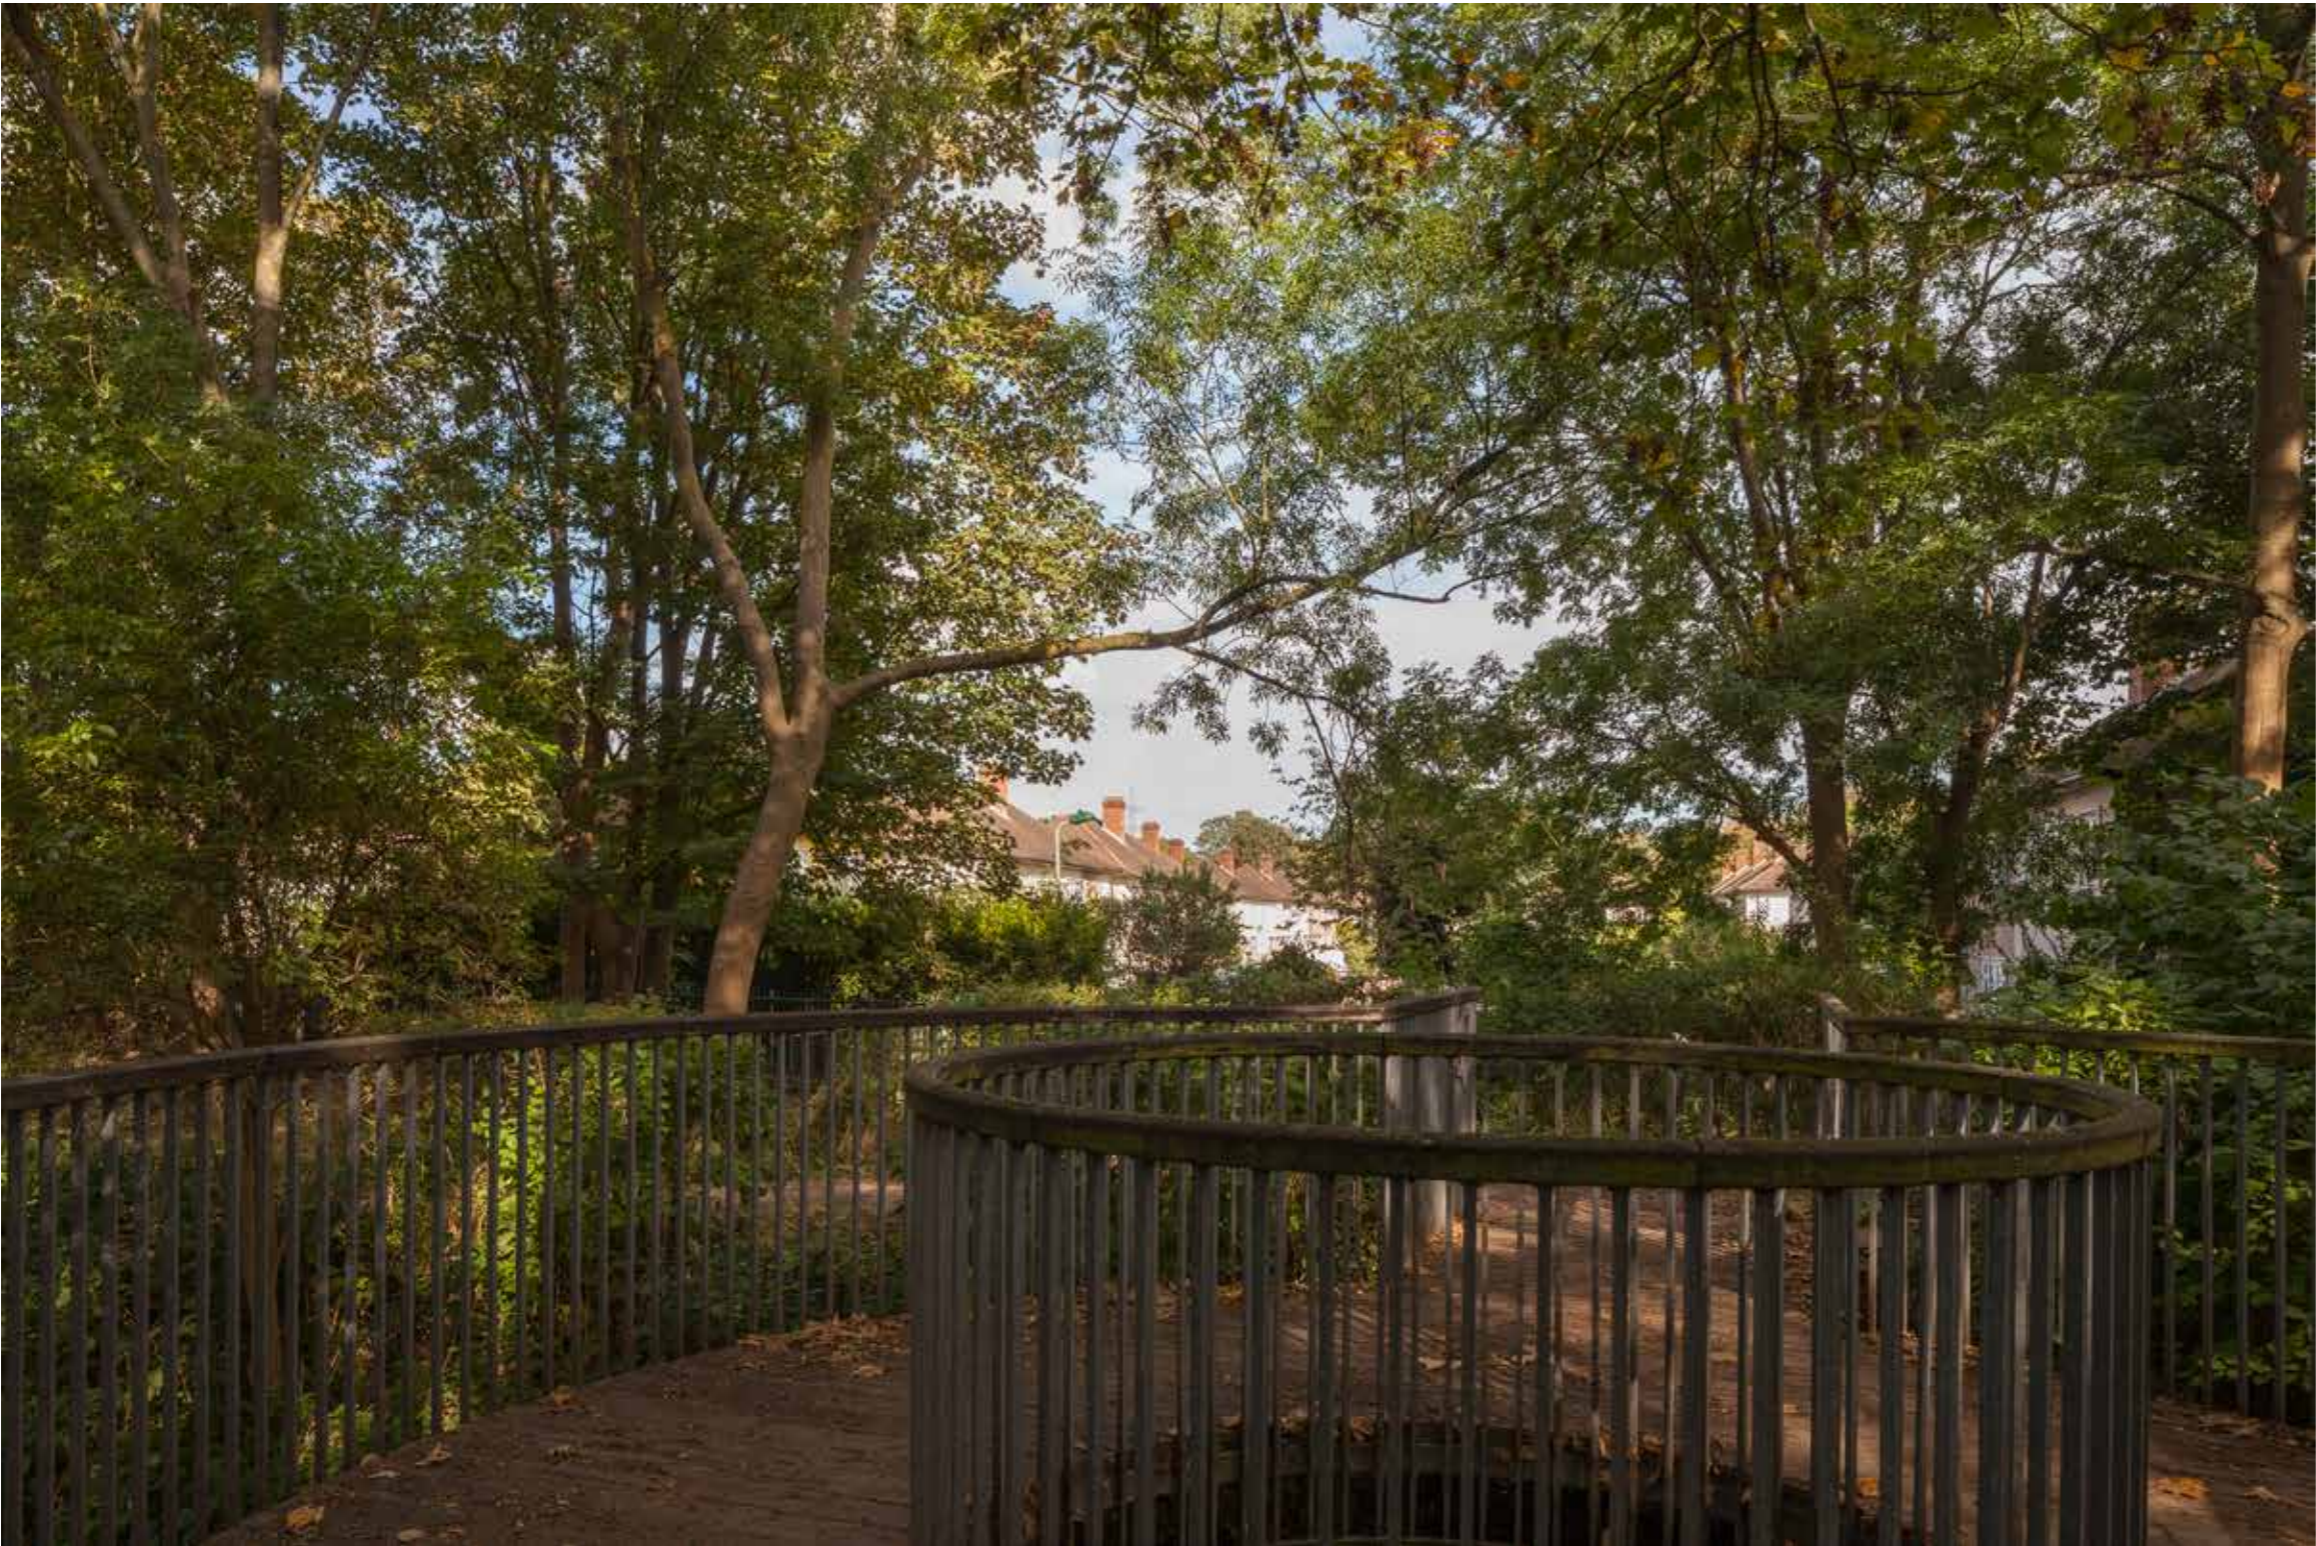
Existing

14. This image was taken from the footbridge over the Wandle River, to the west of the estate, looking back towards Rutter Gardens. The predominant feature in this view is the bridge and the trees around it. Parts of the terraces along Rutter Gardens are visible through the trees.

22. The visual impact of the Ravensbury Estate in its existing form is neutral. The scale and architecture of the existing buildings work well in their existing context, though the density of the built form is rather low on the estate. Images 2 and 6 in particular also show the limited permeability through the estate, with image 2 highlighting the lack of connections to the adjacent Ravensbury Park and the River Wandle.

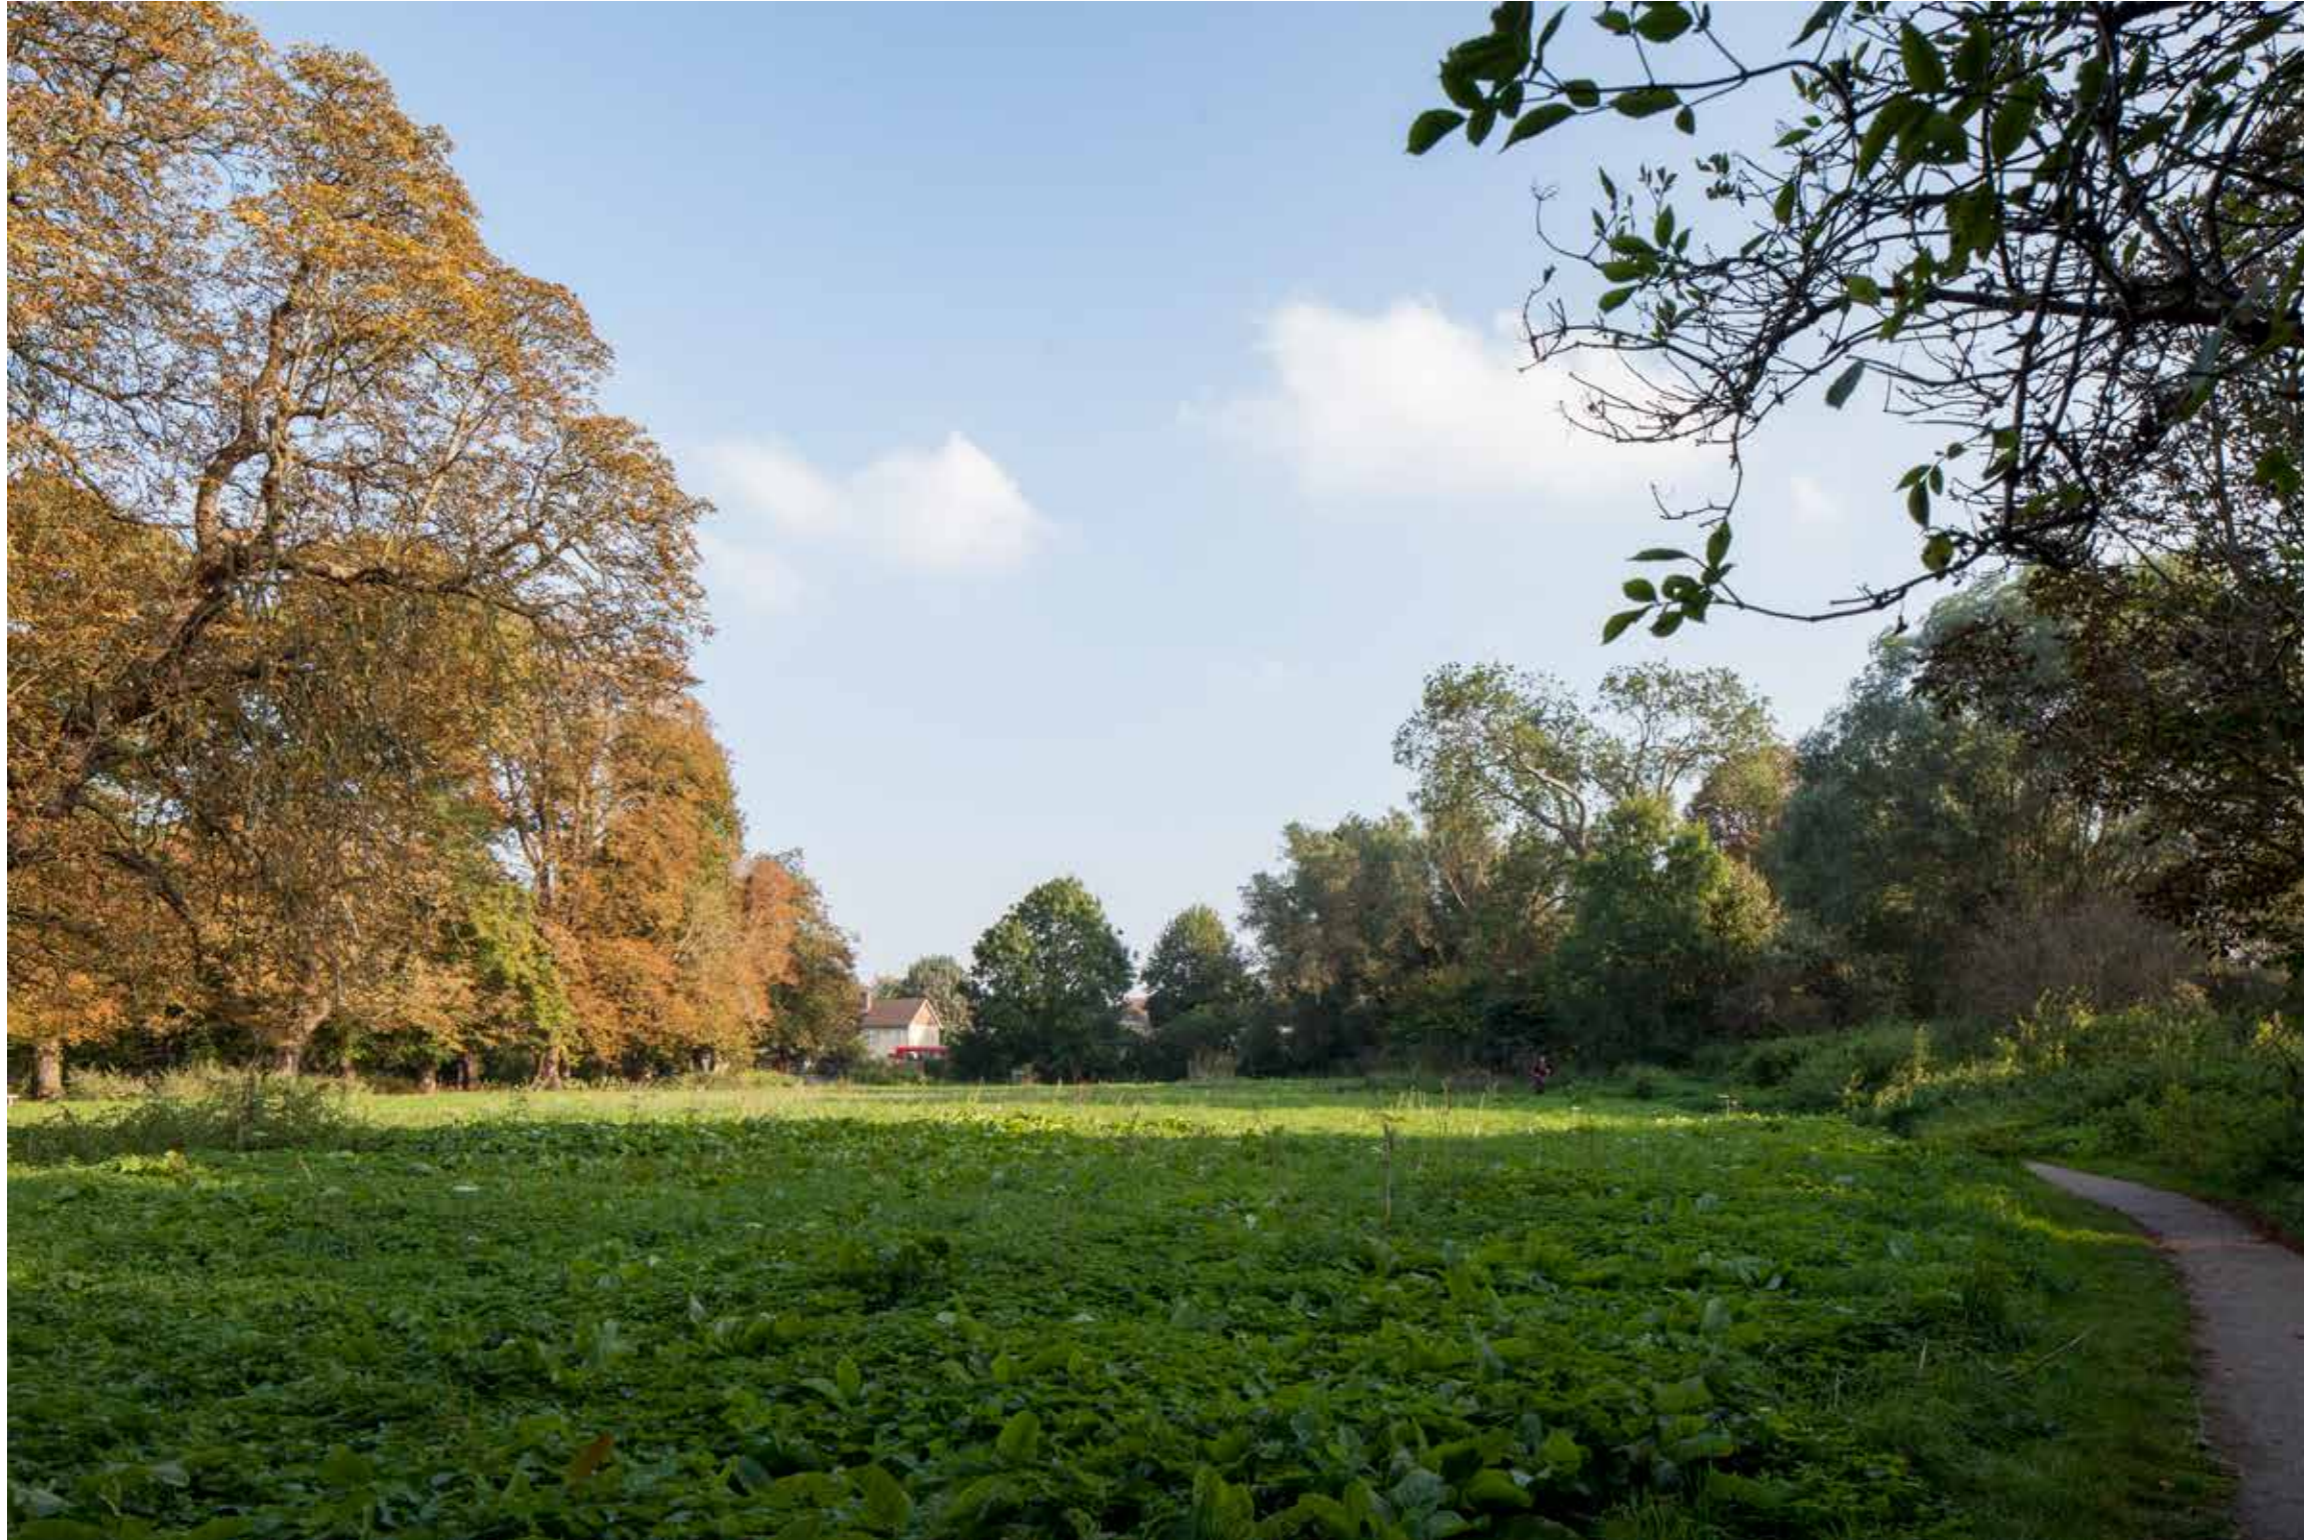
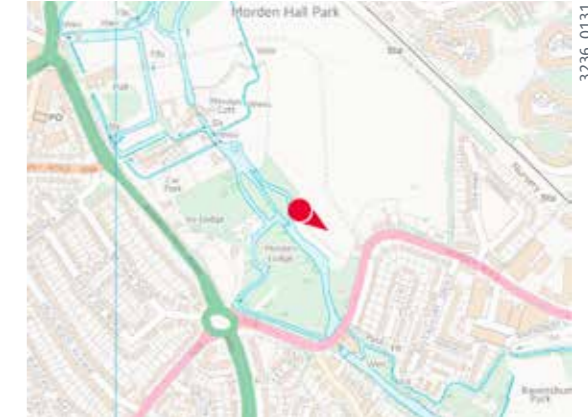
Existing

15. This viewpoint is located along a footpath on the southwest edge of Morden Hall Park, facing south. The main aspect of this image is the park itself, with its landscaping and trees. Some houses from within the estate are visible in the centre of the image through the landscaping.

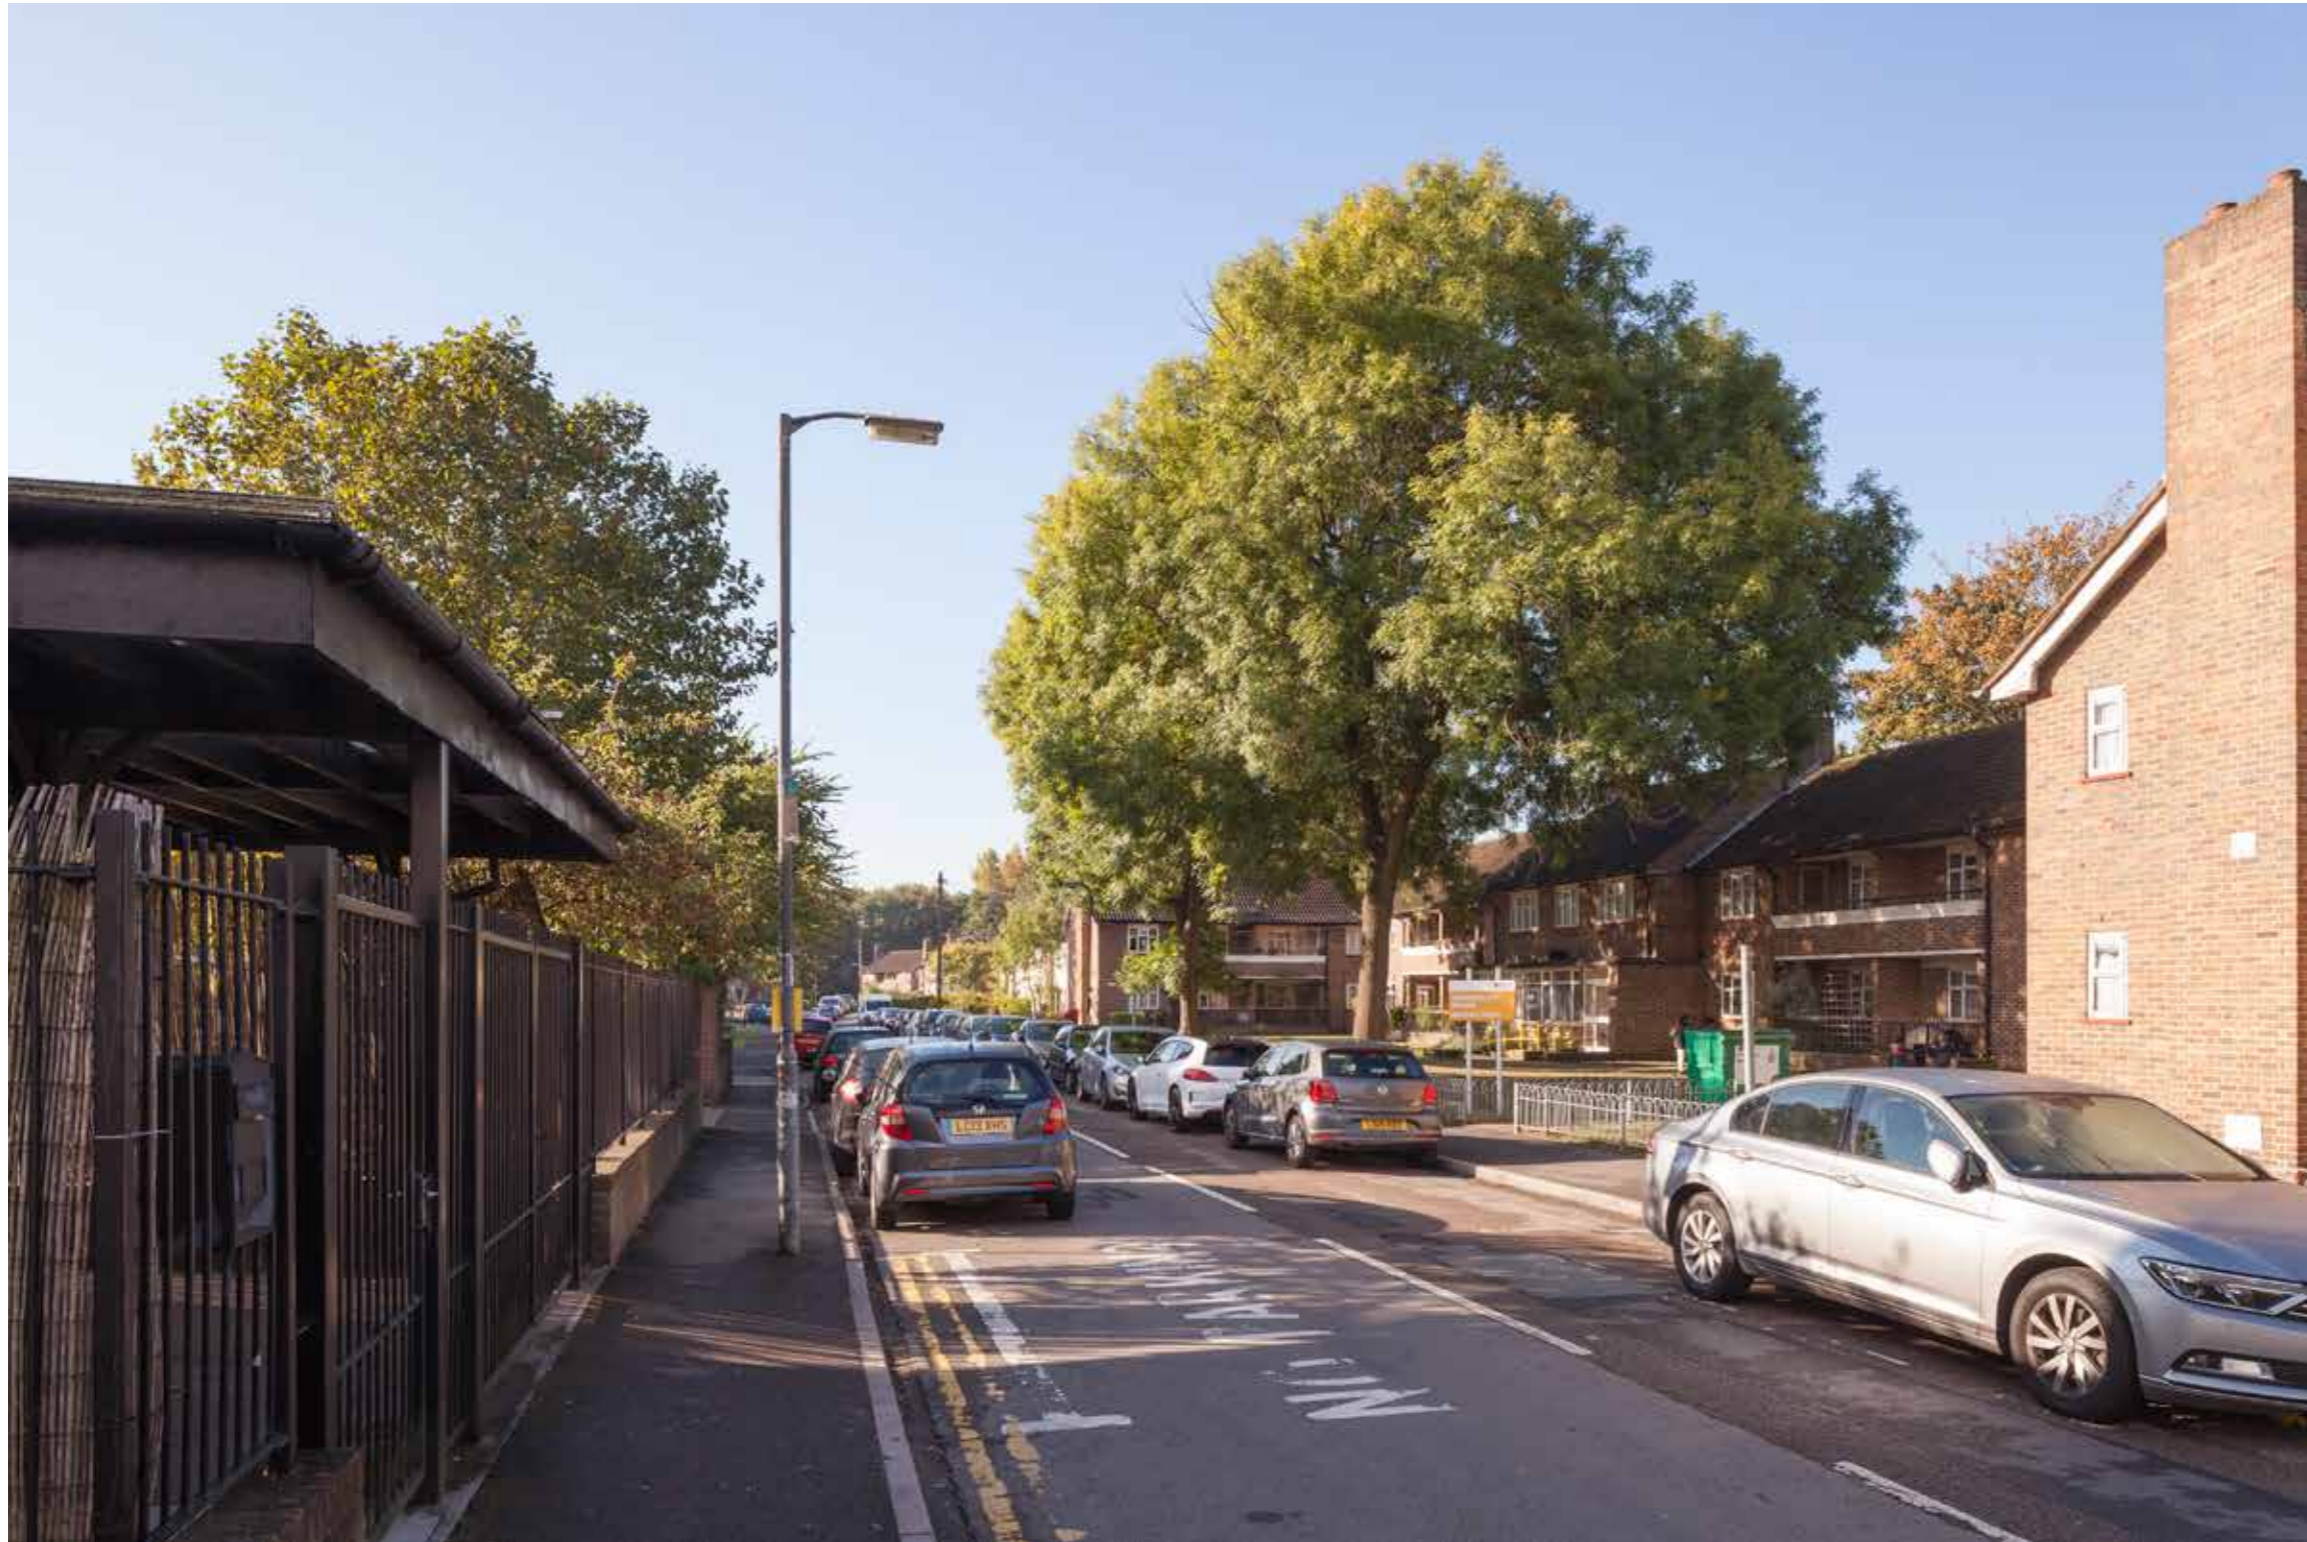
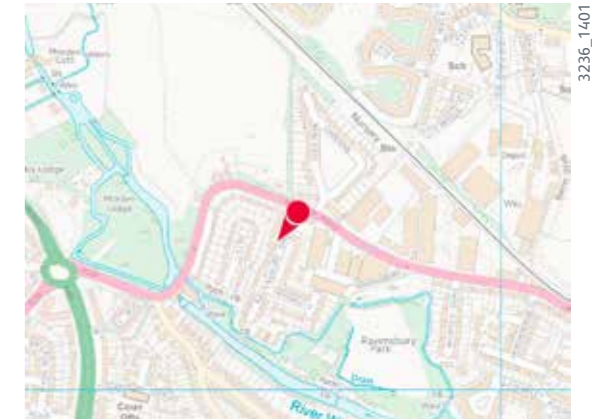
Existing

- 1.16 This image was taken from Ravensbury Grove, on the corner with Morden Road, facing south, into the estate. The main element in this image is the street itself, along with the landscaping surrounding it and in particular the two trees in front of the flats, in the centre of the image. Buildings belonging to the estate can be seen through the landscaping along much of the street. The gate and railings seen to the left of the image are not part of the Ravensbury Estate.

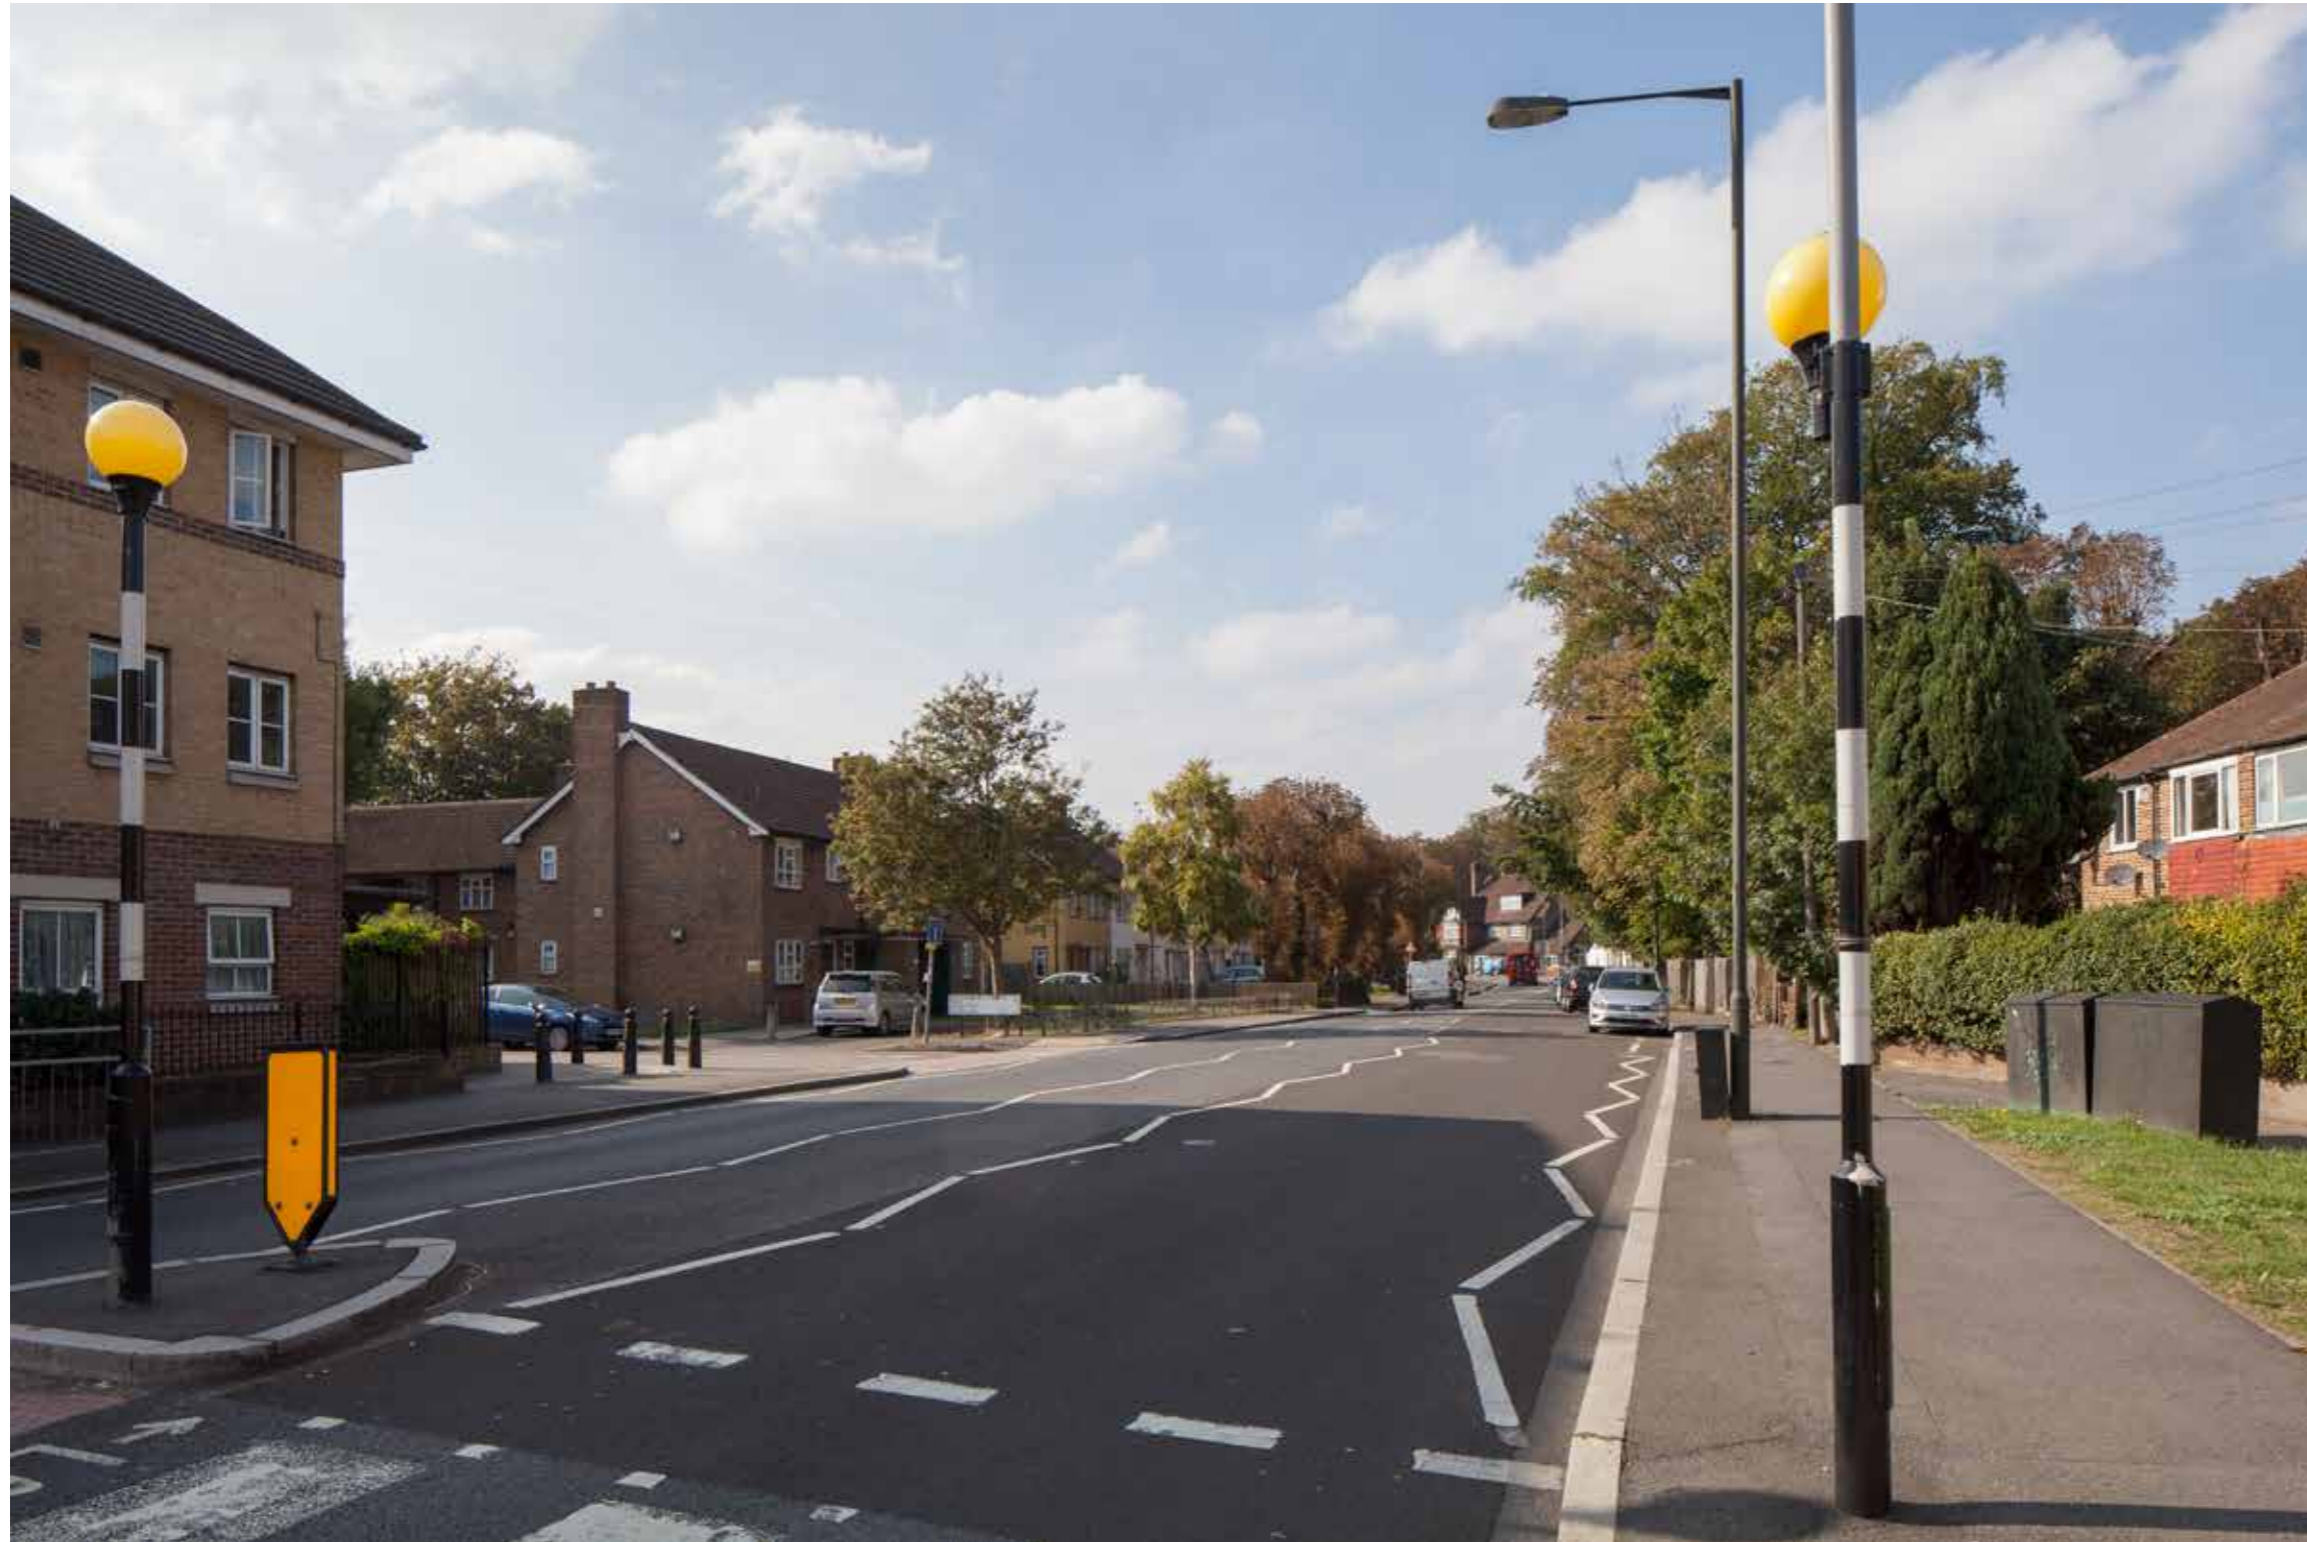
Existing

17. This viewpoint is located along Morden Road, near the junction with Deer Park Gardens, facing west along Morden Road and the east edge of the Ravensbury Estate. Morden Road is the main element seen in this image. The houses and landscaping either side of the road are also noticeable. The grade II listed White Cottage is seen in the distance on the bend of Morden Road, but is not very noticeable from here.

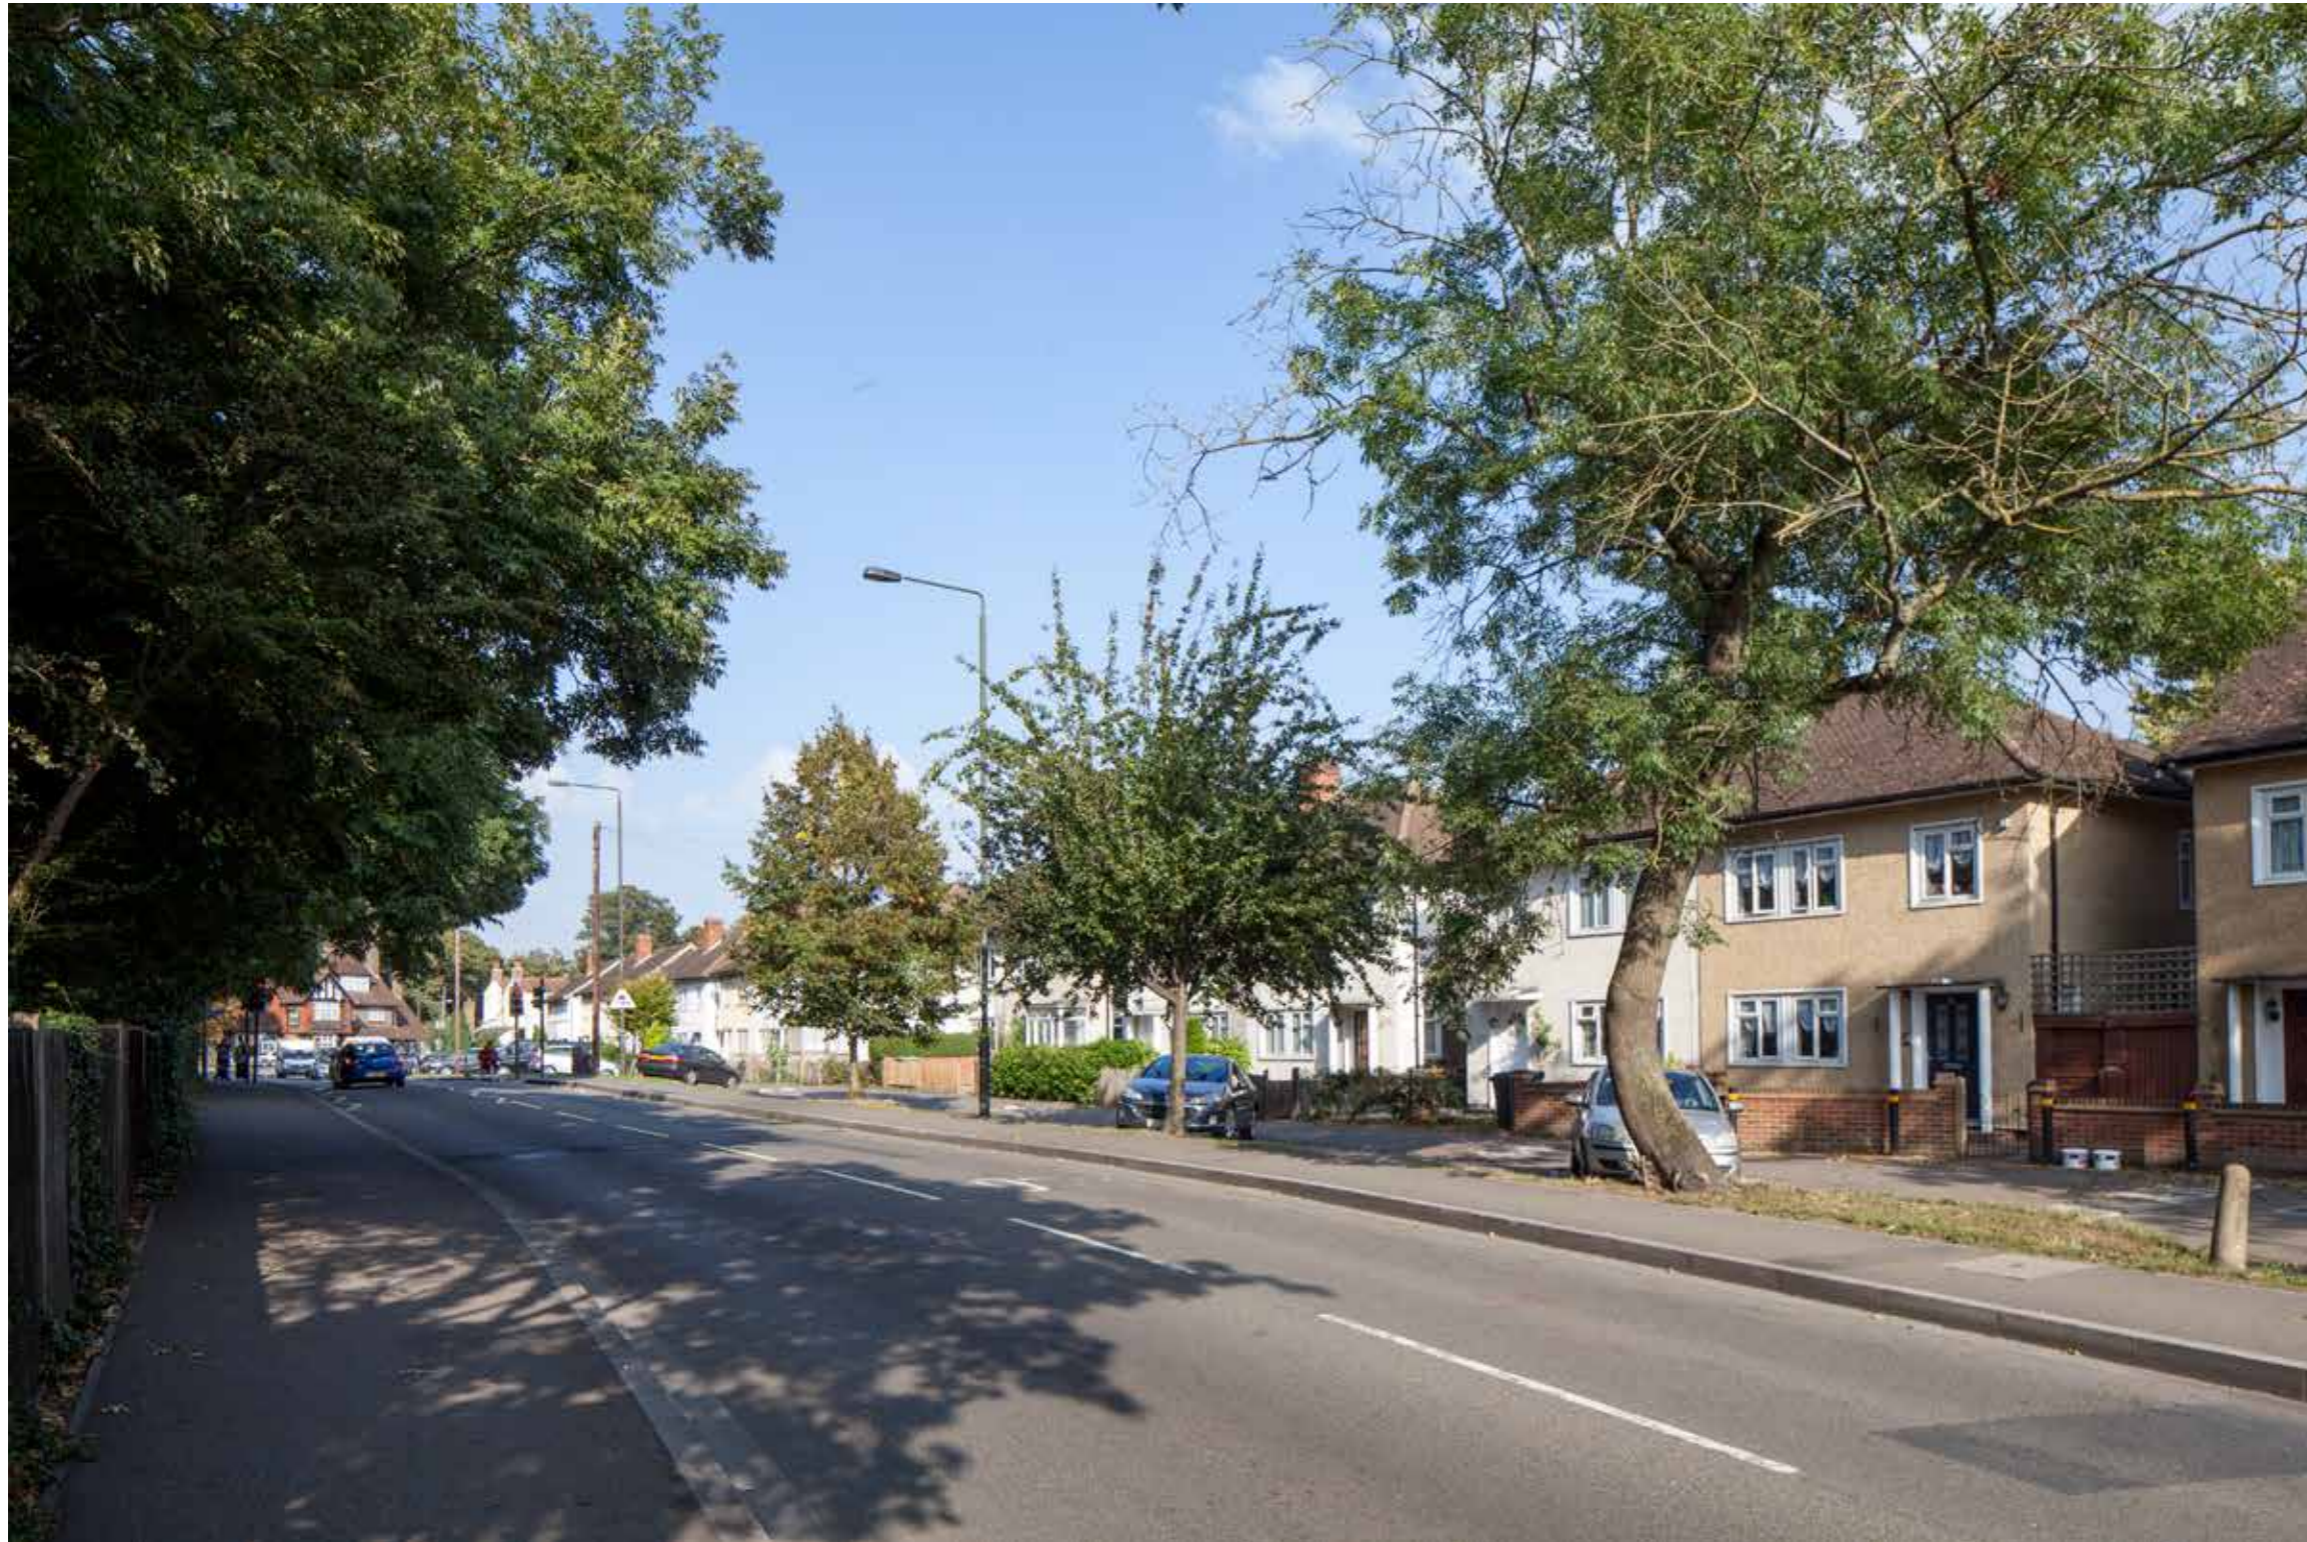
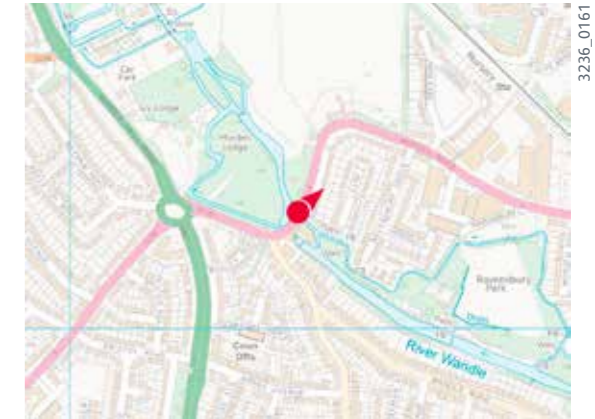
Existing

- 1.18 This viewpoint is located across the street from the estate, on Morden Road, facing east. This image shows Morden Road, as well as the sliproad in front of the estate, as well as the trees that are planted along it. The semi-detached houses of the estate are clearly seen along the sliproad, till the bend of Morden Road.
