Ravensbury Estate, Morden
Visual Impact Study
October 2016

Ravensbury Estate, Morden

Visual Impact Study

October 2016

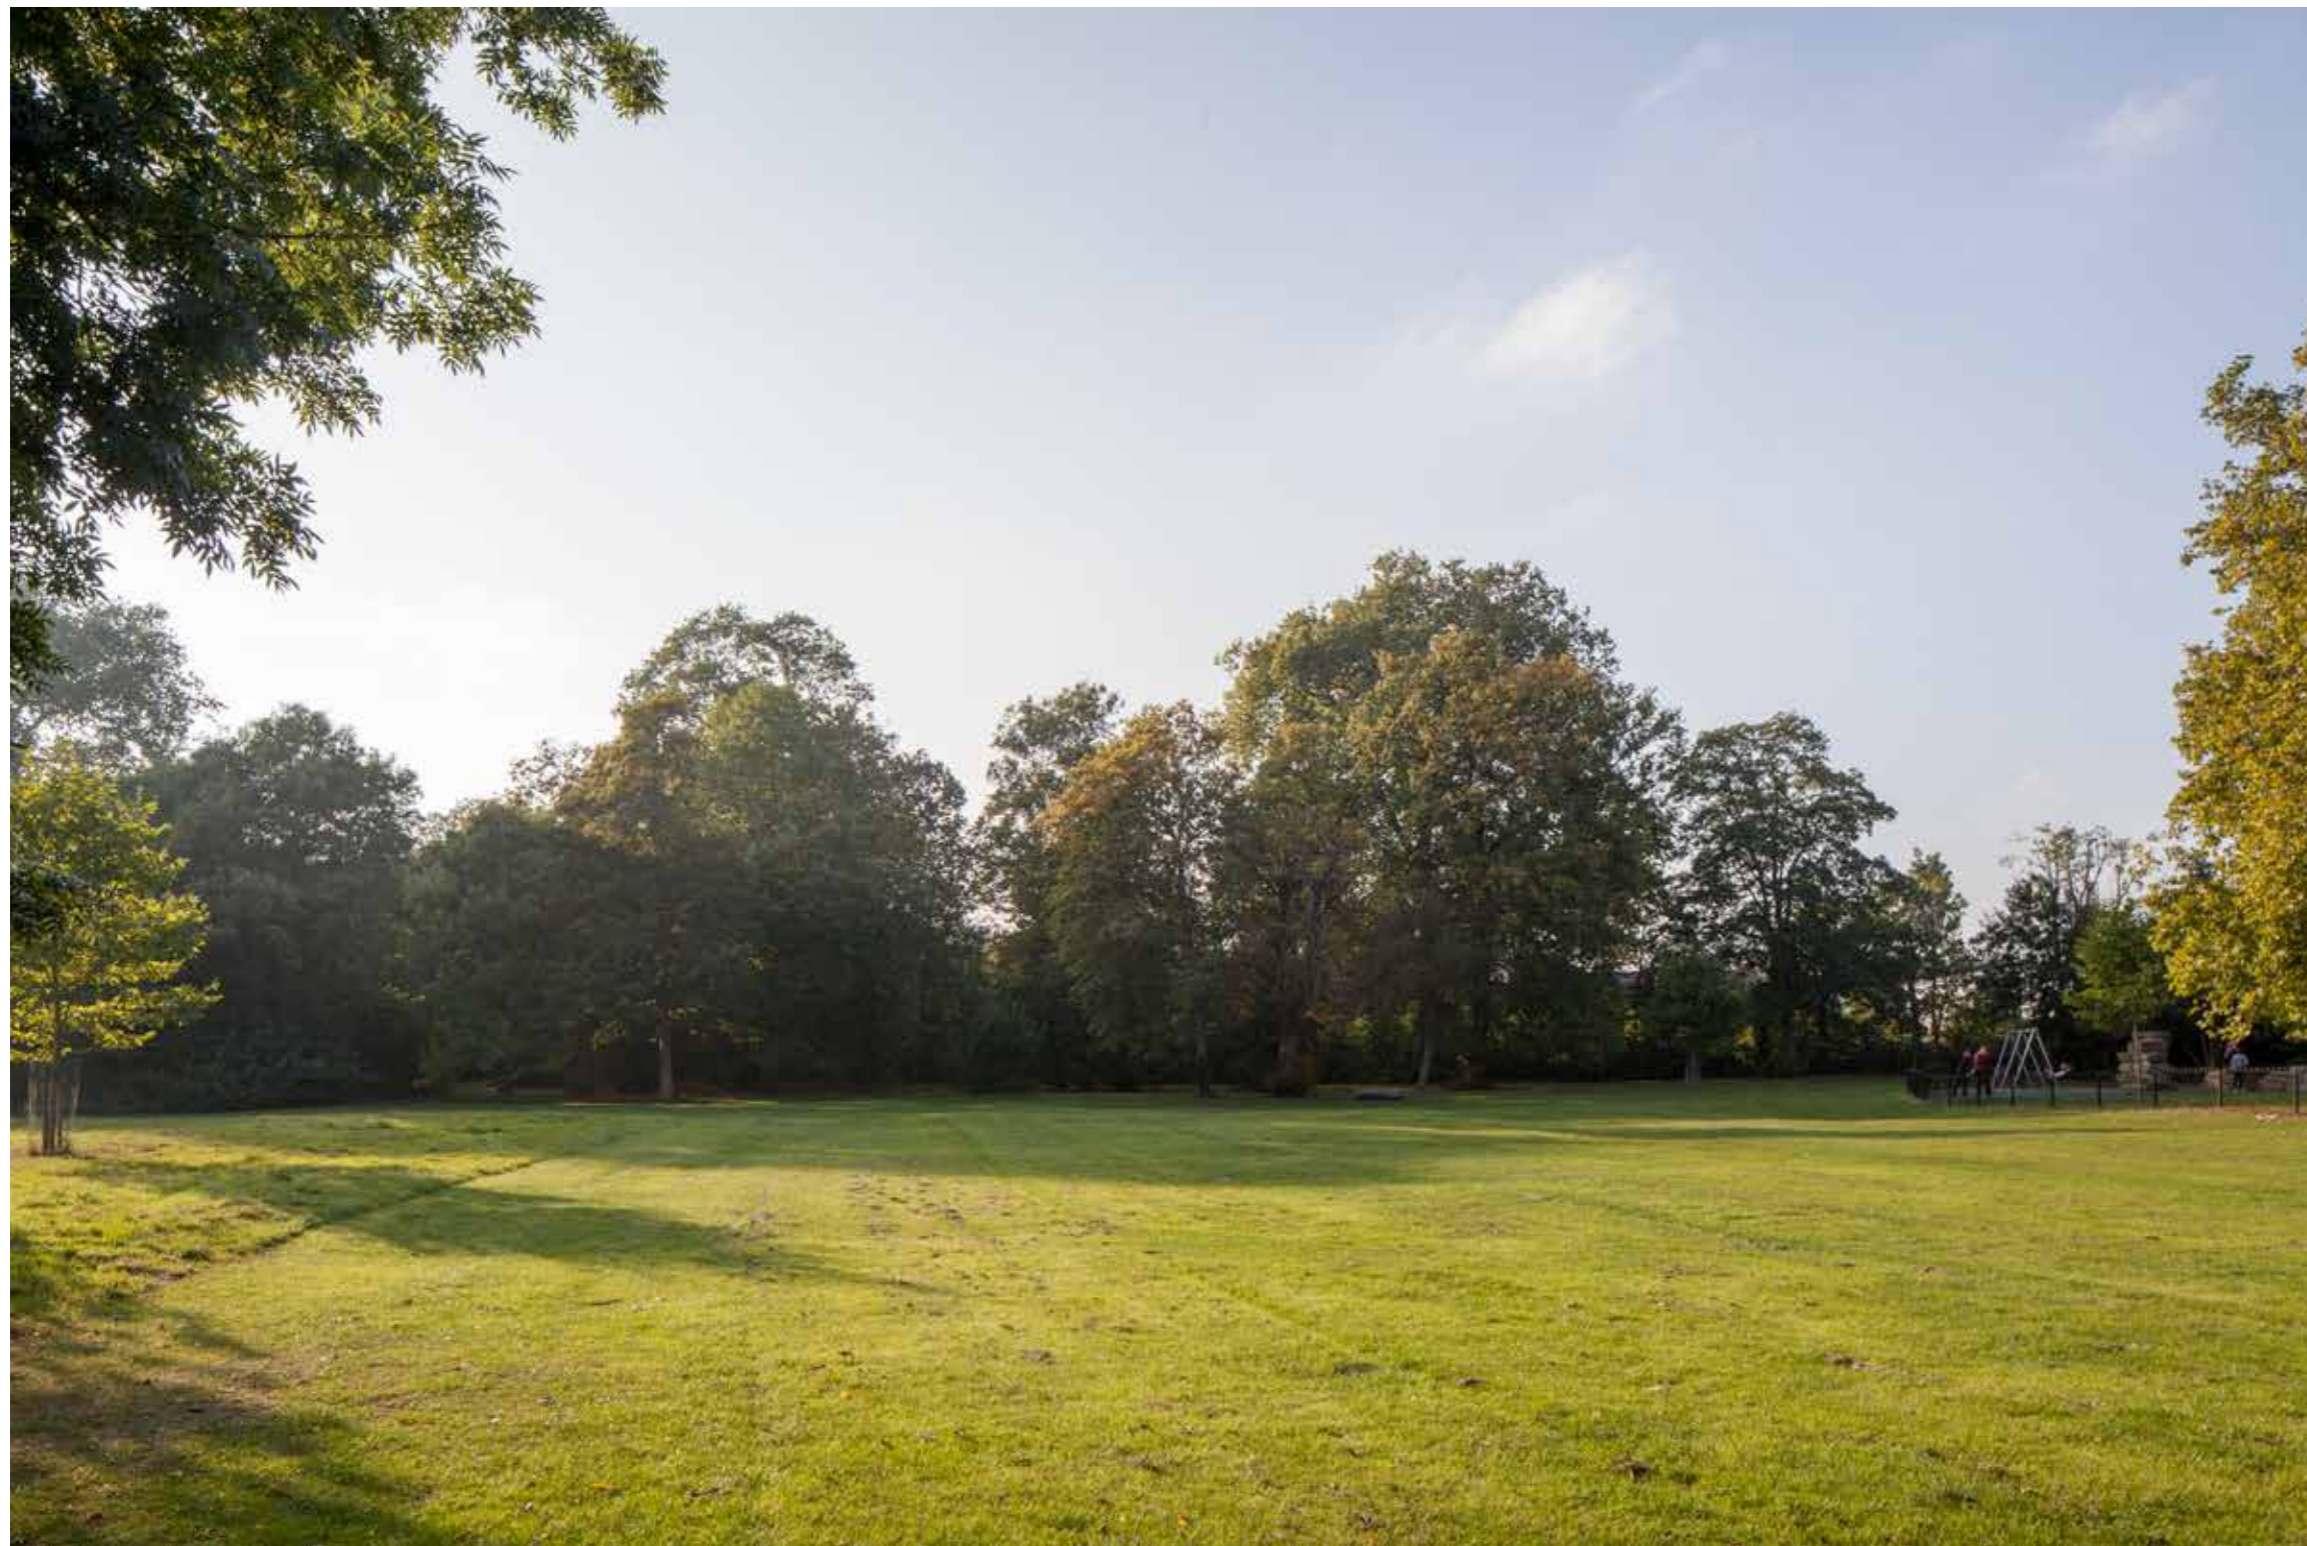
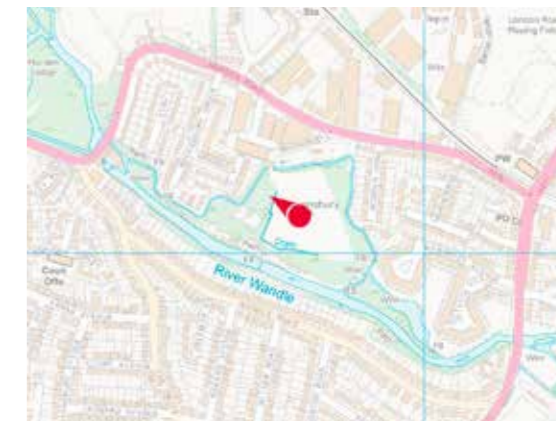
Existing

19. This image was taken from within Ravensbury Park, facing northwest, towards the direction of the estate. This image offers a view from within the park, with a foreground of grass and a background of mature landscaping and trees. The estate cannot be seen from this location, when trees are in leaf.

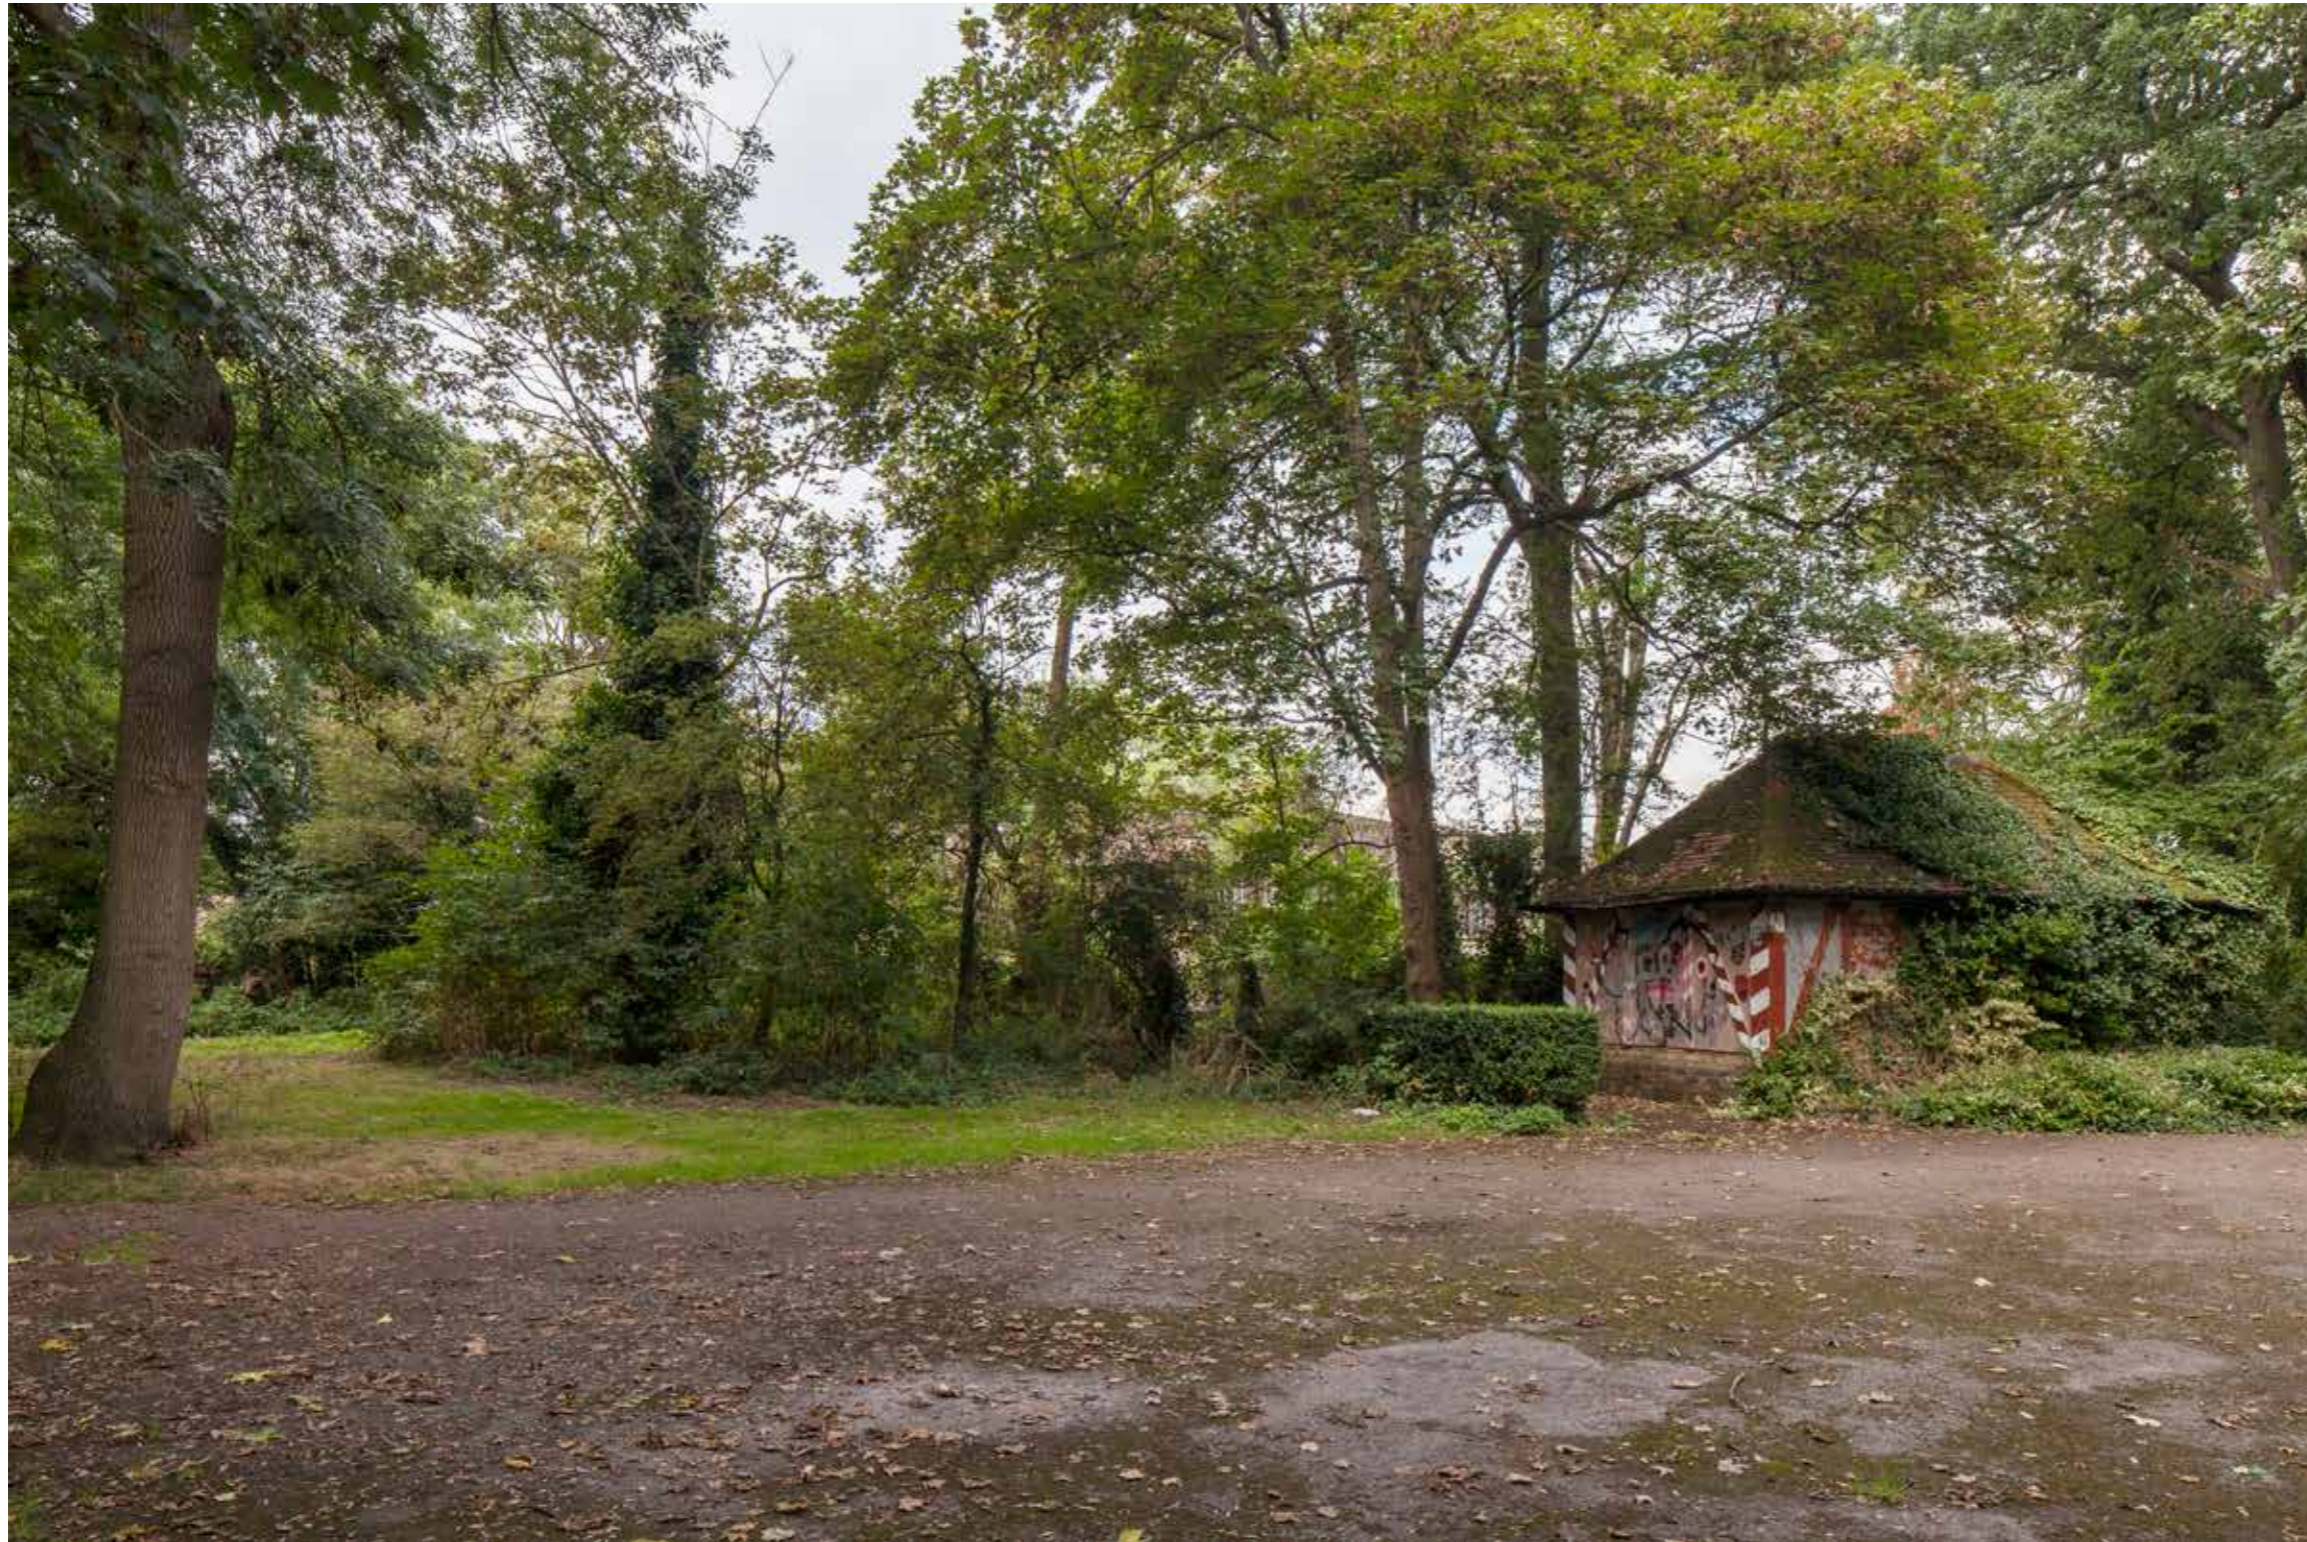
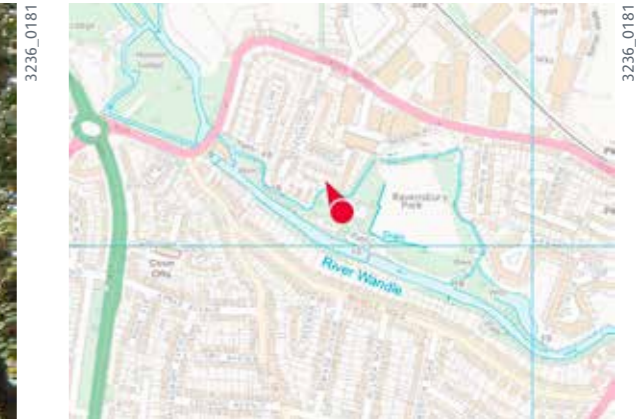
Existing

- 1.20 This viewpoint is located in the west edge of Ravensbury Park, facing north towards the direction of the estate. The park and the trees are the main feature in this image. To the right of the image is an outbuilding that has been left to disrepair. In the background, between the tree foliage, parts of the estate buildings are barely visible.
