Asbestos Reinspection Report
(with Priority Assessments)

St Peter & Paul Primary School
Cricket Green
Mitcham
Surrey
CR4 4LA

Project Number: B-90420
Issue Date: 31st March 2020
Issue No: 1

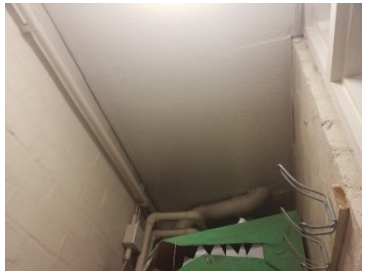
Surveyor	Richard Rayner	Room/Area	0/013A - Stores
Survey Date	06 March 2020	Level of Identification	Cross Reference (X)
Building	St Peter & Paul Primary School	Sample No	XJM020810/03
Floor	Ground Floor	Item	Textured Coating To Ceiling
Item Accessibility	Difficult	Amount	2m²

A - Product Type:		B - Extent of Damage:		C – Surface Treatment		D – Asbestos Type		Material Ass (M.A) (A+B+C+D):
Textured Coating	1	Good Condition	0	Composite materials; reinforced plastics, resins, vinyl tiles, sealed decorative finishes, etc.	0	Chrysotile	1	**2**

1 = Normal Occupant Activity = (E)	**1**	**E –** Main type of activity	1	**Total Priority Score (P.A.) = (1+2+3+4):**	**5**	**Total Risk Ass' Score (P.A. + M.A)**	**7**	**Risk Coding**	**VERY LOW**
2 = Disturbance = (F+G+H)/3	**1**	**F –** Location	2	**G –** Accessibility	0	**H –** Extent		0	
3 = Exposure potential = (I+J+K)/3	**2**	**I –** Number of occupants	1	**J –** Frequency of use	3	**K –** Average time in use		1	
4 = Maintenance activity = (L+M)/2	**1**	**L –** Type of maintenance	1	**M –** Frequency of maintenance	1	**Recommendation:** Manage & Re-inspect

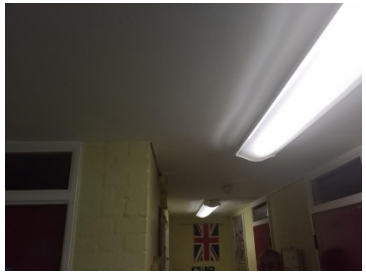
Surveyor	Richard Rayner	Room/Area	0/016D - Corridor
Survey Date	06 March 2020	Level of Identification	Cross Reference (X)
Building	St Peter & Paul Primary School	Sample No	XJM020810/03
Floor	Ground Floor	Item	Textured Coating To Ceiling
Item Accessibility	Difficult	Amount	**6m²**

A - Product Type:		B - Extent of Damage:		C – Surface Treatment		D – Asbestos Type		Material Ass (M.A) (A+B+C+D):
Textured Coating	1	Good Condition	0	Composite materials; reinforced plastics, resins, vinyl tiles, sealed decorative finishes, etc.	0	Chrysotile	1	**2**

1 = Normal Occupant Activity = (E)	**2**	**E –** Main type of activity	2	**Total Priority Score (P.A.) = (1+2+3+4):**	**6**	**Total Risk Ass' Score (P.A. + M.A)**	**8**	**Risk Coding**	**VERY LOW**
2 = Disturbance = (F+G+H)/3	**1**	**F –** Location	2	**G –** Accessibility	0	**H –** Extent	1		
3 = Exposure potential = (I+J+K)/3	**2**	**I –** Number of occupants	2	**J –** Frequency of use	3	**K –** Average time in use	0		
4 = Maintenance activity = (L+M)/2	**1**	**L –** Type of maintenance	0	**M –** Frequency of maintenance	1	**Recommendation:** Manage & Re-inspect

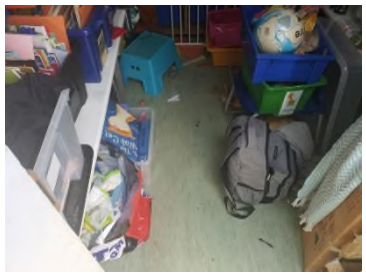
Surveyor	Richard Rayner	Room/Area	0/018A - Stores
Survey Date	06 March 2020	Level of Identification	Cross Reference (X)
Building	St Peter & Paul Primary School	Sample No	XJM020810/05
Floor	Ground Floor	Item	Floor Tiles And Adhesive
Item Accessibility	Difficult	Amount	**5m²**

A - Product Type:		B - Extent of Damage:		C – Surface Treatment		D – Asbestos Type		Material Ass (M.A) (A+B+C+D):
Floor Tiles	1	Good Condition	0	Composite materials; reinforced plastics, resins, vinyl tiles, sealed decorative finishes, etc.	0	Chrysotile	1	**2**

1 = Normal Occupant Activity = (E)	**1**	**E –** Main type of activity	1	**Total Priority Score (P.A.) = (1+2+3+4):**	**5**	**Total Risk Ass' Score (P.A. + M.A)**	**7**	**Risk Coding**	**VERY LOW**
2 = Disturbance = (F+G+H)/3	**1**	**F –** Location	2	**G –** Accessibility	0	**H –** Extent		1	
3 = Exposure potential = (I+J+K)/3	**2**	**I –** Number of occupants	1	**J –** Frequency of use	3	**K –** Average time in use		1	
4 = Maintenance activity = (L+M)/2	**1**	**L –** Type of maintenance	1	**M –** Frequency of maintenance	1	**Recommendation:** Manage & Re-inspect

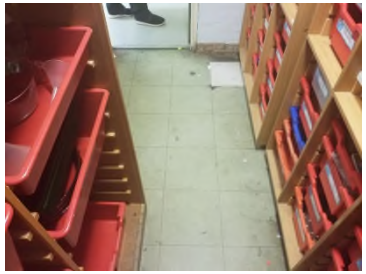
Surveyor	Richard Rayner	Room/Area	0/021 - Stores
Survey Date	06 March 2020	Level of Identification	Cross Reference (X)
Building	St Peter & Paul Primary School	Sample No	XJM020810/05
Floor	Ground Floor	Item	Floor Tiles And Adhesive
Item Accessibility	Difficult	Amount	**5m²**

A - Product Type:		B - Extent of Damage:		C – Surface Treatment		D – Asbestos Type		Material Ass (M.A) (A+B+C+D):
Floor Tiles	1	Low Damage	1	Composite materials; reinforced plastics, resins, vinyl tiles, sealed decorative finishes, etc.	0	Chrysotile	1	**3**

1 = Normal Occupant Activity = (E)	**1**	**E –** Main type of activity	1	**Total Priority Score (P.A.) = (1+2+3+4):**	**5**	**Total Risk Ass' Score (P.A. + M.A)**	**8**	**Risk Coding**	**VERY LOW**
2 = Disturbance = (F+G+H)/3	**1**	**F –** Location	2	**G –** Accessibility	0	**H –** Extent		1	
3 = Exposure potential = (I+J+K)/3	**2**	**I –** Number of occupants	1	**J –** Frequency of use	3	**K –** Average time in use		1	
4 = Maintenance activity = (L+M)/2	**1**	**L –** Type of maintenance	1	**M –** Frequency of maintenance	1	**Recommendation:** Manage & Re-inspect

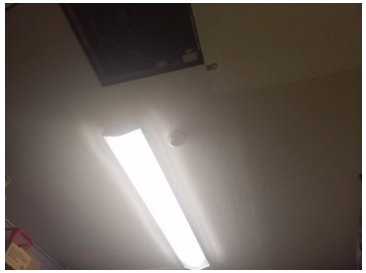
Surveyor	Richard Rayner	Room/Area	0/022 - Stores
Survey Date	06 March 2020	Level of Identification	Cross Reference (X)
Building	St Peter & Paul Primary School	Sample No	XJM020810/03
Floor	Ground Floor	Item	Textured Coating To Ceiling
Item Accessibility	Difficult	Amount	**8m²**

A - Product Type:		B - Extent of Damage:		C – Surface Treatment		D – Asbestos Type		Material Ass (M.A) (A+B+C+D):
Textured Coating	1	Good Condition	0	Composite materials; reinforced plastics, resins, vinyl tiles, sealed decorative finishes, etc.	0	Chrysotile	1	**2**

1 = Normal Occupant Activity = (E)	**1**	**E –** Main type of activity	1	**Total Priority Score (P.A.) = (1+2+3+4):**	**5**	**Total Risk Ass' Score (P.A. + M.A)**	**7**	**Risk Coding**	**VERY LOW**
2 = Disturbance = (F+G+H)/3	**1**	**F –** Location	2	**G –** Accessibility	0	**H –** Extent		1	
3 = Exposure potential = (I+J+K)/3	**2**	**I –** Number of occupants	1	**J –** Frequency of use	3	**K –** Average time in use		1	
4 = Maintenance activity = (L+M)/2	**1**	**L –** Type of maintenance	1	**M –** Frequency of maintenance	1	**Recommendation:** Manage & Re-inspect

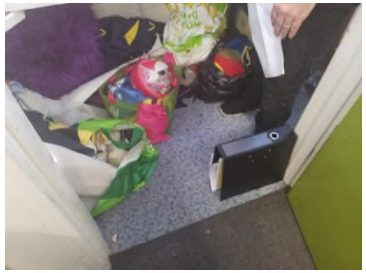
Surveyor	Richard Rayner	Room/Area	0/032 - Stores
Survey Date	06 March 2020	Level of Identification	Presumed (P)
Building	St Peter & Paul Primary School	Sample No	P
Floor	Ground Floor	Item	Parquet Flooring Adhesive
Item Accessibility	Difficult	Amount	**3m²**

A - Product Type:		B - Extent of Damage:		C – Surface Treatment		D – Asbestos Type		Material Ass (M.A) (A+B+C+D):
Bitumen Products	1	Low Damage	1	Composite materials; reinforced plastics, resins, vinyl tiles, sealed decorative finishes, etc.	0	Chrysotile	1	**3**

1 = Normal Occupant Activity = (E)	**0**	**E –** Main type of activity	0	**Total Priority Score (P.A.) = (1+2+3+4):**	**1**	**Total Risk Ass' Score (P.A. + M.A)**	**4**	**Risk Coding**	**VERY LOW**
2 = Disturbance = (F+G+H)/3	**0**	**F –** Location	1	**G –** Accessibility	0	**H –** Extent		0	
3 = Exposure potential = (I+J+K)/3	**1**	**I –** Number of occupants	0	**J –** Frequency of use	2	**K –** Average time in use		0	
4 = Maintenance activity = (L+M)/2	**0**	**L –** Type of maintenance	0	**M –** Frequency of maintenance	0	**Recommendation:** No Access - Inspection Required

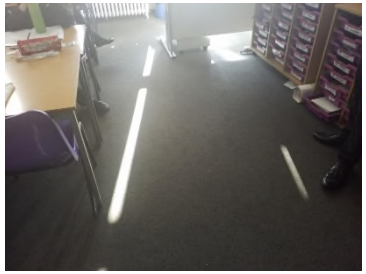
Surveyor	Richard Rayner	Room/Area	0/034 - Classroom
Survey Date	06 March 2020	Level of Identification	Presumed (P)
Building	St Peter & Paul Primary School	Sample No	P
Floor	Ground Floor	Item	Parquet Flooring Adhesive
Item Accessibility	Difficult	Amount	**40m²**

A - Product Type:		B - Extent of Damage:		C – Surface Treatment		D – Asbestos Type		Material Ass (M.A) (A+B+C+D):
Bitumen Products	1	Low Damage	1	Composite materials; reinforced plastics, resins, vinyl tiles, sealed decorative finishes, etc.	0	Chrysotile	1	**3**

1 = Normal Occupant Activity = (E)	**0**	**E –** Main type of activity	0	**Total Priority Score (P.A.) = (1+2+3+4):**	**2**	**Total Risk Ass' Score (P.A. + M.A)**	**5**	**Risk Coding**	**VERY LOW**
2 = Disturbance = (F+G+H)/3	**1**	**F –** Location	1	**G –** Accessibility	0	**H –** Extent		2	
3 = Exposure potential = (I+J+K)/3	**1**	**I –** Number of occupants	0	**J –** Frequency of use	2	**K –** Average time in use		0	
4 = Maintenance activity = (L+M)/2	**0**	**L –** Type of maintenance	0	**M –** Frequency of maintenance	0	**Recommendation:** No Access - Inspection Required

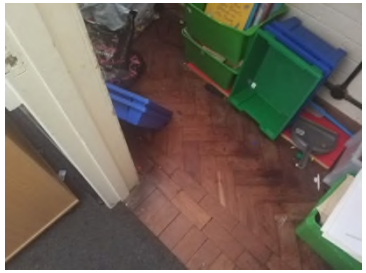
Surveyor	Richard Rayner	Room/Area	0/035 - Stores
Survey Date	06 March 2020	Level of Identification	Presumed (P)
Building	St Peter & Paul Primary School	Sample No	P
Floor	Ground Floor	Item	Parquet Flooring Adhesive
Item Accessibility	Difficult	Amount	**3m²**

A - Product Type:		B - Extent of Damage:		C – Surface Treatment		D – Asbestos Type		Material Ass (M.A) (A+B+C+D):
Bitumen Products	1	Low Damage	1	Composite materials; reinforced plastics, resins, vinyl tiles, sealed decorative finishes, etc.	0	Chrysotile	1	**3**

1 = Normal Occupant Activity = (E)	**0**	**E –** Main type of activity	0	**Total Priority Score (P.A.) = (1+2+3+4):**	**1**	**Total Risk Ass' Score (P.A. + M.A)**	**4**	**Risk Coding**	**VERY LOW**
2 = Disturbance = (F+G+H)/3	**0**	**F –** Location	1	**G –** Accessibility	0	**H –** Extent		0	
3 = Exposure potential = (I+J+K)/3	**1**	**I –** Number of occupants	0	**J –** Frequency of use	2	**K –** Average time in use		0	
4 = Maintenance activity = (L+M)/2	**0**	**L –** Type of maintenance	0	**M –** Frequency of maintenance	0	**Recommendation:** No Access - Inspection Required

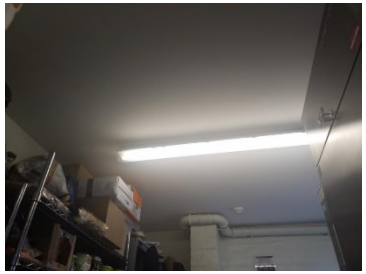
Surveyor	Richard Rayner	Room/Area	0/038C - Kitchen Stores
Survey Date	06 March 2020	Level of Identification	Cross Reference (X)
Building	St Peter & Paul Primary School	Sample No	XJM020810/08
Floor	Ground Floor	Item	Textured Coating To Ceiling
Item Accessibility	Difficult	Amount	**7m²**

A - Product Type:		B - Extent of Damage:		C – Surface Treatment		D – Asbestos Type		Material Ass (M.A) (A+B+C+D):
Textured Coating	1	Good Condition	0	Composite materials; reinforced plastics, resins, vinyl tiles, sealed decorative finishes, etc.	0	Chrysotile	1	**2**

1 = Normal Occupant Activity = (E)	**0**	**E –** Main type of activity	0	**Total Priority Score (P.A.) = (1+2+3+4):**	**0**	**Total Risk Ass' Score (P.A. + M.A)**	**2**	**Risk Coding**	**VERY LOW**
2 = Disturbance = (F+G+H)/3	**0**	**F –** Location	0	**G –** Accessibility	0	**H –** Extent		1	
3 = Exposure potential = (I+J+K)/3	**0**	**I –** Number of occupants	0	**J –** Frequency of use	0	**K –** Average time in use		0	
4 = Maintenance activity = (L+M)/2	**0**	**L –** Type of maintenance	0	**M –** Frequency of maintenance	0	**Recommendation:** Manage & Re-inspect

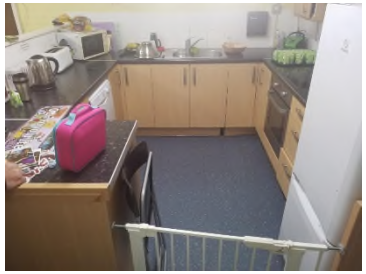
Surveyor	Richard Rayner	Room/Area	0/048 - Kitchen
Survey Date	06 March 2020	Level of Identification	Cross Reference (X)
Building	St Peter & Paul Primary School	Sample No	XJM020810/09
Floor	Ground Floor	Item	Floor Tiles And Adhesive
Item Accessibility	Difficult	Amount	20m²

A - Product Type:		B - Extent of Damage:		C – Surface Treatment		D – Asbestos Type		Material Ass (M.A) (A+B+C+D):
Floor Tiles	1	Low Damage	1	Composite materials; reinforced plastics, resins, vinyl tiles, sealed decorative finishes, etc.	0	Chrysotile	1	**3**

1 = Normal Occupant Activity = (E)	**0**	**E –** Main type of activity	0	**Total Priority Score (P.A.) = (1+2+3+4):**	**1**	**Total Risk Ass' Score (P.A. + M.A)**	**4**	**Risk Coding**	**VERY LOW**
2 = Disturbance = (F+G+H)/3	**1**	**F –** Location	0	**G –** Accessibility	0	**H –** Extent		2	
3 = Exposure potential = (I+J+K)/3	**0**	**I –** Number of occupants	0	**J –** Frequency of use	0	**K –** Average time in use		0	
4 = Maintenance activity = (L+M)/2	**0**	**L –** Type of maintenance	0	**M –** Frequency of maintenance	0	**Recommendation:** Manage & Re-inspect

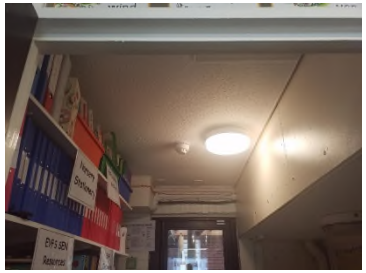
Surveyor	Richard Rayner	Room/Area	0/049 - Office
Survey Date	06 March 2020	Level of Identification	Cross Reference (X)
Building	St Peter & Paul Primary School	Sample No	XJM020810/10
Floor	Ground Floor	Item	Textured Coating To Ceiling
Item Accessibility	Difficult	Amount	6m²

A - Product Type:		B - Extent of Damage:		C – Surface Treatment		D – Asbestos Type		Material Ass (M.A) (A+B+C+D):
Textured Coating	1	Good Condition	0	Composite materials; reinforced plastics, resins, vinyl tiles, sealed decorative finishes, etc.	0	Chrysotile	1	**2**

1 = Normal Occupant Activity = (E)	**0**	**E –** Main type of activity	0	**Total Priority Score (P.A.) = (1+2+3+4):**	**0**	**Total Risk Ass' Score (P.A. + M.A)**	**2**	**Risk Coding**	**VERY LOW**
2 = Disturbance = (F+G+H)/3	**0**	**F –** Location	0	**G –** Accessibility	0	**H –** Extent		1	
3 = Exposure potential = (I+J+K)/3	**0**	**I –** Number of occupants	0	**J –** Frequency of use	0	**K –** Average time in use		0	
4 = Maintenance activity = (L+M)/2	**0**	**L –** Type of maintenance	0	**M –** Frequency of maintenance	0	**Recommendation:** Manage & Re-inspect

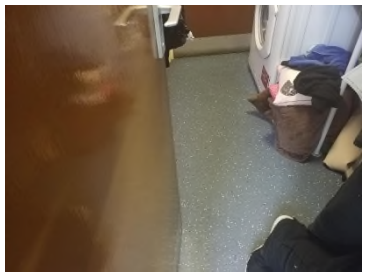
Surveyor	Richard Rayner	Room/Area	0/051 - Utility Room
Survey Date	06 March 2020	Level of Identification	Cross Reference (X)
Building	St Peter & Paul Primary School	Sample No	XJM020810/09
Floor	Ground Floor	Item	Floor Tiles And Adhesive
Item Accessibility	Difficult	Amount	4m²

A - Product Type:		B - Extent of Damage:		C – Surface Treatment		D – Asbestos Type		Material Ass (M.A) (A+B+C+D):
Floor Tiles	1	Low Damage	1	Composite materials; reinforced plastics, resins, vinyl tiles, sealed decorative finishes, etc.	0	Chrysotile	1	**3**

1 = Normal Occupant Activity = (E)	**0**	**E –** Main type of activity	0	**Total Priority Score (P.A.) = (1+2+3+4):**	**0**	**Total Risk Ass' Score (P.A. + M.A)**	**3**	**Risk Coding**	**VERY LOW**
2 = Disturbance = (F+G+H)/3	**0**	**F –** Location	0	**G –** Accessibility	0	**H –** Extent		0	
3 = Exposure potential = (I+J+K)/3	**0**	**I –** Number of occupants	0	**J –** Frequency of use	0	**K –** Average time in use		0	
4 = Maintenance activity = (L+M)/2	**0**	**L –** Type of maintenance	0	**M –** Frequency of maintenance	0	**Recommendation:** Manage & Re-inspect

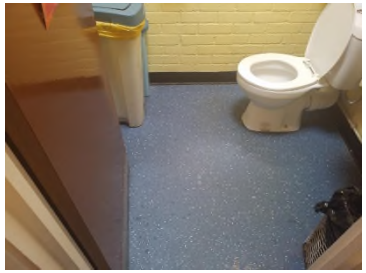
Surveyor	Richard Rayner	Room/Area	0/051A - Staff Toilets
Survey Date	06 March 2020	Level of Identification	Cross Reference (X)
Building	St Peter & Paul Primary School	Sample No	XJM020810/09
Floor	Ground Floor	Item	Floor Tiles And Adhesive
Item Accessibility	Difficult	Amount	**3m²**

A - Product Type:		B - Extent of Damage:		C – Surface Treatment		D – Asbestos Type		Material Ass (M.A) (A+B+C+D):
Floor Tiles	1	Low Damage	1	Composite materials; reinforced plastics, resins, vinyl tiles, sealed decorative finishes, etc.	0	Chrysotile	1	**3**

1 = Normal Occupant Activity = (E)	**0**	**E –** Main type of activity	0	**Total Priority Score (P.A.) = (1+2+3+4):**	**0**	**Total Risk Ass' Score (P.A. + M.A)**	**3**	**Risk Coding**	**VERY LOW**
2 = Disturbance = (F+G+H)/3	**0**	**F –** Location	0	**G –** Accessibility	0	**H –** Extent		0	
3 = Exposure potential = (I+J+K)/3	**0**	**I –** Number of occupants	0	**J –** Frequency of use	0	**K –** Average time in use		0	
4 = Maintenance activity = (L+M)/2	**0**	**L –** Type of maintenance	0	**M –** Frequency of maintenance	0	**Recommendation:** Manage & Re-inspect

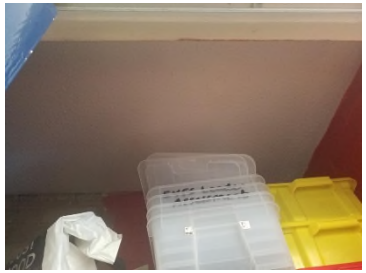
Surveyor	Richard Rayner	Room/Area	0/052 - Stores
Survey Date	06 March 2020	Level of Identification	Cross Reference (X)
Building	St Peter & Paul Primary School	Sample No	XJM020810/10
Floor	Ground Floor	Item	Textured Coating To Ceiling
Item Accessibility	Difficult	Amount	**1m²**

A - Product Type:		B - Extent of Damage:		C – Surface Treatment		D – Asbestos Type		Material Ass (M.A) (A+B+C+D):
Textured Coating	1	Good Condition	0	Composite materials; reinforced plastics, resins, vinyl tiles, sealed decorative finishes, etc.	0	Chrysotile	1	**2**

1 = Normal Occupant Activity = (E)	**0**	**E –** Main type of activity	0	**Total Priority Score (P.A.) = (1+2+3+4):**	**0**	**Total Risk Ass' Score (P.A. + M.A)**	**2**	**Risk Coding**	**VERY LOW**
2 = Disturbance = (F+G+H)/3	**0**	**F –** Location	0	**G –** Accessibility	0	**H –** Extent		0	
3 = Exposure potential = (I+J+K)/3	**0**	**I –** Number of occupants	0	**J –** Frequency of use	0	**K –** Average time in use		0	
4 = Maintenance activity = (L+M)/2	**0**	**L –** Type of maintenance	0	**M –** Frequency of maintenance	0	**Recommendation:** Manage & Re-inspect

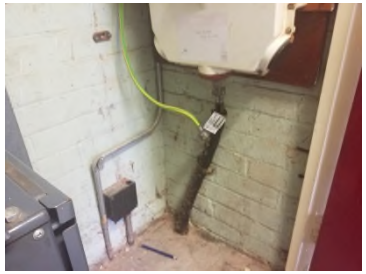
Surveyor	Richard Rayner	Room/Area	0/065 - Ecb
Survey Date	06 March 2020	Level of Identification	Presumed (P)
Building	St Peter & Paul Primary School	Sample No	P
Floor	Ground Floor	Item	Bitumen Cable Wrap
Item Accessibility	Difficult	Amount	**1Lm**

A - Product Type:		B - Extent of Damage:		C – Surface Treatment		D – Asbestos Type		Material Ass (M.A) (A+B+C+D):
Bitumen Products	1	Good Condition	0	Composite materials; reinforced plastics, resins, vinyl tiles, sealed decorative finishes, etc.	0	Chrysotile	1	**2**

1 = Normal Occupant Activity = (E)	**0**	**E –** Main type of activity	0	**Total Priority Score (P.A.) = (1+2+3+4):**	**0**	**Total Risk Ass' Score (P.A. + M.A)**	**2**	**Risk Coding**	**VERY LOW**
2 = Disturbance = (F+G+H)/3	**0**	**F –** Location	0	**G –** Accessibility	0	**H –** Extent	0		
3 = Exposure potential = (I+J+K)/3	**0**	**I –** Number of occupants	0	**J –** Frequency of use	0	**K –** Average time in use	0		
4 = Maintenance activity = (L+M)/2	**0**	**L –** Type of maintenance	0	**M –** Frequency of maintenance	0	**Recommendation:** No Access - Inspection Required

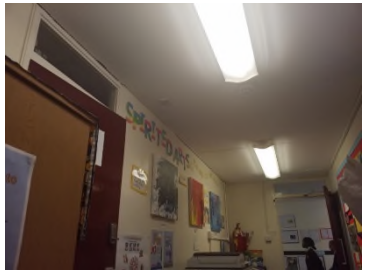
Surveyor	Richard Rayner	Room/Area	0/068 - Corridor
Survey Date	06 March 2020	Level of Identification	Cross Reference (X)
Building	St Peter & Paul Primary School	Sample No	XJM020810/03
Floor	Ground Floor	Item	Textured Coating To Ceiling
Item Accessibility	Difficult	Amount	**12m²**

A - Product Type:		B - Extent of Damage:		C – Surface Treatment		D – Asbestos Type		Material Ass (M.A) (A+B+C+D):
Textured Coating	1	Good Condition	0	Composite materials; reinforced plastics, resins, vinyl tiles, sealed decorative finishes, etc.	0	Chrysotile	1	**2**

1 = Normal Occupant Activity = (E)	**0**	**E –** Main type of activity	0	**Total Priority Score (P.A.) = (1+2+3+4):**	**1**	**Total Risk Ass' Score (P.A. + M.A)**	**3**	**Risk Coding**	**VERY LOW**
2 = Disturbance = (F+G+H)/3	**1**	**F –** Location	0	**G –** Accessibility	0	**H –** Extent	2		
3 = Exposure potential = (I+J+K)/3	**0**	**I –** Number of occupants	0	**J –** Frequency of use	0	**K –** Average time in use	0		
4 = Maintenance activity = (L+M)/2	**0**	**L –** Type of maintenance	0	**M –** Frequency of maintenance	0	**Recommendation:** Manage & Re-inspect
