# Leopold Road Character Assessment

LEOPOLD ROAD  
CONSERVATION AREA

Character Assessment

London Borough of Merton  
2005

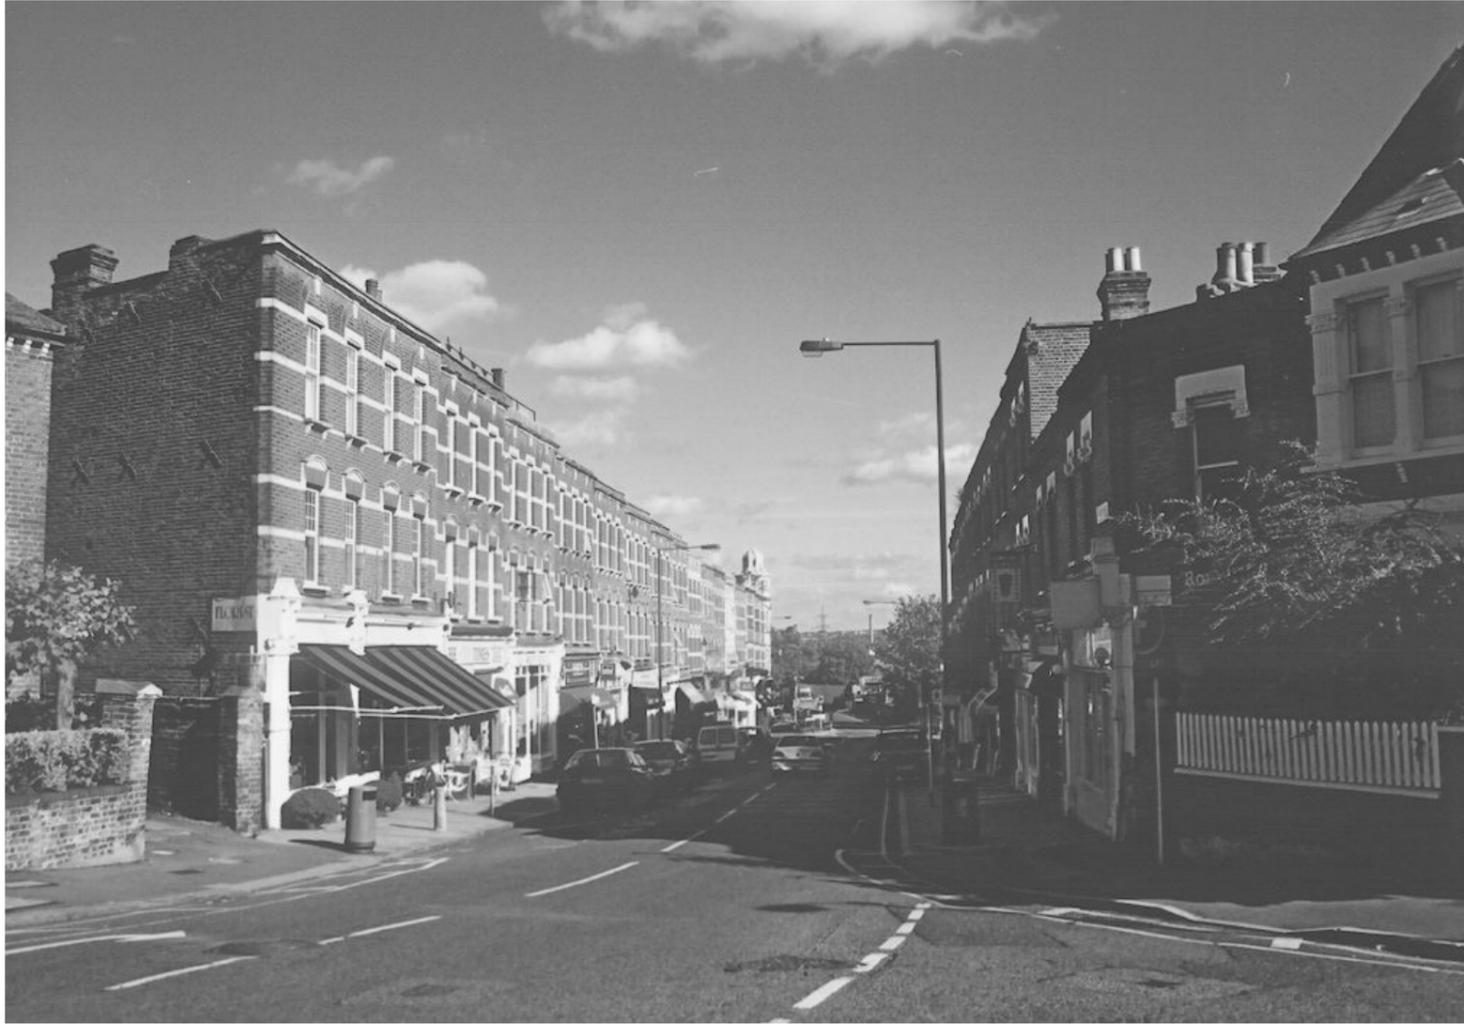
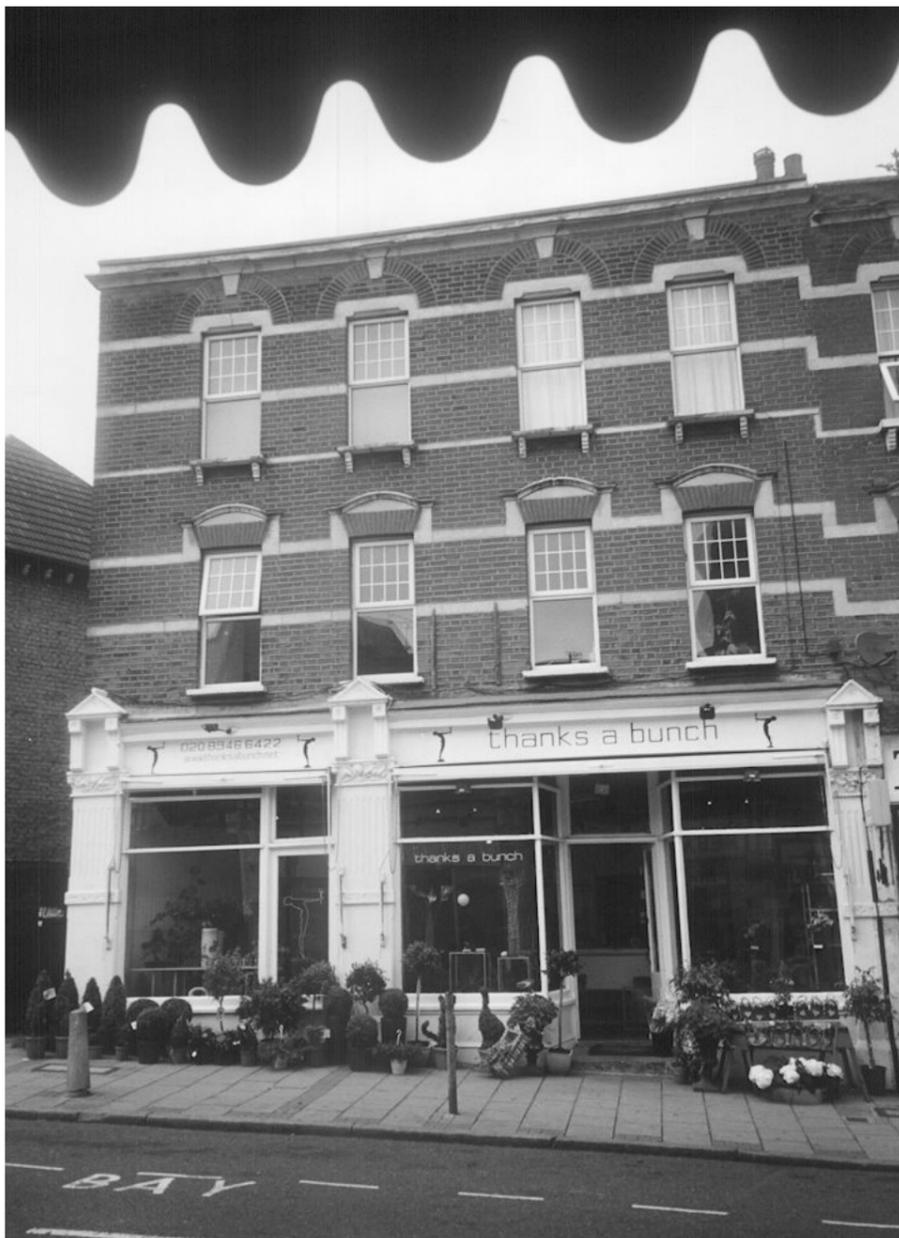
Above: Leopold Road from the western end, illustrating its canyon-like quality. Below, the extra wide façade to No. 32 Leopold Road.

In the case of the Leopold Road Conservation Area, the ratio is about 1:1, providing a highly urban environment which tends to be oppressive without the intimacy which a greater density might generate.

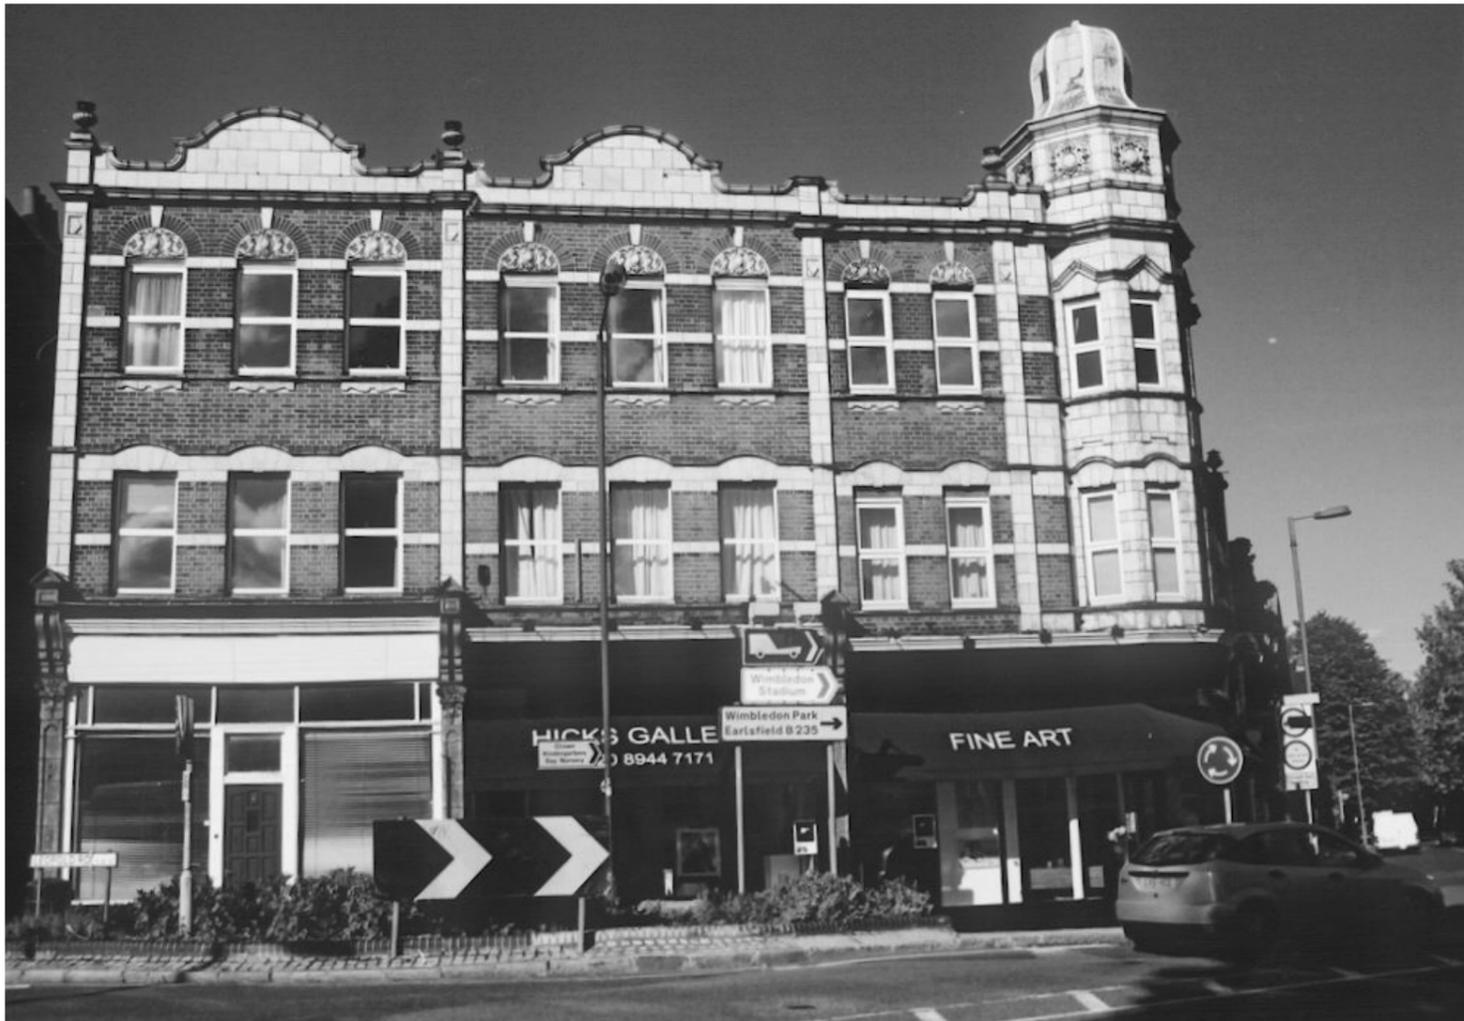
*The north side of Leopold Road and the south end of Strathearn Road from the east.*

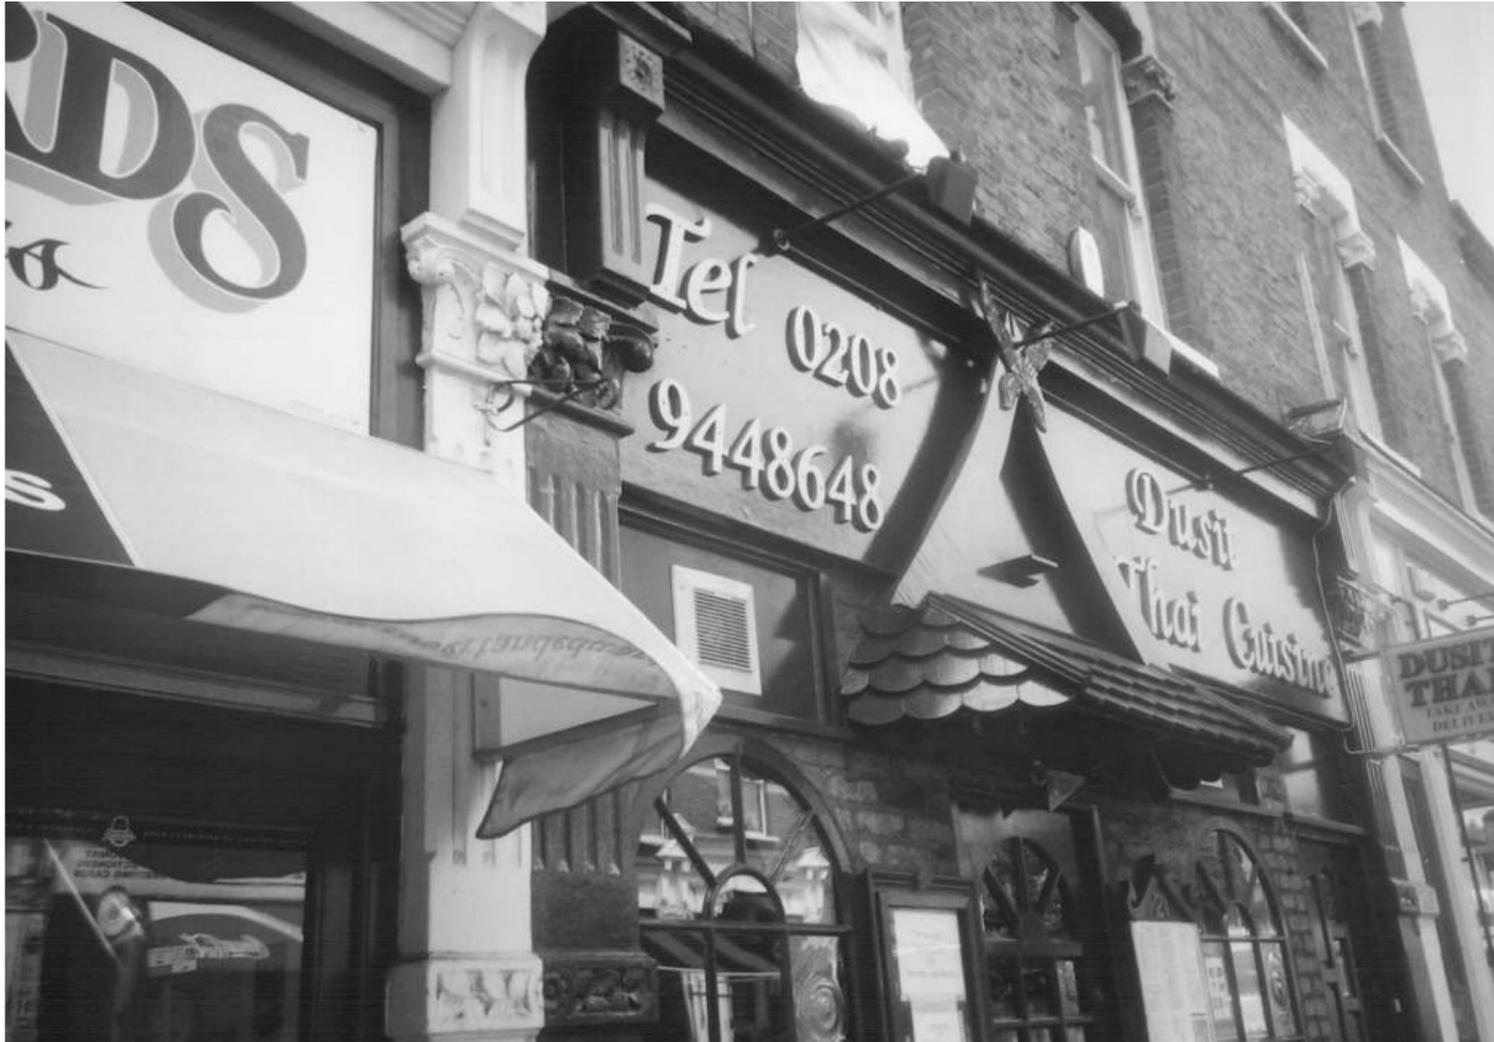
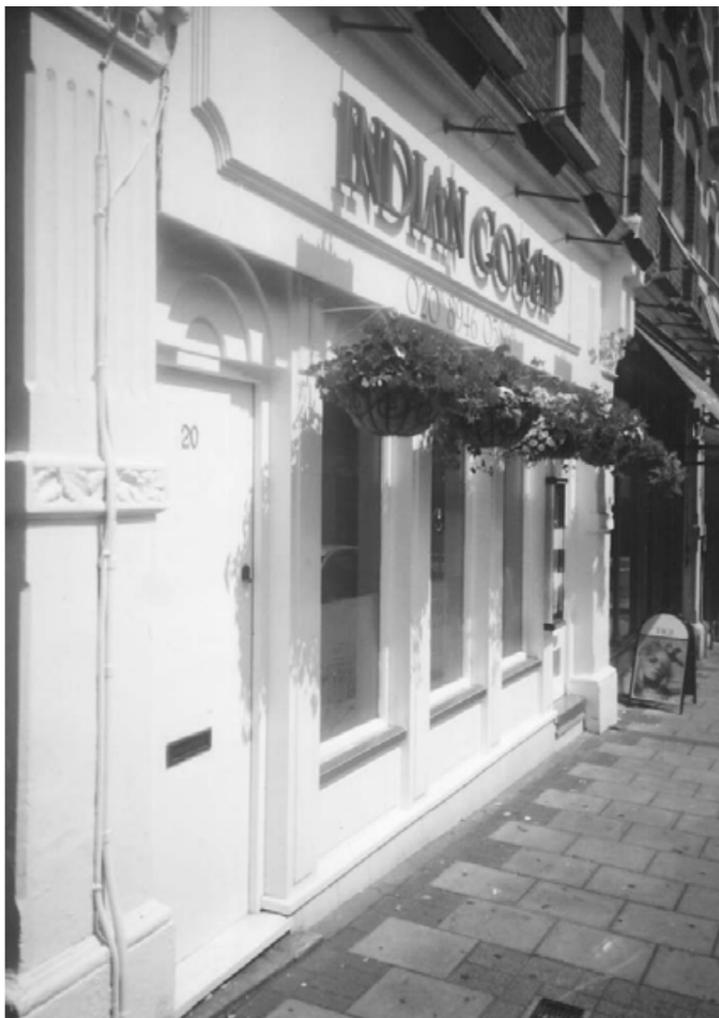
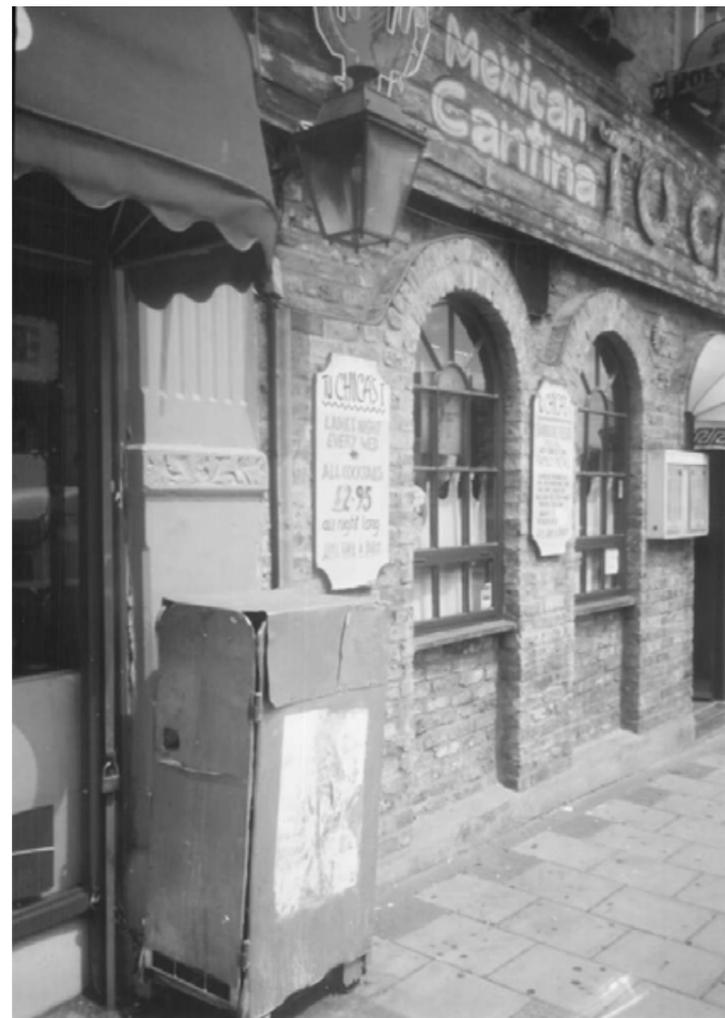
**No. 21,** A Thai restaurant which attempts to create an 'oriental' shop front. **Shop front:** Installed in 1980 when it was changed to a restaurant. A basically solid front of stock bricks (matching those above) with a dark-stained central standard mass-produced doorway topped with a pseudo-Thai canopy, and dark-stained semi-circular arched windows each side. Dark stained panels above the windows accommodate air conditioning extractor grills. The dark stain extends across the halves of the pilasters within the curtilage of No. 21, **Fascia:** The dark stained canopy continues the oriental theme, with gold script lettering and flood lights along the top. **Side access:** The dark stained multi-panelled door is in its original position. **Level of maintenance:** High. **Apparent level of prosperity:** High. **Contribution to the CA:** Neutral.

**No. 20:** Used as an Indian restaurant since 1972, with an attractive modern front installed in 1990 which attempts at period character in the detailing; painted white throughout. **Shop front:** A 5-bay design, with the restaurant entrance at one end, the side entrance at the other and three windows in the centre. Ornamental 'lintels' over the doors and windows. **Fascia:** deepened to accommodate elegant raised lettering on raised panel, spot lit. **Blind:** retained. **Side access:** retained and arranged to form part of composition. **Upper floors:** Original windows replaced with modern plastic replicas. 6-light to upper half of 2<sup>nd</sup>. floor. **Level of maintenance:** high. **Apparent level of prosperity:** high. **Contribution to CA:** positive.

**No. 14:** (with No. 12): Used as a licensed Mexican cantina and coffee bar since 1982 which apparently attempts to create a Mexican 'Wide West' impression, which is a totally unsuitable treatment to a sensitively designed period property. **Shop front:** replaced with two round-arched windows and a doorway in bright blue frames surrounded by multi-coloured yellow brickwork. Menus and other notices in panels between the windows. Pilasters painted yellow and corbels removed. **Fascia:** replaced with rough-hewn horizontal boarding soiled to look weather-beaten. Lettering which may be intended to look as though it is made out of cacti; with a sketch of a cactus at one end. **Blind:** removed. Bright yellow 'Dutch' blind over doorway. **Side entrance:** removed. **Upper floors:** Original windows replaced by modern top-hung casements. A hanging sign has been installed at first floor level. **Level of maintenance:** moderate. **Apparent level of prosperity:** moderate. **Contribution to CA:** Seriously detrimental.

*The facades of three of the 'ethnic' restaurants: above, the idiosyncratic façade to the Thai restaurant at No. 21; below left, the elegant façade to the Indian restaurant at No. 20; and below right, the considerably less elegant façade to the Mexican 'cantina' at Nos. 12 and 14.*

- Only suitably designed shop fronts should be approved which either reflect the period character of the buildings or are of high quality modern design, are appropriate and consisted in scale and proportion along the length of the parade, and result in greater harmony. The production of a shop front design guide would assist shopkeepers to apply for suitable replacements.

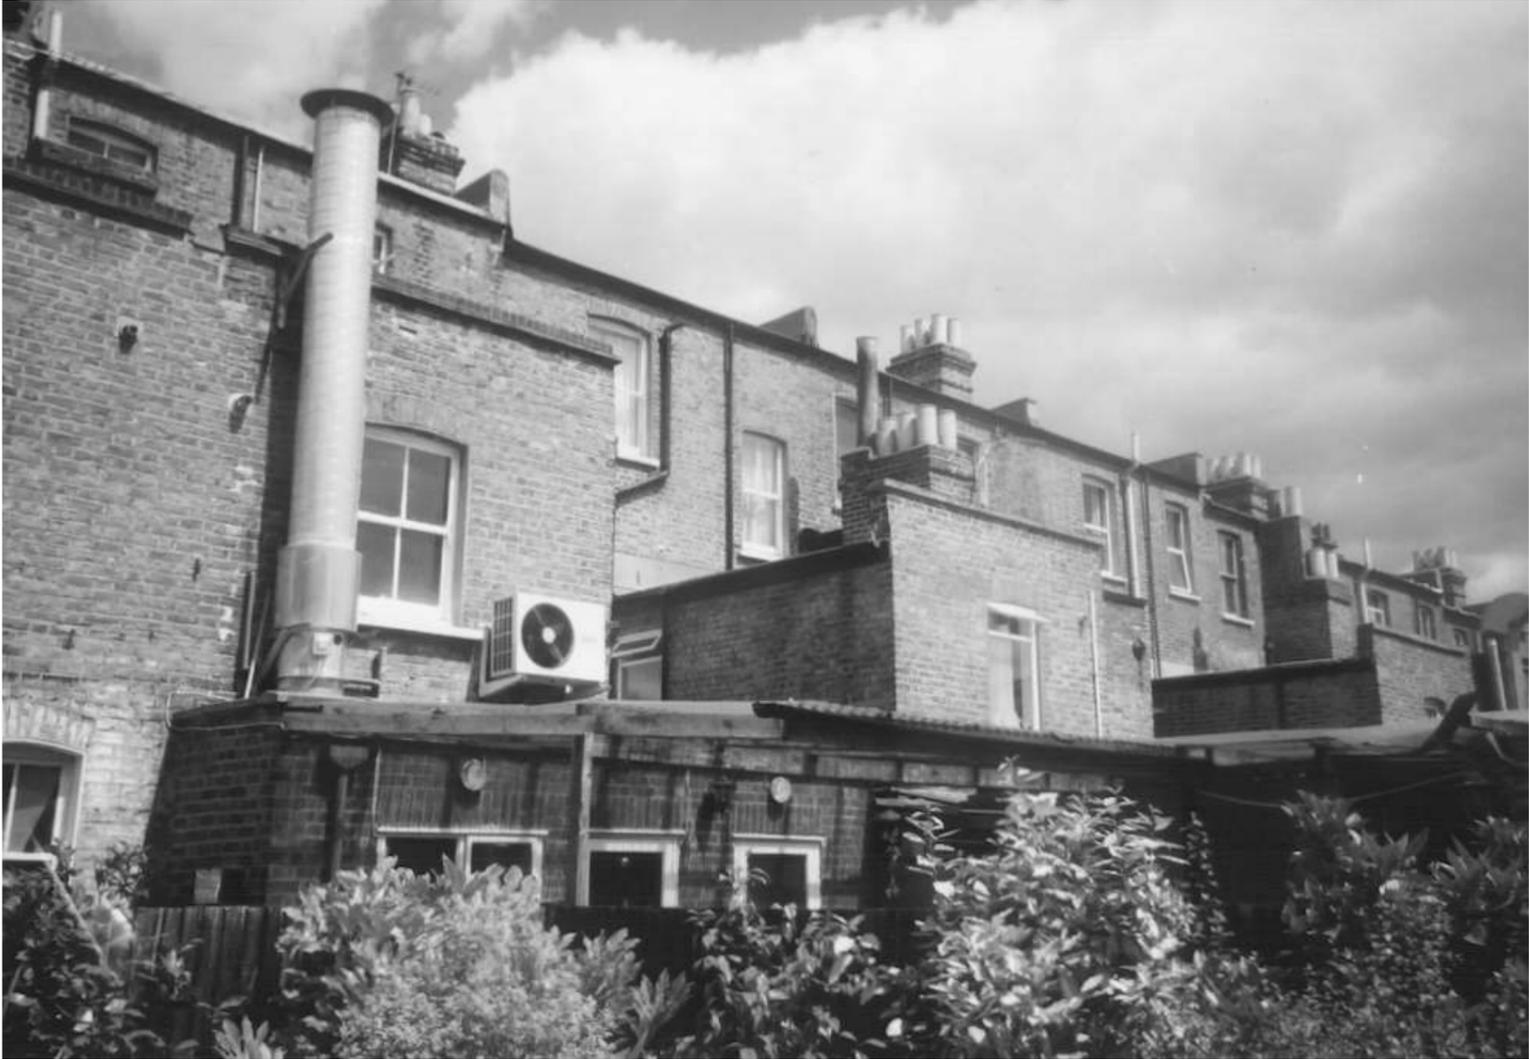
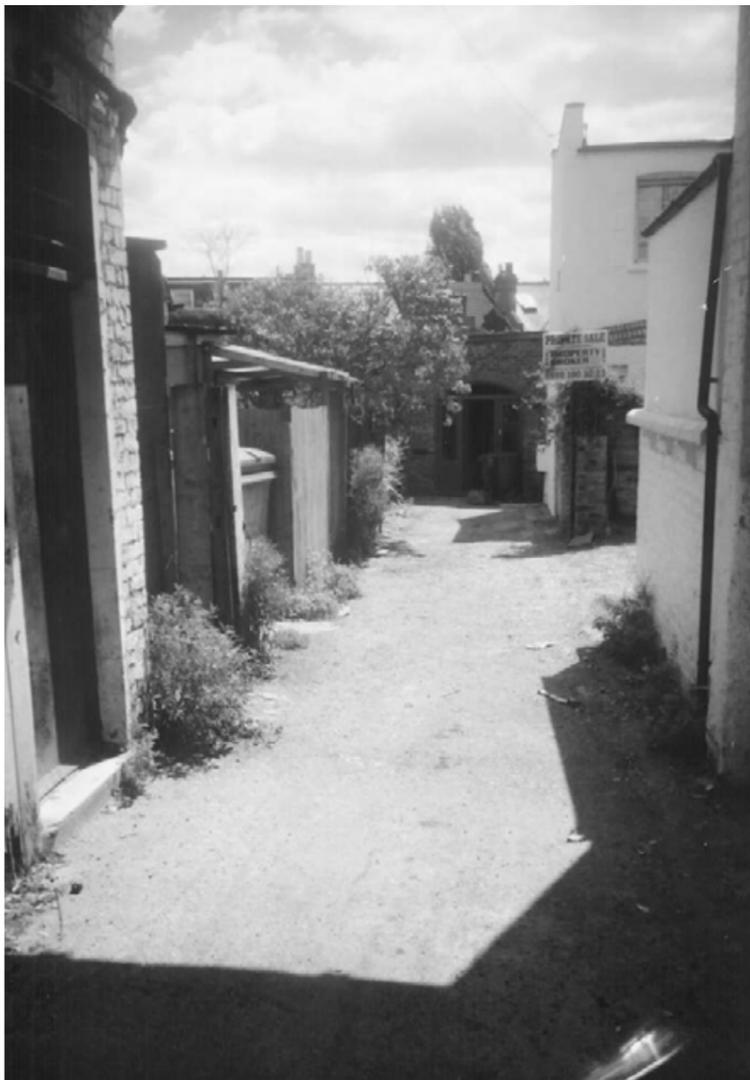
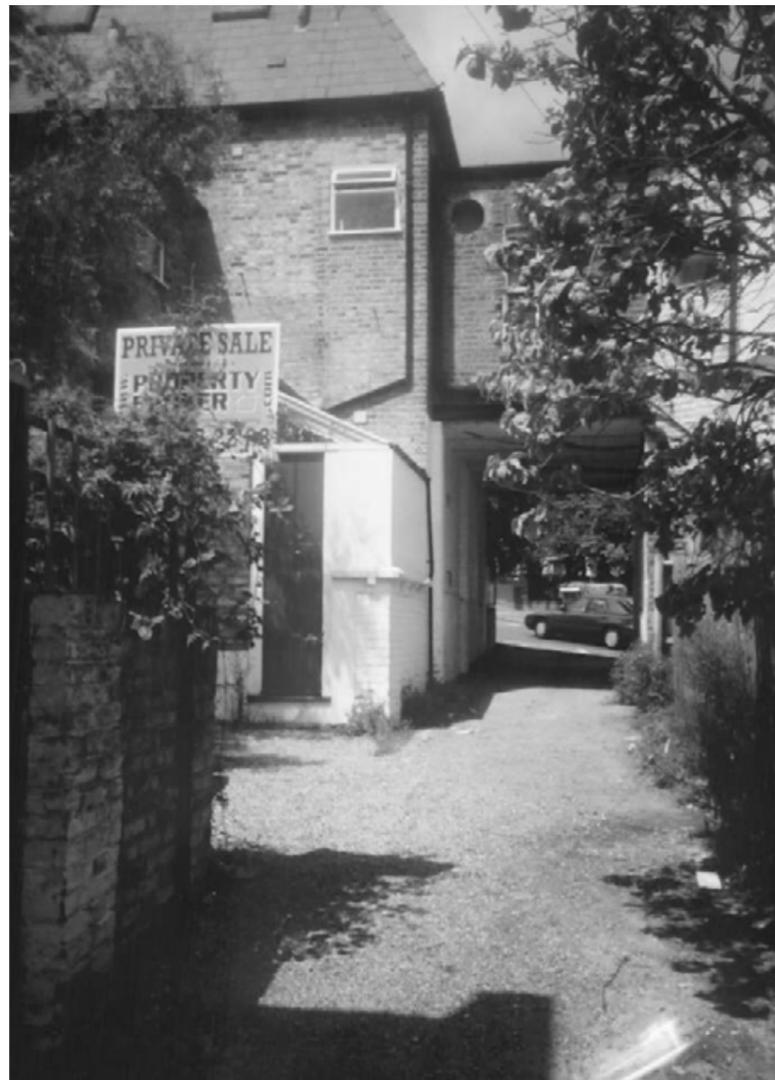
*The rear of the properties on the south side of Leopold Road: above, the rear extensions; below left, the rear yard at the western end from the entrance passageway with 'The Mews' to the right; and below right, looking back to the passageway and the rear No. 1 Woodside.*
