Structural Assessment Report of Ravensbury Grove
Flats
Ravensbury Estate Regeneration
For HTA Design LLP

Scheme No: 11264

Ravensbury Estate
Regeneration

14th October 2014

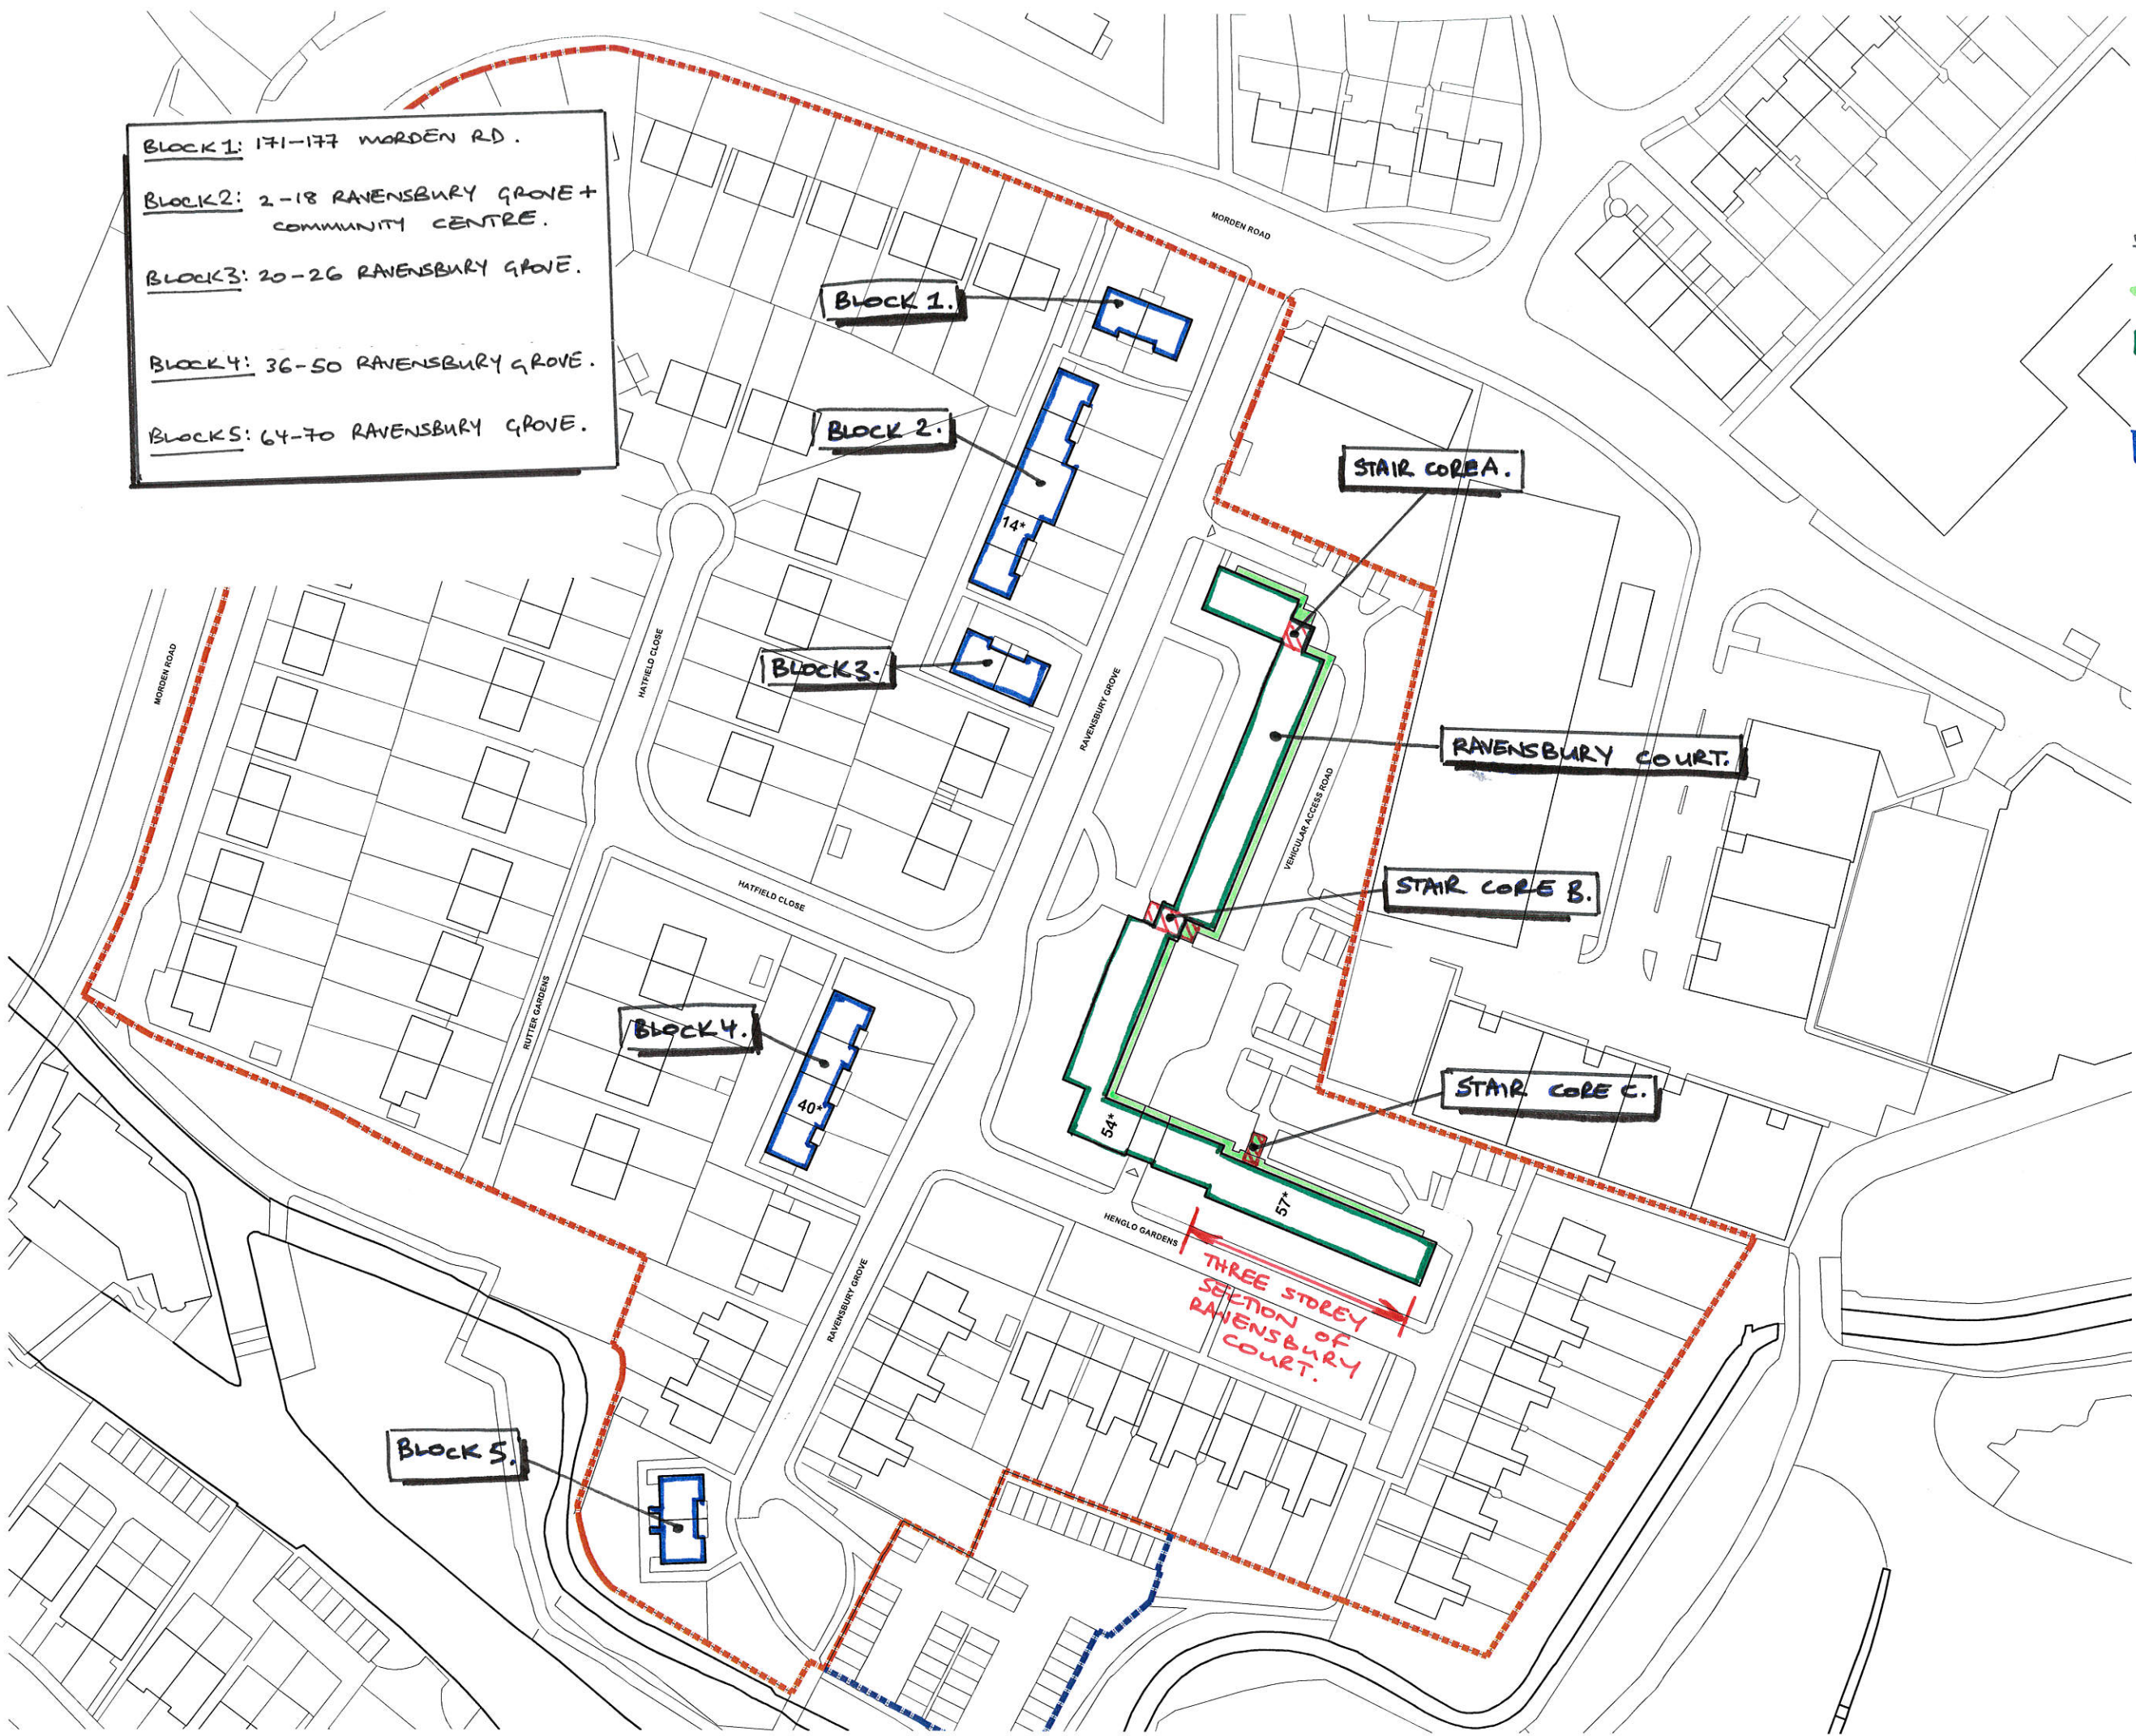
APPROXIMATE OUTLINE OF RAVENSBURY GROVE FLATS BUILDINGS.

CRACKING ABOVE FIRST FLOOR WINDOWS RUNNING DIAGONALLY UP TO EAVES. CRACKING 1-3mm IN MORTAR ONLY.
