MERTON SECTION 19 FLOOD RISK INVESTIGATION REPORT

PREPARED FOR LONDON BOROUGH OF MERTON

Authored by: Adam McCue
Reviewed by: Tom Whitworth
Approved by: Mike Mair
Date: Aug 2023
Version 1.3

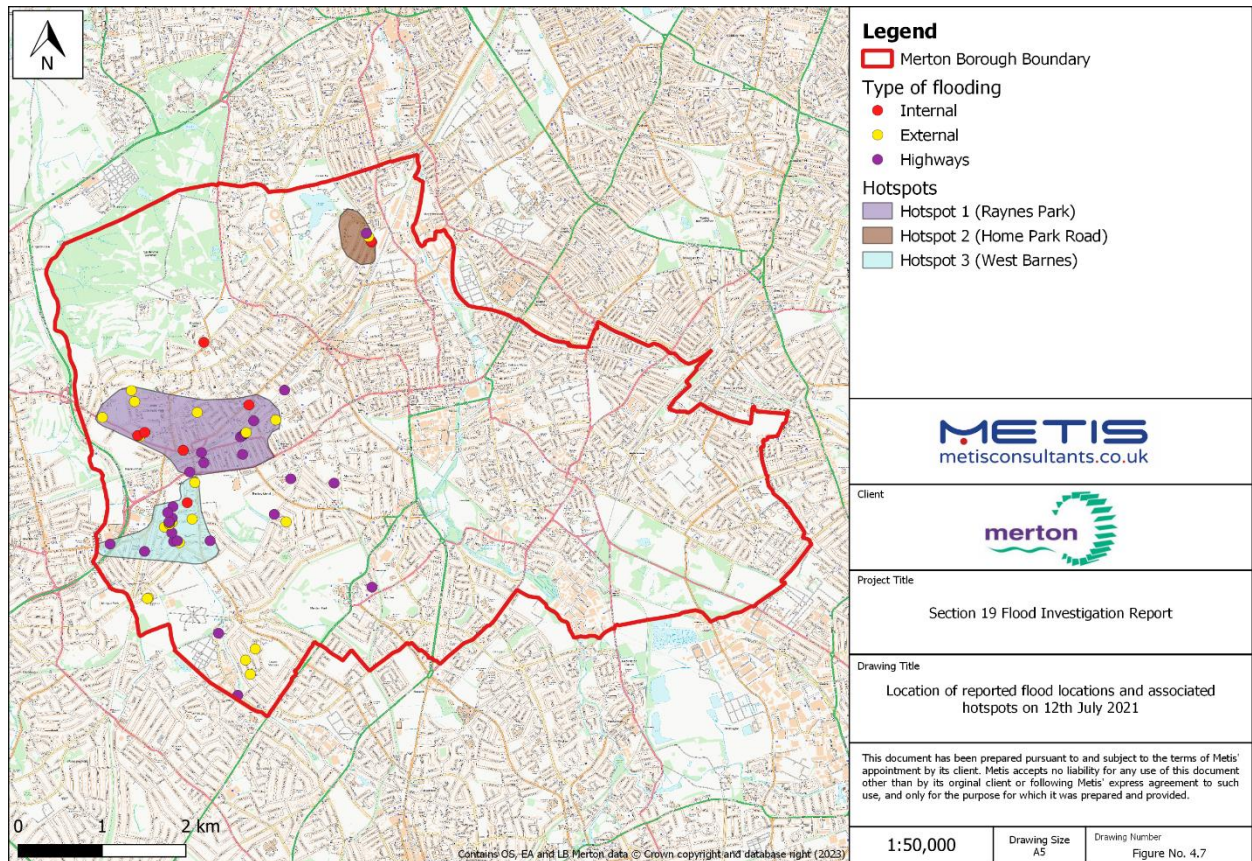
Figure 4.9: Location of reported flood locations and associated hotspots on 12th July 2021

Figure 4.9 and Figure 4.10 display the locations of the flood reports within LB Merton during the 12th and 25th July 2021 events respectively, alongside their respective hotspots. Sections 5.1-5.3 and Sections 6.1-6.2 provide analysis of flood mechanisms within each hotspot for the rainfall events of 12th July 2021 and 25th July 2021 respectively.

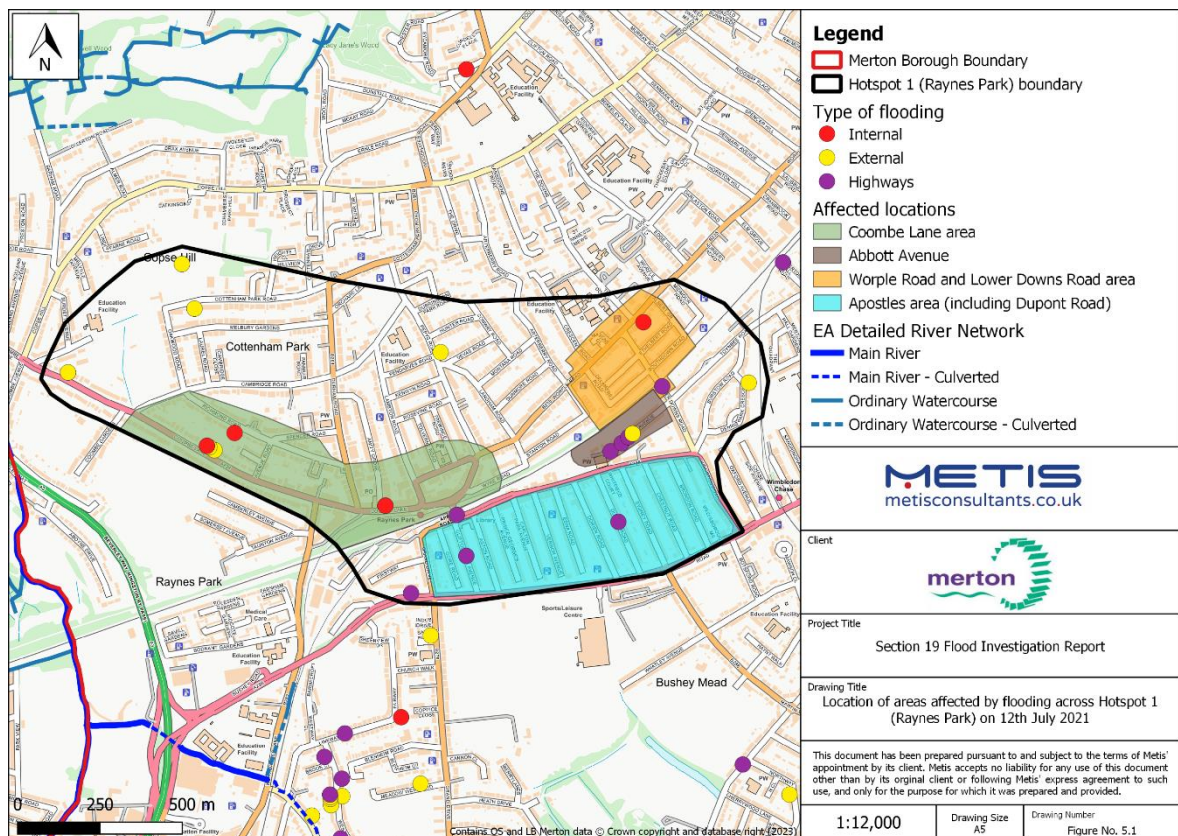
Figure 5.1: Location of areas affected by flooding across Hotspot 1 (Raynes Park)

The four main areas within this hotspot that were impacted by flooding during this event are shown in *Figure 5.1*. These are locations 1-4 in *Table 4.5* and are namely:

- The Coombe Lane area (including Raynes Park Railway Bridge)
- Abbott Avenue
- Worple Road and Lower Downs Road
- The Apostles Area (including Dupont Road).

Flooding at this hotspot began at approximately 16:00 on the 12th July 2021 and resulted in internal flooding to two residential properties on Coombe Lane and Richmond Road, and to several commercial properties along Coombe Lane near Raynes Park railway station. Basement areas of properties along Worple Road near the junction with Lower Downs Road were also impacted during this event. Flooding to external areas of properties also occurred throughout this hotspot, whilst

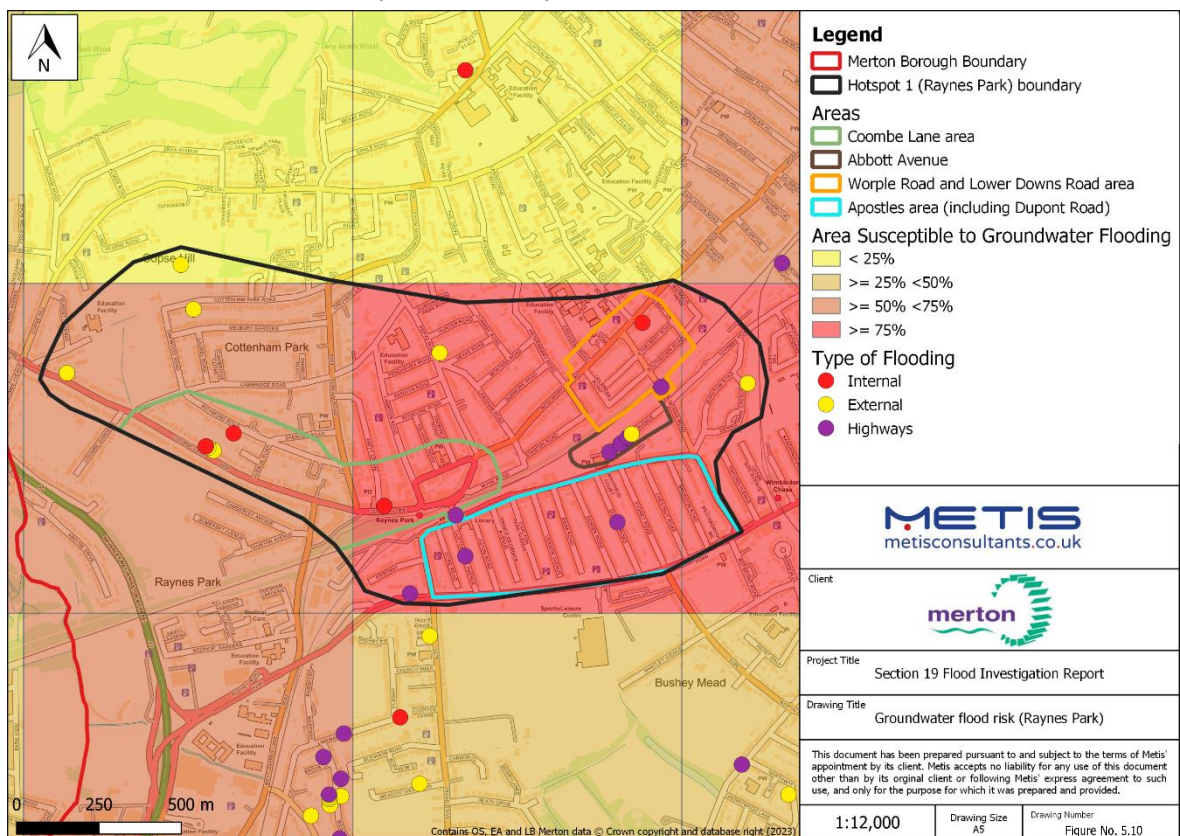
Figure 5.10: Groundwater flood risk (Raynes Park)

The EA’s Areas Susceptible to Groundwater Flooding (AStGWF) data use a 1km² grid to show the proportion of each 1km² grid square that is susceptible to groundwater flooding emerging. This dataset shows that approximately half of this hotspot is covered by a grid square where $\geq 75\%$ of this area is susceptible to groundwater flooding. Most of the Coombe Lane area and all of Abbott Avenue are situated within this high-susceptibility area. The rest of this hotspot is primarily located in areas where $\geq 50\% < 75\%$ of land is susceptible to groundwater flood emergence, whilst $< 25\%$ of land in small areas in the north of the hotspot are susceptible to groundwater flooding. *Figure 5.10* shows the EA AStGWF map for this hotspot.

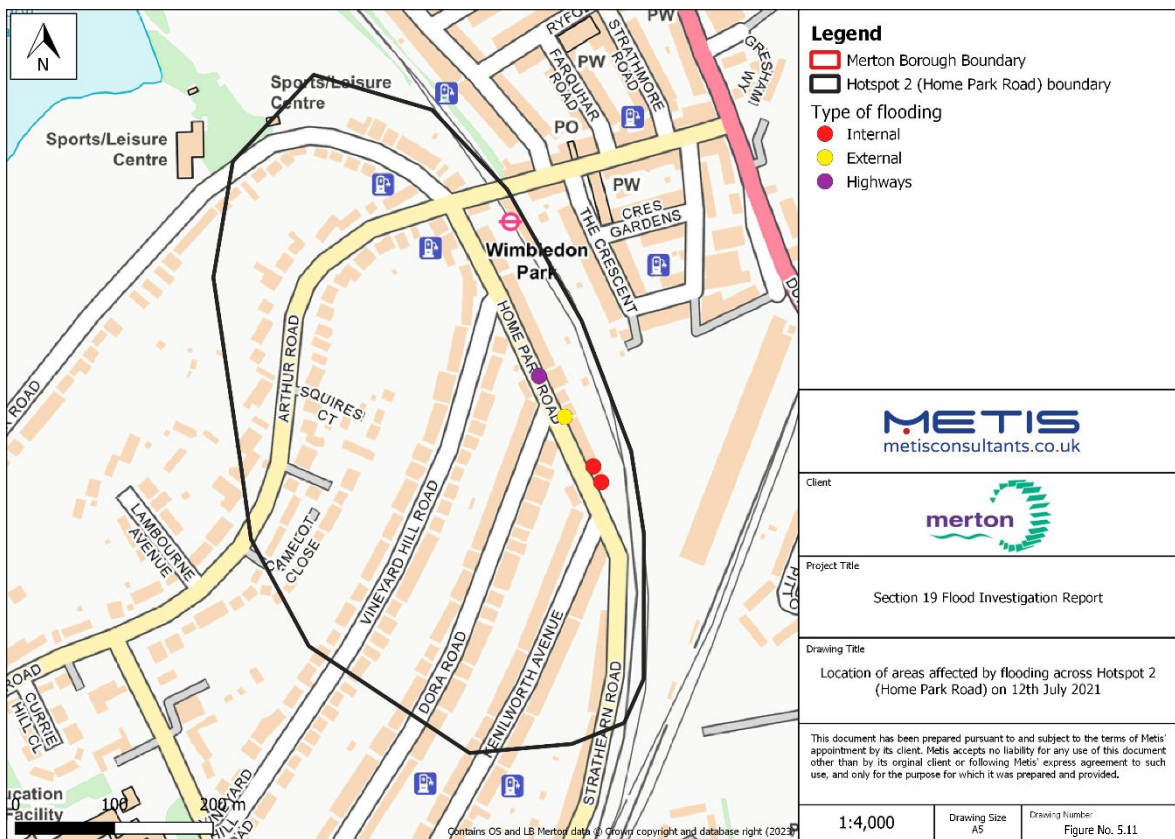
Figure 5.11: Location of areas affected by flooding across Hotspot 2 (Home Park Road)

This location correlates to location 5 in *Table 4.5*. Flooding at this location was primarily to properties along the eastern-most portion of Home Park Road, near the junctions with Strathearn Road, Kenilworth Avenue, Dora Road and Vineyard Hill Road. This is shown in *Figure 5.11* alongside the types of reported flooding within the hotspot during this event.

Highways flooding occurred at this location, with much of this section of Home Park Road being covered by several inches of floodwater, whilst external flooding occurred to the front and rear gardens of several properties. Internal flooding of ground floors and basements occurred to two residential properties, with floodwaters reaching up to the door handles in the basement of one property. A surface water sewer running below Home Park Road near the junction with Dora Road partially collapsed during this event. The TWUL SFHD shows that four instances of sewer flooding occurred within postcode area SW19 7 during this event, in which Home Park Road is situated. Since multiple residential properties flooded internally during this event, flooding at this location

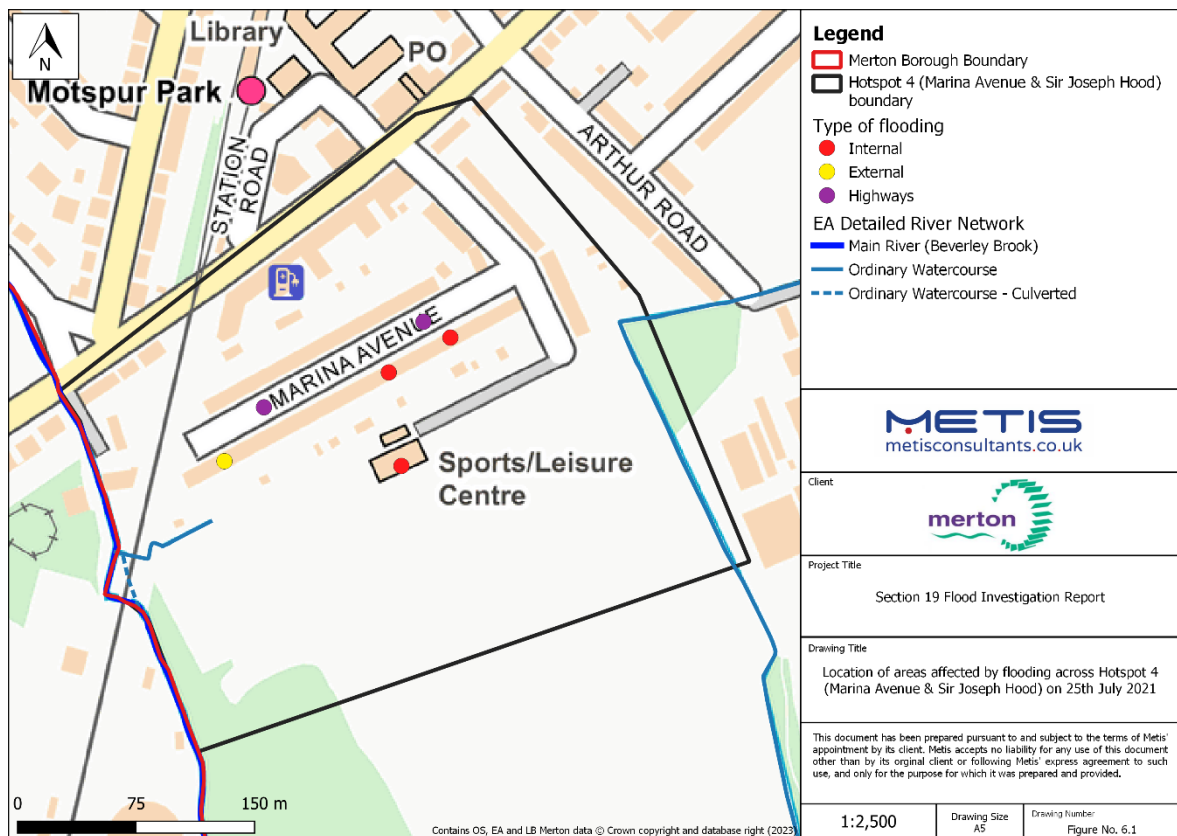
Figure 6.1: Location of areas affected by flooding across Hotspot 4 (Marina Avenue & Sir Joseph Hood)

On the 25th July 2021, flooding at this location began following rainfall that started at approximately 14:10 according to Hydromaster hotspot location gauges. *Figure 6.1* shows the affected locations within this hotspot according to flood reports to Merton Council. Marina Avenue and Sir Joseph Hood (locations 9 and 10 within *Table 4.5*) are the impacted areas in this hotspot, with Marina Avenue being located to the north of Sir Joseph Hood (which includes the sports/leisure centre shown in *Figure 6.1* and the adjacent playing fields).

Flood reports to Merton Council indicate that flooding within this hotspot resulted in internal flooding to two residential properties on Marina Avenue and one residential property within the pavilion inside Sir Joseph Hood Memorial Park, which is Merton Council-owned land. Flooding to external areas of properties also occurred within this hotspot, whilst *Figure 6.2* shows the extensive highway flooding to approximately 30m of the road and 65m of the footway in Marina Avenue during this event. Much of the Sir Joseph Hood Memorial Playing Fields also experienced flooding, particularly in areas situated closer to the river line to the west. The TWUL SFHD indicates that one

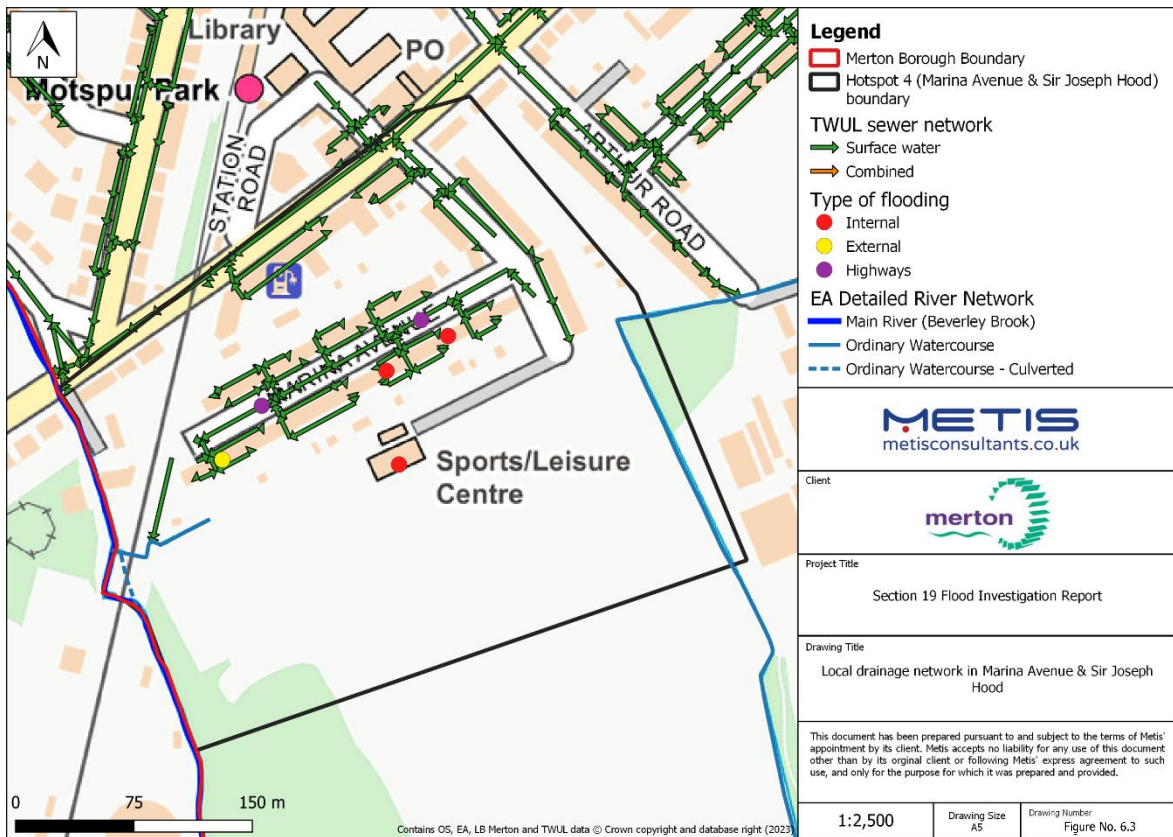
Figure 6.3: Local drainage network in the Marina Avenue & Sir Joseph Hood hotspot

Figure 6.3 shows the local TWUL sewer networks within this hotspot using data obtained directly from TWUL. The sewer network within this hotspot is relatively small in comparison to those located in the aforementioned hotspots elsewhere in LB Merton. A 230mm diameter surface water sewer pipe flows in a westerly direction along Marina Avenue, after which it converges into a 300mm diameter surface water sewer pipe at the road’s western end that discharges into the adjacent Beverley Brook. Marina Avenue’s sewer network does not appear to receive flow from sewer networks located on adjacent streets, whilst there is no sewer network present in the Sir Joseph Hood location itself.

[Map16 gully sensor data](#) provided by Merton Council confirm that prior to the flooding incident, gullies in the Sir Joseph Hood pavilion area had been cleaned in December 2020. As gullies in this location were not cleaned again until October 2022, it is likely that they are not part of Merton Council’s high-priority cleansing programme and are instead cleaned at least once every three years

as part of the standard programme. Gullies on Marina Avenue are not included in Merton Council’s current programme, and so historical information on their cleansing programme priority is not available on Map16.
