SECTION 19
FLOOD RISK INVESTIGATION REPORT

PREPARED FOR THE LONDON BOROUGH OF MERTON

Created by Darragh Creegan, George
Tzelepis and Mike Mair
Approved by Michael Arthur
Date June 2019
Version 1.3

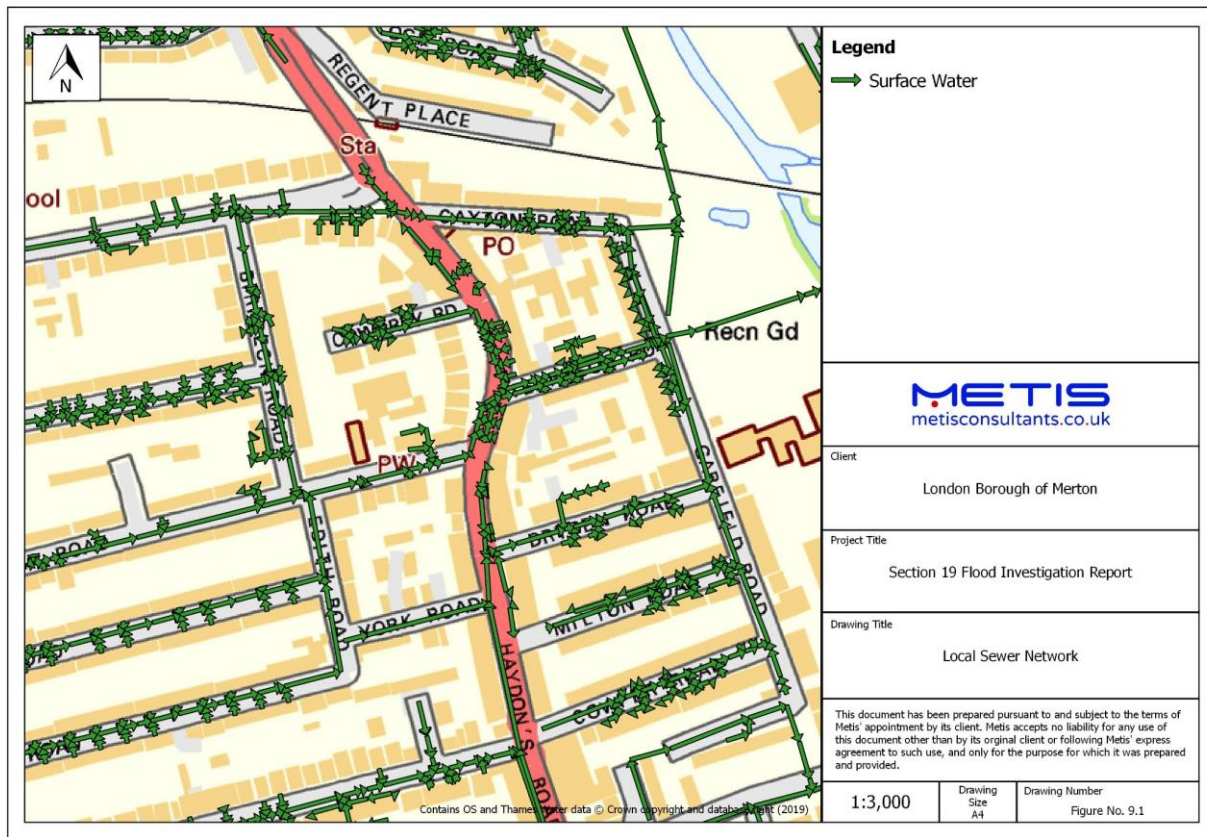
Figure 9.1 Local sewer network in this location

A surface water sewer runs from west to east along Effra Road. This sewer varies in diameter between 225 mm and 300 mm until the junction with Ashley Road. From this point eastwards the sewer diameter is predominantly 375 mm, apart from one section between Ashley Road and Edith Road which is 225 mm diameter. Several surface water sewers from adjacent roads including Edith Road and Evelyn Road connect into this. The sewer on Effra Road connects into a 600 mm diameter sewer in Haydon's Road which runs to the east before discharging into the River Wandle.

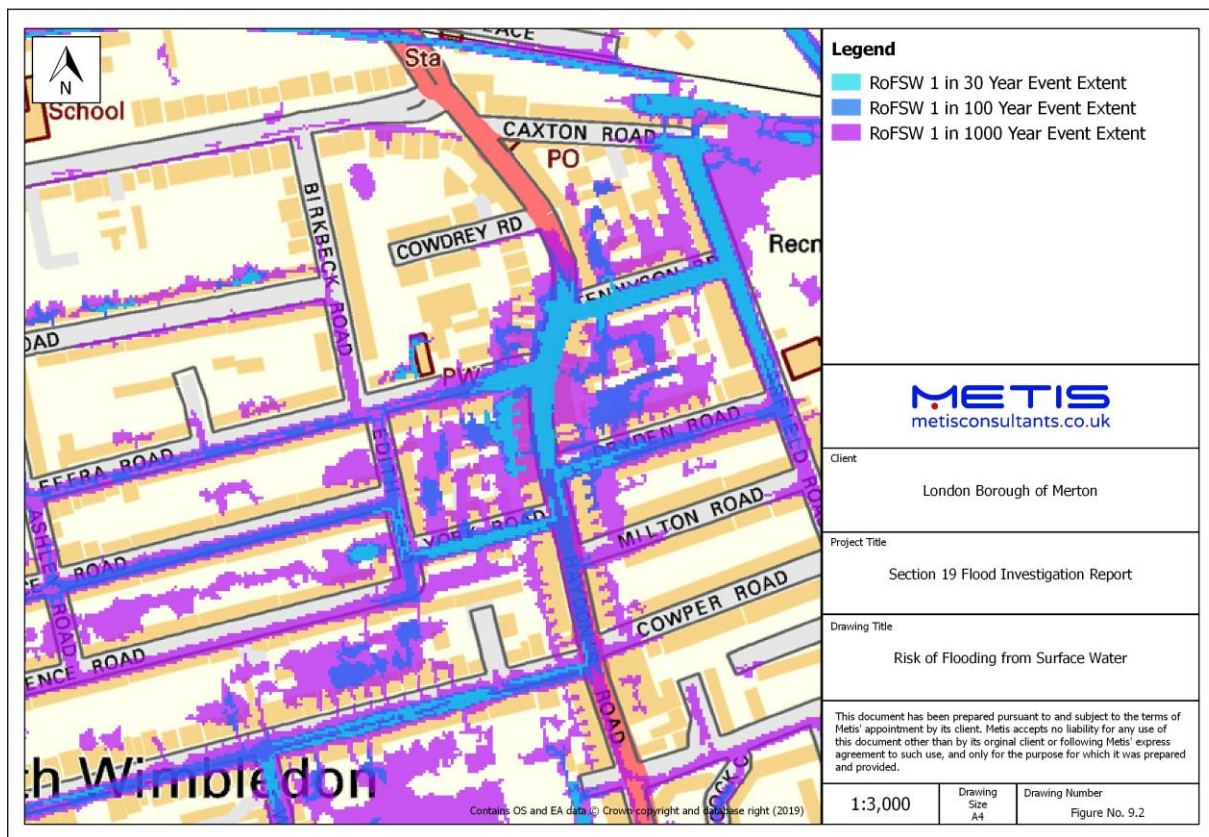
Figure 9.2 Risk of flooding from surface water in this location

The location falls within drainage catchment DC26 (as defined in Merton's 2015 [Level 1 Strategic Flood Risk Assessment](#)). *Figure 9.2* shows that Effra Road at the junction with Haydon's Road is predicted to be at high risk of flooding from surface water. This junction is also at medium risk of surface water flooding as well as Effra Road as far as the junction with Ashley Road, Edith Road and York Road. Some properties on Haydon's Road, Effra Road and Edith Road are also predicted to be at medium risk of surface water flooding. Many of the roads and properties are also predicted to be at low risk of surface water flooding.

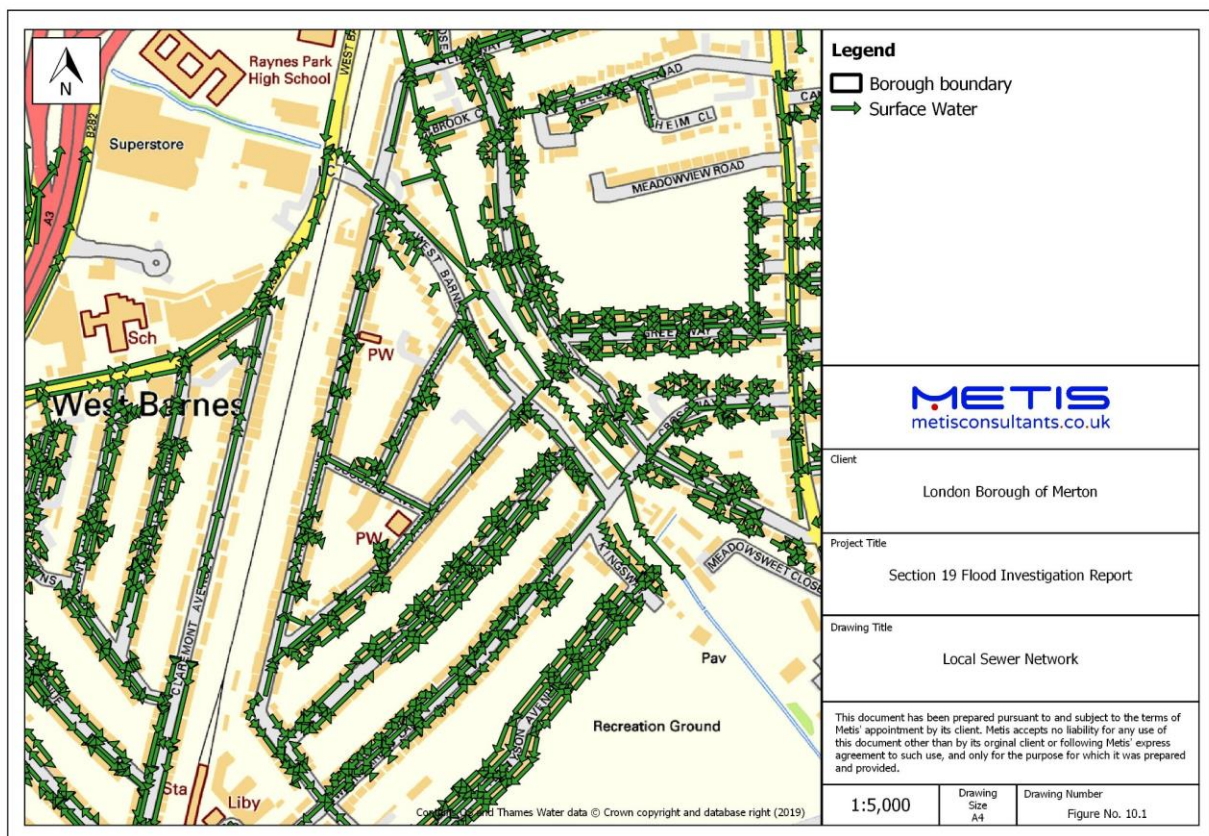
Figure 10.1 Local sewer network in this location

At the above mentioned manhole, there is a 225 mm diameter surface water sewer on Adela Avenue flowing in a south westerly direction. This flows to a manhole approximately 100 m along Adela Avenue. TWUL asset records suggest that, at the other end of Adela Avenue, a 225 mm diameter surface water sewer flows from the junction with Seaforth Avenue. This flows north-easterly towards the flooding location, collecting surface water from the adjacent Douglas Avenue, and falling to the same manhole 100 m south west of the Adela Avenue and West Barnes Lane junction. An additional 225 mm diameter sewer flows under Estella Avenue from the junction with Douglas Avenue. This connects with two short 225 mm diameter surface water sewers from West Barnes Lane prior to discharging into the Pyl Brook culvert (via a 300 mm diameter sewer) immediately north-westwards of the affected properties in the 2016 and 2017 flooding incidents.

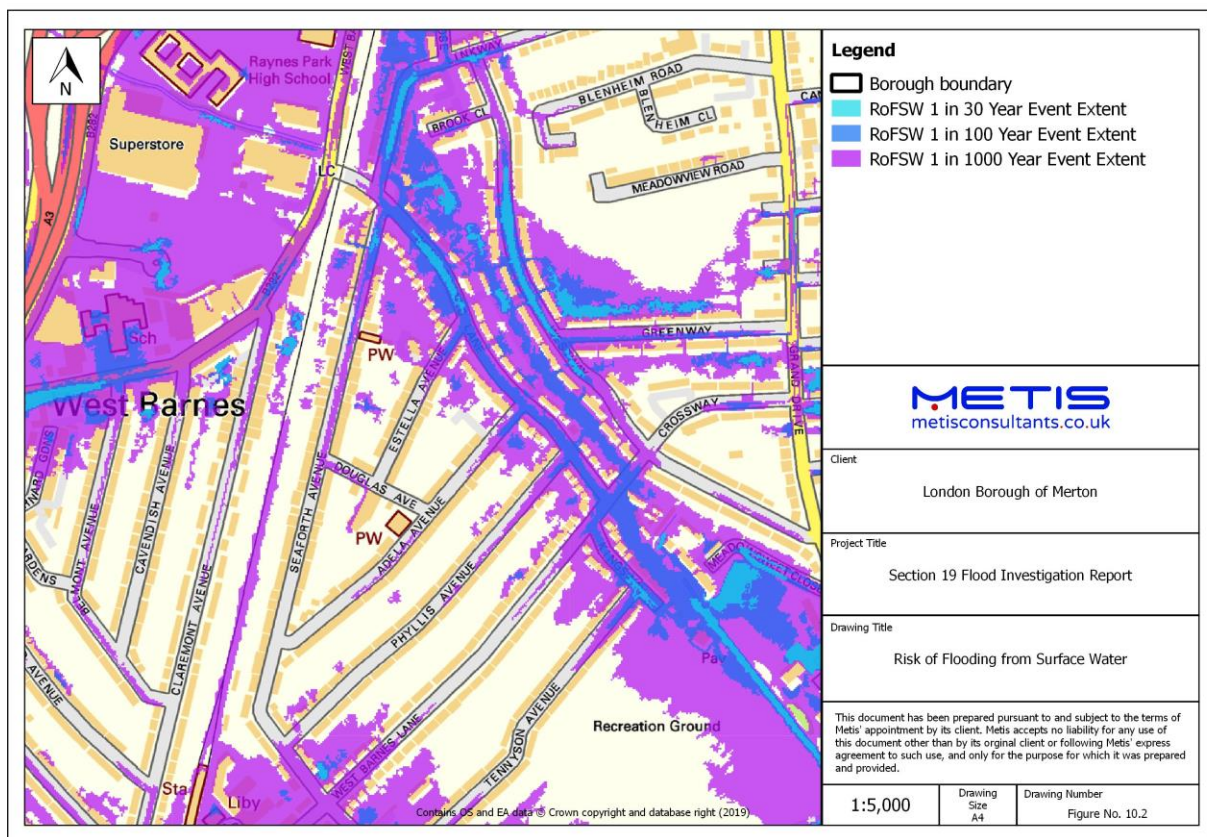
Figure 10.2 Risk of flooding from surface water in this location

The location falls within drainage catchment DC30 (as defined in Merton’s 2015 [Level 1 Strategic Flood Risk Assessment](#)). *Figure 10.2* shows that the nearest predicted high risk area is 150 m north-west of the flooding location area along West Barnes Lane. None of the area which flooded in 2016 or 2017 is predicted to be at high risk of surface water flooding. The entirety of West Barnes Lane is predicted to be at medium risk of surface water flooding, and this is predicted to extend approximately 50 m up Adela Avenue on the southern side of the road. Properties 144-170 (even numbers only) on the eastern side of West Barnes Lane are predicted to be at risk in the medium risk extent. Most properties, on either side of West Barnes Lane and those at the lower ends of Adela Avenue, Estella Avenue and Seaforth Avenue, are predicted to be at low risk of surface water flooding.

The low risk extent also covers properties on the other side of the culverted Pyl Brook (including the Westway).

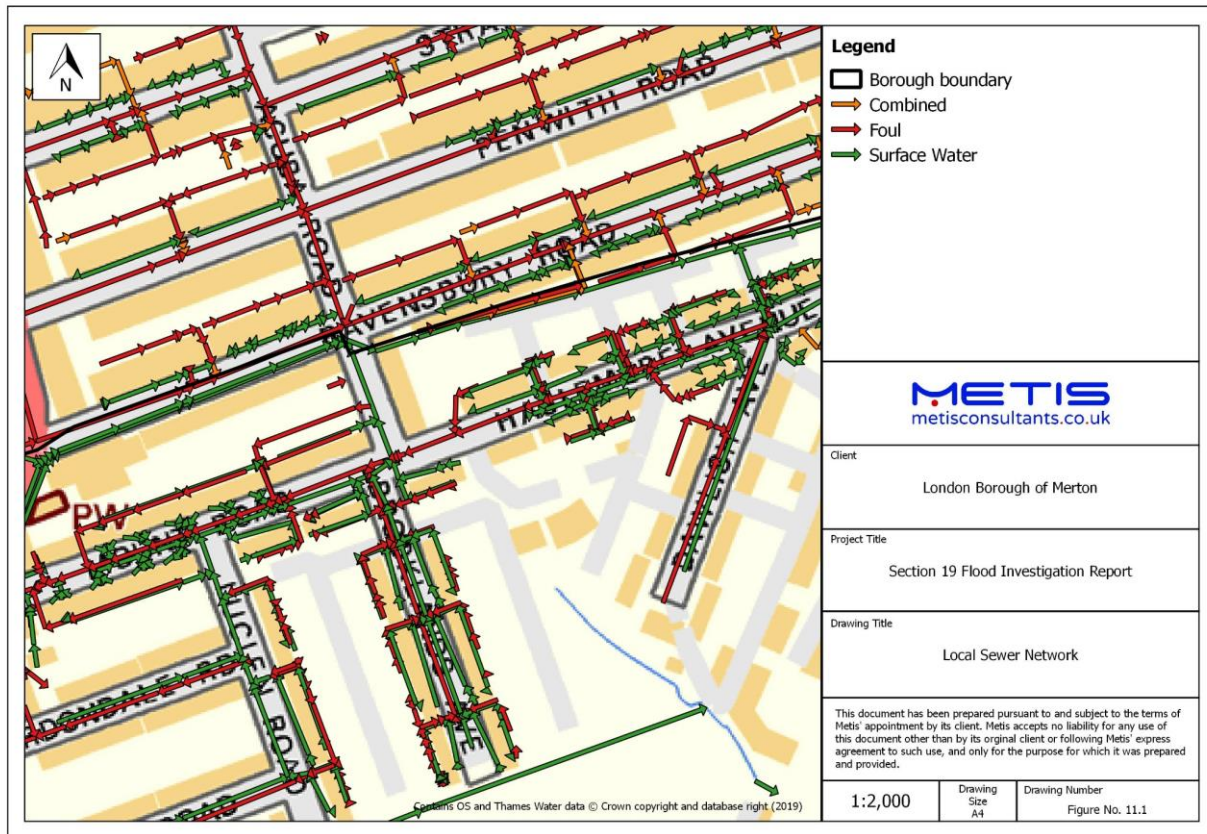
Figure 11.1 Local sewer network in this location

A 225 mm diameter foul sewer runs north on Acuba Road in the London Borough of Wandsworth. This connects into a 450 mm diameter sewer at the junction with Penwith Road which runs eastwards from here. A 225 mm diameter foul sewer runs from west to east on Ravensbury Road. East of the junction with Acuba Road this increases in diameter to 300 mm. There are some smaller combined sewers on Ravensbury Road and Penwith Road where both foul and surface water sewers connect into the foul sewers.

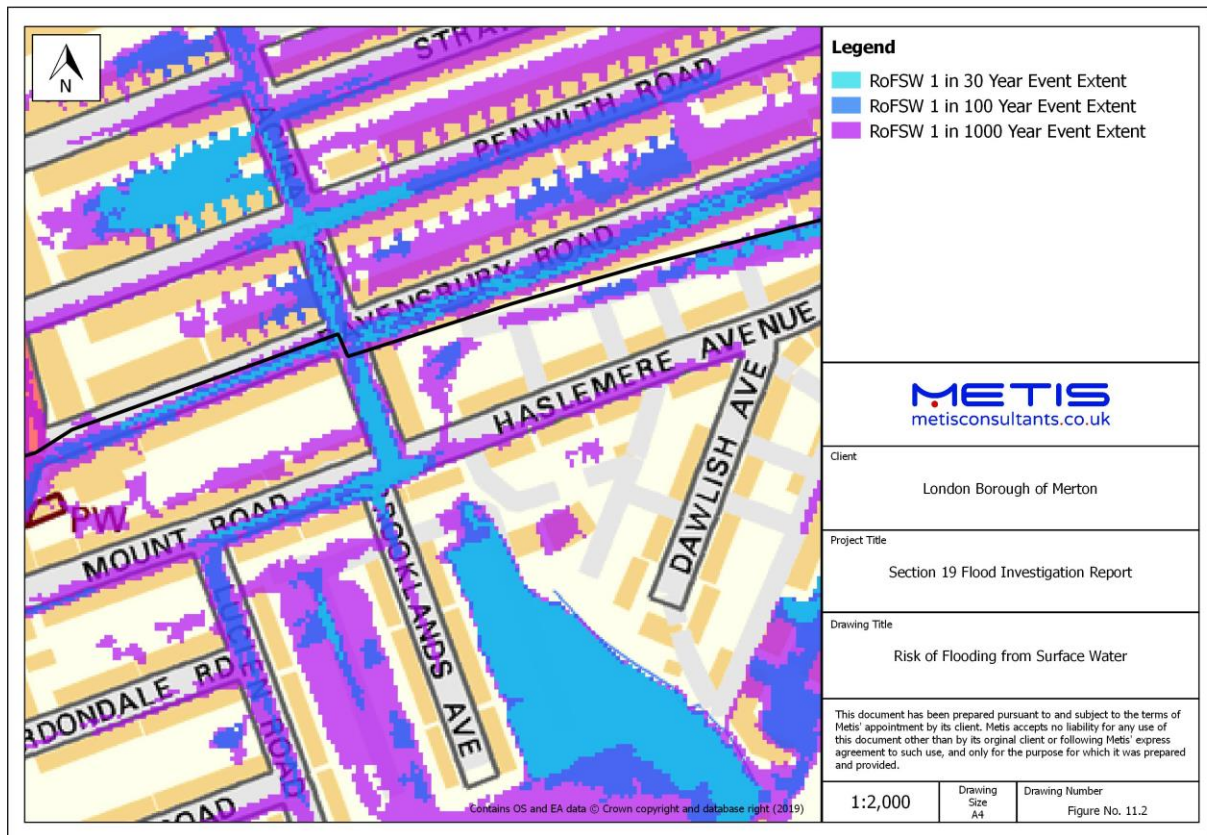
Figure 11.2 Risk of flooding from surface water in this location

The location falls within drainage catchment DC16 (as defined in Merton’s 2015 [Level 1 Strategic Flood Risk Assessment](#)). *Figure 11.2* shows that Acuba Road, Ravensbury Road and the junction of Acuba Road, Mount Road and Brooklands Avenue are at high risk of surface water flooding. The allotments to the east of Brooklands Avenue adjacent to the ordinary watercourse is also predicted to be at high risk. The same areas are also identified to be at medium risk of surface water flooding

along with Ravensbury Road and Penwith Road. Almost all of the roads in the local area are identified to be at low risk of surface water flooding.

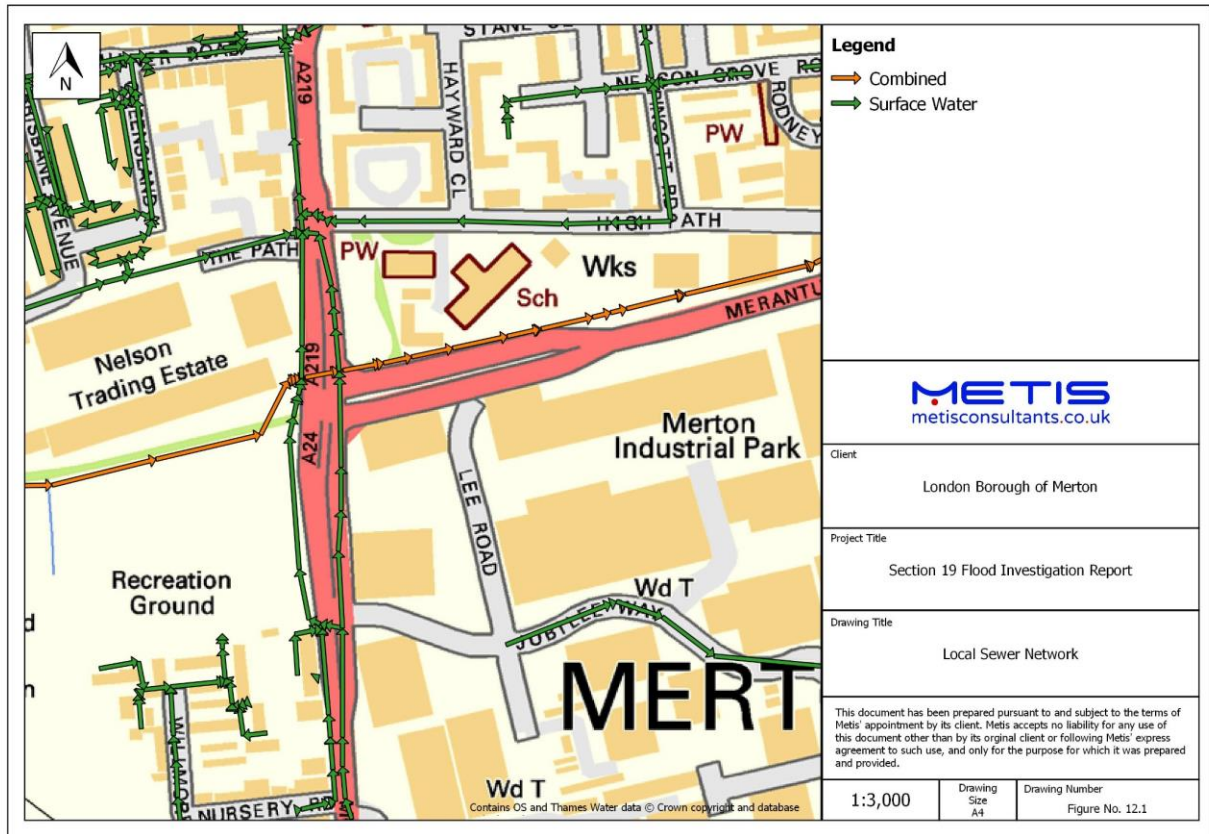
Figure 12.1: Local sewer network in this location

Figure 12.1 shows that the sewer network in Merantun Way is combined, flowing from east to west, crossing Morden Road, and the size of the pipe is 1050 mm. In Morden Road there are two surface water pipes, one on the west side of the road serving the south to the north with diameter 450 mm and one on the east side draining in parallel, with diameter 300 mm.

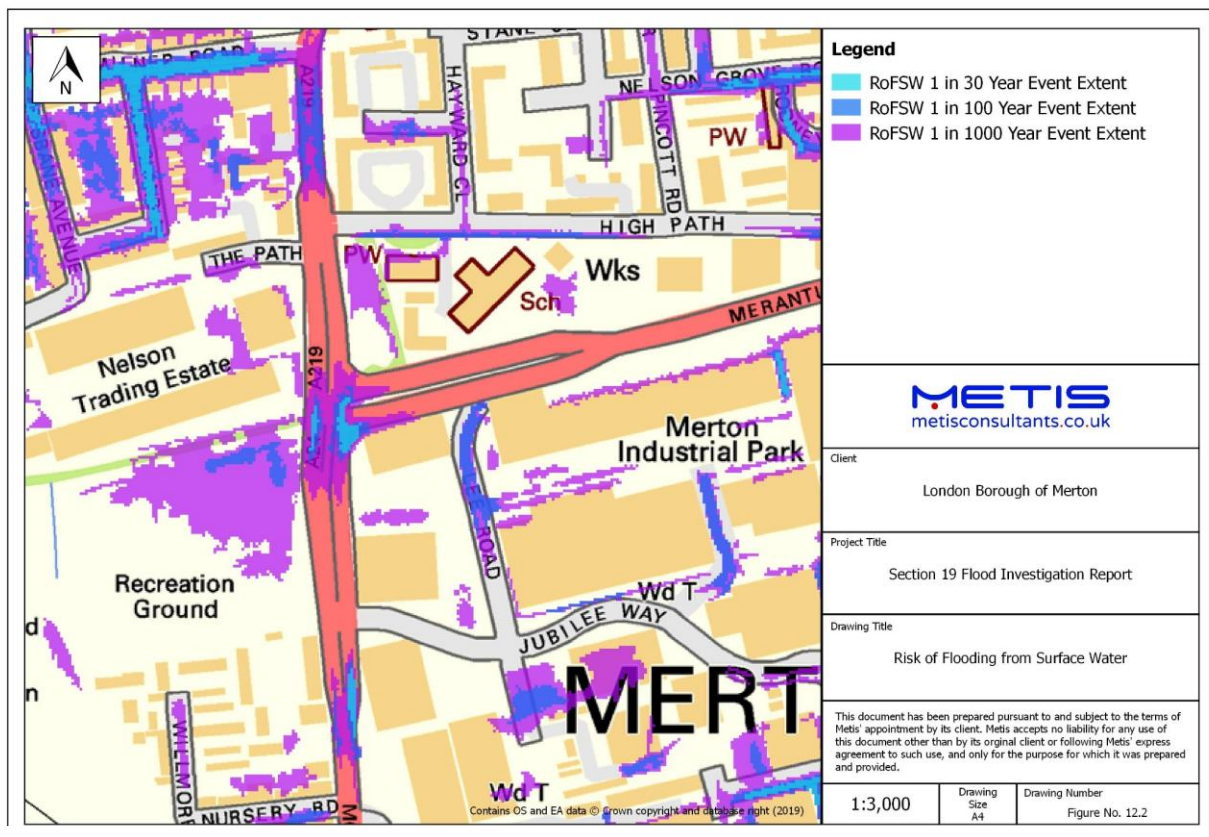
Figure 12.2: Risk of flooding from surface water in this location

The location falls within drainage catchment DC26 (as defined in Merton’s 2015 [Level 1 Strategic Flood Risk Assessment](#)). *Figure 12.2* shows that a small part of the junction of Merantun Way and Morden Road is at high or medium risk of surface water flooding, while the majority of both Merantun Way and Morden Road are at low risk. The EA’s Flood Map for Planning shows that the junction of the two roads, the Abbey Recreation Ground, properties on the west side of Morden Road and properties in the north of Merantun Way are located within Flood Risk Zone 2.
