Wimbledon Park Lake

Site Investigation Report

**Report Ref:
A112771 V1**

Project: Wimbledon Lake
Client: London Borough of Merton
Job Number: A112771
File Origin: \\londondc02\100SJS\Projects\A110000\A112771 Wimbledon Lake\Report\WYG Ground Investigation Report Wimbledon Lake_FINALv2.docx

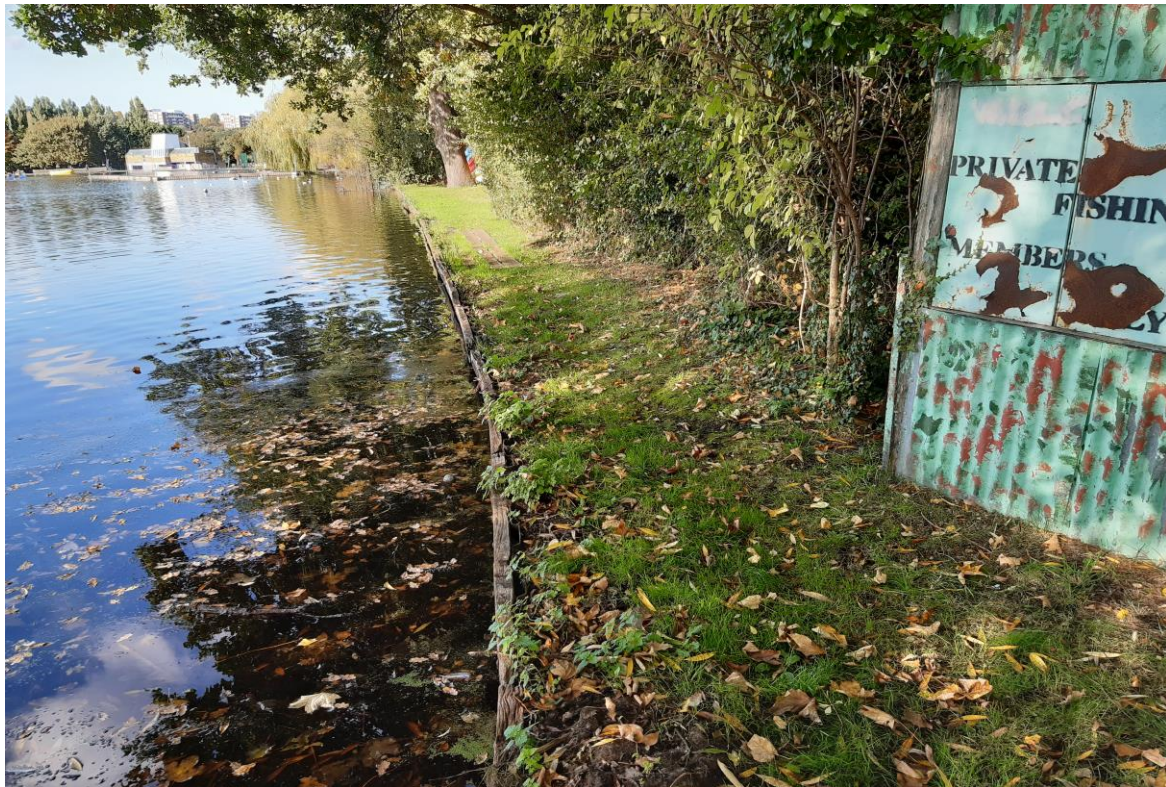
The public access route deviates away from the edge of the reservoir and sheet piles to the north of a densely vegetated fenced enclosure located to the east of the lake. The fender/rubbing strip is either not present in this area or in very poor condition (Photos 2 & 13, Appendix C) and it is assumed that the timber fendering has deteriorated and subsequently removed.

Plate 2 View north from the eastern most extent along grass fishing bank

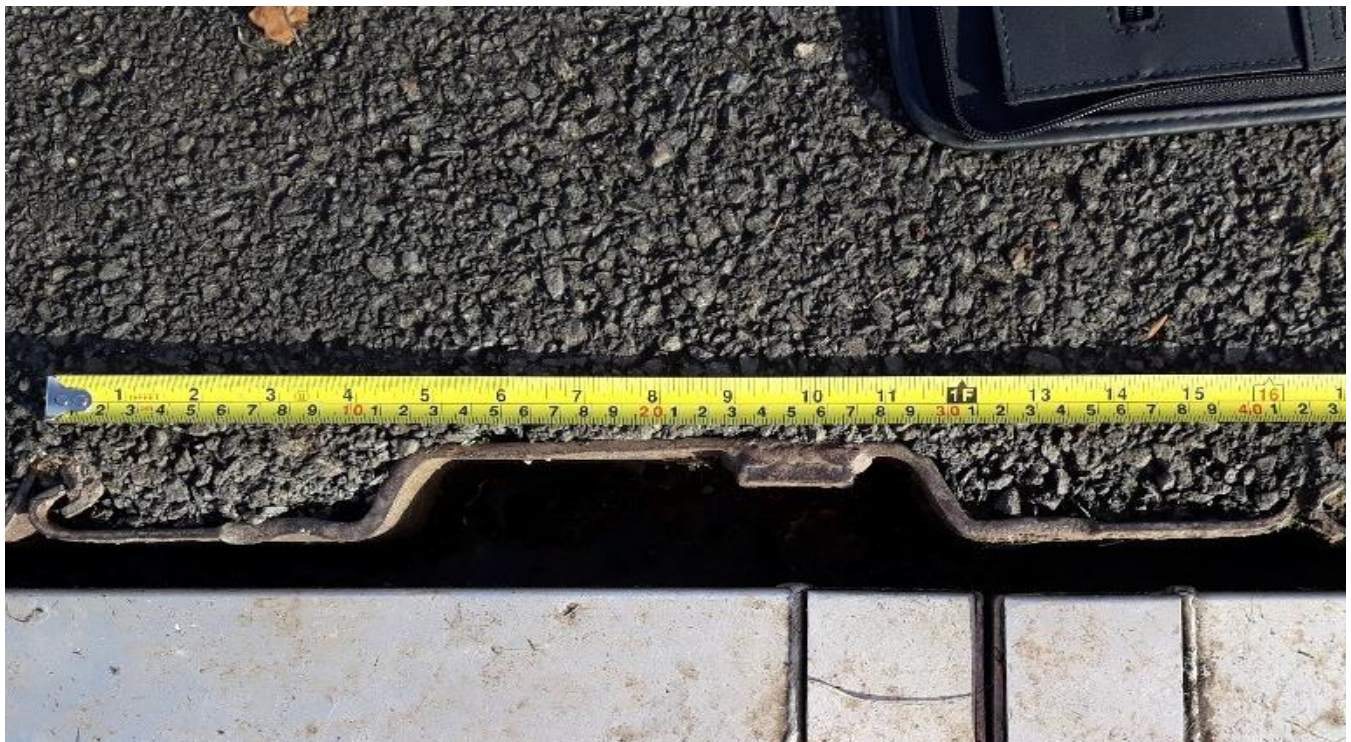
Plate 6 Close up of pile top (adjacent to jetty by sailing club)

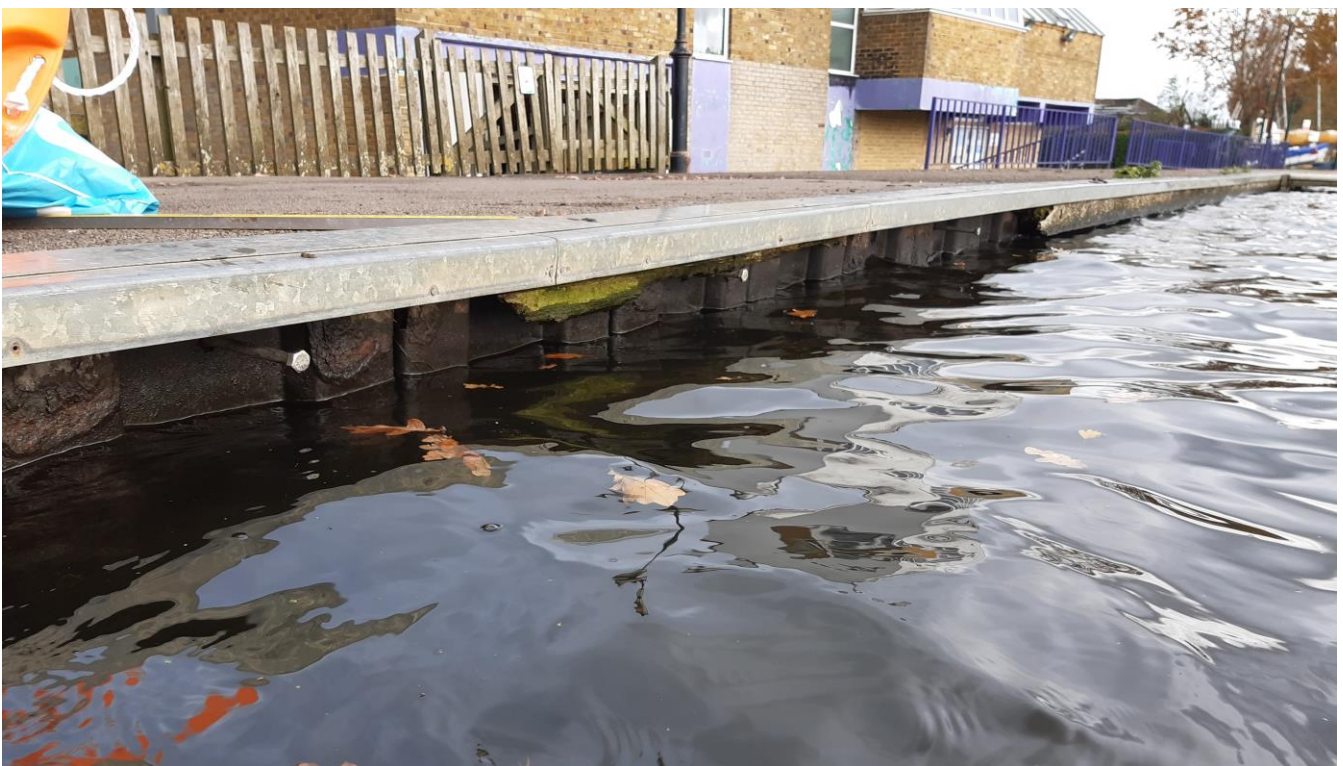
Plate 8 Degredation of the timber fender/rubbing strip in the foreground

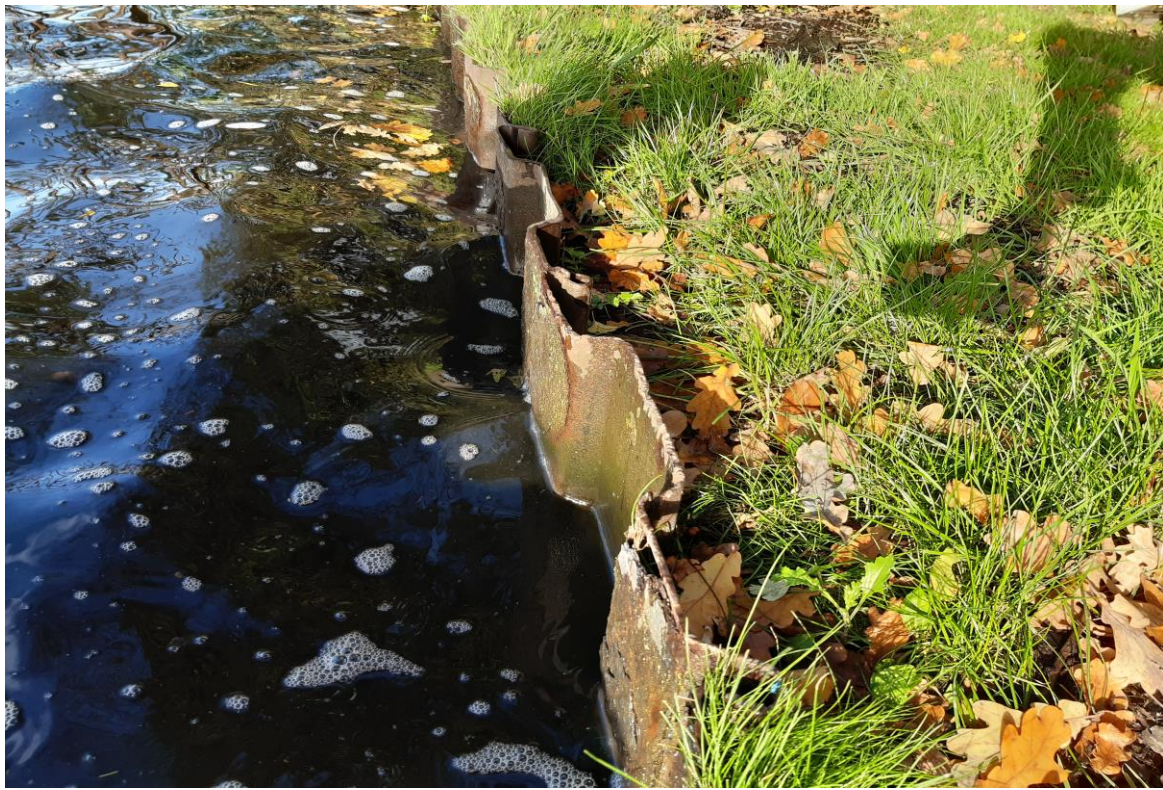
The plan profile of the sheet piles was clearly visible where the capping has been lost. In these areas the piles stand proud of the adjacent soft ground by approximately 50 to 150mm (see for example (Photo 13, Appendix C). Localised distortion of the pile head was noted, possibly occurring during the installation of the piles, and there is also evidence of corrosion. Vernier callipers confirmed the sheet piles range in thickness between 3.9 and 4.0mm. Accordingly, it is anticipated that the original pile thickness specification is likely to have been 5/32", however the plan profile could not be matched to a recorded historic pile section and the pile section has instead been traced to indicate the plan form (Drawing A112771-LDN-N-03 (Pile Section), included as Appendix B.3).

Plate 13 Area of sheet pile where timber fendering and metallic capping is not present

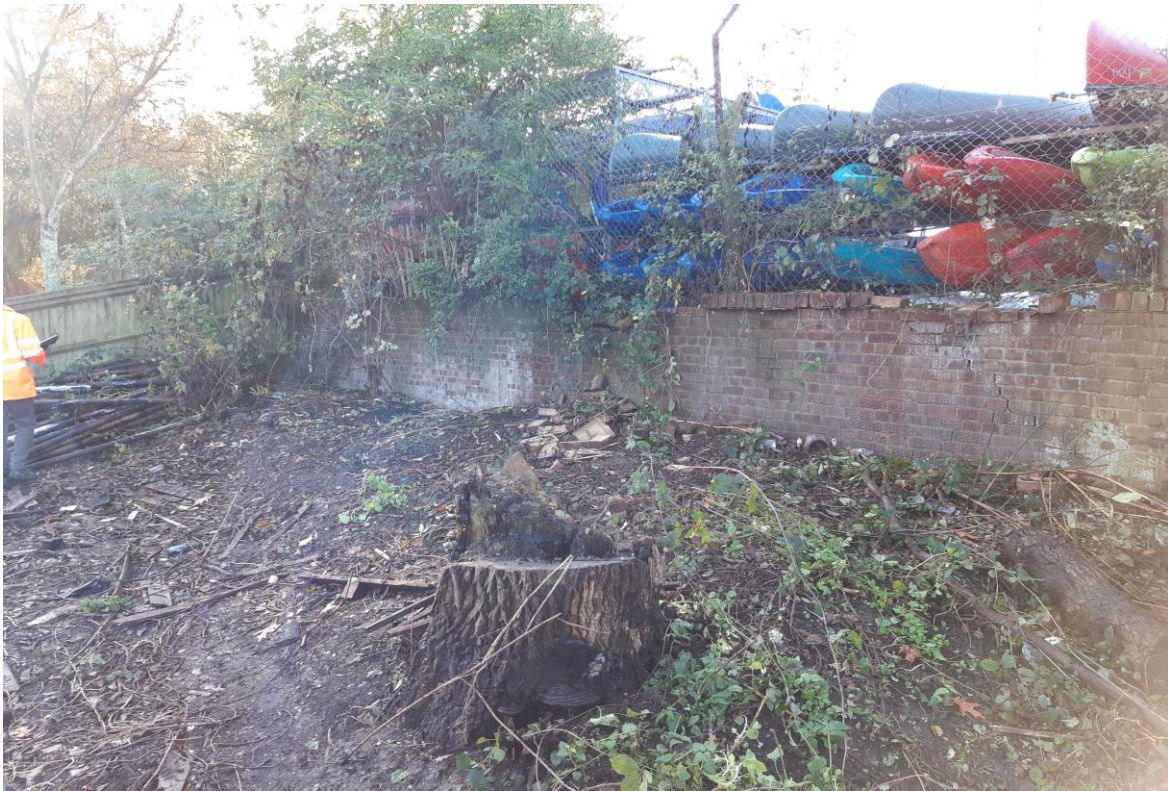
The masonry retaining wall located to the south of the bowling pavilion building forms part of the embankment structure and supports the embankment crest providing a level area for storage / facilities south of the building (Photo 14, Appendix C). The age of the retaining wall has not been confirmed but it is constructed using relatively modern building materials (mortared red brick and concrete block).

The north end of the retaining wall comprises five blockwork courses and measures approximately 1.4m in height (Photo 14, Appendix C). The blockwork portion of the wall includes returns but it is unclear if these were included to strengthen the wall or to form separate storage areas in front of the wall. The ground level of the embankment crest behind the wall is level with the top of the blockwork wall, and assuming the base of the wall is at or directly below the asphalt surfacing, it is estimated that the wall is retaining c. 1.4m of fill material (Photo 15, Appendix C).

- Other than the close / tight cracks that extend from more significant cracking originating at upper levels, the lower sections of the wall showed limited obvious signs of structural distress. (Photos 14, 15 & 16).

Plate 14 Retaining wall to the south of the bowls pavilion

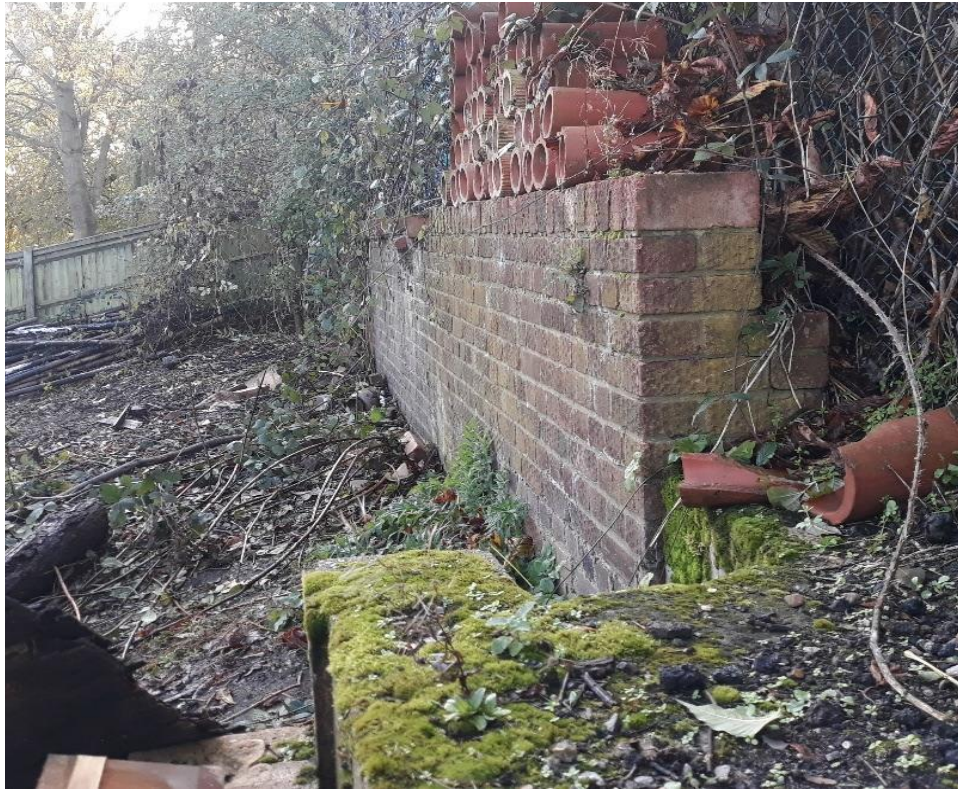
Photo 15, Appendix C. The ground level at the base of the wall is approximately 0.4m below the top of the blockwork section (Photo 16, Appendix C).

Plate 15 View along the retaining wall from the top of the adjacent blockwork wall

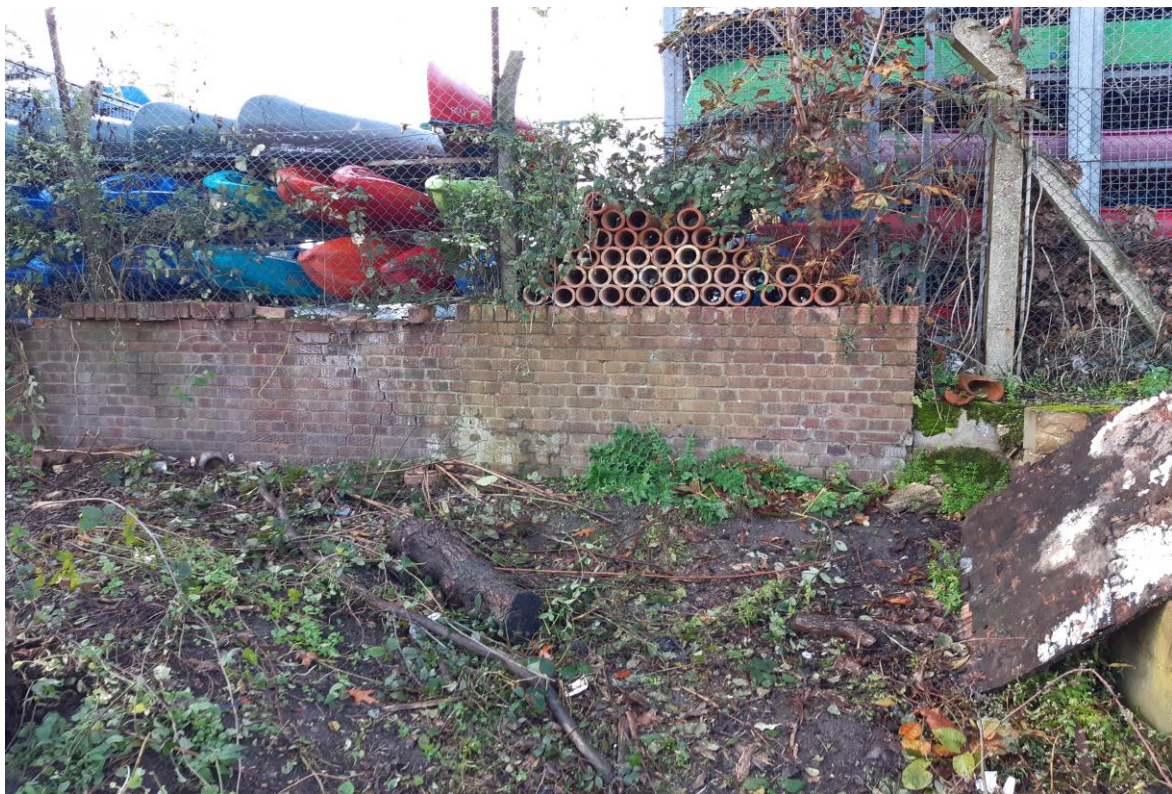
Plate 16 Retaining wall and block work wall

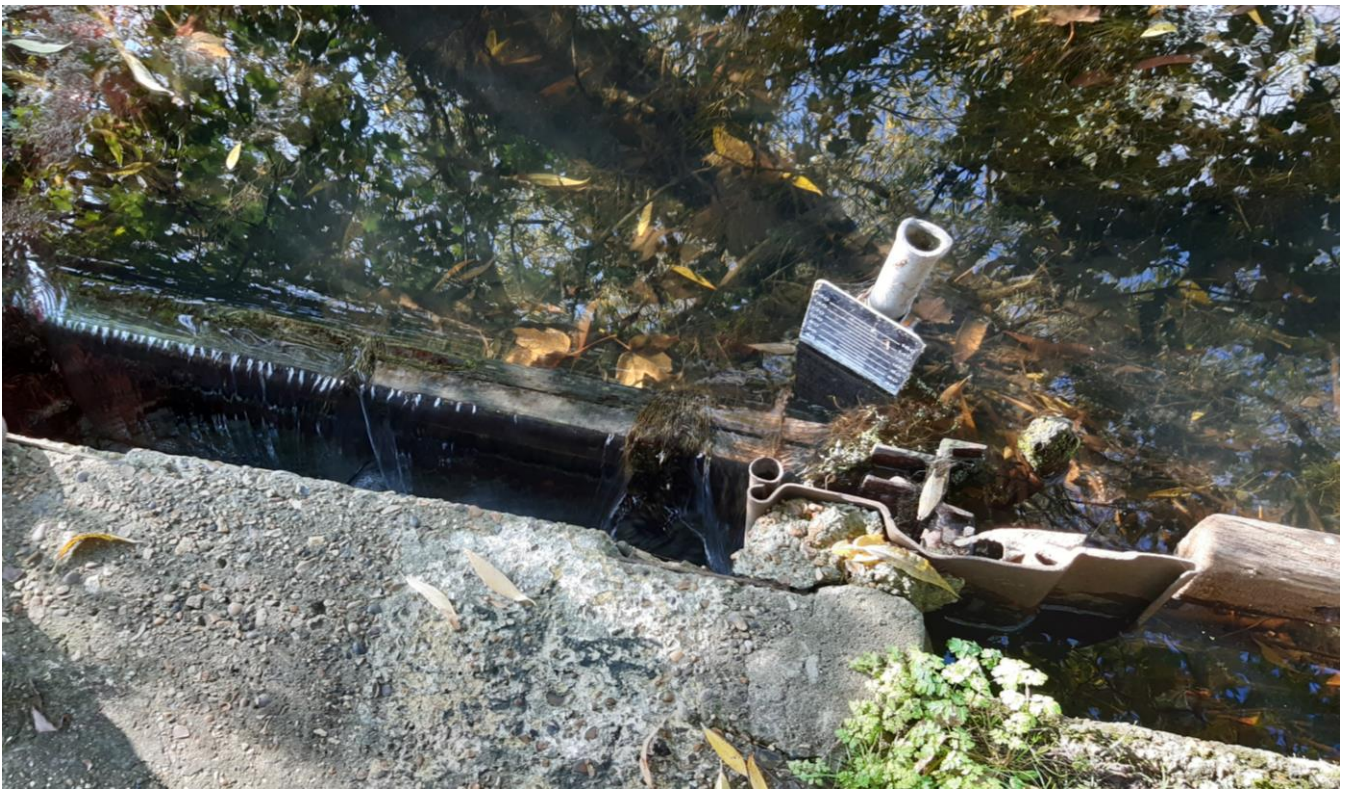
The weir comprises a break in the sheet piling measuring approximately 1.3m wide through which water is controlled by rectangular treated timber stoplogs. At the time of the investigation the crown of the stoplogs was set at approximately 17.504mAOD. This corresponds to a zero-reference elevation of 0.044m below the water level resulting in a minor flow over the stoplog into the stilling pond at the time of the investigation (Photo 17). The stoplog was secured by steel slots welded to the sheet piles on each side to allow vertical adjustment of the stoplog. A concrete platform supported by the stilling pond retaining walls bridges the weir adjacent to the stoplogs, which limits the height of the channel to 360mm on the upstream side and 500mm on the downstream side. The initial overflow channel is 1.3m wide and tapers into an approximately 700mm wide, and 4m long concrete channel. The base of this channel includes 4No. 200mm high steps.

Plate 17 Lake overflow stoplogs

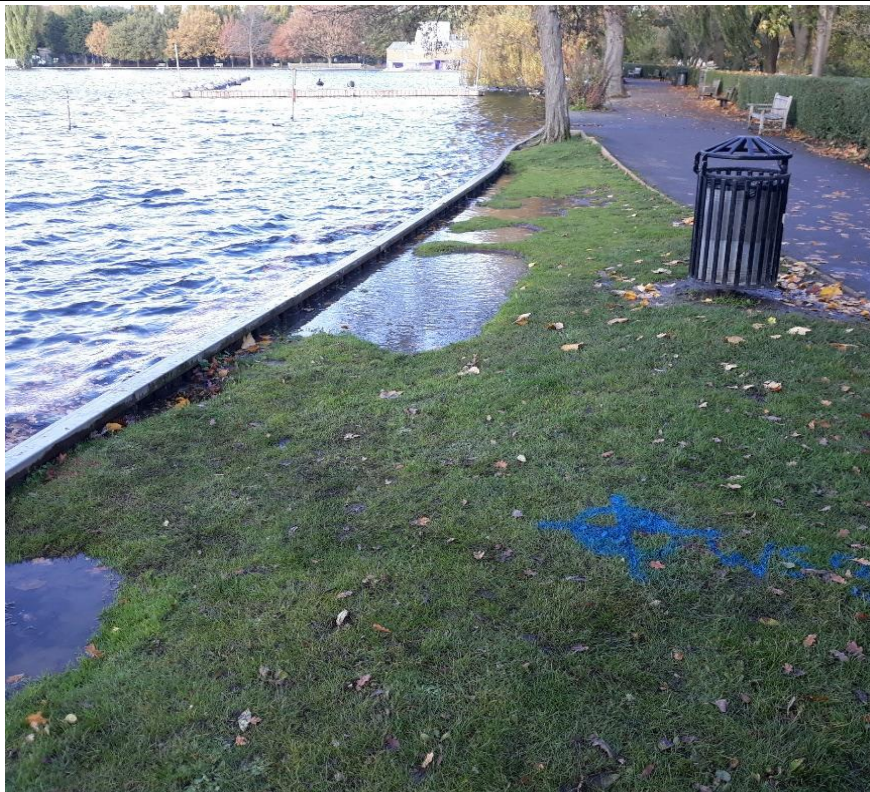
Plate 20 General view of sheet piles looking north. Note: piles in this area stand proud of the retained material and loss of section to the piles permits water to pass through and pond behind.

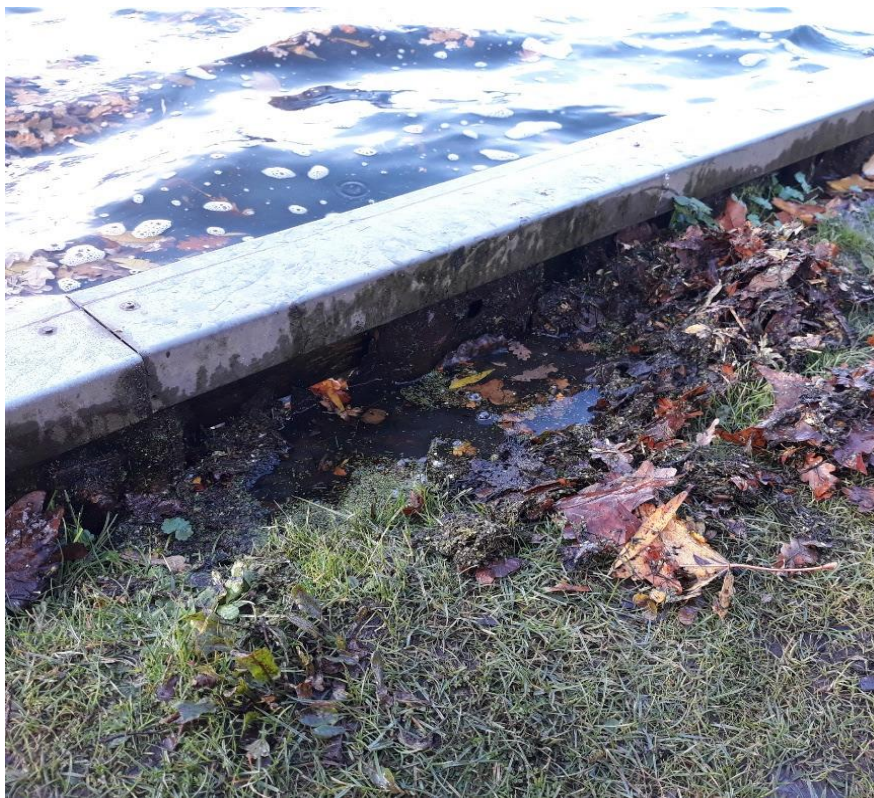
Plate 21

Rear of sheet pile where pile stands proud of the retained material and loss of section to the piles permits water to pass through and pond behind

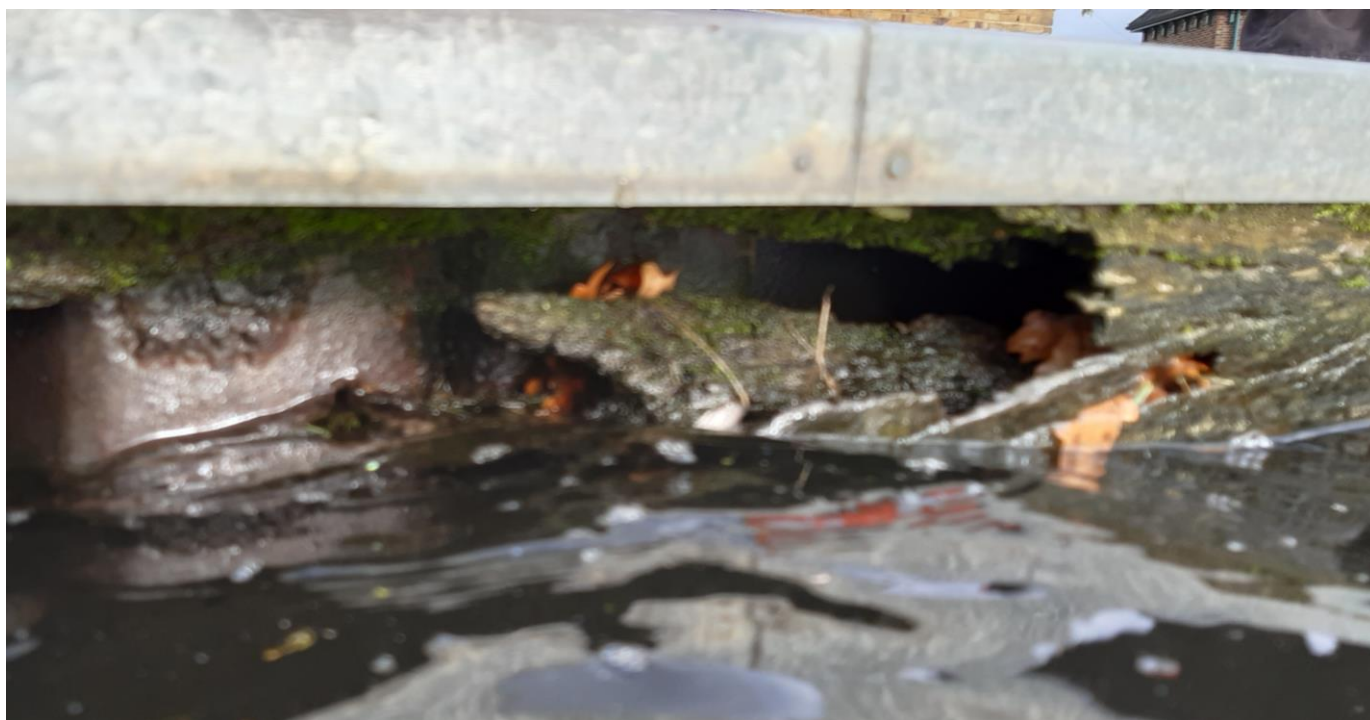
Plate 22

Close up view of top of piles where timber fendering has been lost

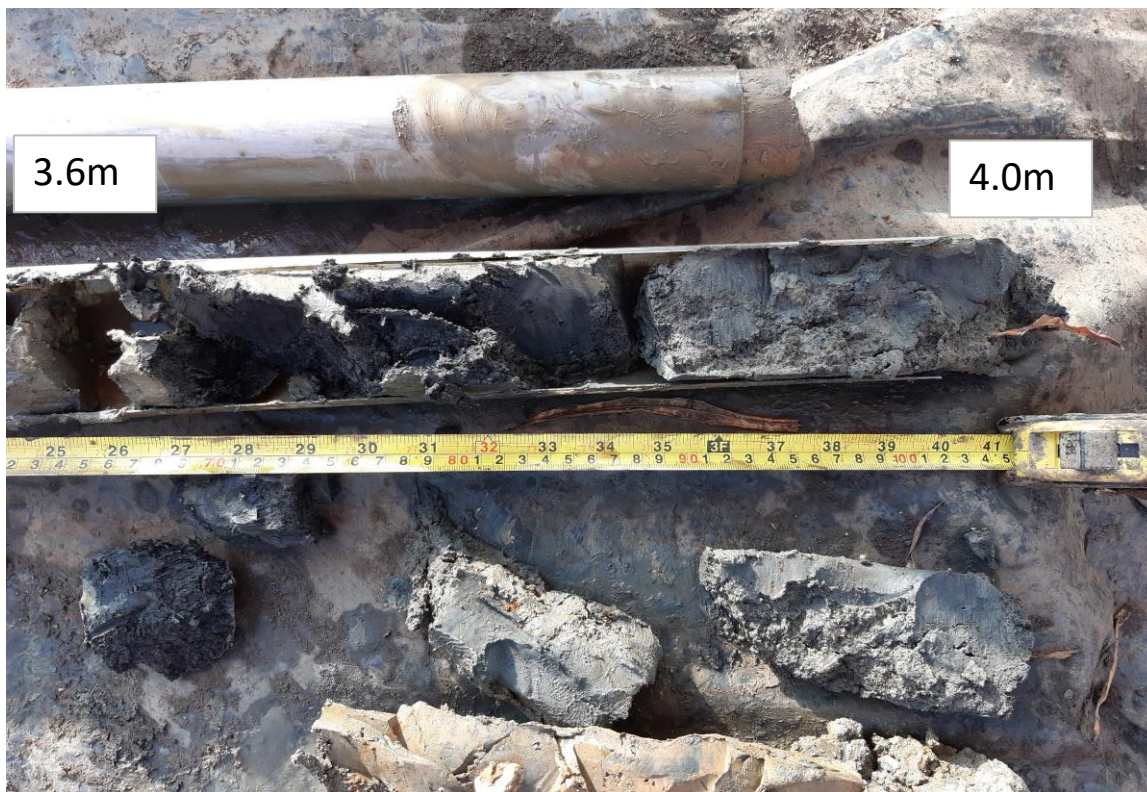
Plate 78

WS06: 3.6-4.0m showing organic rich layer

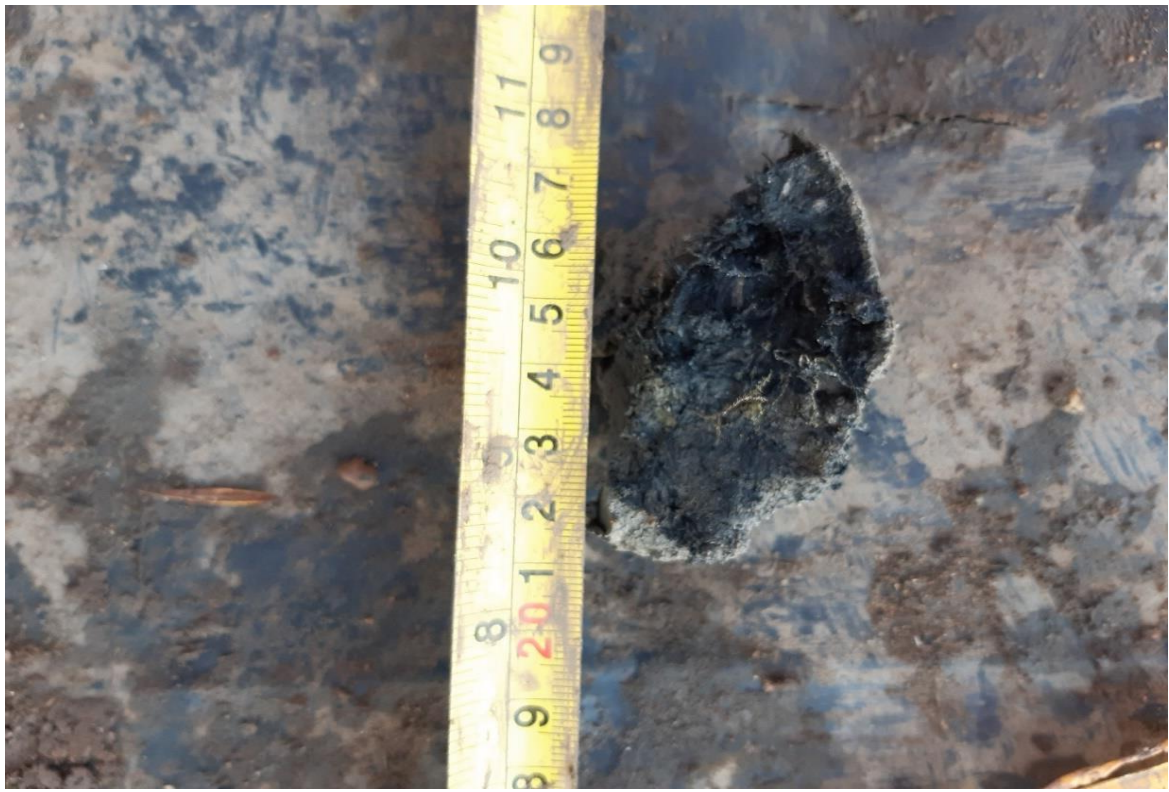
Plate 79 Sample of organic rich material from WS06 (approx. 3.8m bgl)

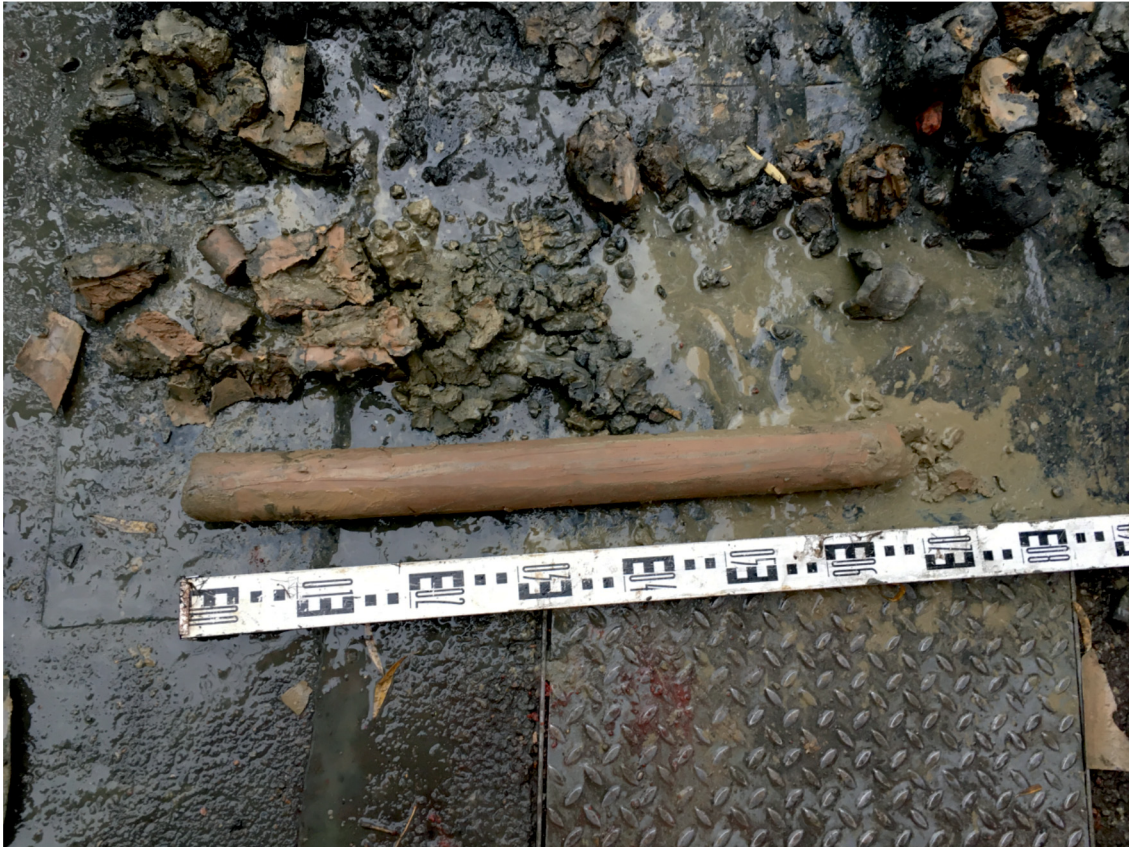
- 4.2.1 Only two of the four observed window samples (WBD19_WS02 and WS03) recorded natural London Clay deposits lying at approximately c 11m and 13m OD respectively (see Fig 3). In comparison with the levels of London Clay recorded around the lake (18-25m OD to the west and c 20m OD to the east), the levels of London Clay in the window samples indicate truncation, presumably during the lake's construction in the 18th Century.

Fig 3 Photograph showing in situ London Clay from WBD19_WS02

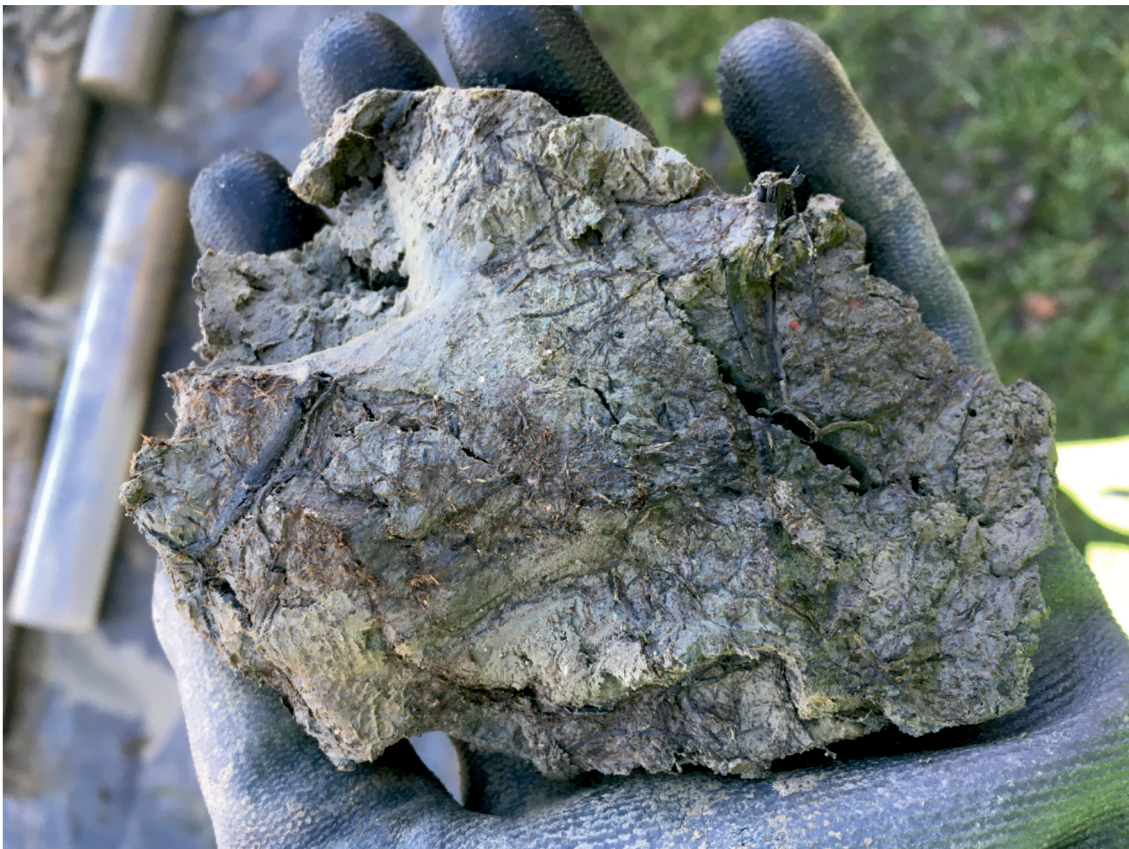
- 4.2.2 The *in situ* London Clay is overlain by redeposited London Clay containing frequent organics (eg WBD19_WS03, between 14.93 and 12.95m OD, see Fig 4) and anthropogenic material (eg in WBD19_WS04, ceramic between 14.5m and 13.7m OD, and brick and concrete between 13.7m and 12.8m OD).

Fig 4 Photograph showing unidentifiable organics and CBM flecks in redeposited London Clay (WBD19_WS03)

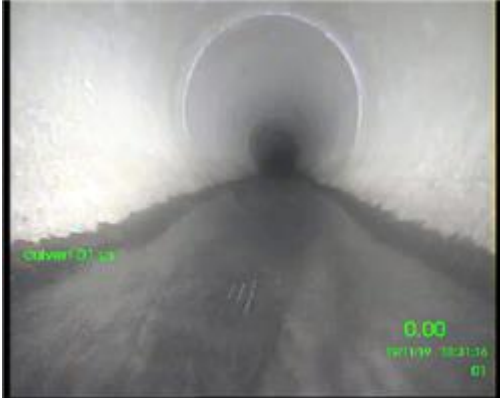
Pos	Video Ref	Code	Cont.	Description	Image
00.0m	0:00:00	OF		Start node type, outfall, reference Outfall 01 Outfall 01	Image Provided - Ref: 0_0

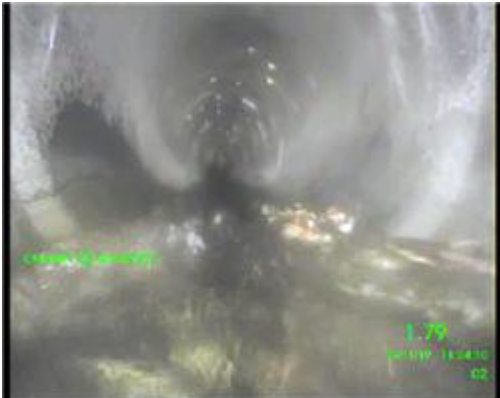
01.8m	0:00:00	RM		Roots mass: 10% cross-sectional area loss at joint - Severity 4	Image Provided - Ref: 1_1

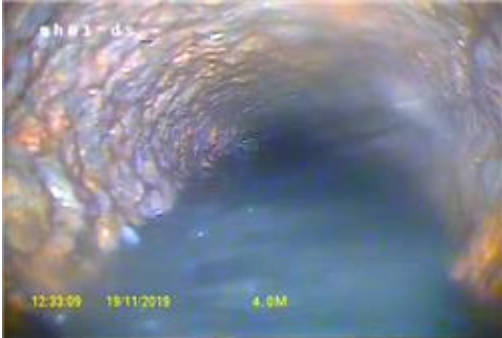
Pos	Video Ref	Code	Cont.	Description	Image
04.0m	0:00:34	DEZ	F2	Other Defect End from 12 o'clock to 12 o'clock: 20% cross-sectional area loss - Severity 2 Rust/Corrosion	
04.1m	0:01:28	WL		Water level: 100% Height/Diameter	Image Provided - Ref: 3_4

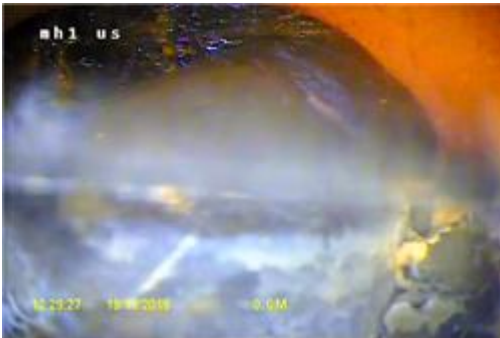
00.0m	0:00:00	DEX		Other settled deposits: 100% cross-sectional area loss - Severity 3 Build up of Leaves/Branches	Image Provided - Ref: 4_1

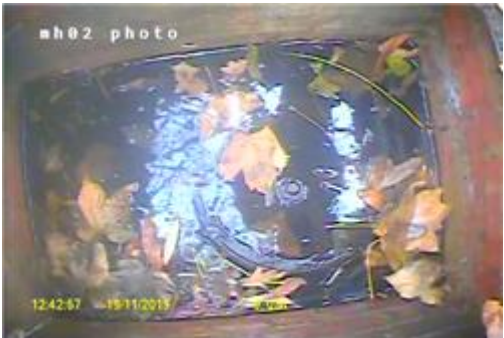
00.0m	0:00:00	REM		General remark Photo of Valve Downstream from mh01	Image Provided - Ref: 5_1

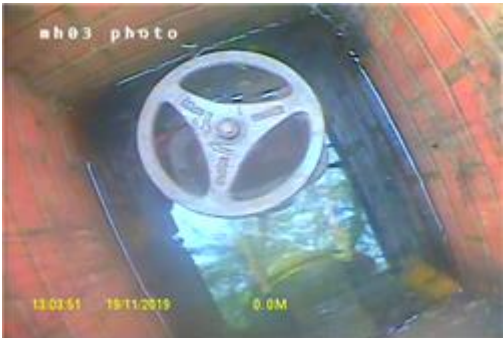
00.0m	0:00:00	REM		General remark Photo of Valve Upstream of mh04	Image Provided - Ref: 6_1

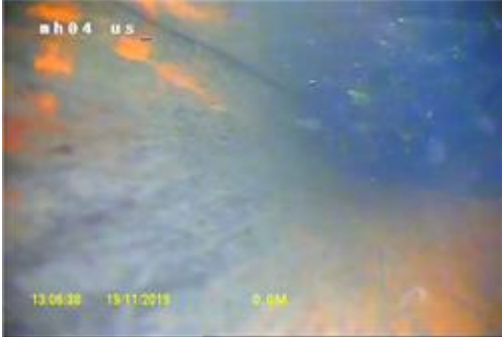
Pos	Video Ref	Code	Cont.	Description	Image
00.0m	0:00:00	MH		Start node type, manhole, reference mh04 us mh04 us	Image Provided - Ref: 7_0

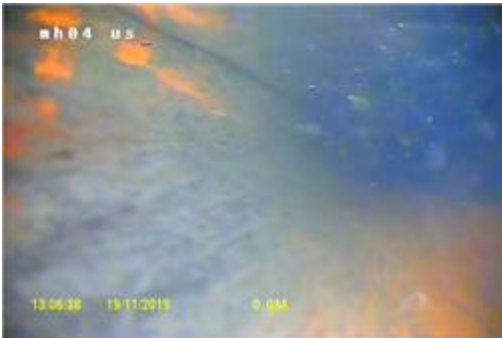
00.0m	0:00:00	CU W		Loss of vision, camera under water	Image Provided - Ref: 7_1

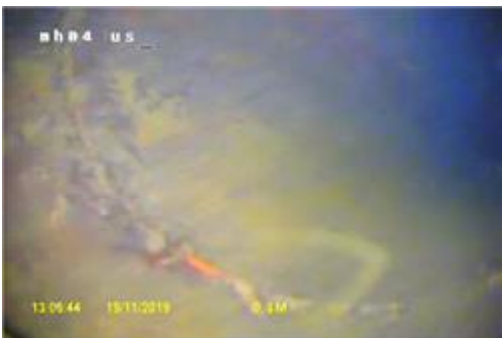
00.8m	0:00:06	LR		Line of drain/sewer deviates right	Image Provided - Ref: 7_2

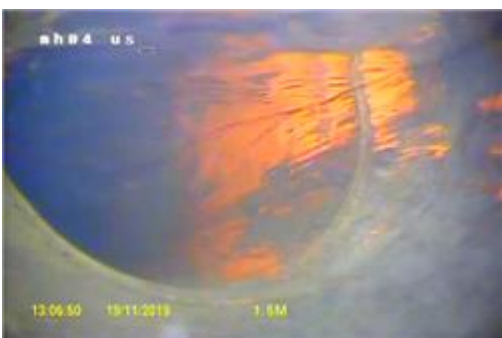
01.6m	0:00:12	LL		Line of drain/sewer deviates left	Image Provided - Ref: 7_3

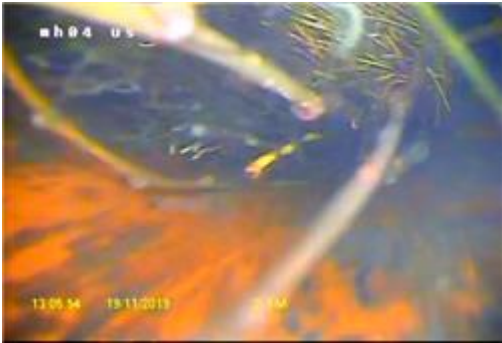
Pos	Video Ref	Code	Cont.	Description	Image
02.1m	0:00:15	DEX		Other settled deposits: 100% cross-sectional area loss - Severity 3 Branches and Vegetation from Lake	Image Provided - Ref: 7_4

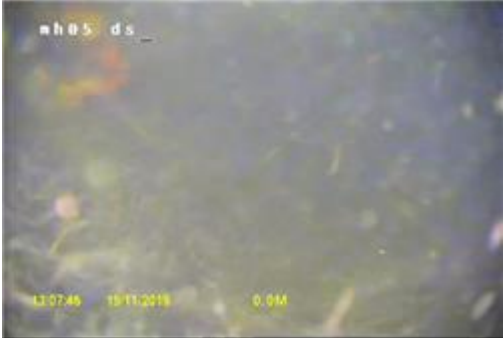
Pos	Video Ref	Code	Cont.	Description	Image
00.0m	0:00:00	MH		Start node type, manhole, reference mh05 ds mh05 ds	Image Provided - Ref: 8_0

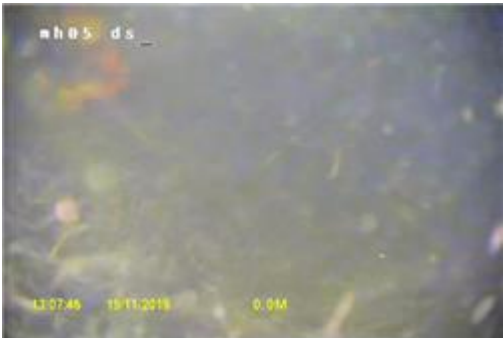
00.0m	0:00:00	CU W		Loss of vision, camera under water	Image Provided - Ref: 8_1

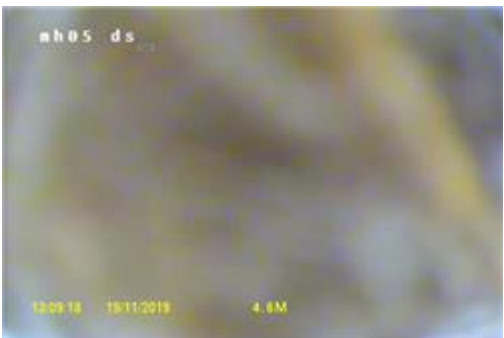
04.6m		SA		Survey abandoned Survey Abandoned - Unable to Push Camera Further	Image Provided - Ref: 8_9999

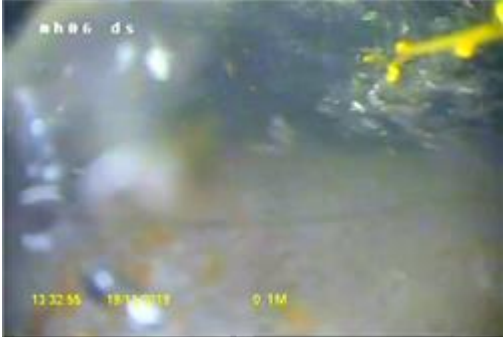
Pos	Video Ref	Code	Cont.	Description	Image
00.0m	0:00:00	MH		Start node type, manhole, reference mh06 ds mh06 ds	Image Provided - Ref: 9_0

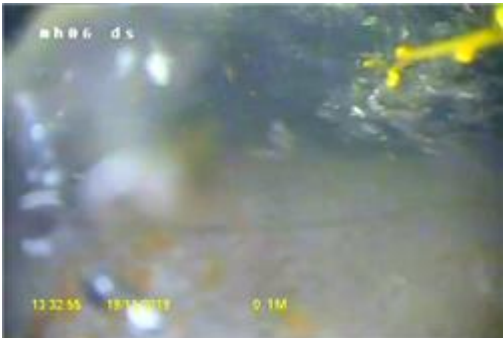
00.0m	0:00:00	CU W		Loss of vision, camera under water	Image Provided - Ref: 9_1

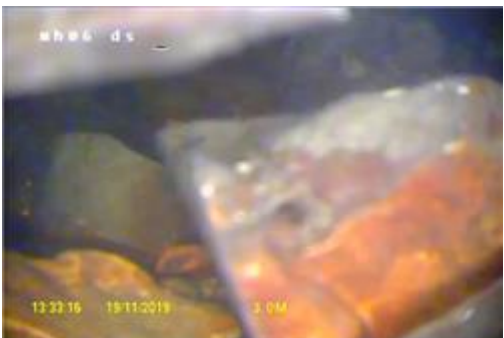
03.0m	0:00:23	DER		Settled deposits coarse: 40% cross-sectional area loss - Severity 3 Debris Under Water Level	Image Provided - Ref: 9_2

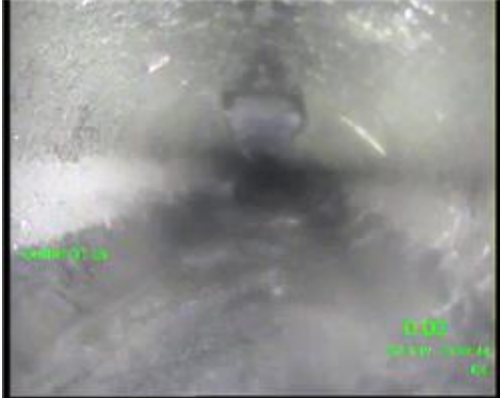
Pos	Video Ref	Code	Cont.	Description	Image
00.0m	0:00:00	OF		Start node type, outfall, reference Outfall 03 us Outfall 01 us	Image Provided - Ref: 10_0

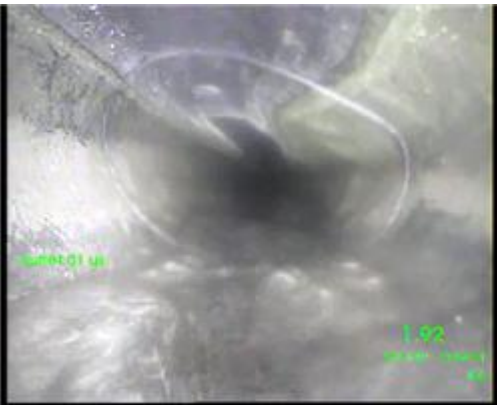
Pos	Video Ref	Code	Cont.	Description	Image
01.9m		SA		Survey abandoned Survey Abandoned - Unable to Pass Deformed Sewer	<p>Image Provided - Ref: 10_9999</p>
