Structural Assessment Report of Orlit Houses Revision A Ravensbury Estate Regeneration For HTA Design LLP

Ravensbury Estate
Regeneration

Structural Assessment Report
of Orlit Houses

6th November 2014

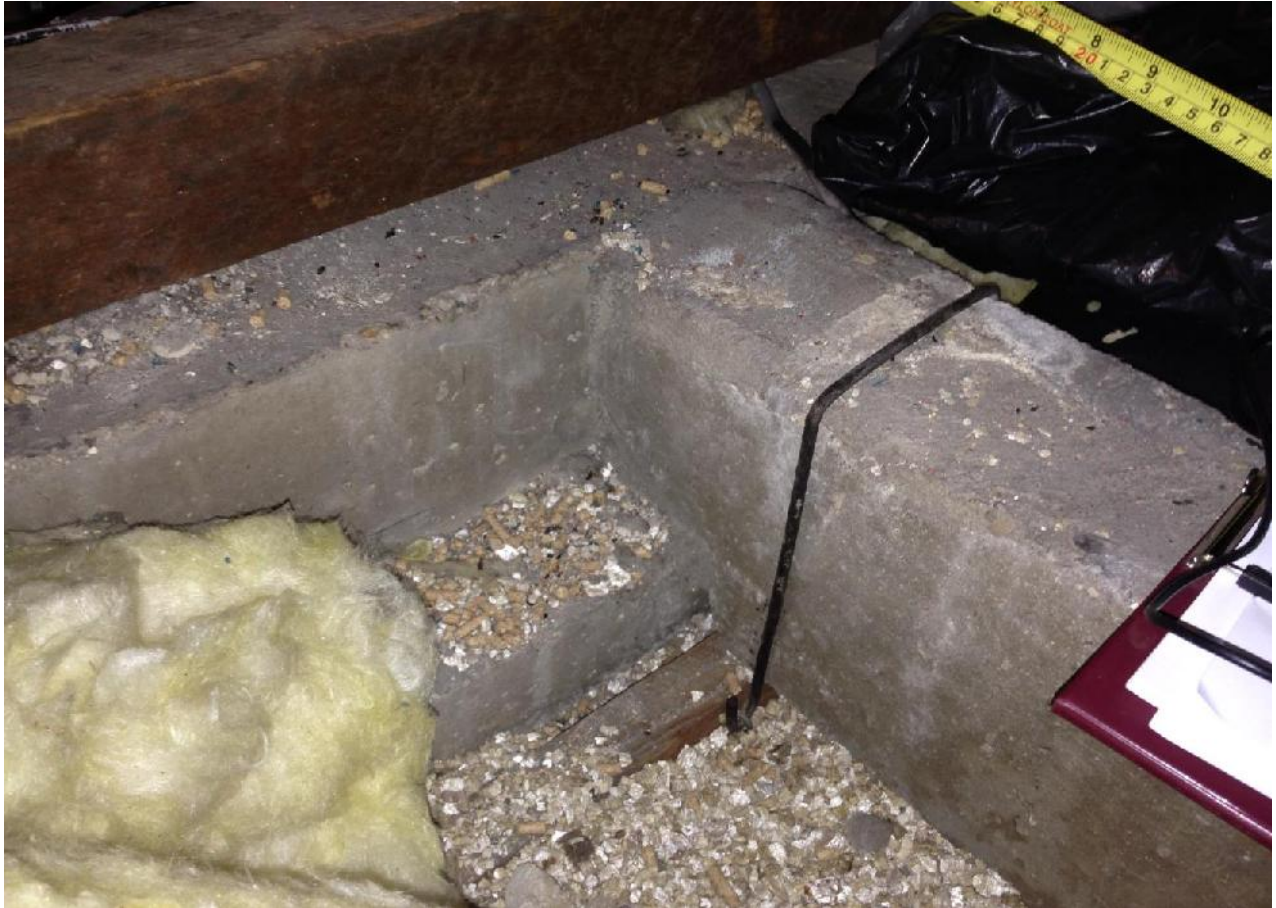
- 3.14 There is no secondary timber floor structure or boarding on top of the concrete beams at first floor ceiling level within the observed roof spaces. Timber battens below the concrete beams support the ceiling finishes in a similar way to first floor level. The timber battens are hung from the secondary beams in the floor space using small (approx. 4mm) diameter metal bars, as illustrated in Photographs C1 and C13.

Photograph C1 – Primary beam and secondary beam connection and ceiling hanger

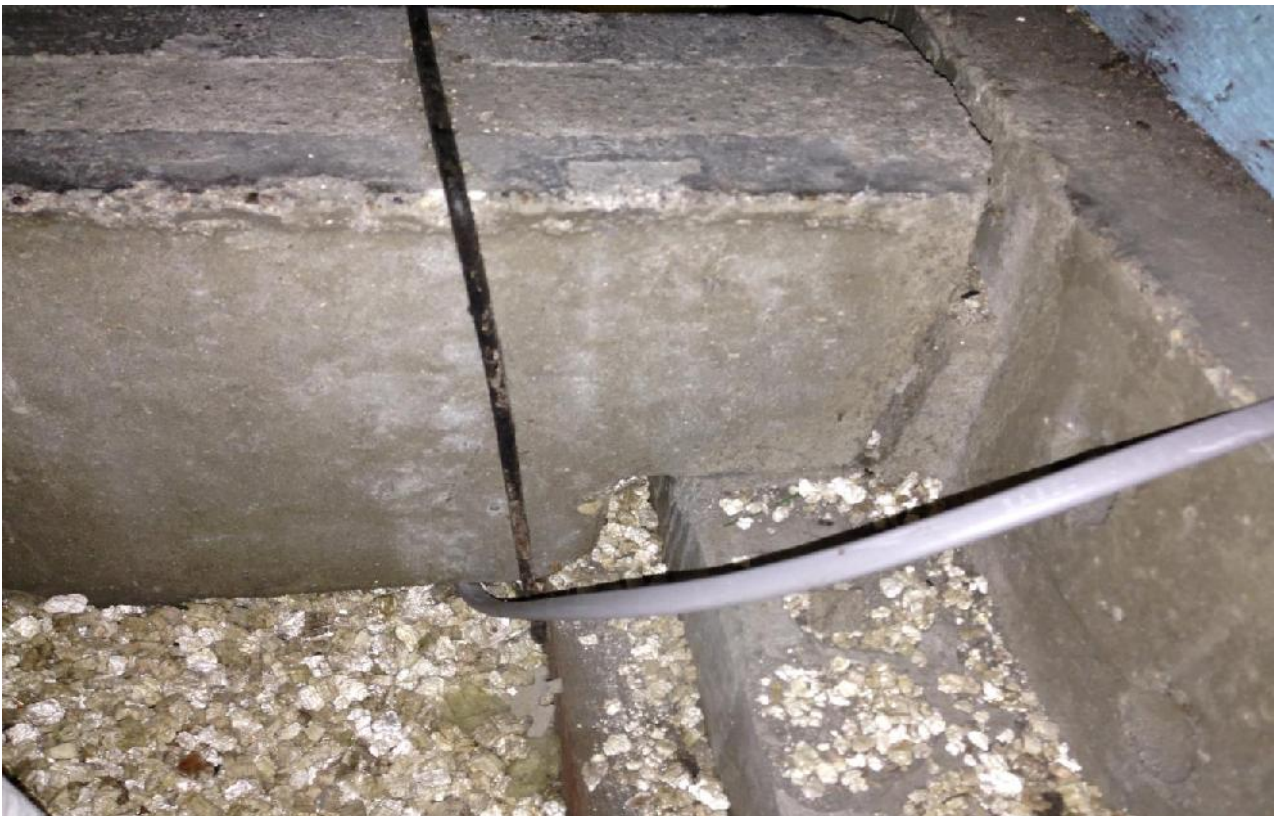
Photograph C2 – Discontinuity of mortar/concrete between primary beam and secondary beam connection

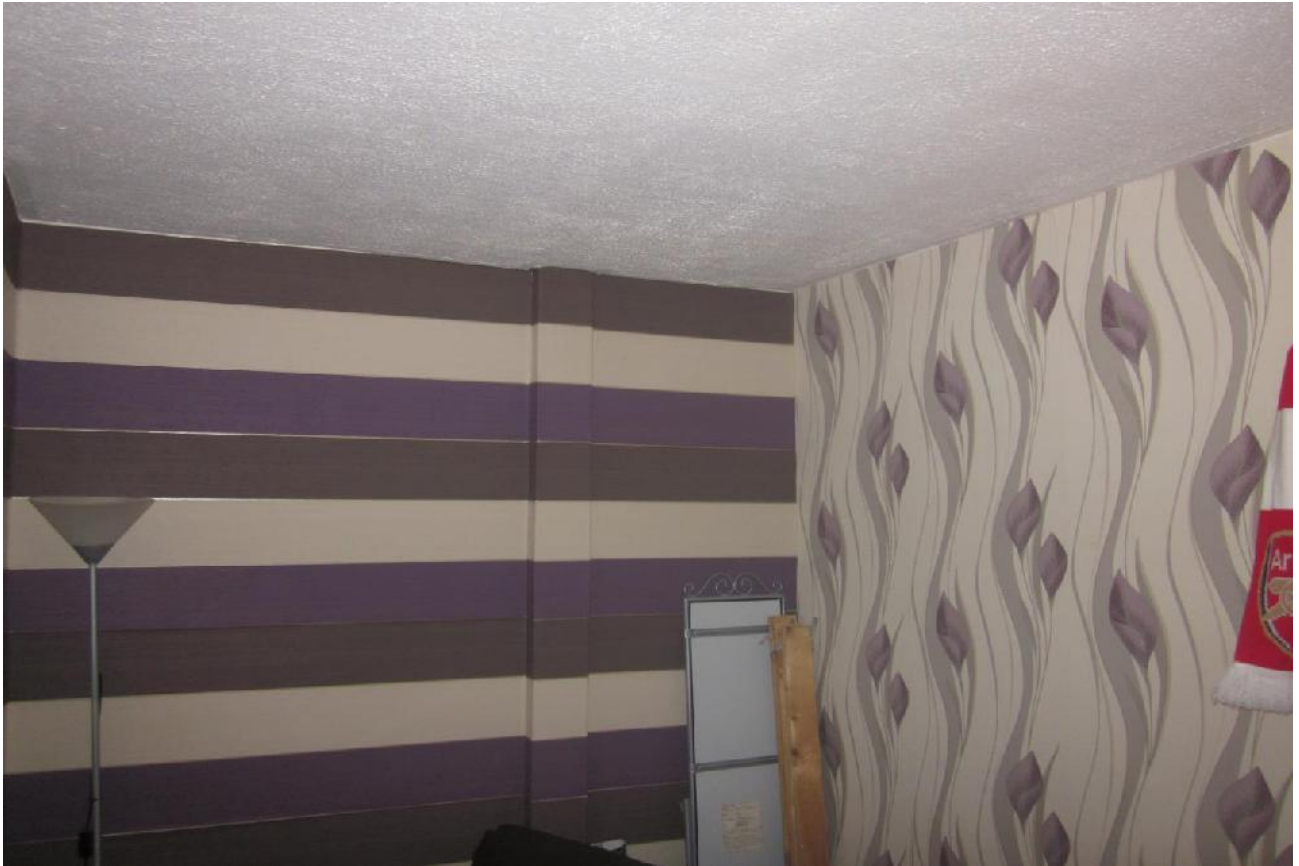
Photograph C10 – Evidence of internal column projection on party wall line into room

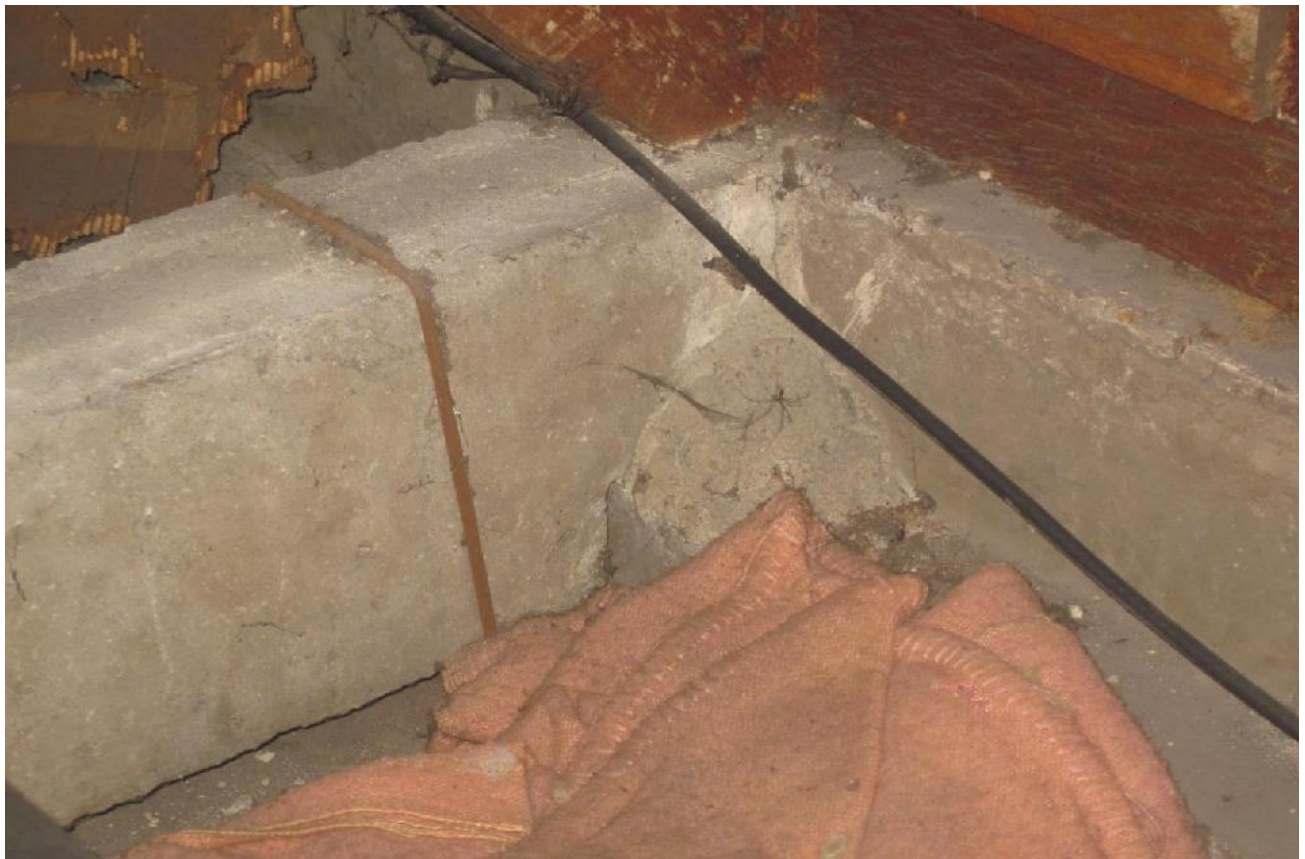
Photograph C11 – Concrete stitch

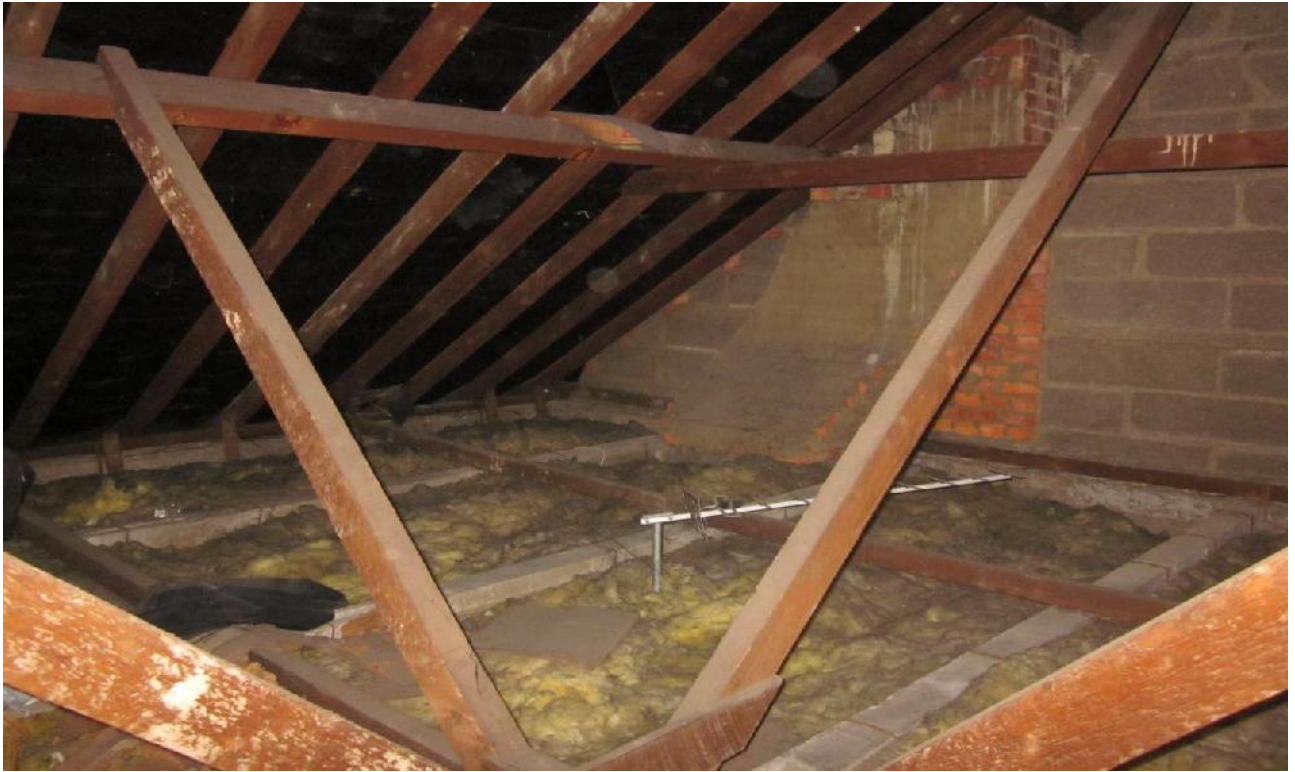
Photograph C12 – 124 Morden Road roof structure

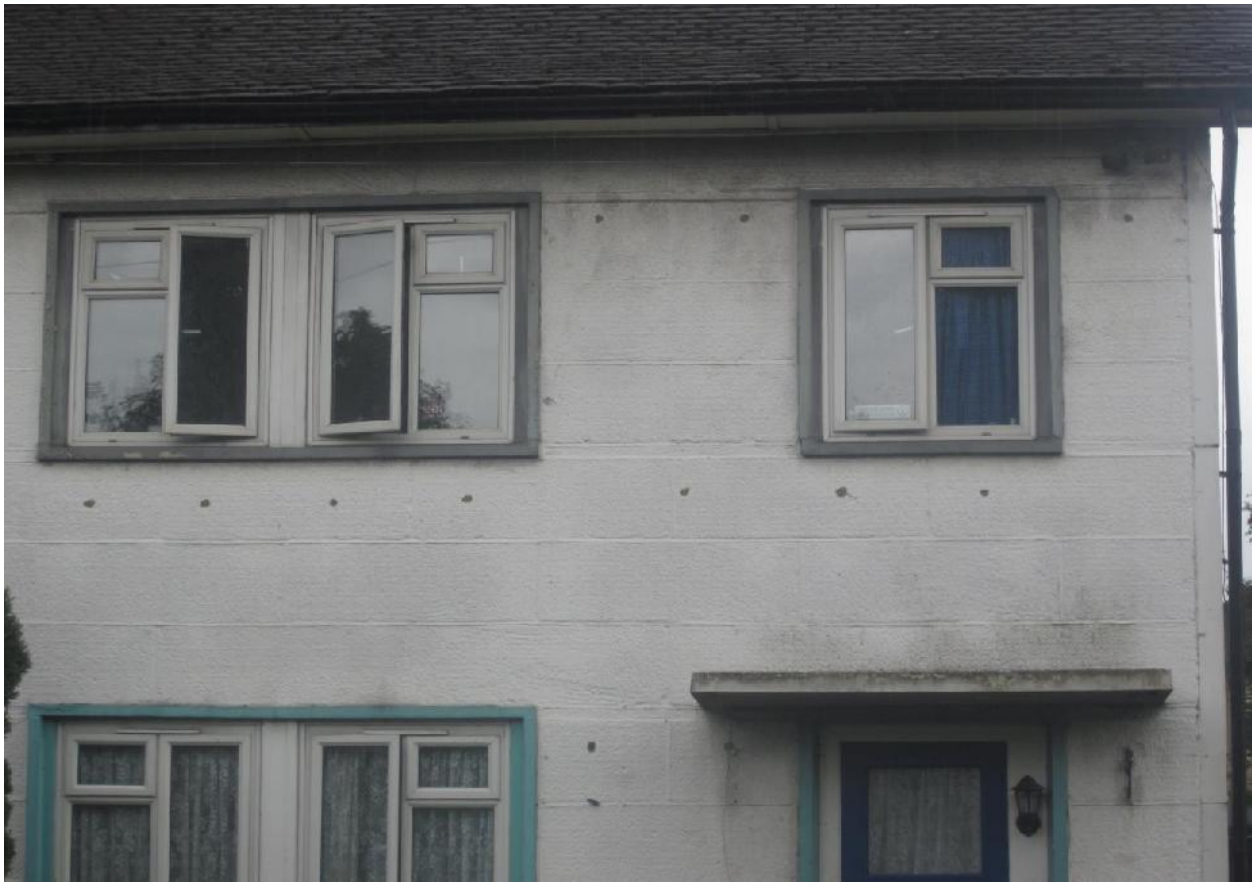
Photograph C18 – Circular markings on elevation

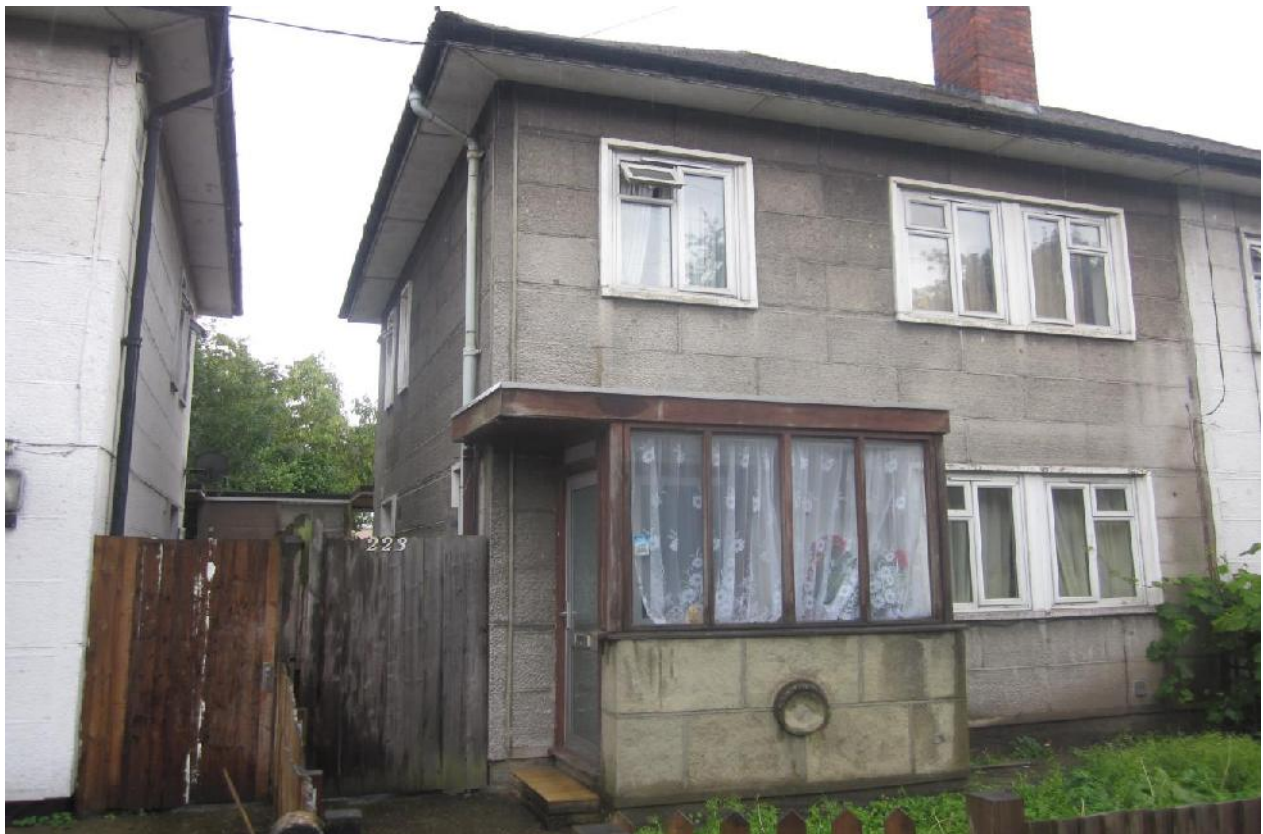
Photograph C19 – Example of no finishes to cladding and porch extension

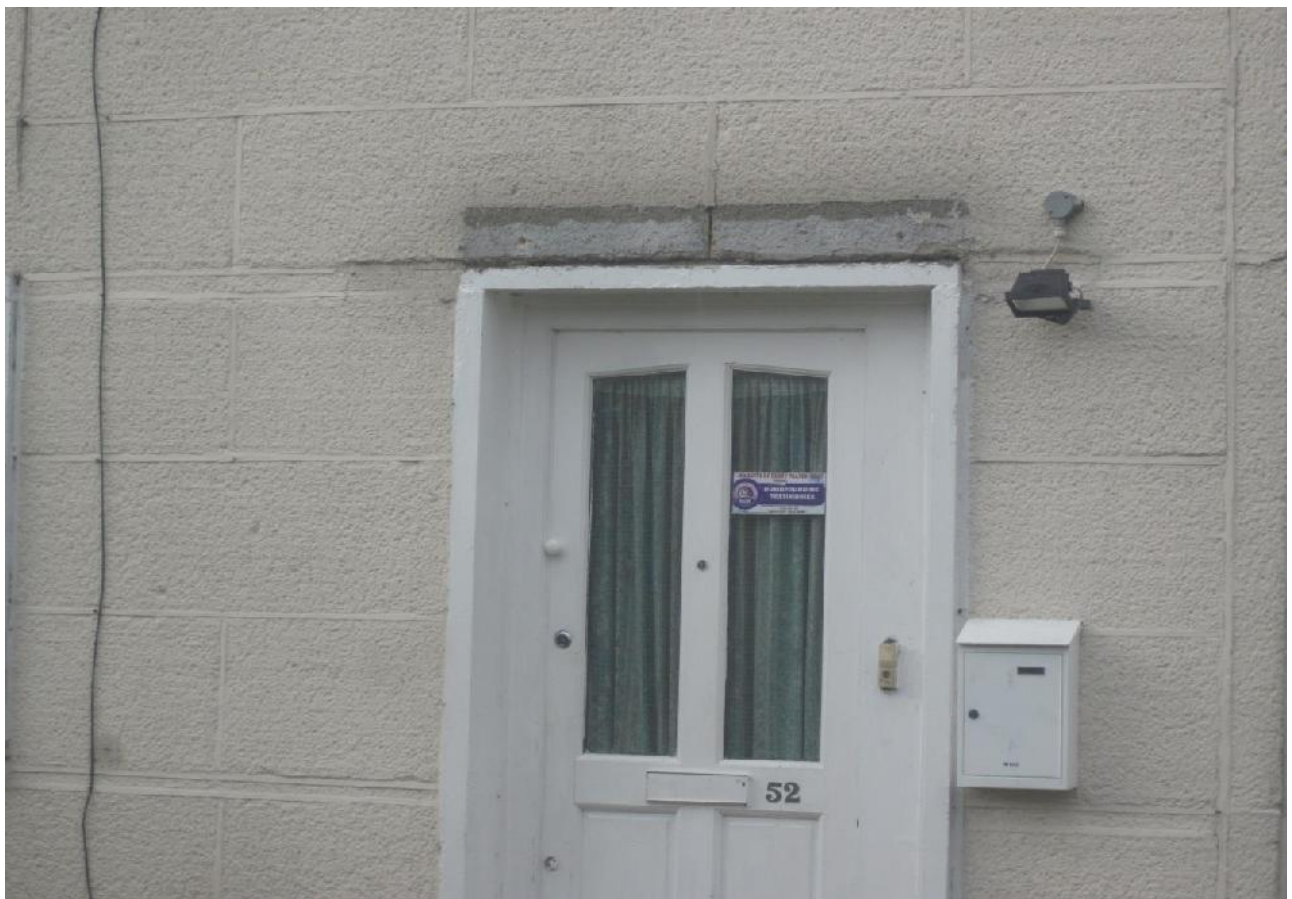
Photograph C25 – Example of removed canopy

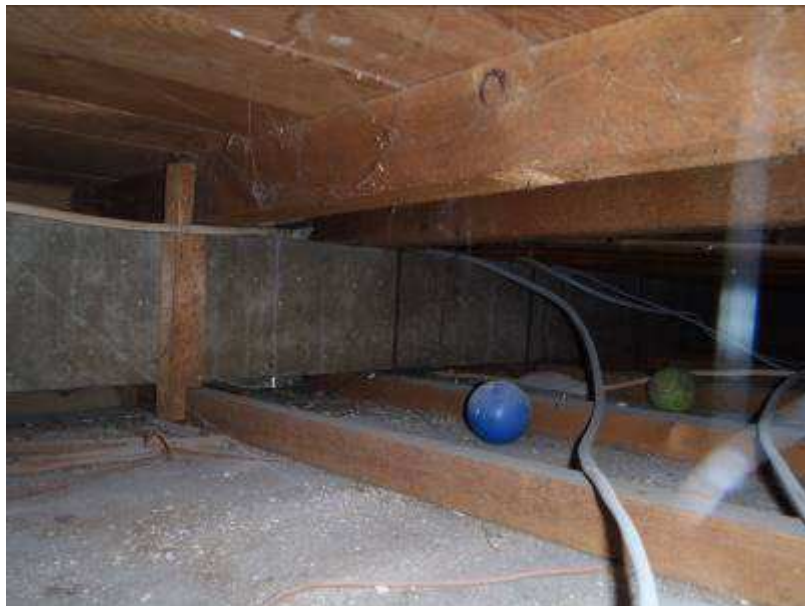
Plate R3: View of typical 1st Floor structure at No. 20 Hatfield Close

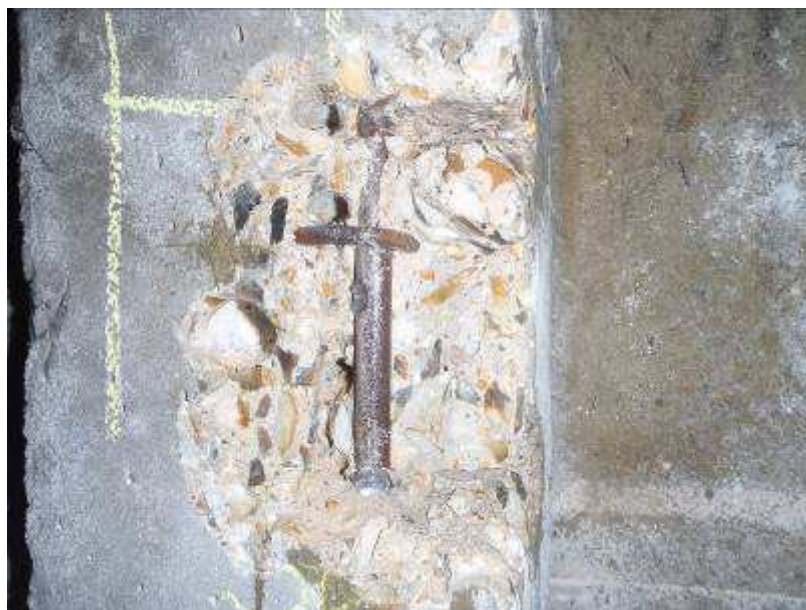
A total of eighteen localised breakouts were carried out to the various precast concrete elements forming the structures in order to size and inspect the reinforcement. The reinforcement was generally observed to be in good condition, generally exhibiting light surface corrosion only.

Plate R7: View of column Breakout A2 at No. 241 Morden Road.

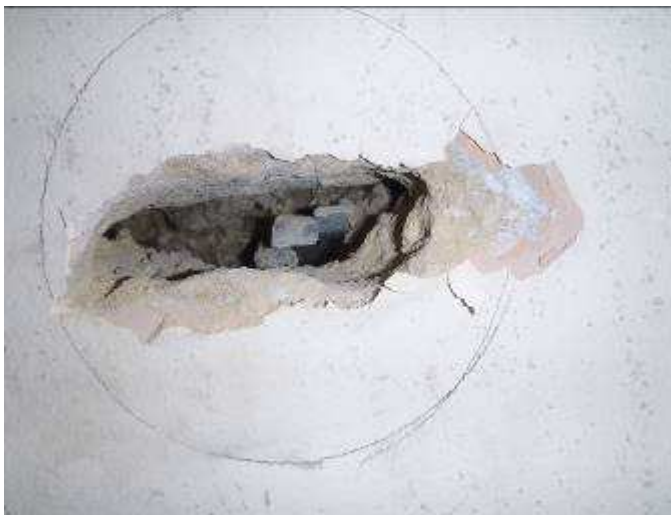
Plate R9: View of tie fishtail end embedded within internal blockwork skin at Breakout D6 to No. 20 Hatfield Close.

The galvanised wall ties were observed to be in good condition where inspected during this investigation.

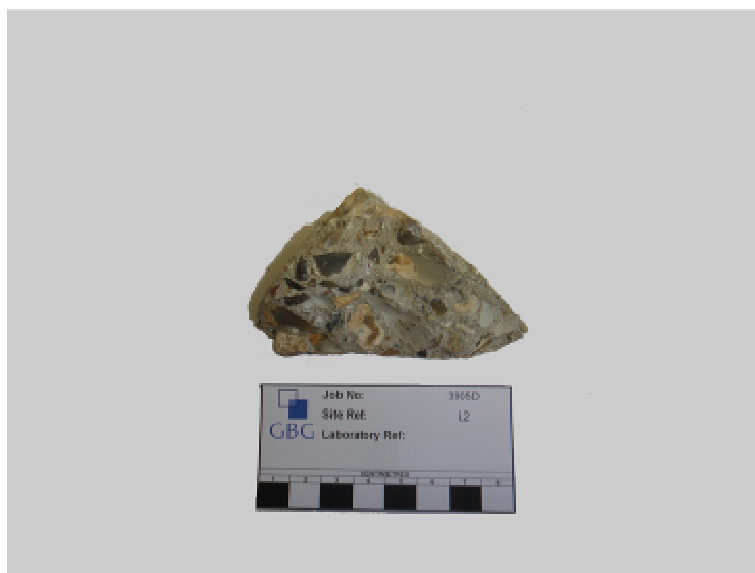
The cement pastes were apparently of good quality and compaction, with excess surface voidage generally judged at 0.5%. The cement pastes of two of the samples (L3C from a column and L2D from a

Plate R11: View of concrete lump sample L2D from a 1st Floor secondary beam at No. 20 Hatfield Close.

secondary beam) were light grey in colour, whilst the cement pastes of the remaining six samples were off-white to light grey in colour.

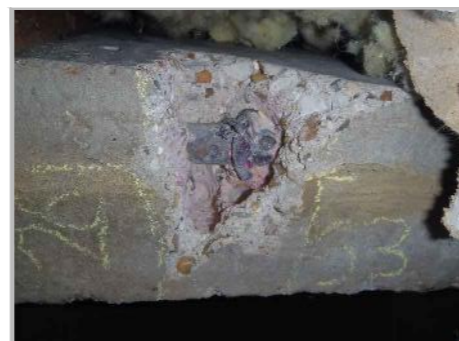
PA5a: VIEW OF B/O A1 TO SOFFIT OF ROOF SECONDARY BEAM

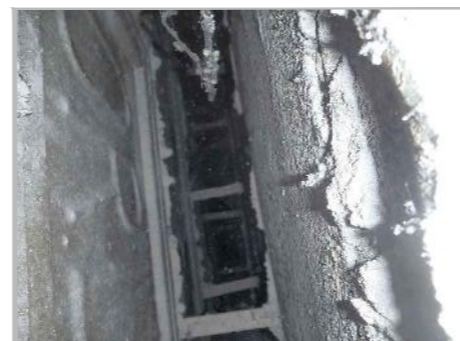
GALVANISED STEEL WALL TIES WITHIN CAVITY ON EASTERN SIDE OF SECONDARY BEAM. TIES SPACED TYPICALLY AT 400mm c/c VERTICALLY AND 250-350mm c/c HORIZONTALLY. TIES OBSERVED TO BE IN GOOD CONDITION.

PA5b: VIEW LOOKING DOWN CAVITY ON EASTERN SIDE OF SECONDARY BEAM

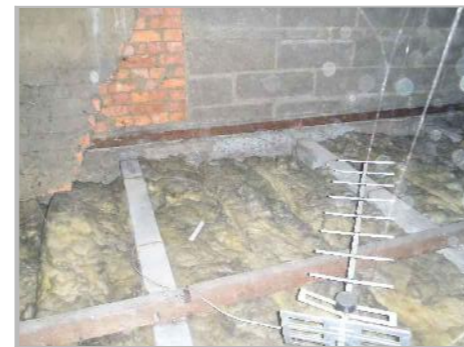
PA2a: VIEW OF SECONDARY BEAMS SPANNING ONTO NORTHERN PRIMARY BEAM

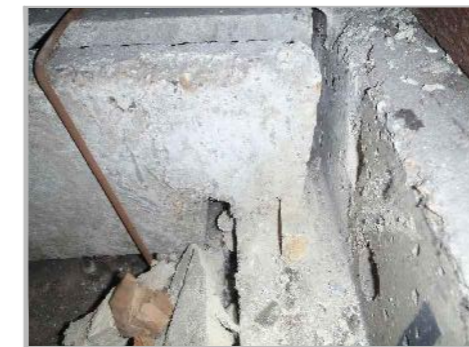
PA3a: VIEW OF SECONDARY BEAM BEARING ONTO PRIMARY BEAM AT SECTION AA-AA POST REMOVAL OF MORTAR HAUNCH

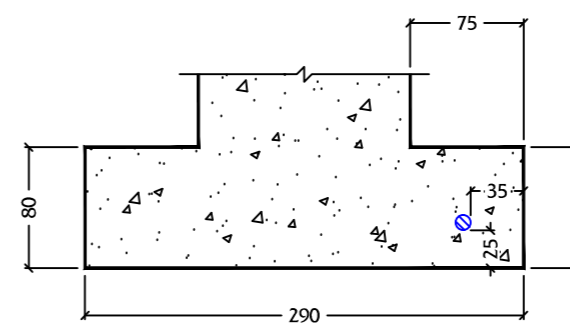
FIG.A6: DETAILS OF B/O A3 TO SOFFIT OF ROOF PRIMARY BEAM SCALE 1:5

10mmØ PLAIN ROUND LONGITUDINAL BAR AT 25mm SOFFIT COVER AND 35mm SIDE COVER. BAR OBSERVED TO BE IN GOOD CONDITION EXHIBITING LIGHT SURFACE CORROSION ONLY.

GALVANISED STEEL WALL TIES PRESENT WITHIN CAVITY IN VICINITY OF B/O A3. TIES SPACED TYPICALLY AT 400mm c/c VERTICALLY AND 250-350mm c/c HORIZONTALLY. TIES OBSERVED TO BE IN GOOD CONDITION.

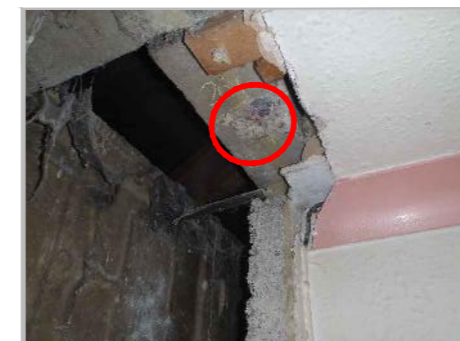
PA6a: GENERAL VIEW OF B/O A3 TO SOFFIT OF PRIMARY BEAM

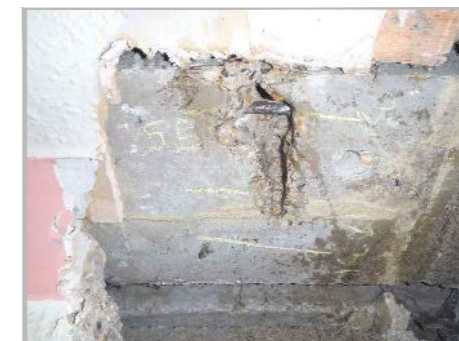
PA6b: VIEW LOOKING UP AT B/O A3 TO SOFFIT OF PRIMARY ROOF BEAM

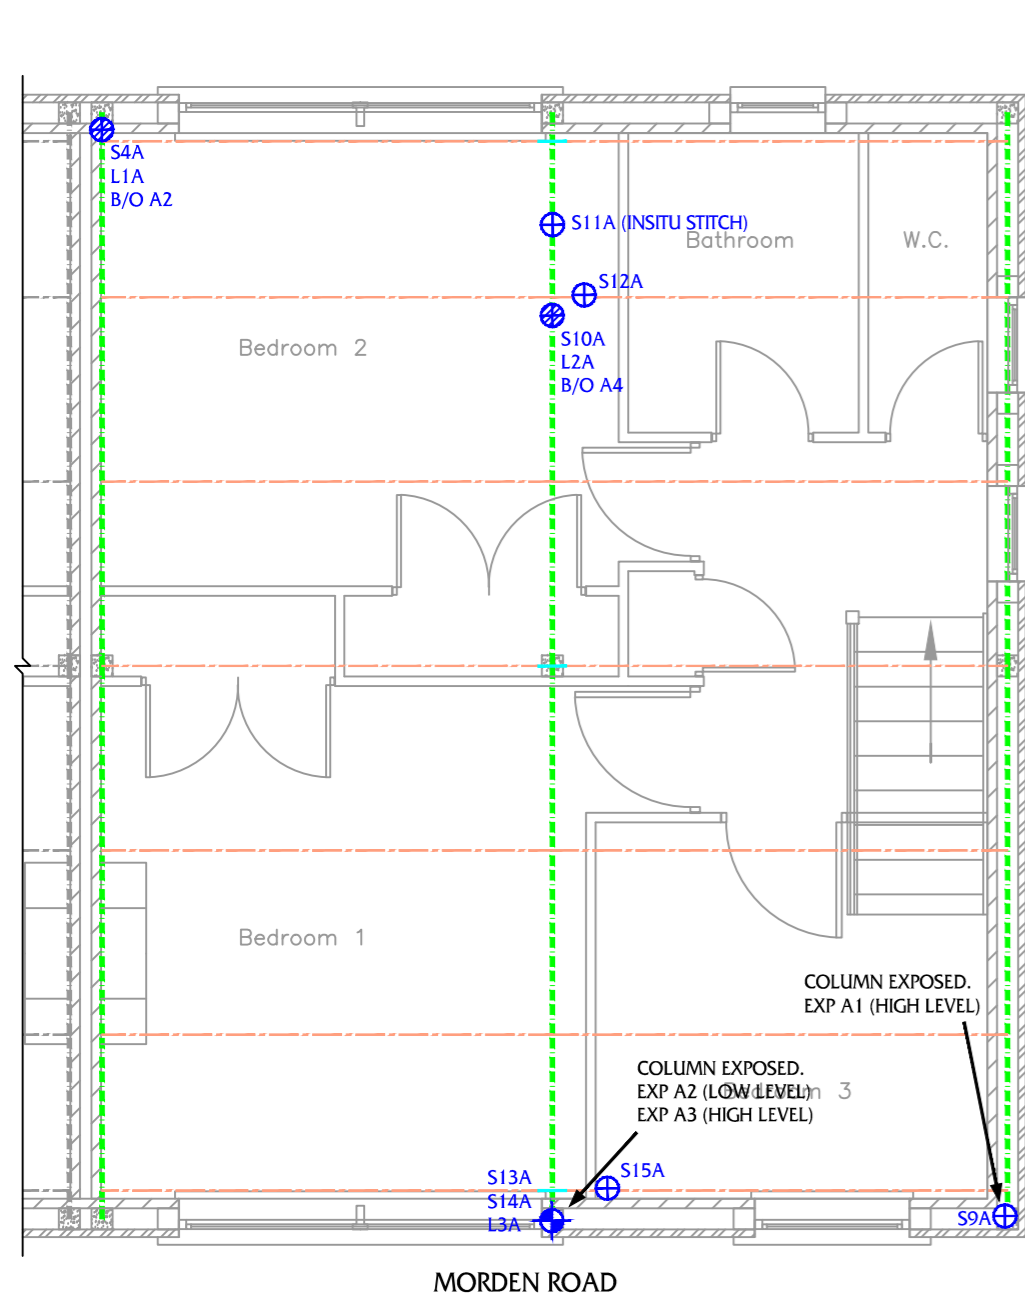
FIG.A7: 1ST FLOOR PLAN SHOWING LOCATIONS OF SAMPLES AND BREAKOUTS NOT TO SCALE

NO SIGNIFICANT DEFECTS NOTED TO BEAMS AND COLUMNS WHERE INSPECTED.

CRACKING AND DETERIORATION NOTED TO EXTERNAL CORNER CLADDING PANELS.

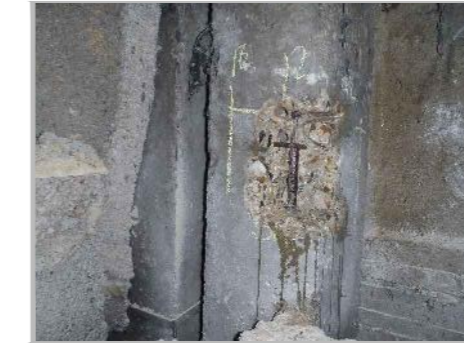
10mmØ PLAIN ROUND VERTICAL BAR AT 15mm COVER
5mmØ PLAN ROUND HORIZONTAL LINK AT 2-3mm MINIMUM COVER

BOTH BARS IN GOOD CONDITION EXHIBITING LIGHT SURFACE CORROSION ONLY.
CARBONATION DEPTH: 15mm

PA8a: VIEW OF B/O A2 TO 1ST FLOOR COLUMN WITHIN CAVITY

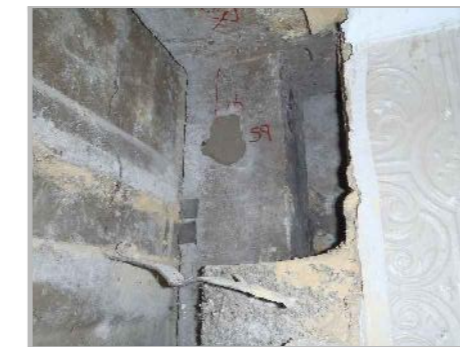
GALVANISED WALL TIES PRESENT WITHIN CAVITY IN VICINITY OF EXPOSURE EXP A1. TIES SPACED TYPICALLY AT 400mm c/c VERTICALLY AND 250-350mm c/c HORIZONTALLY. TIES OBSERVED TO BE IN GOOD CONDITION.

PA9b: CLOSER VIEW OF COLUMN HEAD AND SOFFIT OF ROOF PRIMARY BEAM AT EXPOSURE EXP A1

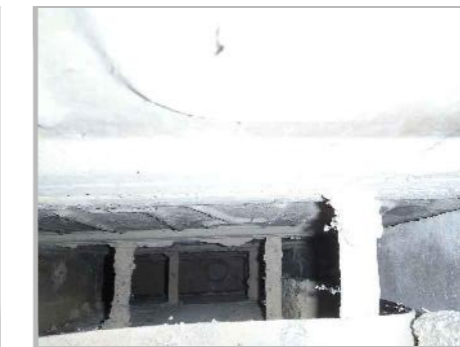
PA9c: VIEW LOOKING DOWN CAVITY ADJACENT TO 1ST FLOOR COLUMN AT EXPOSURE EXP A1

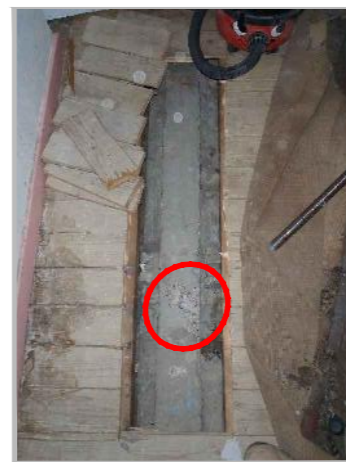
PA10a: GENERAL VIEW OF 1ST FLOOR EXPOSURE AT B/O A4

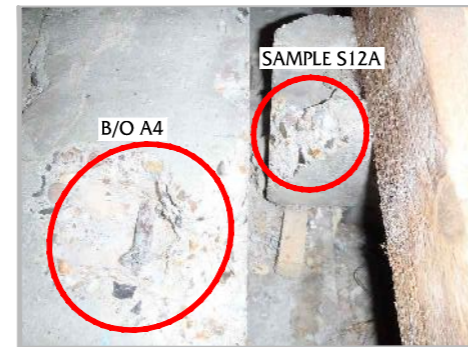
PA10b: CLOSER VIEW OF B/O A4. NOTE ALSO SECONDARY BEAM BEARING ONTO PRIMARY BEAM

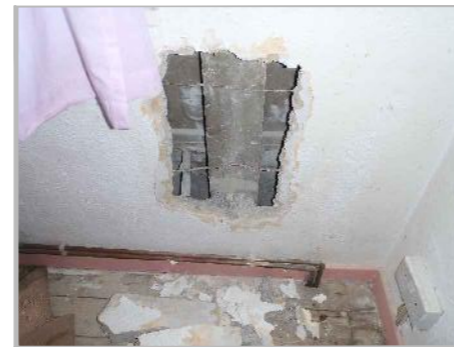
PA11a: GENERAL VIEW OF EXPOSURE EXP A2

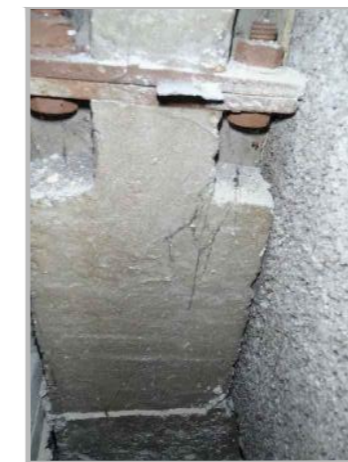
PA11b: VIEW OF COLUMN CONNECTION AT 1ST FLOOR LEVEL

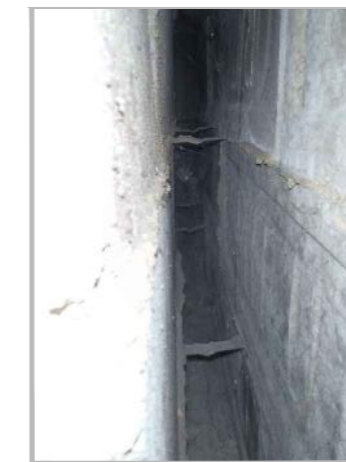
PA11c: VIEW LOOKING SOUTH FROM EXPOSURE EXP A2 WITHIN CAVITY

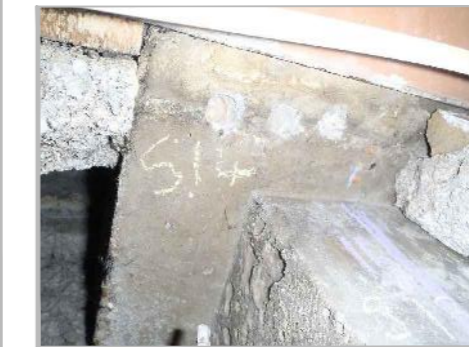
PA11d: VIEW LOOKING UP AT PRIMARY ROOF BEAM BEARING ONTO COLUMN HEAD AT EXPOSURE EXP A3

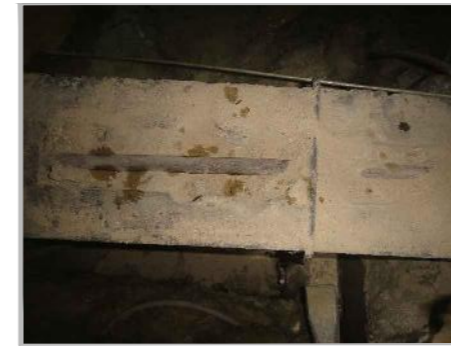
PB2b: VIEW LOOKING DOWN AT BREAKOUT B/O B1

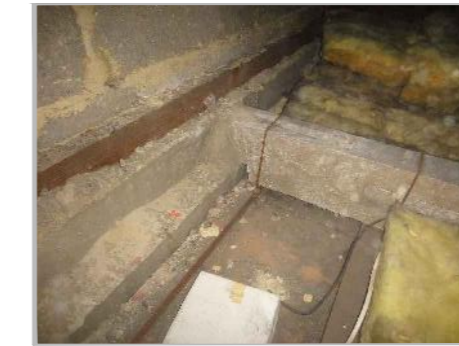
PB3b: SECONDARY BEAM BEARING ONTO EASTERN PRIMARY BEAM. NOTE CHANGE IN BEAM SECTION. PREFORMED SLOT WITH NO CONTINUITY BAR AND MORTAR HAUNCH AT BEAM BEARING.

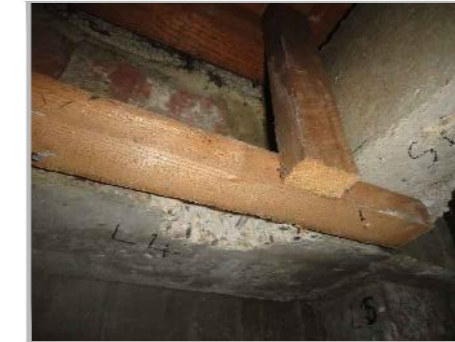
PB6a: GENERAL VIEW OF B/O B7 TO 1ST FLOOR PRIMARY BEAM

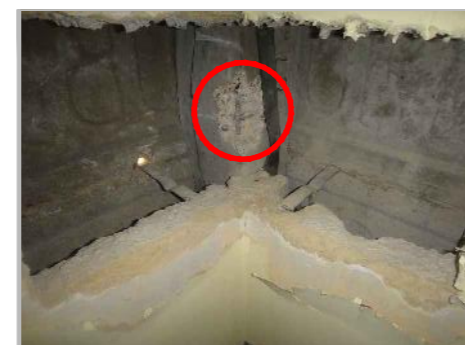
PB12a: VIEW OF B/O B6 TO GROUND FLOOR COLUMN AT HIGH LEVEL. NOTE ALSO EXPOSED WALL TIES

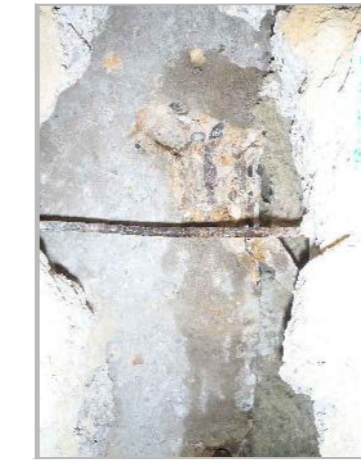
DETAILS OF B/O C41
1. 10mmØ PLAIN ROUND VERTICAL BAR AT 14mm COVER.
BAR IN GOOD CONDITION EXHIBITING LIGHT SURFACE CORROSION ONLY. CARBONATION DEPTH: 10mm

PC6a: VIEW OF B/O C4 TO 1ST FLOOR COLUMN

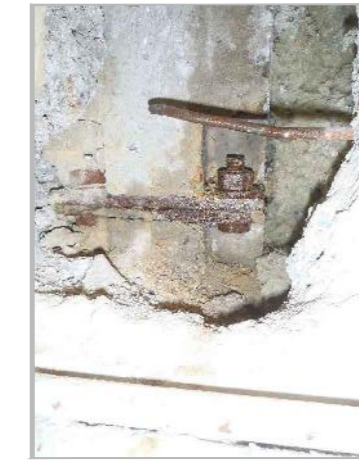
2 No. 6mm THICK PLATES BOLTED TOGETHER. 20mm BOLT HEADS (10.2mmØ THREAD)

PC6b: VIEW OF 1ST FLOOR TO GROUND FLOOR COLUMN CONNECTION DETAIL

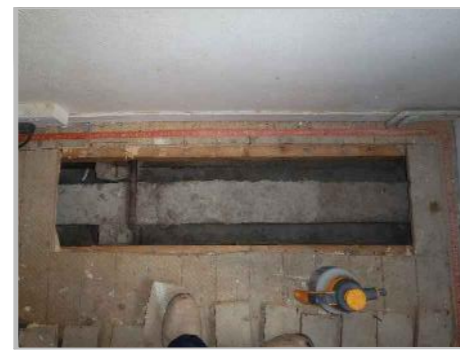
PC7a: GENERAL VIEW OF 1ST FLOOR EXPOSURE TO B/O C5

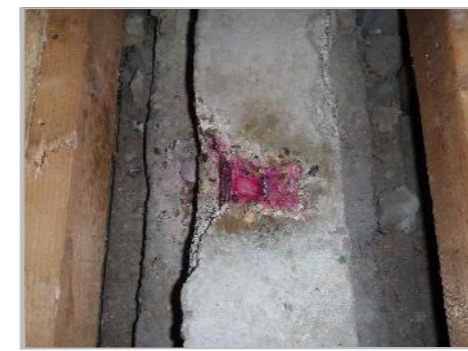
PC7b: VIEW OF B/O C5 TO TOP OF PRIMARY BEAM

BOTH BARS IN GOOD CONDITION EXHIBITING LIGHT SURFACE CORROSION ONLY. CARBONATION DEPTH: 20mm

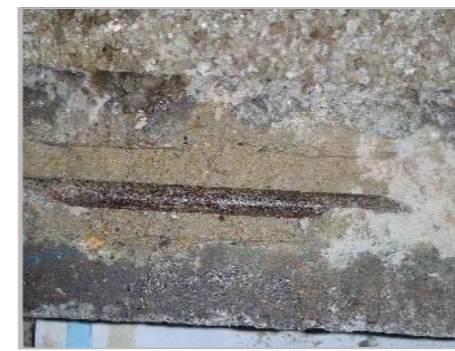
PD2a: VIEW OF B/O D4 TO TOP OF ROOF SECONDARY BEAM

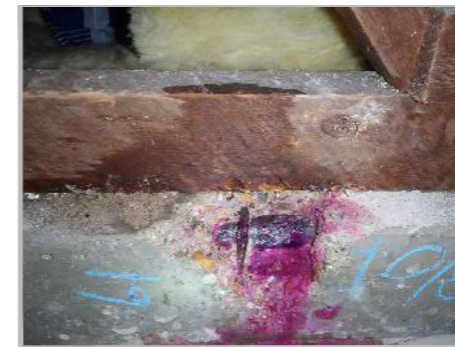
PD3a: VIEW OF B/O D5 TO ROOF PRIMARY BEAM

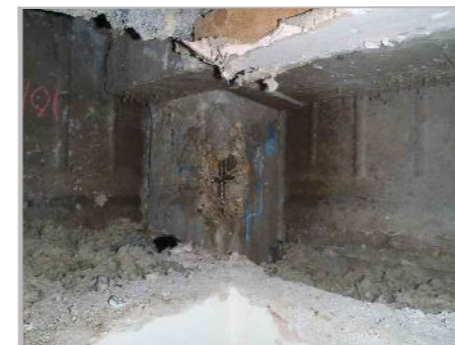
ALL BARS OBSERVED TO BE IN GOOD CONDITION EXHIBITING LIGHT SURFACE CORROSION ONLY. CARBONATION DEPTH: 22mm AT B/O D1 AND 15mm AT B/O D2.

PD5a: VIEW OF B/O D1 TO GROUND FLOOR COLUMN. NOTE INSULATION WITHIN CAVITIES.

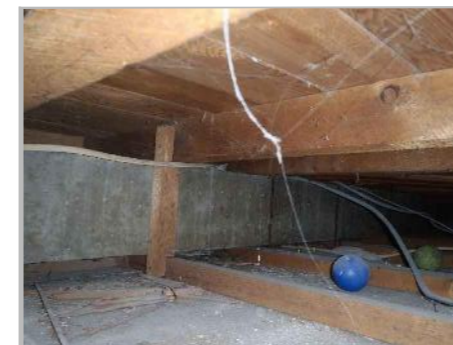
PD5b: VIEW LOOKING SOUTH FROM B/O D1 WITHIN 1ST FLOOR CEILING VOID

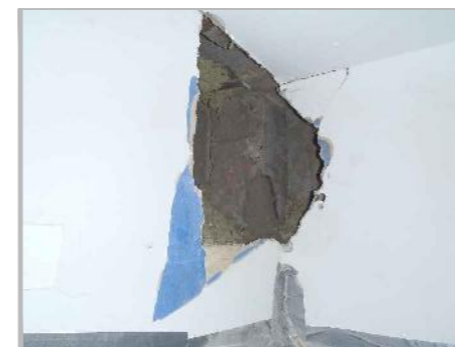
BAR OBSERVED TO BE IN GOOD CONDITION EXHIBITING LIGHT SURFACE CORROSION ONLY. CARBONATION: 25mm.

PD6a: VIEW OF 1ST FLOOR COLUMN. NOTE PHOTO TAKEN POST REINSTATEMENT OF B/O D1

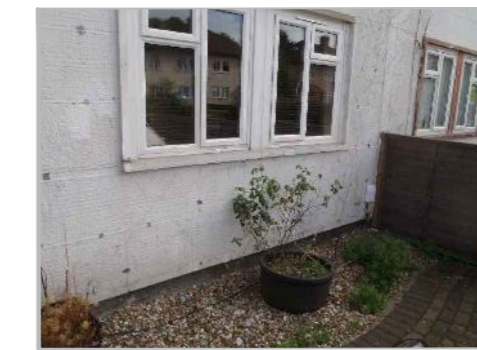
PD9a: PART VIEW OF SOUTHERN SIDE OF WALL TIE SURVEY AREA D1

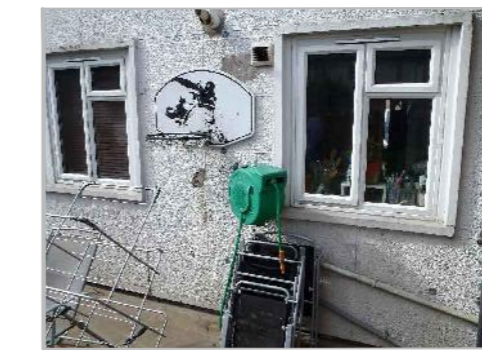
PD13a: PART VIEW OF WALL TIE SURVEY AREA D3

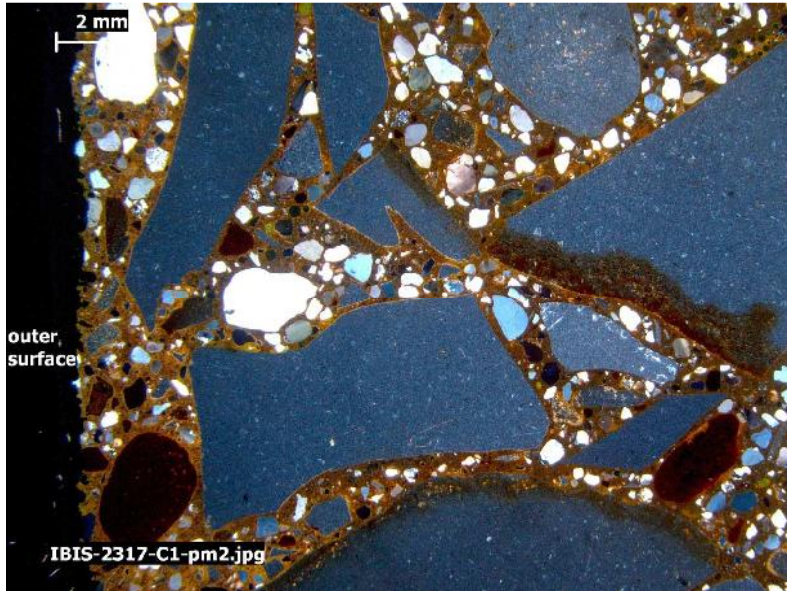
Photomicrograph 3

The outer surface is indicated to the left in this view and the matrix is completely carbonated, the matrix having lightened in colour from the change in crystallinity.

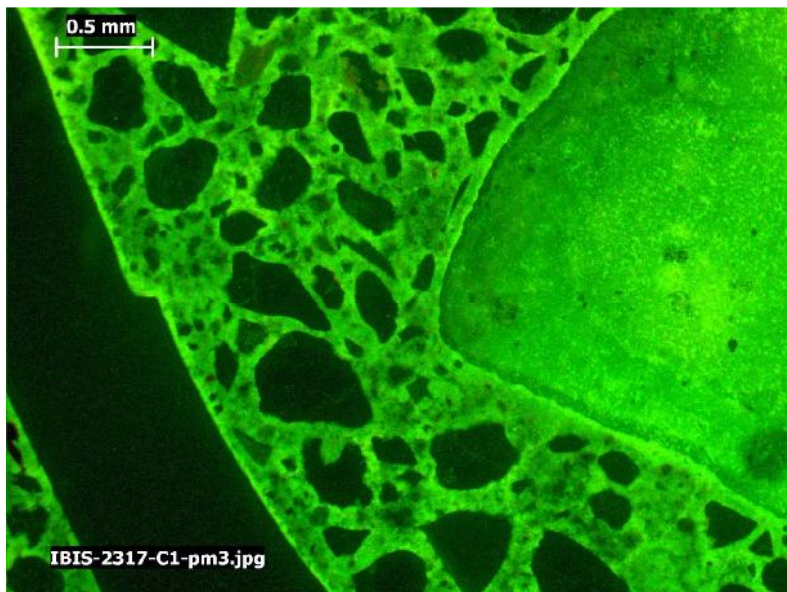
Photomicrograph 4

Typical view of the concrete matrix and the apparent microporosity that was exhibited due to the carbonation effects.

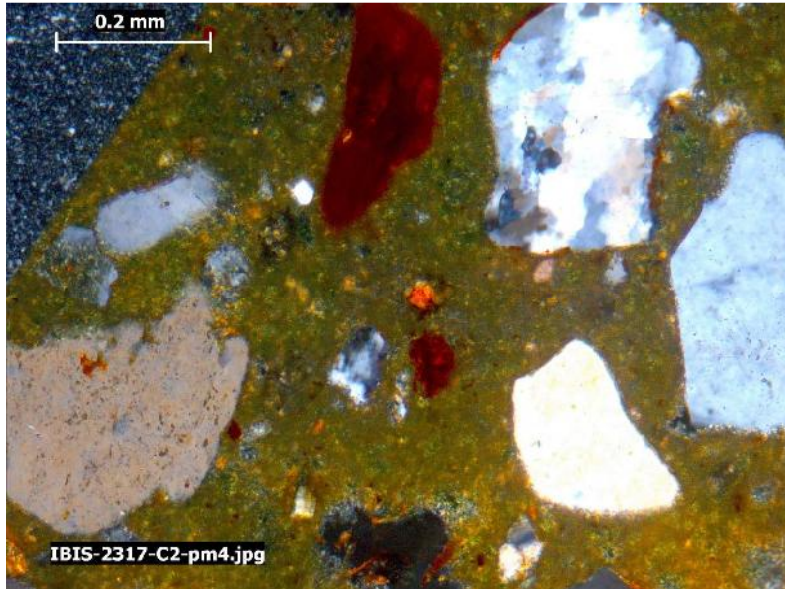
Photomicrograph 5

Typical view of the carbonation effects at the deepest part of the sample, which were not complete but which resulted in a lack of portlandite.

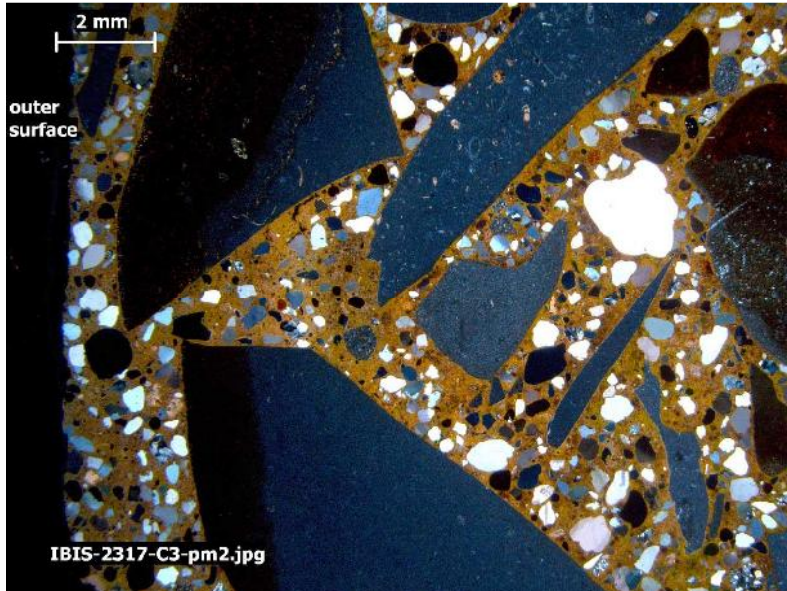
Photomicrograph 3

The outer surface is indicated to the left in this view and the matrix is completely carbonated, the matrix having lightened in colour from the change in crystallinity.

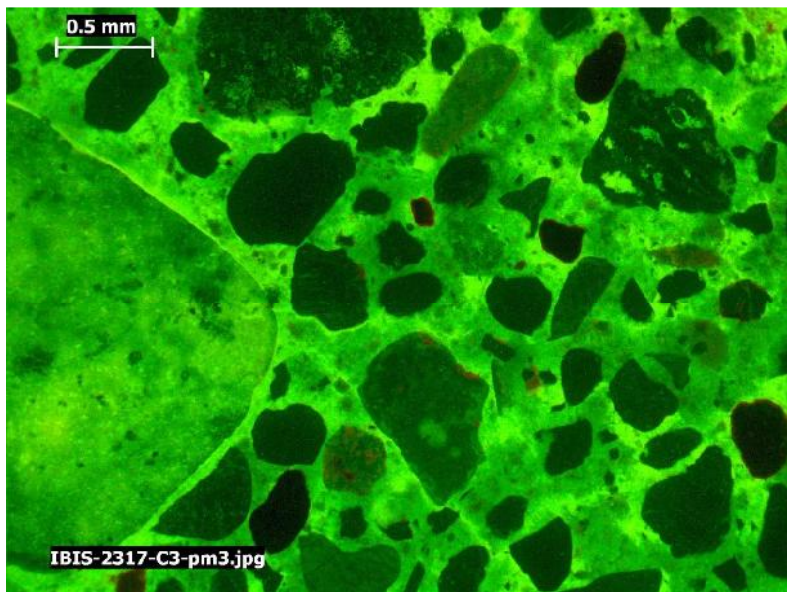
Photomicrograph 4

Typical view of the concrete matrix and the apparent microporosity that was exhibited due to the carbonation effects.

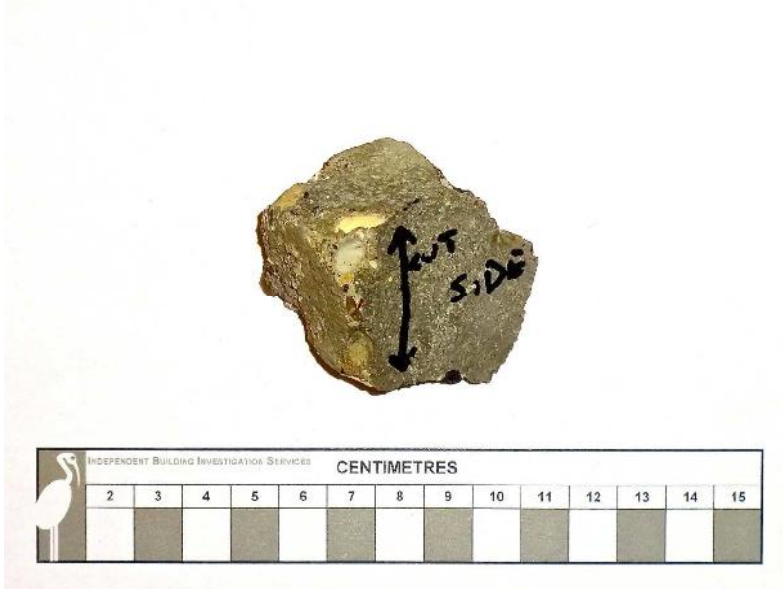
Photograph 1

General view of the as-received concrete sample with the outer surface indicated by "NT Side". The sample appeared to have been taken from the corner of a feature so that three surfaces were represented.

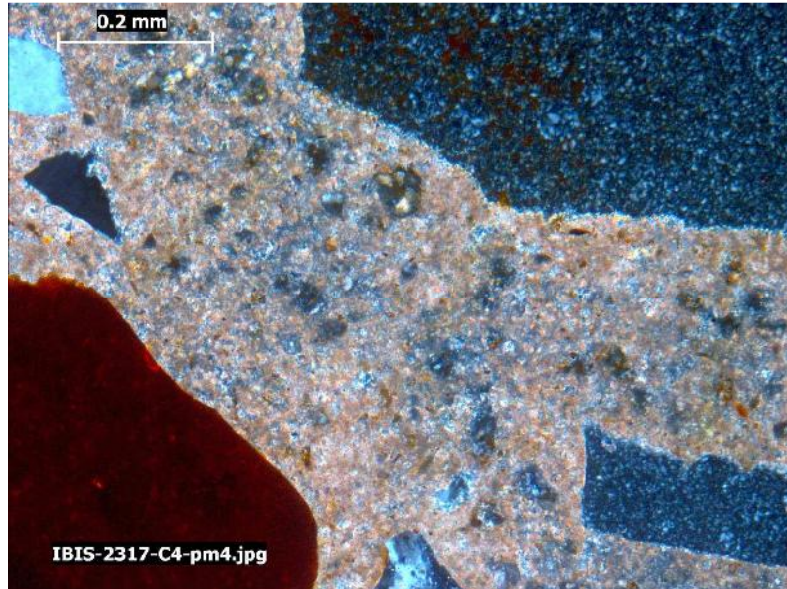
Photomicrograph 5

Typical view of the carbonation effects at the deepest part of the sample, which resulted in a lack of portlandite.

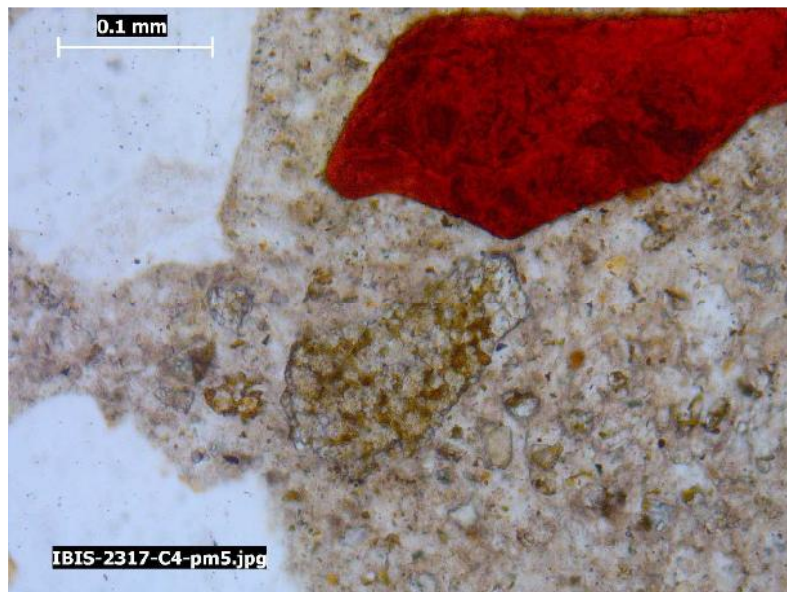
Photomicrograph 6

Some of the typical Ordinary Portland type cement grains that were present throughout the sample, a particularly large grain being present at the centre.
