Structural Assessment Report of Orlit Houses  
Revision A  
Ravensbury Estate Regeneration  
For HTA Design LLP

Scheme No: 11264

6<sup>th</sup> November 2014

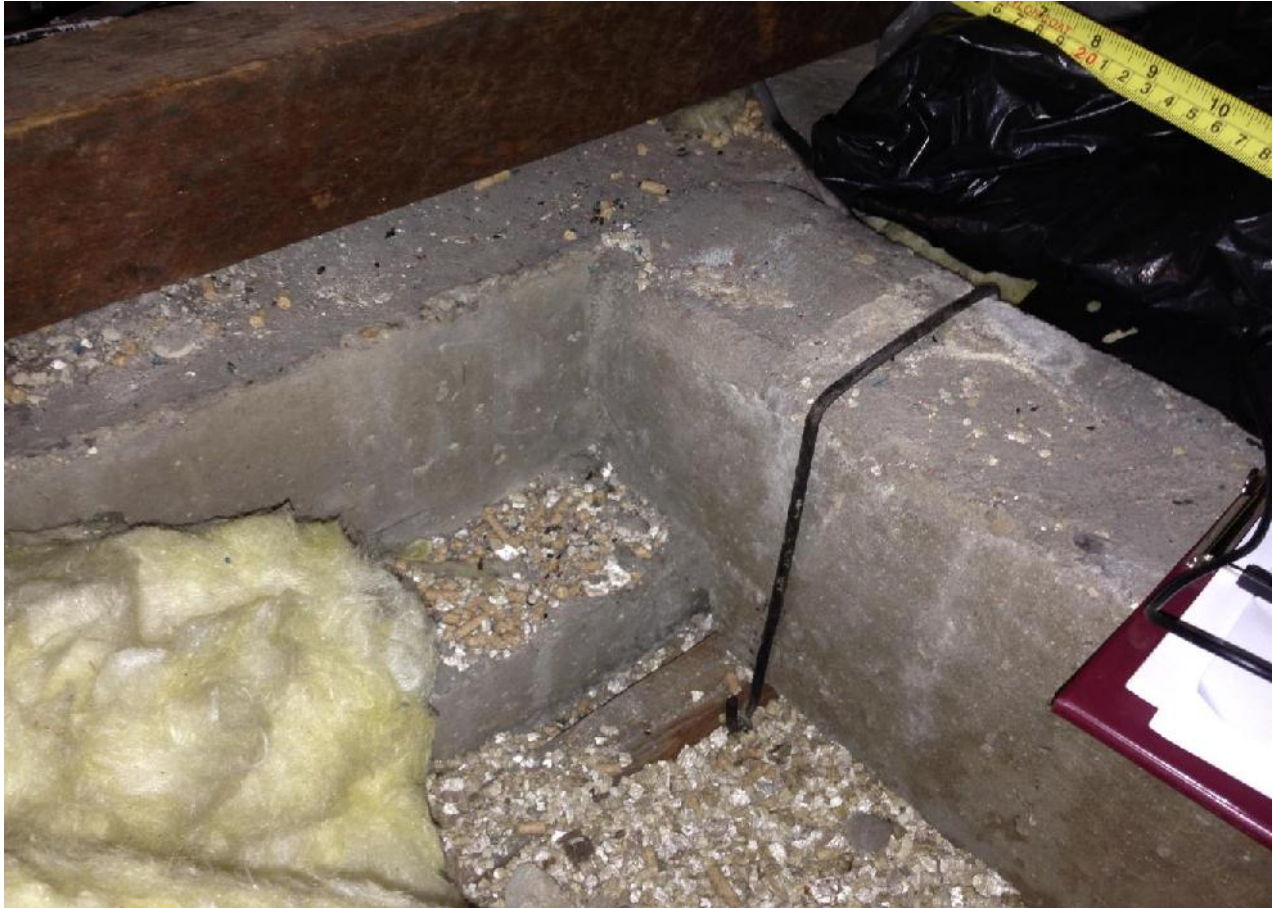
**Photograph C1 – Primary beam and secondary beam connection and ceiling hanger**

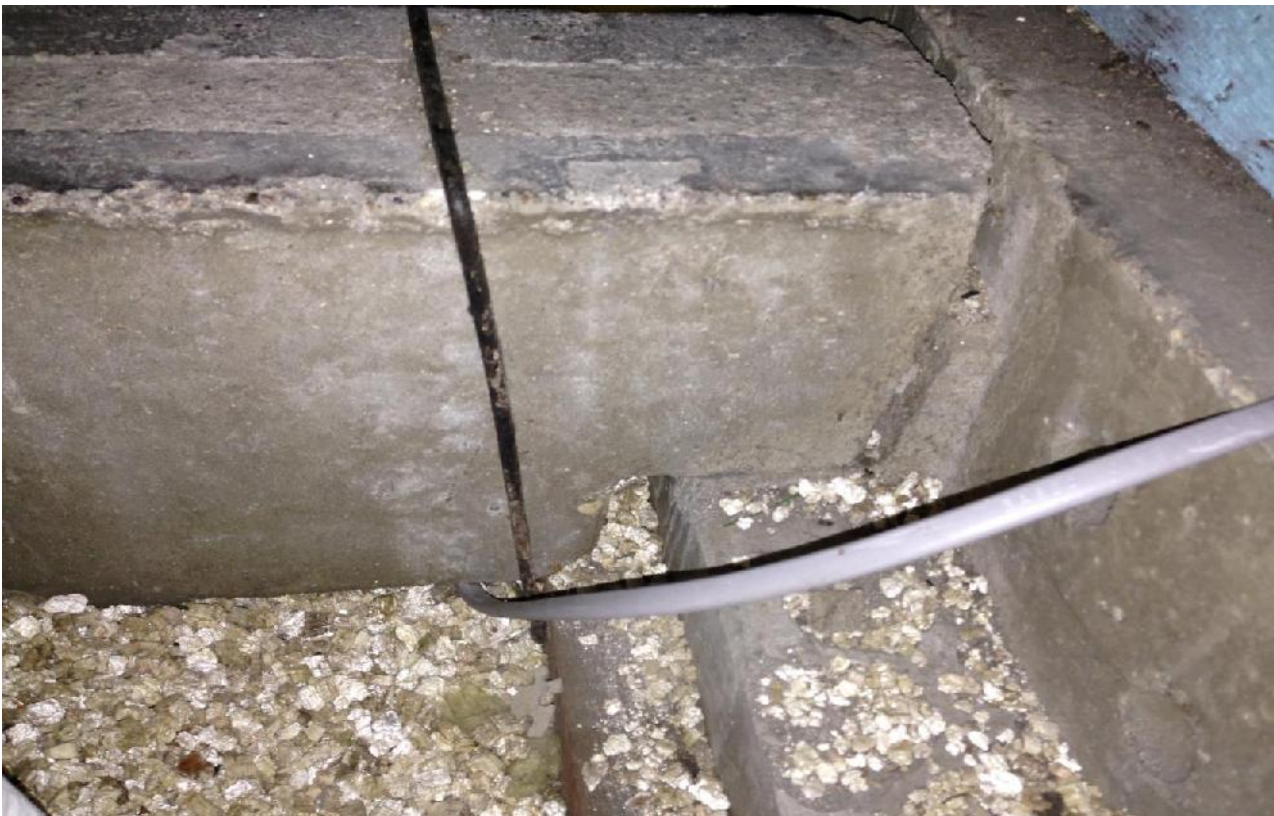
**Photograph C2 – Discontinuity of mortar/concrete between primary beam and secondary beam connection**

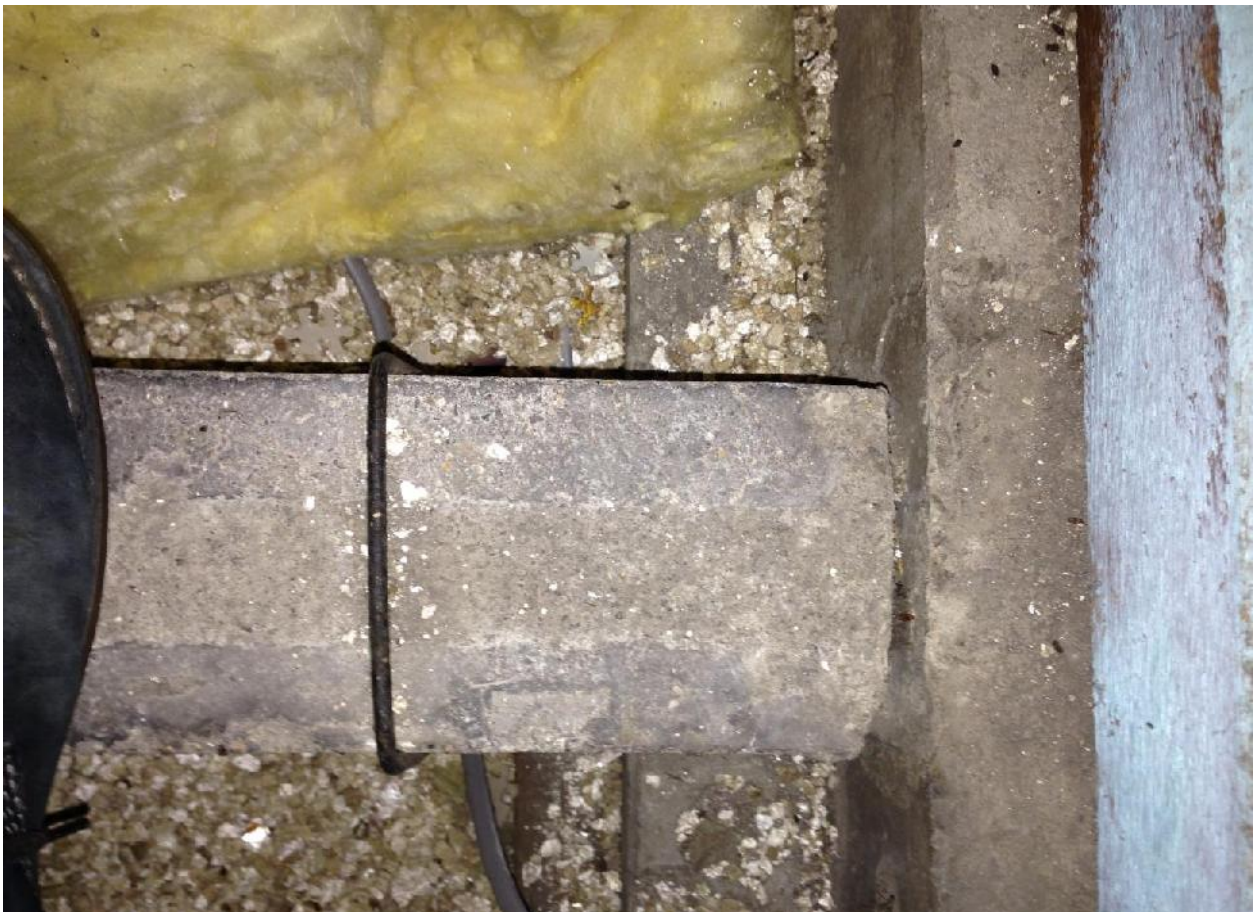
**Photograph C4 – Discontinuity of mortar/concrete between primary beam and secondary beam connection**

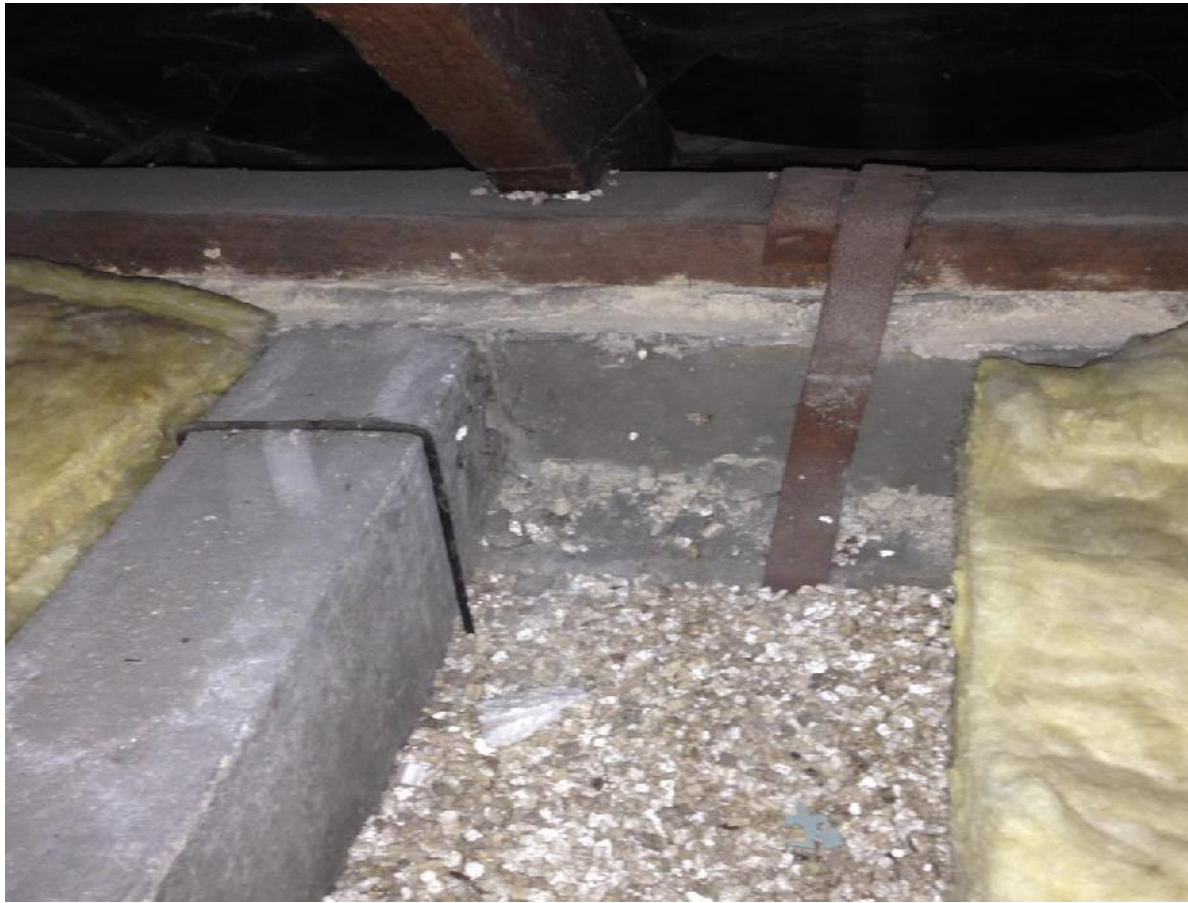
**Photograph C5 – Roof sole plate strapping to primary beam**

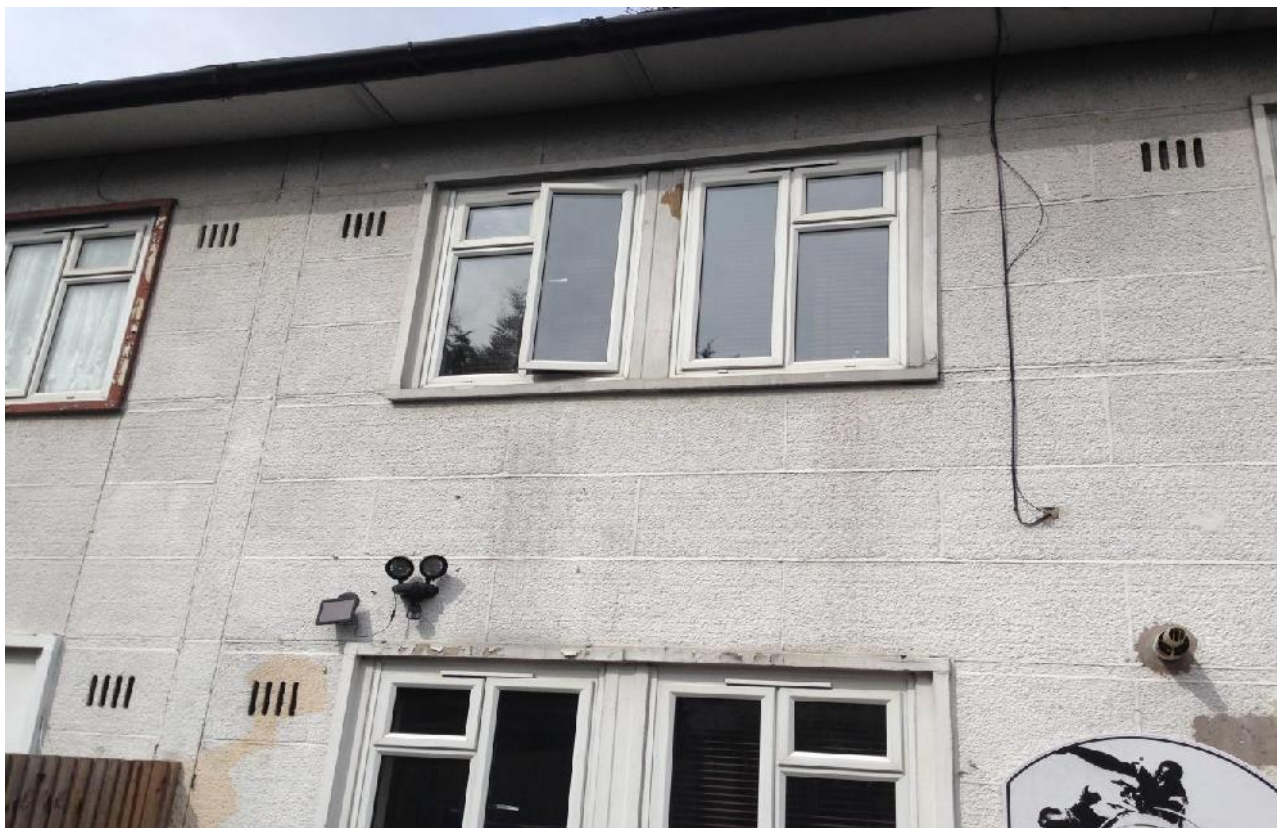
**Photograph C8 - 'Grilled' cladding panels in elevation**

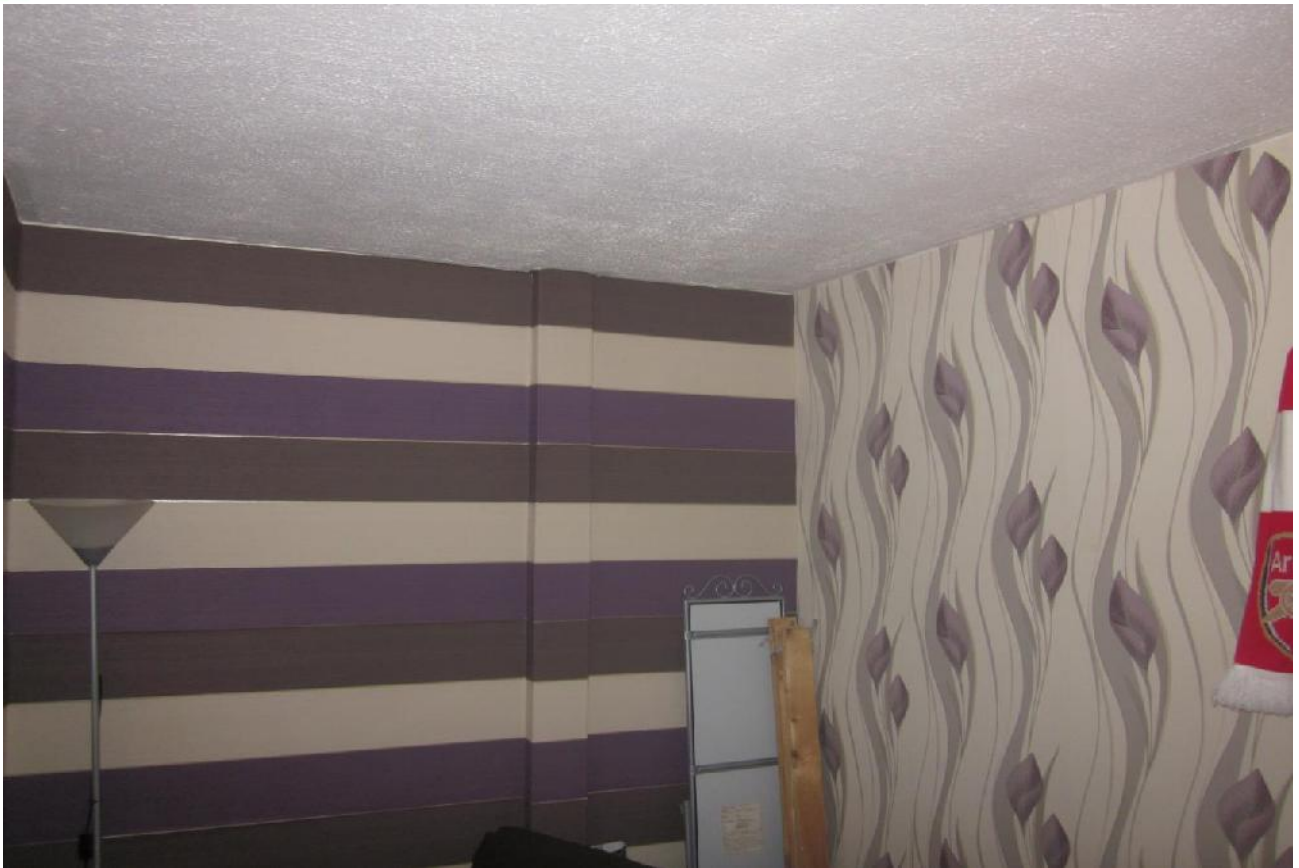
**Photograph C10 – Evidence of internal column projection on party wall line into room**

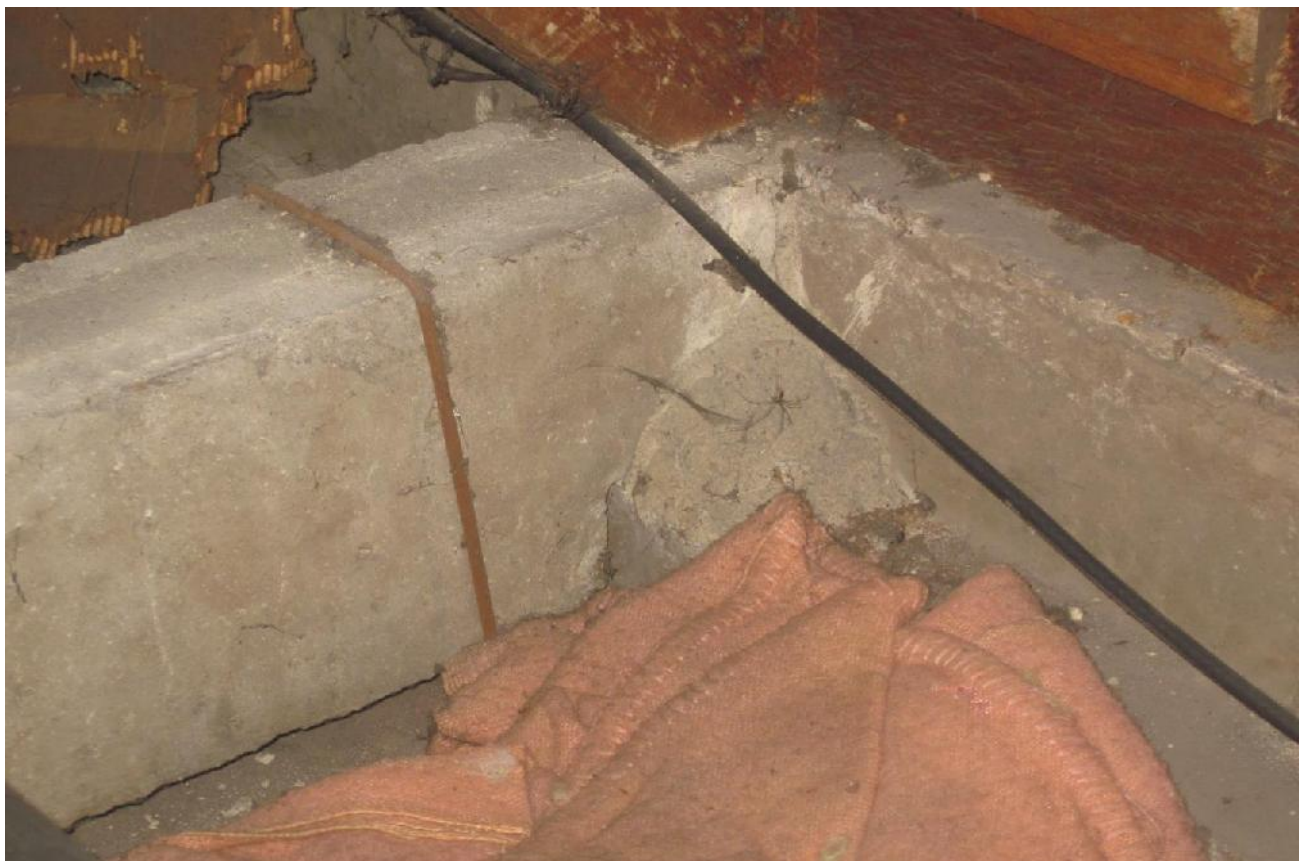
**Photograph C11 – Concrete stitch**

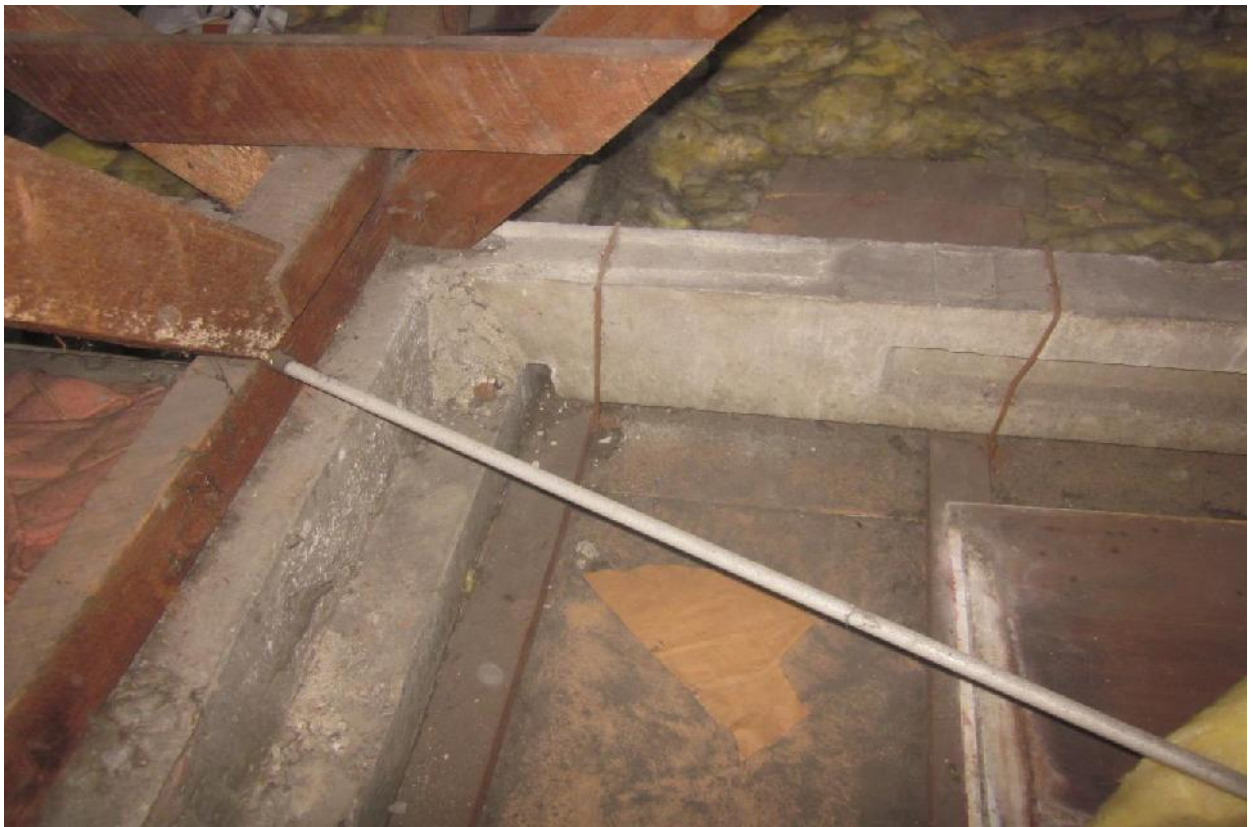
**Photograph C13 – Primary beam and secondary beam stitch connection detail and ceiling hanger**

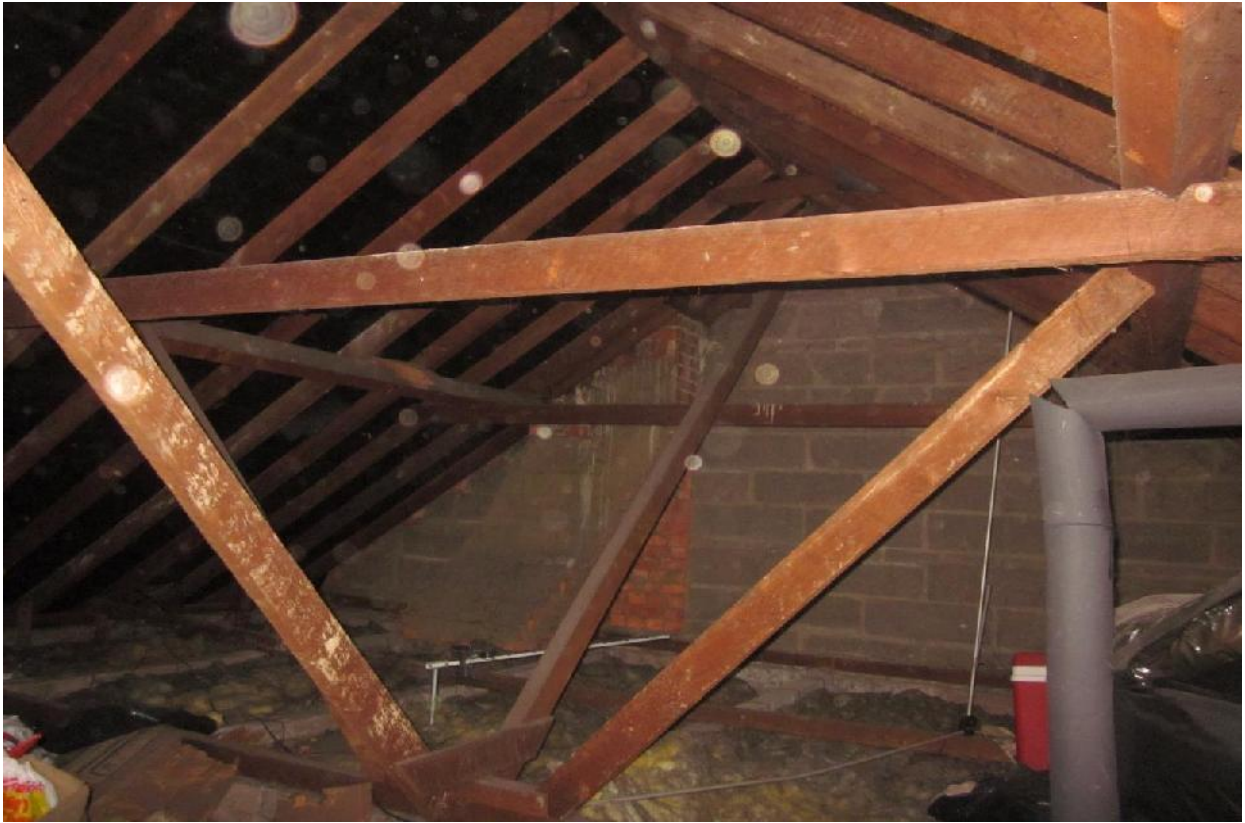
**Photograph C14 – 241 Morden Road roof structure**

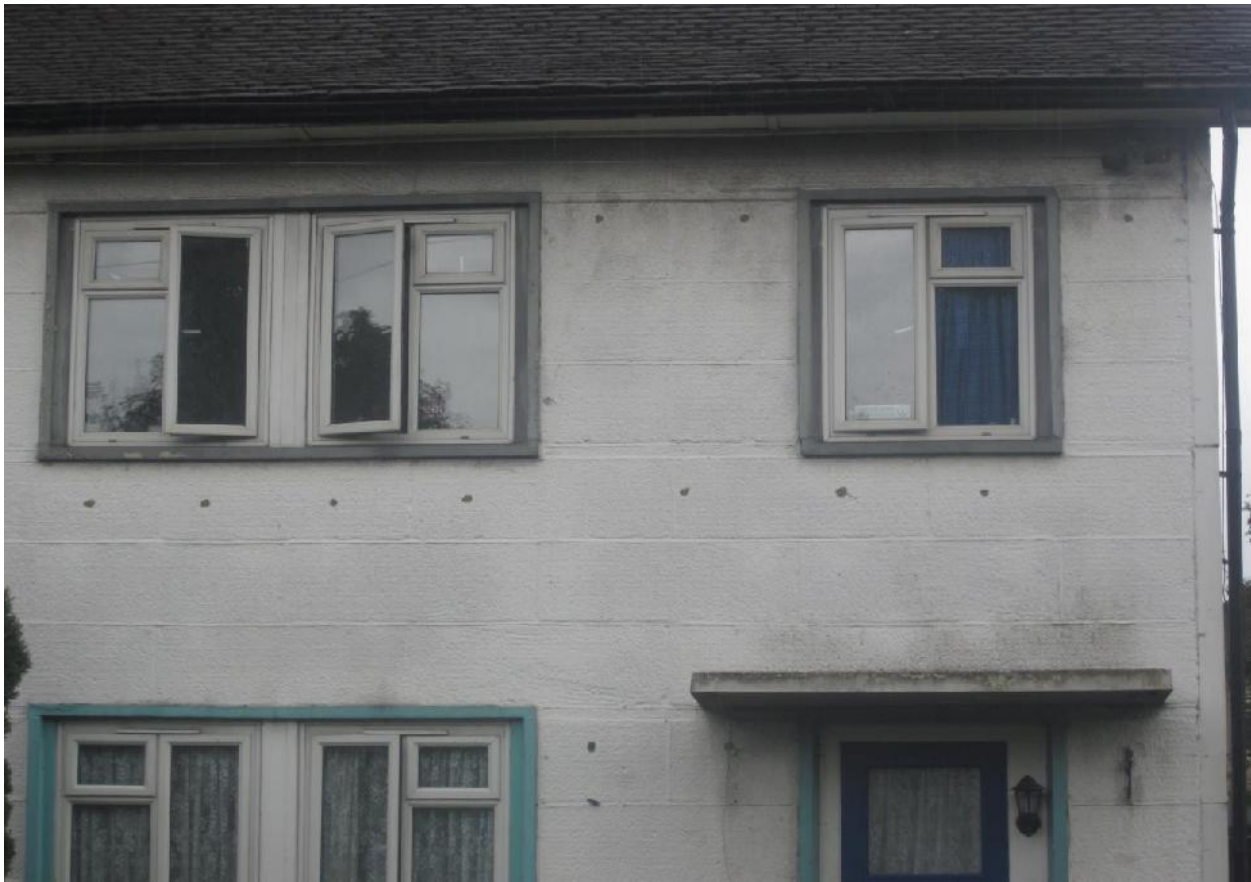
**Photograph C18 – Circular markings on elevation**

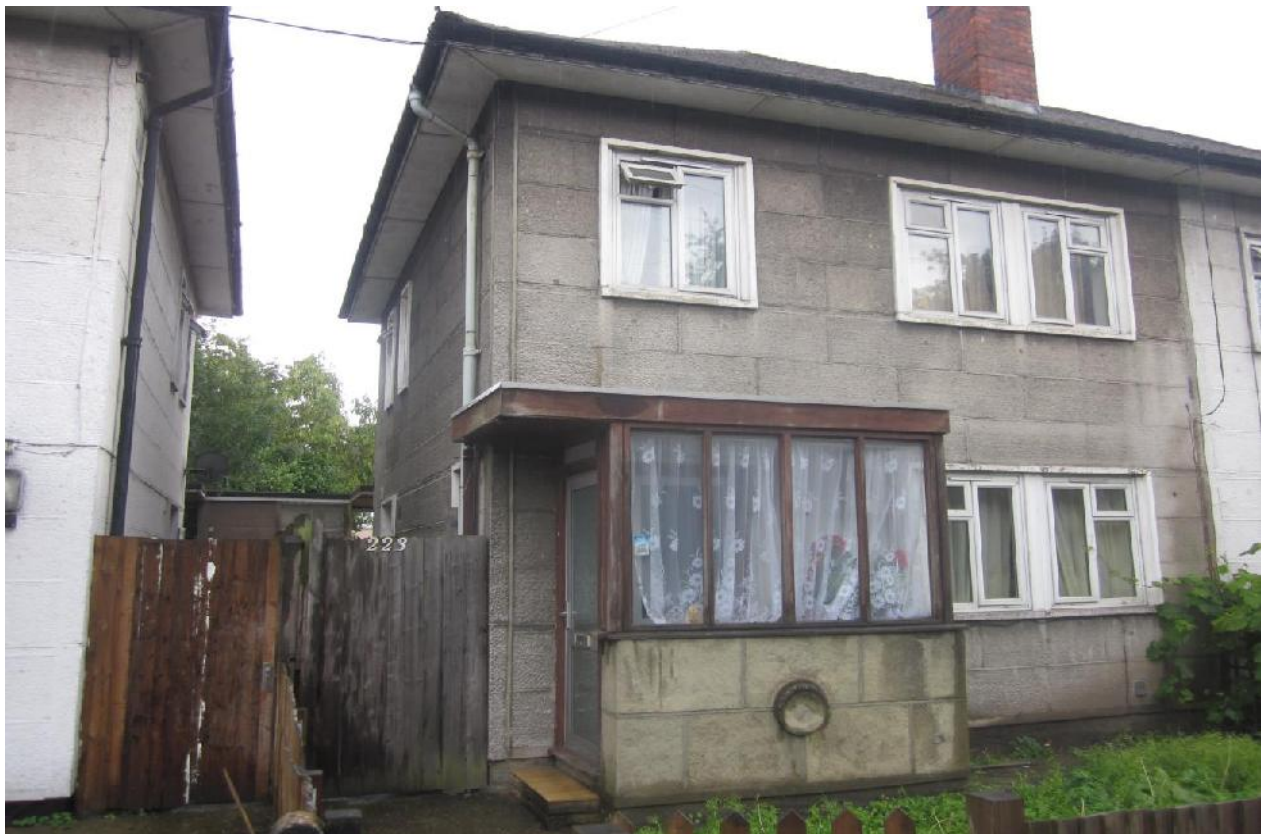
**Photograph C19 – Example of no finishes to cladding and porch extension**

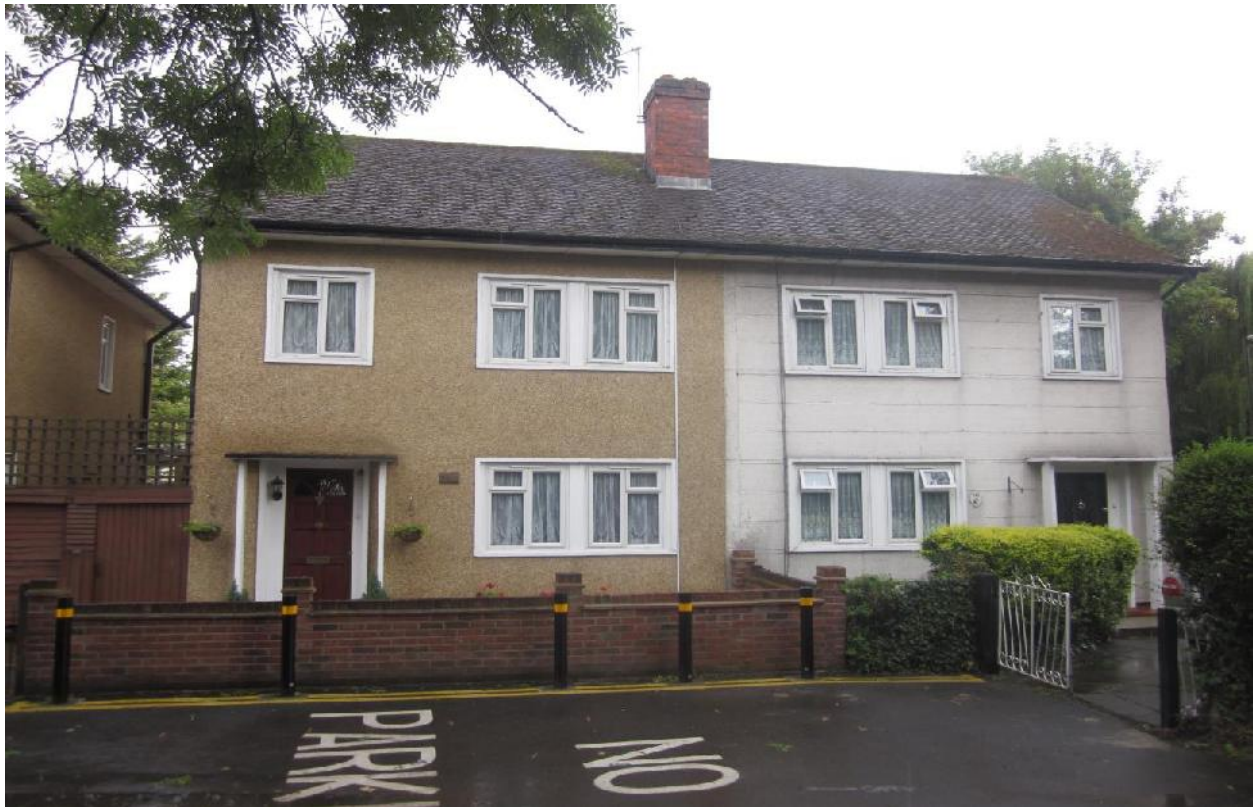
**Photograph C20 – Pebble dashed elevation**

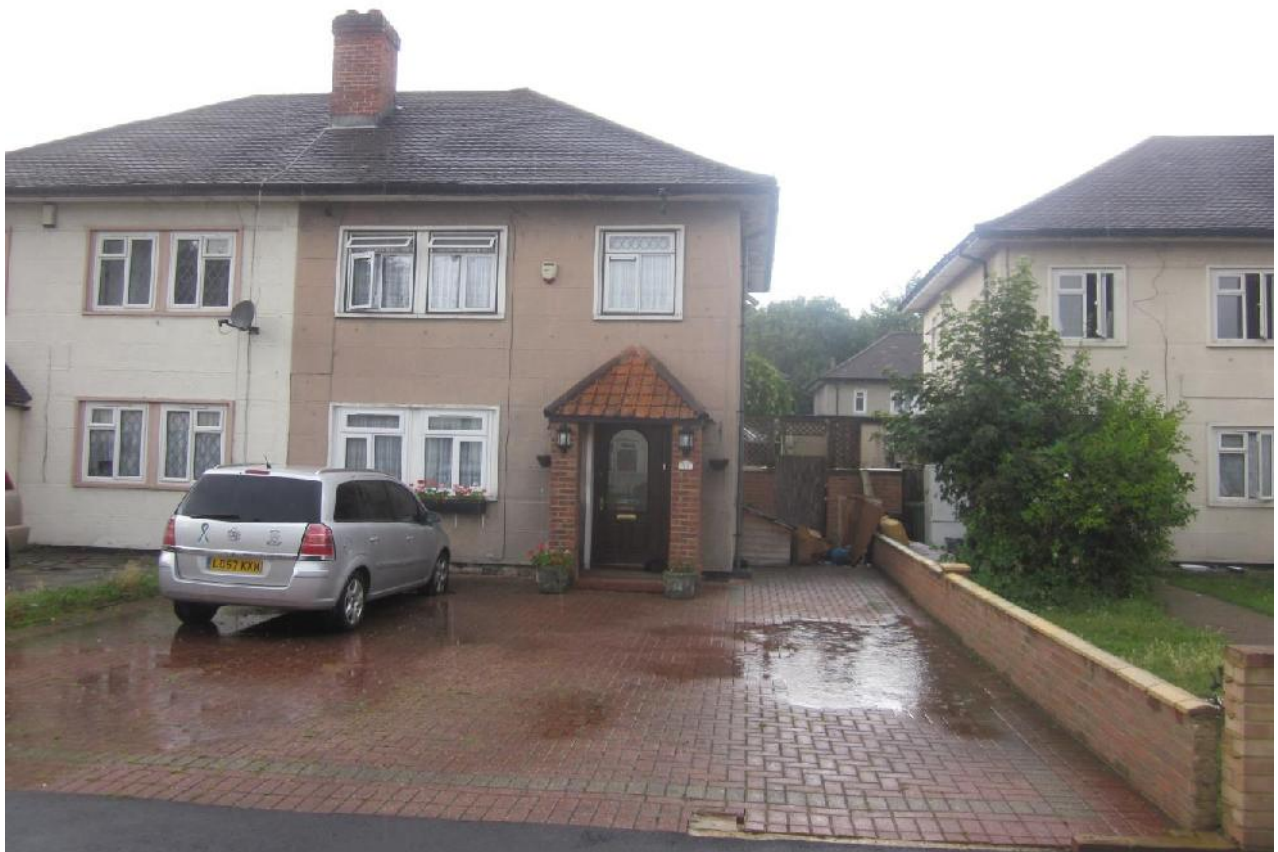
**Photograph C21 – Porch alteration**

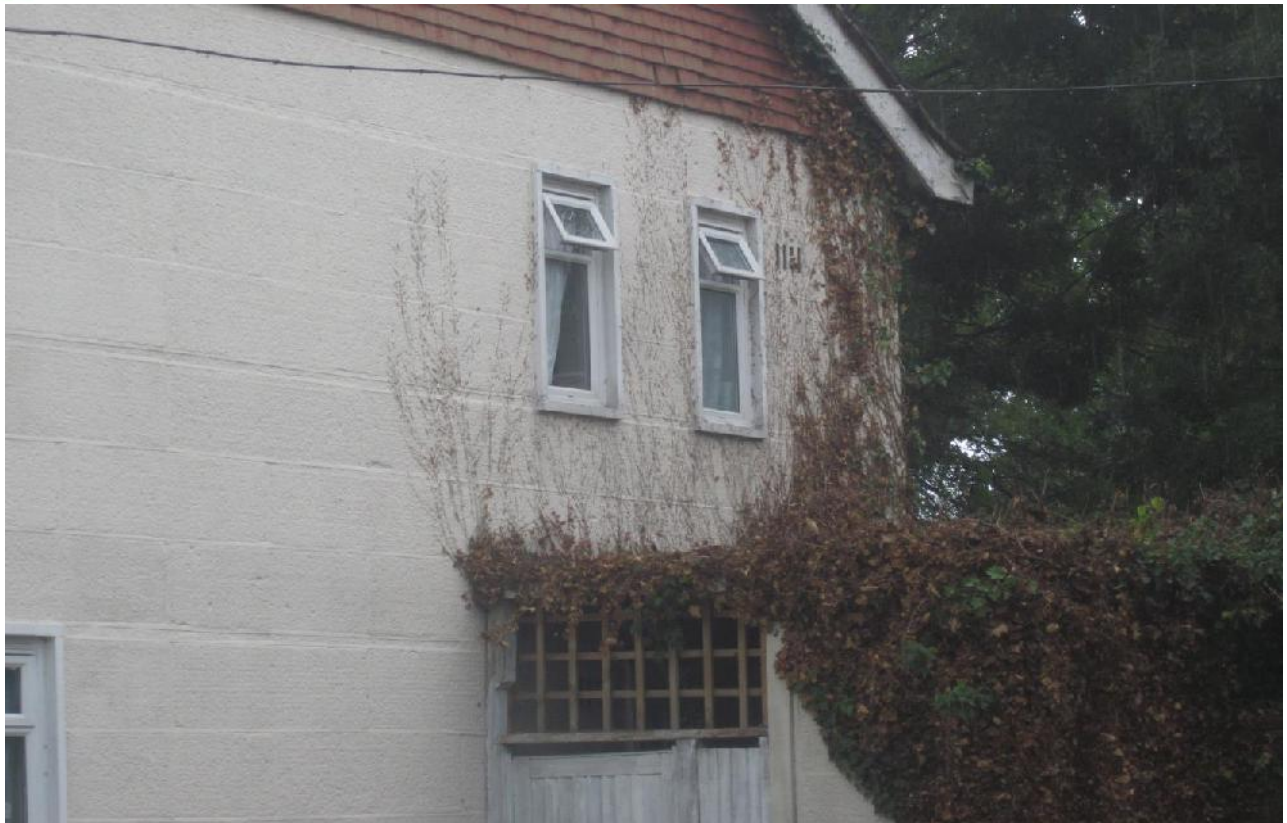
**Photograph C24 – Vegetation on elevation**

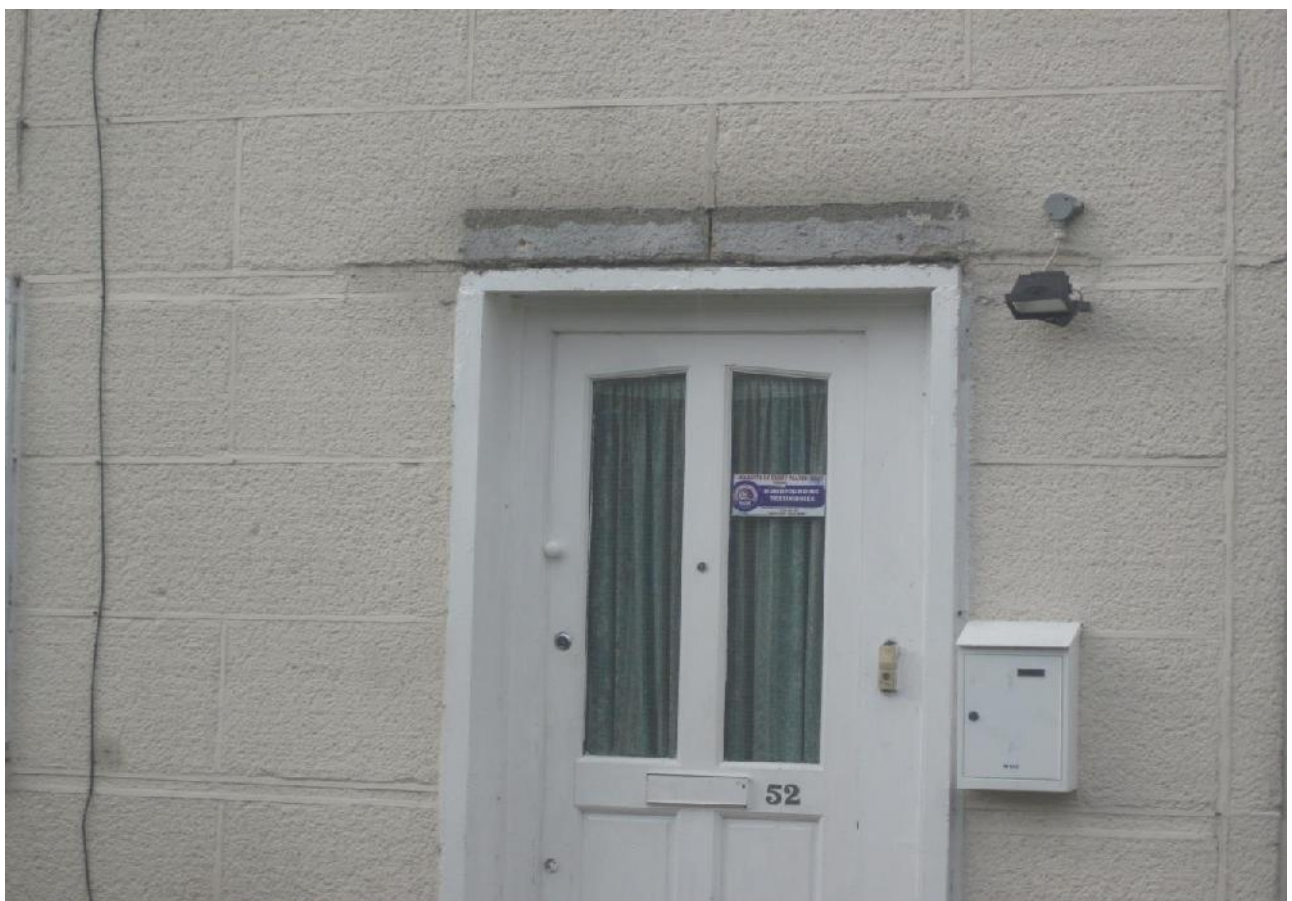
**Photograph C25 – Example of removed canopy**

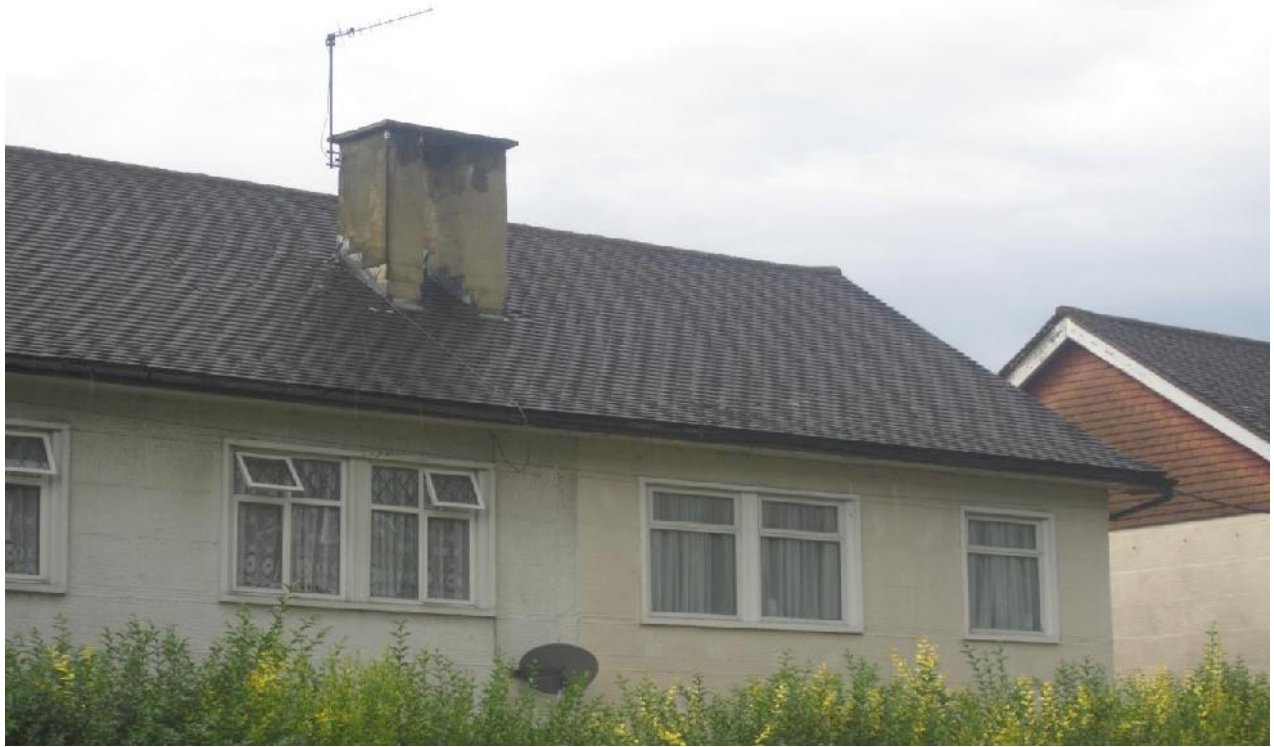
**Photograph C26 - Double stack Chimney**

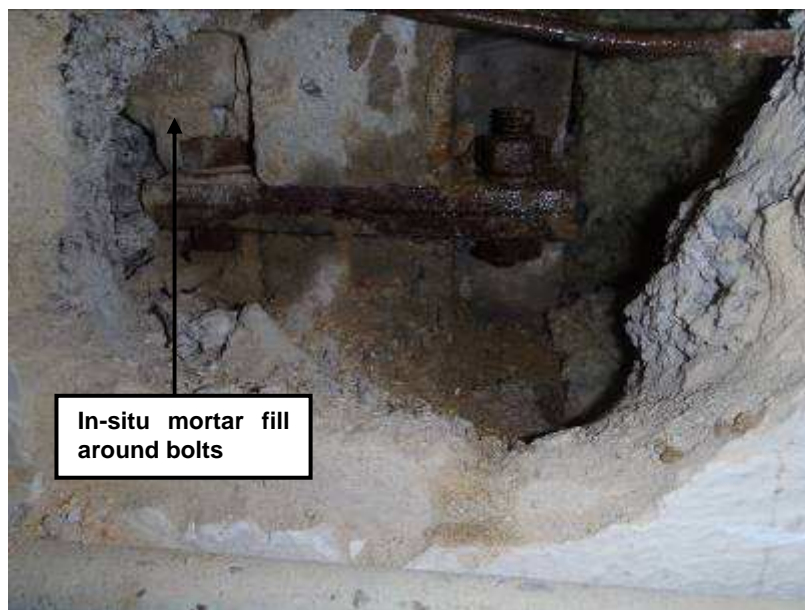
Plate R4: View of Ground Floor to 1<sup>st</sup> Floor column connection at No. 1 Rutter Gardens. Note in-situ mortar fill around bolts partially removed for inspection.

The steel column connection plates and bolts exhibited light to moderate surface corrosion where inspected, however, no significant section loss was noted. See Plate R4 above.

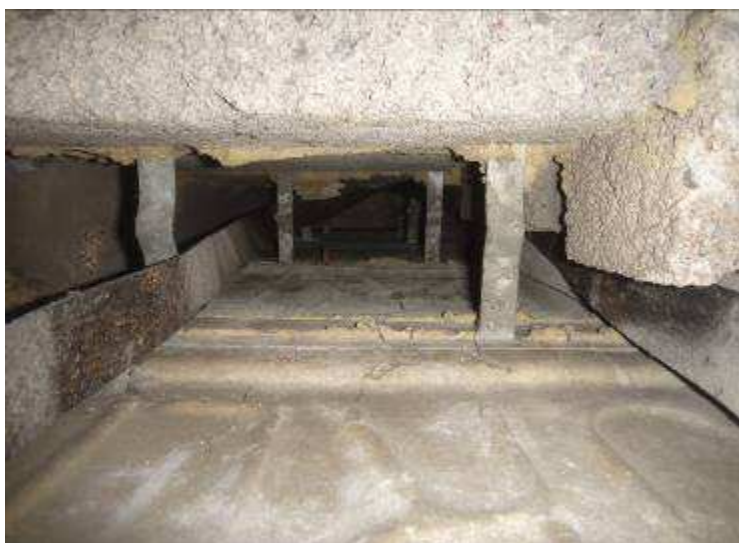
Plate R6: View looking up towards cavity wall ties above Breakout B3 at No. 193 Morden Road.

The galvanised wall ties were observed to be in good condition where inspected during this investigation.

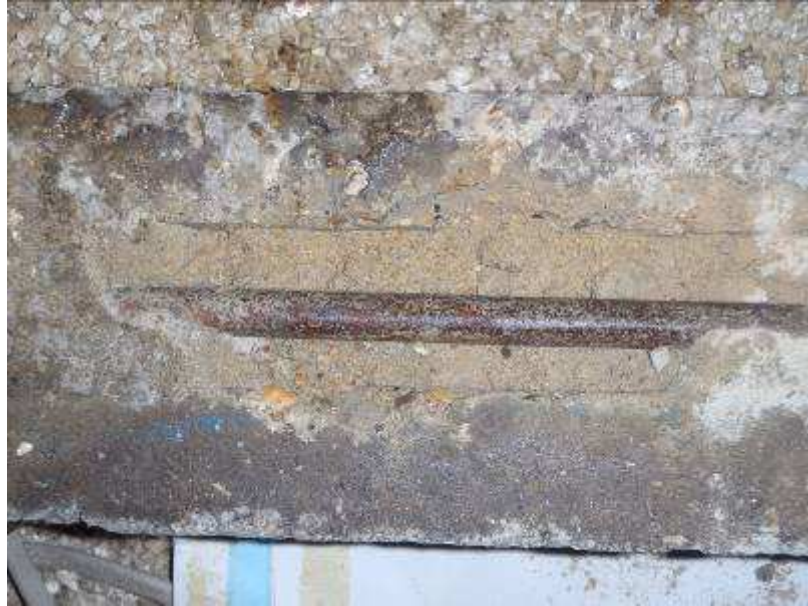
At each property a single continuity bar was exposed at the central roof secondary beam to primary beam connection (over the central column). At each location the continuity bars was observed to be in good condition, exhibiting light surface corrosion only.

Plate R8: View of Breakout D2 to roof secondary beam continuity bar over central column at No. 20 Hatfield Close.

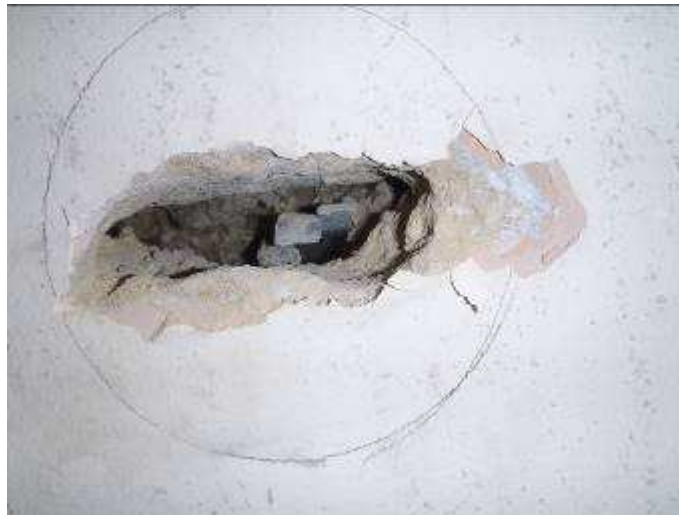
Plate R9: View of tie fishtail end embedded within internal blockwork skin at Breakout D6 to No. 20 Hatfield Close.

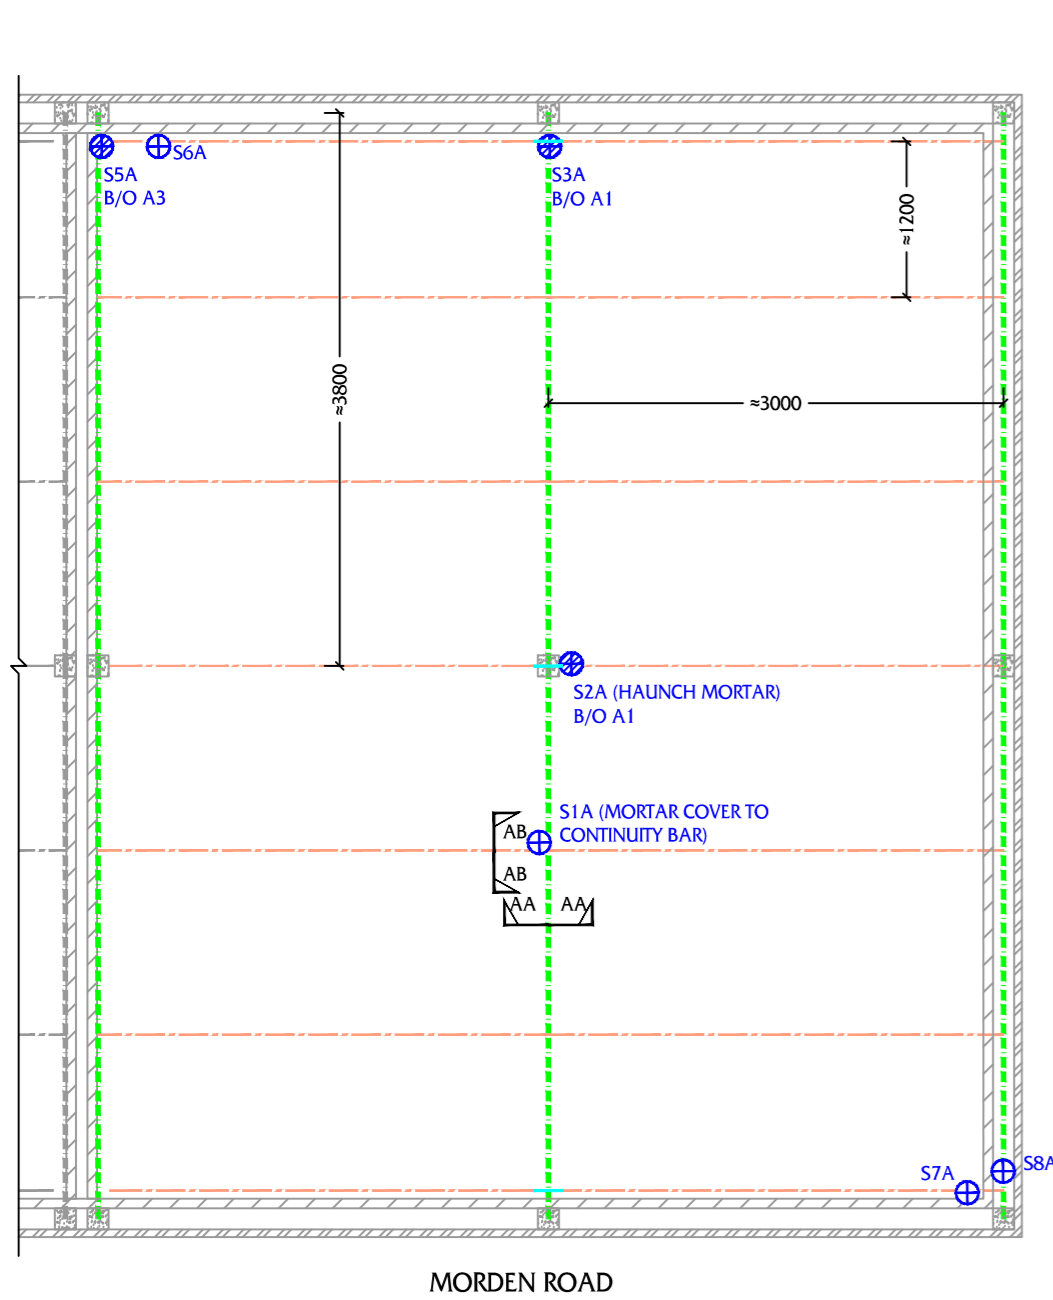
FIG.A1: ROOF PLAN SHOWING LOCATIONS OF SAMPLES AND BREAKOUTS NOT TO SCALE

**NOTES**  
NO SIGNIFICANT DEFECTS NOTED TO BEAMS WHERE INSPECTED.  
CRACKING AND DETERIORATION NOTED TO EXTERNAL CORNER CLADDING PANELS.

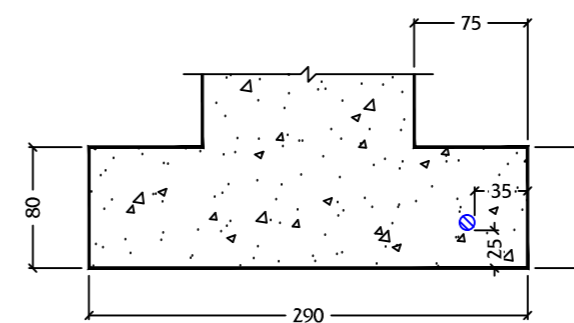
FIG.A6: DETAILS OF B/O A3 TO SOFFIT OF ROOF PRIMARY BEAM SCALE 1:5

10mmØ PLAIN ROUND LONGITUDINAL BAR AT 25mm SOFFIT COVER AND 35mm SIDE COVER. BAR OBSERVED TO BE IN GOOD CONDITION EXHIBITING LIGHT SURFACE CORROSION ONLY.

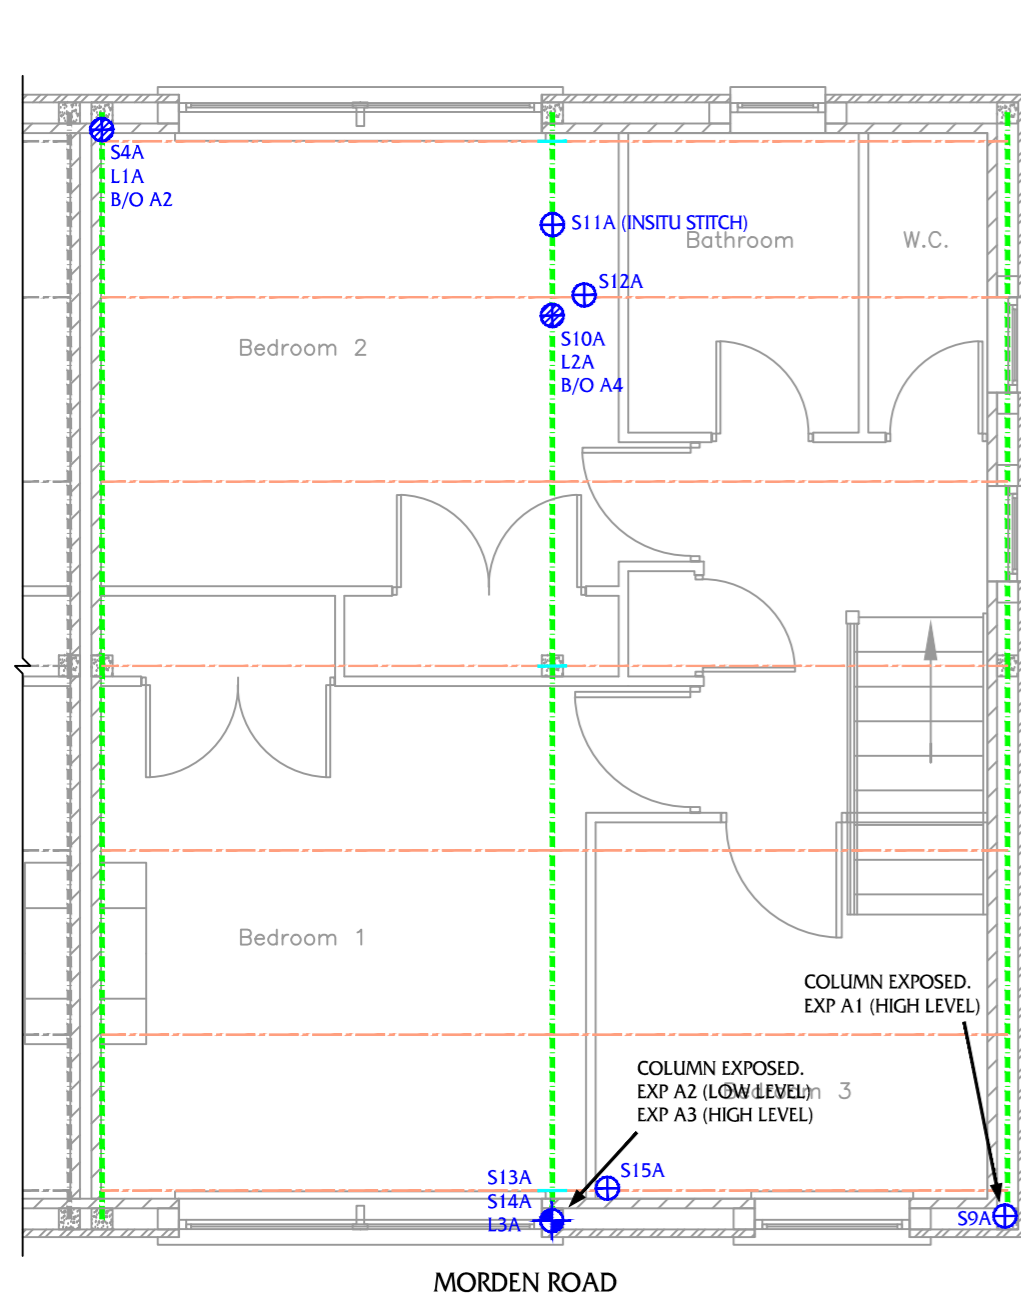
FIG.A7: 1ST FLOOR PLAN SHOWING LOCATIONS OF SAMPLES AND BREAKOUTS NOT TO SCALE

**NOTES**  
NO SIGNIFICANT DEFECTS NOTED TO BEAMS AND COLUMNS WHERE INSPECTED.  
CRACKING AND DETERIORATION NOTED TO EXTERNAL CORNER CLADDING PANELS.

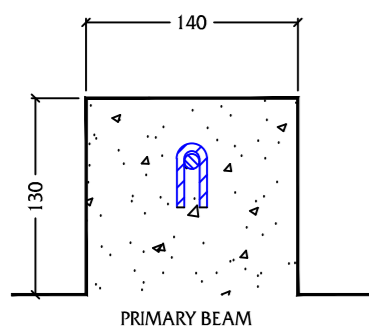
FIG.A10: DETAILS OF B/O A4 TO TOP OF 1ST FLOOR PRIMARY BEAM SCALE 1:5

**DETAILS OF B/O 4**  
10mmØ PLAIN ROUND LONGITUDINAL BAR AT 37mm TOP COVER.  
5mmØ PLAN ROUND VERTICAL LINK AT TOP 30mm COVER.  
BOTH BARS IN GOOD CONDITION EXHIBITING LIGHT SURFACE CORROSION ONLY.  
CARBONATION DEPTH: 3-4mm
