Structural Assessment Report of Orlit Houses  
Revision A  
Ravensbury Estate Regeneration  
For HTA Design LLP

Scheme No: 11264

6<sup>th</sup> November 2014

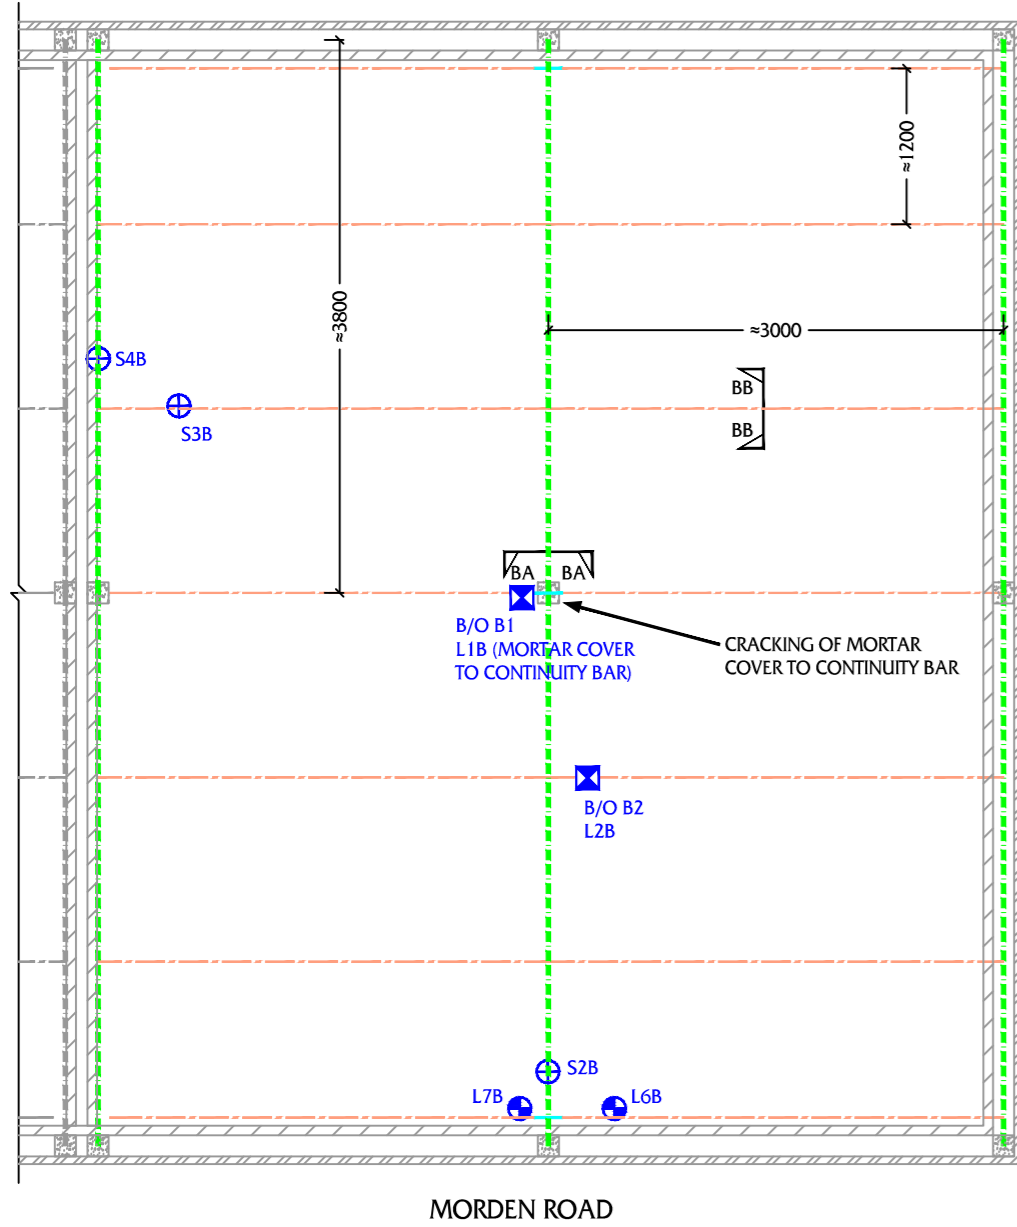
FIG.B1: ROOF PLAN SHOWING LOCATIONS OF SAMPLES AND BREAKOUTS NOT TO SCALE

**NOTES**  
NO SIGNIFICANT DEFECTS NOTED TO BEAMS WHERE INSPECTED.  
CRACKING AND DETERIORATION NOTED TO EXTERNAL CORNER CLADDING PANELS.

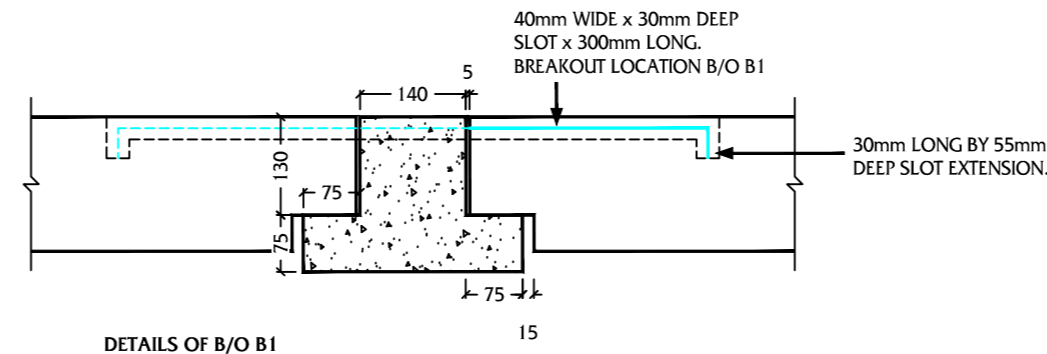
FIG.B2: SECTION BA-BA THROUGH ROOF PRIMARY BEAM SHOWING DETAILS OF BREAKOUT B/O B1 SCALE 1:10

**DETAILS OF B/O B1**  
10mmØ PLAIN ROUND CONTINUITY BAR EMBEDDED WITHIN INSITU MORTAR FILLED PRE-FORMED SLOT. TOP COVER TO BAR 5mm. BAR OBSERVED TO BE IN GOOD CONDITION EXHIBITING LIGHT SURFACE CORROSION ONLY. INSITU MORTAR EXHIBITS CRACKING.

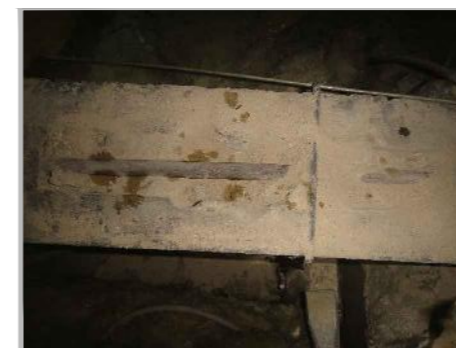
PB2b: VIEW LOOKING DOWN AT BREAKOUT B/O B1

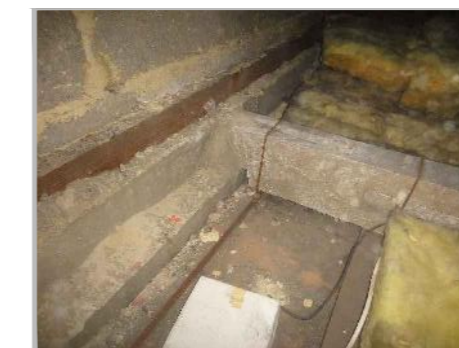
PB3b: SECONDARY BEAM BEARING ONTO EASTERN PRIMARY BEAM. NOTE CHANGE IN BEAM SECTION. PREFORMED SLOT WITH NO CONTINUITY BAR AND MORTAR HAUNCH AT BEAM BEARING.

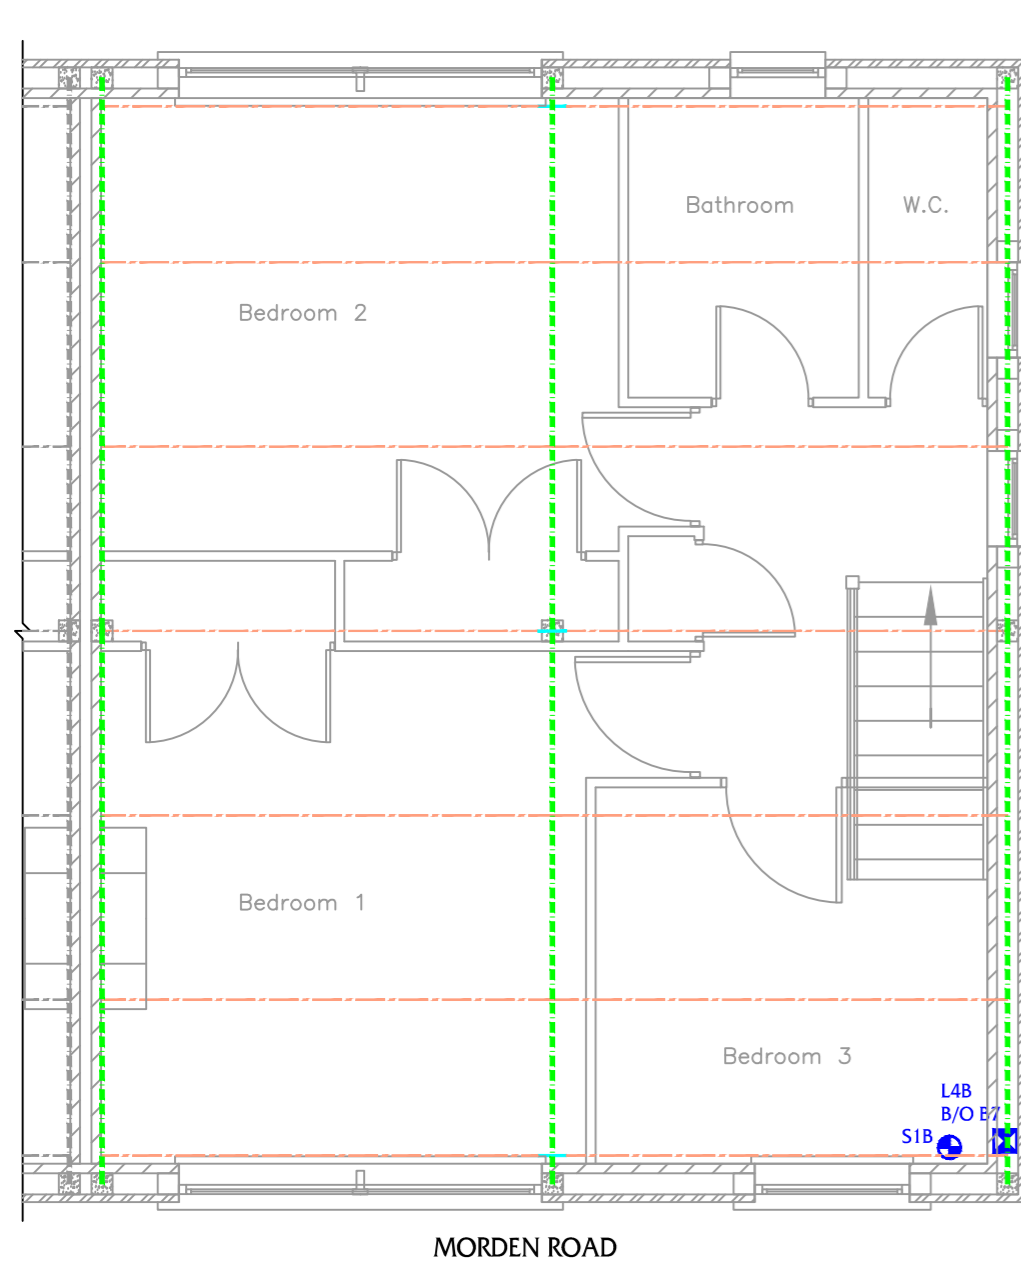
FIG.B5: 1ST FLOOR PLAN SHOWING LOCATIONS OF SAMPLES AND BREAKOUTS NOT TO SCALE

**NOTES**  
NO SIGNIFICANT DEFECTS NOTED TO BEAMS AND COLUMNS WHERE INSPECTED.  
CRACKING AND DETERIORATION NOTED TO EXTERNAL CORNER CLADDING PANELS.

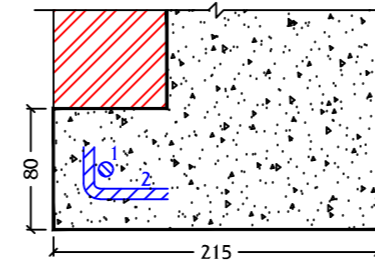
FIG.B6: DETAILS OF B/O B7 TO SOFFIT OF 1ST FLOOR PRIMARY BEAM SCALE 1:5

- 10mmØ PLAIN ROUND BAR AT 30mm SIDE COVER AND 35mm SOFFIT COVER.
- 8mmØ PLAIN ROUND LINK BAR AT 20mm SIDE AND SOFFIT COVER.

BARS EXHIBIT LIGHT TO MODERATE SURFACE CORROSION. CARBONATION DEPTH: 2-3mm

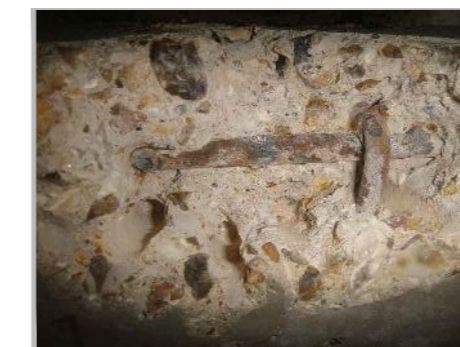
PB6b: CLOSER VIEW OF B/O B7

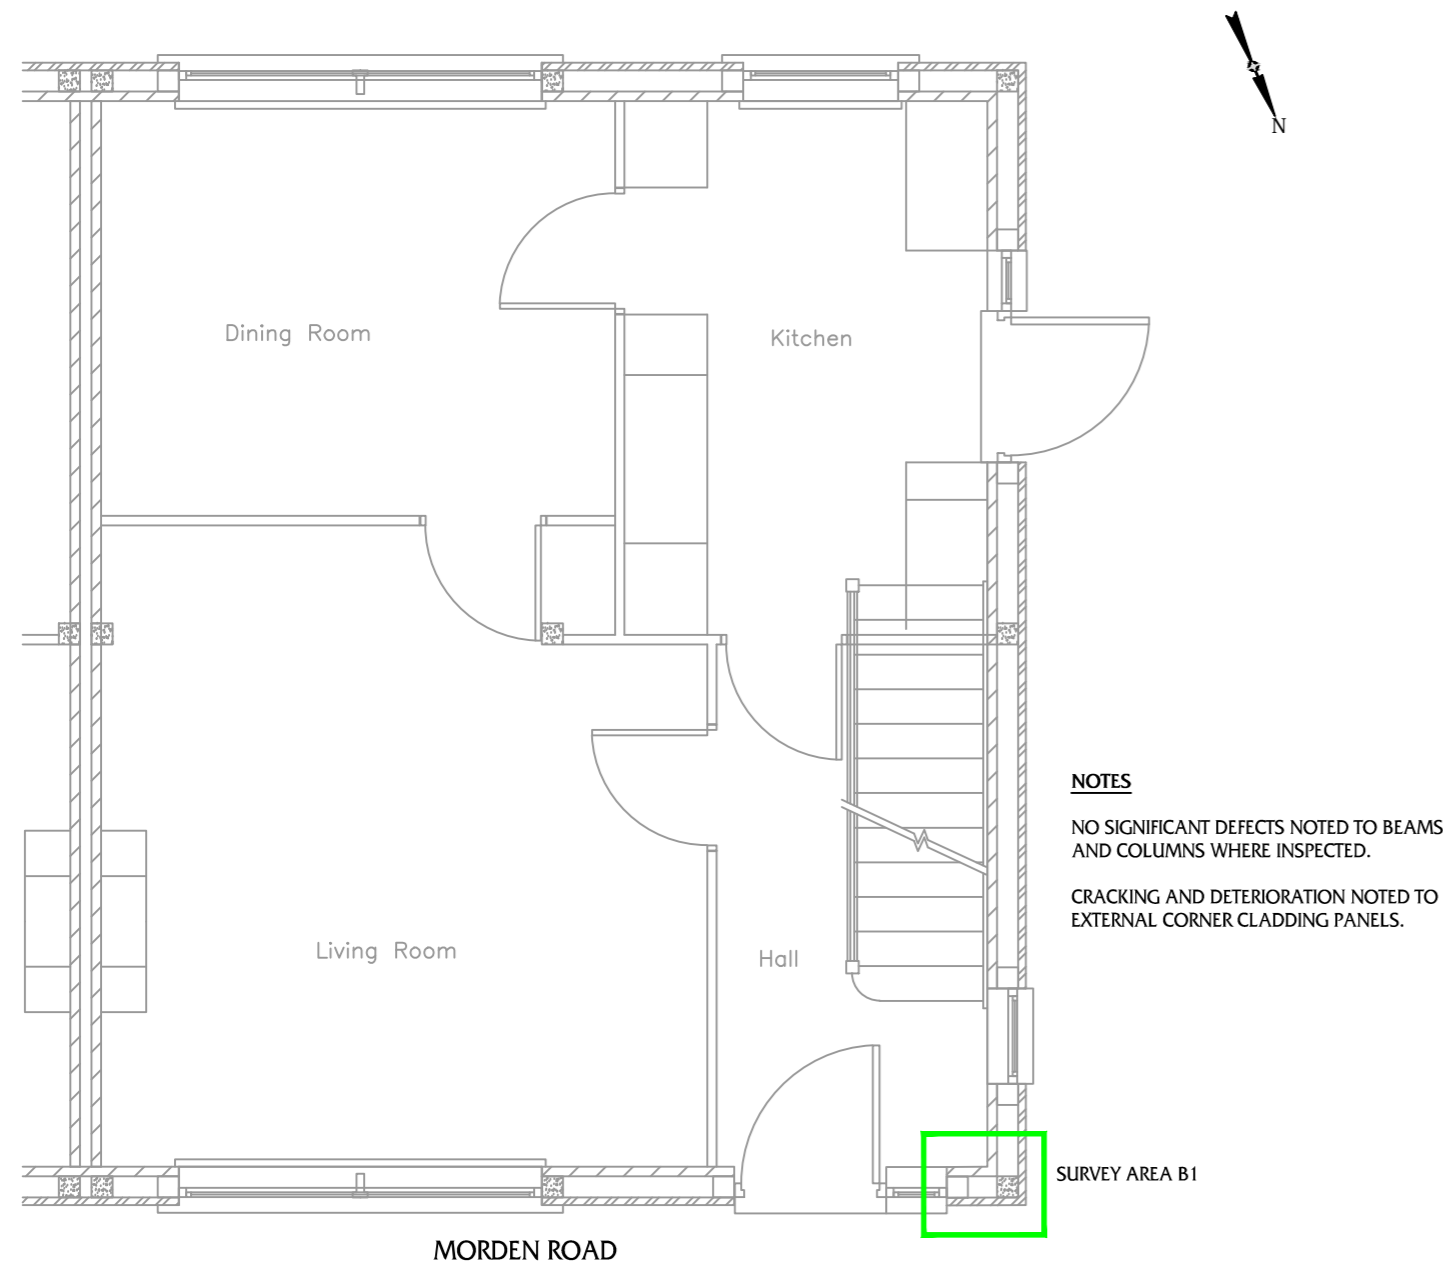
FIG.B8: GROUND FLOOR PLAN SHOWING LOCATIONS OF SAMPLES AND BREAKOUTS NOT TO SCALE

**NOTES**  
NO SIGNIFICANT DEFECTS NOTED TO BEAMS AND COLUMNS WHERE INSPECTED.  
CRACKING AND DETERIORATION NOTED TO EXTERNAL CORNER CLADDING PANELS.

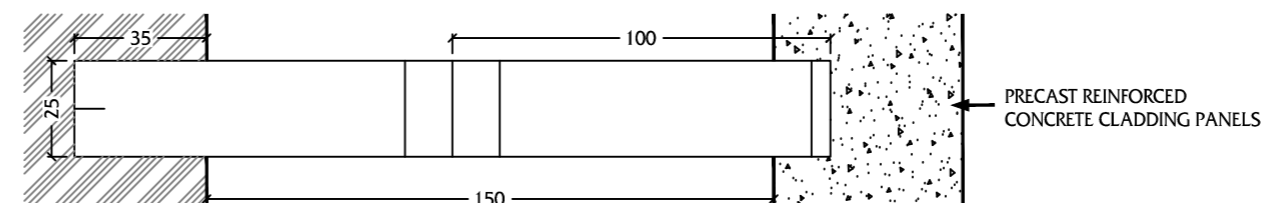
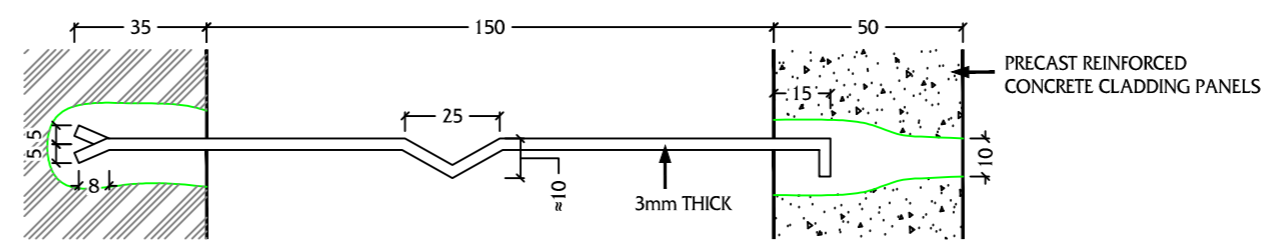
FIG.B10: DETAILS OF WALL TIES AT B/O B3 AND B/O B4 SCALE 1:2

**NOTES**  
DIMENSIONS HERE MEASURED AT B/O B3 AND B/O B4

**NOTES**  
DIMENSIONS HERE MEASURED AT B/O B3

**NOTES**  
GALVANISED STEEL WALL TIES OBSERVED TO BE IN SOUND CONDITION.

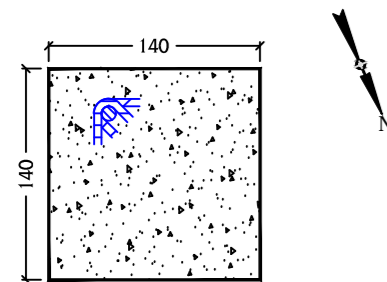
FIG.B11: DETAILS OF GROUND FLOOR COLUMN AT B/O B5 (LOW LEVEL) SCALE 1:5

**DETAILS OF BREAKOUT**  
10mmØ PLAIN ROUND VERTICAL BAR AT 25mm MINIMUM COVER.  
5mmØ PLAIN ROUND LINK BAR AT 20mm MINIMUM COVER.  
BOTH BARS EXHIBIT LIGHT SURFACE CORROSION ONLY.  
CARBONATION DEPTH: 1mm

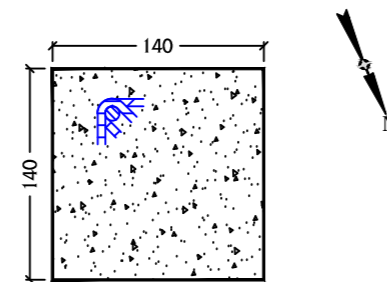
FIG.B12: DETAILS OF GROUND FLOOR COLUMN AT B/O B6 (HIGH LEVEL) SCALE 1:5

**DETAILS OF BREAKOUT**  
10mmØ PLAIN ROUND VERTICAL BAR AT 25mm MINIMUM COVER.  
5mmØ PLAIN ROUND LINK BAR AT 20mm MINIMUM COVER.  
BOTH BARS EXHIBIT LIGHT SURFACE CORROSION ONLY.  
CARBONATION DEPTH: 2-5mm

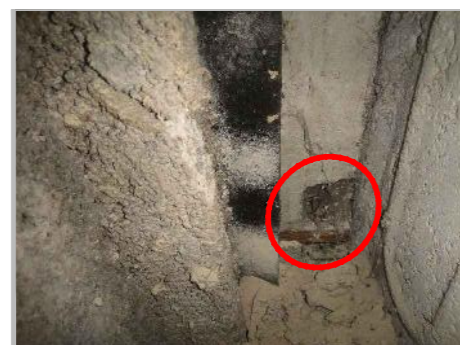
PB11a: VIEW OF B/O B5 TO GROUND FLOOR COLUMN AT LOW LEVEL

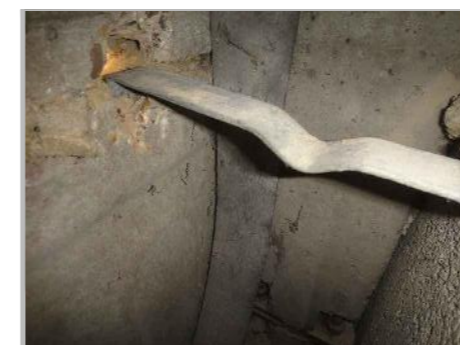
PB12a: VIEW OF B/O B6 TO GROUND FLOOR COLUMN AT HIGH LEVEL. NOTE ALSO EXPOSED WALL TIES

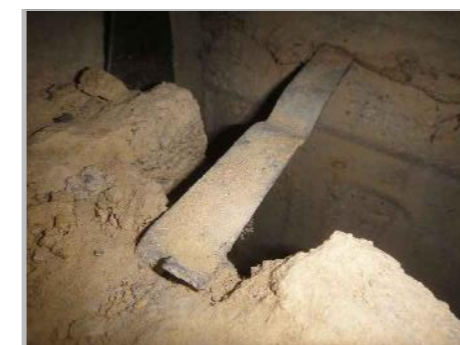
PB10a: VIEW OF B/O B3 TO WALL TIE EMBEDMENT WITHIN CLADDING

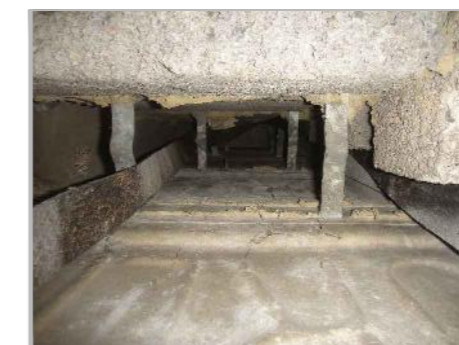
PB10b: VIEW OF B/O B4 TO WALL TIE EMBEDMENT WITHIN INTERNAL BLOCKWORK SKIN

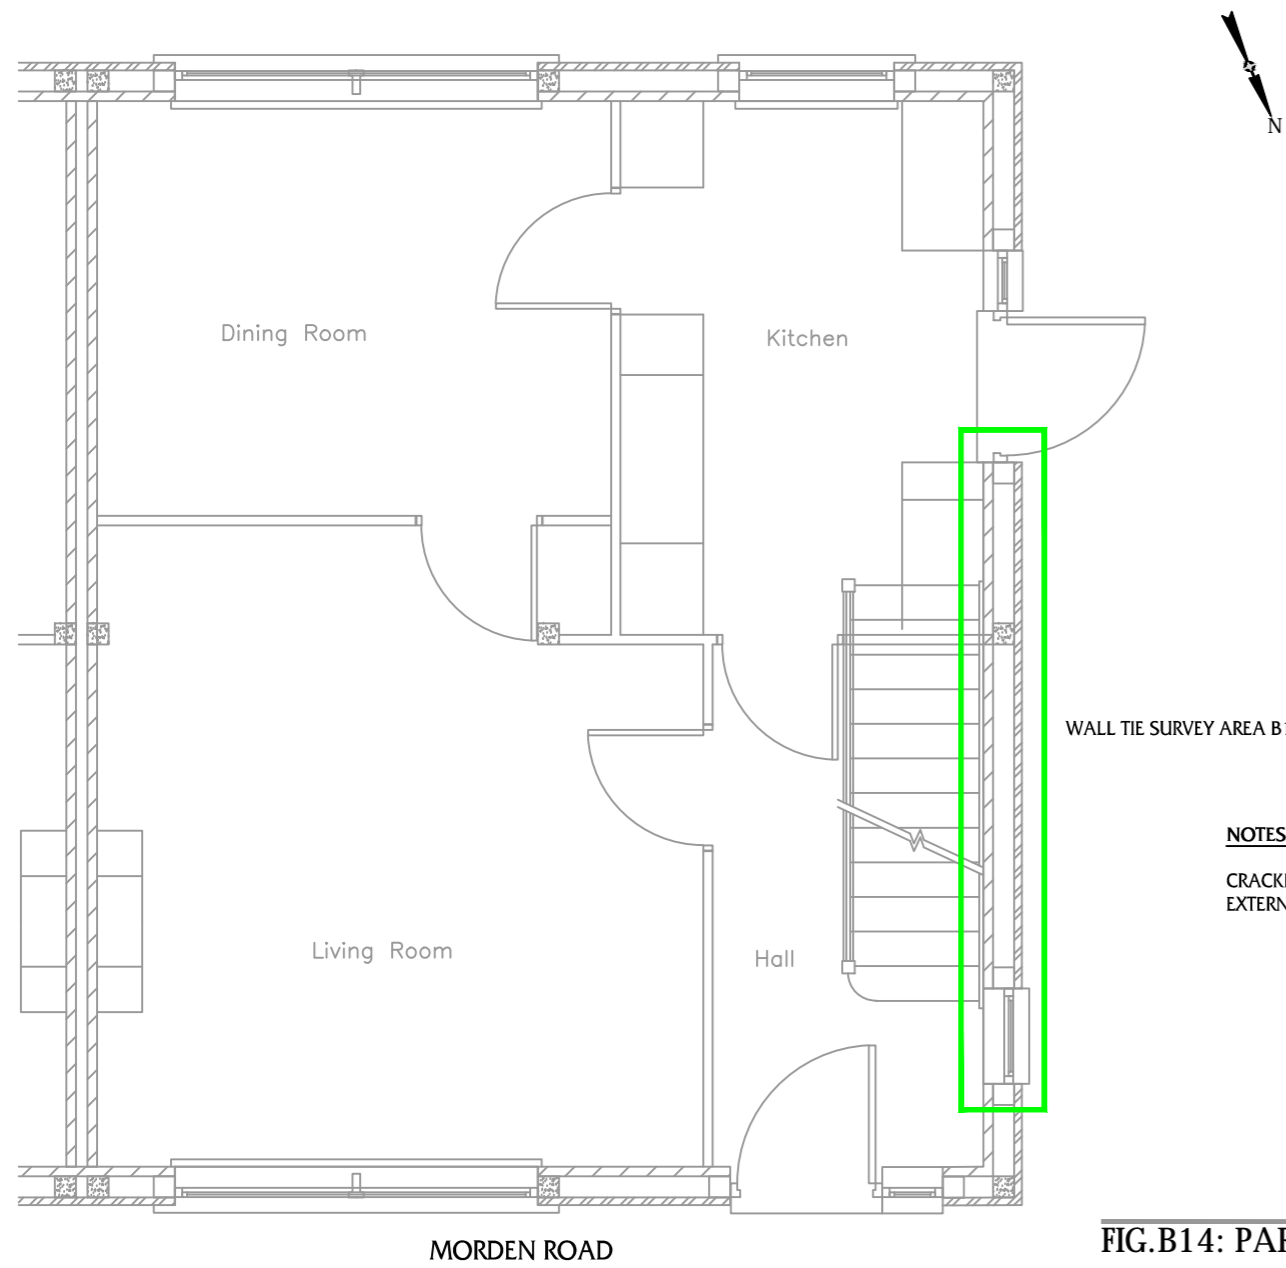
FIG.B13: GROUND FLOOR PLAN SHOWING LOCATION OF WALL TIE SURVEY NOT TO SCALE

**NOTES**  
CRACKING AND DETERIORATION NOTED TO EXTERNAL CORNER CLADDING PANELS.

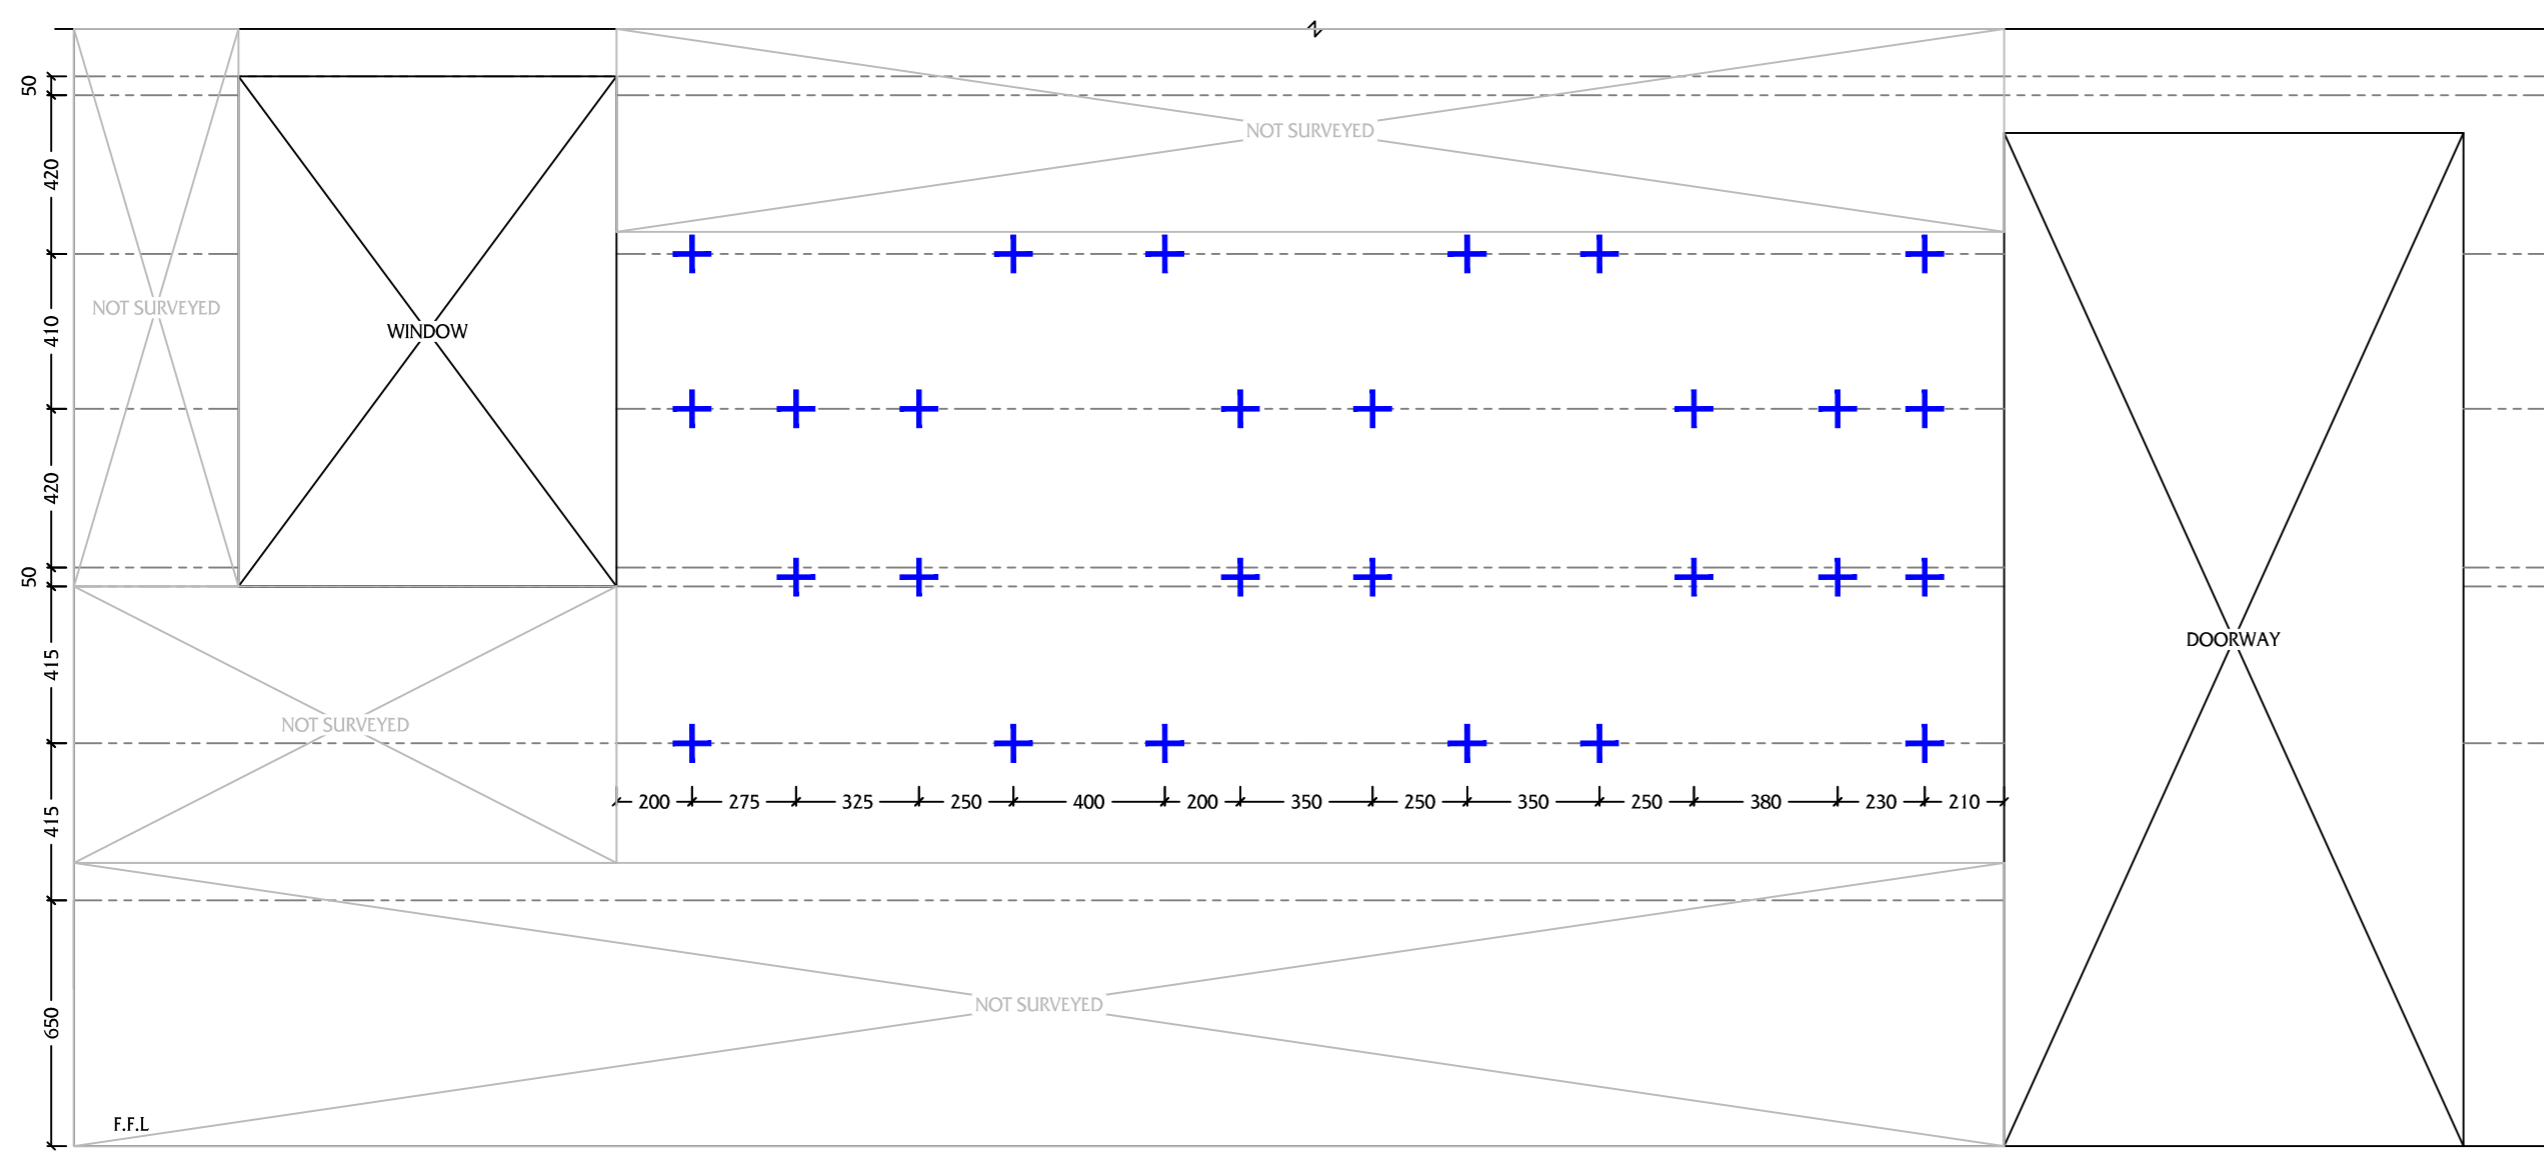
FIG.B14: PART WESTERN GROUND FLOOR ELEVATION SHOWING RESULTS OF WALL TIE SURVEY B1 SCALE 1:20

**NOTES**  
VERTICAL JOINTS BETWEEN PRECAST CLADDING PANELS OMITTED FROM SKETCH

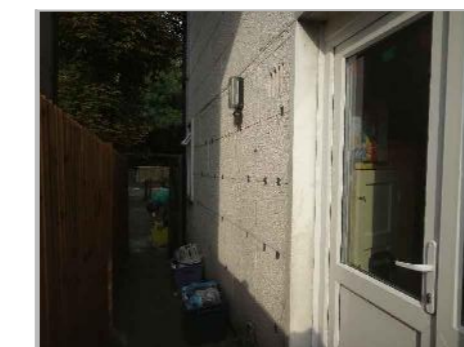
PB.14a: VIEW OF WALL TIE SURVEY AREA B1 ON WESTERN SIDE OF PROPERTY AT GROUND FLOOR LEVEL

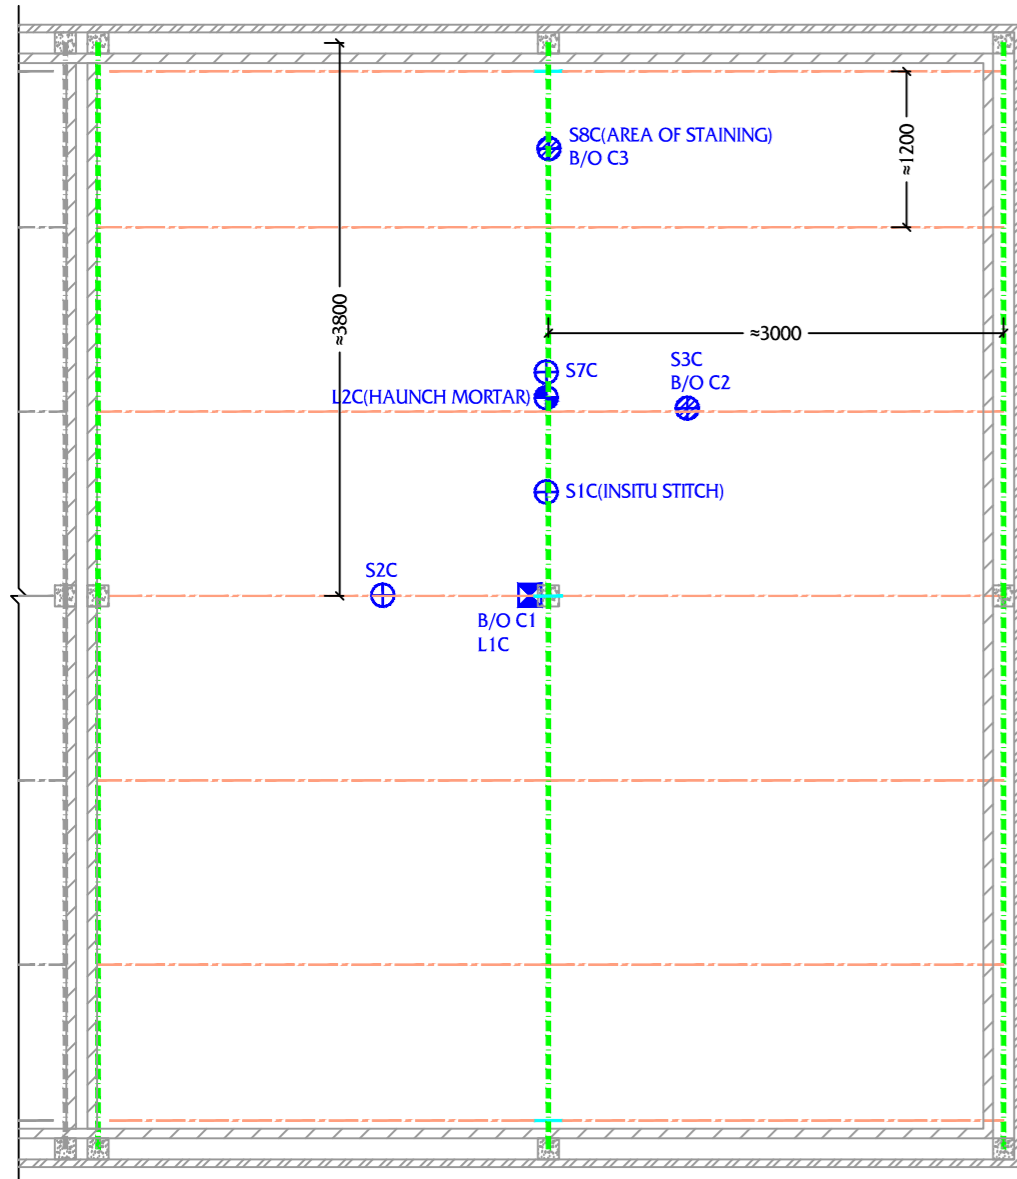
FIG.C1: ROOF PLAN SHOWING LOCATIONS OF SAMPLES AND BREAKOUTS NOT TO SCALE

NO SIGNIFICANT DEFECTS NOTED TO BEAMS WHERE INSPECTED.

CRACKING AND DETERIORATION NOTED TO EXTERNAL CORNER CLADDING PANELS.

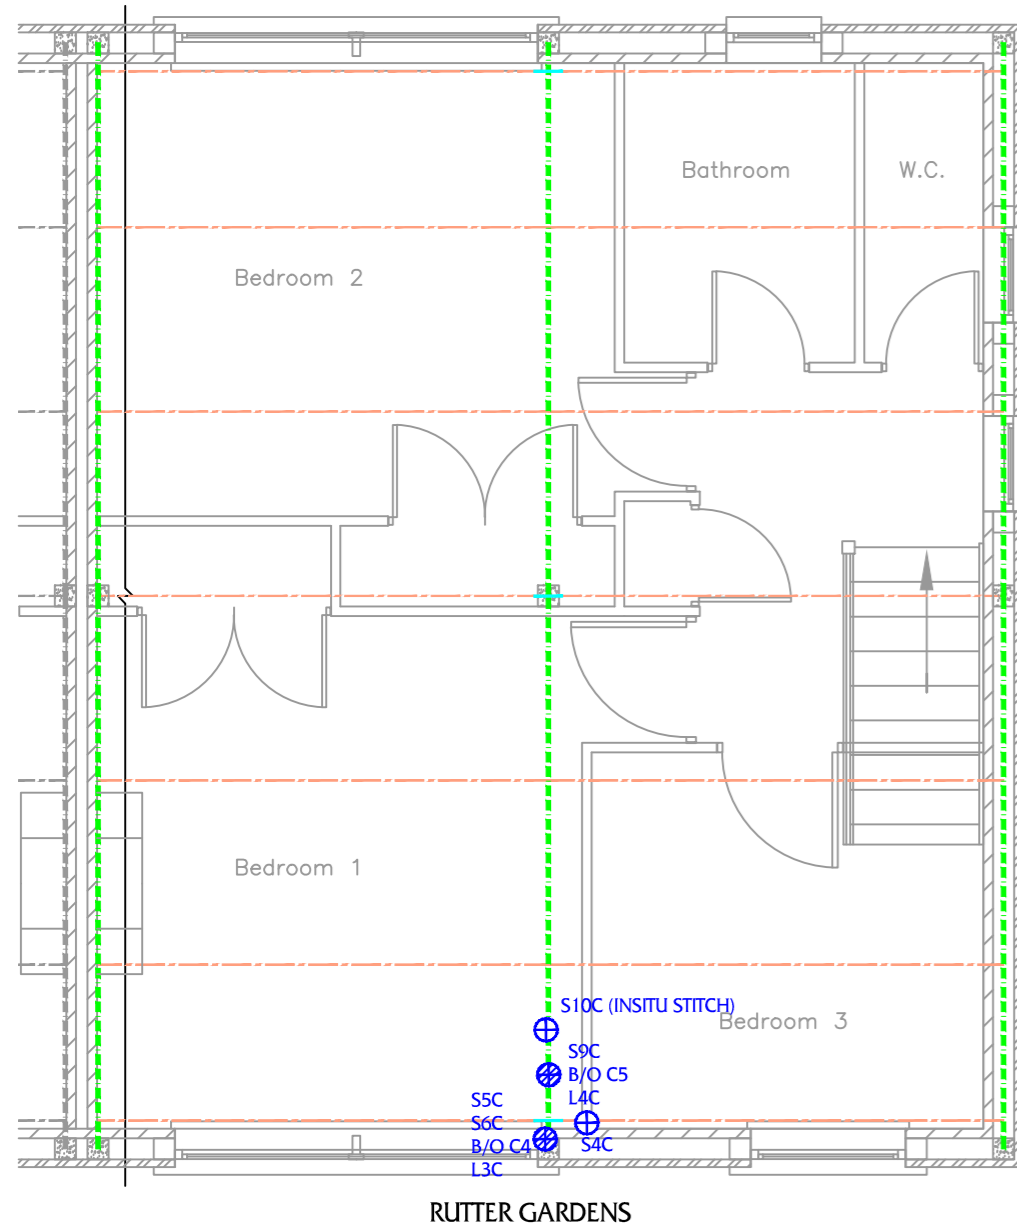
FIG.C5: 1ST FLOOR PLAN SHOWING LOCATIONS OF SAMPLES AND BREAKOUTS NOT TO SCALE

**NOTES**  
NO SIGNIFICANT DEFECTS NOTED TO BEAMS WHERE INSPECTED.  
CRACKING AND DETERIORATION NOTED TO EXTERNAL CORNER CLADDING PANELS.

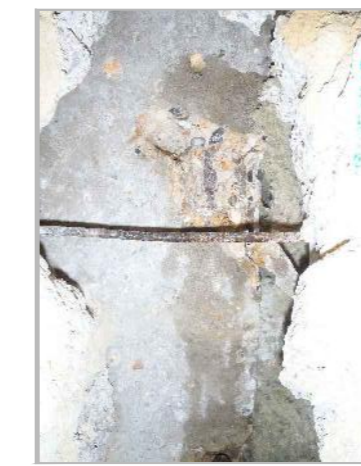
**DETAILS OF B/O C41**  
1. 10mmØ PLAIN ROUND VERTICAL BAR AT 14mm COVER.  
BAR IN GOOD CONDITION EXHIBITING LIGHT SURFACE CORROSION ONLY. CARBONATION DEPTH: 10mm

PC6a: VIEW OF B/O C4 TO 1ST FLOOR COLUMN

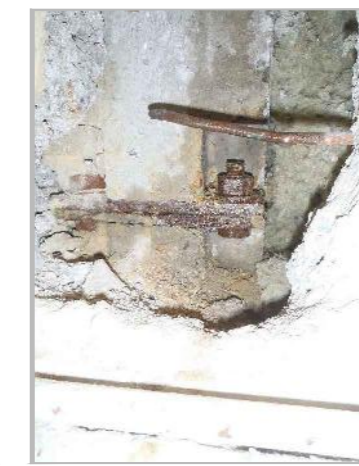
2 No. 6mm THICK PLATES BOLTED TOGETHER. 20mm BOLT HEADS (10.2mmØ THREAD)

PC6b: VIEW OF 1ST FLOOR TO GROUND FLOOR COLUMN CONNECTION DETAIL

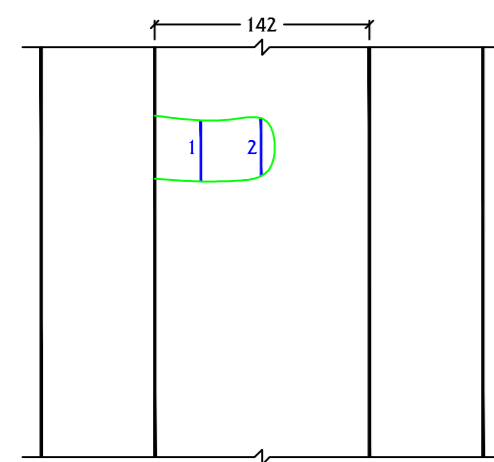
FIG.C7: DETAILS OF B/O C5 TO TOP OF 1ST FLOOR PRIMARY BEAM - PLAN VIEW SCALE 1:5

BOTH BARS IN GOOD CONDITION EXHIBITING LIGHT SURFACE CORROSION ONLY. CARBONATION DEPTH: 20mm

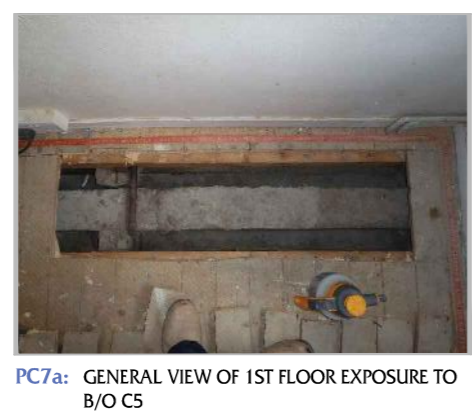
PC7a: GENERAL VIEW OF 1ST FLOOR EXPOSURE TO B/O C5

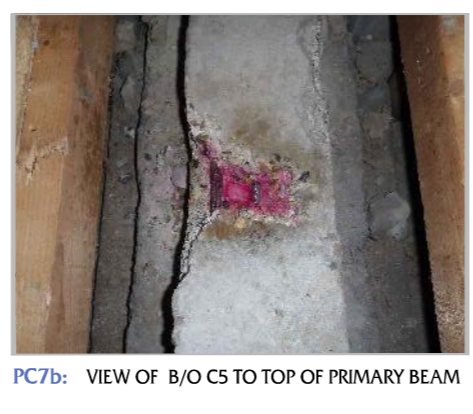
PC7b: VIEW OF B/O C5 TO TOP OF PRIMARY BEAM

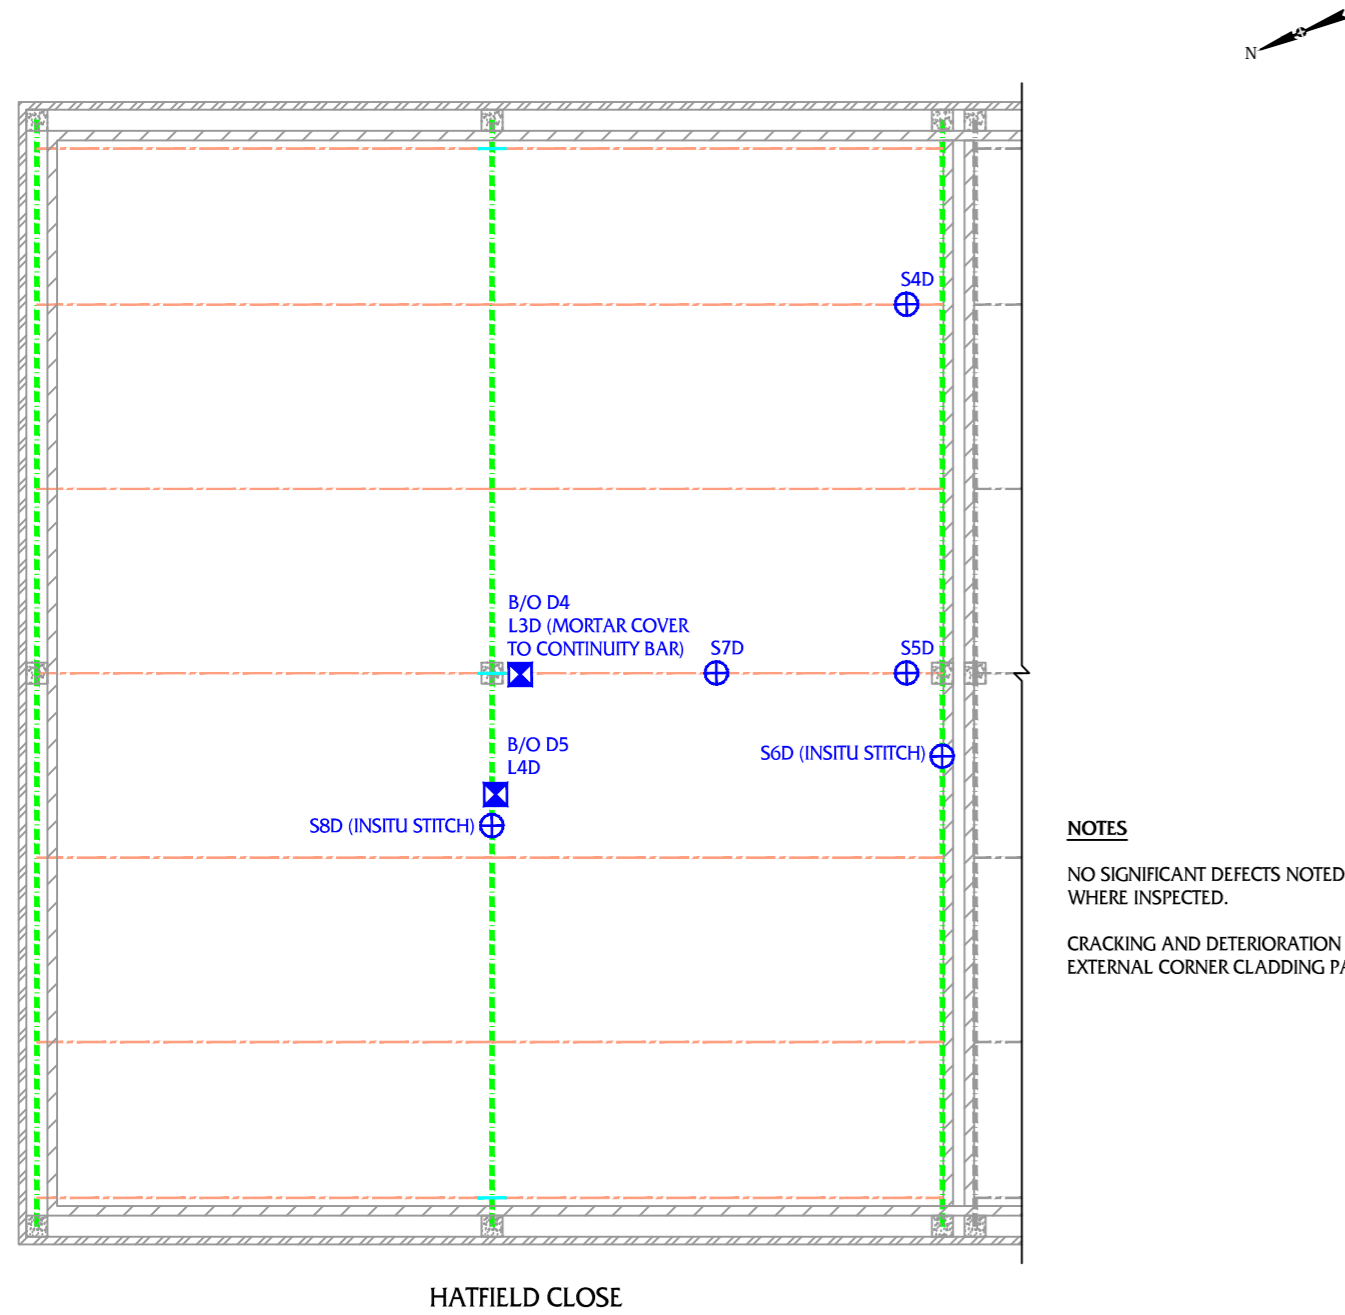
FIG.D1: ROOF PLAN SHOWING LOCATIONS OF SAMPLES AND BREAKOUTS NOT TO SCALE

**NOTES**  
NO SIGNIFICANT DEFECTS NOTED TO BEAMS WHERE INSPECTED.  
CRACKING AND DETERIORATION NOTED TO EXTERNAL CORNER CLADDING PANELS.

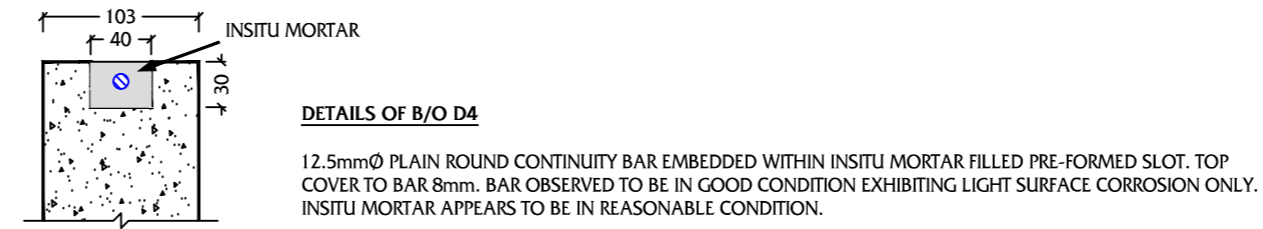
PD2a: VIEW OF B/O D4 TO TOP OF ROOF SECONDARY BEAM

FIG.D2: DETAILS OF BREAKOUT B/O D4 TO TOP OF ROOF SECONDARY BEAM SCALE 1:5

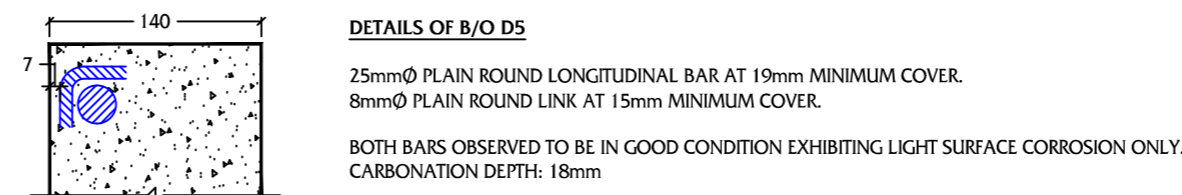
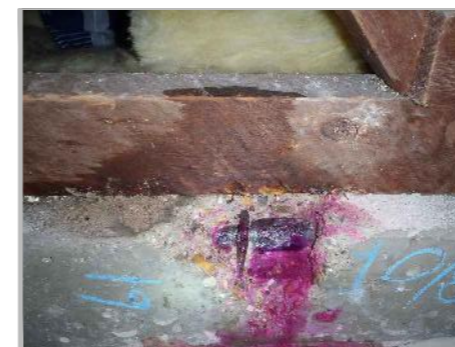
PD3a: VIEW OF B/O D5 TO ROOF PRIMARY BEAM

FIG.D3: DETAILS OF B/O D5 TO TO ROOF PRIMARY BEAM SCALE 1:5

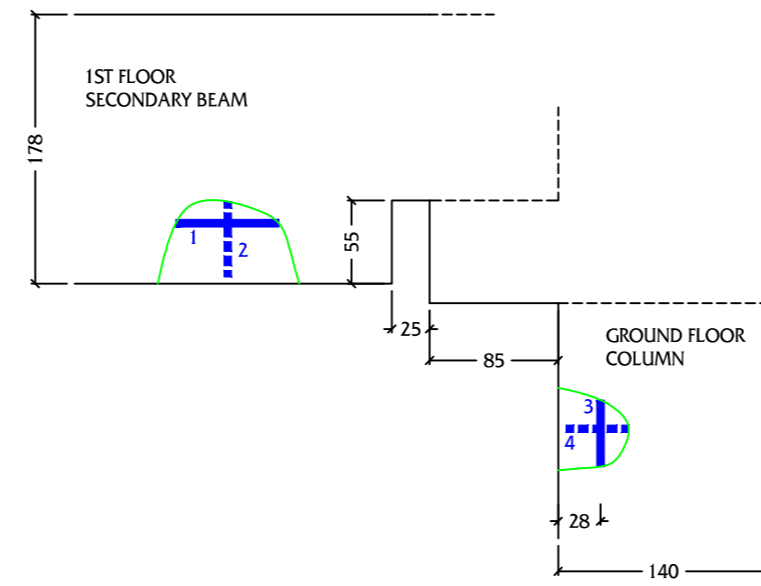
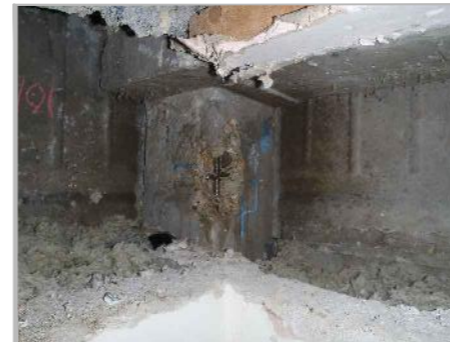
PD5a: VIEW OF B/O D1 TO GROUND FLOOR COLUMN. NOTE INSULATION WITHIN CAVITIES.

FIG.D5: PART ELEVATION ON WESTERN SIDE OF 1ST FLOOR SECONDARY BEAM TO GROUND FLOOR COLUMN CONNECTION AT B/O D1 AND B/O D3 SCALE 1:5

- 20mmØ PLAIN LONGITUDINAL ROUND BAR AT 25 MINIMUM COVER.
- 5mmØ PLAIN ROUND LINK AT 20 MINIMUM COVER.
- 10mmØ PLAIN VERTICAL ROUND BAR AT 22 MINIMUM COVER.
- 5mmØ PLAIN ROUND LINK AT 17 MINIMUM COVER.

ALL BARS OBSERVED TO BE IN GOOD CONDITION EXHIBITING LIGHT SURFACE CORROSION ONLY. CARBONATION DEPTH: 22mm AT B/O D1 AND 15mm AT B/O D2.

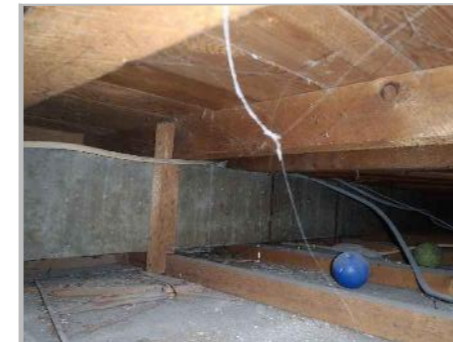
PD5b: VIEW LOOKING SOUTH FROM B/O D1 WITHIN 1ST FLOOR CEILING VOID

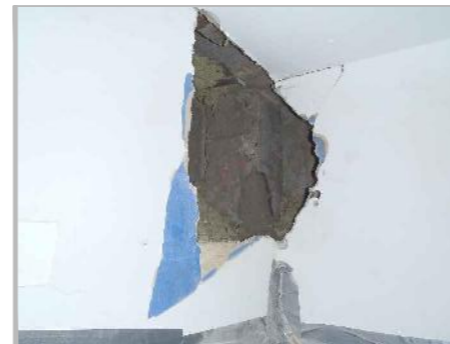
10mmØ PLAIN ROUND VERTICAL BAR AT 15mm MINIMUM COVER.

BAR OBSERVED TO BE IN GOOD CONDITION EXHIBITING LIGHT SURFACE CORROSION ONLY. CARBONATION: 25mm.

PD6a: VIEW OF 1ST FLOOR COLUMN. NOTE PHOTO TAKEN POST REINSTATEMENT OF B/O D1

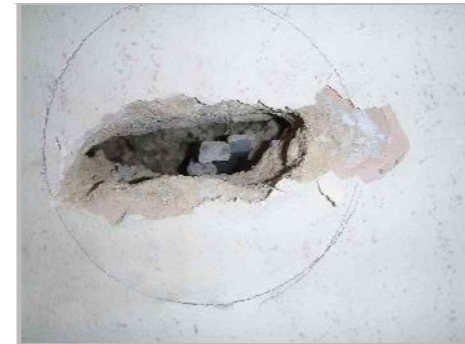
PD8a: VIEW OF B/O D6 AND EXPOSED WALL TIE

FIG.D8: DETAILS OF B/O D6 TO INTERNAL BLOCKWORK WALL AT GROUND FLOOR LEVEL

DETAILS OF B/O D6  
GALVANISED STEEL WALL TIE EXPOSED AND FOUND TO BE IN GOOD CONDITION.  
DEPTH OF TIE EMBEDMENT WITHIN INTERNAL BLOCKWORK SKIN: 35mm.  
NOTE CAVITY FILLED WITH INSULATION.

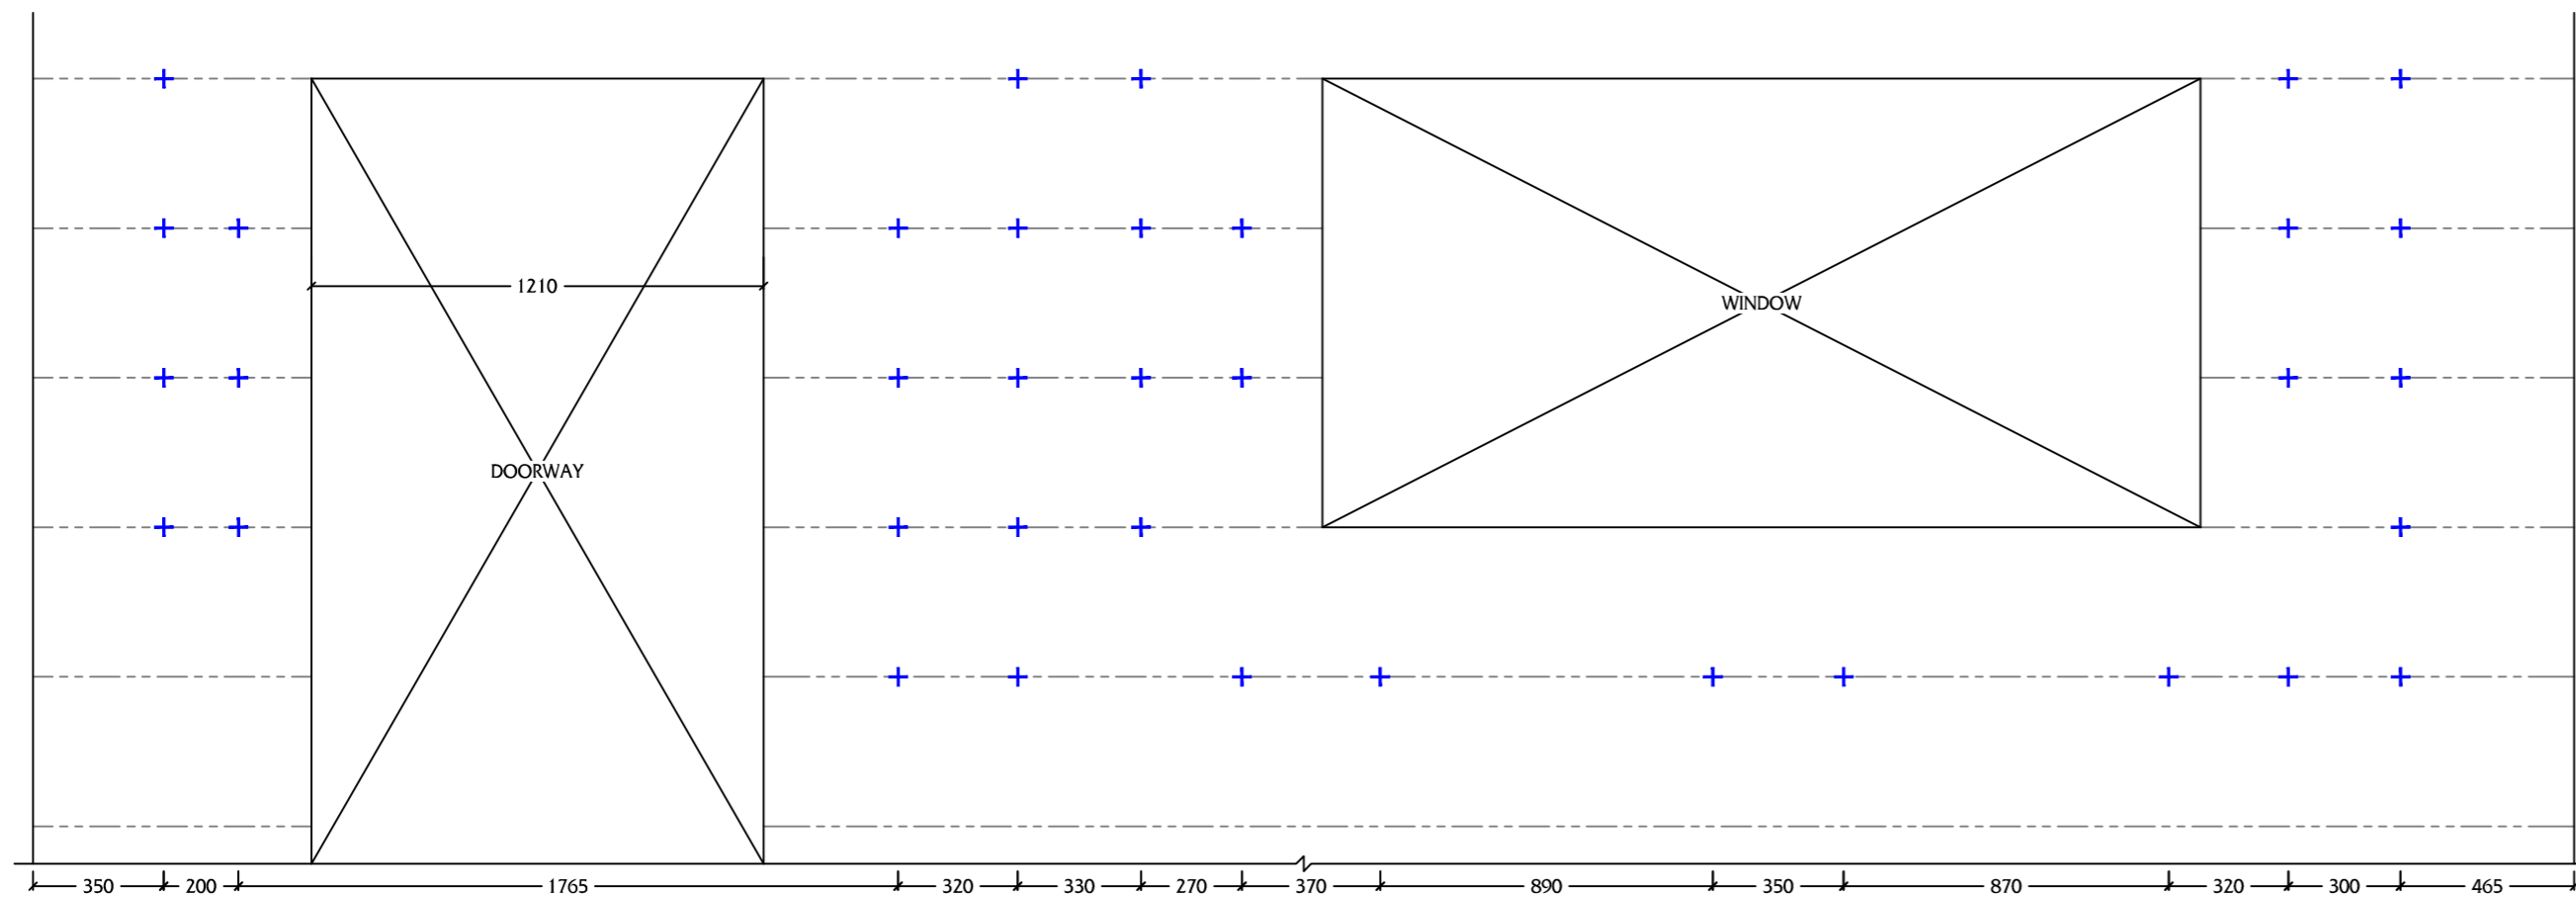
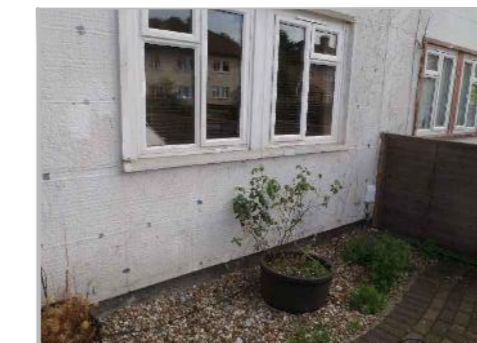
PD9a: PART VIEW OF SOUTHERN SIDE OF WALL TIE SURVEY AREA D1

**NOTES**  
CRACKING AND DETERIORATION NOTED TO EXTERNAL CORNER CLADDING PANELS.

FIG.D9: PART WESTERN (FRONT) GROUND FLOOR ELEVATION SHOWING RESULTS OF WALL TIE SURVEY D1 SCALE 1:20
