Structural Assessment Report of Orlit Houses  
Revision A  
Ravensbury Estate Regeneration  
For HTA Design LLP

Scheme No: 11264

6<sup>th</sup> November 2014

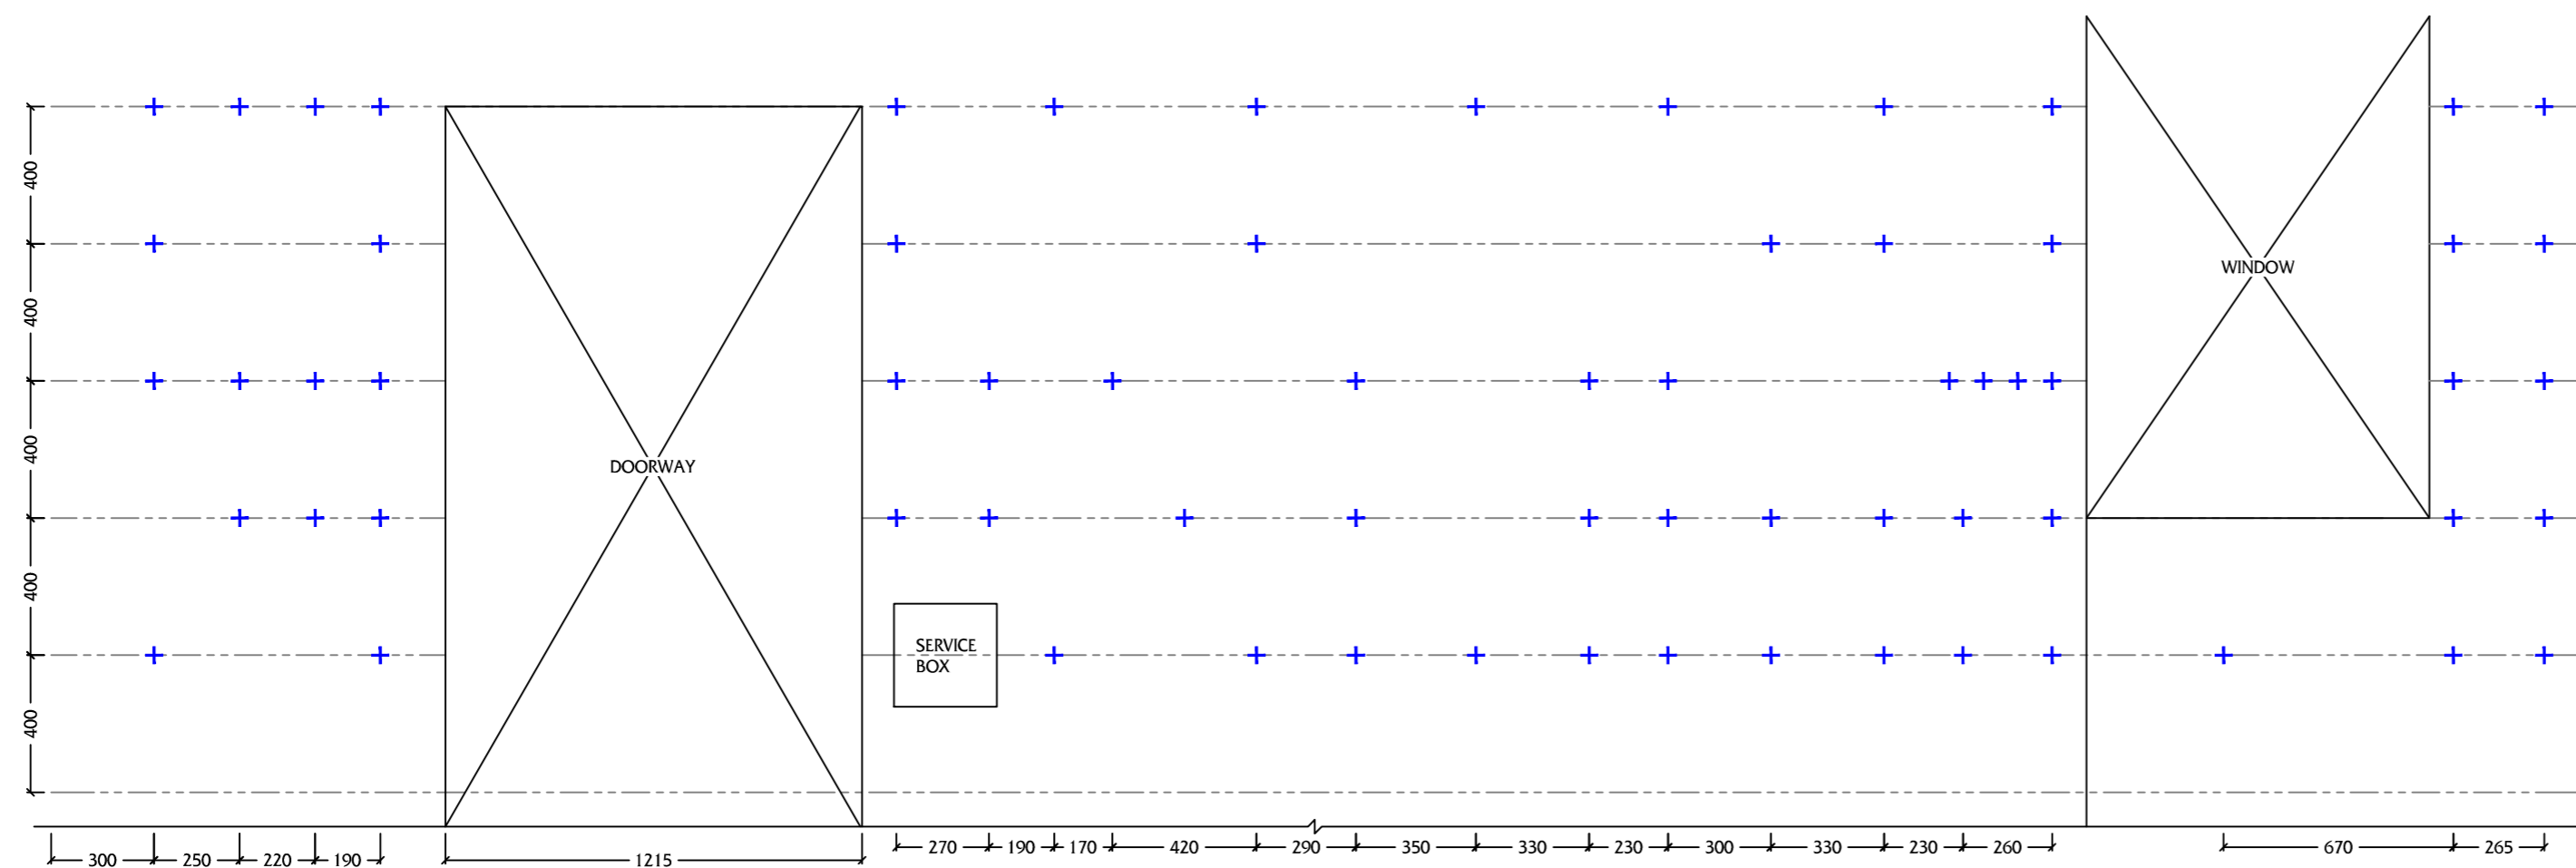
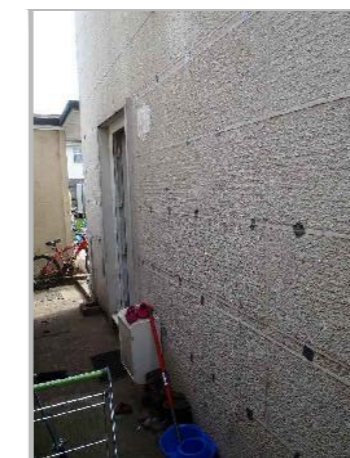
PD11a: PART VIEW OF EASTERN SIDE OF WALL TIE SURVEY AREA D2

**NOTES**  
CRACKING AND DETERIORATION NOTED TO EXTERNAL CORNER CLADDING PANELS.

FIG.D11: PART NORTHERN GROUND FLOOR ELEVATION SHOWING RESULTS OF WALL TIE SURVEY D2 SCALE 1:20

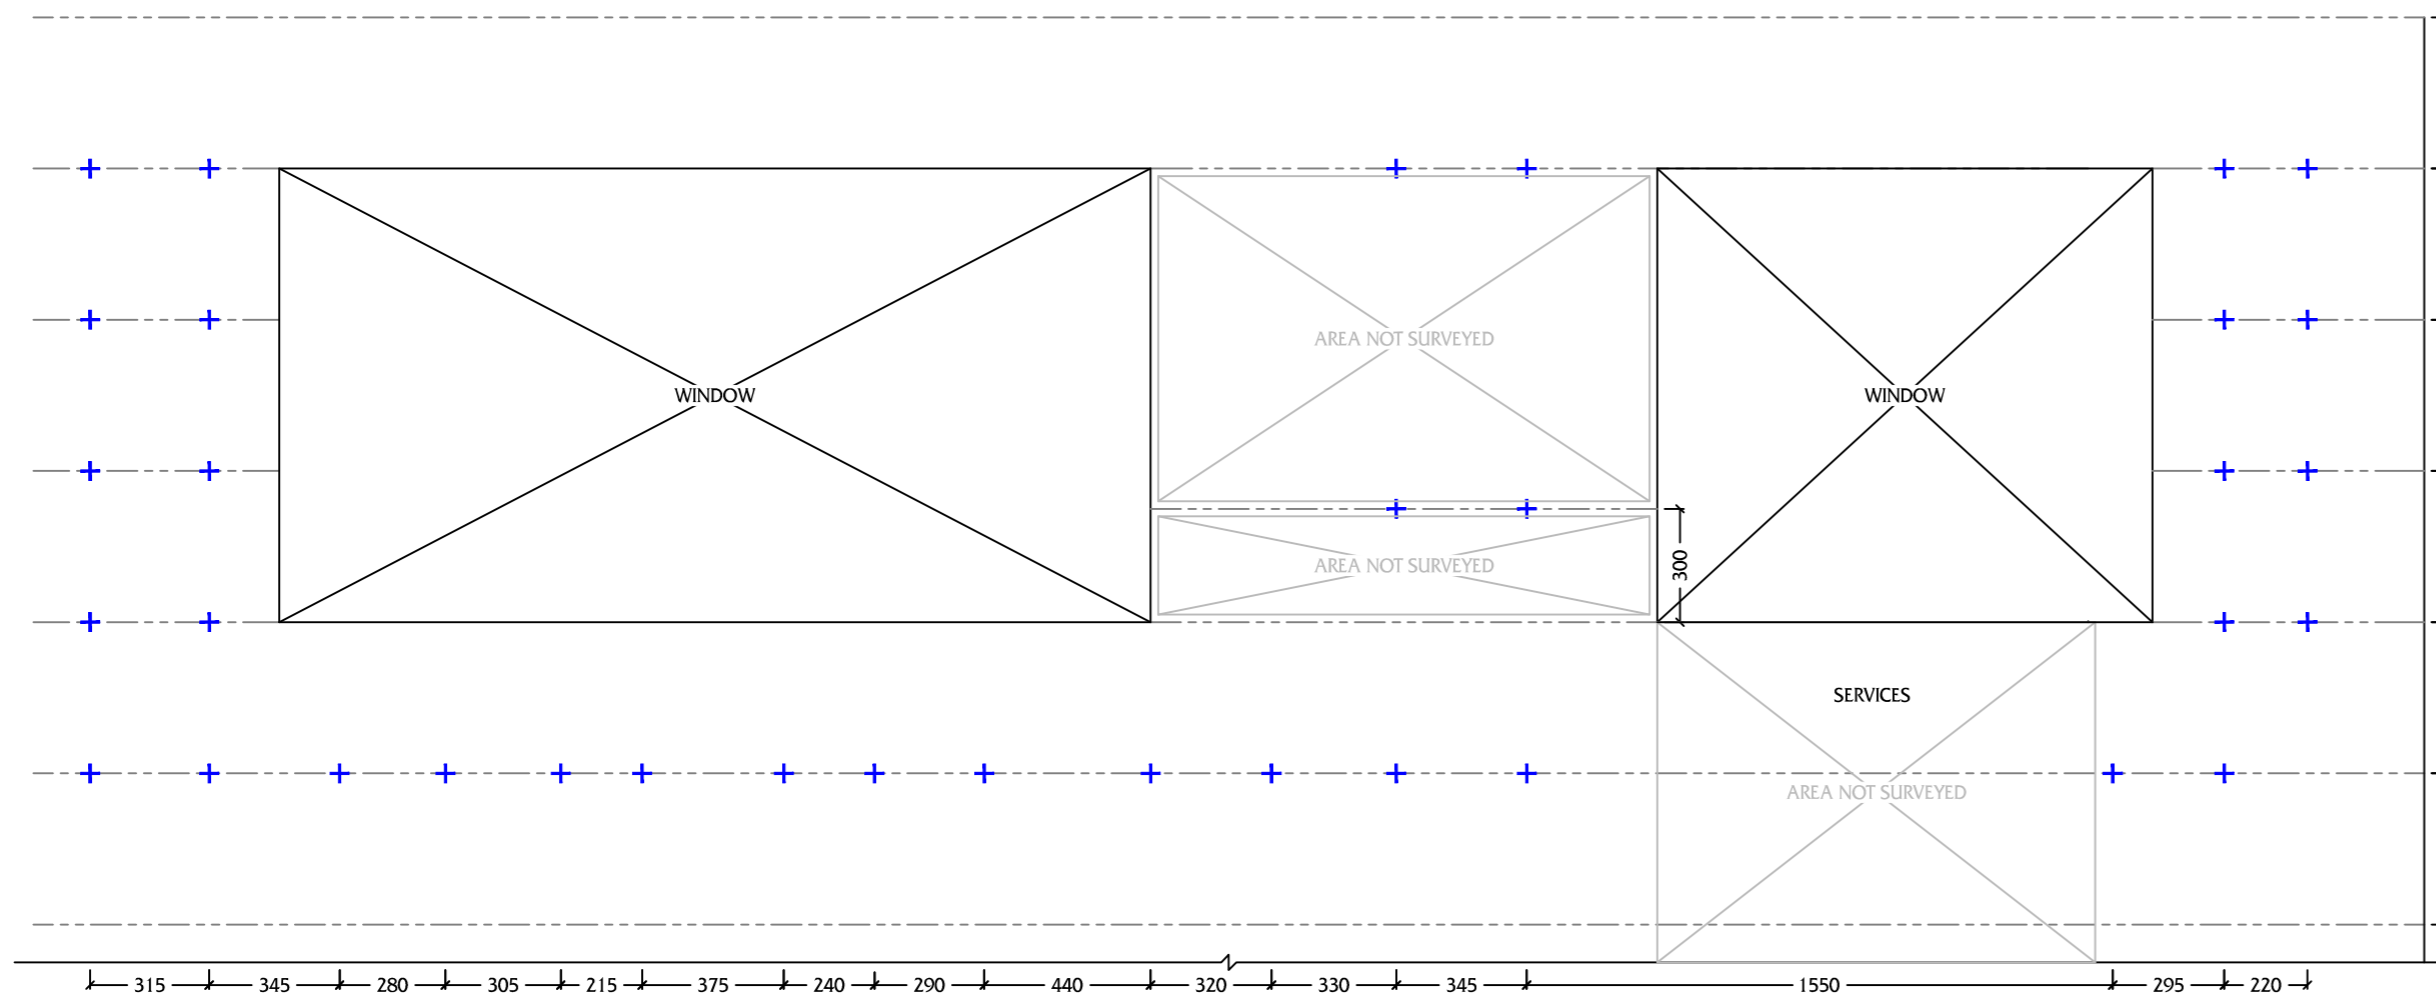
FIG.D13: PART EASTERN GROUND FLOOR ELEVATION SHOWING RESULTS OF WALL TIE SURVEY D3 SCALE 1:20

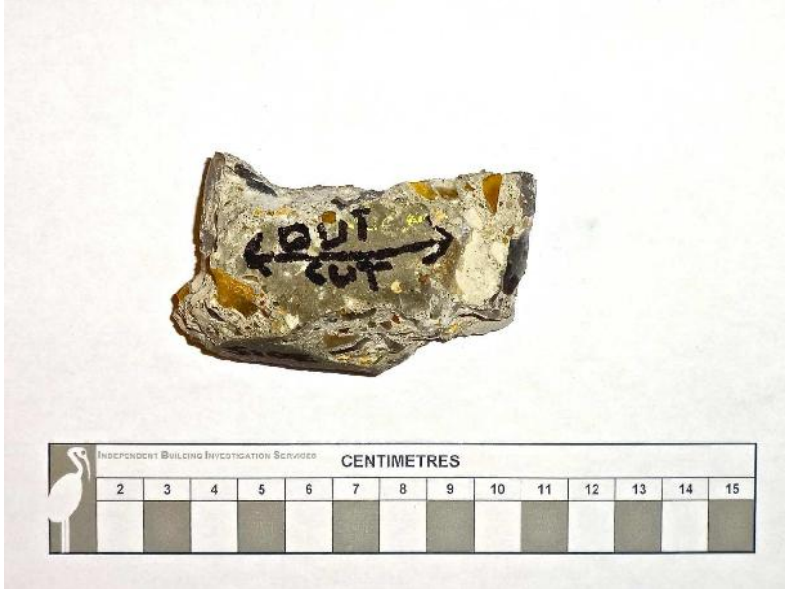
**Photograph 1**

General view of the as-received concrete sample with the apparent outer surface shown facing upwards and another surface facing the rule.

The brown and grey particles in this view are chert particles of apparent flint type.

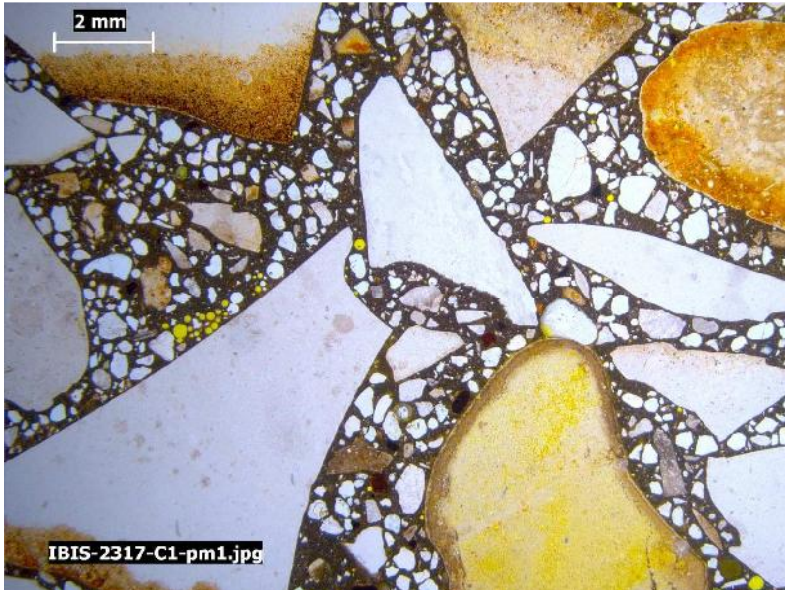
**Photomicrograph 2**

Typical view of the concrete constituents with variably brown chert coarse and fine aggregate particles amongst much finer clear quartz and quartzite fine aggregate particles. The particles appeared to be packed together very well.

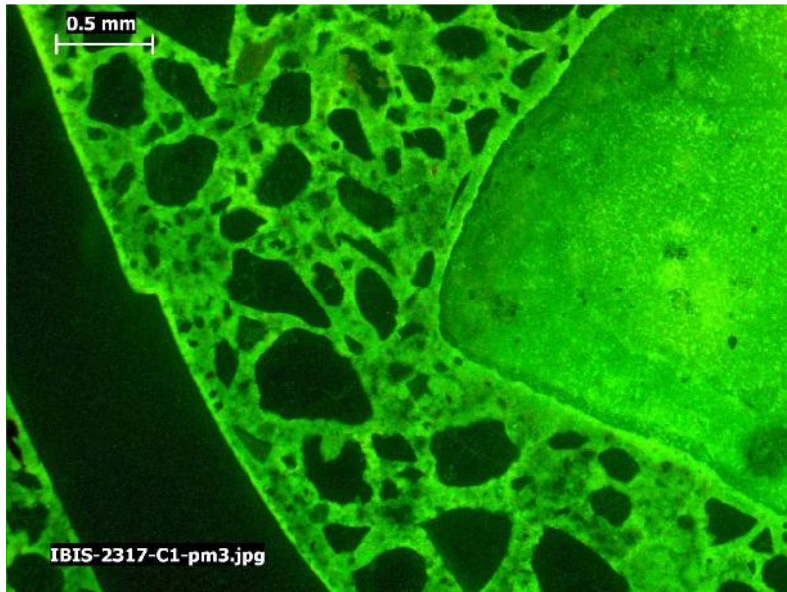
**Photomicrograph 4**

Typical view of the concrete matrix and the apparent microporosity that was exhibited due to the carbonation effects.

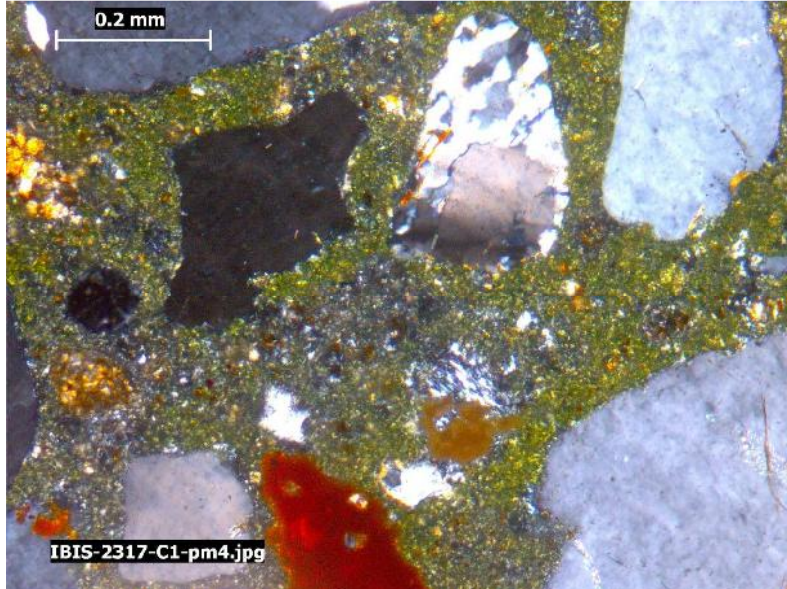
**Photomicrograph 5**

Typical view of the carbonation effects at the deepest part of the sample, which were not complete but which resulted in a lack of portlandite.

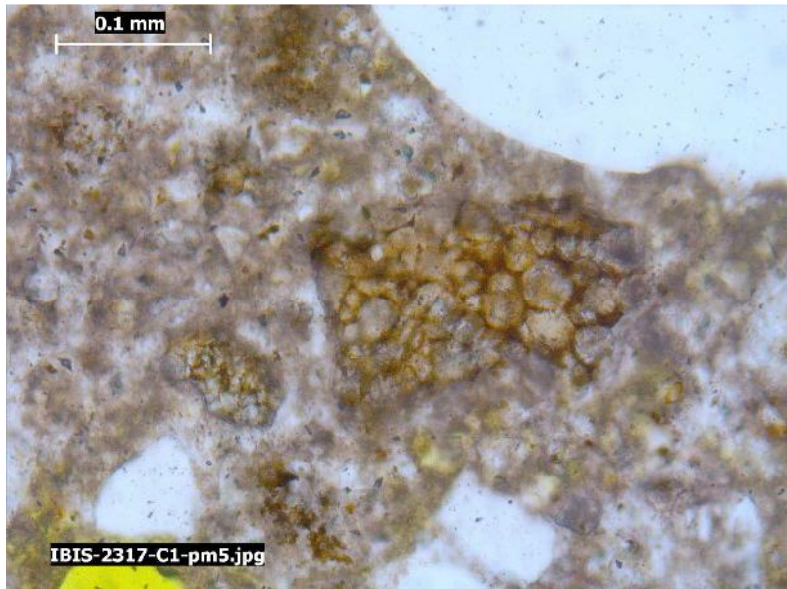
**Photomicrograph 6**

Some of the typical Ordinary Portland type cement grains that were present throughout the sample, a particularly large grain being visible at the centre.

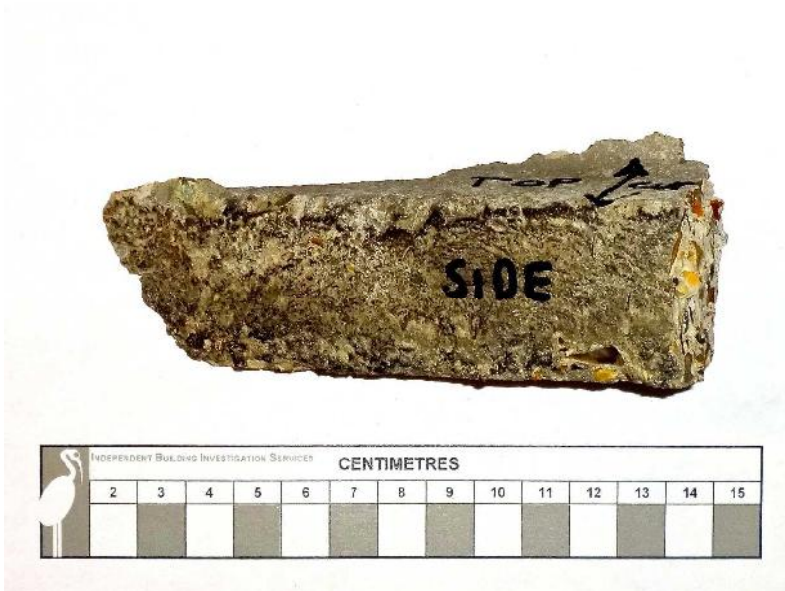
**Photograph 1**

General view of the as-received concrete sample, which exhibited top, side and soffit surfaces. The top surface has been oriented to the top in this view.

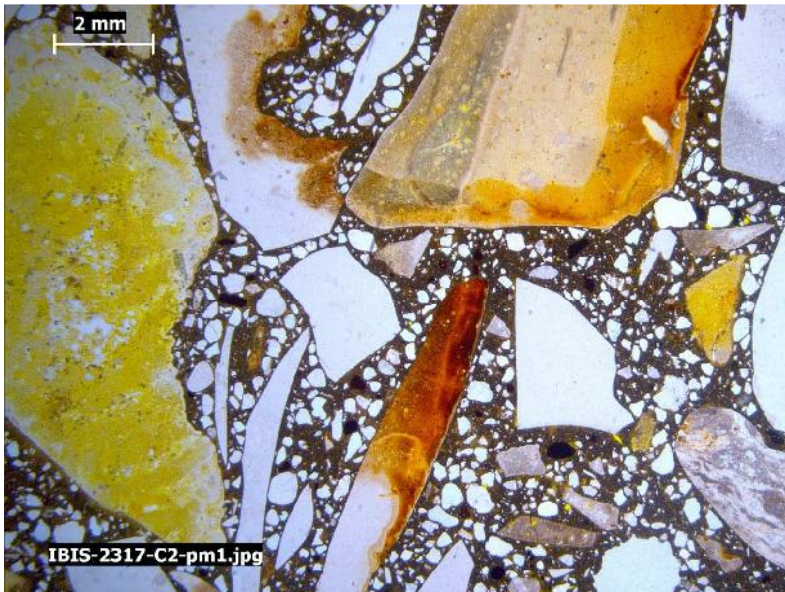
**Photomicrograph 2**

Typical view of the concrete constituents with variably brown chert coarse and fine aggregate particles amongst much finer clear quartz and quartzite fine aggregate particles. The particles appeared to be packed together very well. The yellow particle to the left is also chert and is highly microporous.

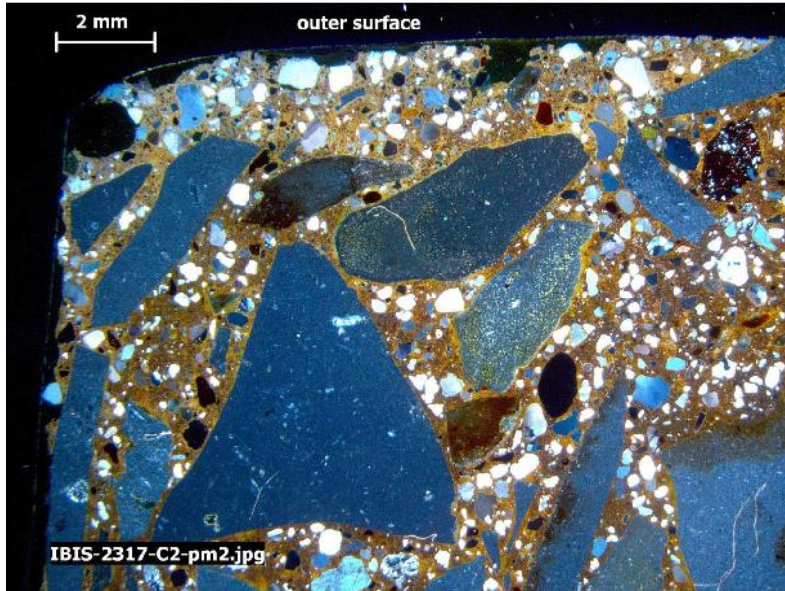
**Photomicrograph 3**

<b>Carbonation*</b> <i>(incl. depths, variations and relation to surface cracking)</i>	<p>Carbonation was present throughout the sample received and thus present to a depth of at least 37 mm.</p> <p>Patchy carbonation effects were visible at a depth of 32 mm.</p>
<b>Portlandite</b> <i>(incl. size, shape, abundance and distribution of crystallites)</i>	<p>Portlandite not observed within the sample, which was likely a consequence of the extensive and essentially complete carbonation effects.</p>
<b>Other Concrete Details</b> <i>(incl. applied finishes, inclusions and impurities)</i>	<p>None observed.</p>
<b>Reinforcement</b> <i>(incl. types, sizes, depths, orientations, evidence of corrosion)</i>	<p>None present in the sample.</p>
<b>Evidence of Cracking</b> <i>(incl. crack styles, abundance and relation to other features)</i>	<p>Sporadic microcracking of the cement matrix apparent, this exploiting aggregate particle boundaries.</p>

The outer surface is indicated to the top and is also present to the left in this view. The matrix is completely carbonated, it having lightened in colour from the change in crystallinity.

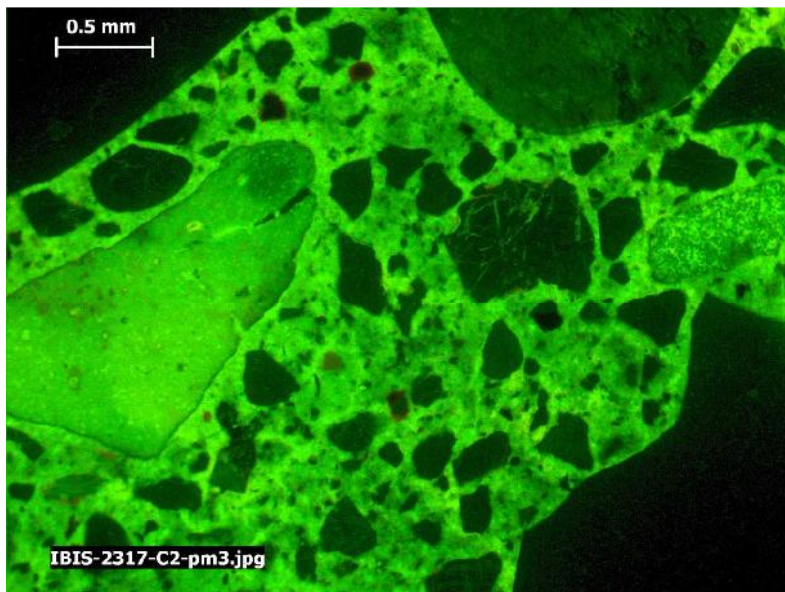
**Photomicrograph 4**

Typical view of the concrete matrix and the apparent microporosity that was exhibited due to the carbonation effects.

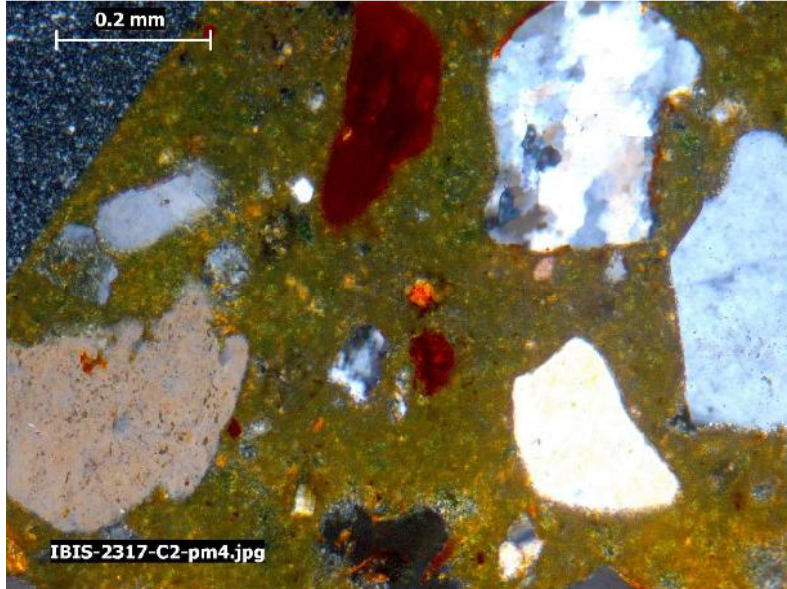
**Photomicrograph 5**

Typical view of the carbonation effects at the deepest part of the sample, which were not complete but which resulted in a lack of portlandite.

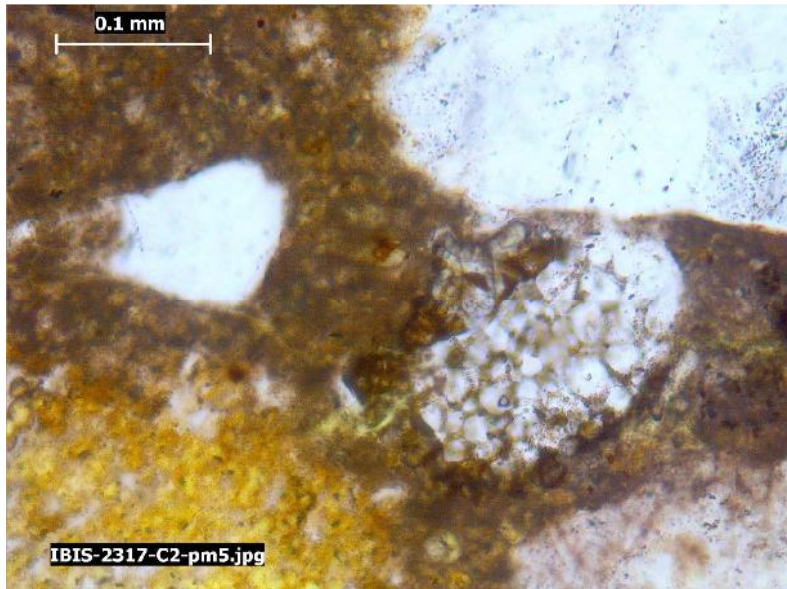
**Photomicrograph 6**

Some of the typical Ordinary Portland type cement grains that were present throughout the sample, a particularly large grain being visible below right of centre.

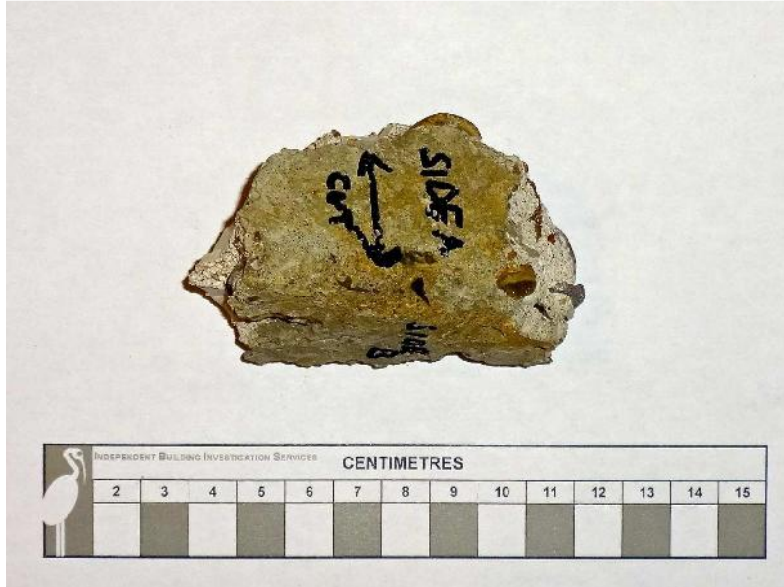
**Photograph 1**

General view of the as-received concrete sample with "Side A" of the apparent outer surface shown and "Side B" to the bottom.

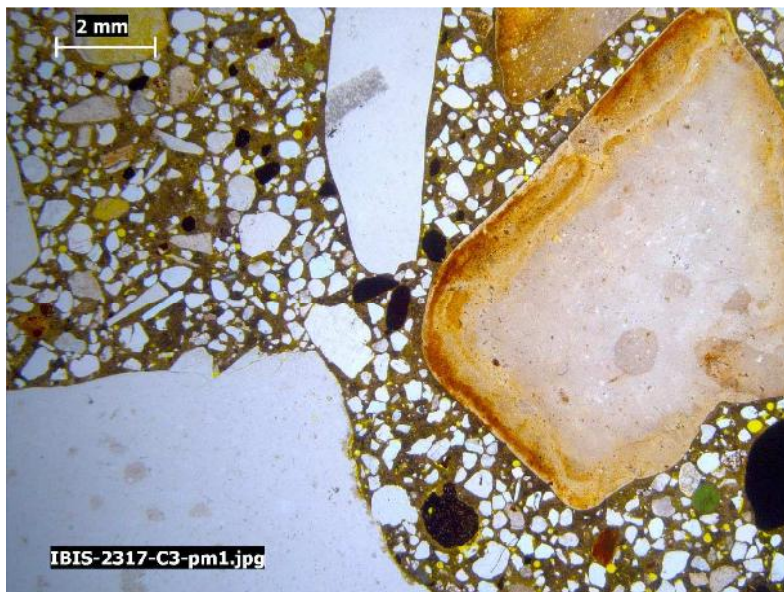
**Photomicrograph 2**

Typical view of the concrete constituents with variably brown chert coarse and fine aggregate particles amongst much finer clear quartz and quartzite fine aggregate particles. The particles appeared to be packed together very well.

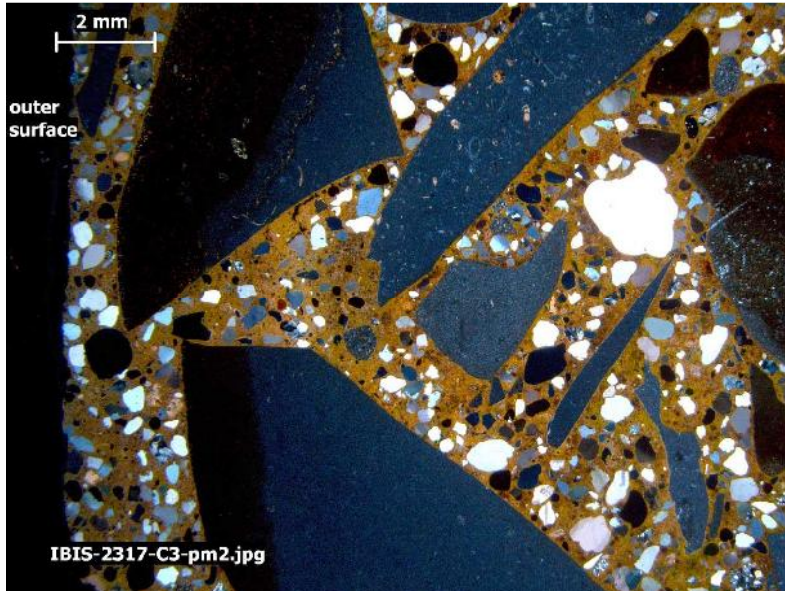
**Photomicrograph 3**

The outer surface is indicated to the left in this view and the matrix is completely carbonated, the matrix having lightened in colour from the change in crystallinity.

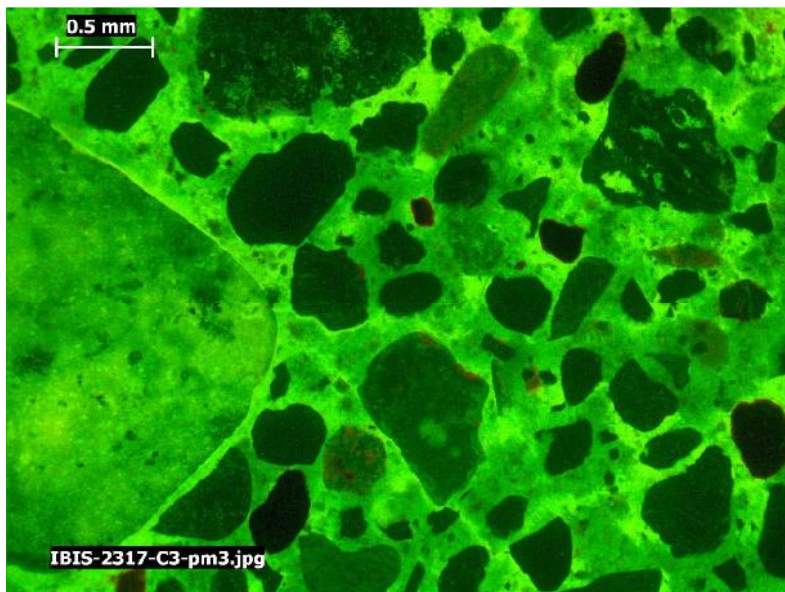
**Photomicrograph 4**

Typical view of the concrete matrix and the apparent microporosity that was exhibited due to the carbonation effects.

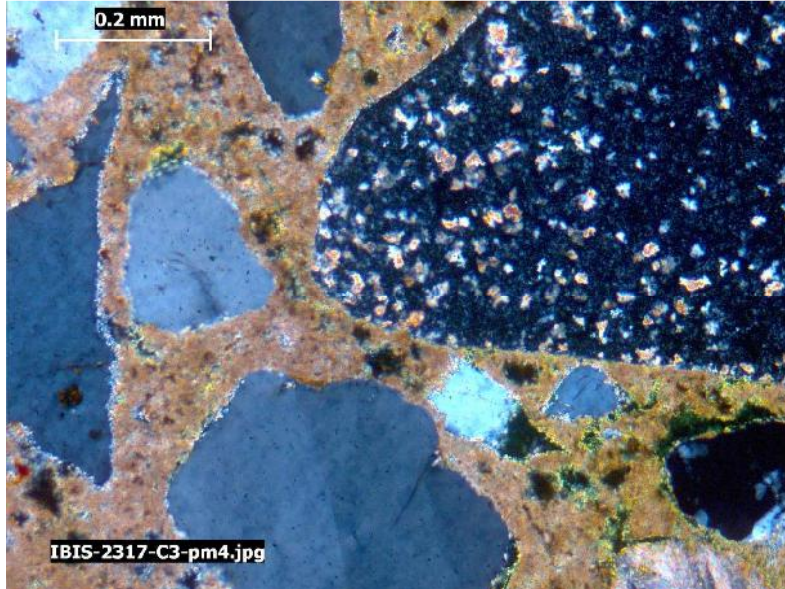
**Photomicrograph 5**

Typical view of the carbonation effects at the deepest part of the sample, which resulted in a lack of portlandite. Some carbonate has grown within a porous chert particle to the top right.

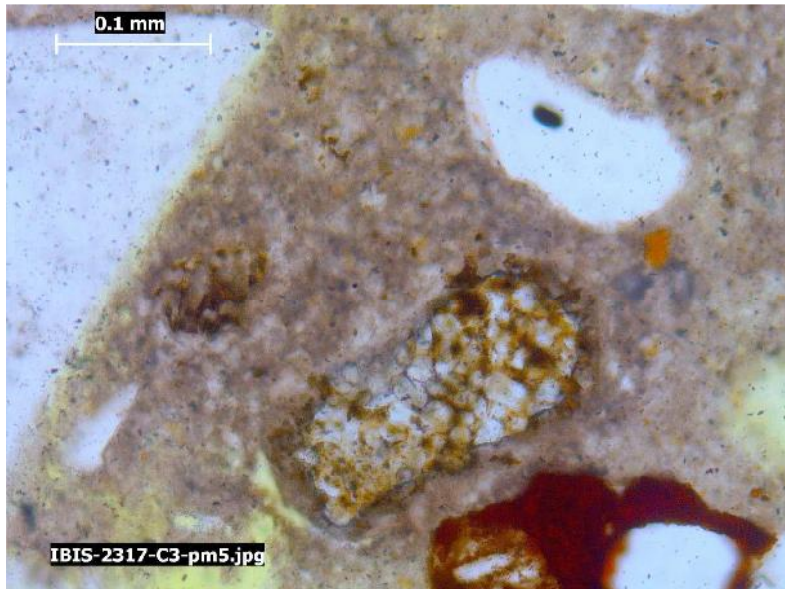
**Photomicrograph 6**

Some of the typical Ordinary Portland type cement grains that were present throughout the sample, a particularly large grain being visible below centre.

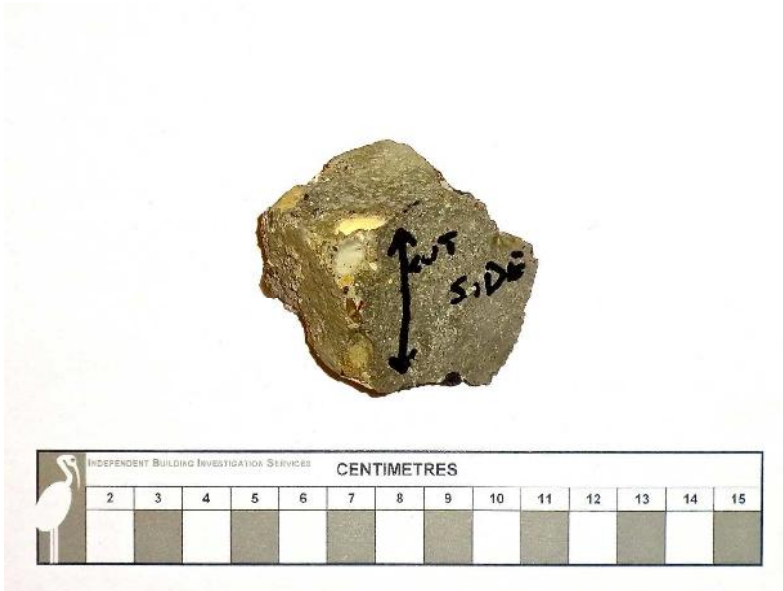
**Photograph 1**

General view of the as-received concrete sample with the outer surface indicated by "NT Side". The sample appeared to have been taken from the corner of a feature so that three surfaces were represented.

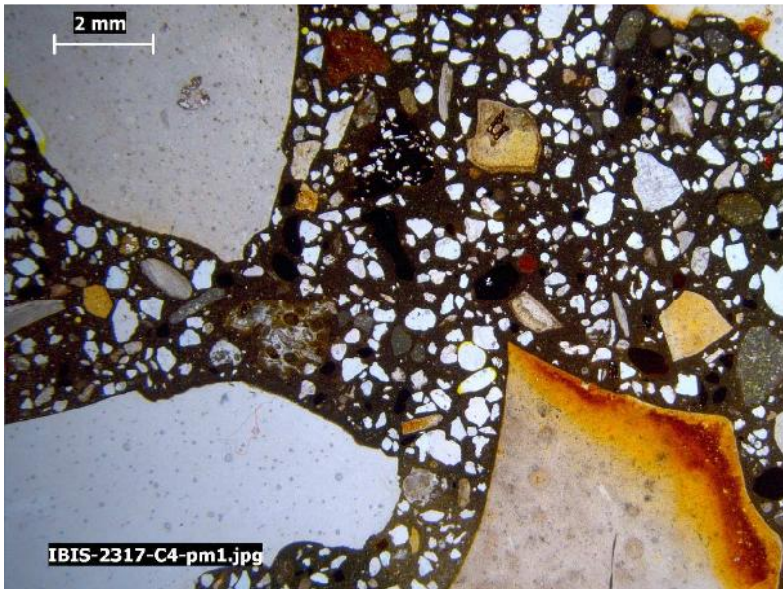
**Photomicrograph 2**

Typical view of the concrete constituents with variably brown chert coarse and fine aggregate particles amongst much finer clear quartz and quartzite fine aggregate particles. The particles appeared to be packed together very well.

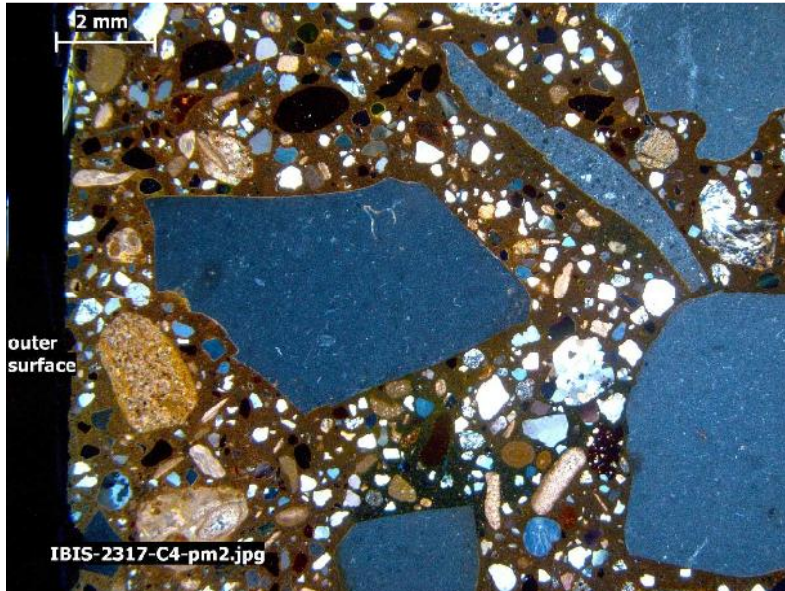
**Photomicrograph 3**

The outer surface is indicated to the left in this view and the matrix is completely carbonated, the matrix having lightened in colour from the change in crystallinity.

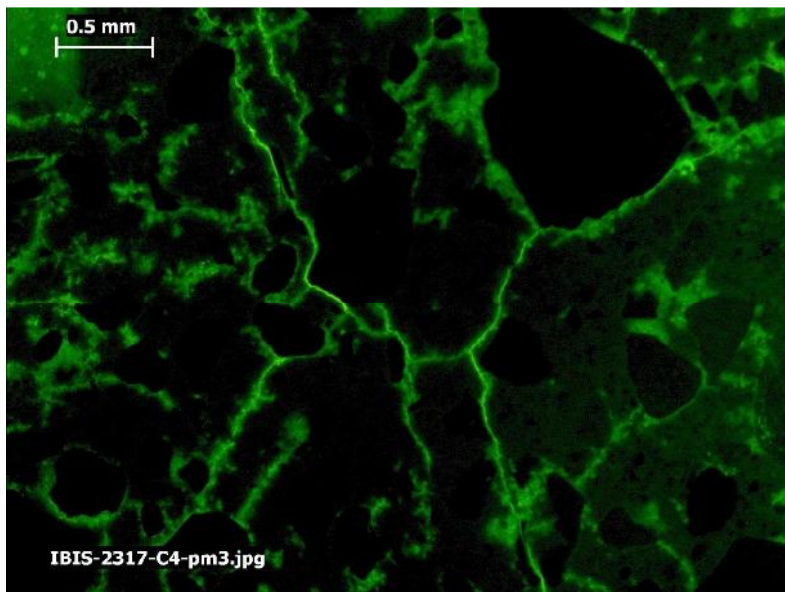
**Photomicrograph 4**

Typical view of the concrete matrix, which was not correctly impregnated but revealed a number of microcracks. The microcracks extended throughout the concrete forming a network.

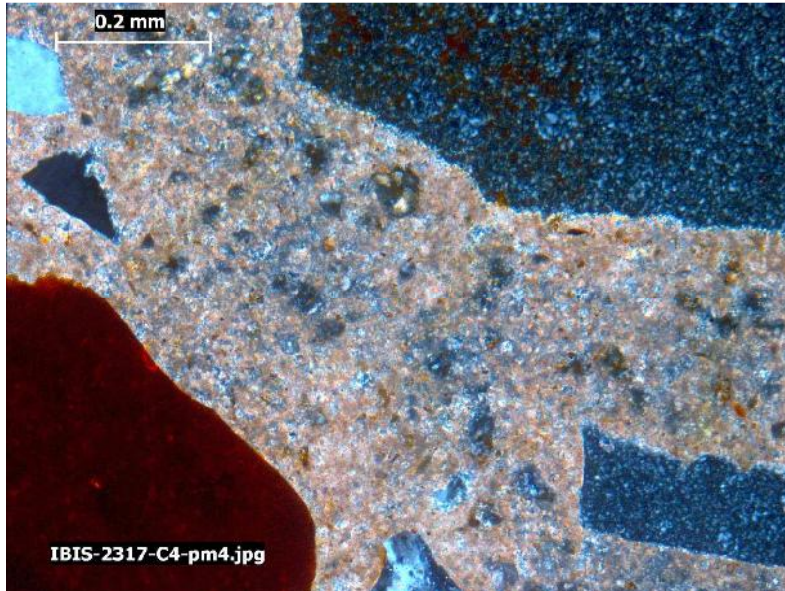
**Photomicrograph 5**

Typical view of the carbonation effects at the deepest part of the sample, which resulted in a lack of portlandite.

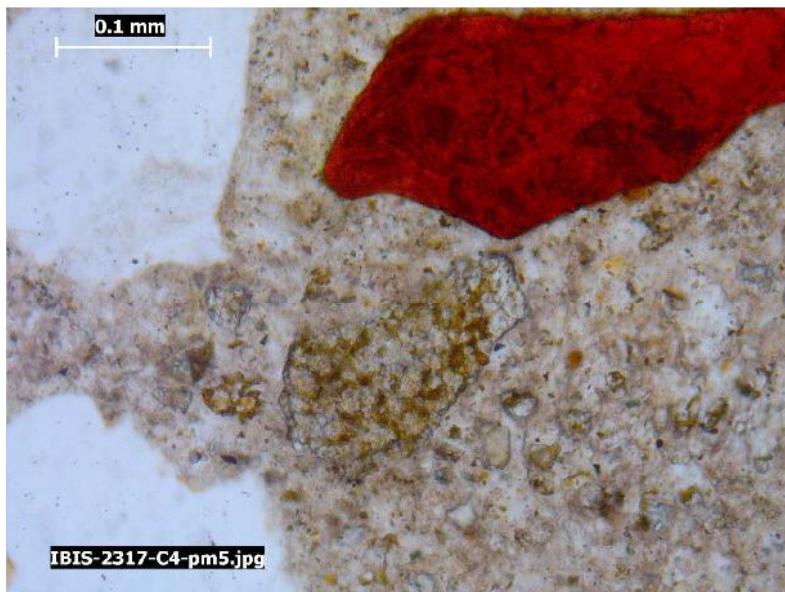
**Photomicrograph 6**

Some of the typical Ordinary Portland type cement grains that were present throughout the sample, a particularly large grain being present at the centre.
