Asbestos Reinspection Report (with Priority Assessments)

**St Mark's Primary School
St Mark's Road
Mitcham
Surrey
CR4 2LF**

**Project Number: B-90577
Issue Date: 22ND April 2020
Issue No: 1**

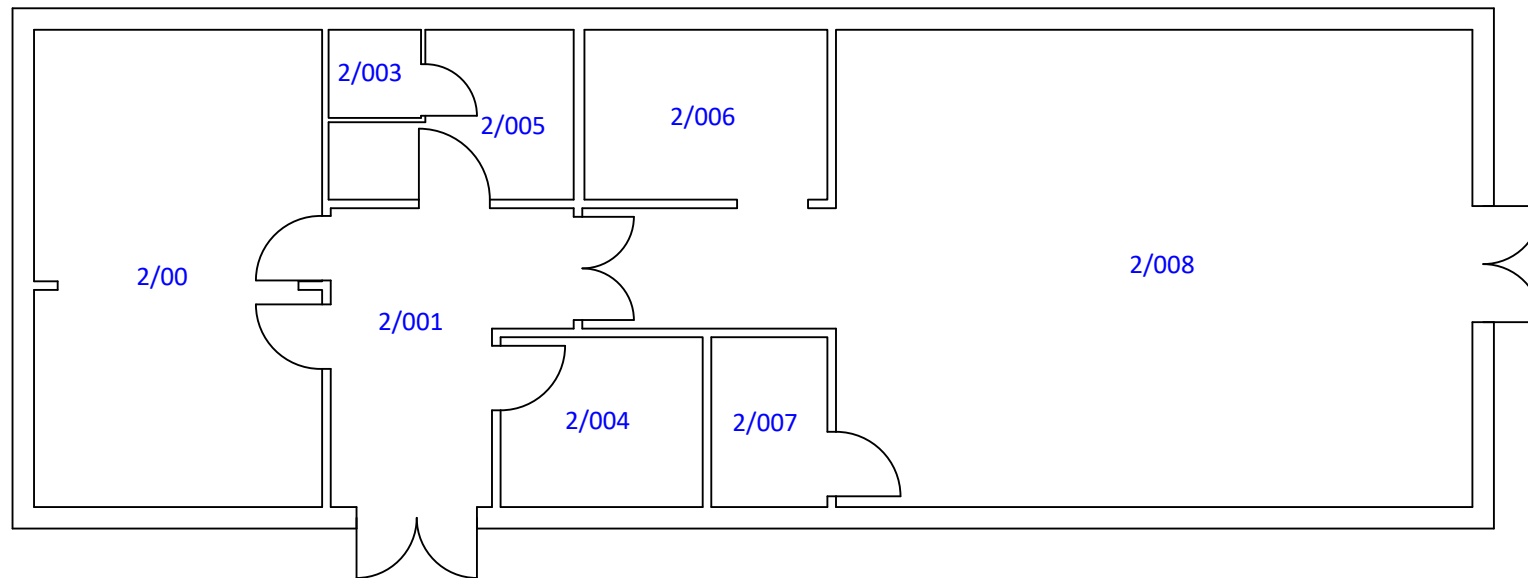
Chidrens Centre Ground Floor Plan

SURVEY PLAN - Standard

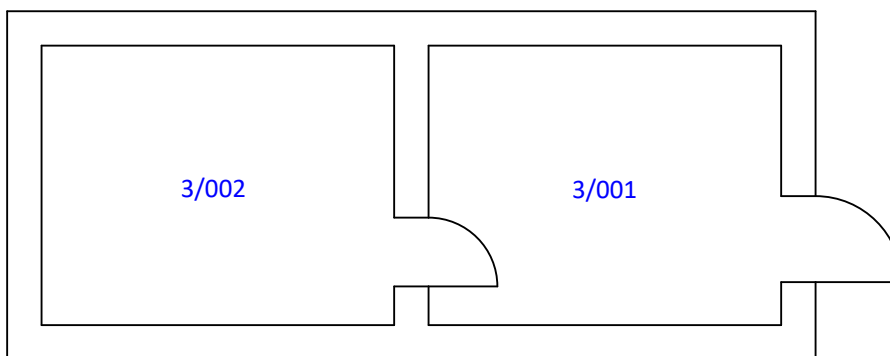
**Parent Building
 Ground Floor Plan**

- Cross Referenced Sample - No Asbestos Detected
